San Felipe Creek Restoration Project Mitigation Monitoring Annual Report Year 2 – 2020

Santa Clara Valley Habitat Agency

DUDEK

DECEMBER 2020

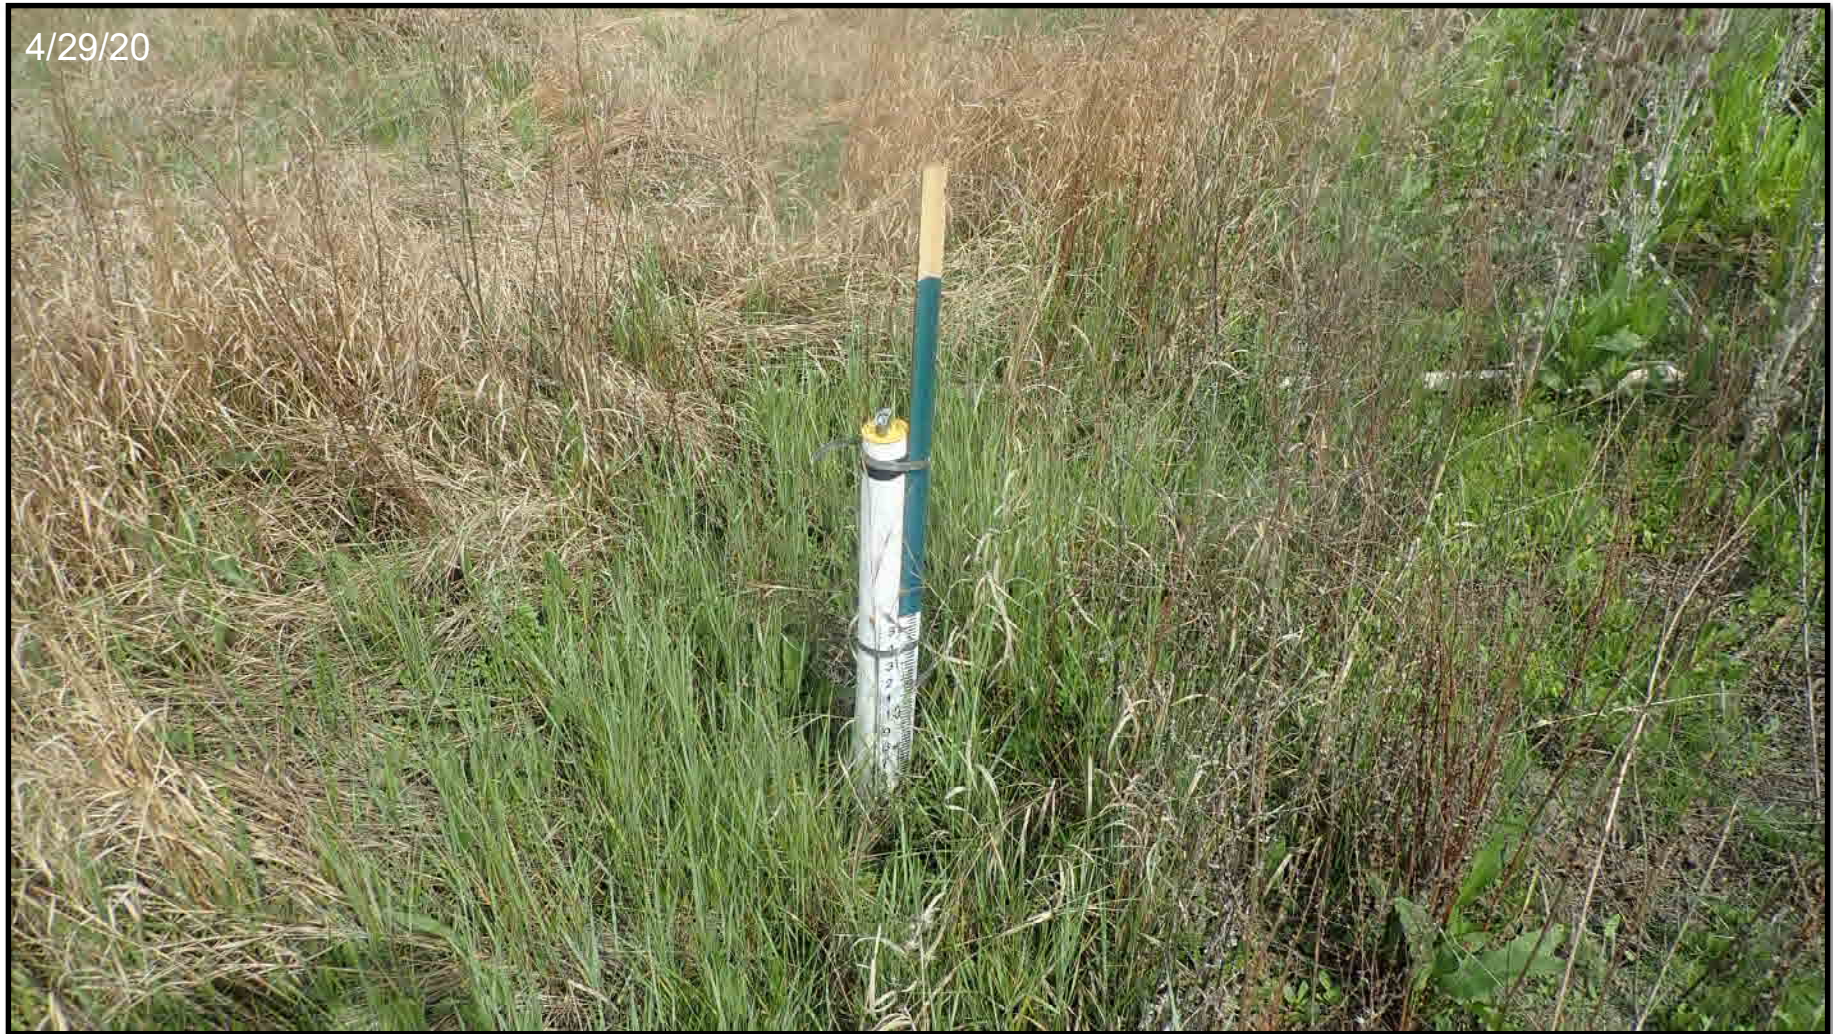
Figure 12. Seasonal wetland water level gage CTSW, seasonal wetland SW03, April 29, 2020, San Felipe Creek Restoration Project, Joseph D. Grant Park, Santa Clara County, California. Staff observed moist/saturated soils (visible in the foreground) on this day.

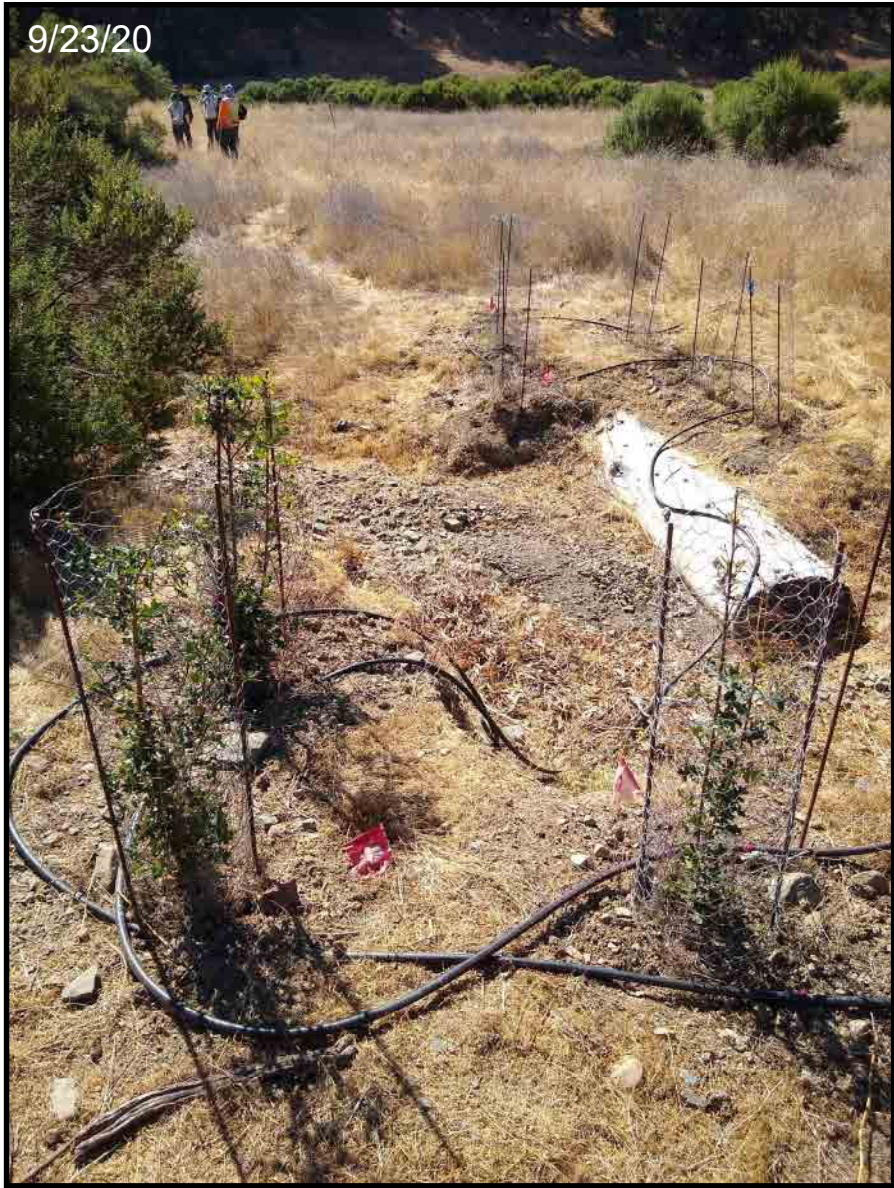
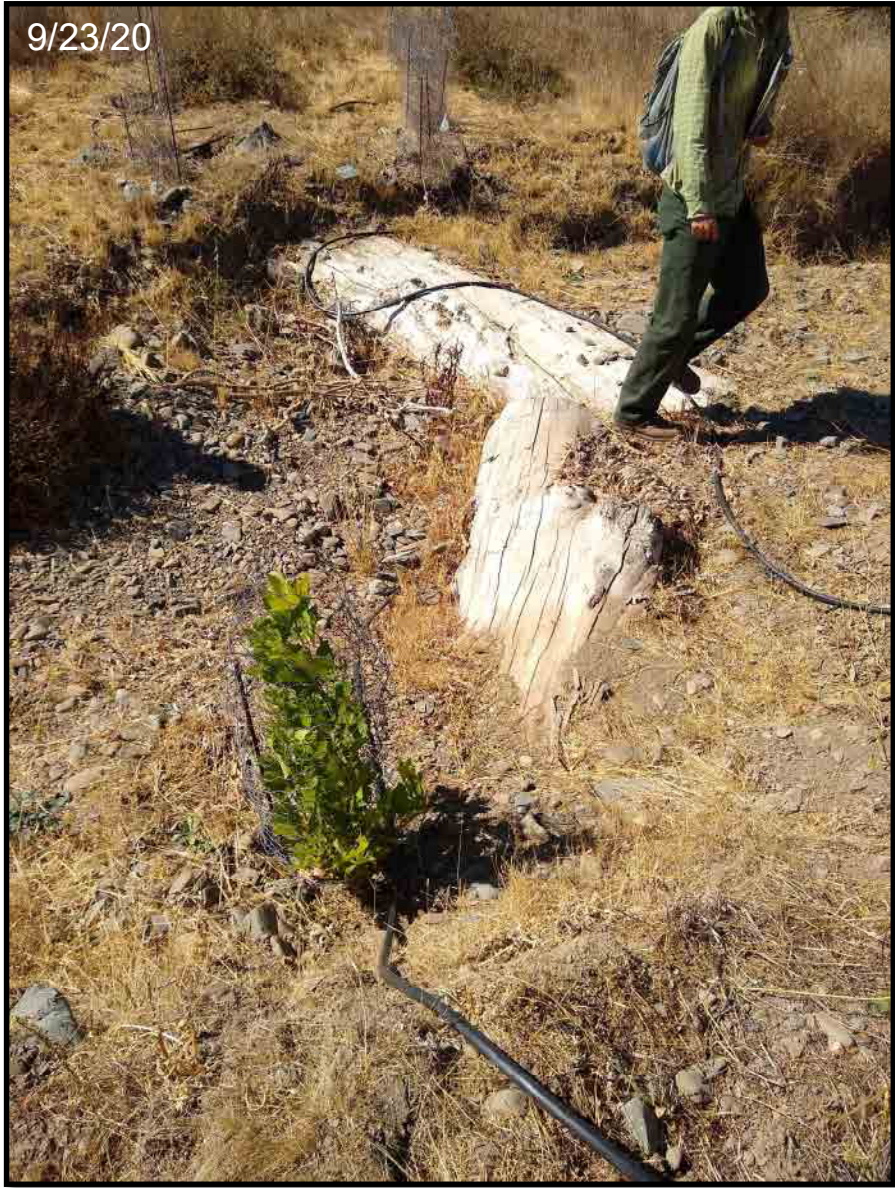
Figure 13. Plantings at living log jams, September 23, 2020, San Felipe Creek Restoration Project, Joseph D. Grant Park, Santa Clara County, California.

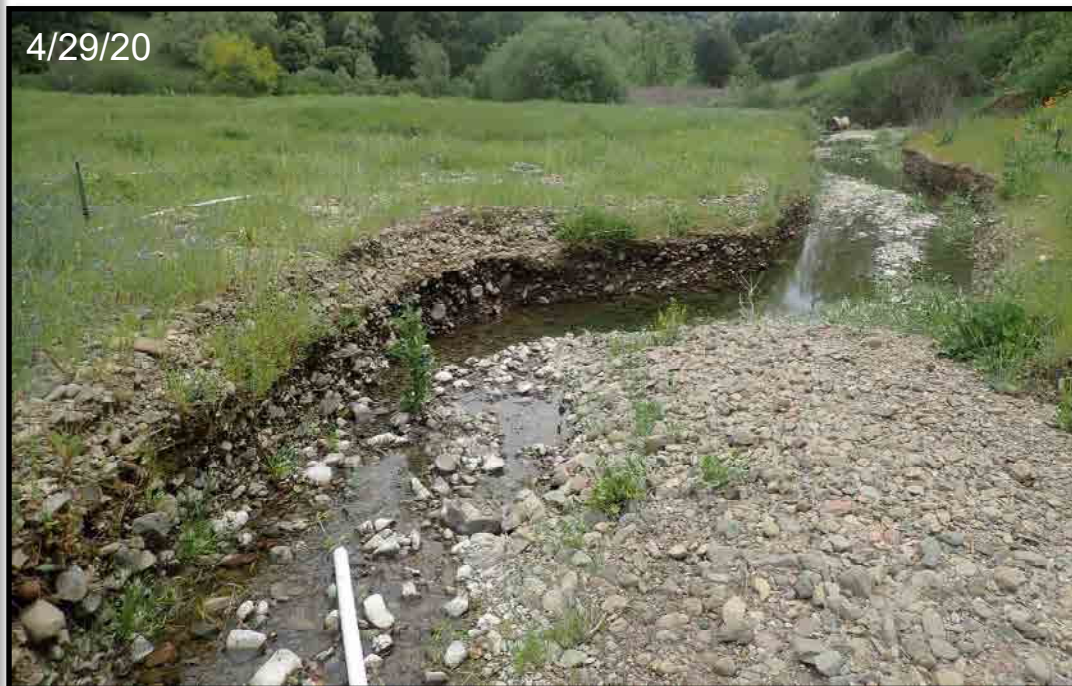
Figure 14. Comparison of San Felipe Creek at created floodplain ID03-02 between Year-1 and Year-2, looking downstream, San Felipe Creek Restoration Project, Joseph D. Grant Park, Santa Clara County, California.

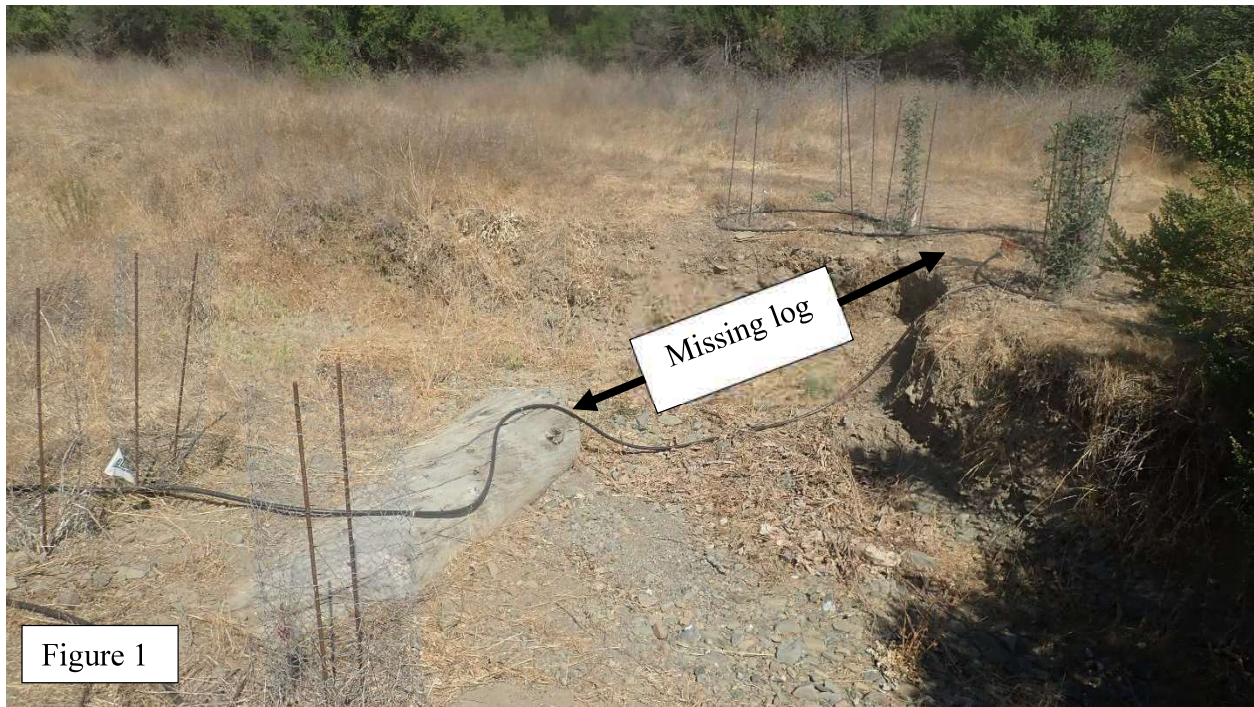
2. ID03-02

The Team seeks to offset the risk of the new channel evolving to become a dominant and/or incised single thread channel. Geomorphically, we observe the reach to be a depositional reach that is sequestering large volumes of sediment in extreme events and then slowly metering it out in subsequent years to maintain sediment transport continuity. The straight nature of the current primary channel, however, may have been induced by a lack of established vegetation during the wetter-than-normal conditions and high flows experienced during Water Year 2019, the first year after construction of the project. In addition, an irrigation pipe may have exacerbated the condition by wracking debris, slowing flow and encouraging deposition in the former channel alignment. The irrigation pipe has already been relocated; however, it may need to be moved again as part of the adaptive measures described below.

The engineer's representative should be on-site to direct log selection and placement. There are a number of logs on site from which the appropriate one should be selected and installed. We may utilize the log that was dislodged; however we may also select a log with some root-mass or branching, which may better achieve the desired function. The log should be placed longitudinally, embedded halfway into the bed and bank, roughly parallel to the bank and direction of flow, and backfilled with a well-graded sand, gravel, and cobble mixture to match the grade adjacent to the oaks. We recommend this material be sourced from ID03-02 (see below).
