# ANNUAL RESTORATION MONITORING REPORT

## YEAR 4

SAN FELIPE CREEK RESTORATION PROJECT  
SANTA CLARA VALLEY HABITAT AGENCY

**JANUARY 2023**

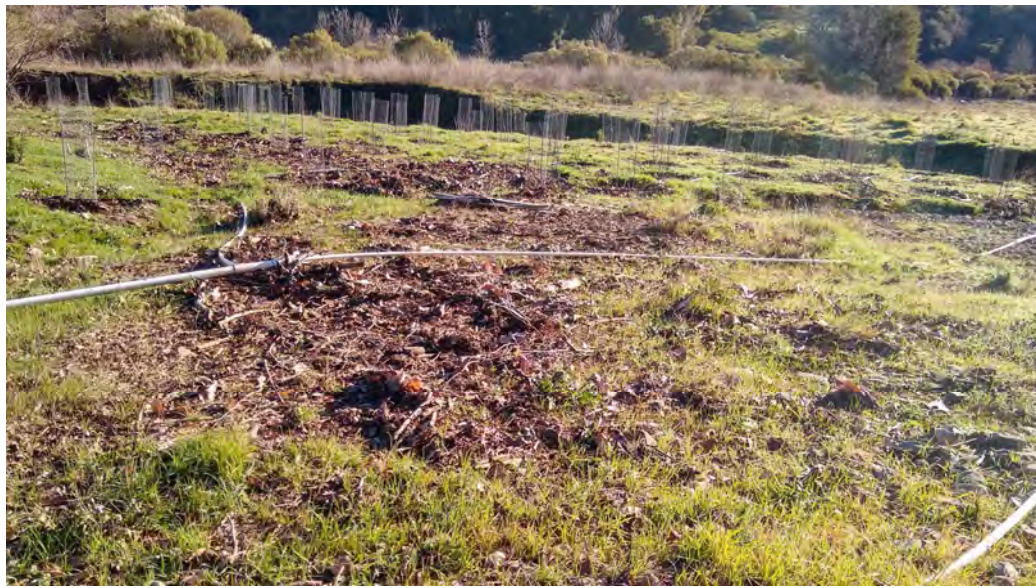
ID03-02: 1/25/2022  
Debris on the floodplain surface of ID03-02 suggests flood flows engaged the floodplain during WY2022.

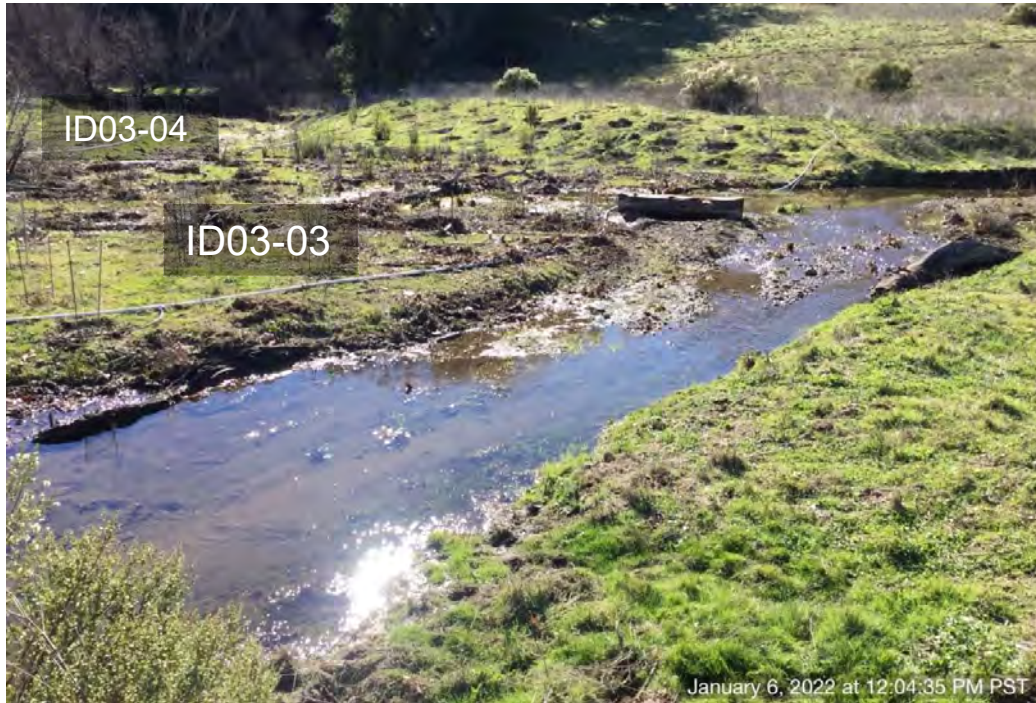
ID03-03/04: 1/6/2022  
Flows spreading across the floodplain at ID03-03 and ID03-04 (background). Flood flows engaged the floodplains during WY2022. San Felipe Creek enters from the right of frame.

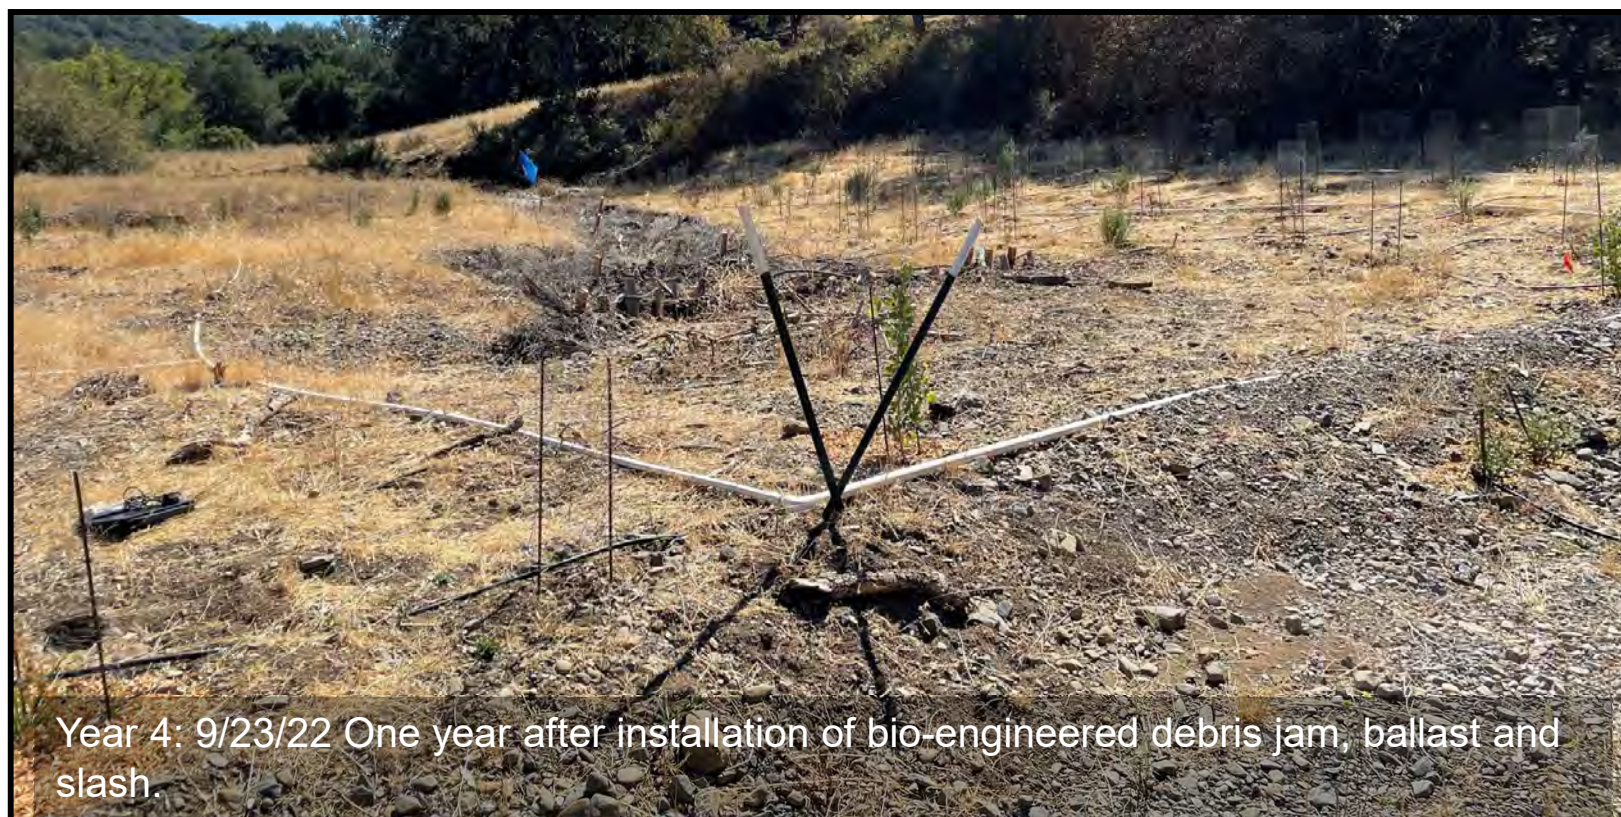
Year 4: 9/23/22 One year after installation of bio-engineered debris jam, ballast and slash.

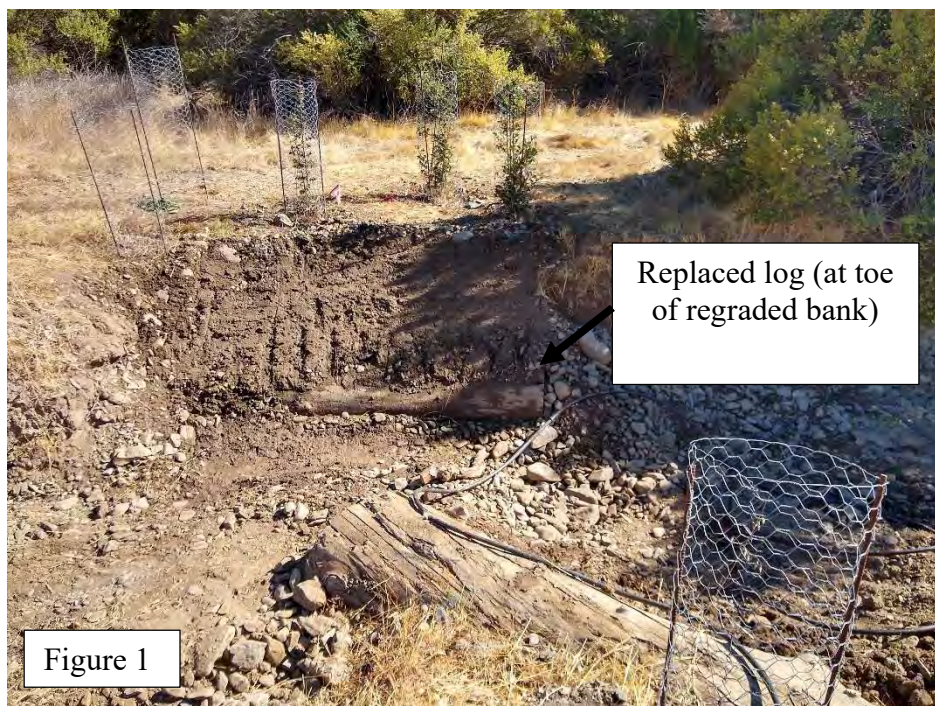
On November 4, 2020, HRS worked under Balance’s field direction and in accordance with the adaptive management plan to replace the dislodged log. The log placement was reconfigured with the aim of protecting oak seedlings that had established on the left bank. Figure 1 shows the living log jam after the repair.
