# ANNUAL RESTORATION MONITORING REPORT

## YEAR 6

SAN FELIPE CREEK RESTORATION PROJECT  
SANTA CLARA VALLEY HABITAT AGENCY

**FEBRUARY 10, 2025**

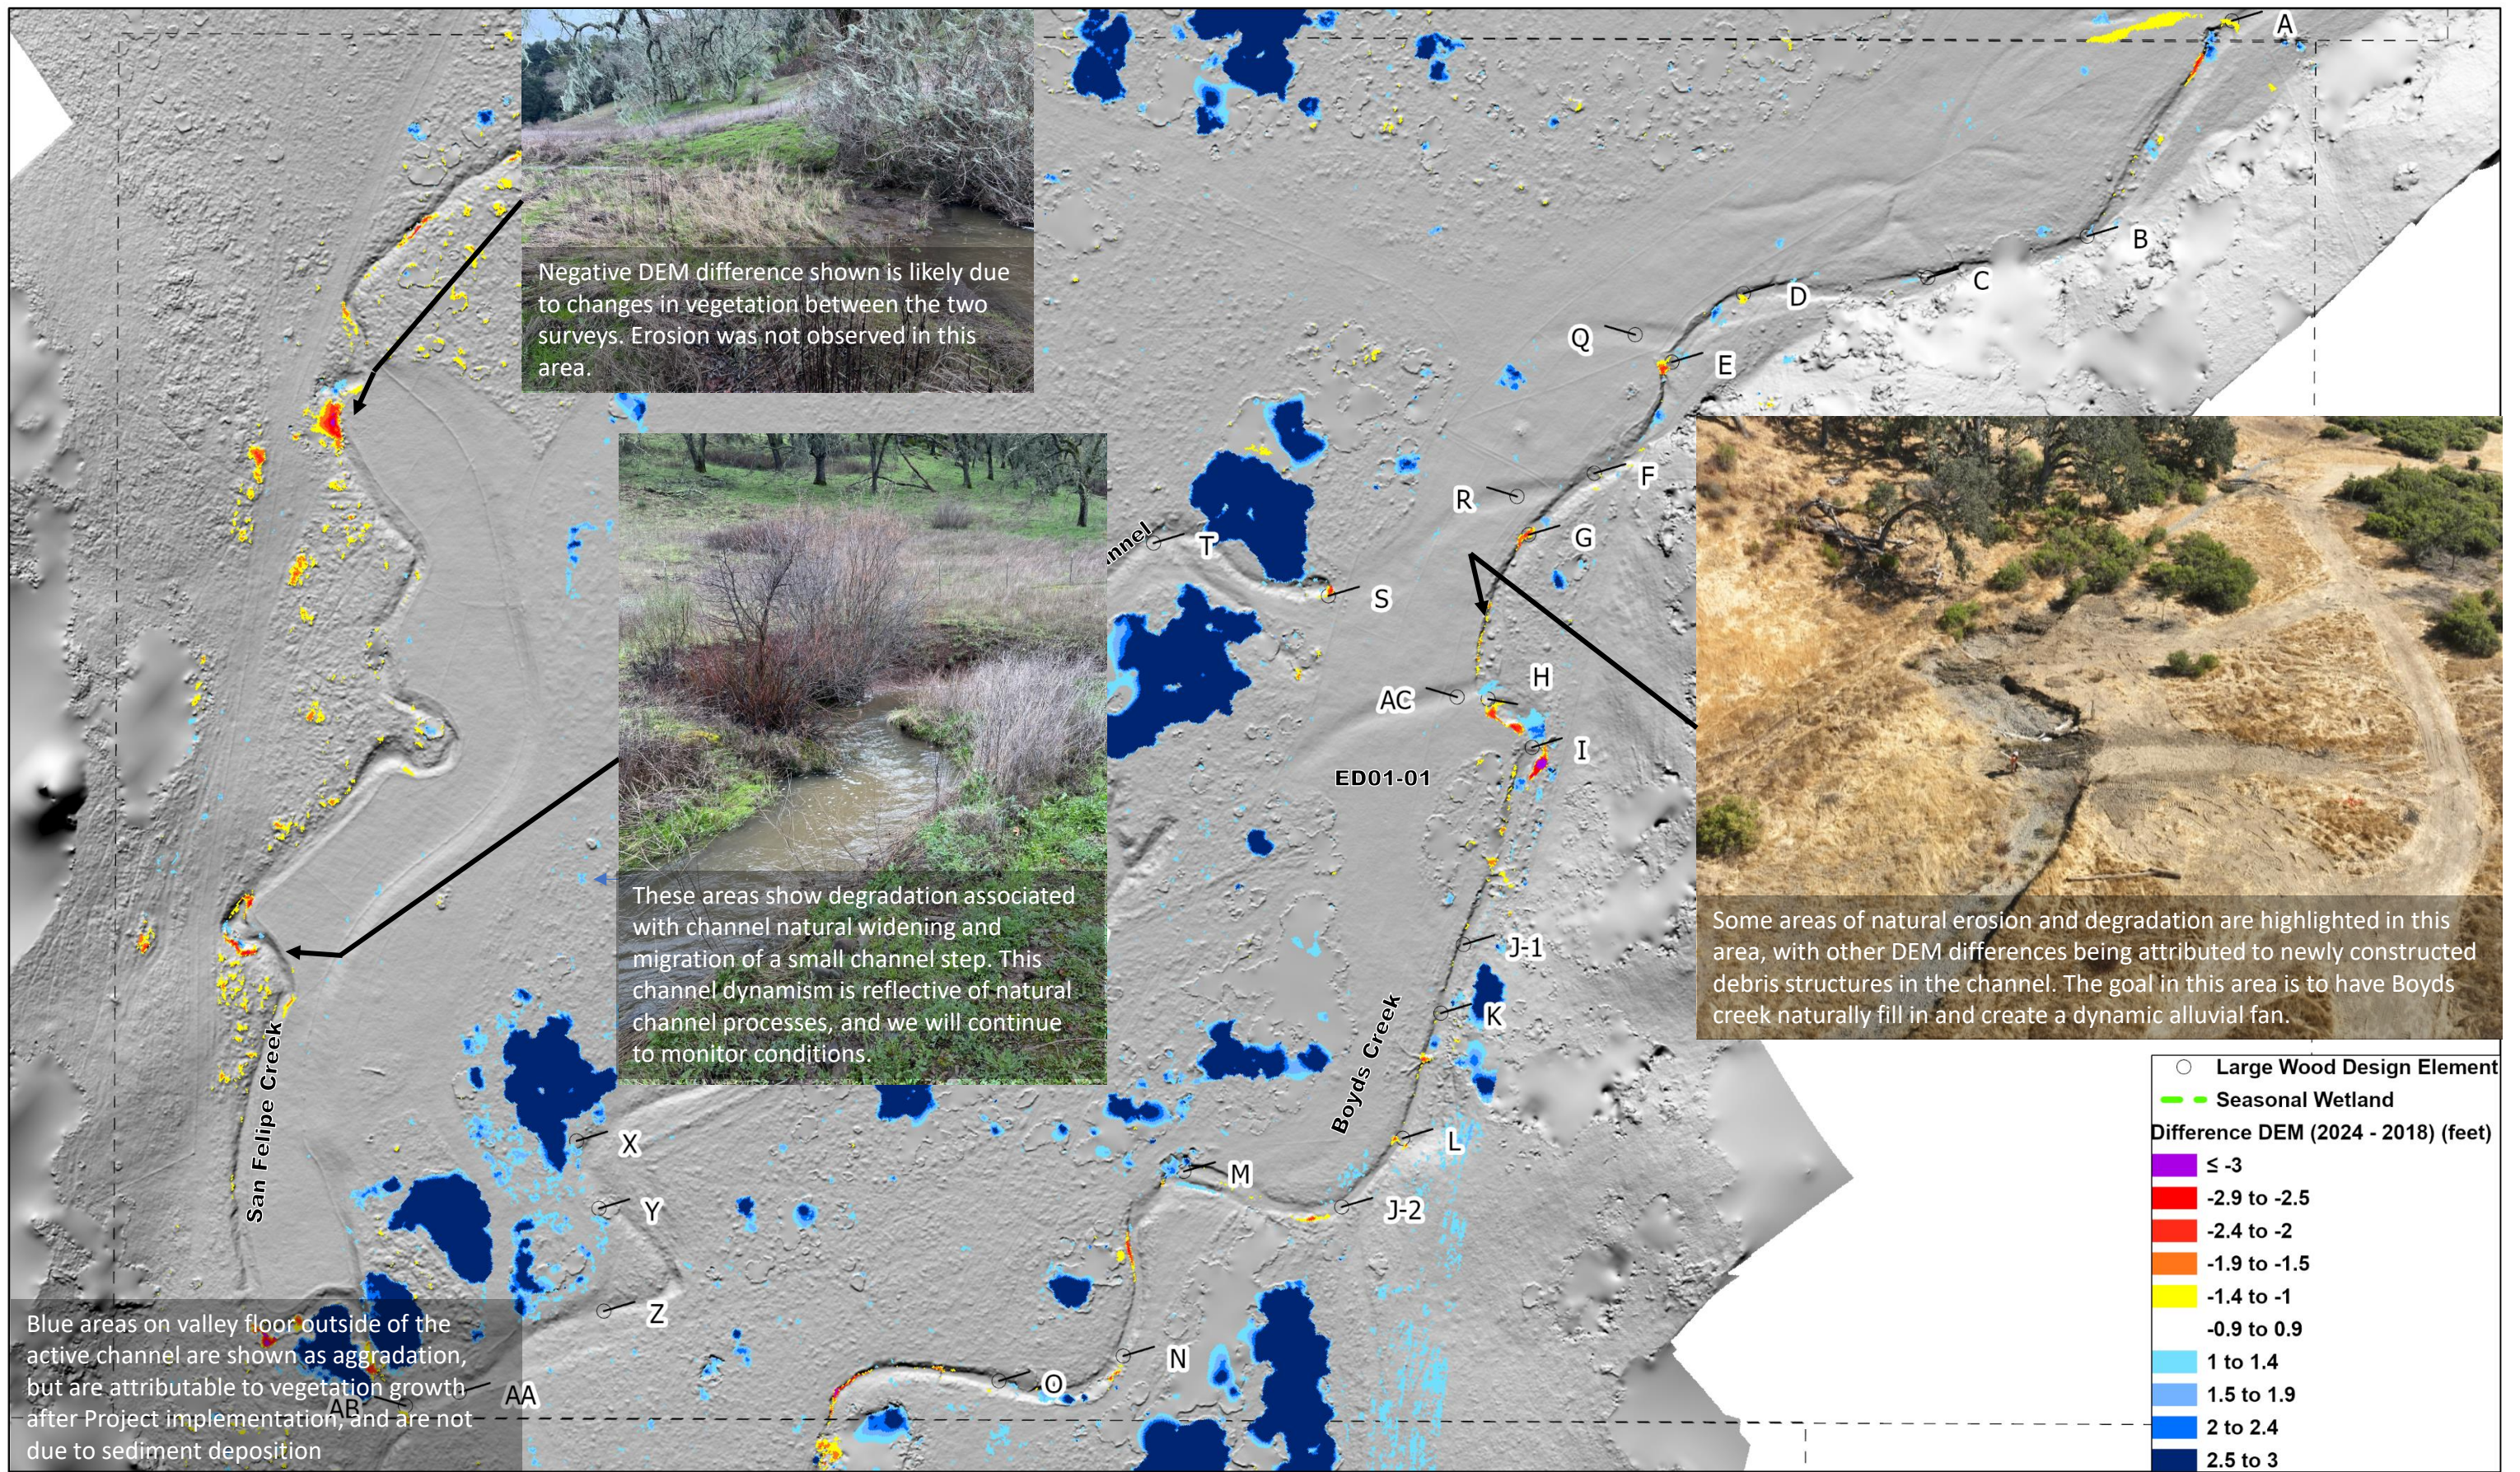
**Figure 14b.** 2024 and 2018 DEM comparison, San Felipe Creek Restoration, Joseph D. Grant Park, Santa Clara County, California

Blue areas on valley floor outside of the active channel are shown as aggradation, but are attributable to vegetation growth after Project implementation, and are not due to sediment deposition

Most of the aggradation and degradation shown in San Felipe Creek in this reach occurred in 2023. Dynamism within this reach is reflective of natural channel processes and is desired. It does not threaten the function of the project.

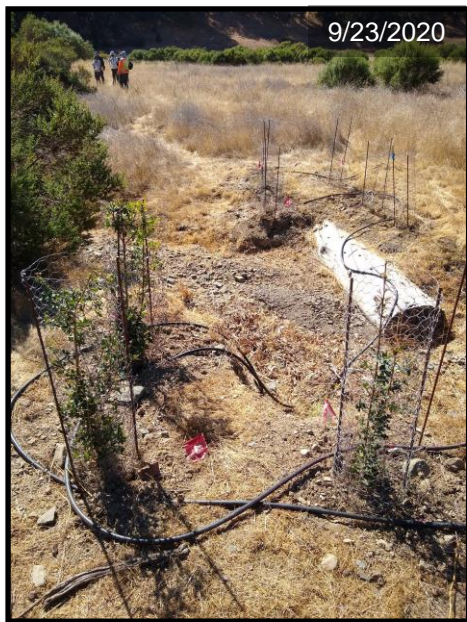
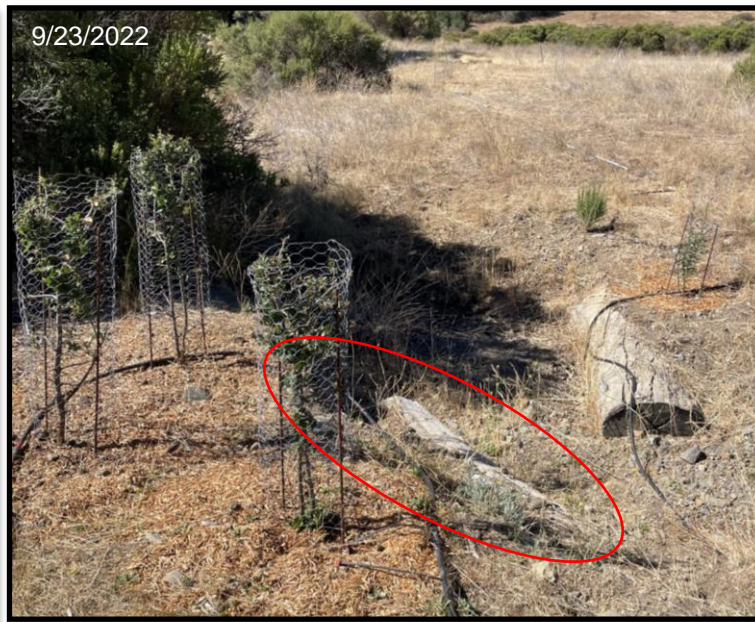
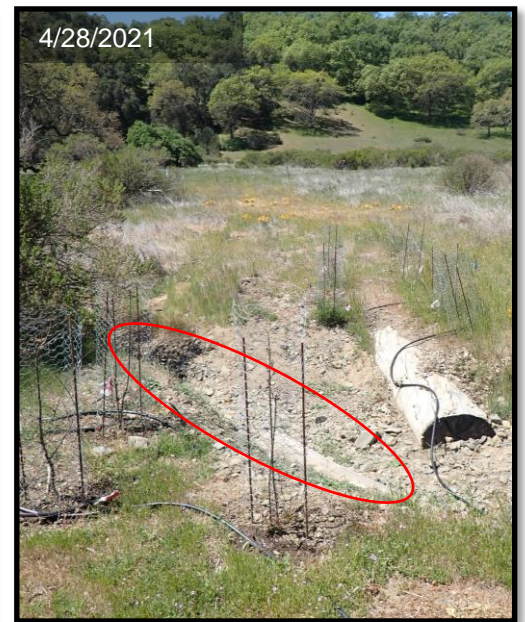
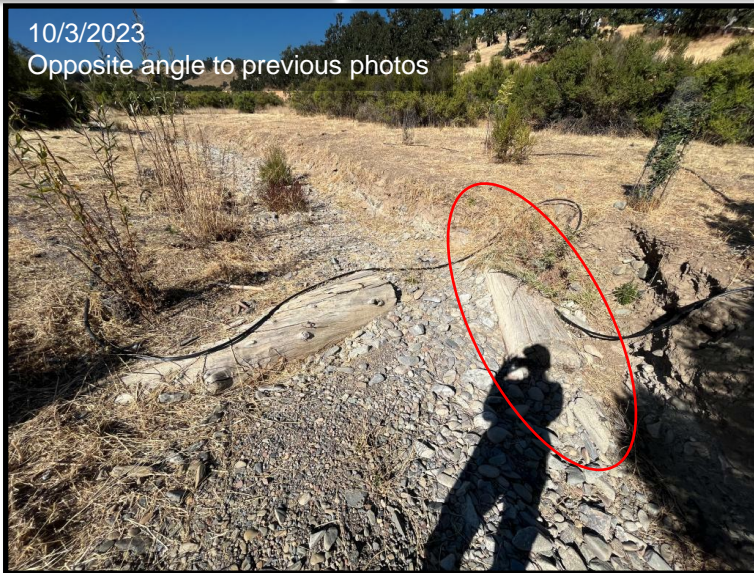
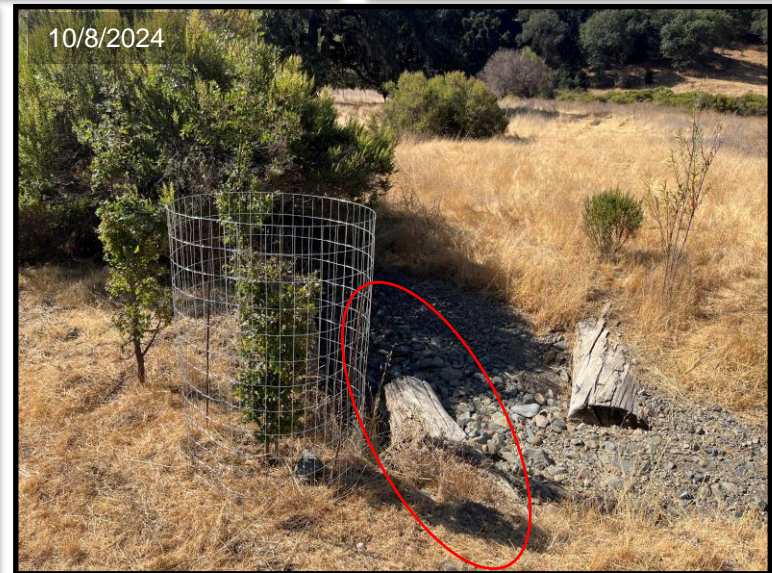
Figure 16. Plantings at living log jams, September 23, 2020 (top left), April 28, 2021, September 23, 2022, October 3, 2023, and October 8, 2024. Year 6 San Felipe Creek Restoration Project, Joseph D. Grant Park, Santa Clara County, California. See replaced log in red oval in 2021-2024 photos

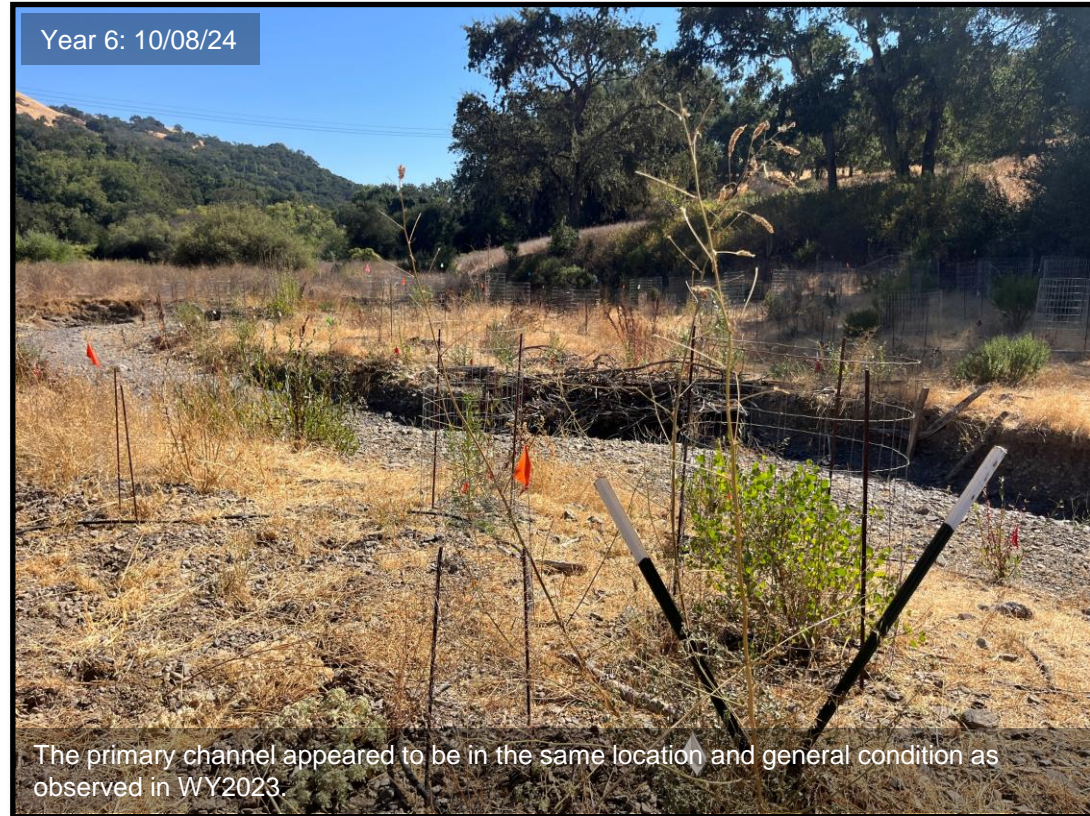
The primary channel appeared to be in the same location and general condition as observed in WY2023
