Coyote Ridge Ponds Restoration Project, Ponds CR1 and CR4 Year 6 Monitoring Report

December 5, 2025

From: Kelli Camara, Camara Environmental Consulting *in collaboration with* Biotic Resources Group and George McMenamin, &
Nathan Hale, Santa Clara Valley Habitat Agency

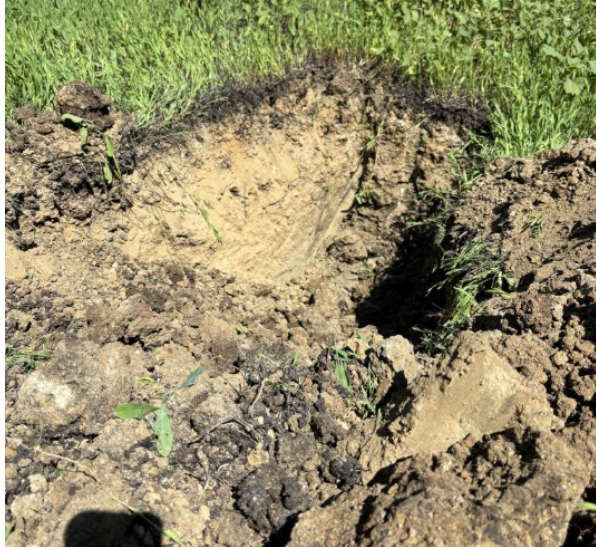
2a (5/29/2025)

Hale were also in attendance to consider and analyze soils and think through solutions. This investigation revealed spatial variability in soil conditions, with one portion of the pond (estimated to be representative of approximately 20% of the pond bottom) showing problematic soil conditions consisting of unconsolidated clays with poor structural integrity. Sandy texture was identified within portions of this subsurface area.

Figure 2. Photos of CR-1 1-day repair. Photo 2a shows poor quality clay pond soil in test excavation; 2b shows higher quality clay soil typical of remainder of pond area in test excavation; 2c shows excavated low quality soil area—after soils were dug out—being refilled with the higher quality clay; 2d shows excavator in process of compaction of pond bottom; 2e shows completed repair with fence reinstalled (and superfluous posts removed from pond); 2f shows ingress/egress with effective erosion control after rain events: native seed germinated, wattles, straw, and scattered branches functional, and no erosional rilling.

Therefore, the pond was determined to have a minor area (i.e., ~20% of the pond bottom) with inadequate soil and a large supply of adequate clays elsewhere in the pond to enable redistribution into the minor problem area. After evaluation of the pond infrastructure and a determination made by the project engineer that the pond bottom was the most likely issue, the new evidence of the inadequate soil area was presumed to be the leading culprit for poor hydrological function. And the limited poor soil area meant that an effort could be made to relocate native soil materials within the pond bottom without importing materials/soils from outside of the Coyote Ridge Reserve property (i.e., Máyyan 'Ooyákma Coyote Ridge). Therefore, an adaptive management plan was adopted to relocate the inadequate soils, replace them with high quality excess clay soils, compact the replaced soils, and redistribute the unconsolidated soils throughout the pond bottom surface.

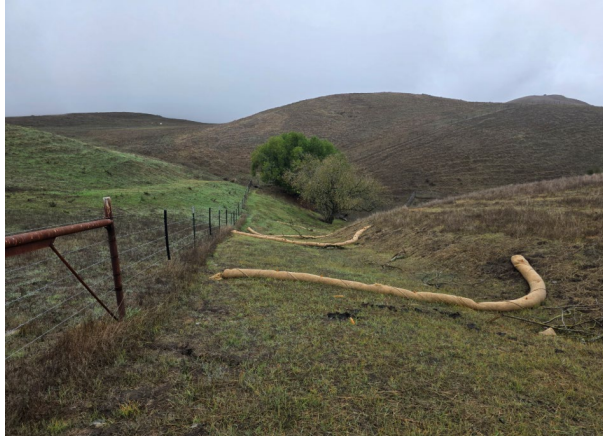
2f (11/19/2025)

A moderately heavy precipitation event occurred on October 13 & 14, 2025, after which the pond and temporary disturbance areas were visually inspected by Habitat Agency staff. No erosion was observed. Seed germination has since been observed throughout the temporary disturbance area. Photos of the pond inspection and repair can be furnished upon request.

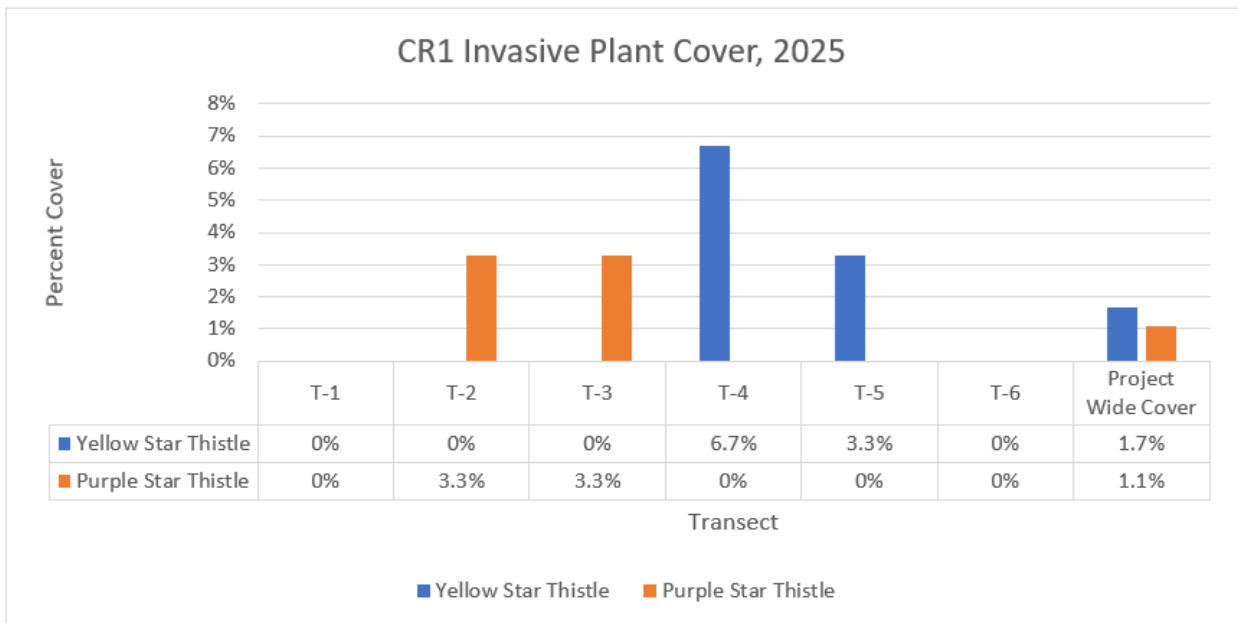
Figure 1. CR1 Invasive Plant Transects 2025

The 2025 observations at CR1 found cover by all invasive plant species to be 2.8%, which meets the performance standard of $\leq 5\%$ (Figure 1). Cover was provided by yellow star thistle (1.7%) and purple star thistle (1.1%). Of the six transects used to document cover, only two transects (T-4 and T-5) supported yellow star thistle. Two of the six transects supported purple star thistle (T-2 and T-3).

The 2025 transects detected only two invasive plant species: yellow star thistle and purple star thistle. Project-area wide cover was 1.7% for yellow star thistle and 1.1% for purple star thistle. For a project-wide total of 2.8%. This value is below 5%, which meet the performance standard.
