**Pacheco Creek Restoration Project
Year 2 (2025) Annual Monitoring Report**

Project No. 4291-04

December 10, 2025

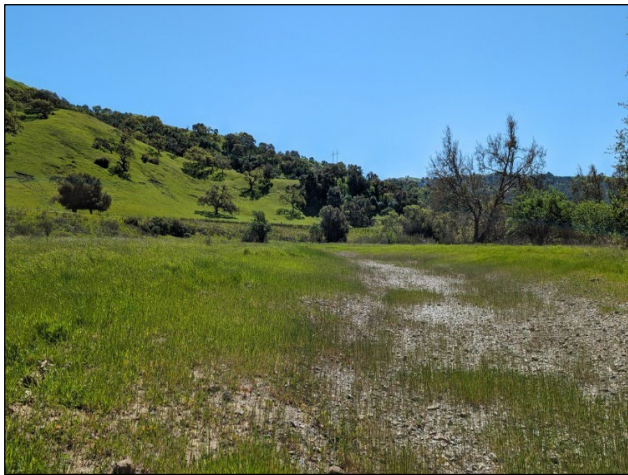
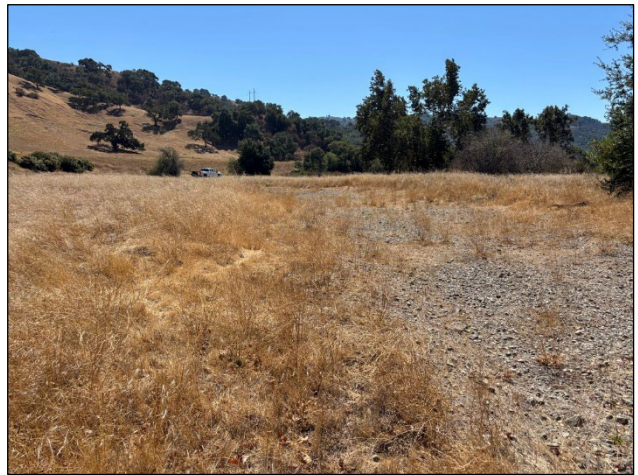
Photopoint 3. Showing Seasonal Wetland Looking Northeast in Year 1 monitoring on July 17, 2024 (Left) and in Year 2 monitoring on May 22, 2025 (Right)

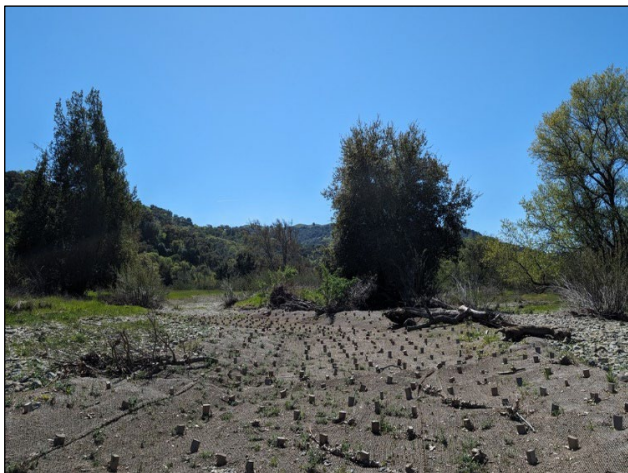
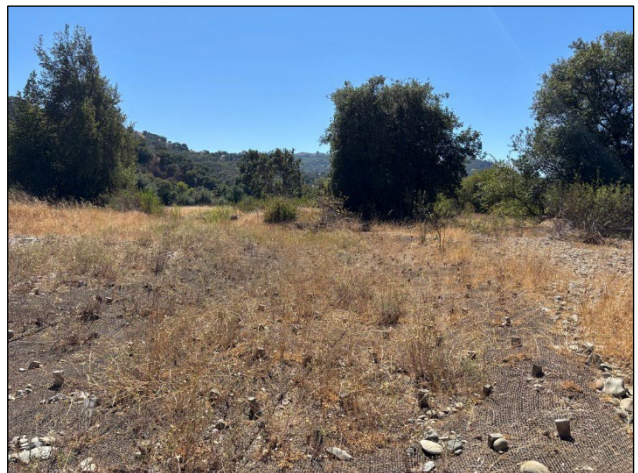
Photopoint 4. As-Built Conditions Looking South, Showing Graded Secondary Channel 6 on March 20, 2024 (Left) and in Year 2 monitoring on September 19, 2025 (Right)

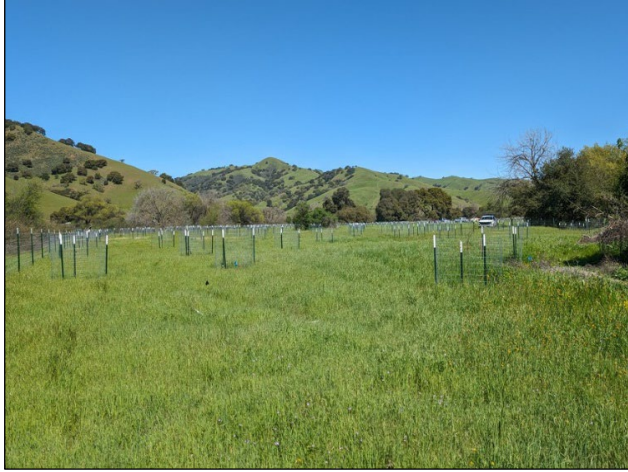
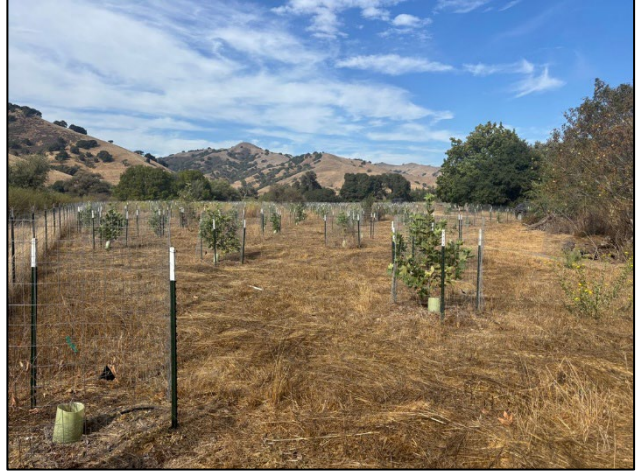
Photopoint 5. As-Built Conditions Looking South, Showing Graded Secondary Channel 7 on March 20, 2024 (Left) and in Year 2 monitoring on September 19, 2025 (Right)

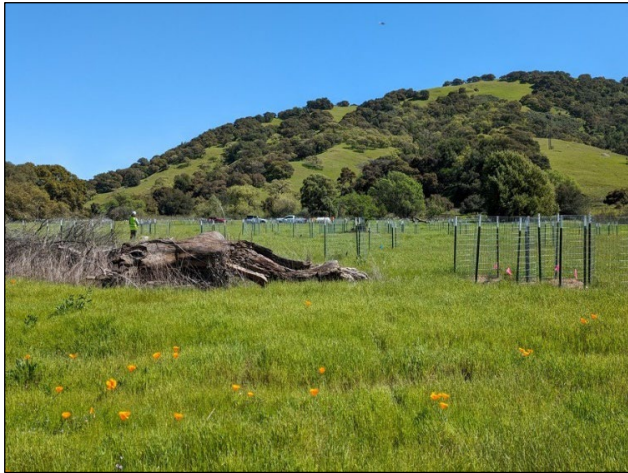
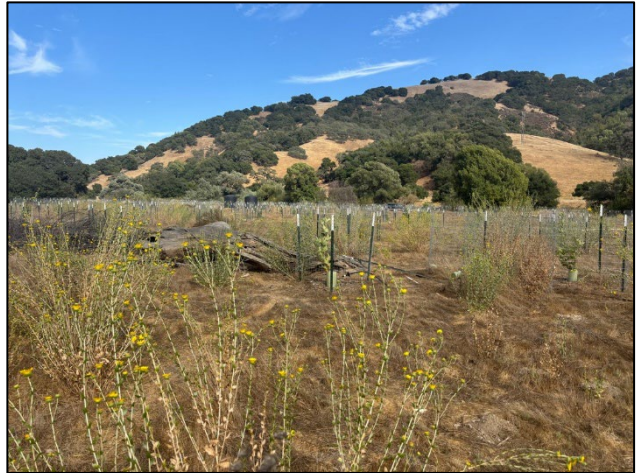
Photopoint 6. As-Built Conditions Looking North, Showing SAW 1 From Southernmost Corner on March 20, 2024 (Left) and in Year 2 monitoring on September 19, 2025 (Right)

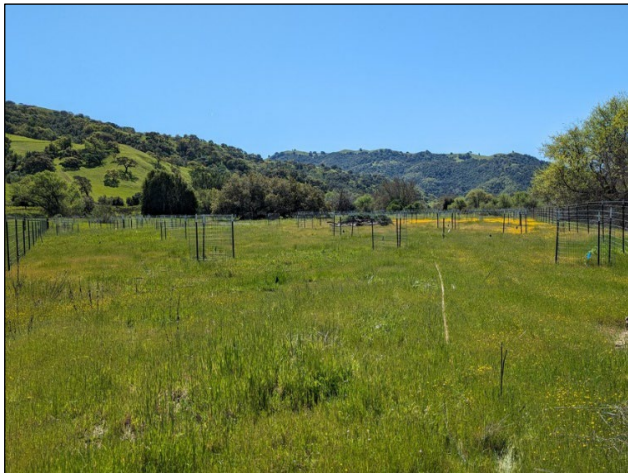
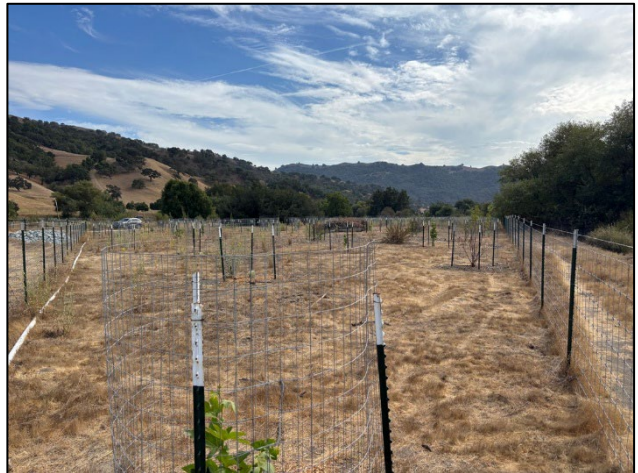
Photopoint 7. As-Built Conditions Looking East, Showing SAW 1 From West Fence Line on March 20, 2024 (Left) and in Year 2 monitoring on September 19, 2025 (Right)

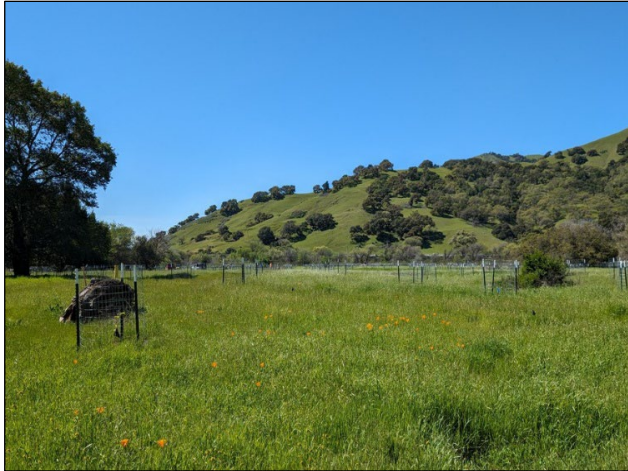
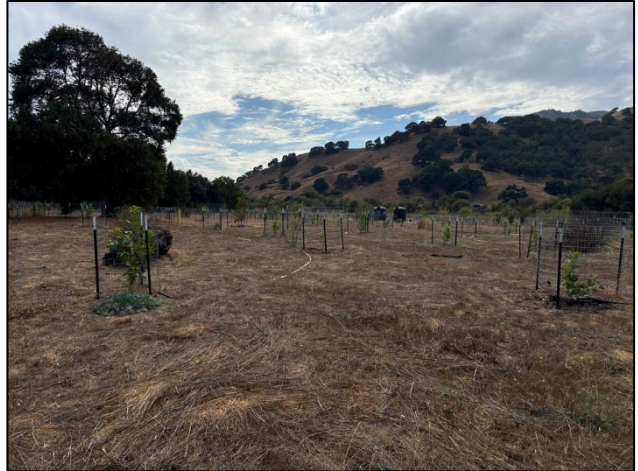
Photopoint 8. As-Built Conditions Looking South, Showing SAW 1 From Northwest Corner on March 20, 2024 (Left) and in Year 2 monitoring on September 19, 2025 (Right)

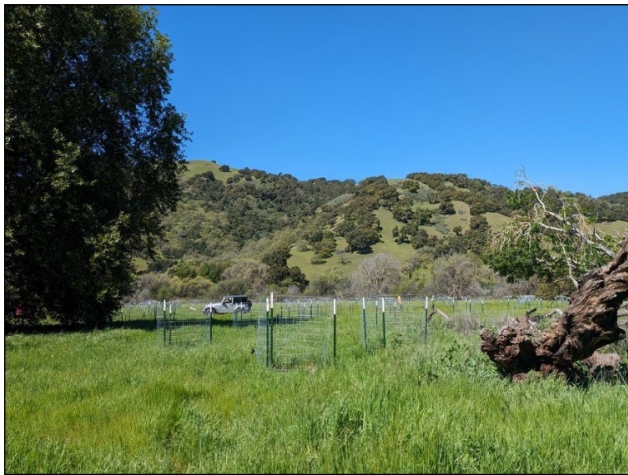
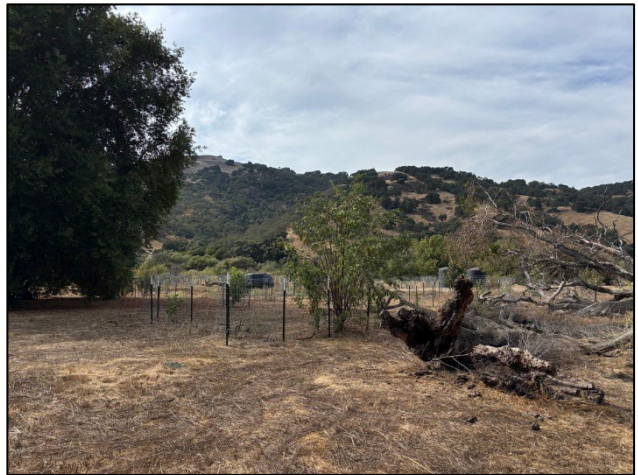
Photopoint 9. As-Built Conditions Looking West, Showing SAW 1 From Northeast Corner on March 20, 2024 (Left) and in Year 2 monitoring on September 19, 2025 (Right)

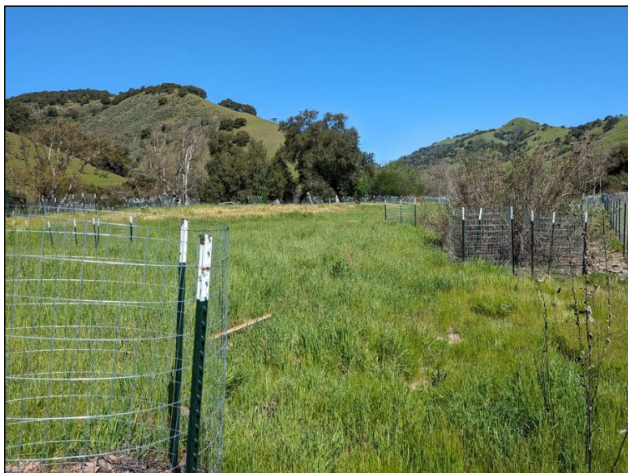
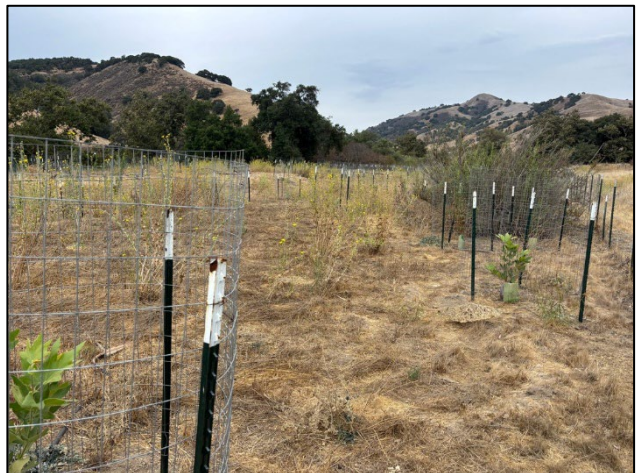
Photopoint 10. As-Built Conditions Looking North, Showing SAW 1 From Southeast Corner on March 20, 2024 (Left) and in Year 2 monitoring on September 19, 2025 (Right)

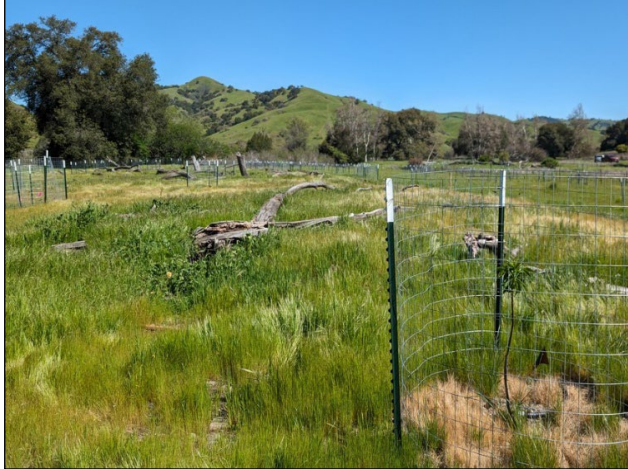
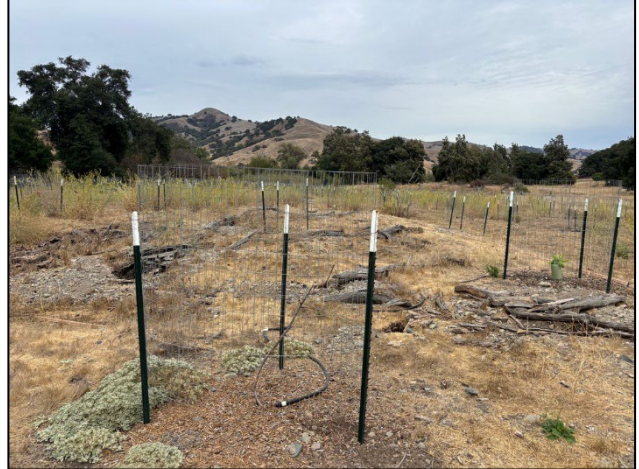
Photopoint 11. As-Built Conditions Looking North, Showing SAW 2 From Southeast Corner on March 20, 2024 (Left) and in Year 2 monitoring on September 19, 2025 (Right)

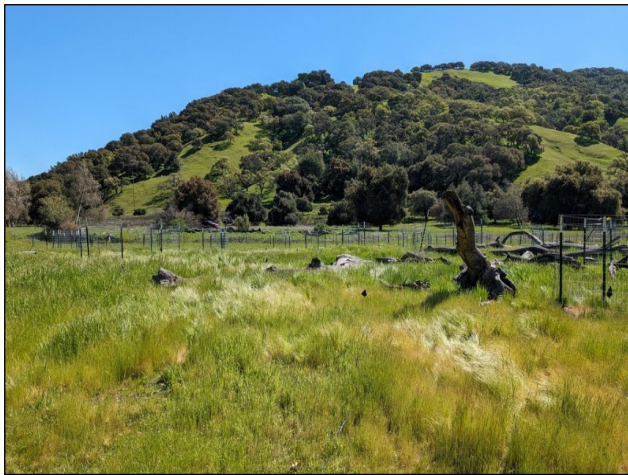
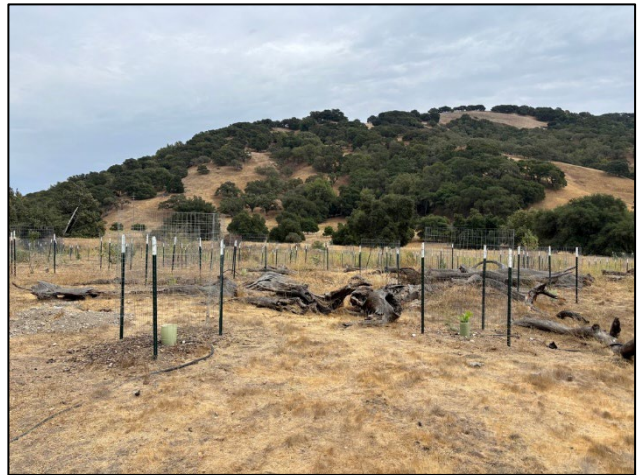
Photopoint 12. As-Built Conditions Looking North, Showing SAW 2 From Southern Fenceline on March 20, 2024 (Left) and in Year 2 monitoring on September 19, 2025 (Right)

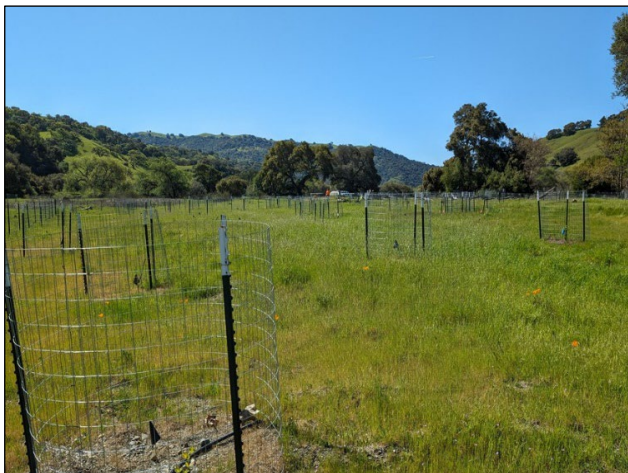
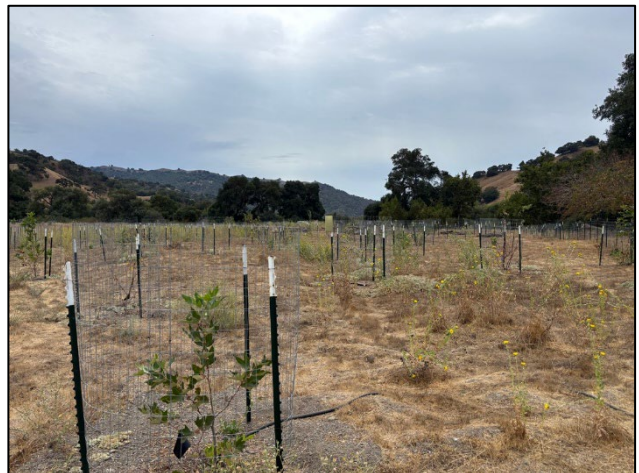
Photopoint 13. As-Built Conditions Looking East, Showing SAW 2 From Western Fenceline on March 20, 2024 (Left) and in Year 2 monitoring on September 19, 2025 (Right)

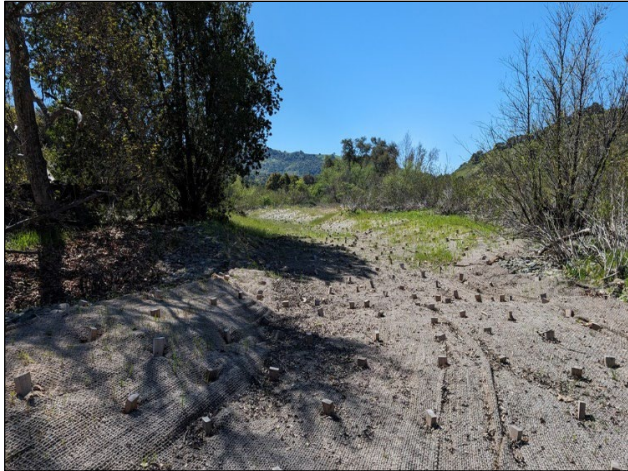
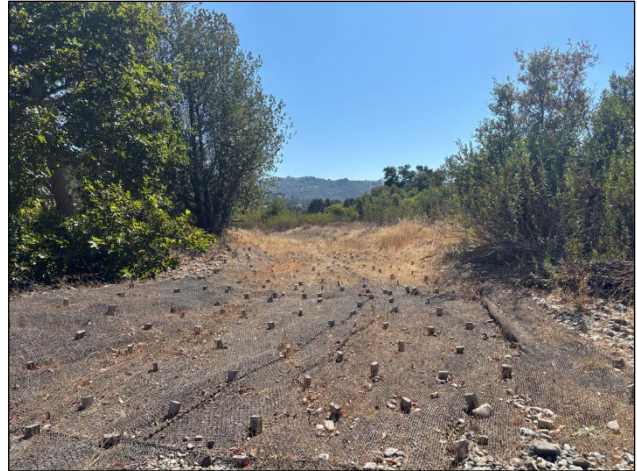
Photopoint 14. As-Built Conditions Looking South, Showing SAW 2 From Northern Corner on March 20, 2024 (Left) and in Year 2 monitoring on September 19, 2025 (Right)

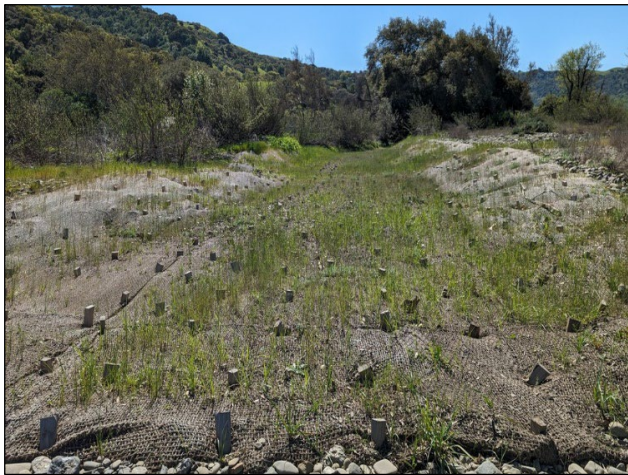
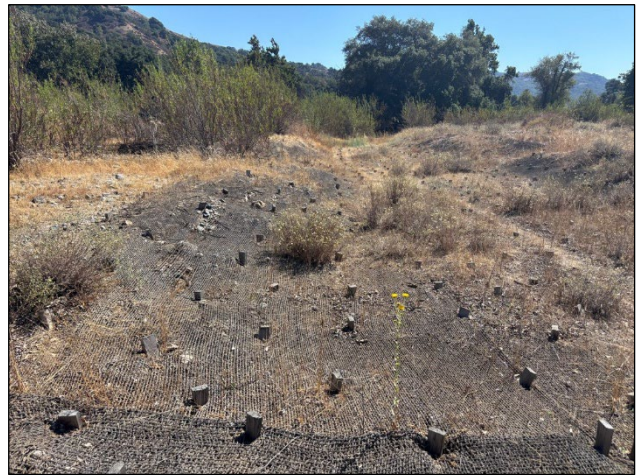
Photopoint 15. As-Built Conditions Looking South, Showing Graded Secondary Channel 4 on March 20, 2024 (Left) and in Year 2 monitoring on September 19, 2025 (Right)

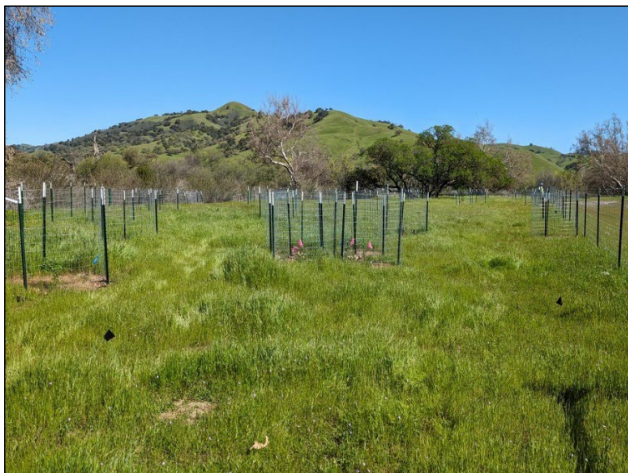
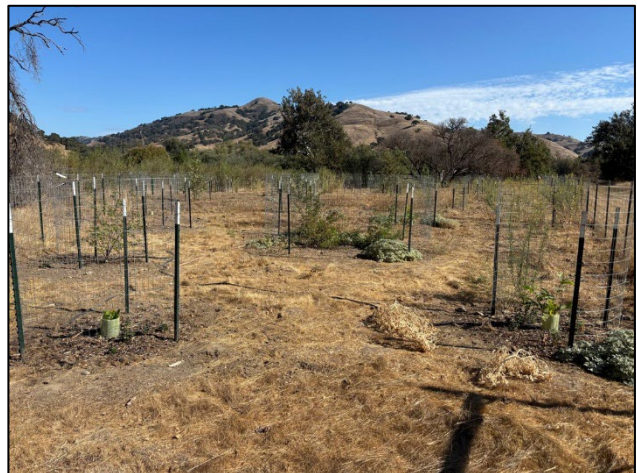
Photopoint 16. As-Built Conditions Looking South, Showing Graded Secondary Channel 3 on March 20, 2024 (Left) and in Year 2 monitoring on September 19, 2025 (Right)

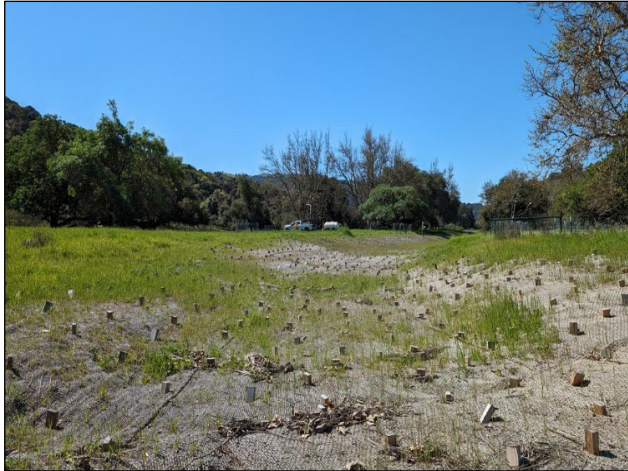
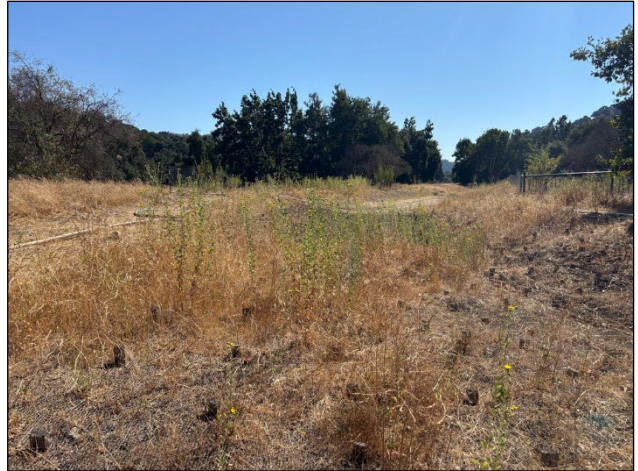
Photopoint 17. As-Built Conditions Looking Northeast, Showing SAW 3 From Southern Corner on March 20, 2024 (Left) and in Year 2 monitoring on September 19, 2025 (Right)

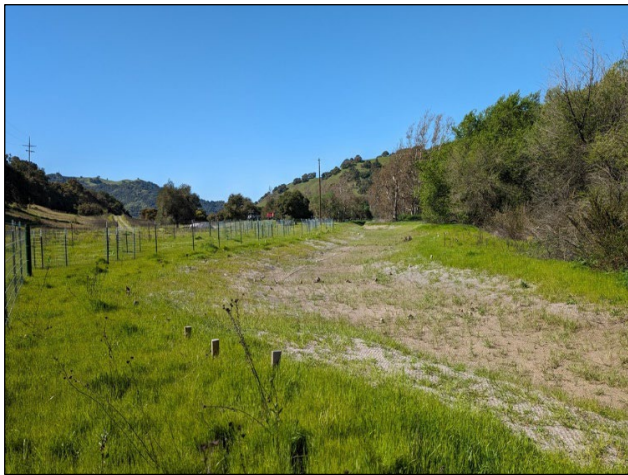
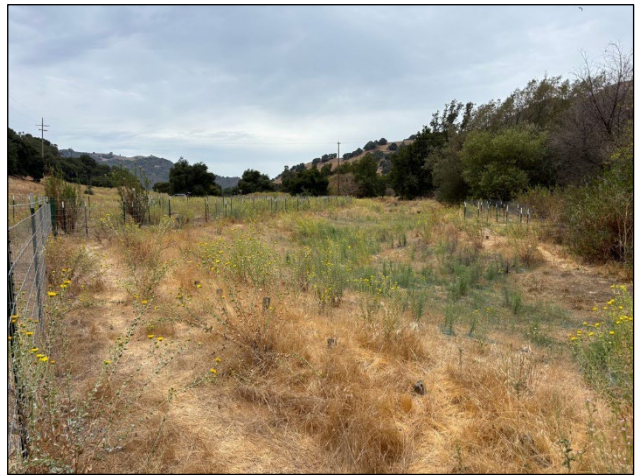
Photopoint 18. As-Built Conditions Looking Southwest, Showing Graded Secondary Channel 2 through SAW 3 on March 20, 2024 (Left) and in Year 2 monitoring on September 19, 2025 (Right)

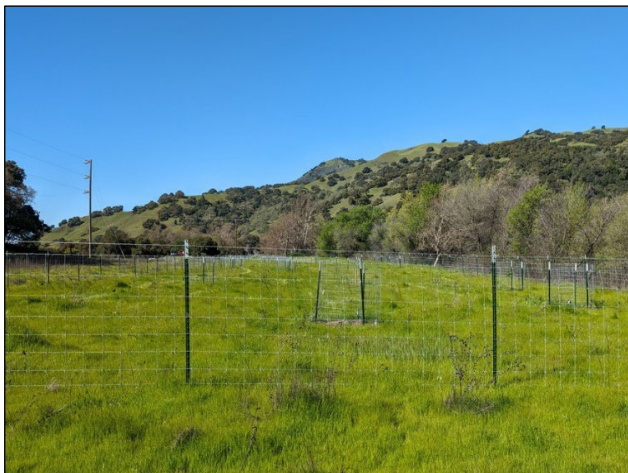
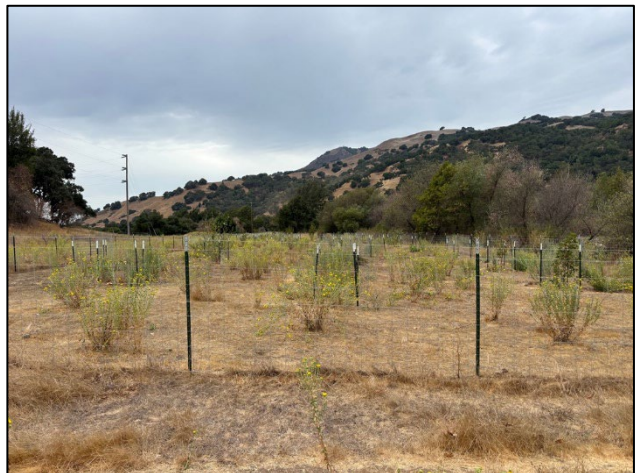
Photopoint 19. As-Built Conditions Looking Southwest, Showing Graded Secondary Channel 1 Adjacent to SAW 4 on March 20, 2024 (Left) and in Year 2 monitoring on September 19, 2025 (Right)

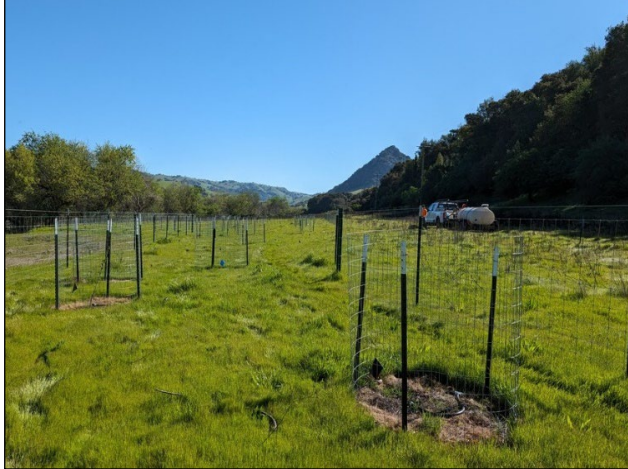
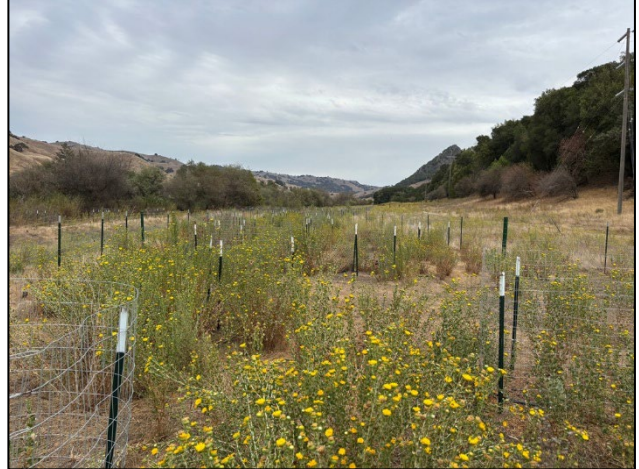
Photopoint 20. As-Built Conditions Looking Southwest, Showing SAW 4 From Outside Northeast Fenceline on March 20, 2024 (Left) and in Year 2 monitoring on September 19, 2025 (Right)

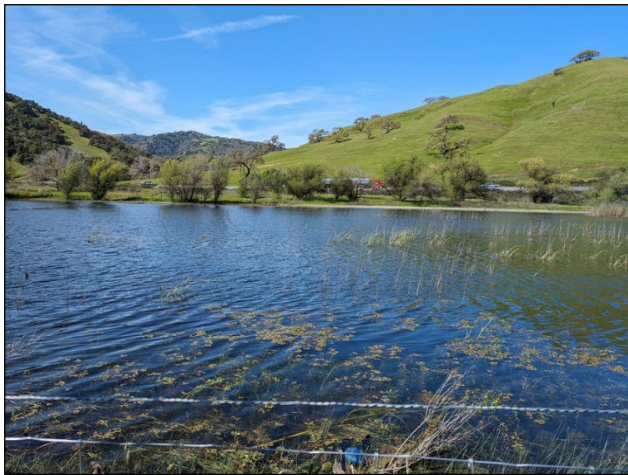
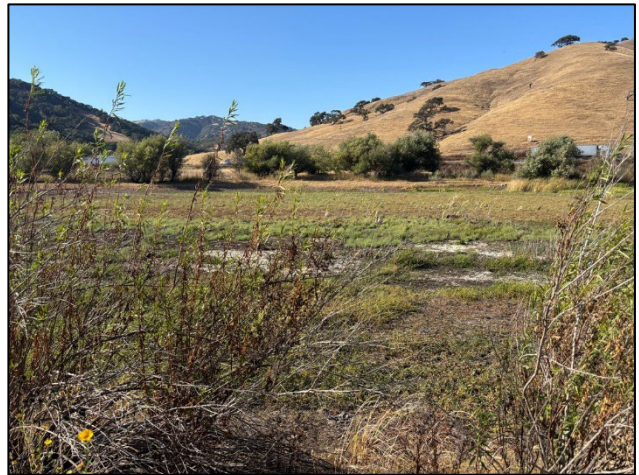
Photopoint 21. As-Built Conditions Looking Northeast, Showing SAW 4 From Southwest Corner on March 20, 2024 (Left) and in Year 2 monitoring on September 19, 2025 (Right)

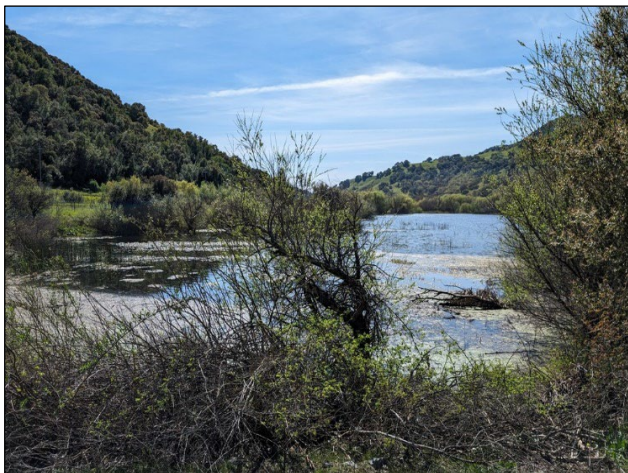
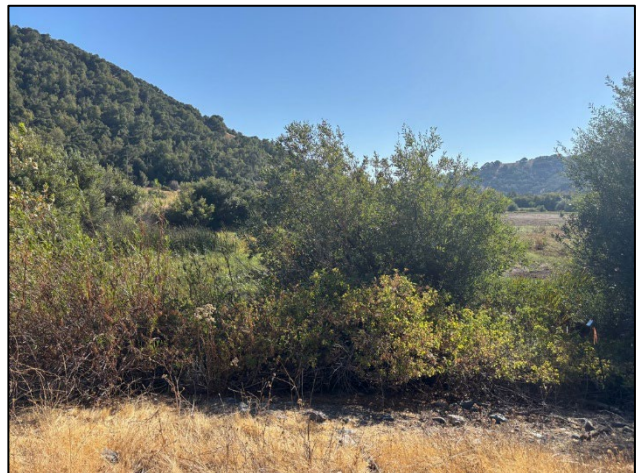
Photopoint 22. As-Built Conditions Looking North, Showing Pond 3 From Southeast Bank Outside Fenceline on March 20, 2024 (Left) and in Year 2 monitoring on September 19, 2025 (Right)

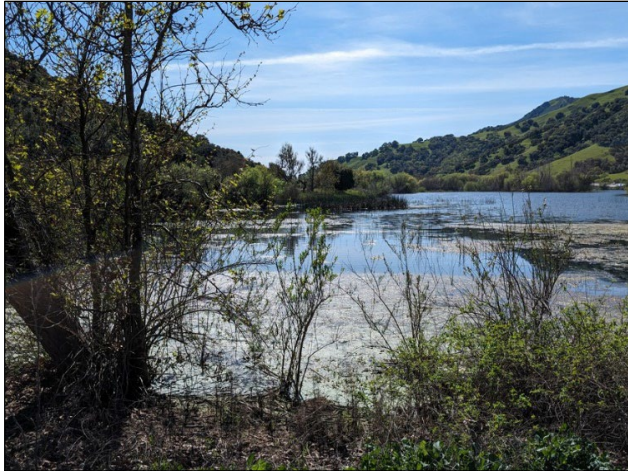
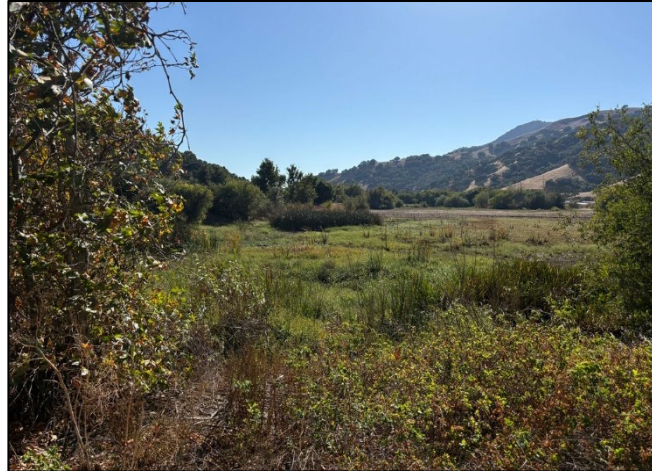
Photopoint 23. As-Built Conditions Looking West, Showing Pond 3 From Bank Inside Fenceline on March 20, 2024 (Left) and in Year 2 monitoring on September 19, 2025 (Right)

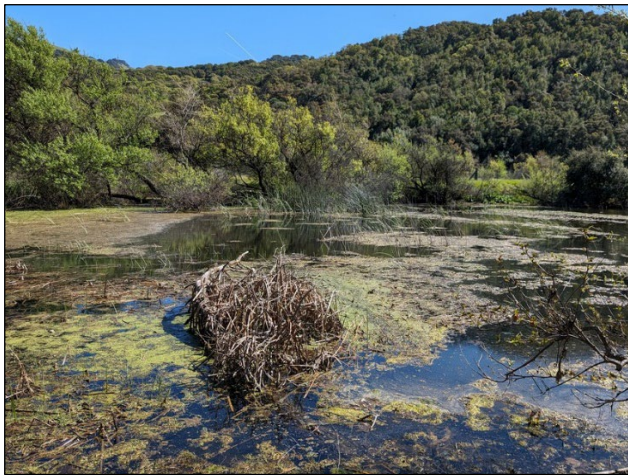
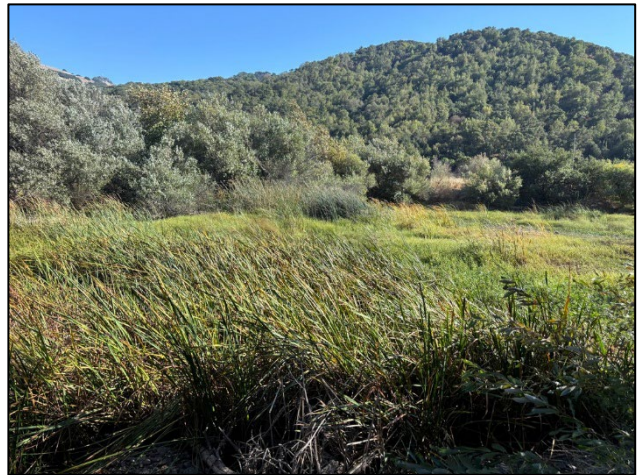
Photopoint 23. As-Built Conditions Looking West, Showing Pond 3 From Bank Inside Fenceline, on March 20, 2024 (Left) and in Year 2 monitoring on September 19, 2025 (Right)

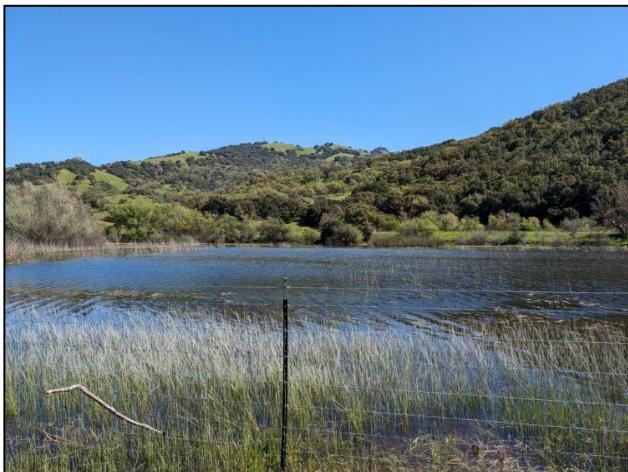
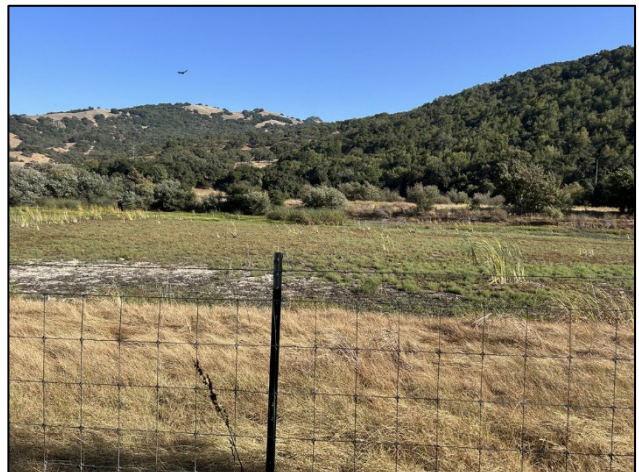
Photopoint 23. As-Built Conditions Looking Southeast, Showing Pond 3 From Peninsula Inside Fenceline on March 20, 2024 (Left) and in Year 2 monitoring on September 19, 2025 (Right)
