SANTA CLARA VALLEY
HABITAT AGENCY

PAJARO RIVER RIPARIAN HABITAT RESTORATION PROJECT

YEAR 1 (2025) ANNUAL MONITORING REPORT

December 5, 2025

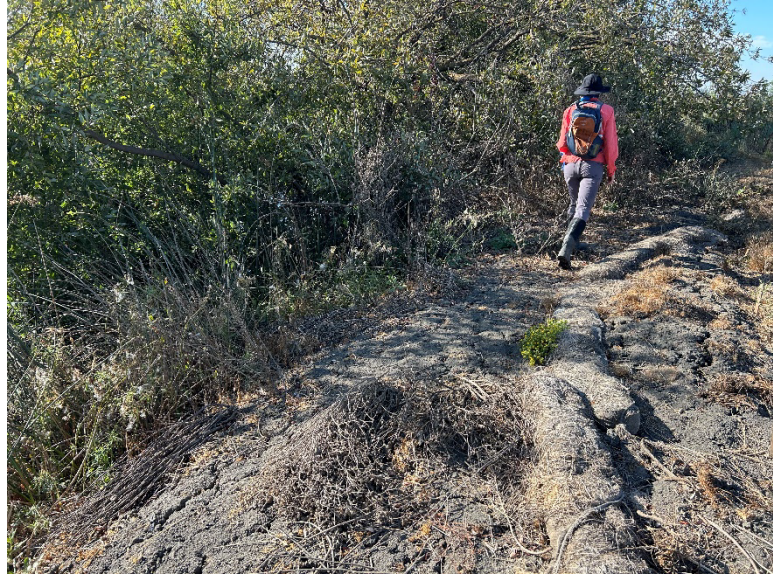
The six potentially unstable bank segments each lacked 75% vegetative cover – this by itself typically renders the bank segment as unstable per Table 1; however, each of these bank segments is composed of extremely cohesive soil (Willows clay, 0% slopes, MLRA 14⁵) that is non-susceptible to fluvial erosion, and each of these bank segments exhibited no other instability elements. As such, a rank of potentially unstable was given to these particular bank segments. Photograph 1 shows an example of one of these potentially unstable bank segments, Erosion Feature #6 in Reach 2a.

Photograph 1. Potentially unstable right bank segment in Reach 2a (Erosion Feature #6).

For Erosion Features #1 through #7, it is recommended that seeding and perhaps additional erosion control measures (e.g., willow plantings, coir at the bank toes, and/or blankets on the bank slopes) be used to try and revegetate the barren portions of these bank segments. These efforts would need to occur at the appropriate time of the year to allow rapid growth of the seedlings. For Erosion Feature #5, a wet-season assessment of the feature should be made to understand if the clay soils have self-corrected prior to implementing corrective measures.

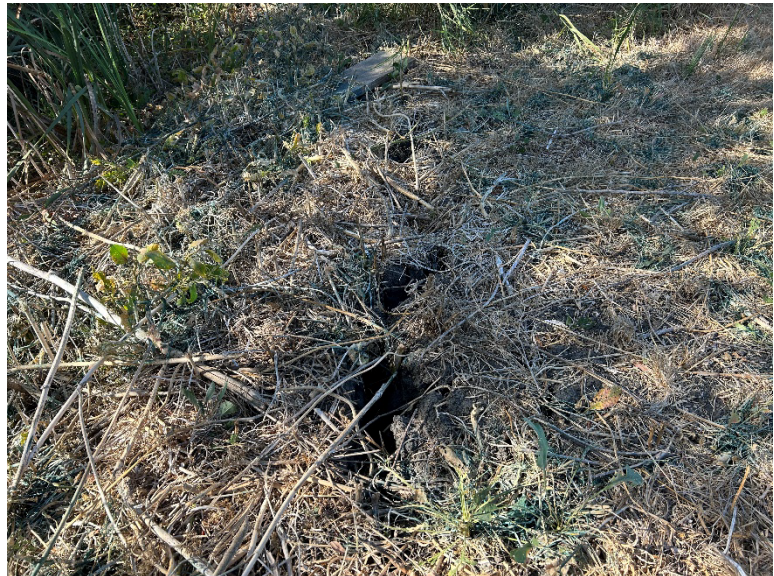
Erosion Feature #5, the only bank segment that was classified as unstable, exhibited one instability element (as shown in Table 1) – a tensile crack that could eventually lead to additional bank retreat in Reach 2a (Photograph 2). However, due to the high soil expansiveness of this streambank, this tensile crack could very well “correct” itself once the precipitation season begins and the soils become saturated once again.⁶ Future monitoring will provide better insight as to how this particular bank segment behaves.

Photograph 2. Unstable right bank segment with tensile crack in Reach 2a (Erosion Feature #5).

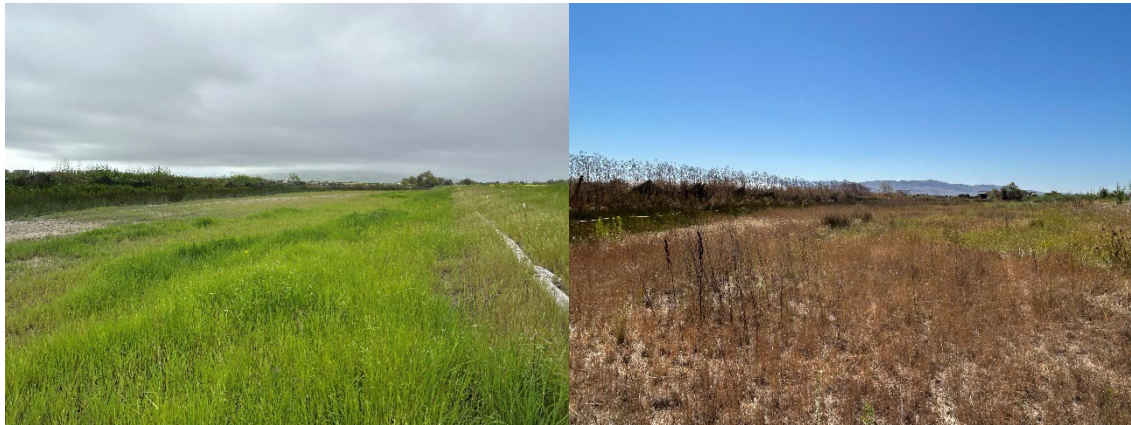
It should be noted that the erosion inventory was conducted in the fall during the driest season in this region of California. During a site visit in the spring of 2024 (soon after Phase 2 restoration activities were conducted), there was ample vegetative coverage on the streambanks in most, if not all, of the areas that were classified as potentially unstable in the fall of 2025. Photographs 3 and 4 show a side-by-side comparison of one such area, at the upstream end of the Project site in Reach 1a.

Photographs 3 and 4. Side-by-side comparisons of floodplain and bank vegetation from spring 2024 and fall 2025 (Reach 1a in the Phase 2 Restoration Area).

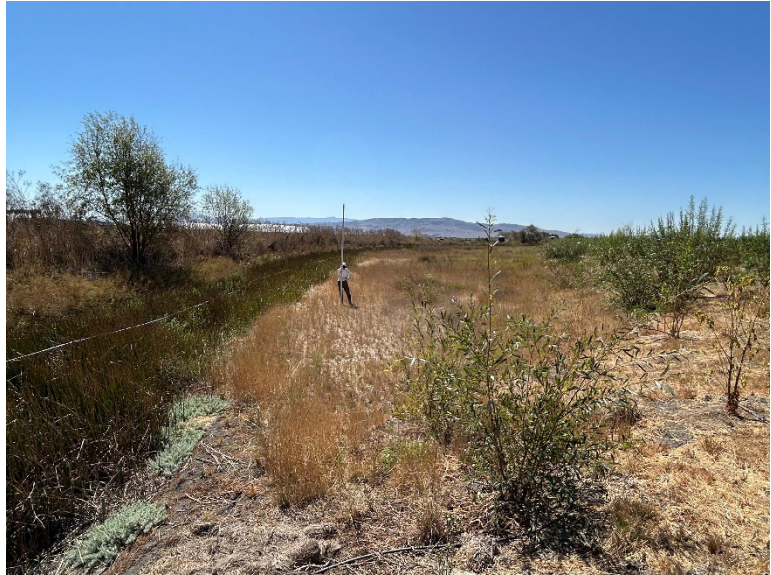
Photograph 5. Looking downstream at upper end of Phase 2 Restoration Area (STA 200).

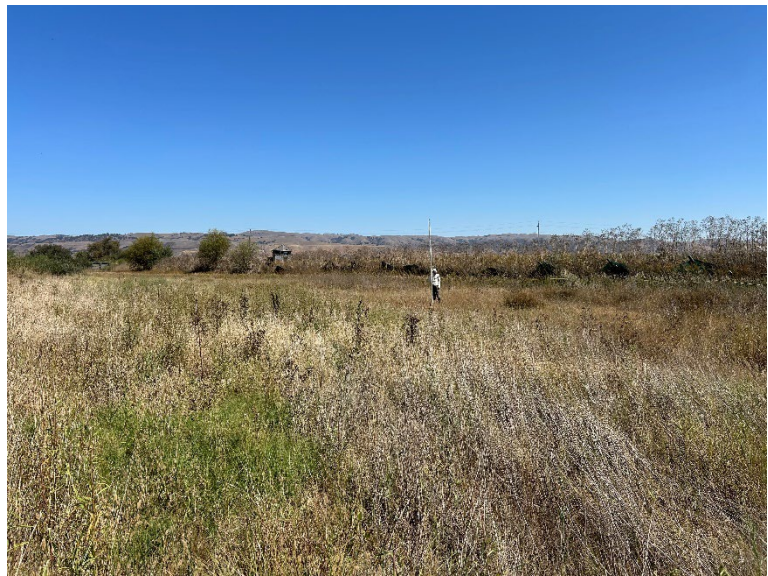
Photograph 6. Looking upstream at lower end of Phase 2 Restoration Area (STA 600).

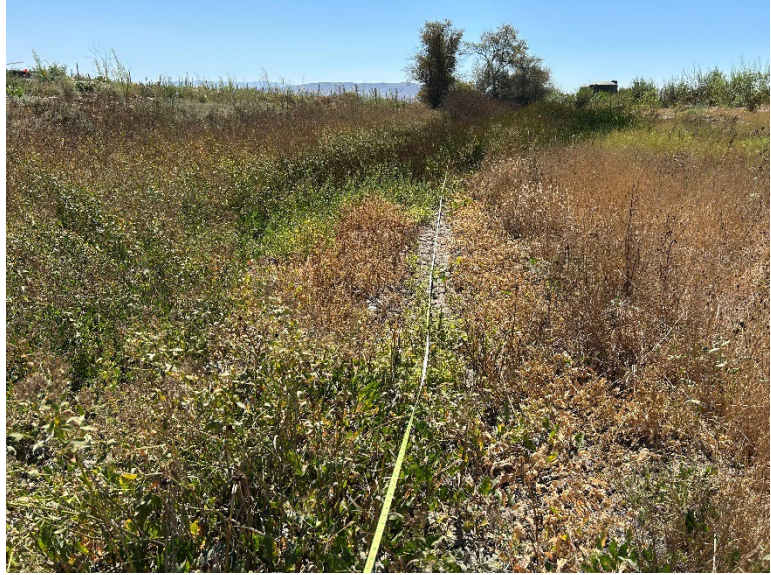
Photograph 7. Looking downstream at pool habitat (STA 975).

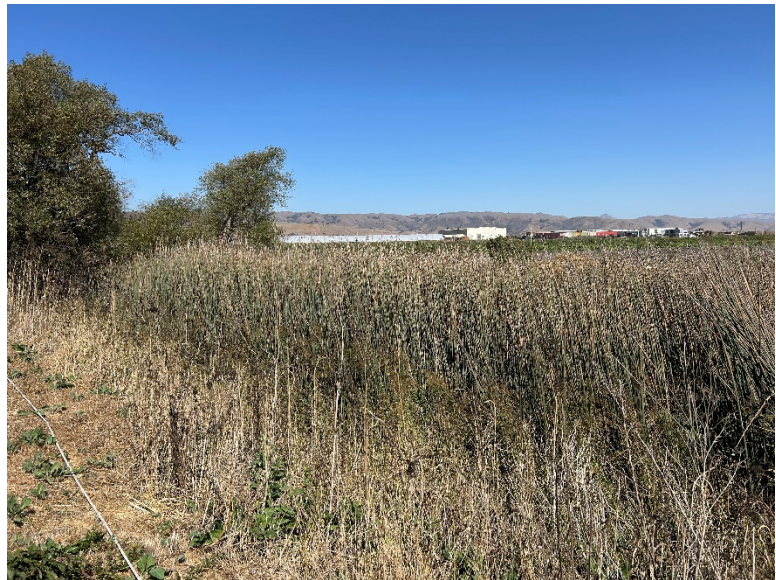
Photograph 8. Looking upstream at dense instream vegetation (STA 1,395).

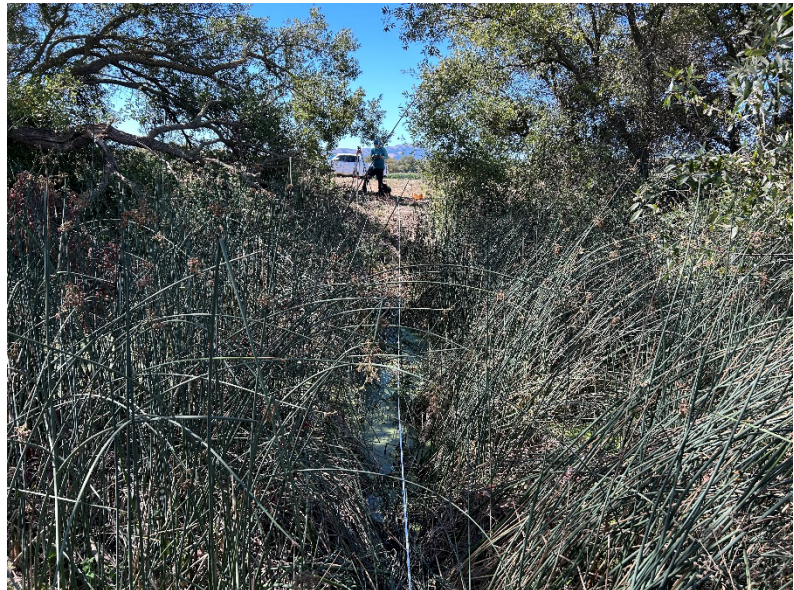
All riparian vegetation (in the form of trees) growing within the active channel margin appears to be mature, suggesting that there have been no major channel adjustments and restabilization following a prior disturbance (Photograph 9).

Photograph 9. Mature willow growth on left bank, cross section XS-6.

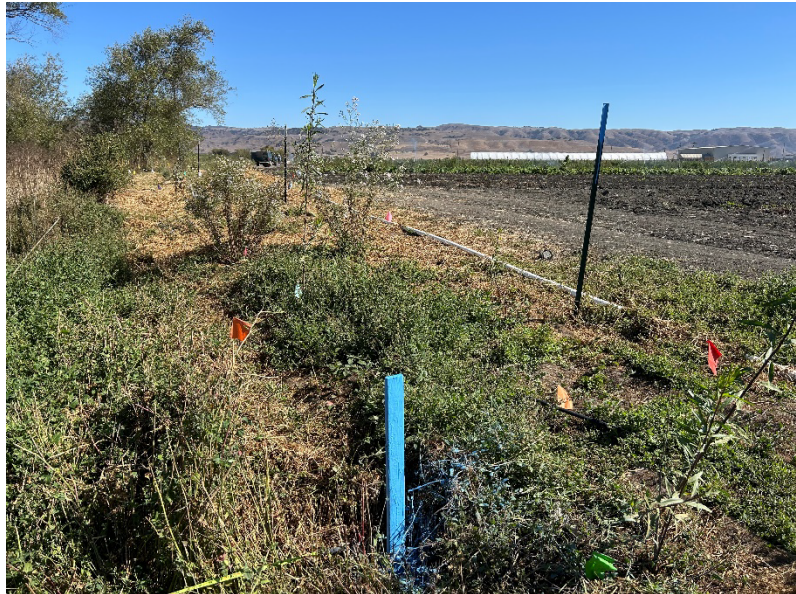
Photograph 10. Stable left bank, cross section XS-3.

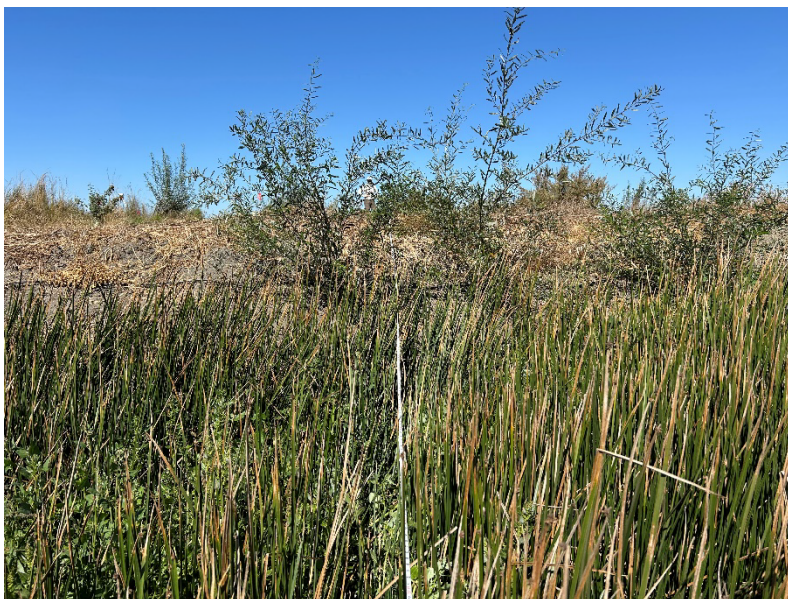
Photograph 11. Potentially unstable right bank, cross section XS-1.

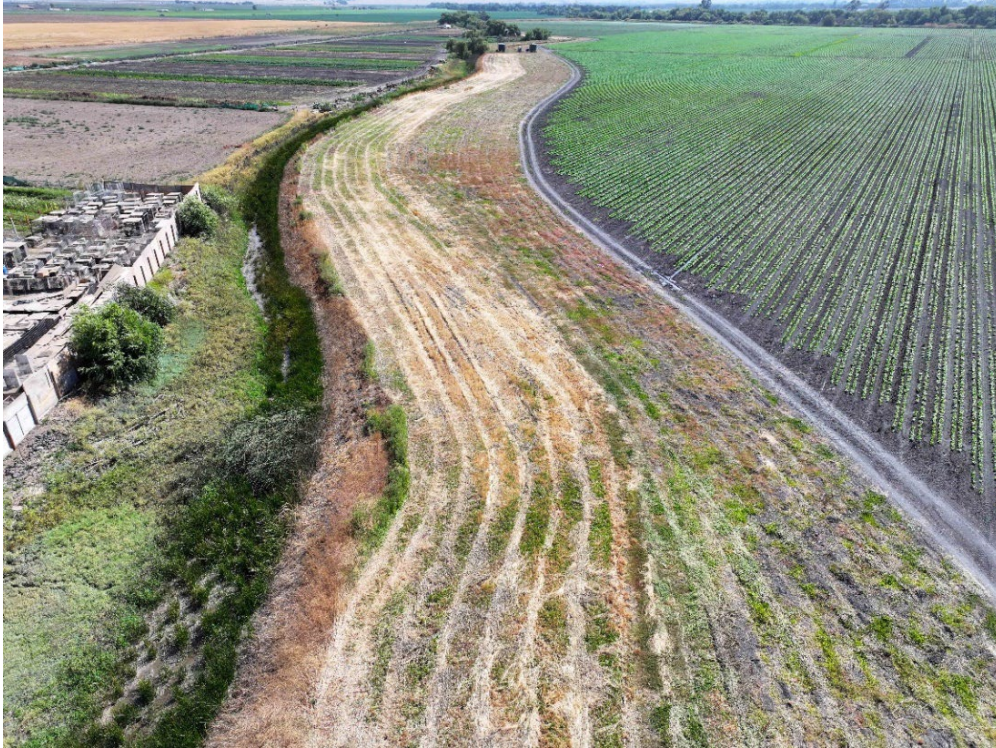
July 2023: Pre-project view (above) looking downstream. Non-native weeds dominated farm setback area that had been mowed.

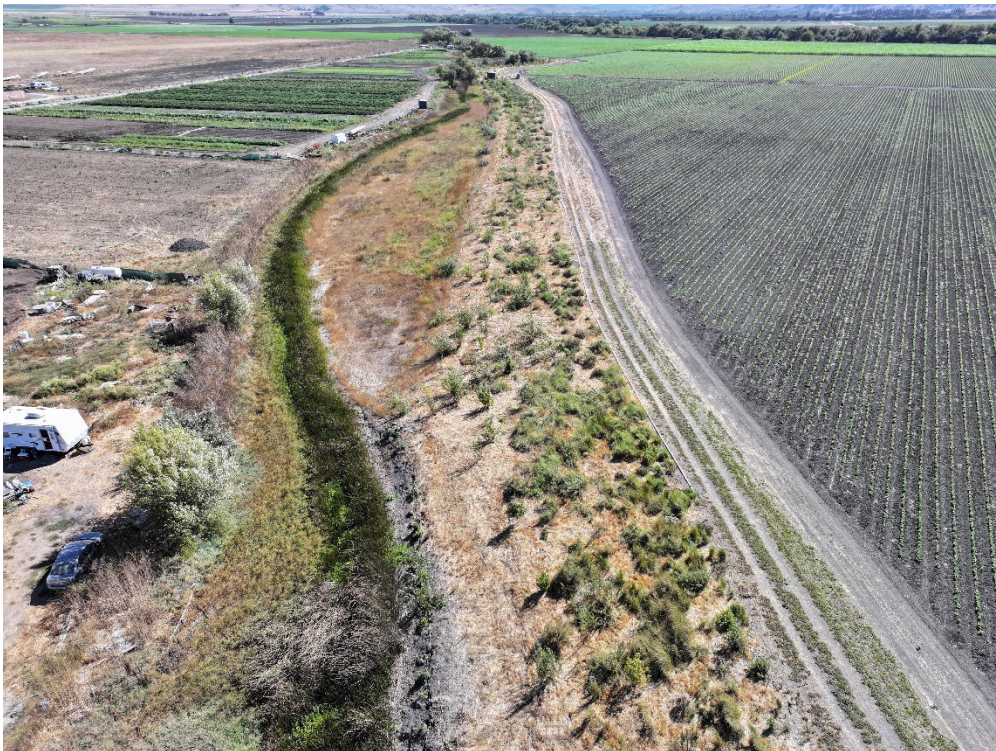
Aug. 2025: Post-grading/planting showing establishing riparian forest and developing seasonal

wetland/marsh complex on right bank of the Pajaro River channel.

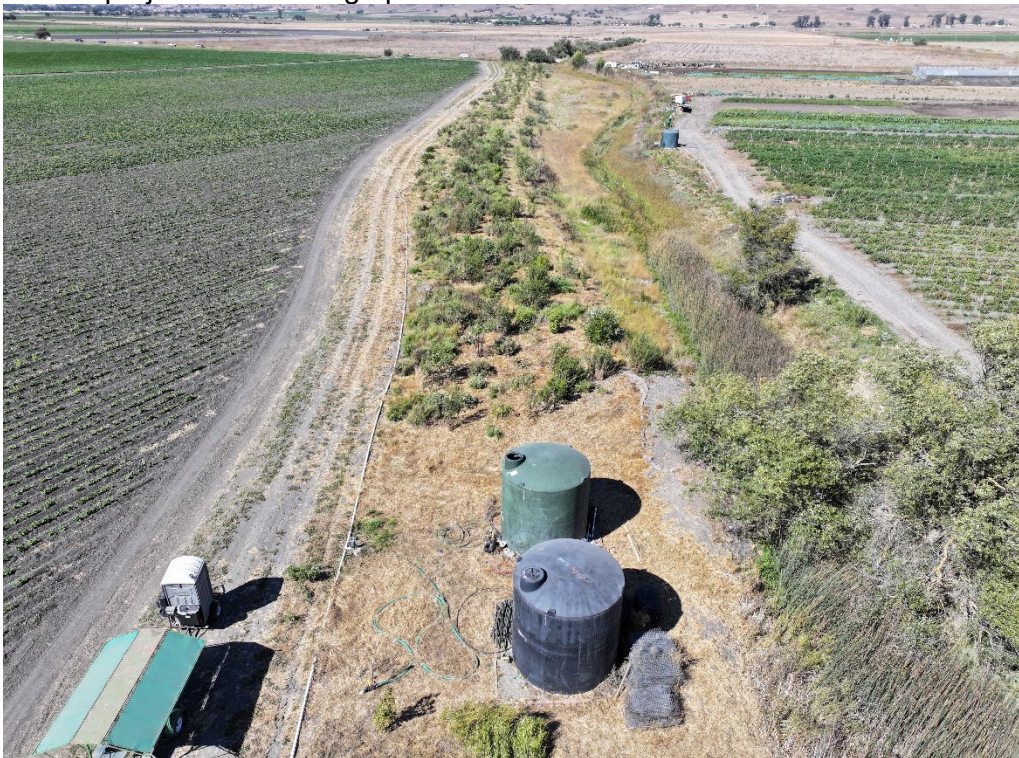
Aug. 2025: Post-grading/planting showing establishing riparian forest and developing seasonal wetland/marsh complex on right bank of the Pajaro River channel.

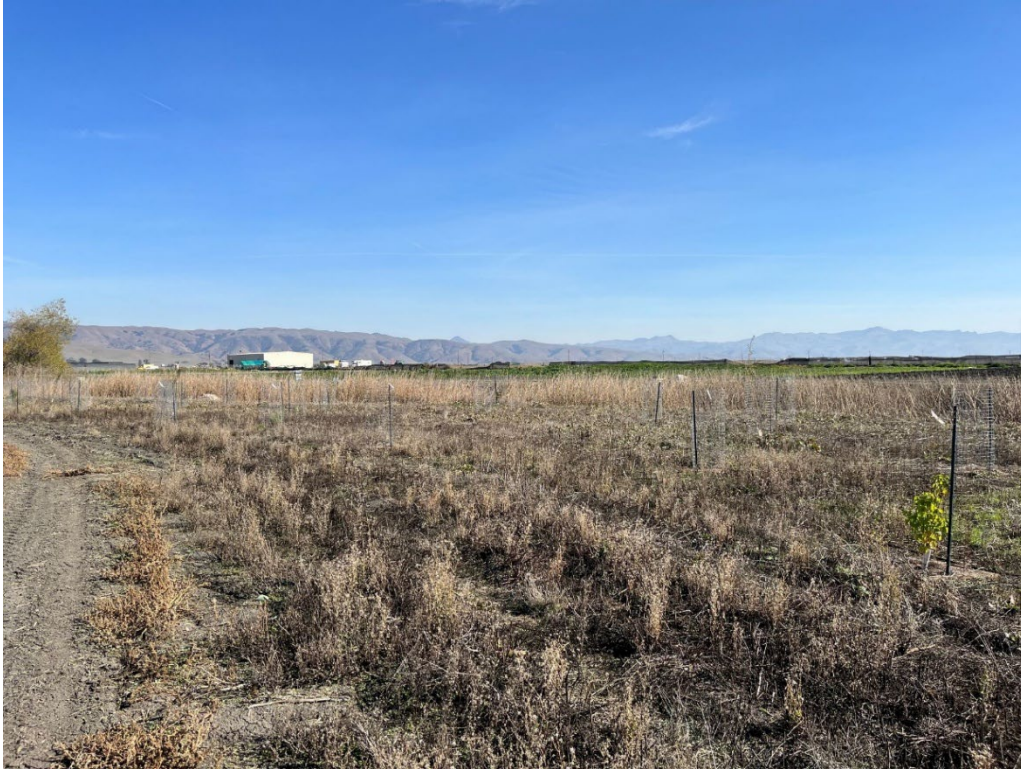
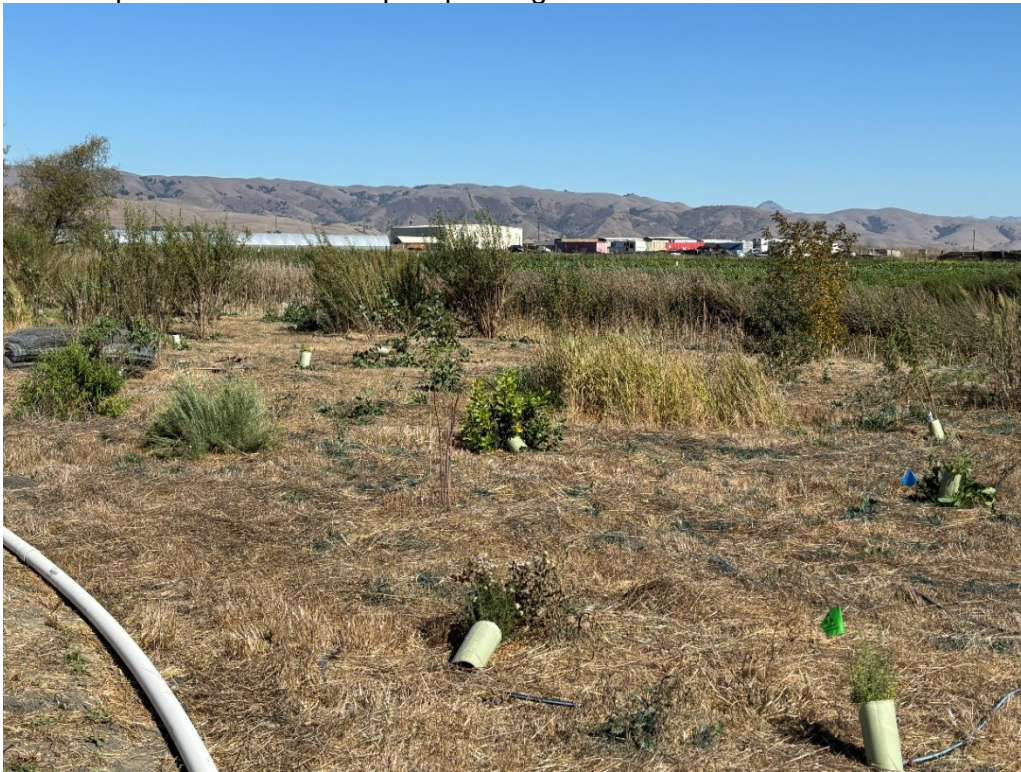
Point 3-A. Looking upstream

December 5, 2022 (above); October 7, 2025 (below).
Both photos taken after a pilot planting trial had been started in this area
