ANNUAL RESTORATION MONITORING REPORT

YEAR 7

SAN FELIPE CREEK RESTORATION PROJECT
SANTA CLARA VALLEY HABITAT AGENCY

DECEMBER 15, 2025

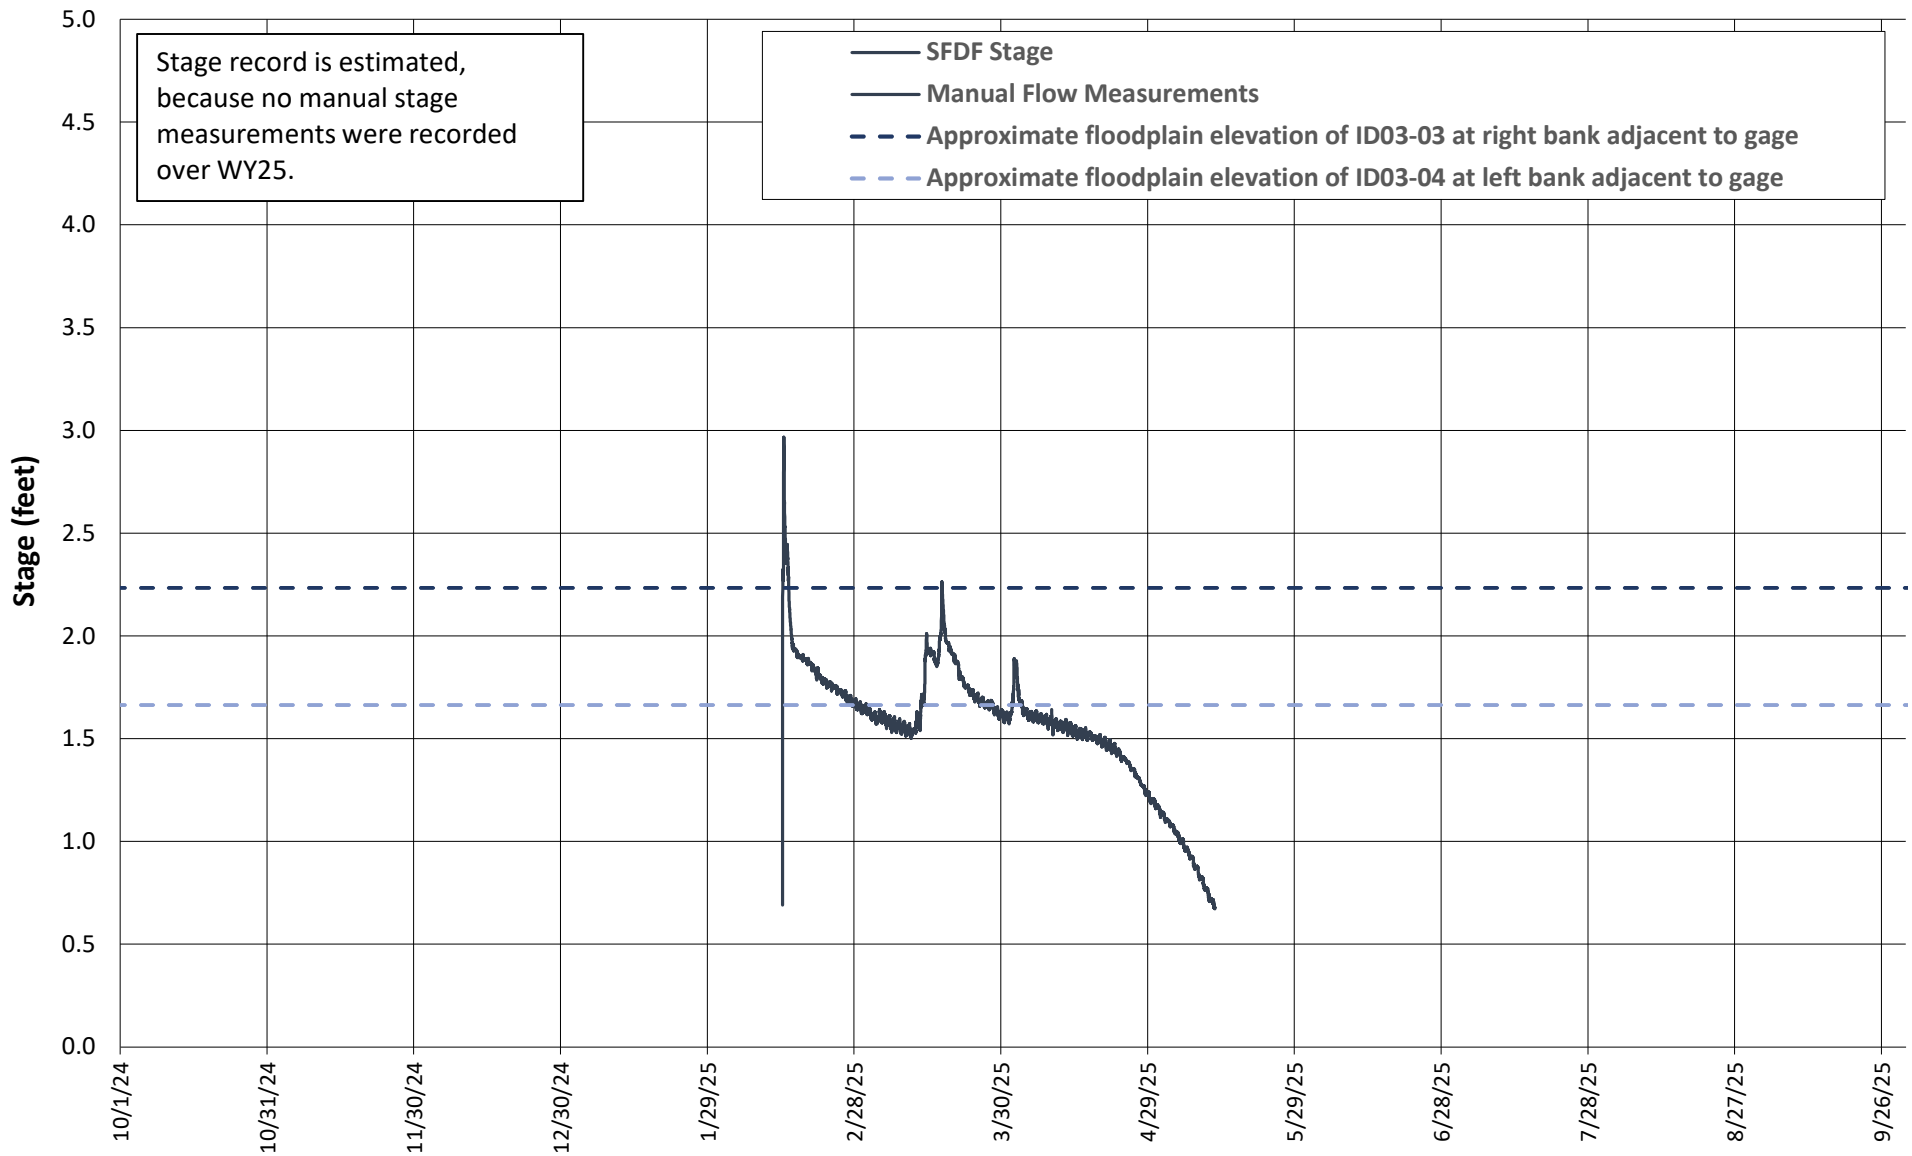
Figure 7. Stage at the San Felipe Creek downstream floodplains station (SFDF), water year 2025, San Felipe Creek Restoration Project, Santa Clara County, California. On December 10, 2021, SFDF was installed between ID03-03 and ID03-04 to evaluate timing and duration of floodplain inundation at ID03-03 and ID03-04.

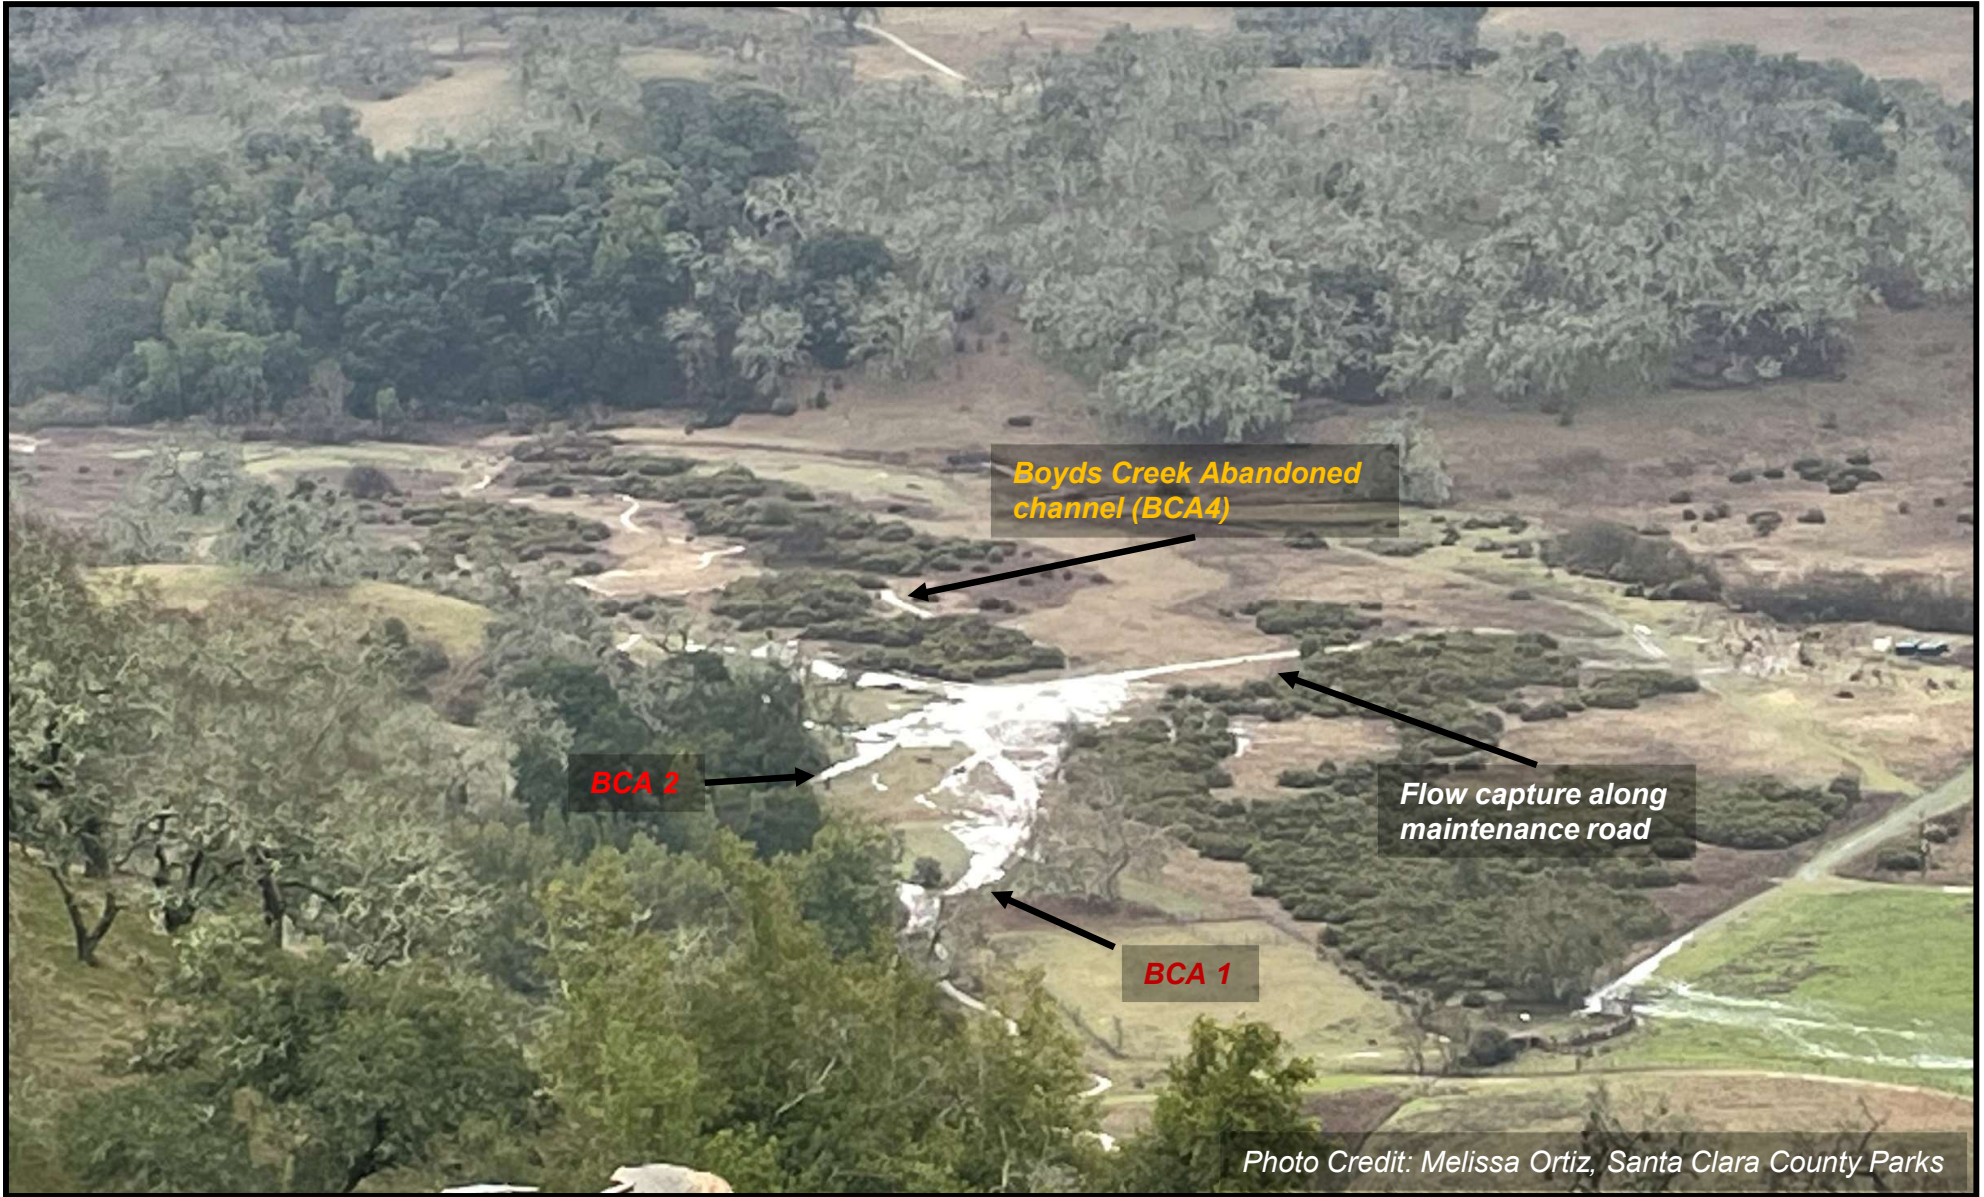
Figure 12. Overview photograph of flow in at least 3 Boyds Creek distributary channels, February 13, 2025. Year 7 San Felipe Creek Restoration Project, Joseph D. Grant Park, Santa Clara County, California. Physical Success Criterion 3 was met in 2025. A 2-year event did not occur, but the newly constructed debris jams in Boyds creek succeeded in diverting more water into the distributary channels and onto the alluvial fan surface.

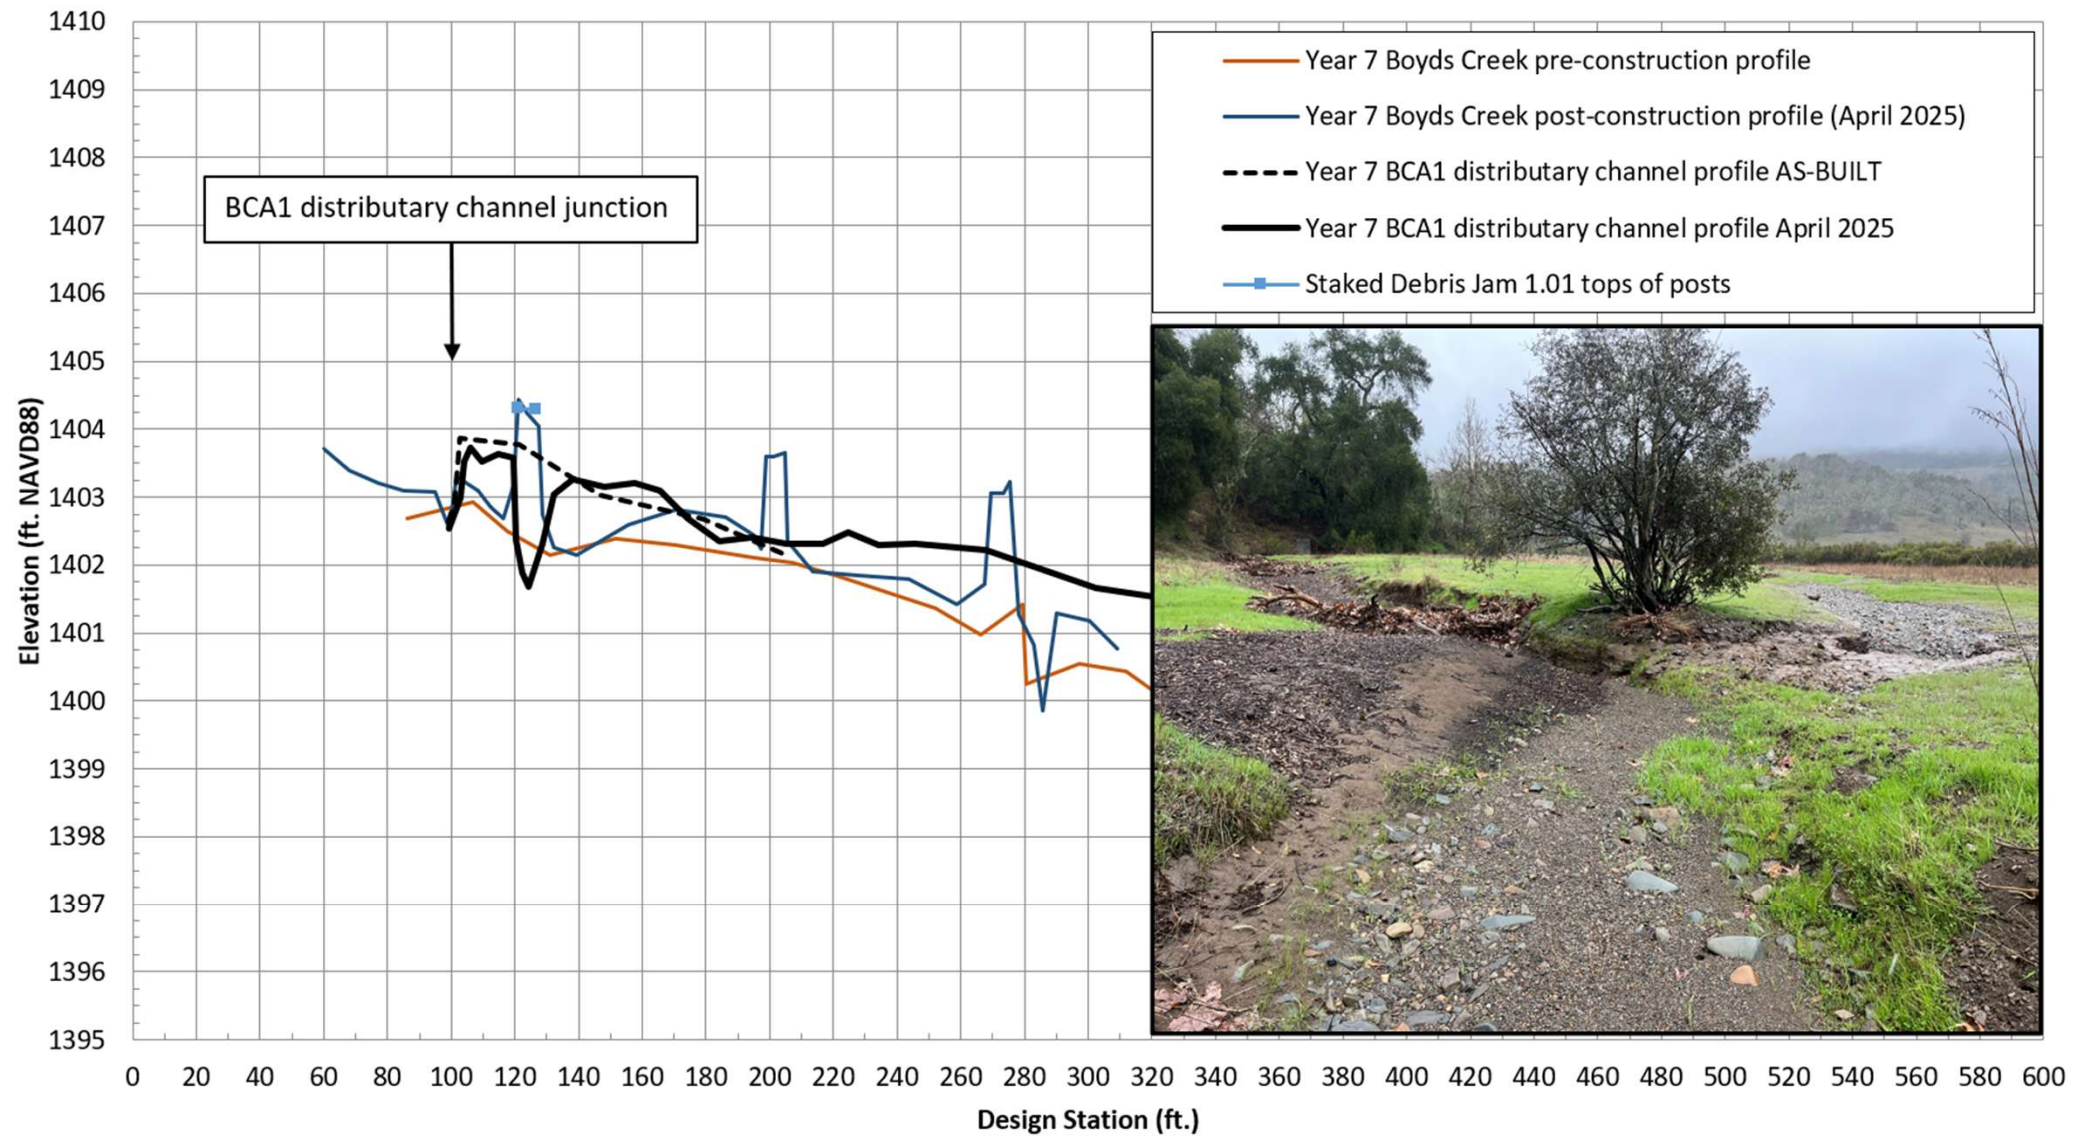
Figure 13. Longitudinal profile comparison pre- and post-Year 7 adaptive management work, and post winter Year 7 (WY2025), Boyds Creek and BCA1 distributary channel, San Felipe Creek Restoration Project, Santa Clara County, California. Note that after the winter of WY2025, the vertical posts trapped debris and leaves effectively and raised the effective height of Staked Debris Jam 1.01. On September 17, 2025, 0.5 to 0.7 feet was removed from the top of the posts in Staked Debris Jam 1.01.

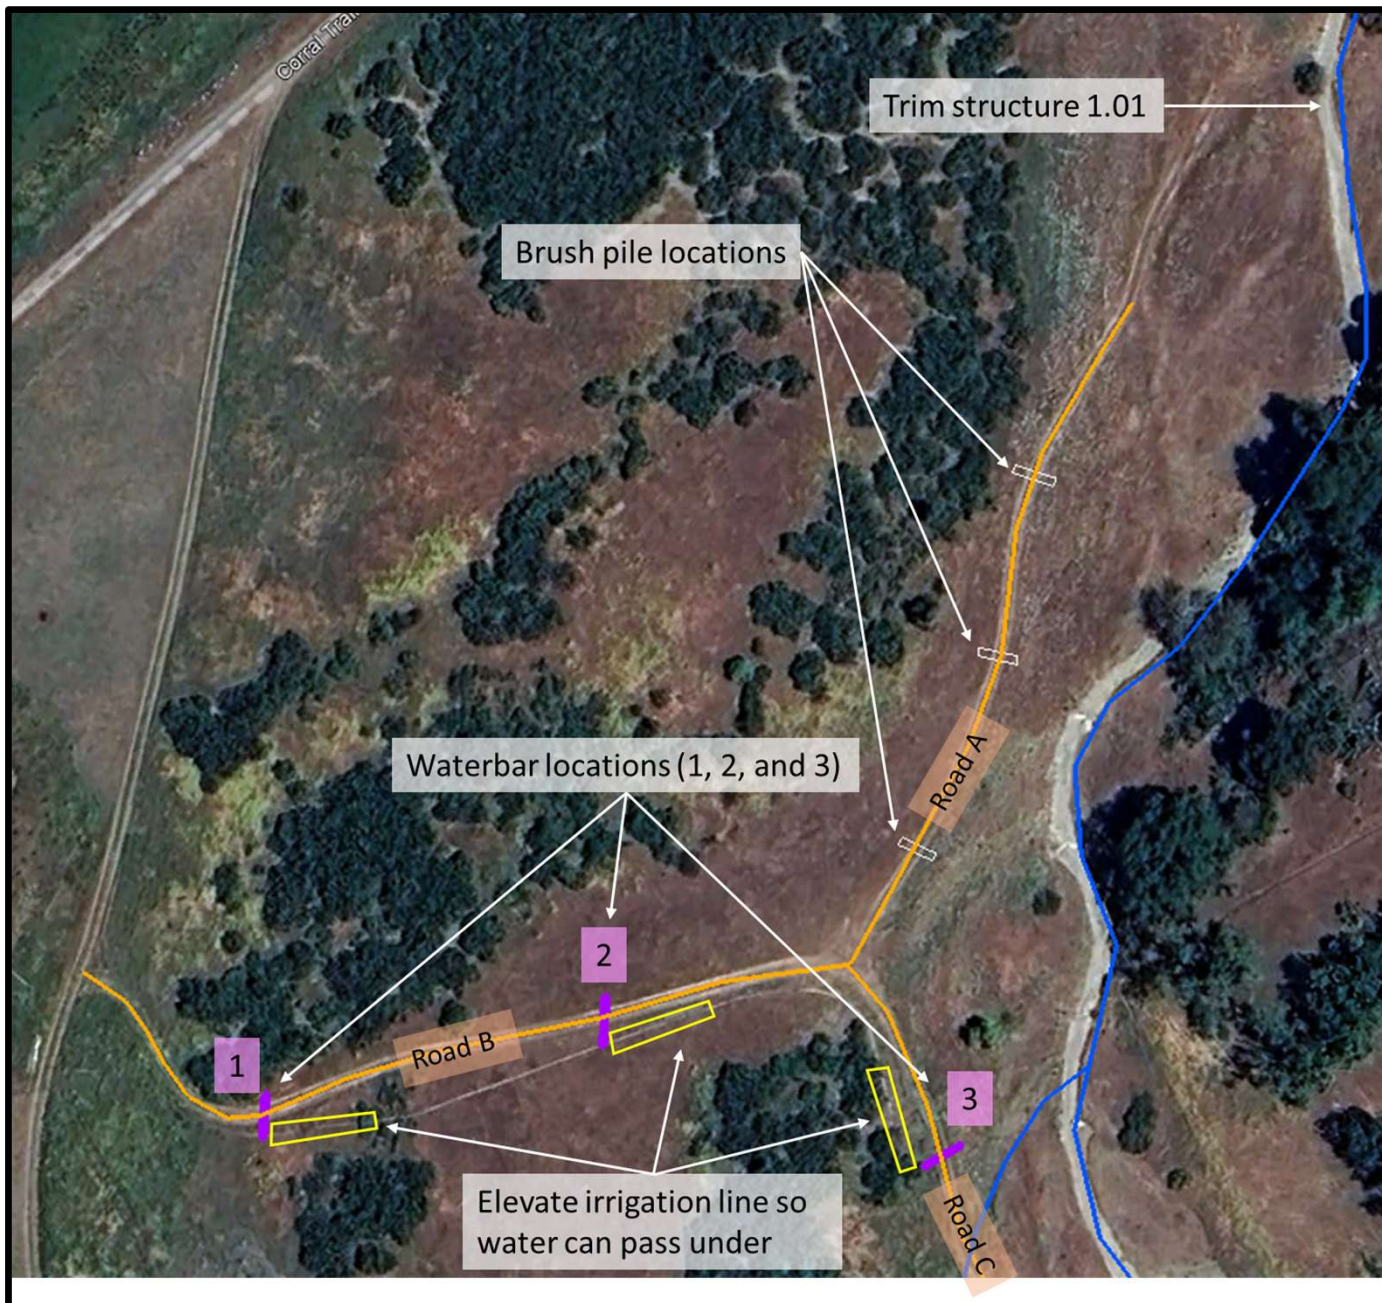
Figure 14. Overview map of Boyds Creek area adaptive management recommendations completed on September 17, 2025. San Felipe Creek Restoration Project, Joseph D. Grant Park, Santa Clara County, California.

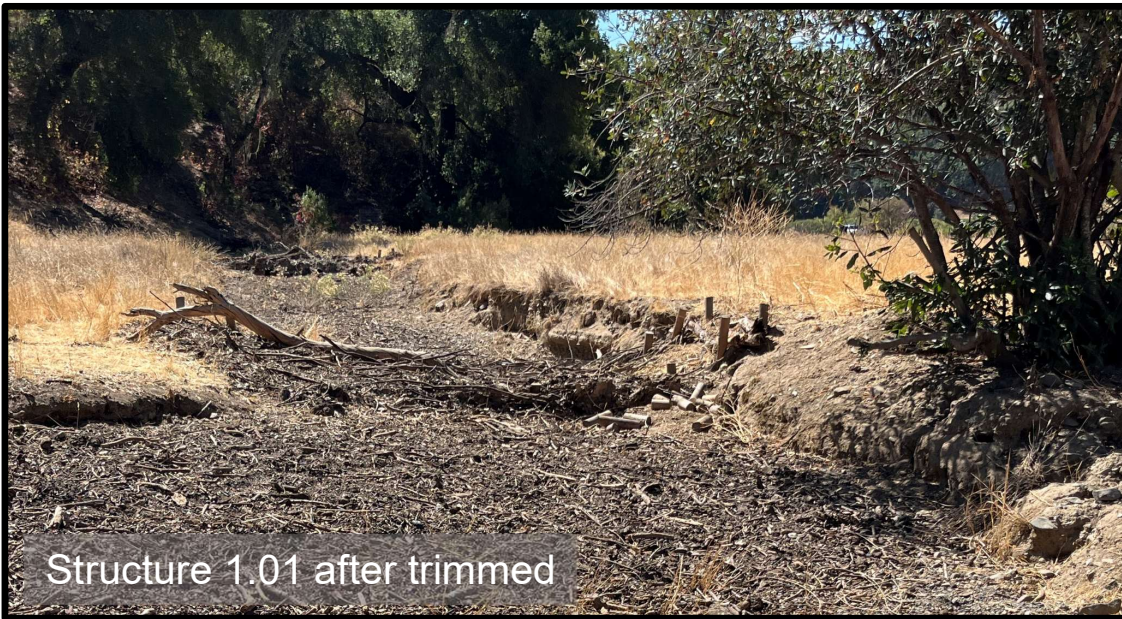
Structure 1.01 after trimmed

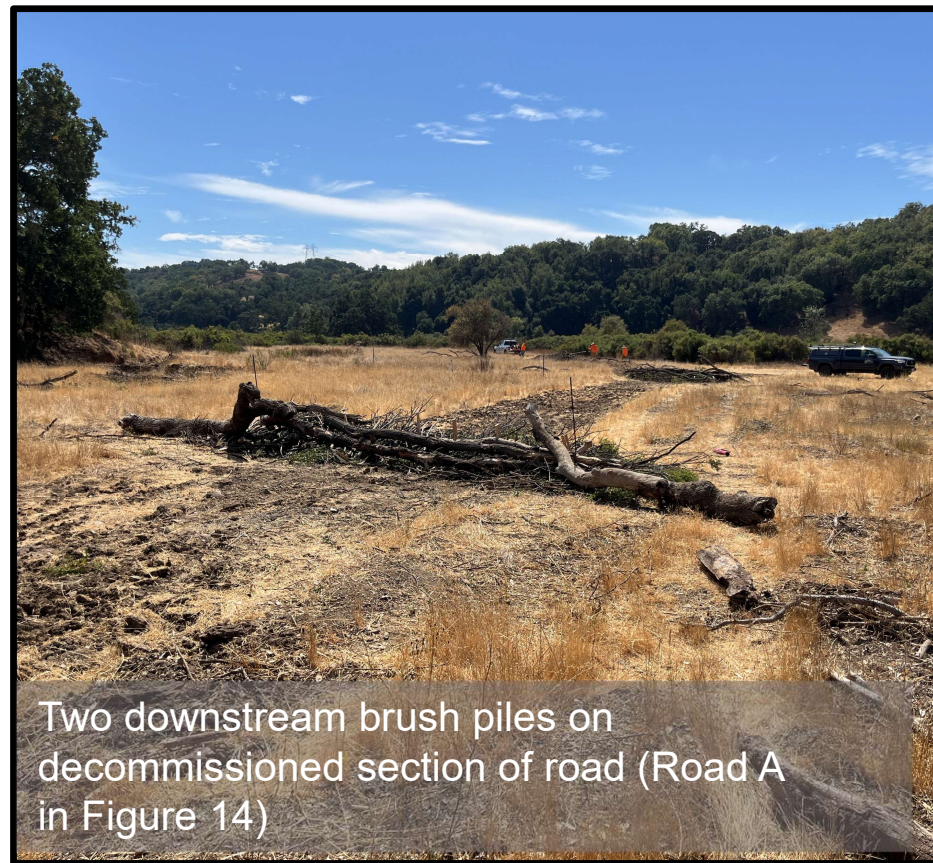
Two downstream brush piles on decommissioned section of road (Road A in Figure 14)

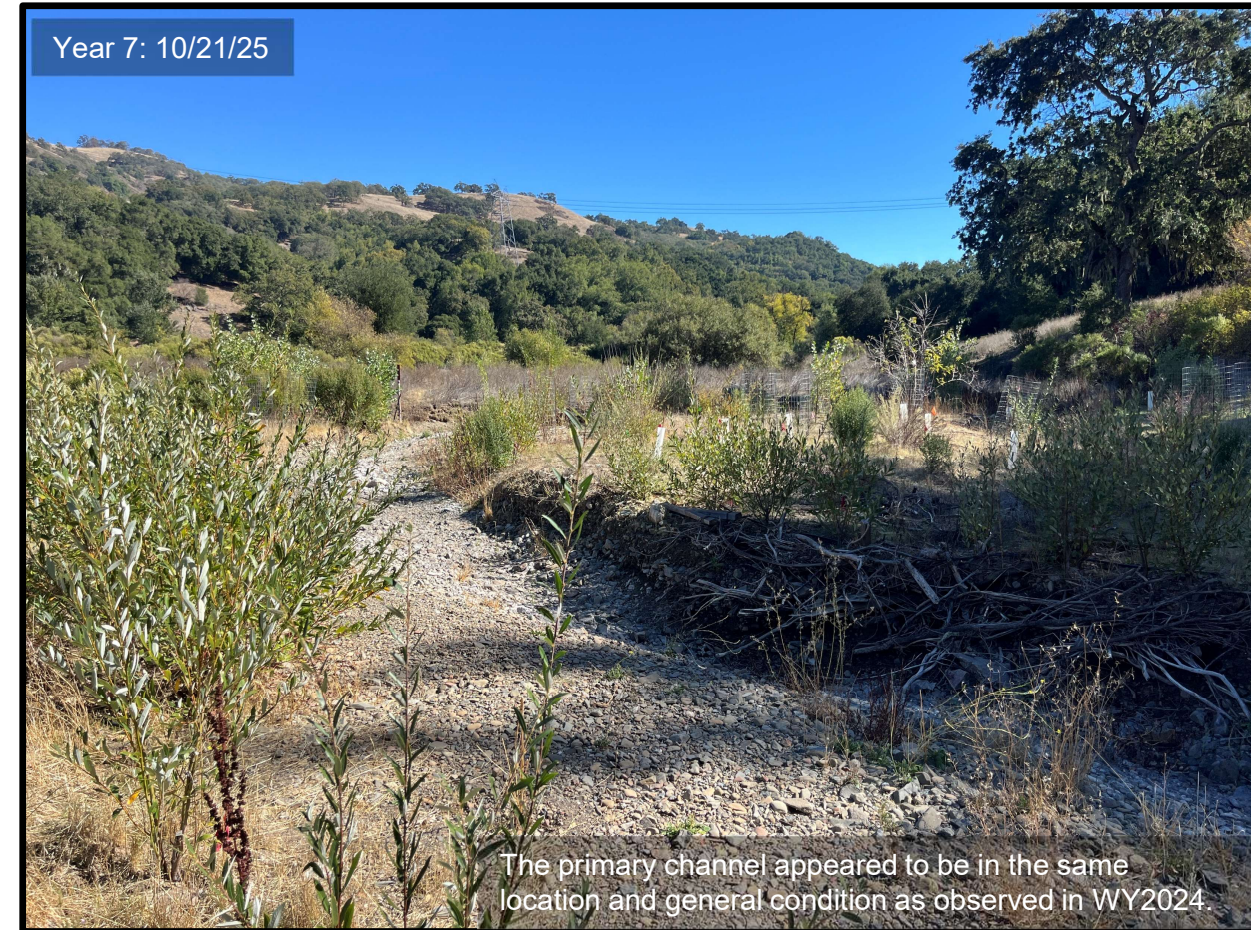
Figure 18. Comparison of San Felipe Creek at created floodplain ID03-02 between Year 1, Year 2 and post-adaptive management in Year 3, Year 4, Year 5, Year 6, and Year 7, looking downstream. San Felipe Creek Restoration Project, Joseph D. Grant Park, Santa Clara County, California.
