**Calero County Park Pond and Wetland  
Restoration Project—  
Year 4 (2020) Monitoring Report**

**Project # 3753-07**

December 30 2020

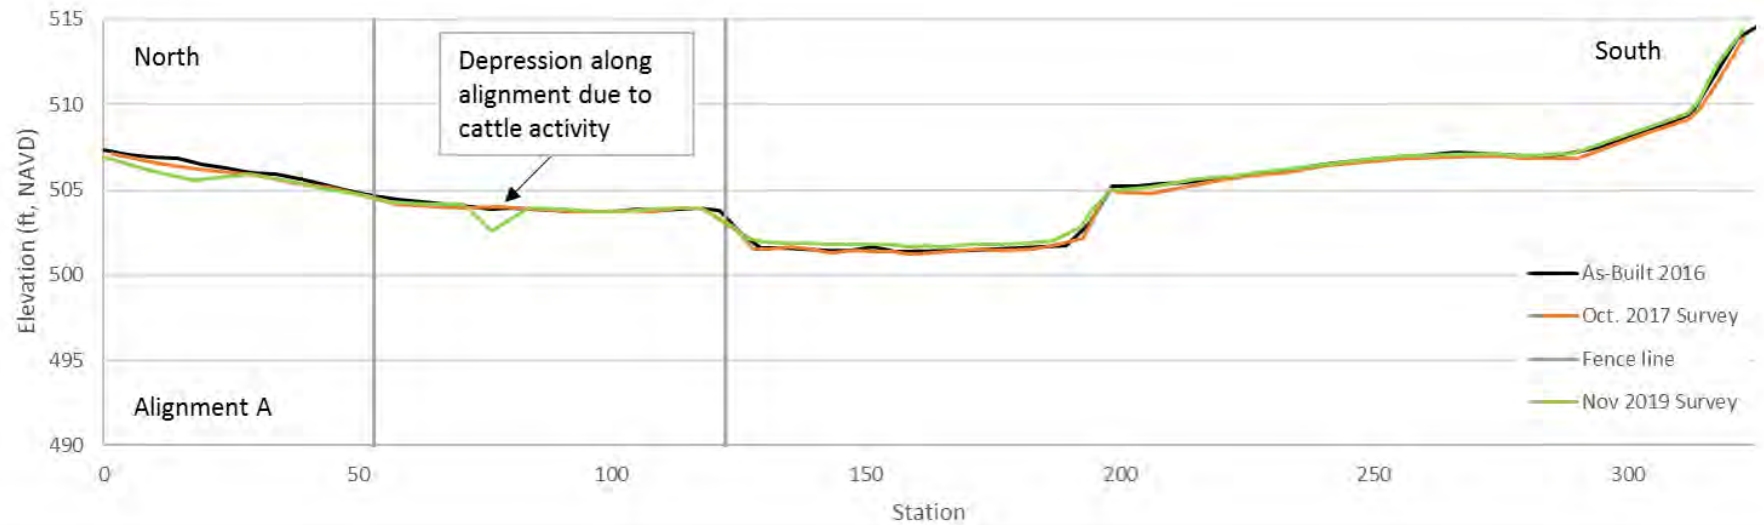
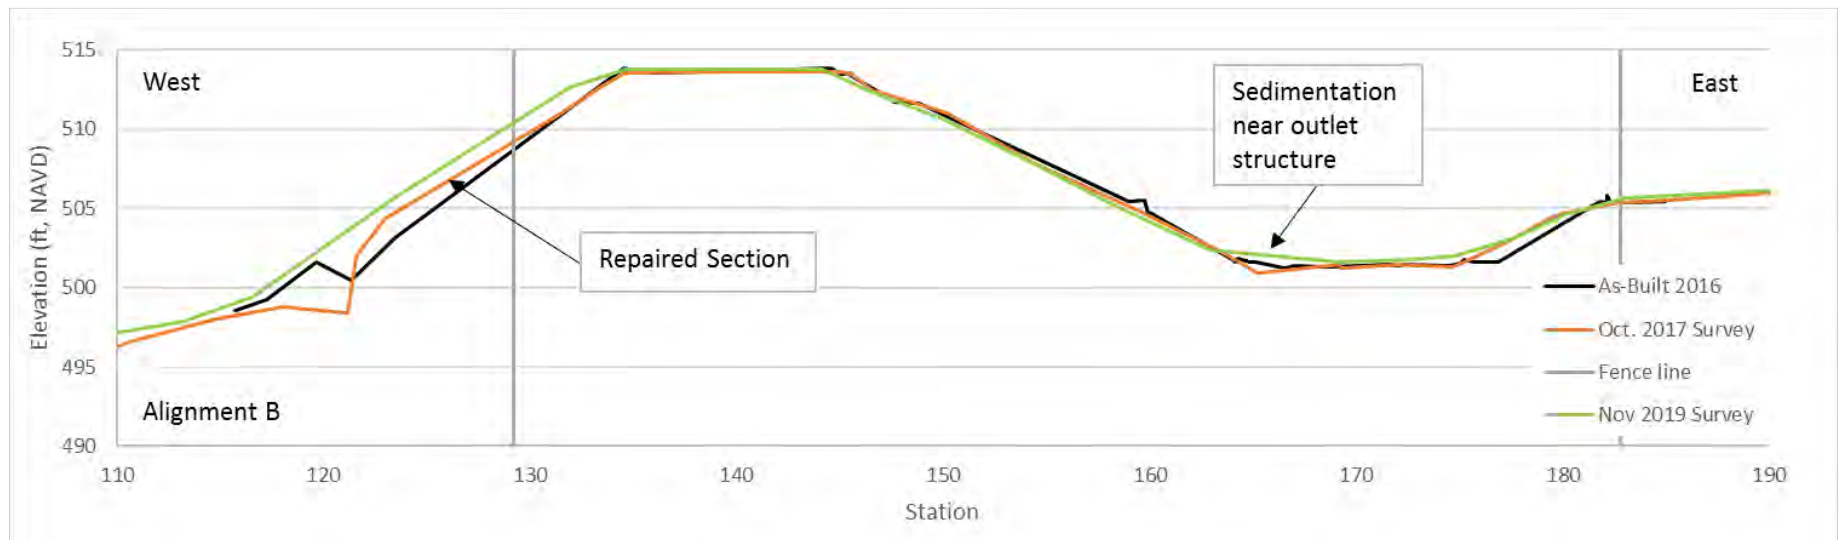
**Figure 4**

Notes: As-built elevations (black line) derived from as-built surface. Berm slump fixed after Year 1 at stations 115-123. Maximum sedimentation occurs on Alignment B at station 165.

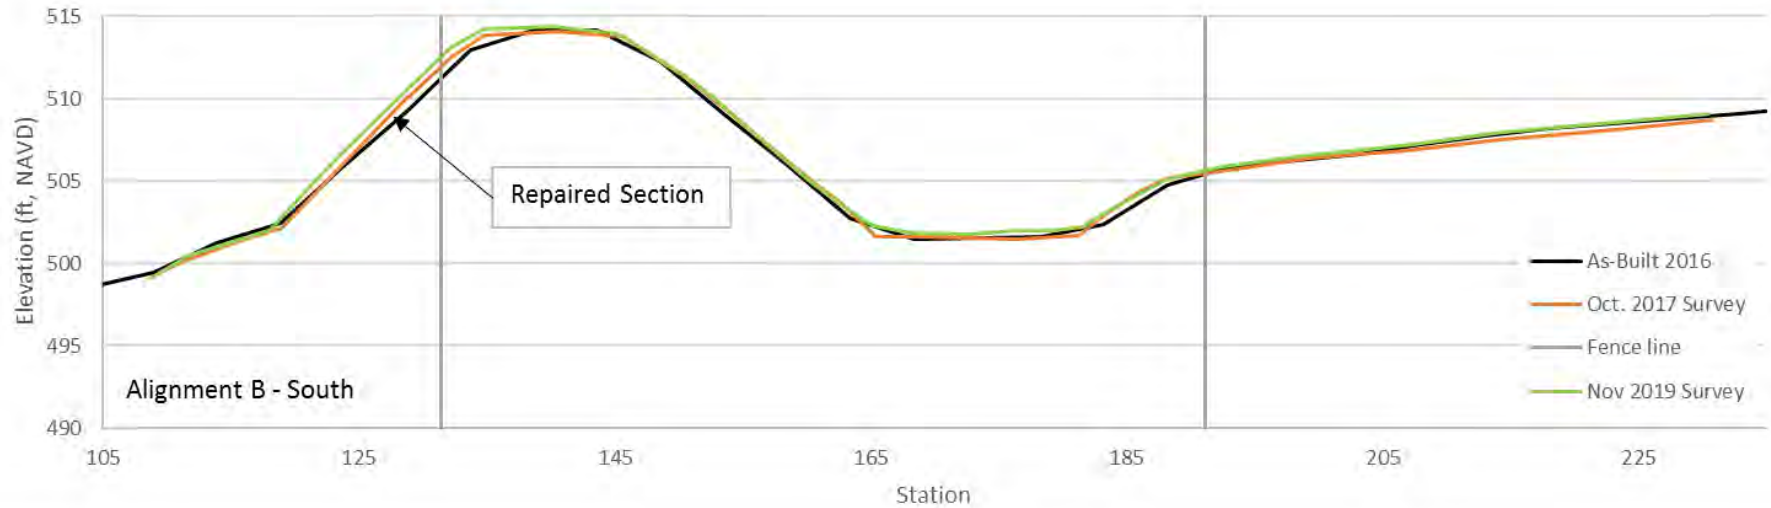
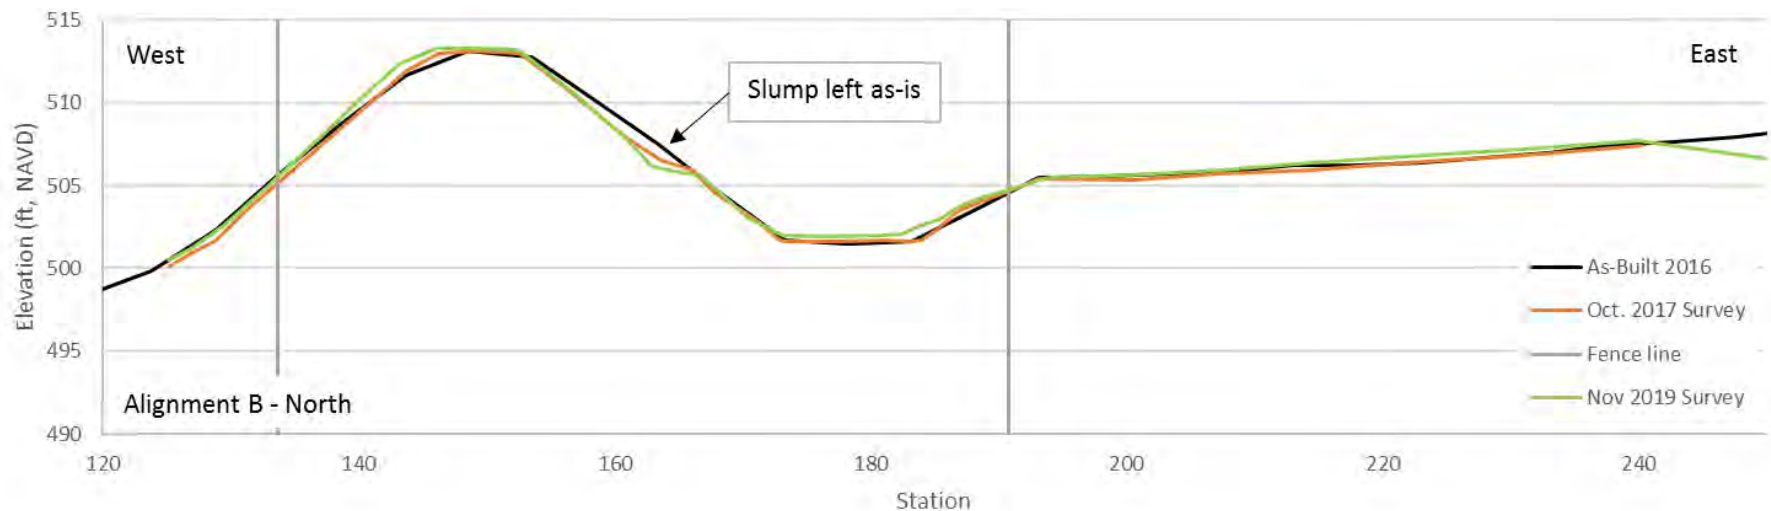
**Figure 5**

Notes: As-built elevations (black line) derived from as-built surface. Minor bank slump on Alignment B – North at station 165.

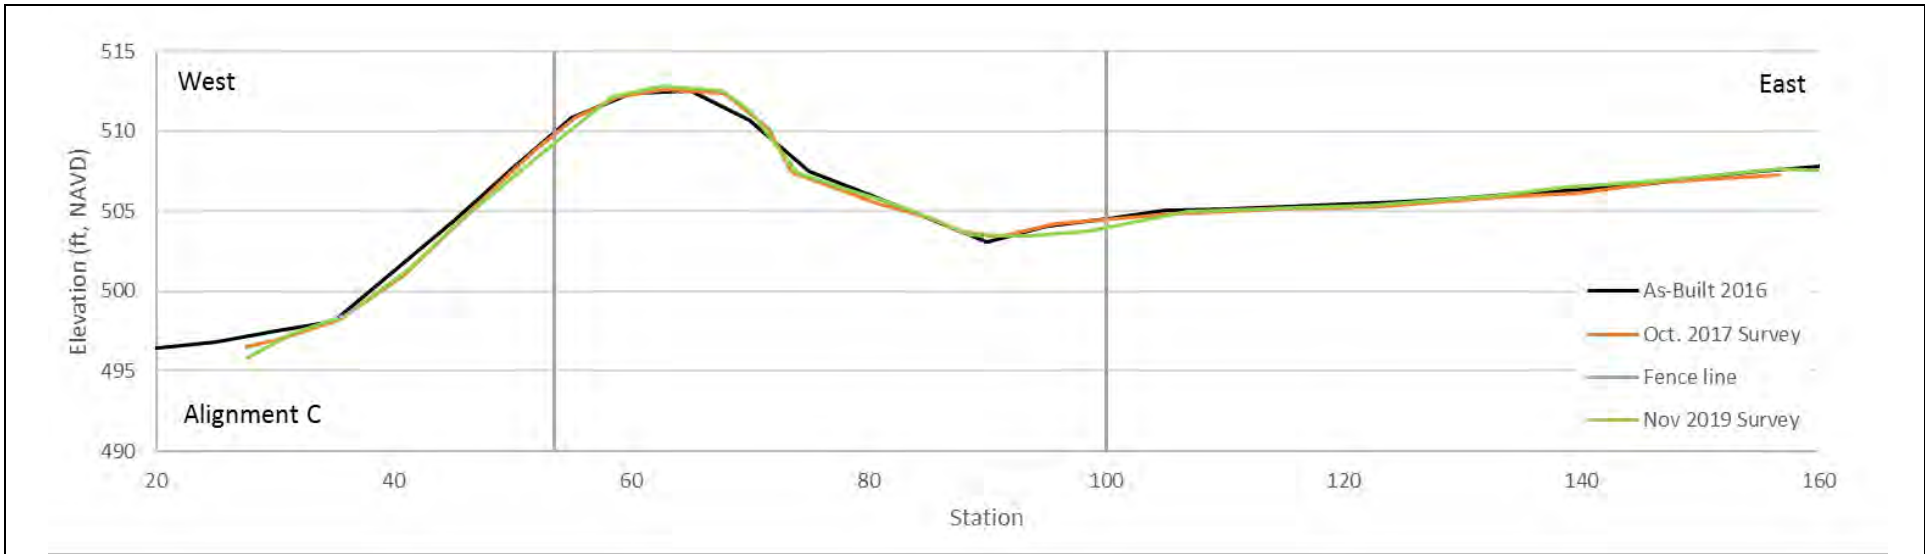
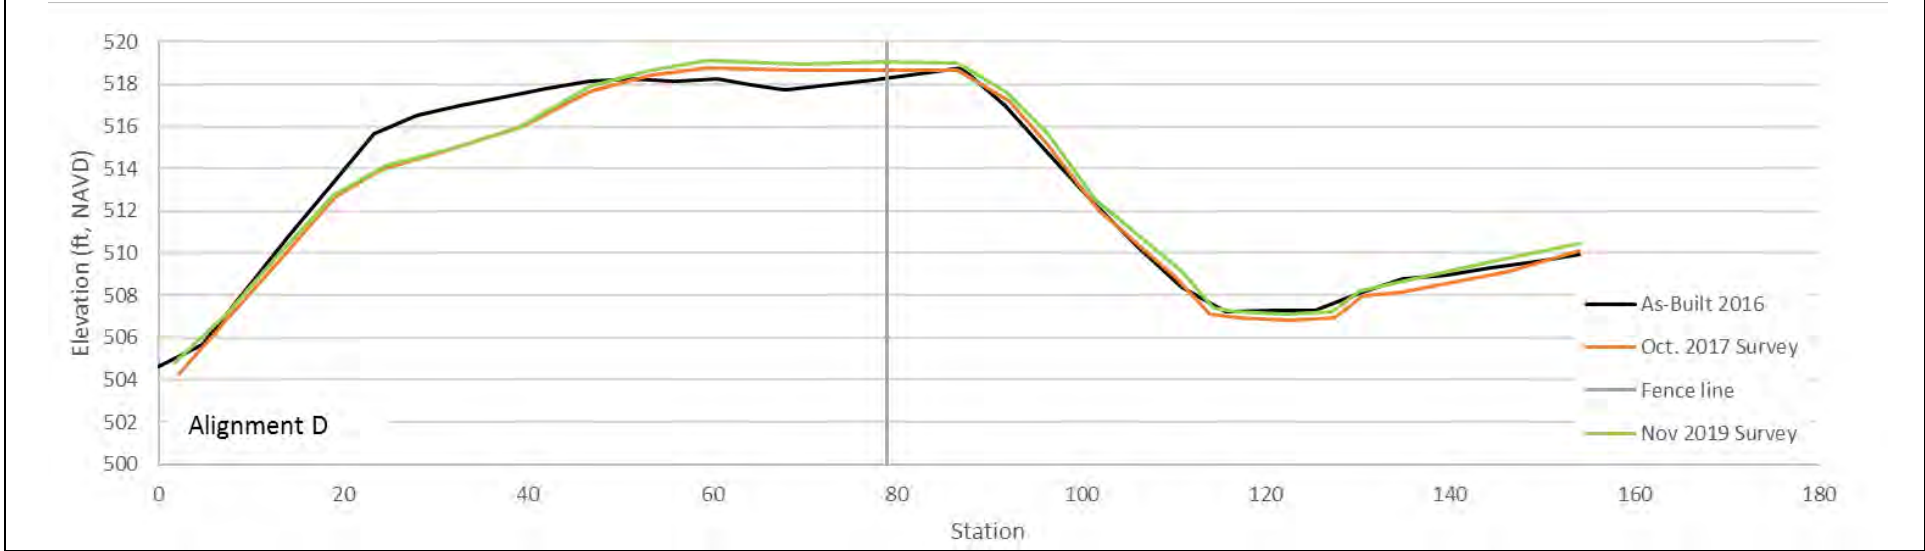
Notes: As-built elevations (black line) derived from as-built surface. Change on Alignment D stations 20-45.

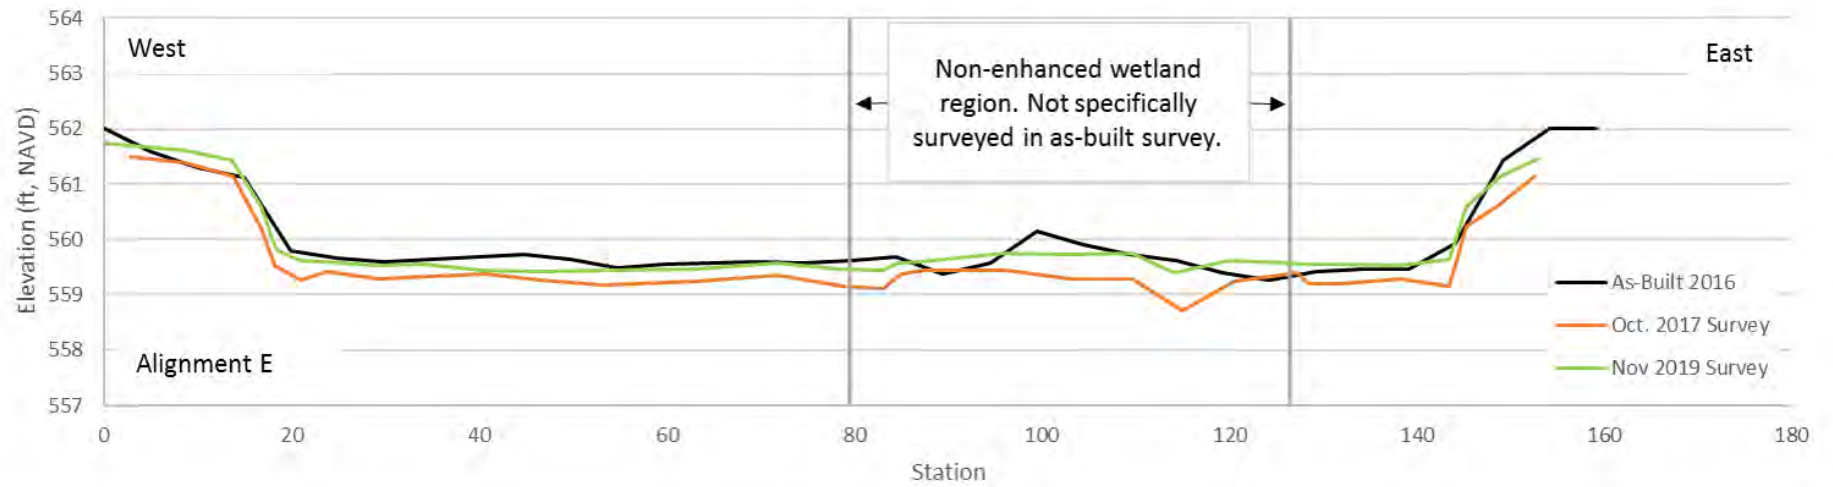
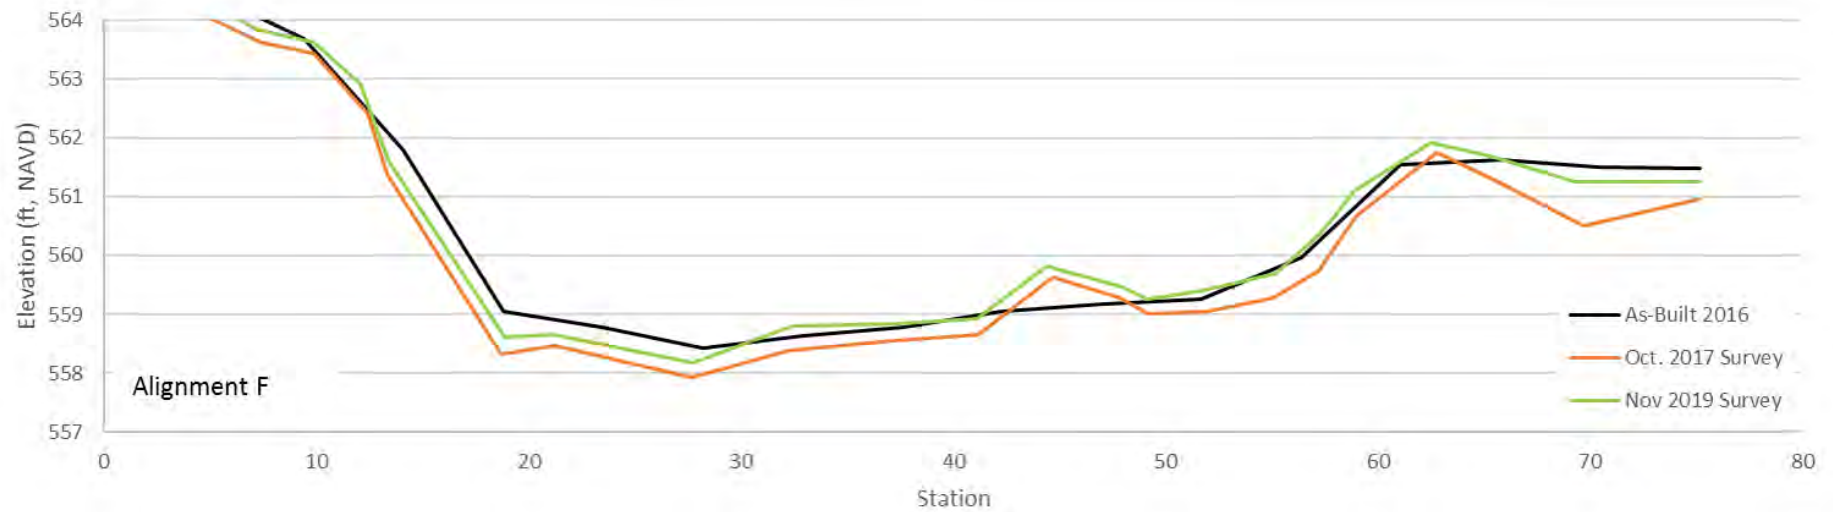
**Figure 7**

Notes: As-built elevations (black line) derived from as-built surface. Sedimentation in upper pond on Alignment F at station 45.
