# Point Blue Report

Pacheco Creek Reserve Contingency

Planting Project

Report to the Santa Clara Valley Habitat Agency

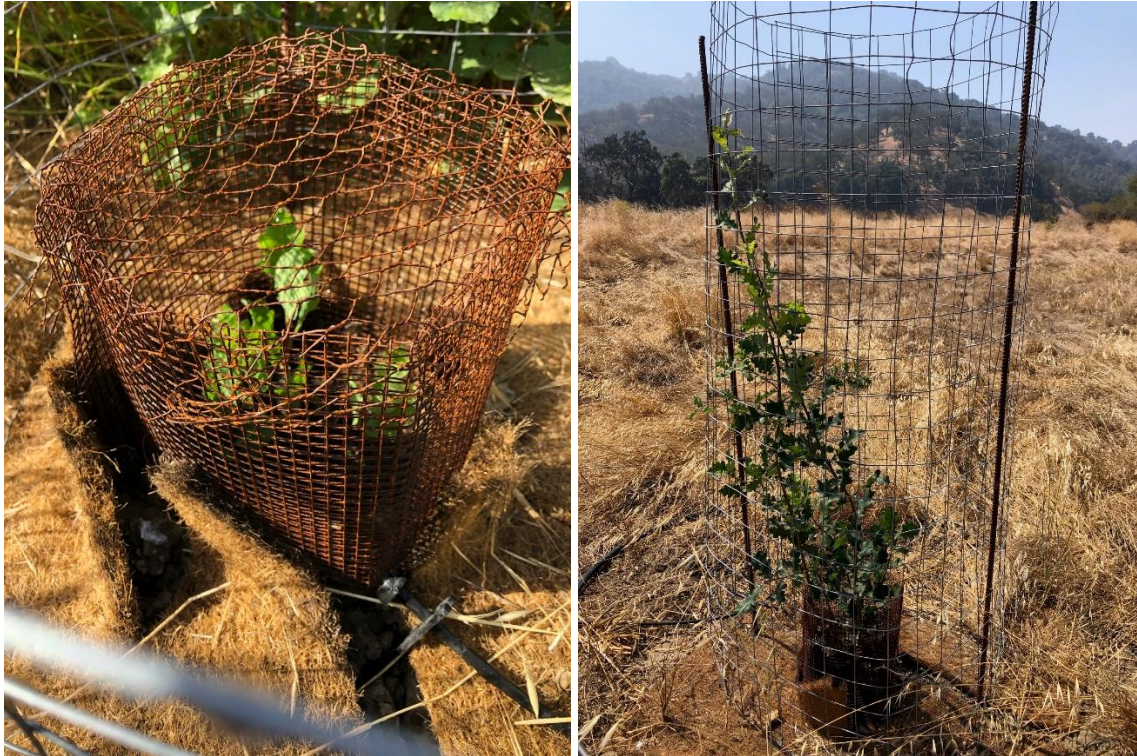
**Figures 4 and 5.** Valley oak acorns planted in March 2020 display germination and growth in May 2020 (left) and late August 2020 (right).

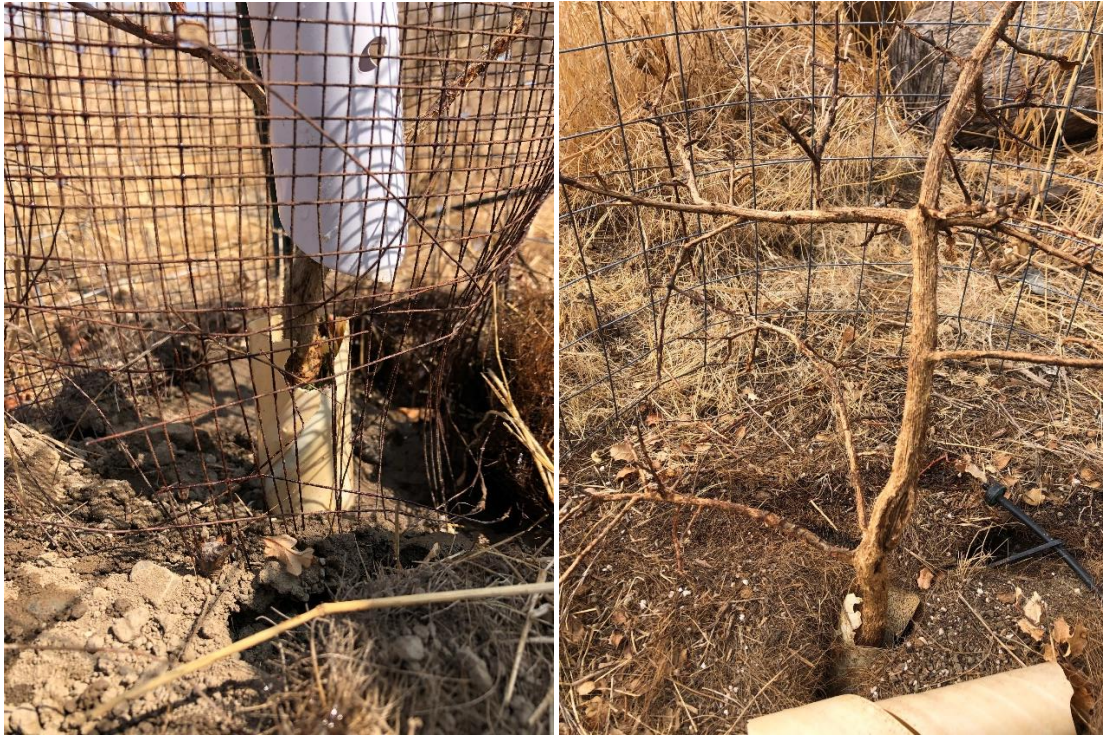
Overall rodent pressure was quite prevalent this year. By mid-June, we began to observe heavy girdling at the base of plants regardless of the plantings being newly installed or in their third year of growth. To account for the girdling, we installed tree wrap, however that effort didn't always thwart rodents (Figure 8) and we further observed later in the summer that rodents had climbed plants and girdled branches and even entire plants (Figure 9). Other rodent pressure included burrowing at the base of plants and exposing and girdling plant roots. By July through the rest of the fall we were repairing  $\frac{1}{4}$ " and  $\frac{1}{2}$ " dripline that had been chewed through by rodents.

**Figures 8 and 9.** Rodent girdling pressure resulted in much of the mortality that occurred this year.

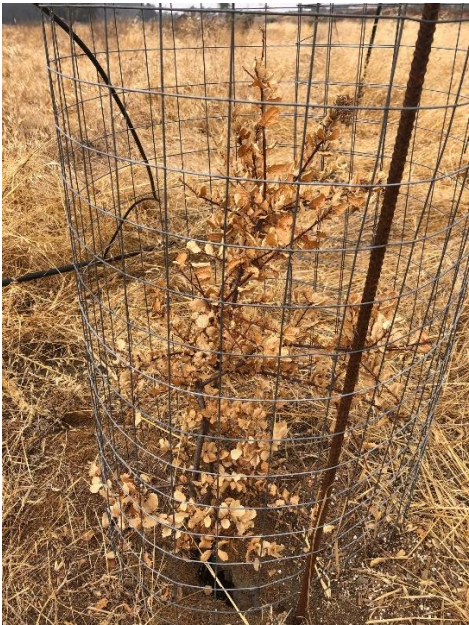
**Figure 10.** A healthy and thriving Coast Live Oak killed by rodent burrowing that exposed and girdled roots.
