Annual Report

Pacheco Creek Reserve Riparian

Restoration Project

Report to the Santa Clara Valley Habitat Agency

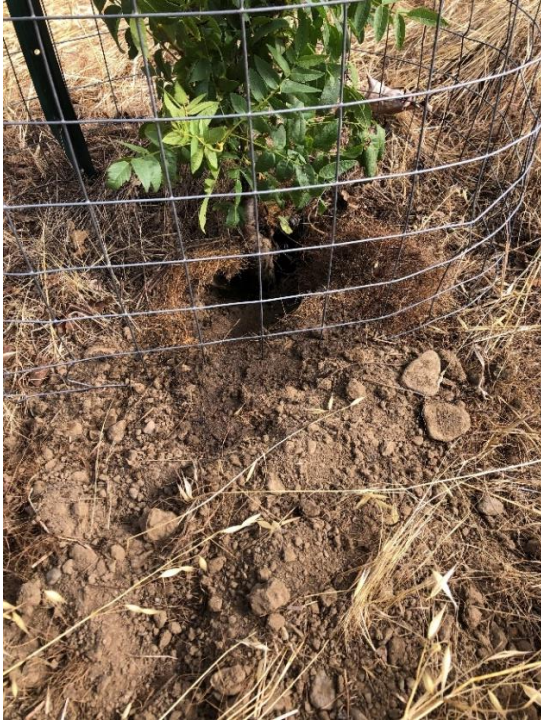
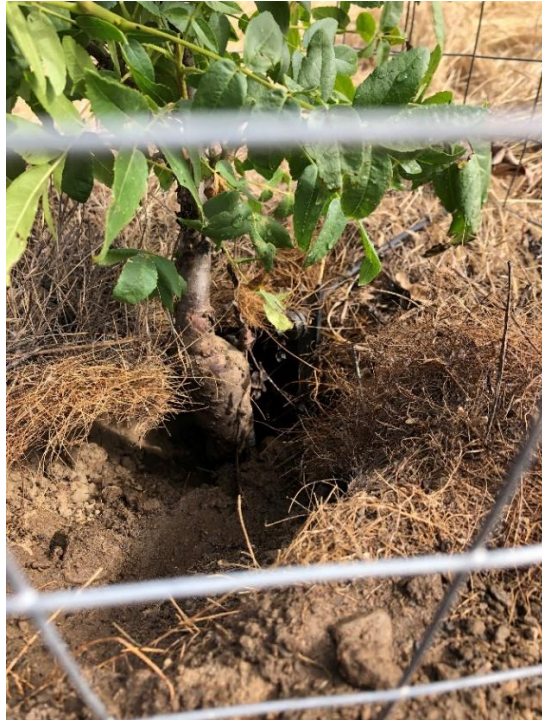
Overall rodent pressure was relatively minimal this past summer and fall. Of note was rodent burrowing at the base of an established walnut plant (Figures 7 and 8) and some of the other newer plantings. Another plant, a Fremont Cottonwood, was basically "clipped" by a rodent nibbling at the base of the plant. Despite aforementioned rodent activity, girdling was rarely observed during maintenance checks.

**Figures 7 and 8.** Third-year walnut with rodent burrowing pressure. We filled the hole and continued to water for the rest of the summer and the walnut tree was able to pull through.

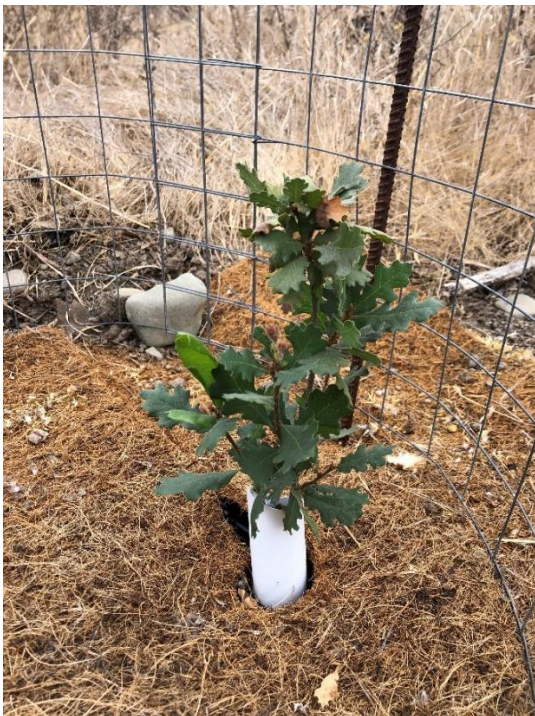
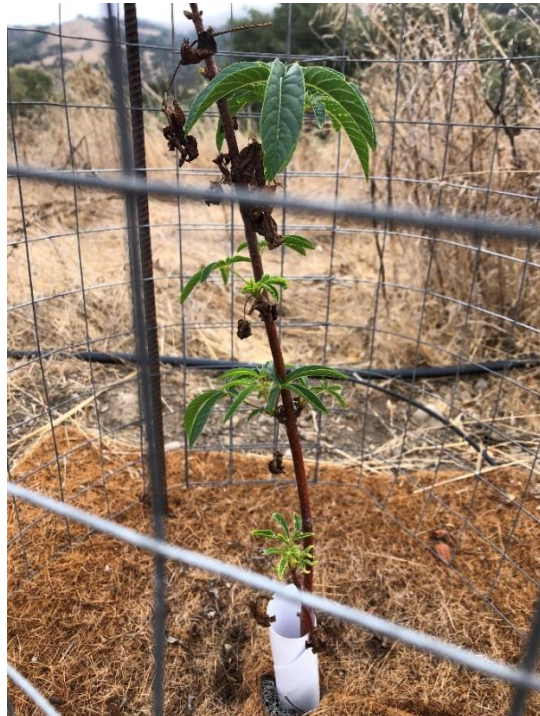
**Figures 9 and 10.** Healthy-looking first-year valley oak and buckeye trees – made it through the summer!
