Annual Report

Pacheco Creek Reserve Riparian Restoration Project

Report to the Santa Clara Valley Habitat Agency

January 2022

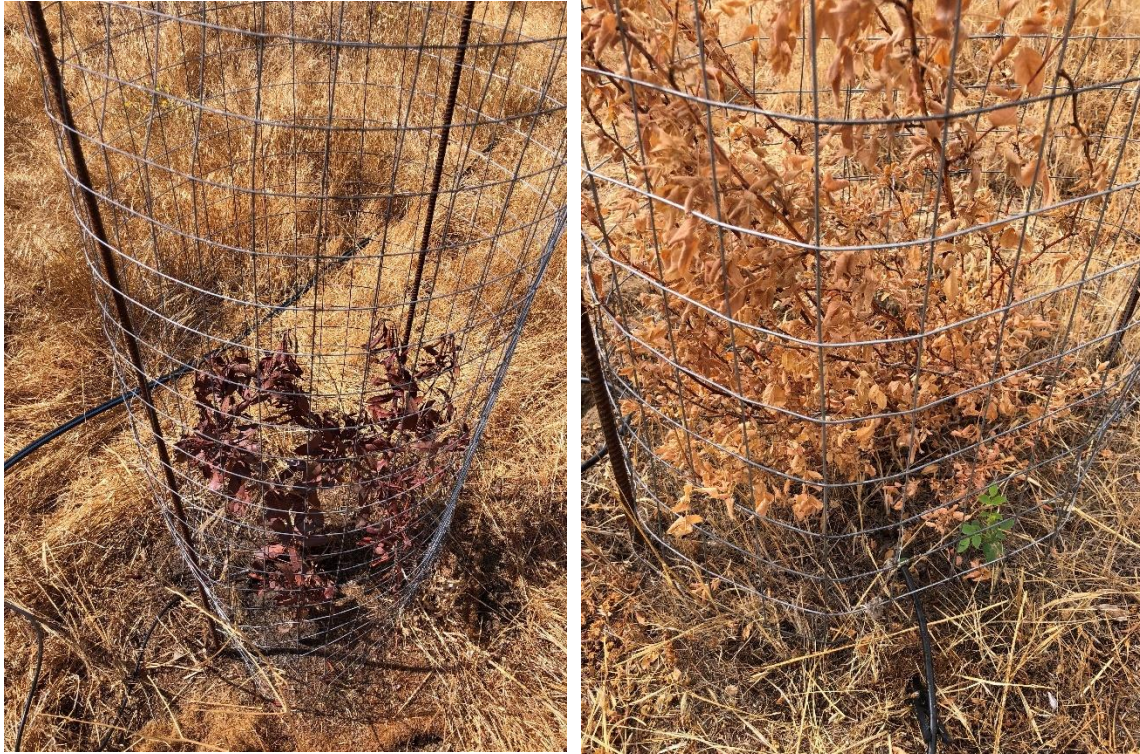
Overall rodent pressure was relatively minimal this past summer and fall. Despite minimal rodent pressure and consistent watering, we did notice some die-off that could not be attributable to anything observable. Of note, however, we experienced issues with water capacity beginning late August into early October. This was likely due to a dirty filter as the battery voltage was prime and there were no blockages within irrigation drip lines.

Figures 6 and 7. Photos from maintenance visit on 8/17/21. Year 2 Toyon (left) and Year 4 California Rose (right), struggling despite no apparent cause of plant mortality.

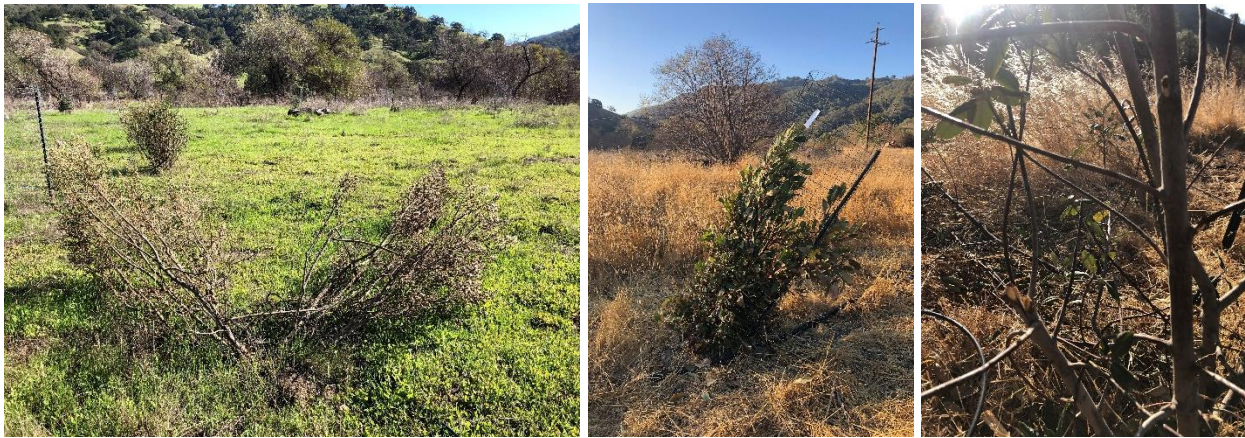
Figures 8, 9, and 10. Various impacts from cattle presence in the planting area. All are established Year 4 plantings and will be monitored for resilience post-impact.
