Local Assistance Grant

SR-152 Pacheco Pass Wildlife Connectivity Study

October – December 2021

## Local Assistance Grant: Coyote Valley Road Ecology Study

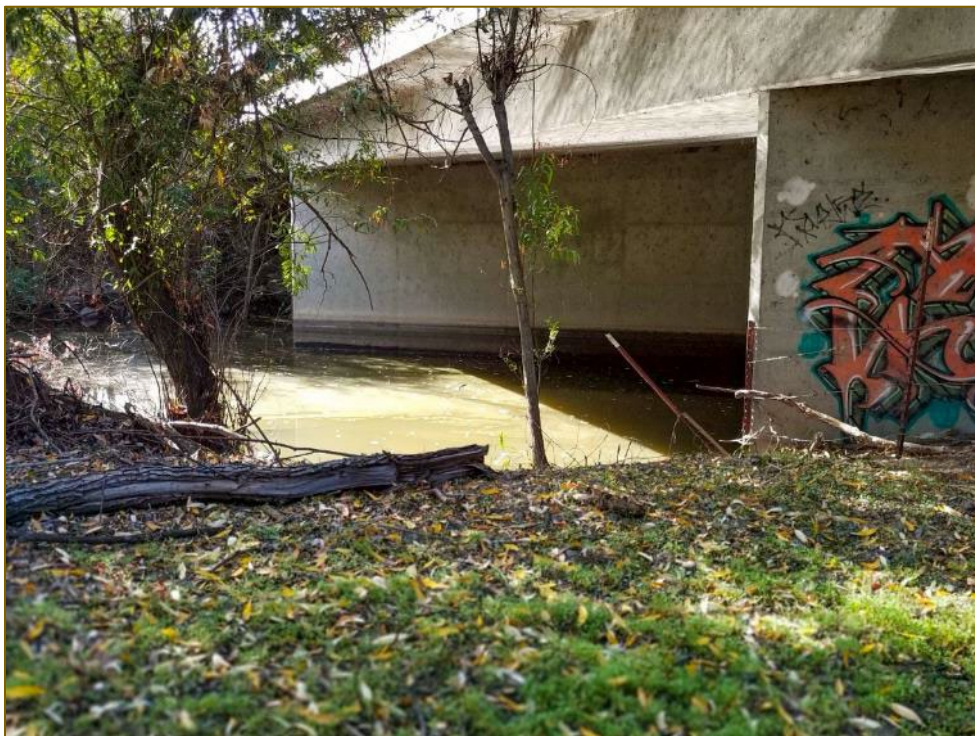
The landowner on the eastbound side has cattle and there is four-strand barbed wire-fencing placed at the openings of the outer sections. There is no fencing at the center section. The habitat beyond the eastbound opening riparian, however it leads to open grassland up into the hills. On the westbound side there are no cattle, and no fencing at any section. The habitat beyond the westbound opening is thick riparian with blackberry (*Rubus ursinus*), bay laurel (*Umbellularia californica*), wild rose (*Rosa californica*), and sycamore (*Platanus racemosa*) situated directly in front of the westbound opening and continuing north along Pacheco Creek.

Figure 4. View of eastbound opening showing water level, and fencing. Facing west.

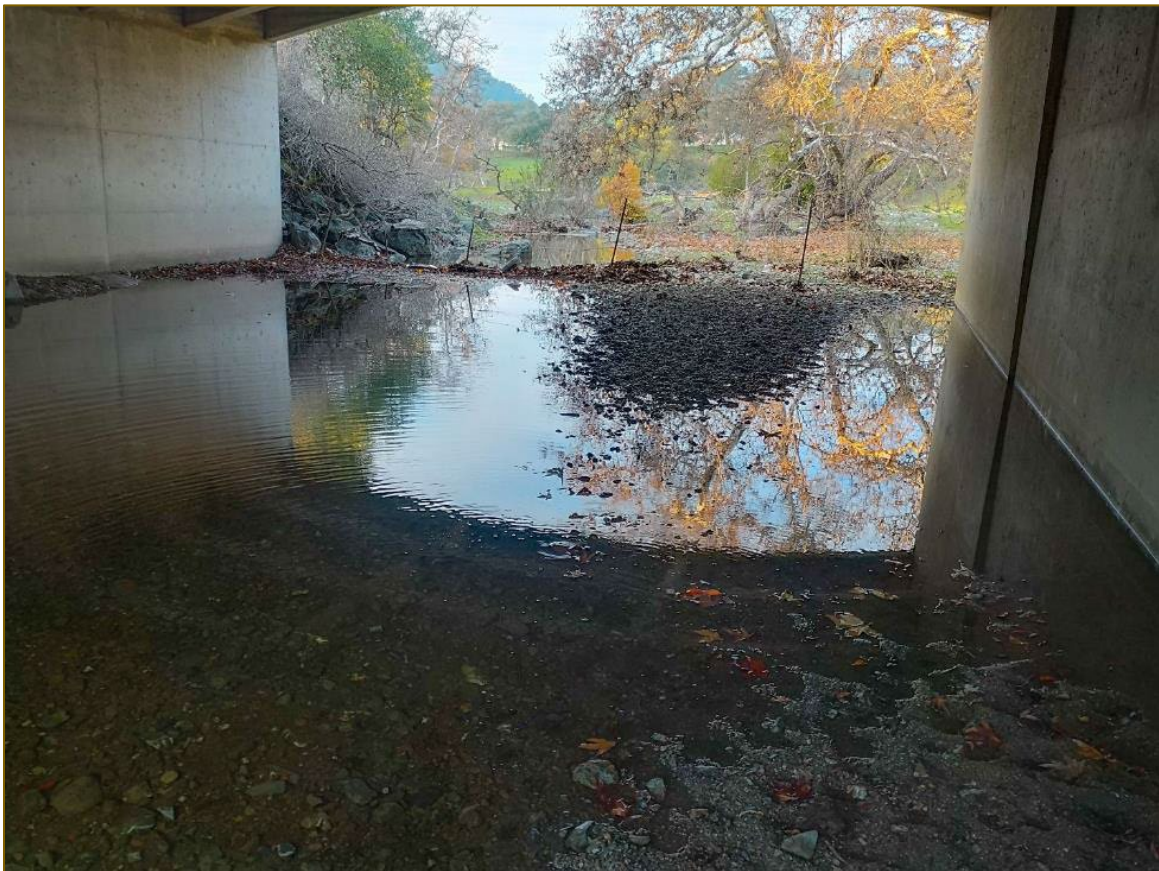
There is four-strand barbed wire fencing running along the westbound opening of the western and center sections, yet there is electrified fencing at the eastern section. There is also cow presence at both the westbound and eastbound sides of the highway. The cows are separated only by the fencing at the westbound opening. In fact, this camera station detects a high amount of cow presence as they routinely group together under the bridge.

Figure 7. View of water level and fencing on 2021-12-21 at center section of bridge 370466. Facing north.

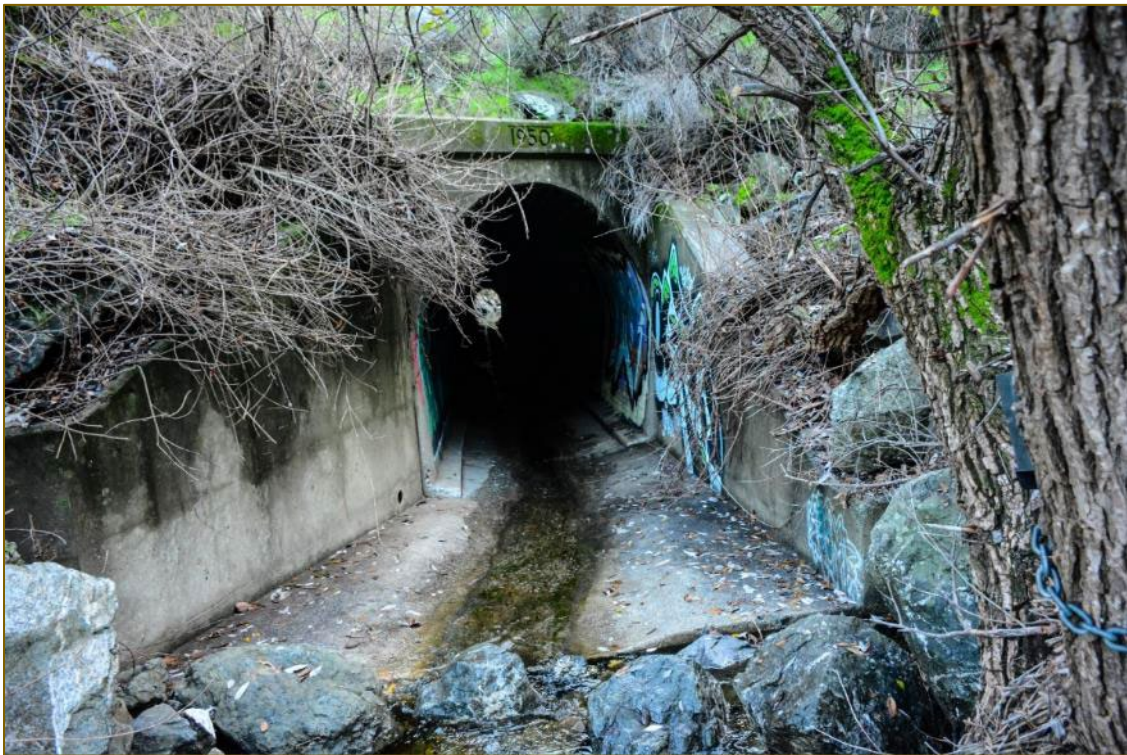
Figure 11. Westbound opening of culvert PM 32.61. Facing south.

Situated at the bottom of steep ravines, this culvert has a sharp decline from the westbound to the eastbound opening (Figure 11). Along with this decline, there is an approximate three-foot drop at the eastbound opening creating enough depth for a small pond which keeps water throughout the majority of the year (Figures 12 and 13). At the westbound opening, there are multiple pools of water spread out and spanning to culvert PM 32.75 to the east. Since the culvert declines to the south (eastbound opening), water does not form a pond like the westbound opening.

However, there has not been a single terrestrial mammal approach or passage at this culvert since deployment. One of the causes could be the pond of water in front of the eastbound opening, along with the steepness of the ravines beyond the westbound opening. Another note, for a rather remote location, there have been multiple people walking through to spray paint the culvert (Figure 14). The camera is detecting birds, and bats showing the camera is fully functional (Figure 15).

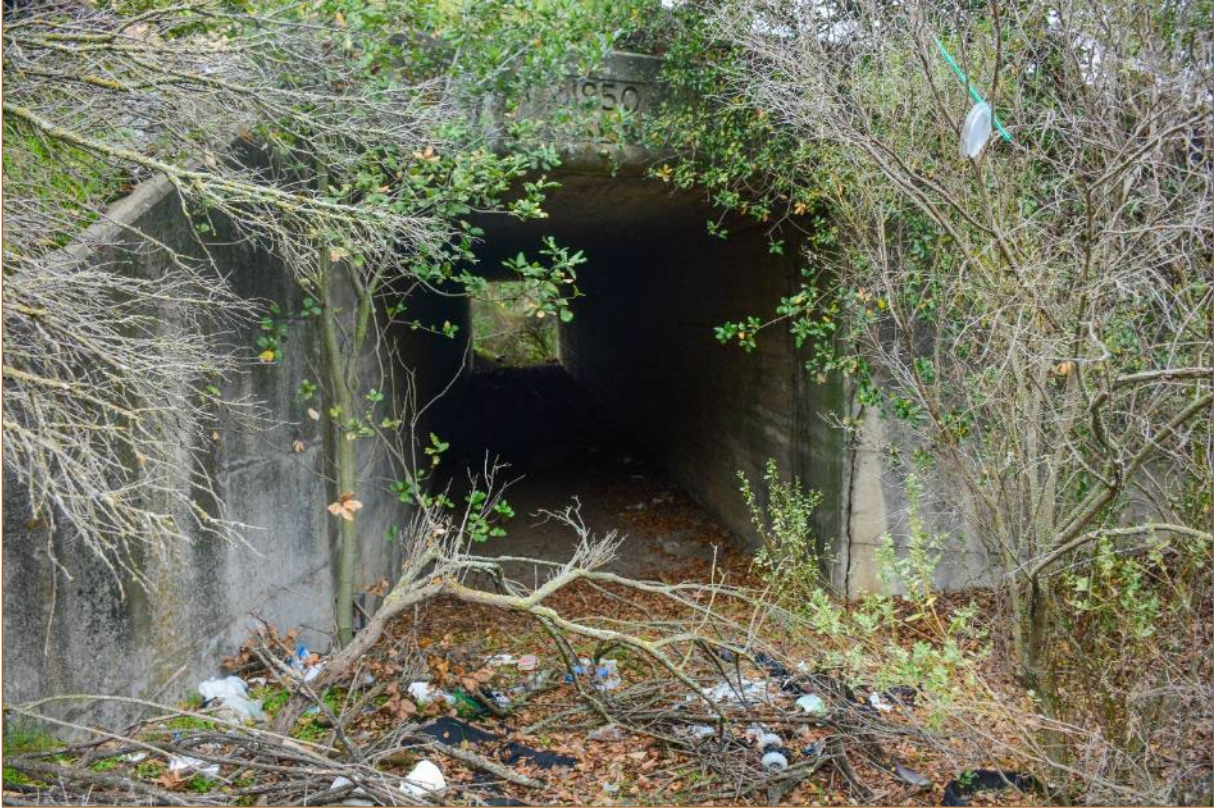
This culvert is set above a smaller drainage located to the west and at the bottom of a deep ravine (Figure 20). The benefit of having a lower drainage below this culvert is water gets diverted via the smaller drainage instead of this structure. For example, during the heaviest and most constant rainfall in December, this culvert had no water running through it.

The eastbound opening has a gate placed in front of it, but there is a gap large enough that medium sized wildlife can still cross through.

Figure 20. Westbound opening of PM 33.04.

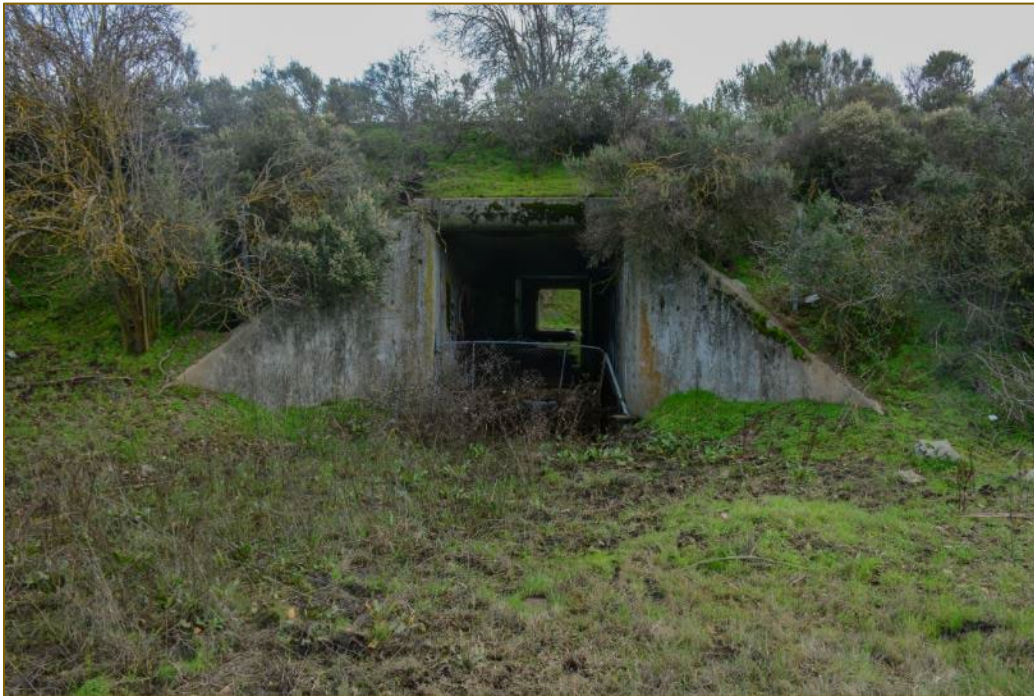
Figure 25. West bound opening of culvert PM 34.64. Facing north.

This site has multiple, medium-size species use on a consistent basis. We have recorded species such as raccoon, coyote, striped skunk, and bobcat approaching, and successfully crossing through this culvert (Figure 25). There have been no deer passages or approaches since camera deployment. There is a gate placed at the westbound opening of the structure, most likely acting as a blockade from cow passage. The eastbound opening has no fence and is clear of any debris. Beyond the eastbound opening there is a ravine that immediately leads west. Also, there is an approximate 2-foot drop from the floor of the culvert creating a small pool of water (Figure 26).

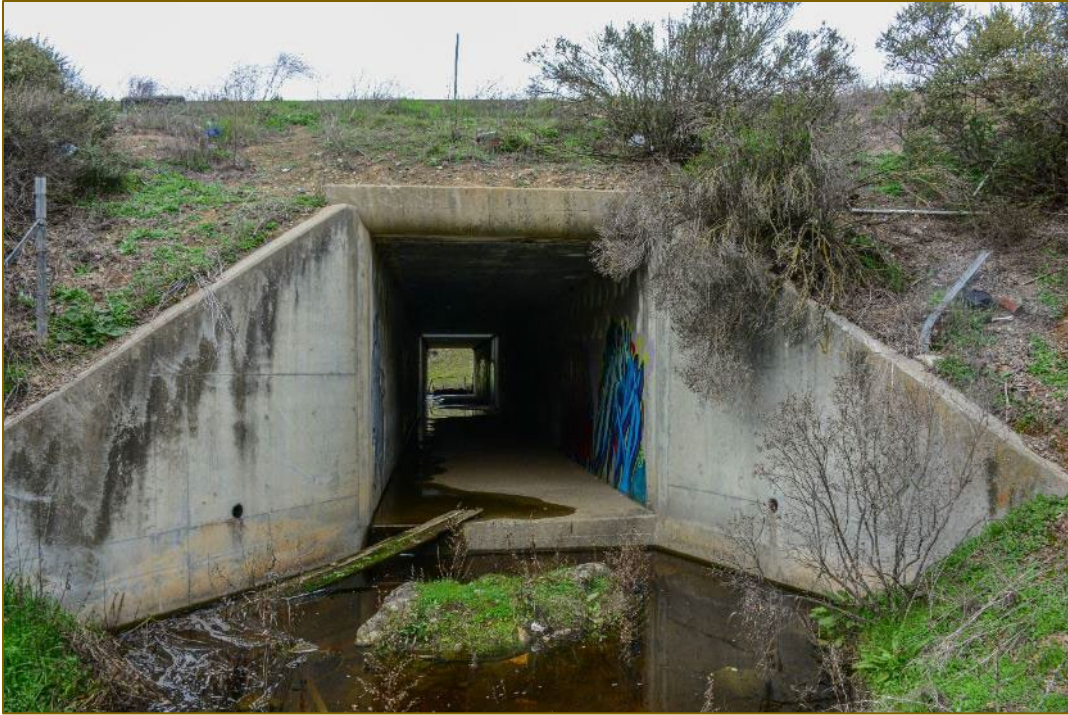
Beyond the westbound opening there is open grassland and a wide shallow pond which spans to the eastbound opening of culvert PM 34.78 (next culvert to the east). After the first rain in November, both the westbound and eastbound openings began holding small pools of water. However, the eastbound opening held a deeper pool due to the two-foot drop. In December, our camera recorded the rising water levels and became submerged. Prior to that, we regularly recorded wildlife passages.

Figure 26. Culvert 34.64 eastbound opening. Facing north.

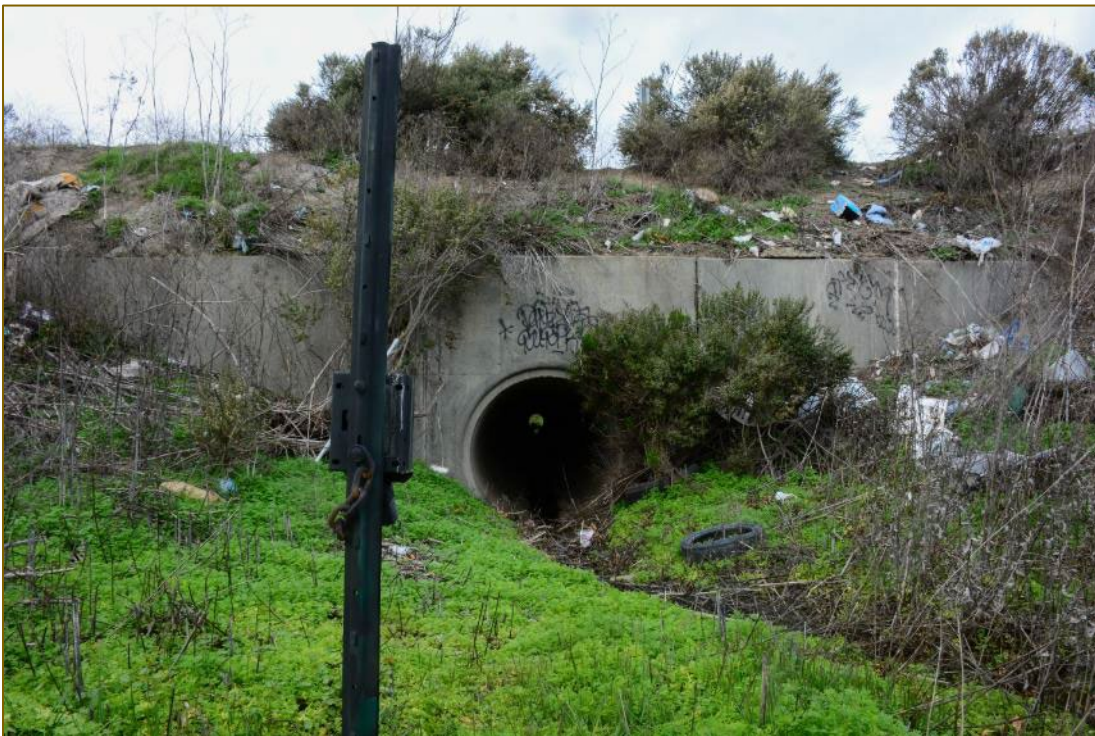
Figure 27. View of westbound opening. Facing north.

From October to December there have been no data collected of successful wildlife usage or approaches at this structure (Figure 27). This is a drastic difference compared to prior months, as there have been recorded presence of coyote approaching, and passages at this site. One explanation for the decline in detections could be the presence of construction crews (Figure 28). In September, one crew began replacing a property boundary fence directly behind the camera. New stakes, and five-strand barbed wire fencing were installed. Furthermore, the turnout located above the culvert, and the area behind the camera station were both utilized to stage equipment (Figure 29).

Then, in October, the entire turnout area above the culvert was regraded, and temporary fencing was replaced with new fencing. This construction lasted until the rain events. Since this culvert is a low use culvert to begin with, it can be assumed that wildlife shifted their routes to culvert PM 34.64, which is very close to the west. In any case, this is the first period where we have not recorded a single animal at this culvert since camera deployment.

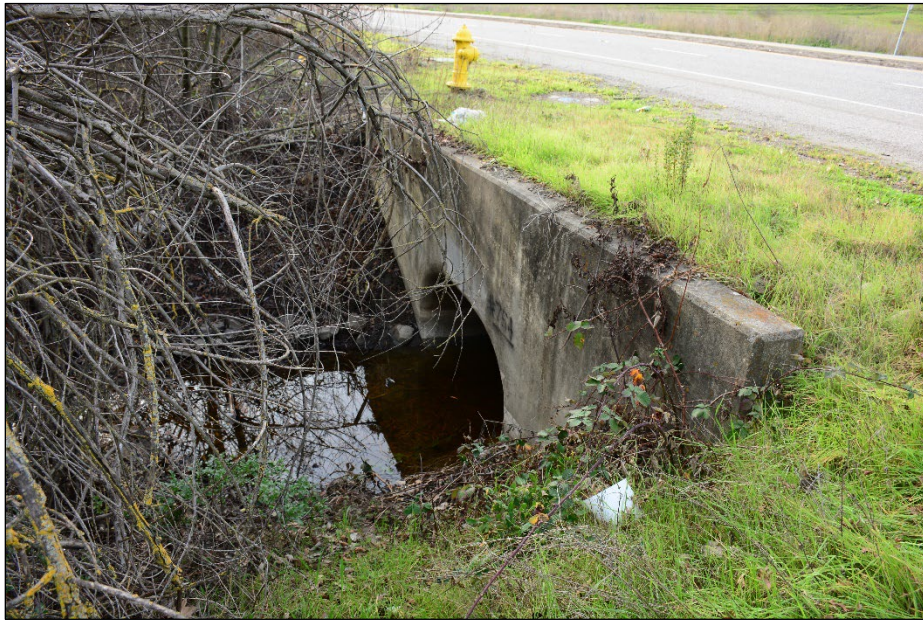
The Bailey Avenue culvert is flooded by water on both the south and north sides (Figures 2-4). We were previously recording multiple species such as bobcat, coyote, skunk, and a raccoon family traveling both south and north through the culvert. However, since the culvert has been flooded, we have not recorded any wildlife traveling through the culvert.

Figure 2. Bailey culvert, south side on 1/13/2021.

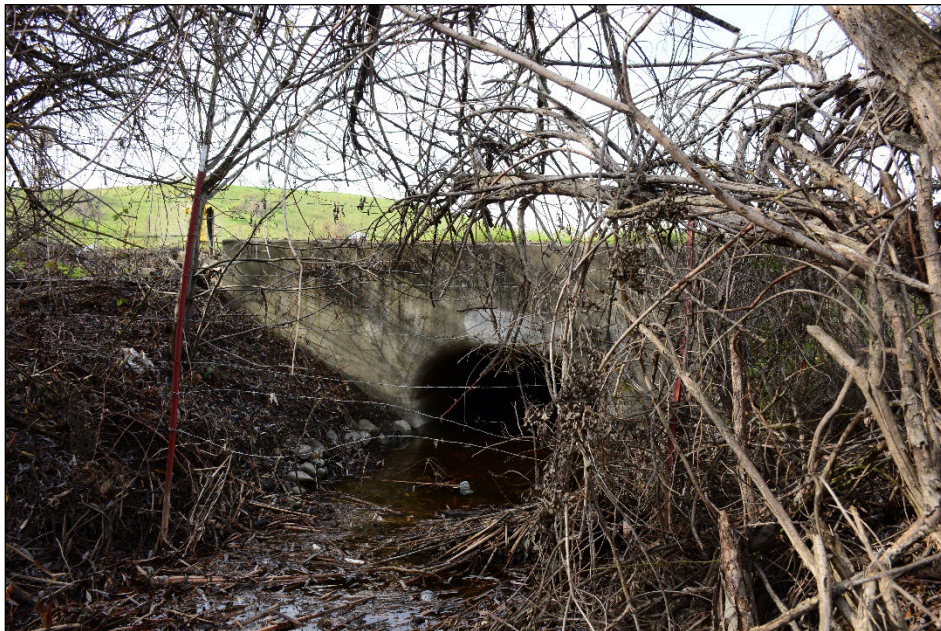
Figure 3. Bailey culvert, south side on 1/13/2021.

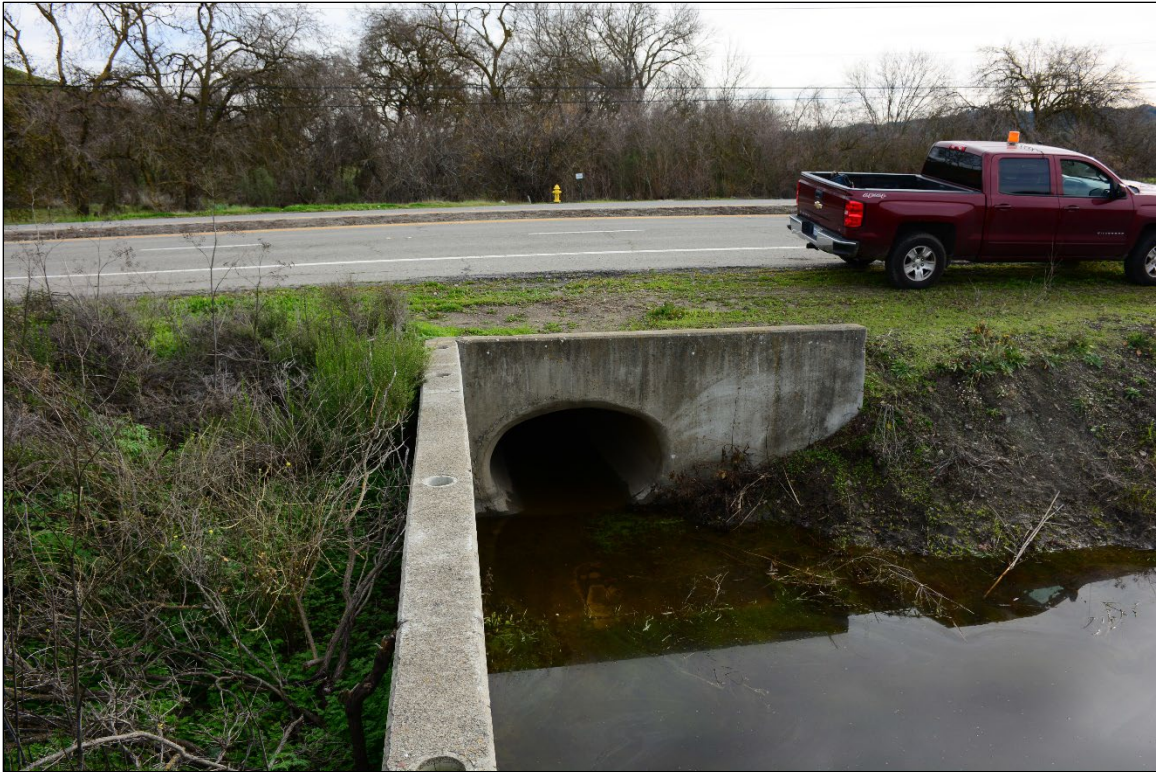
Figure 4. Bailey culvert, north side on 1/13/2021.

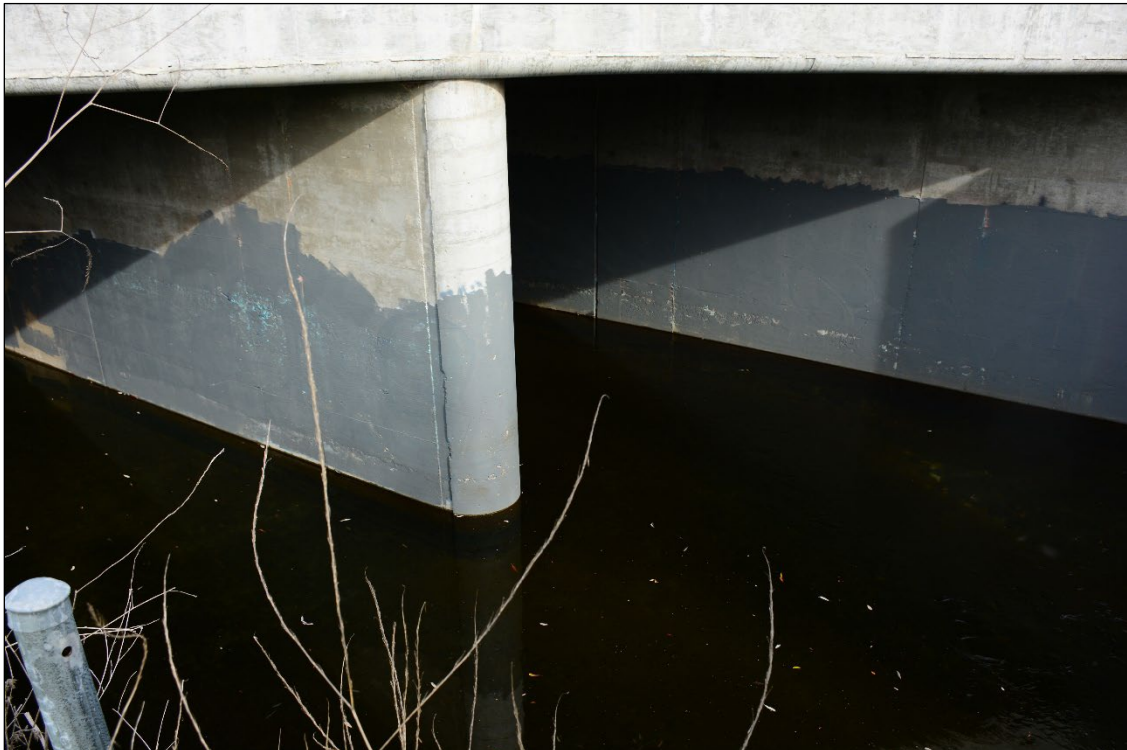
The Fisher Creek culvert at Santa Teresa Boulevard is flooded by water (Figure 5). This large dual box culvert typically remains flooded throughout the year as Valley Water pumps water through Fisher Creek for supplying water to east San Jose. We have not documented any wildlife movement through these culverts.

Figure 5. Santa Teresa Boulevard culvert, west side on 1/13/2021.

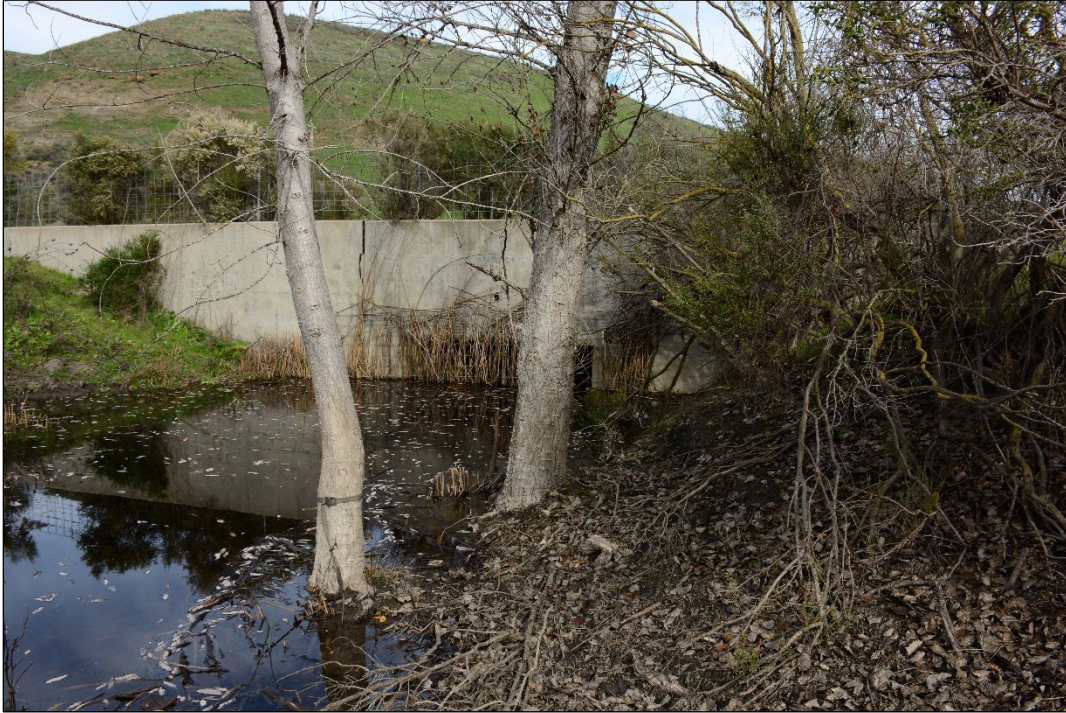
The Laguna Seca culvert at Santa Teresa Boulevard is flooded by water (Figure 6). This culvert was dry during the summer months, however, there is fencing set up on the west side of the culvert (Figure 7). This may be restricting wildlife movement through the culvert as we have only document raccoons traveling through a small opening at the bottom right section of the fence (Figure 8).

Figure 6. Laguna Seca culvert at Santa Teresa Boulevard culvert, west side on 1/13/2021.

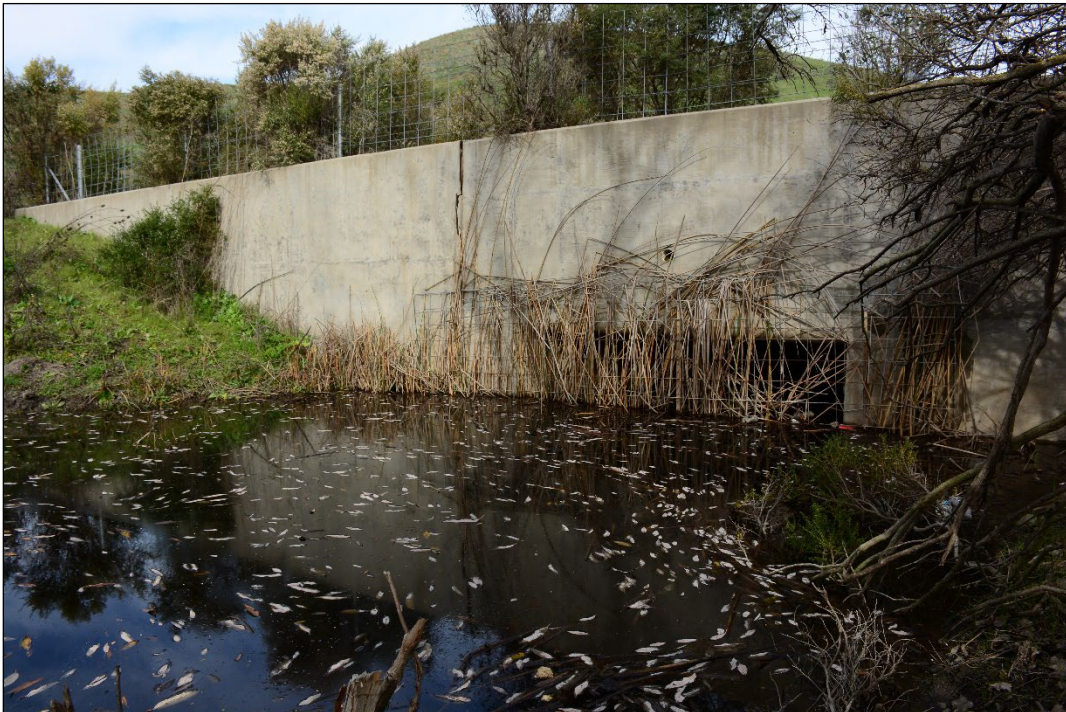
Figure 7. Laguna Seca culvert at Santa Teresa Boulevard culvert, west side on 1/13/2021.

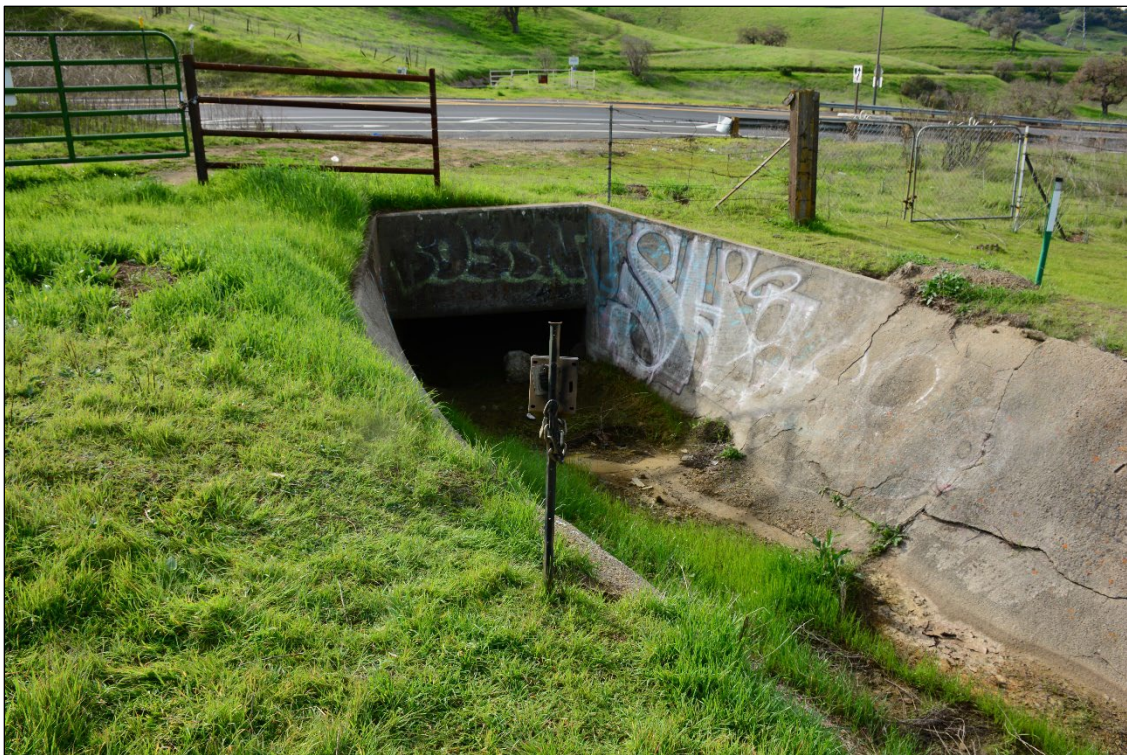
The Coyote Alamitos Canal is not inundated by water on the west side at Tulare Hill or in the mid-section (Figures 7 and 8). However, there is a pool of water on the east side of the canal (Figure 9). Since the beginning of the monitoring period, we have recorded very few detections of wildlife traveling through the culvert. Only several raccoons have been recorded traveling through the canal under Santa Teresa Boulevard.

Figure 7. Coyote Alamitos Canal at Santa Teresa Boulevard, west side at Tulare Hill on 1/13/2021.

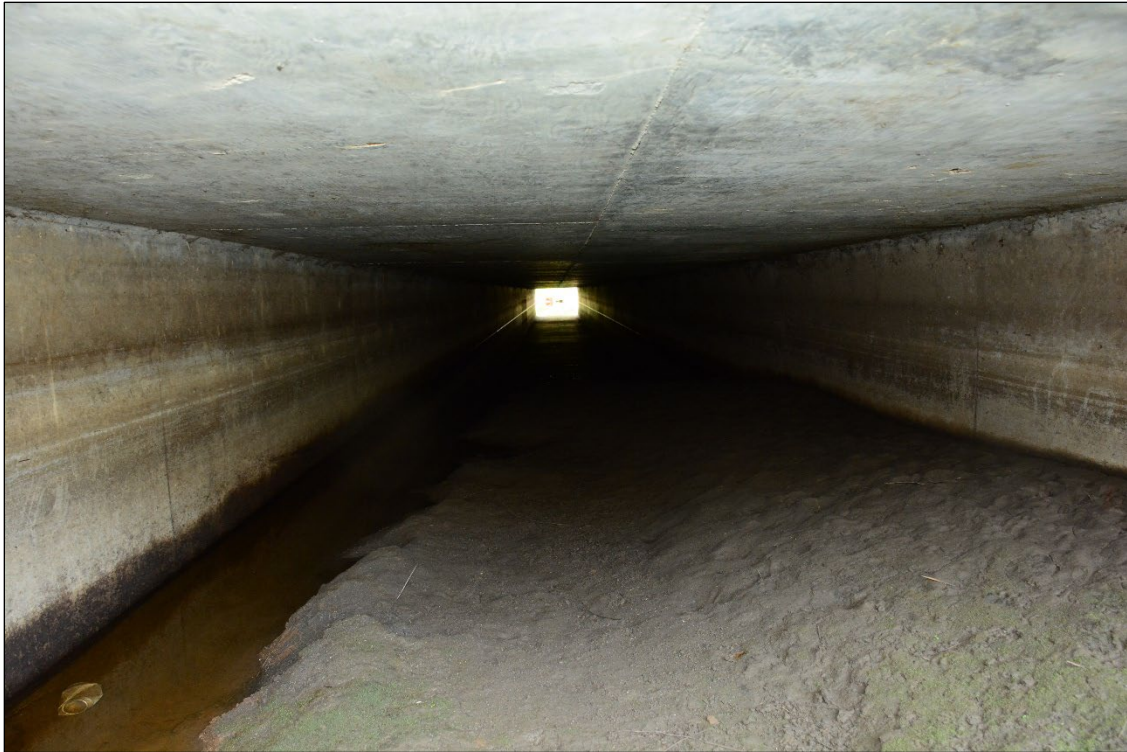
Figure 8. Coyote Alamitos Canal at Santa Teresa Boulevard, mid-section on 1/13/2021.

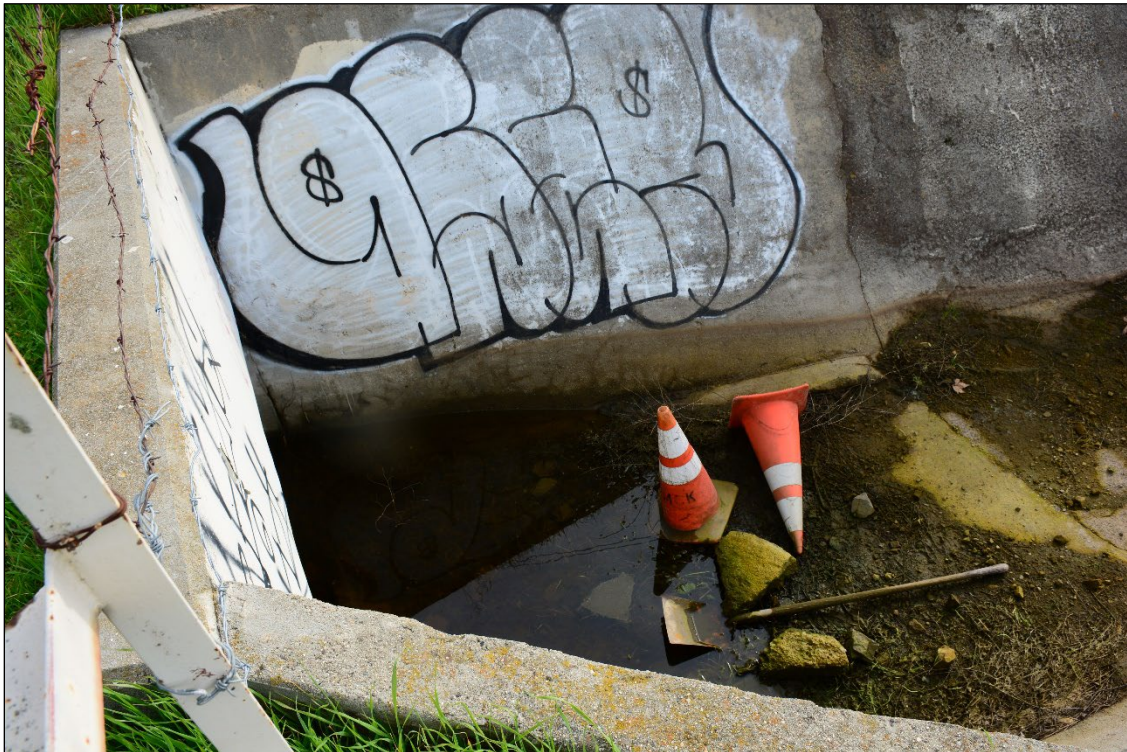
Figure 9. Coyote Alamitos Canal at Santa Teresa Boulevard, east side on 1/13/2021.

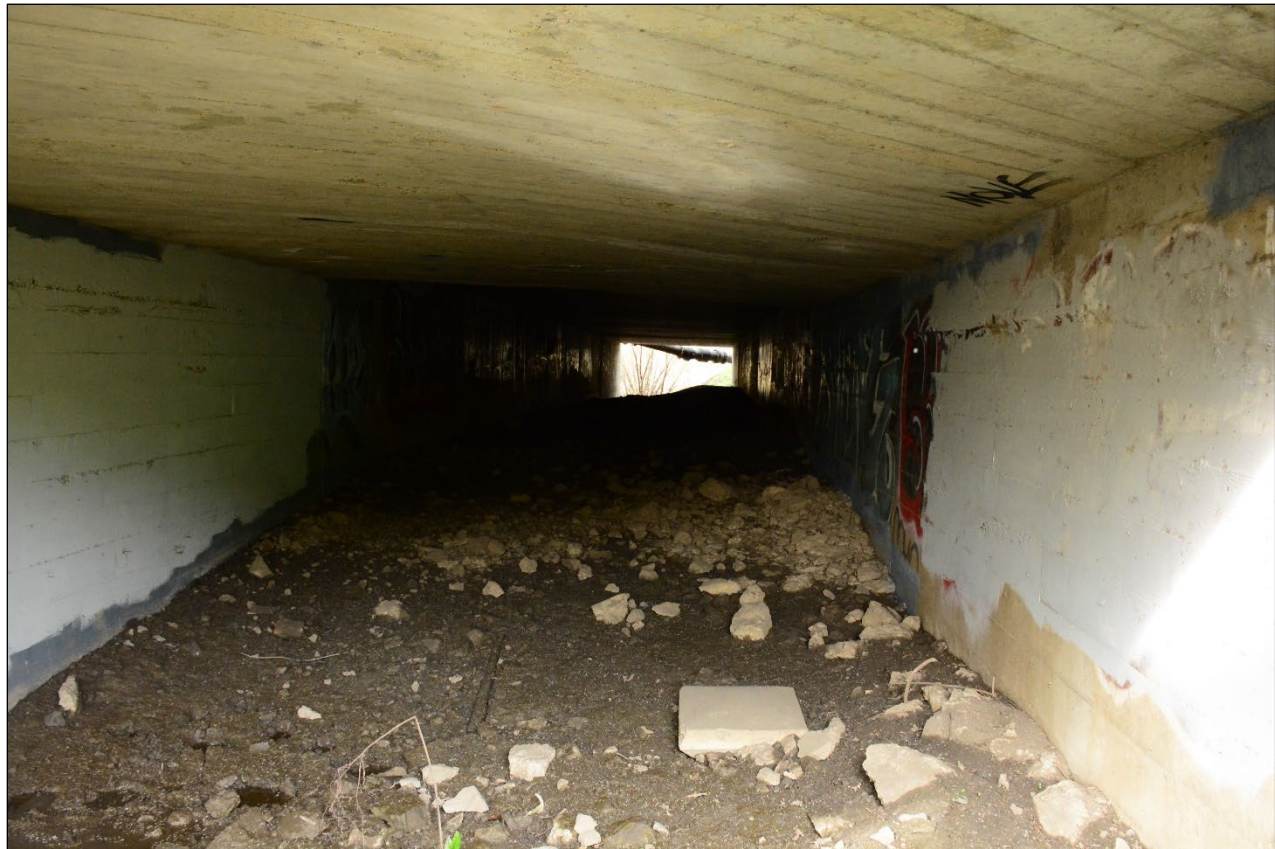
Since 2008, the sediment has significantly built up over time within the three sections of the Bailey Bridge at Fisher Creek (Figures 10-12). The bridge is currently flooded in the mid-section (Figure 13).

Figure 11: Bailey Bridge at Fisher Creek on 1/13/2022.

Throughout a monitoring period from 2008-2009, multiple species were recorded traveling through the Bailey Bridge at Fisher Creek. Of particular importance, deer were recorded routinely traveling through the bridge (Figure 14). The only other structure in Coyote Valley large enough to facilitate large mammal movement under roads is the Santa Teresa Boulevard Fisher Creek culvert. However, this culvert is most often flooded throughout the year, leaving only the Bailey Bridge to facilitate large mammal movement under the roads within the study area. In Figure 15, the sediment build up is so high, it is unlikely that the bridge will facilitate large mammal movement through it. Since the

beginning of the monitoring period, we have only recorded raccoons using the bridge to travel under Bailey Avenue. We highly recommend clearing out the sediment build-up at the Bailey Avenue bridge to make it more permeable for large mammal movement.

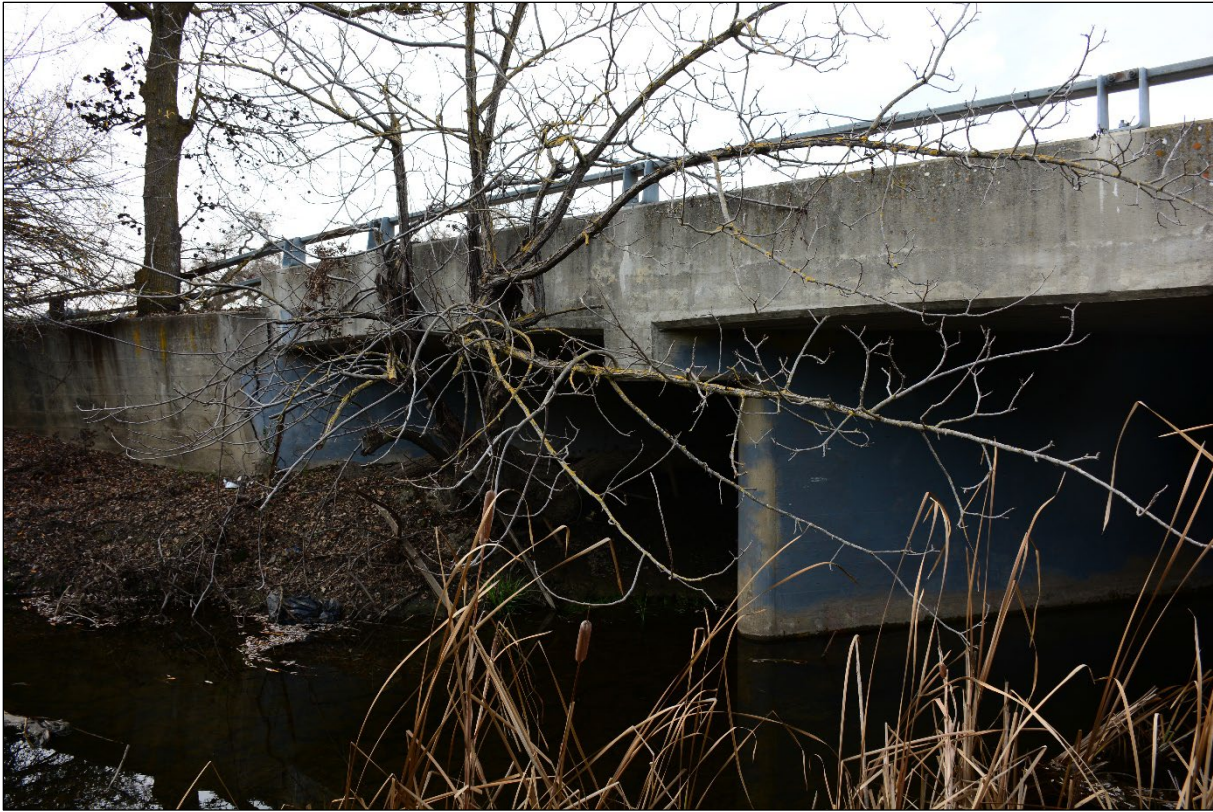
Figure 12: Bailey Bridge at Fisher Creek on 1/13/2022.

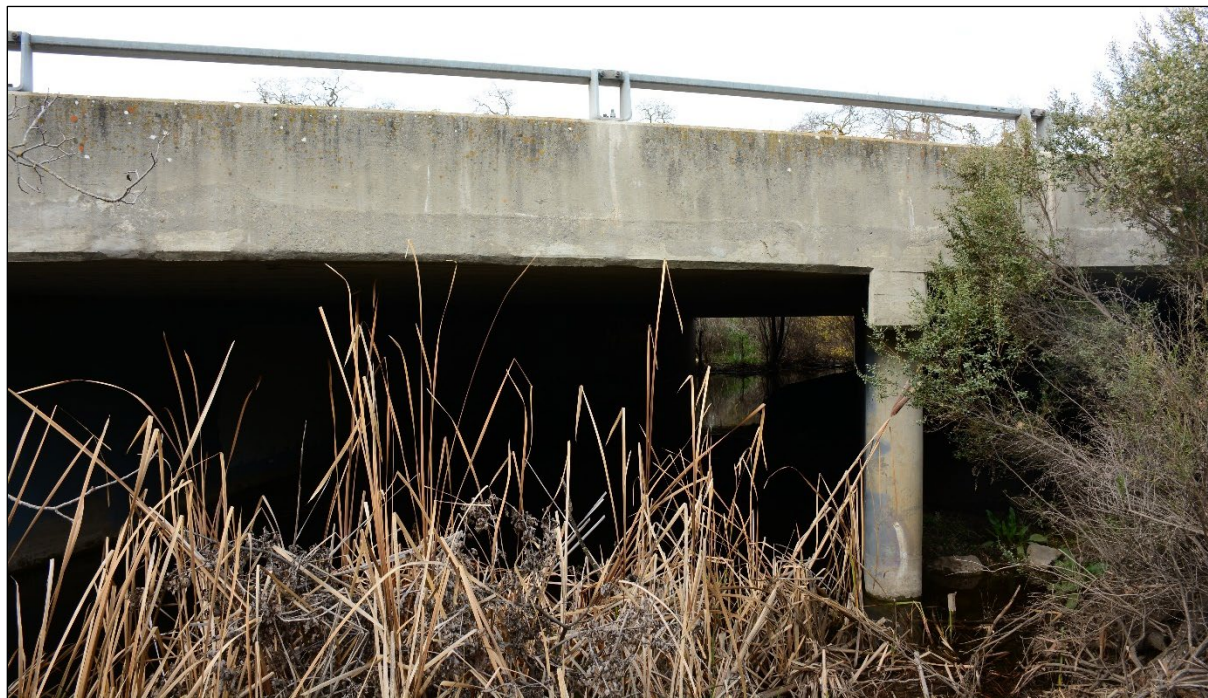
Figure 13: Bailey Bridge at Fisher Creek on 1/13/2022.

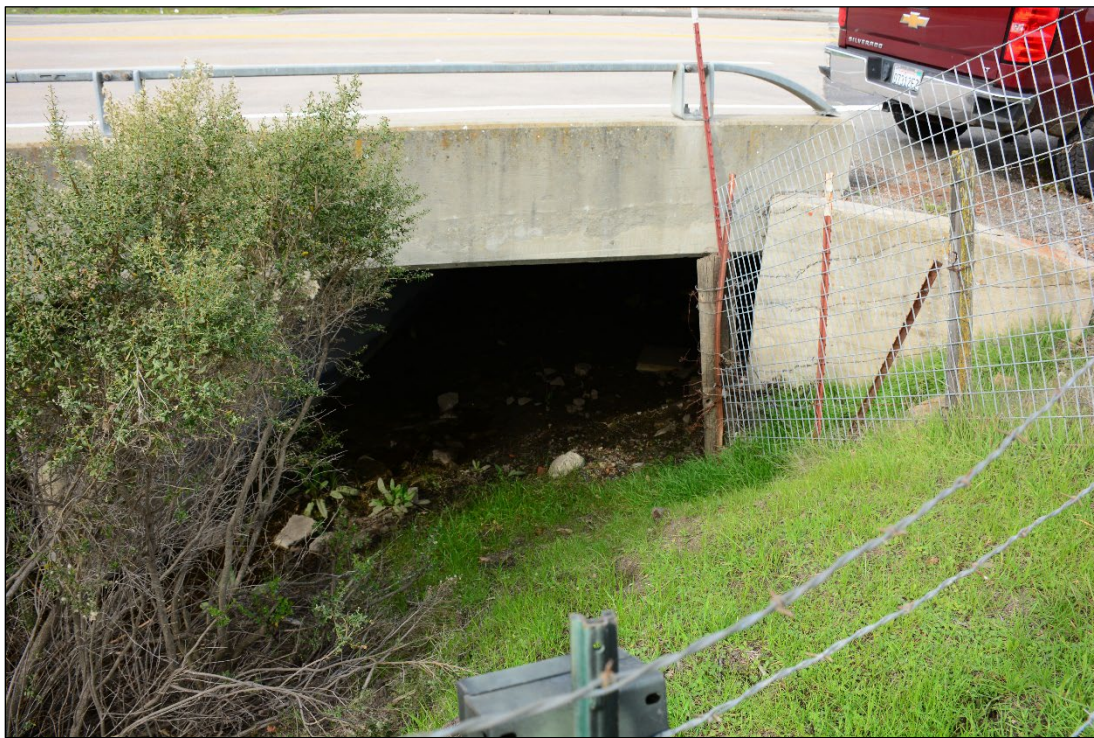
Figure 15: Bailey Bridge at Fisher Creek on 1/14/2021, view from the camera station at the south most eastern section of the bridge.
