ANNUAL RESTORATION MONITORING REPORT YEAR 5

SAN FELIPE CREEK RESTORATION PROJECT
SANTA CLARA VALLEY HABITAT AGENCY

DECEMBER 2023

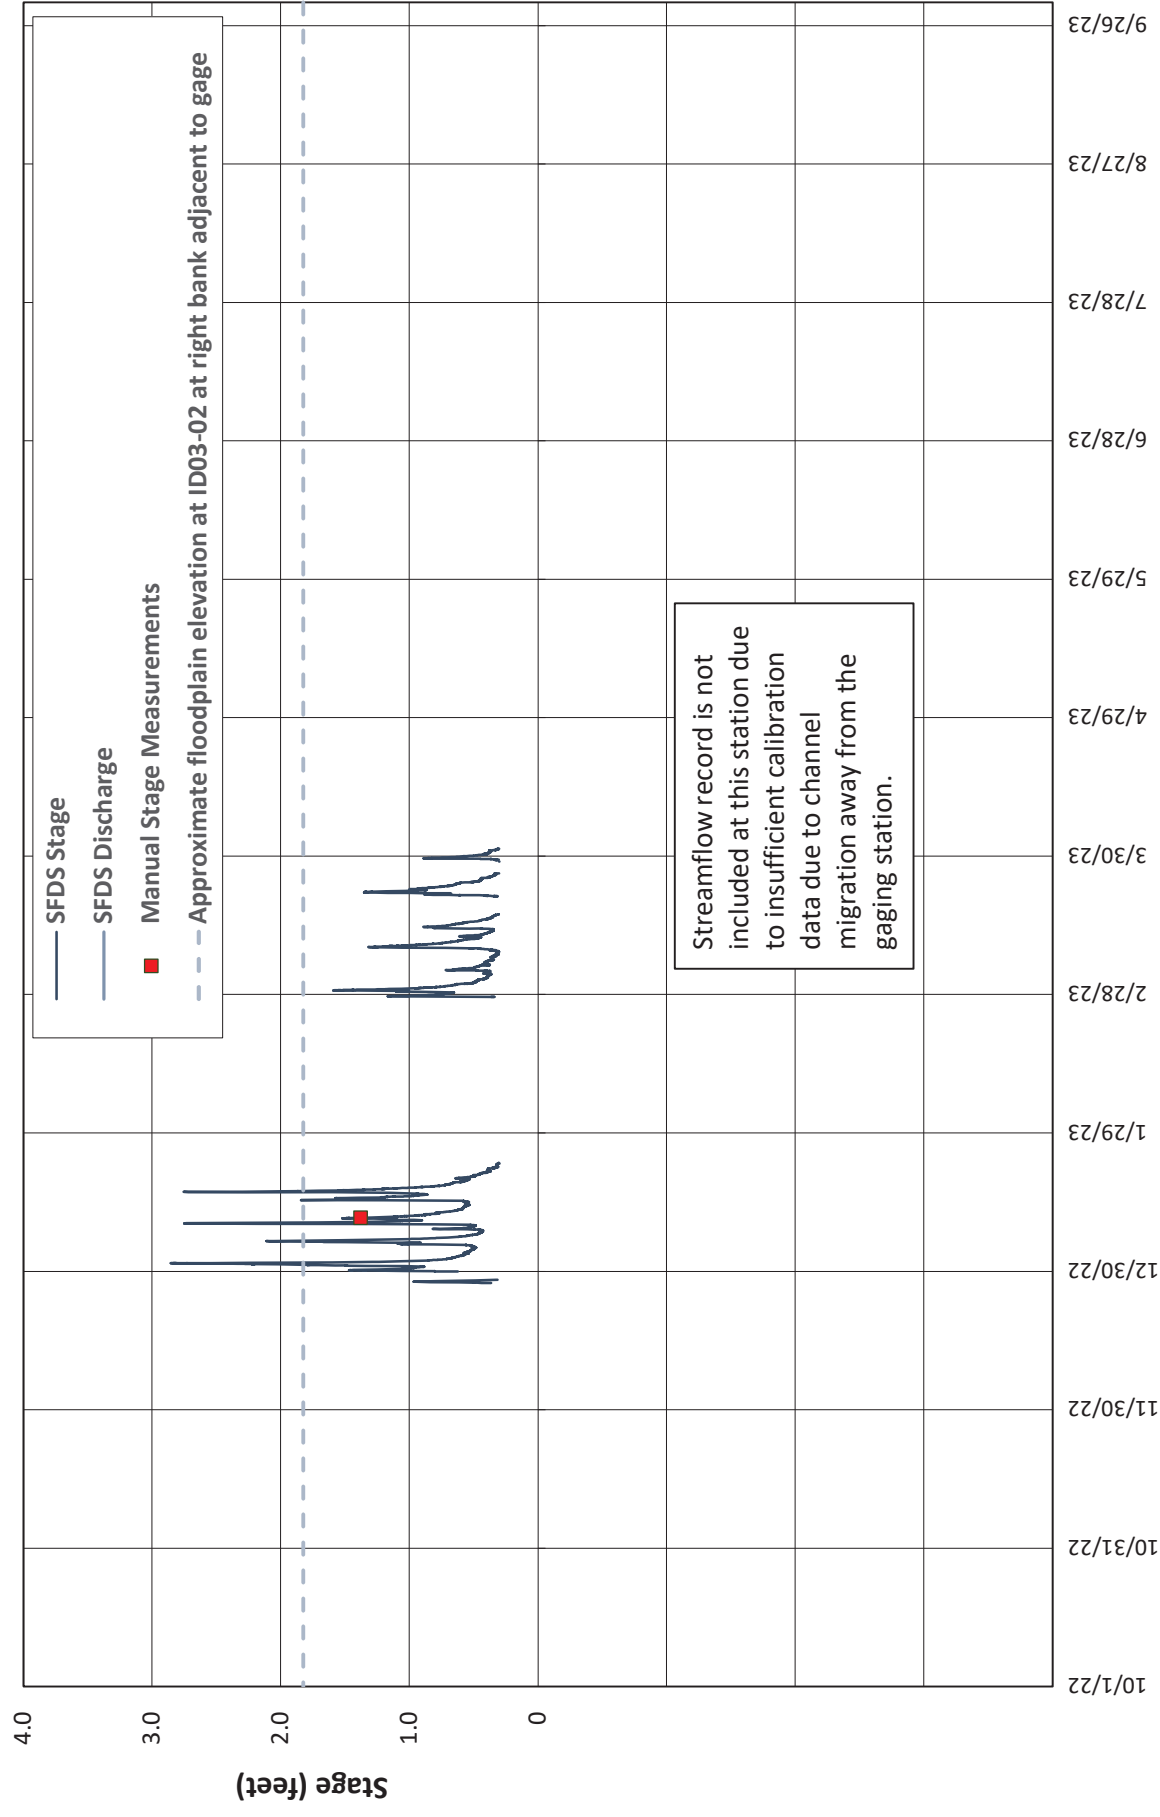
Figure 6. Stage at the San Felipe Creek downstream station (SFDS), water year 2023, San Felipe Creek Restoration Project, Santa Clara County, California. On December 10, 2021, SFDS was relocated to the northeast apex of the channel bend at ID03-02. During January, 2023 storms, the channel migrated away from the gage location. The gage was moved to a new location in October, 2023.

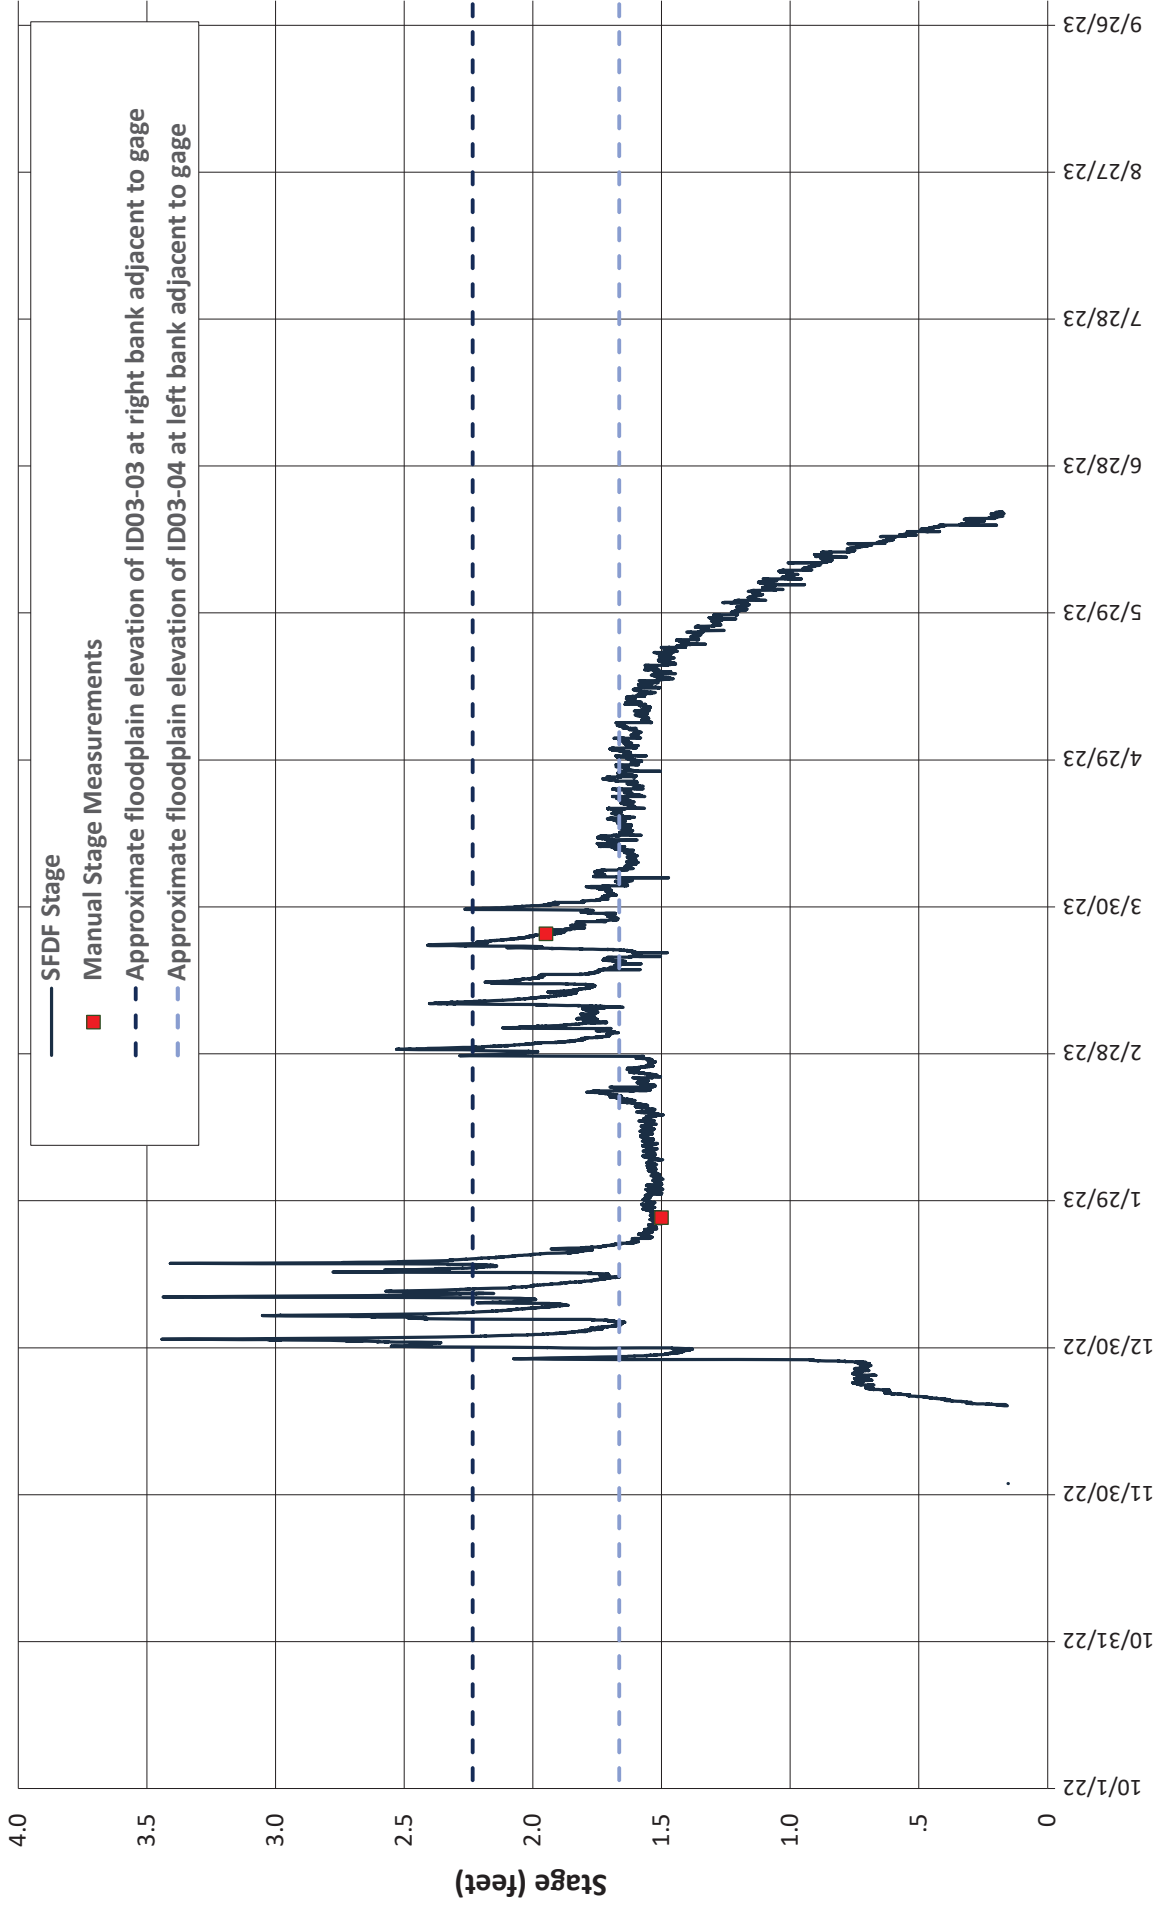
Figure 7. Stage at the San Felipe Creek downstream floodplains station (SFDF), water year 2023, San Felipe Creek Restoration Project, Santa Clara County, California. On December 10, 2021, SFDF was installed between ID03-03 and ID03-04 to evaluate timing and duration of floodplain inundation at ID03-03 and ID03-04.

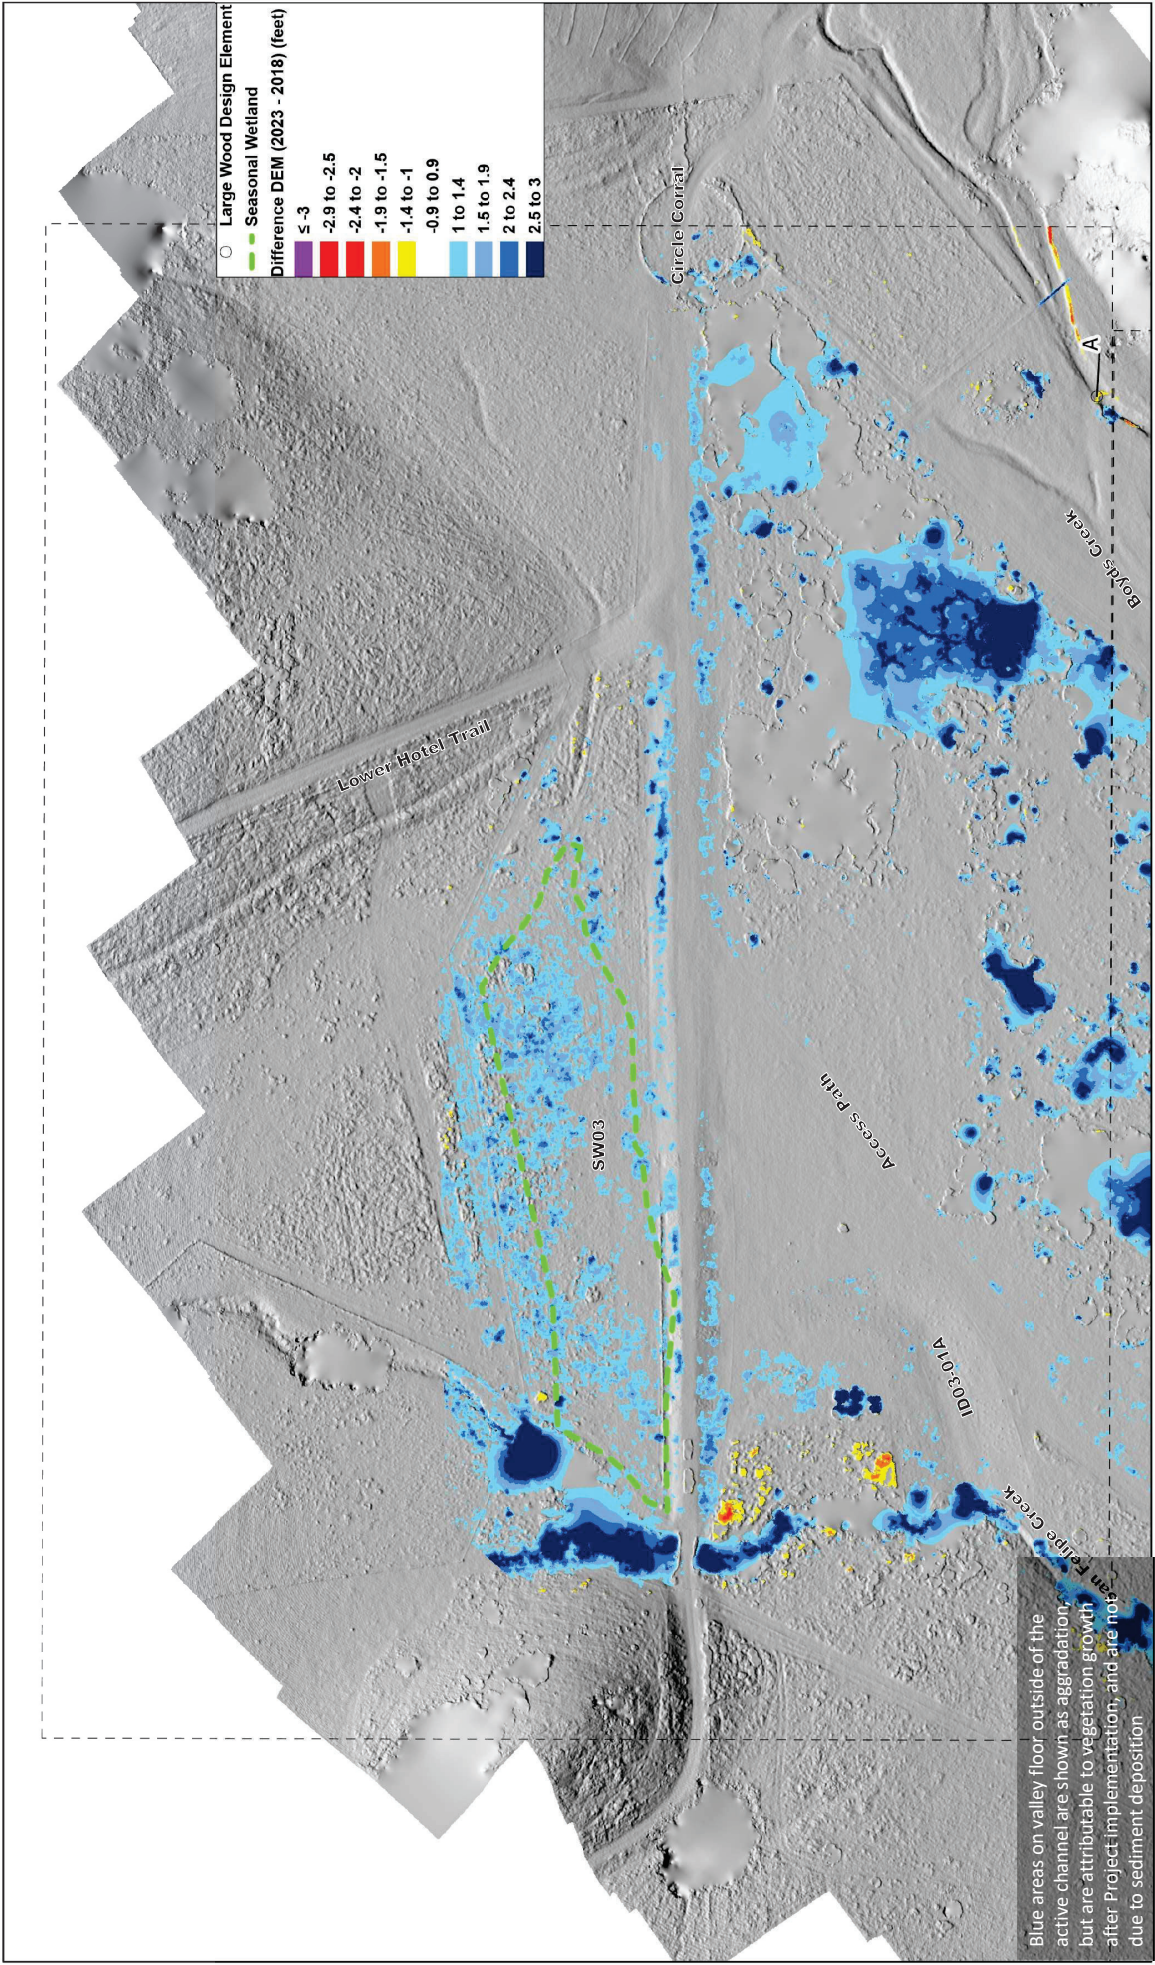
Figure 13a. 2023 and 2018 DEM comparison, San Felipe Creek Restoration, Joseph D. Grant Park, Santa Clara County, California

Blue areas on valley floor outside of the active channel are shown as aggradation, but are attributable to vegetation growth after Project implementation, and are not due to sediment deposition

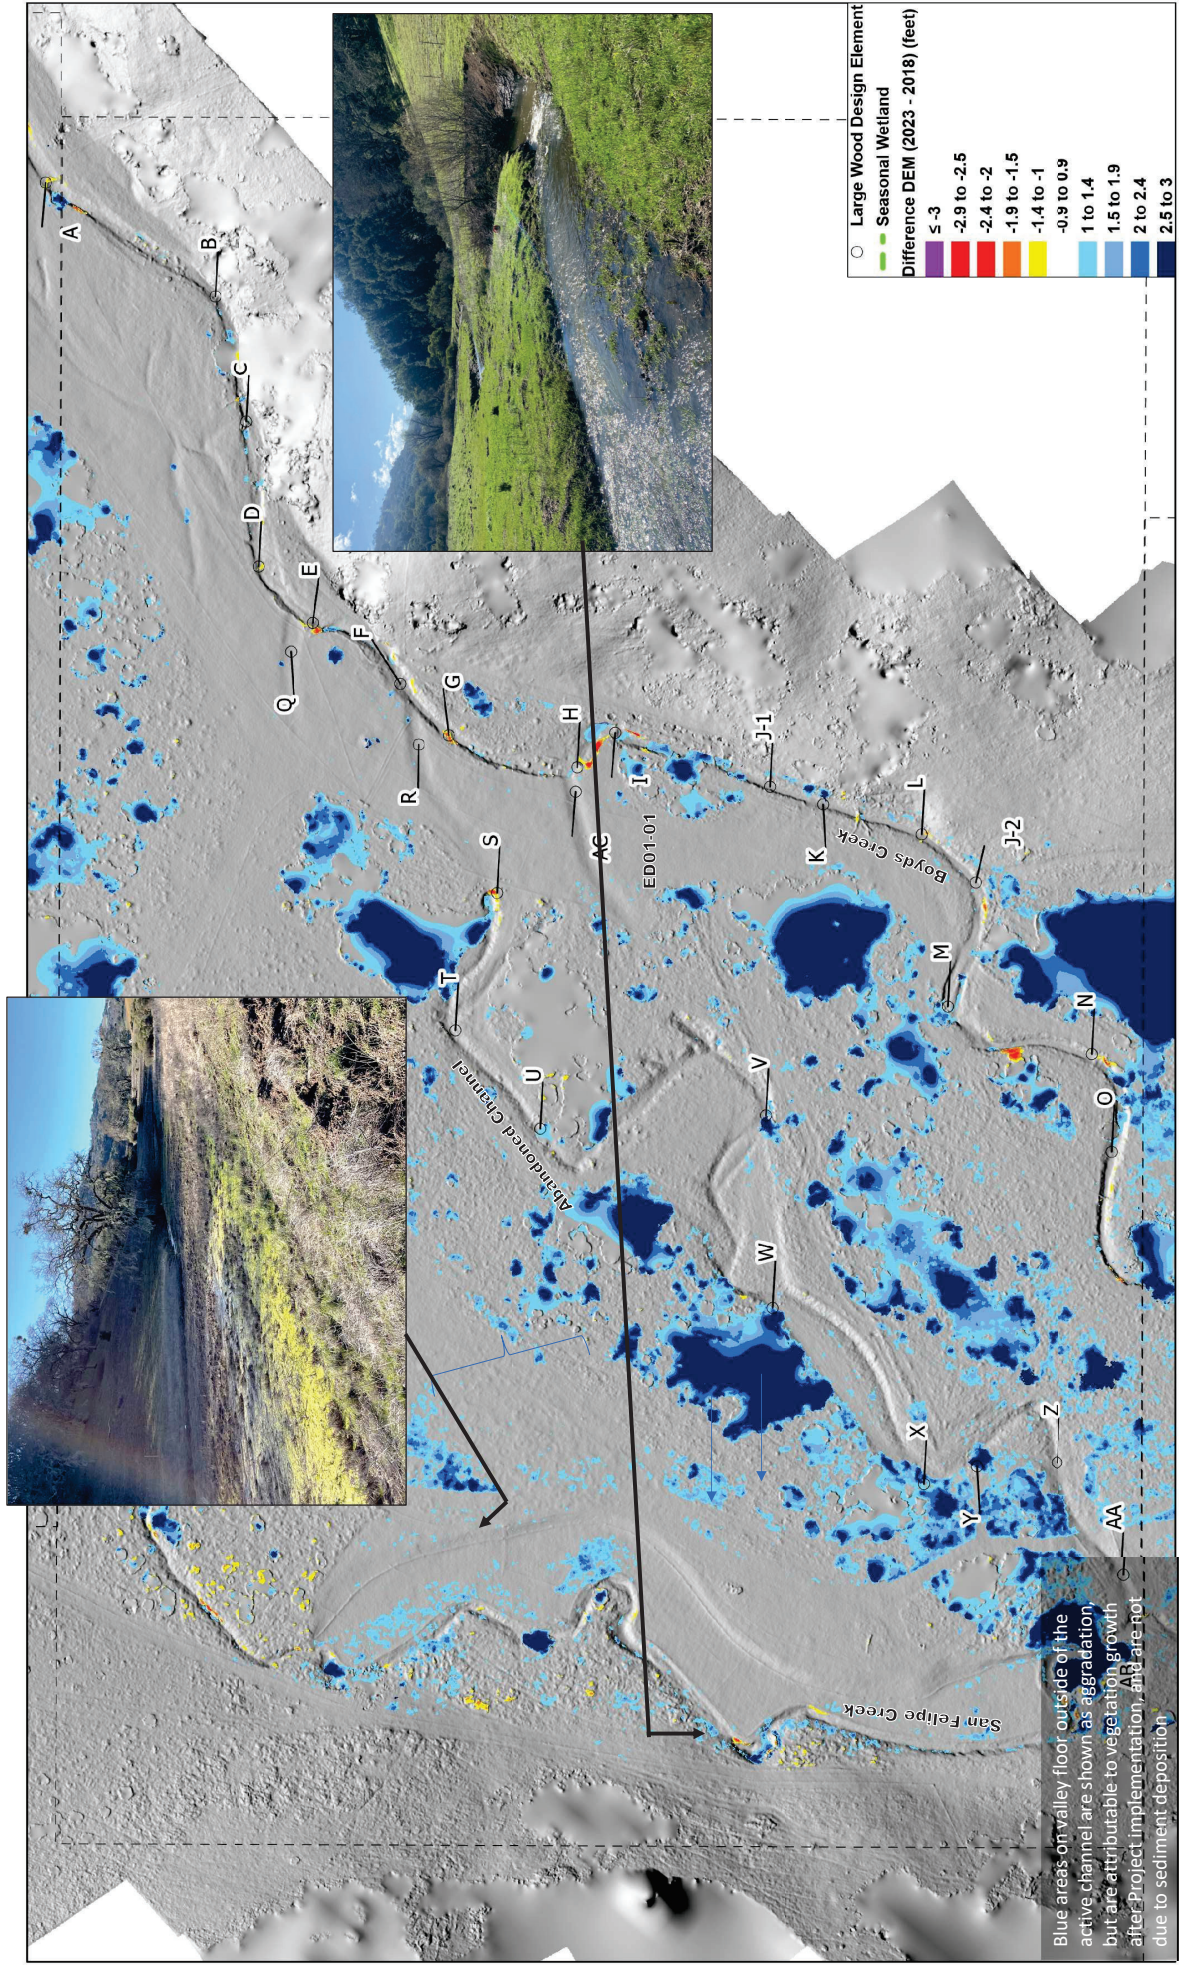
Figure 13b. 2023 and 2018 DEM comparison, San Felipe Creek Restoration, Joseph D. Grant Park, Santa Clara County, California

Blue areas on valley floor outside of the active channel are shown as aggradation, but are attributable to vegetation growth after Project implementation, and are not due to sediment deposition

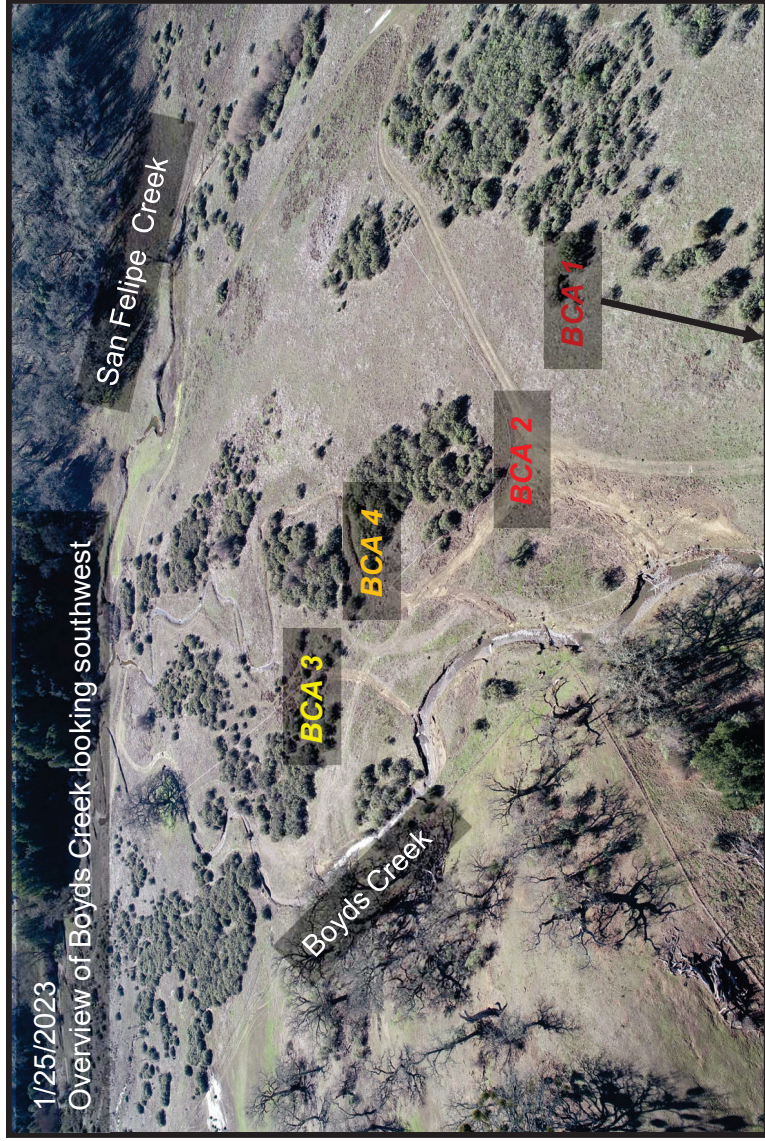
Figure 15. Observations of flow in all Boyds Creek distributary channels, January 10, 2023. Year 5 San Felipe Creek Restoration Project, Joseph D. Grant Park, Santa Clara County, California. Physical Success Criterion 3 was met in 2023. We are not concerned about the progression of the pre-existing knickpoint on BCA 4, the channel has not headcut to the buried log grade control installed as part of the project.
