SR-152 Pacheco Pass Regional Wildlife Connectivity Study 2021-2022
NCCP Local Assistance Grant # Q2030902

Prepared by Tanya Diamond & Ahíga Sandoval
Pathways for Wildlife

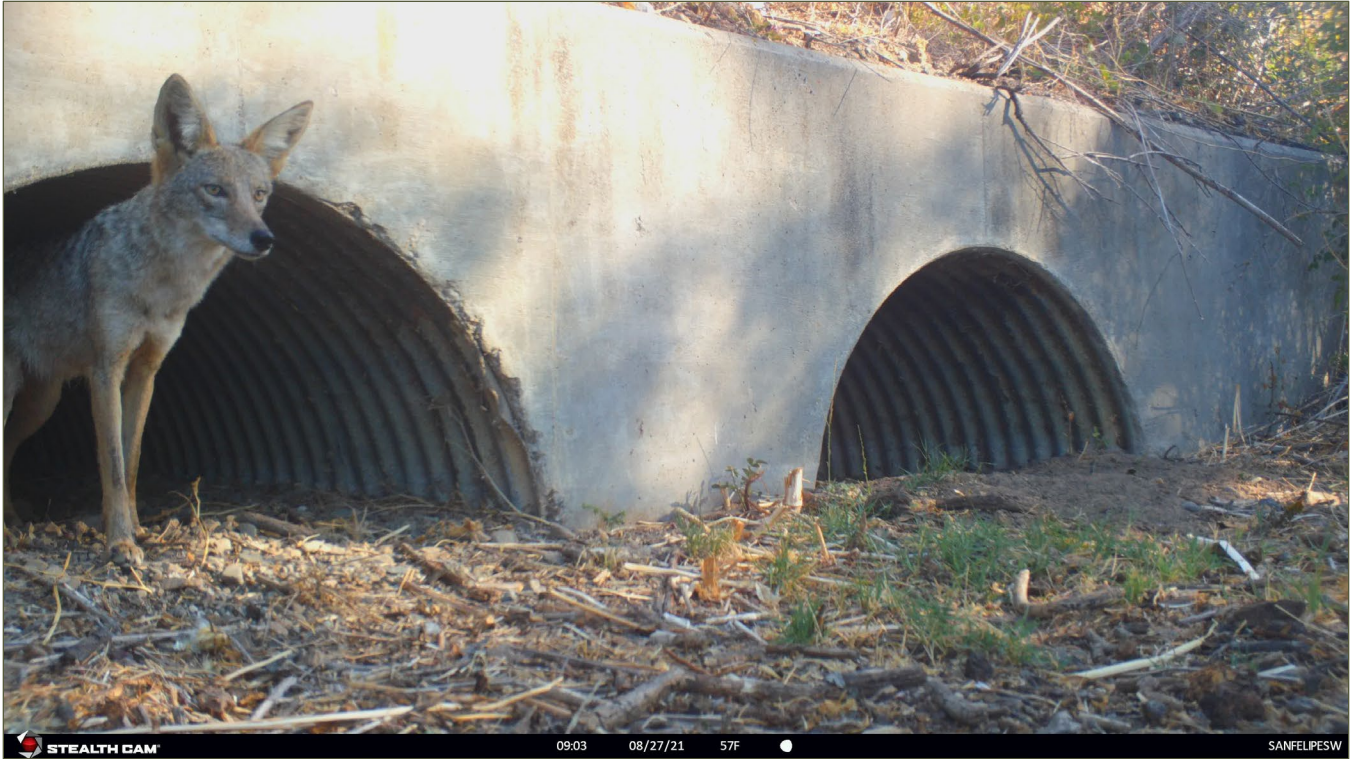
Coyote at a SR-152 Pacheco Pass culvert.

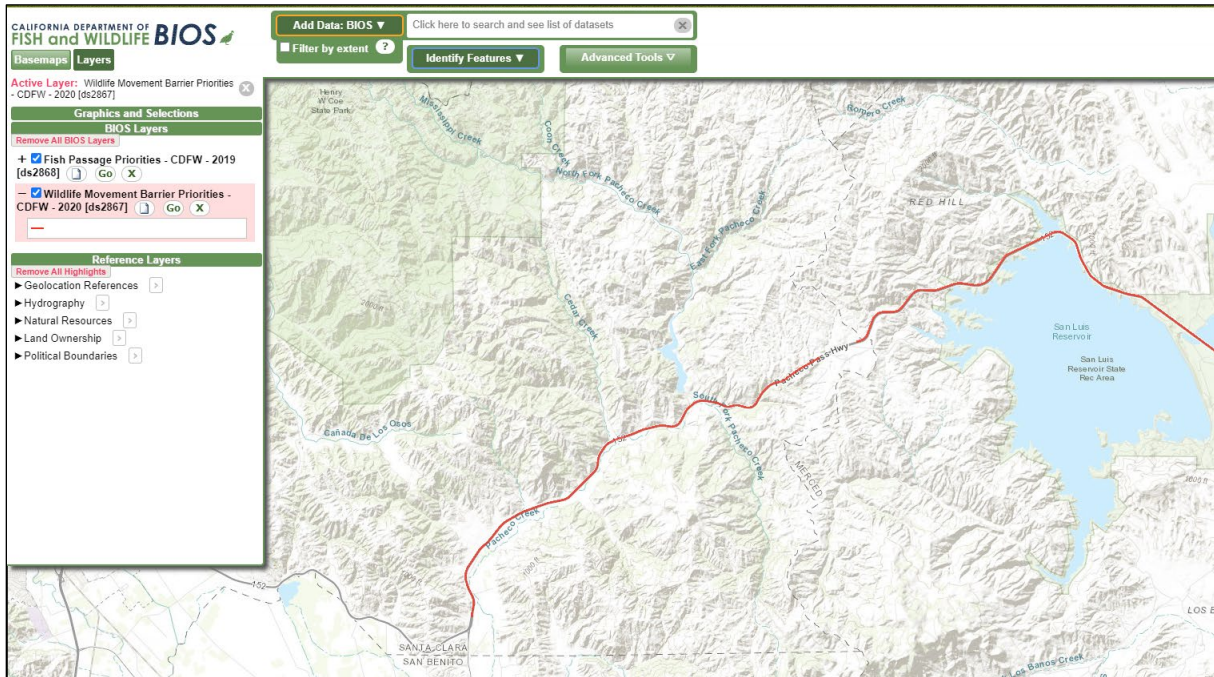
Figure 1. CDFW’s 2020 Wildlife Movement Barrier Priorities list from DFW’s BIOS website, SR-152 Pacheco Pass.

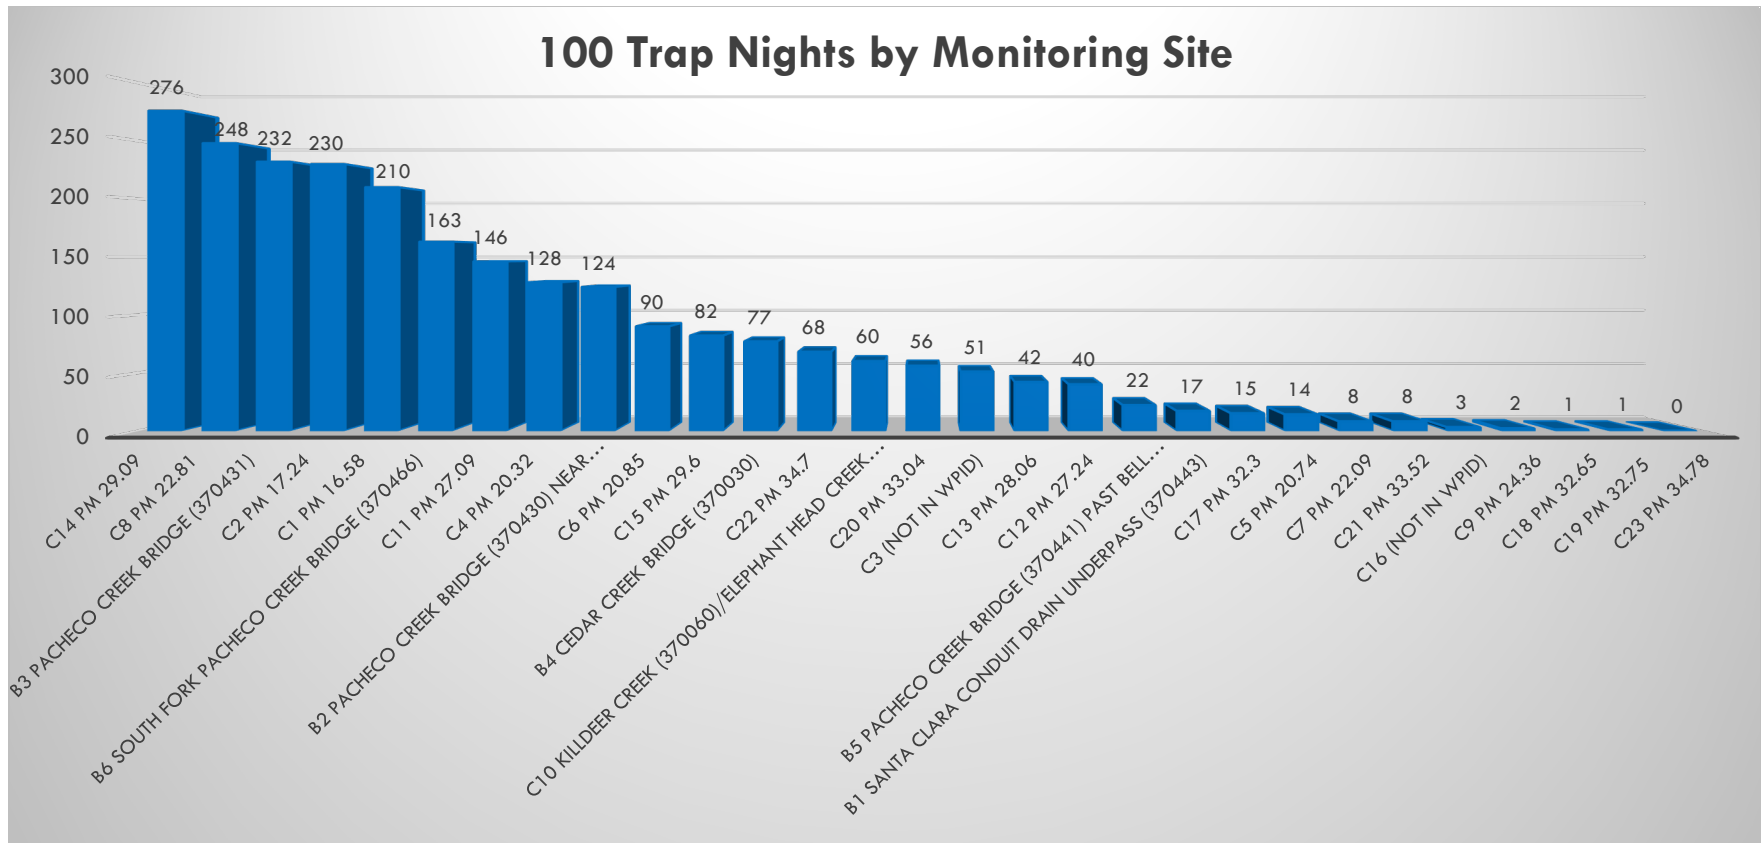
Figure 7. 100 Trap Night Analysis results with native species and wild pig (domestic animals not included).

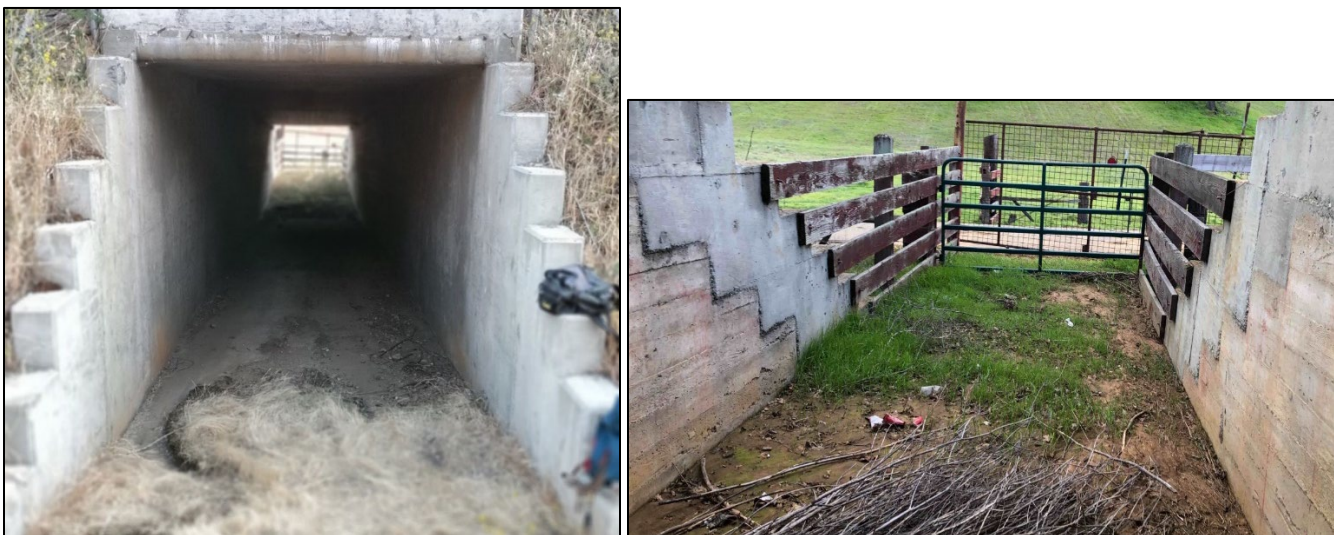
Figure 14. C3 large box culvert. Gate visible at opposite opening.

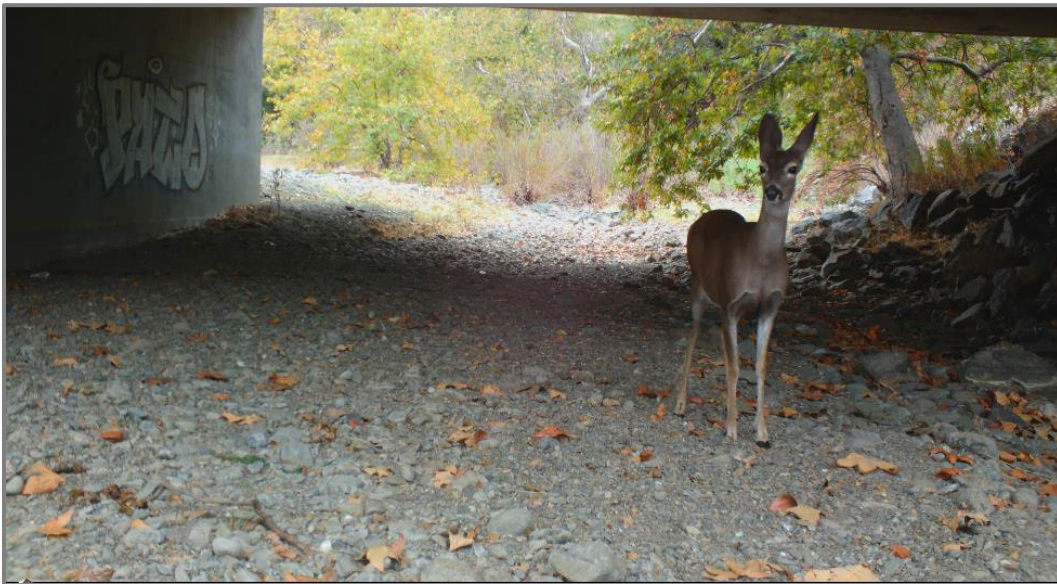
Figure 66. Mule deer doe crossing under the South Fork Pacheco Creek Bridge (370466) heading toward barbed wire fence.

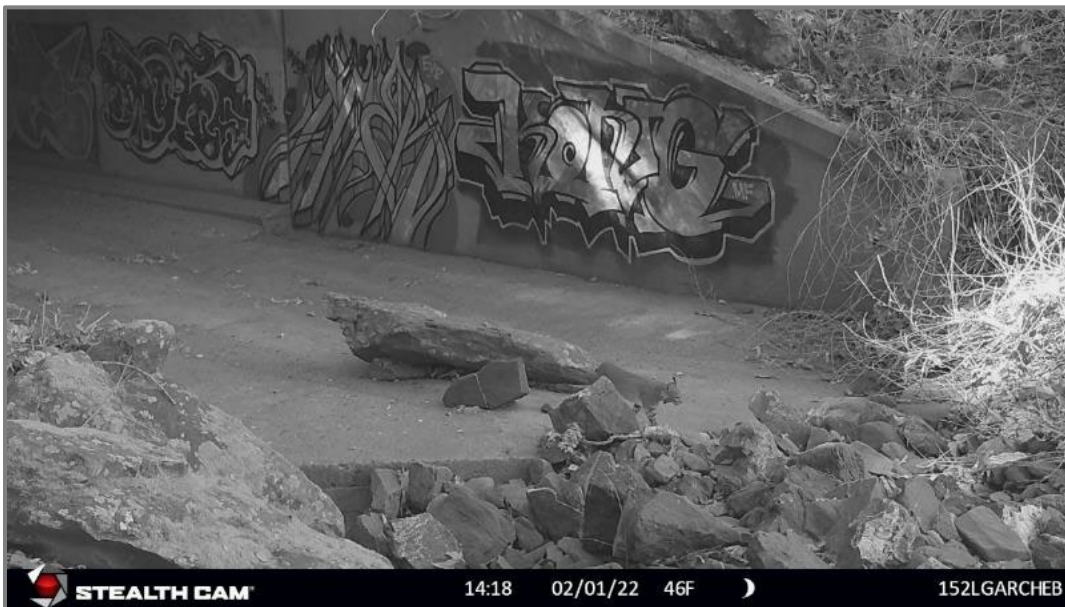
Figure 70. Bobcat at the SR-152 large arch culvert on 2/1/2022.

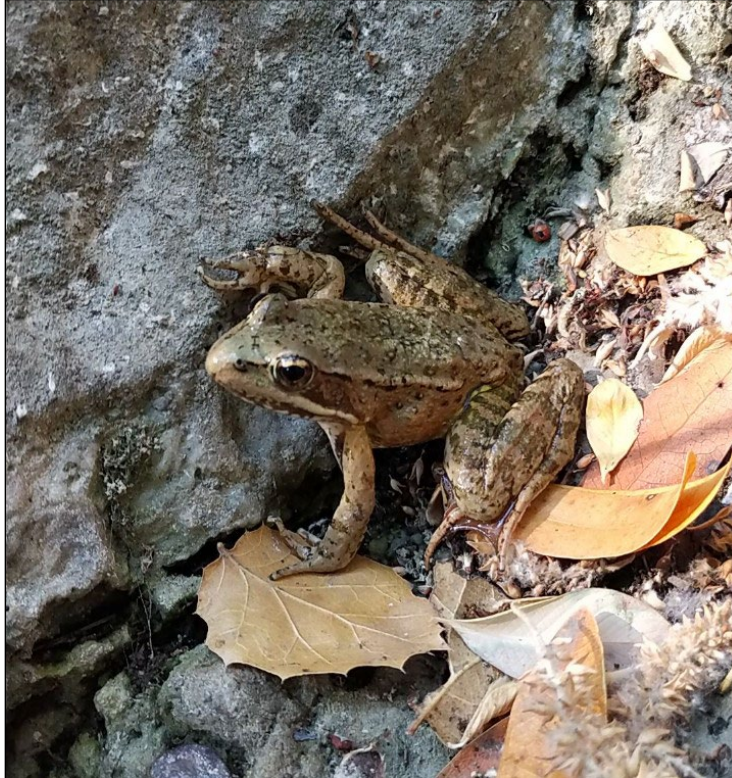
Figure 71. California red-legged frog recorded at C17 PM 32.3. on June 18, 2021.

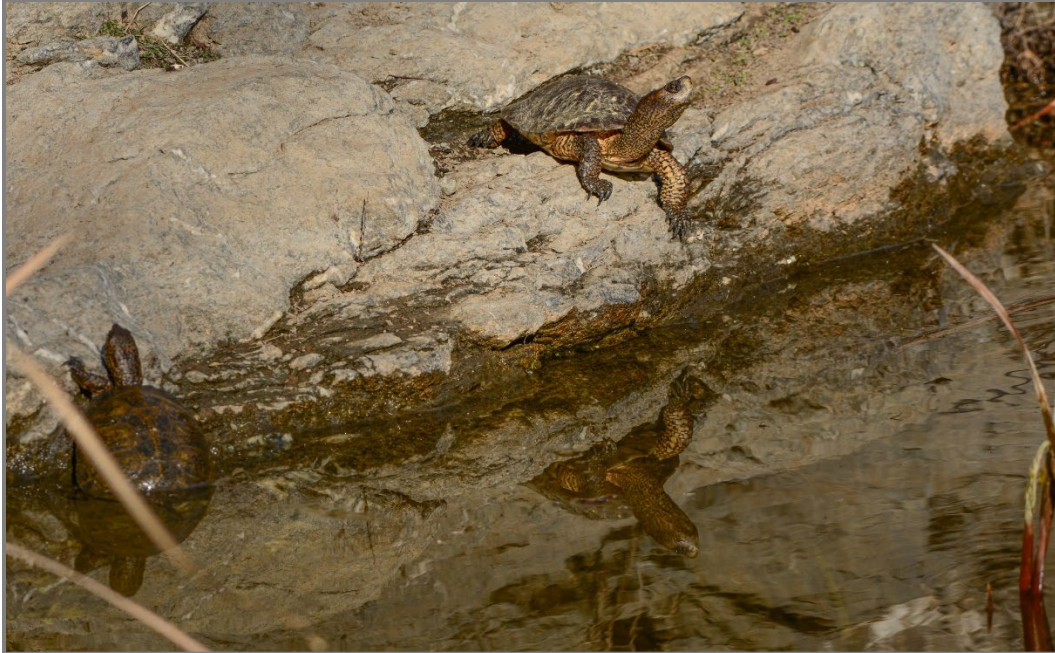
Figure 77. Western pond turtles at culvert PM 32.75 westbound opening pond on February 18, 2022.

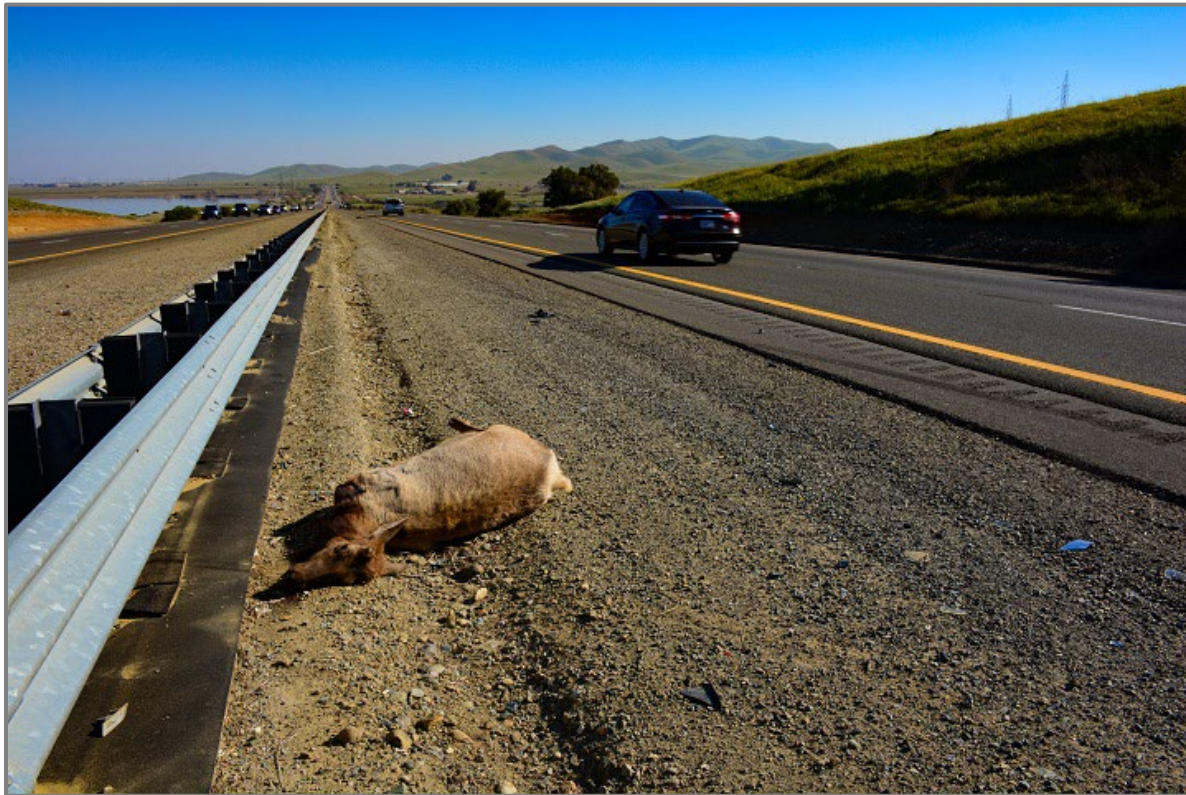
Figure 96. Male tule elk hit on February 17, 2022.

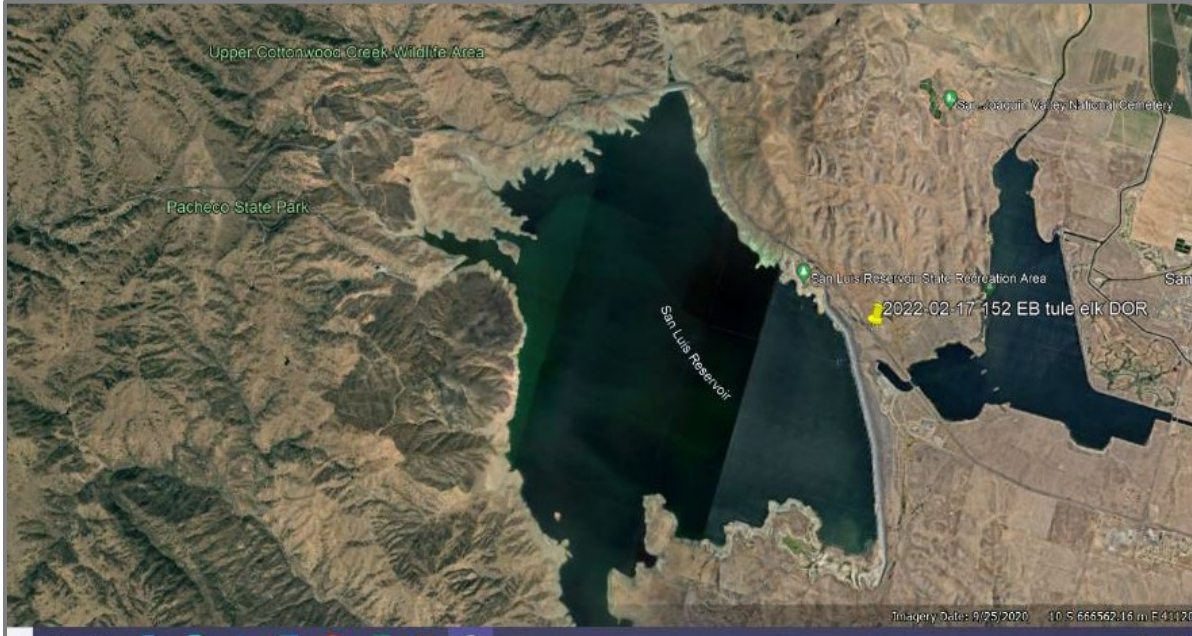
Figure 98. Location of where the male tule elk was hit on February 17, 2022.

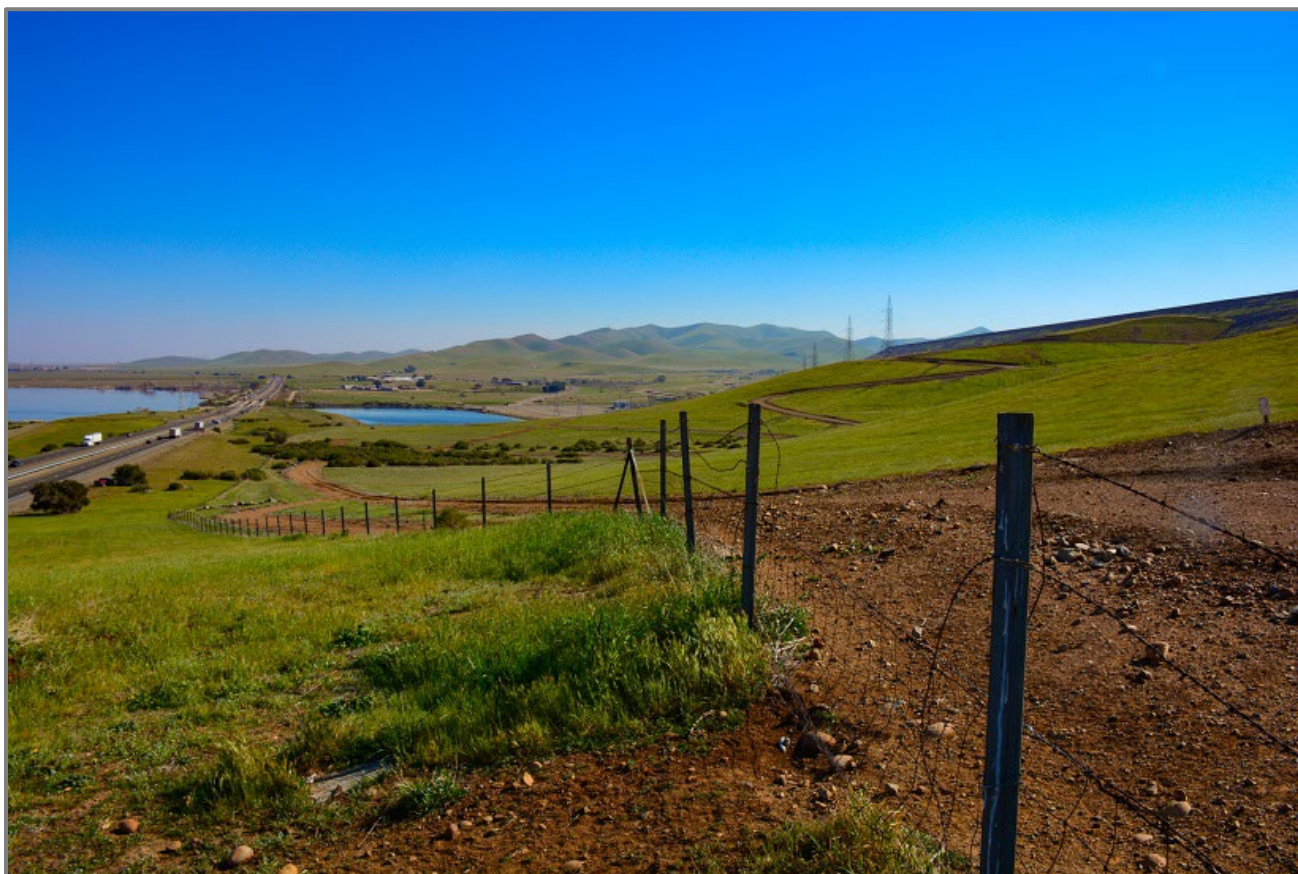
Figure 98. Fence line where trail led from highway, disturbed soil, top missing strands of barbed wire, and woven wire fencing at base.

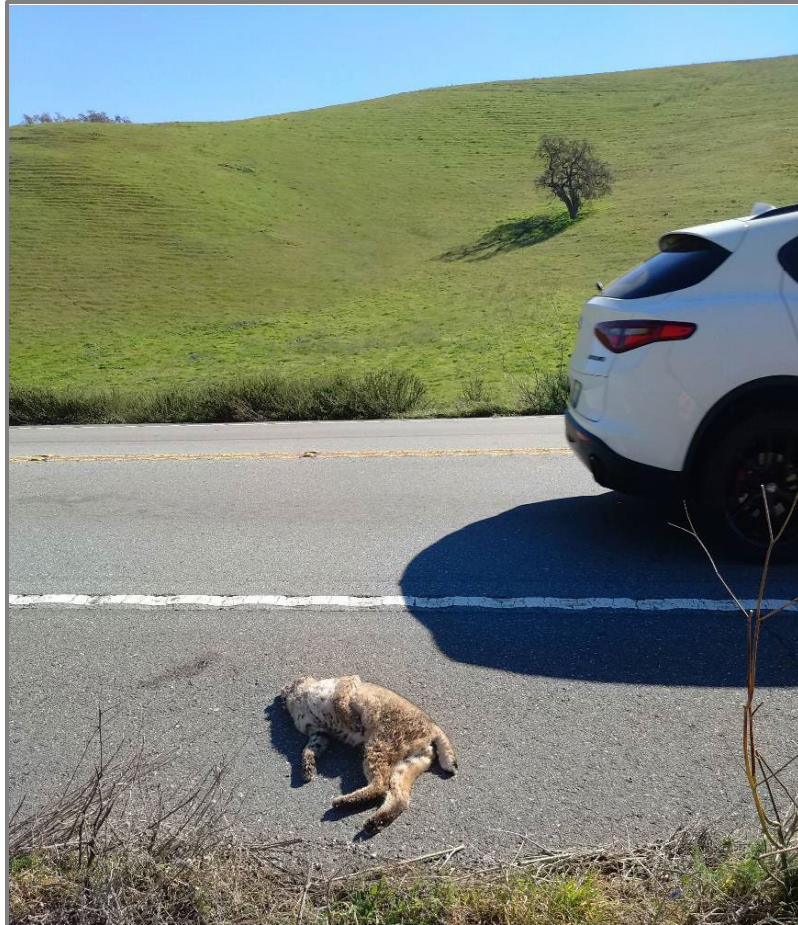
Figure 99. SR-152 bobcat hit on February 10, 2022.

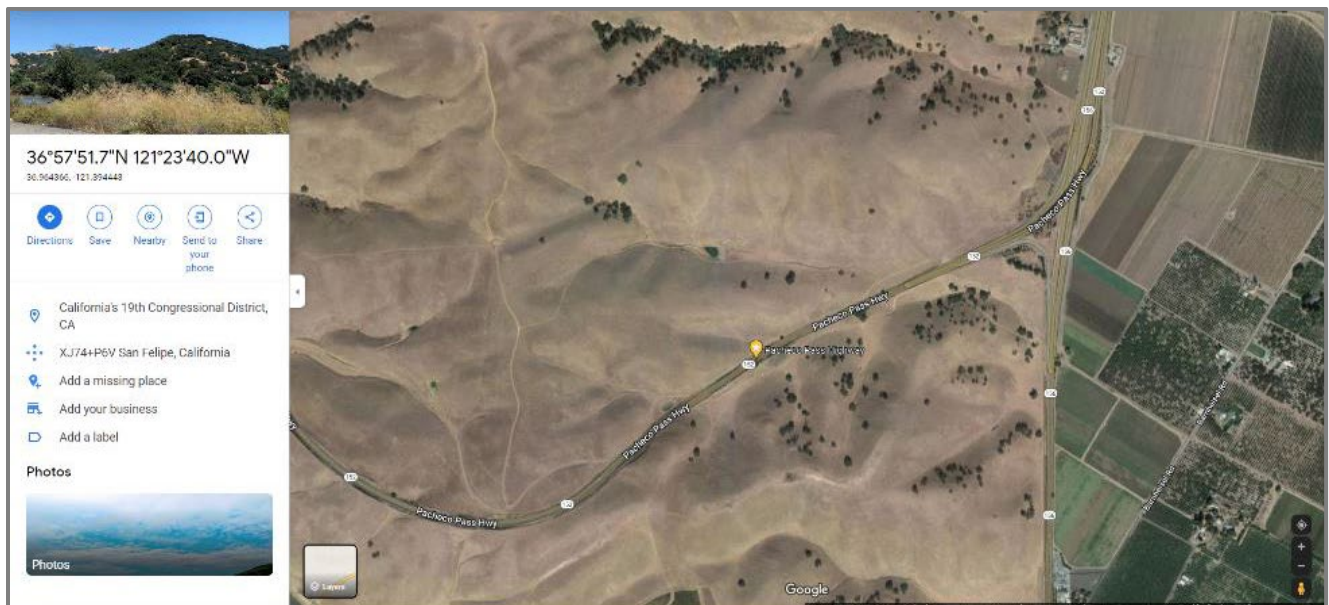
Figure 100. Location where the bobcat was hit on February 10, 2022.

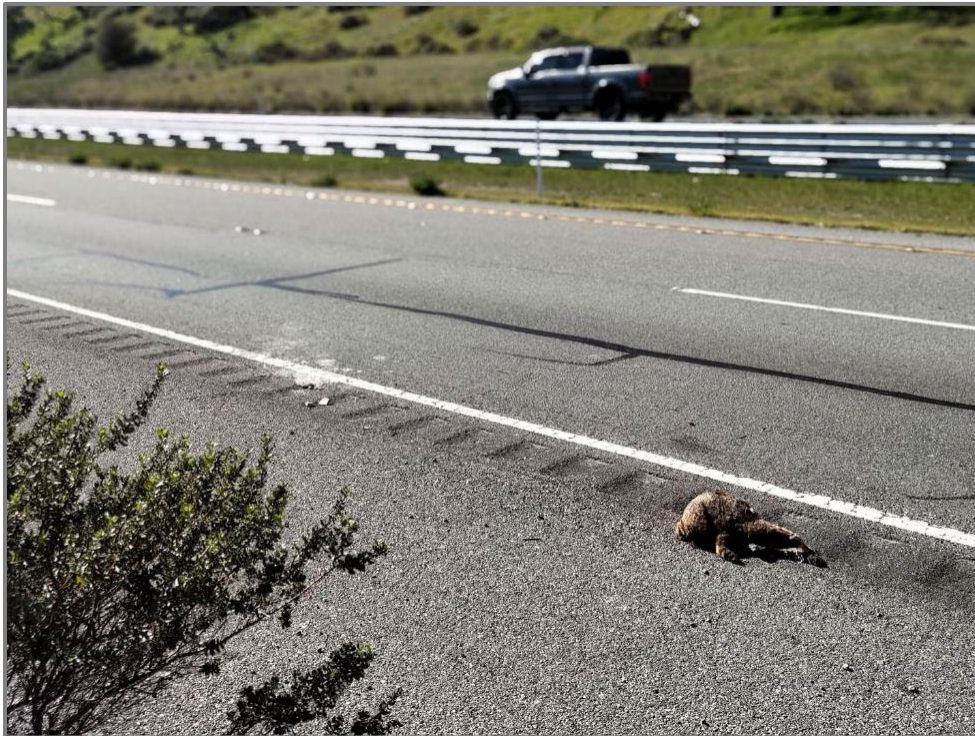
Figure 101. SR-152 bobcat hit on February 11, 2022.

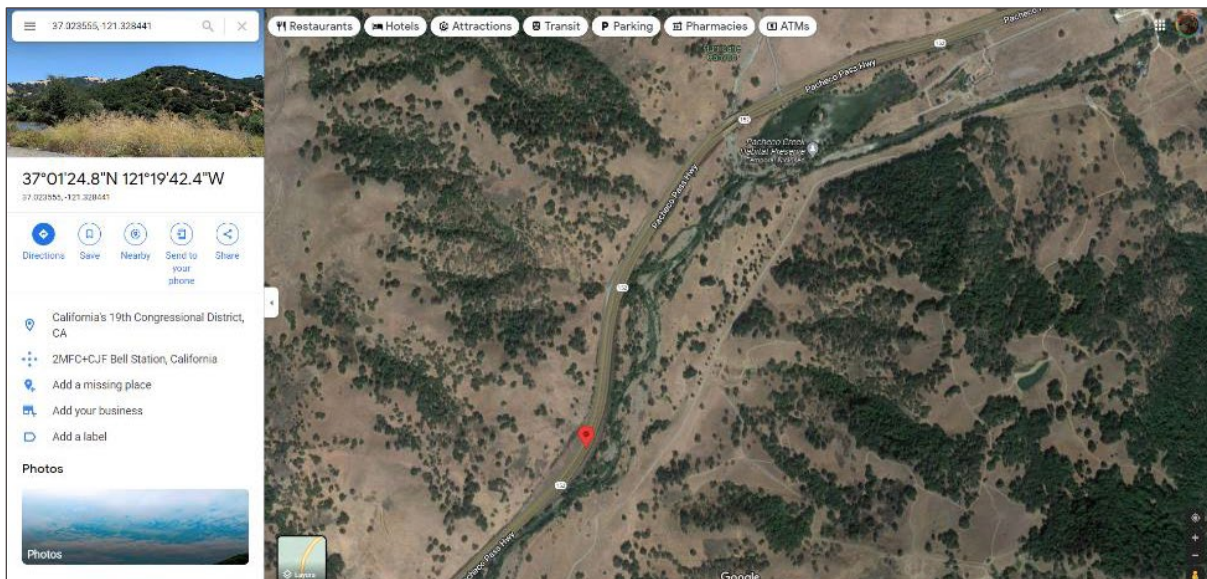
Figure 102. Location where the bobcat was hit on February 11, 2022 by the Pacheco Creek Reserve.

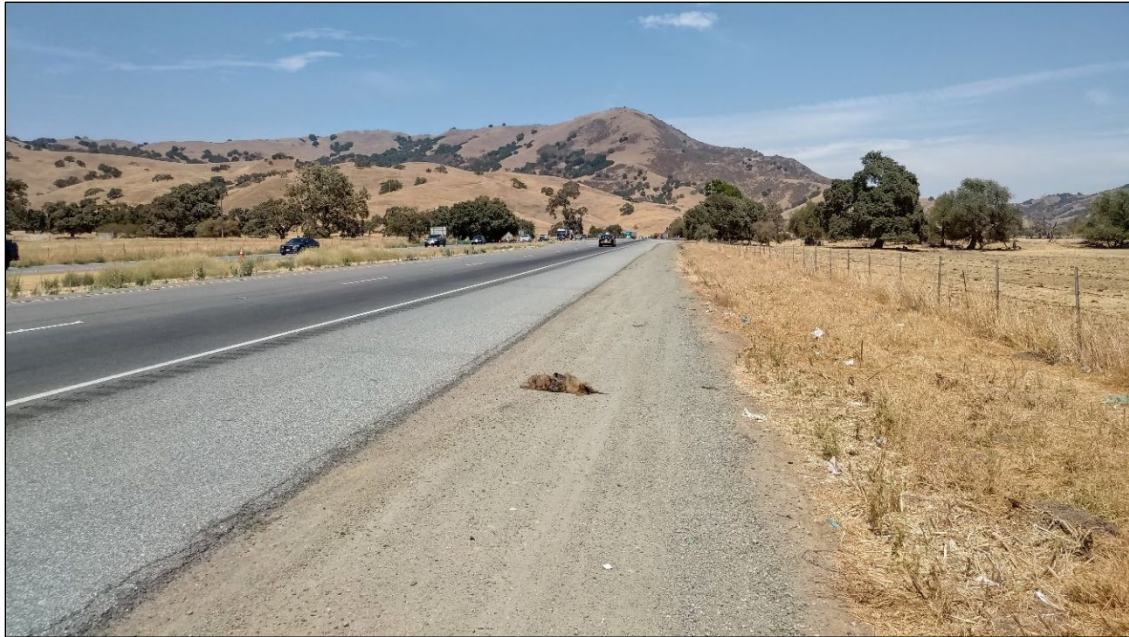
Figure 103. Coyote hit on SR-152 on July 28,2021.

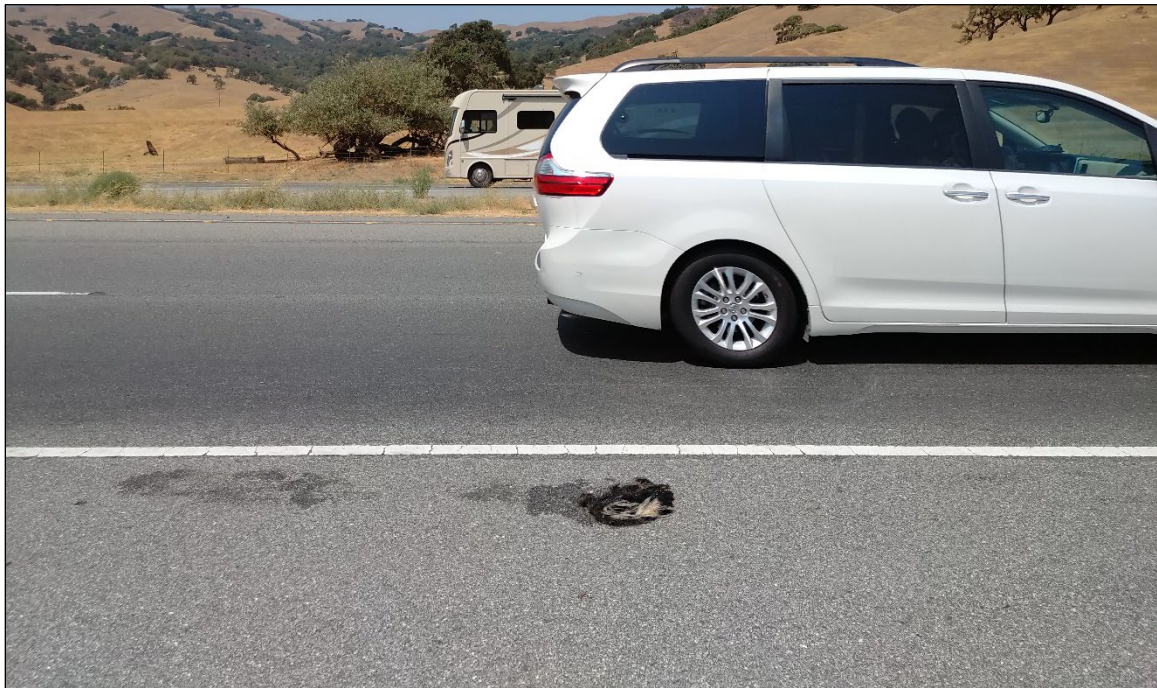
Figure 106. Skunk hit on SR-152 on August 24, 2021.

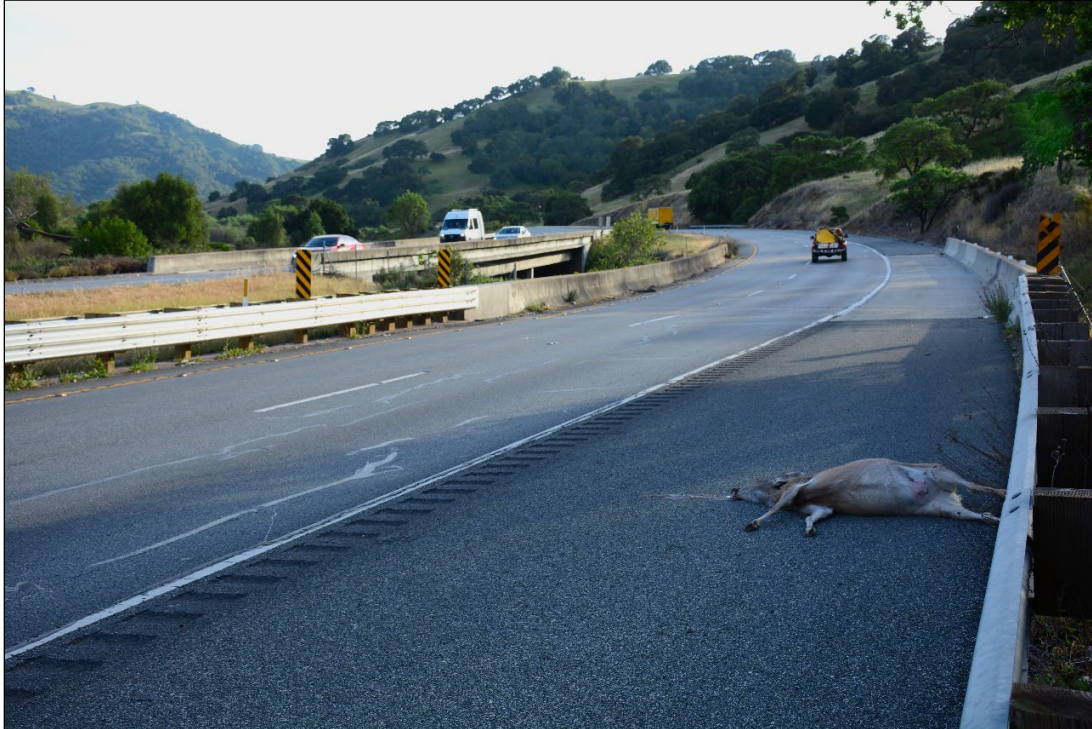
Figure 107. Female mule deer hit on May 15, 2022 on SR-152 by the Cedar Creek bridge, west facing view.

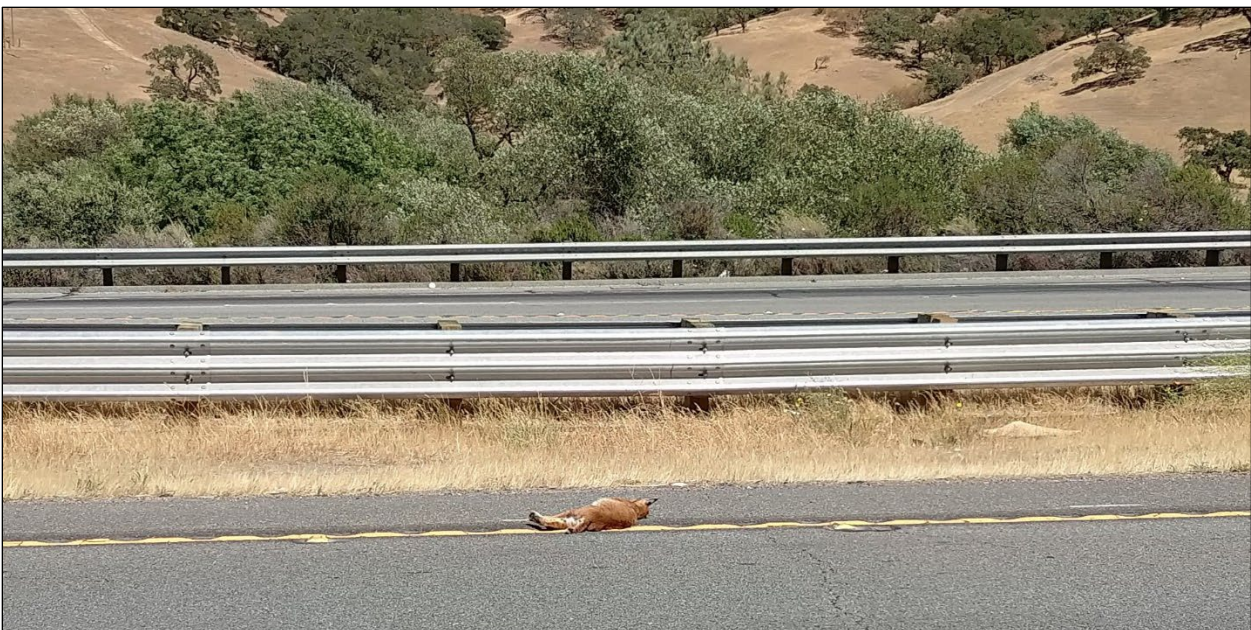
Figure 110. Bobcat found hit on June 26, 2022, westbound lane at the median, near C12 PM 27.24, in which we have been recording multiple bobcat individuals and mountain lion passages through the culvert.

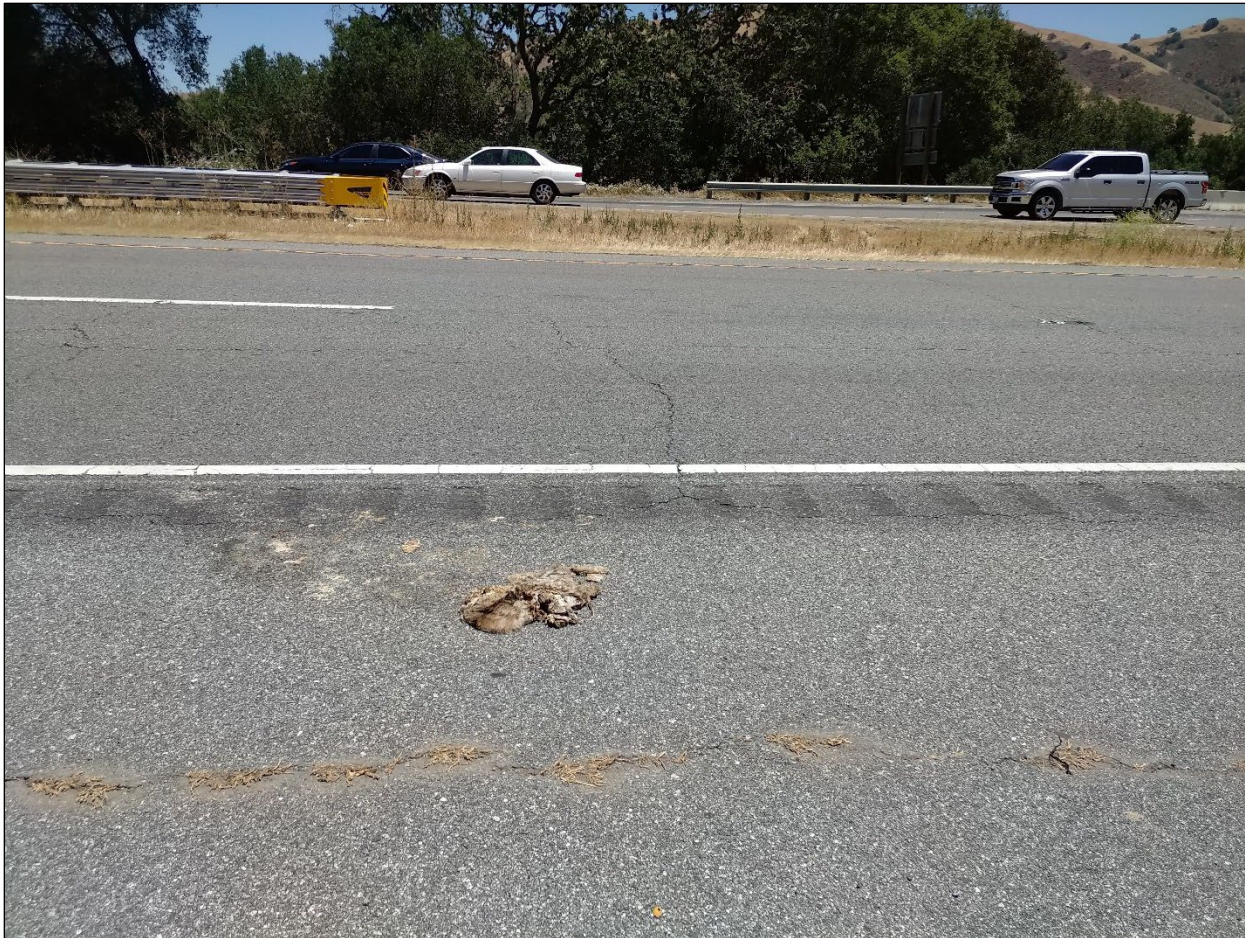
Figure 111. Coyote found hit on June 24, 2022, westbound lane by Walnut Ave. This is by the culvert where domestic dogs have been recorded chasing wildlife through the culvert.

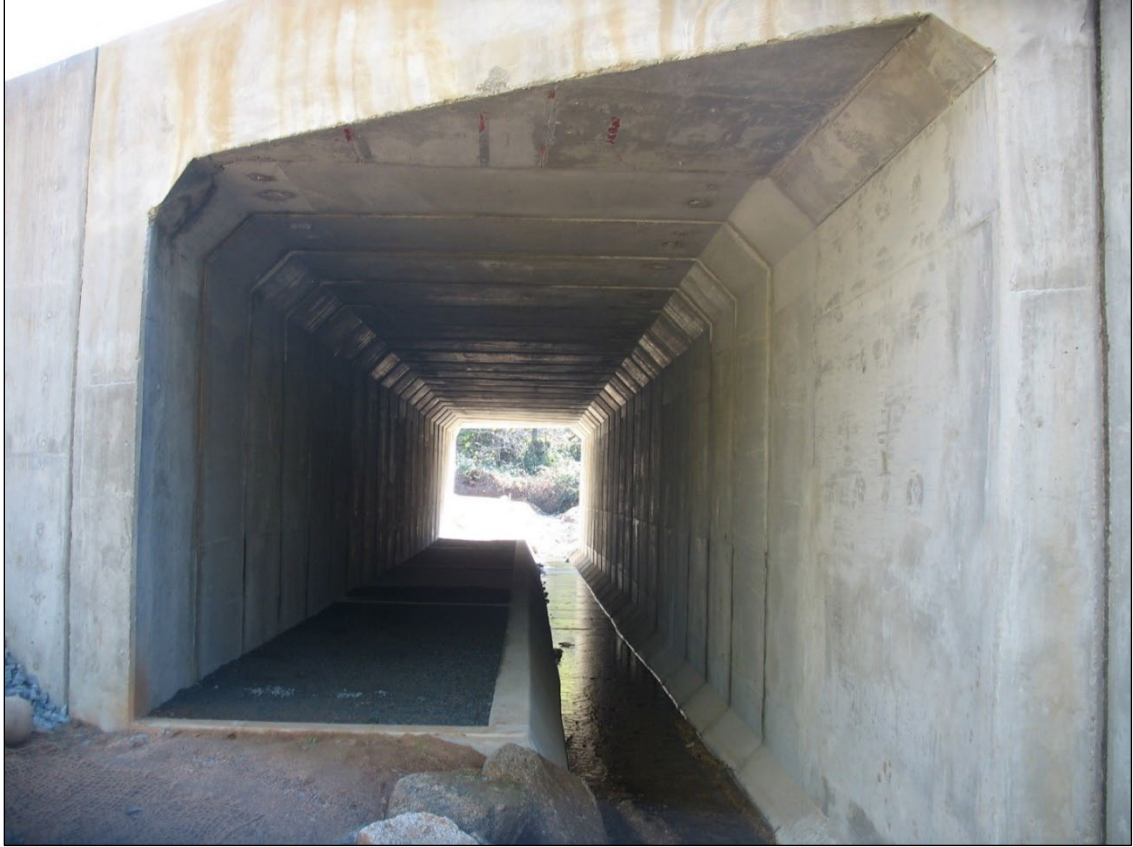
Figure 111. Culvert retrofit on SR-89 by Ken Russo, Senior Environmental Planner, Branch Chief Unit M5, Resource Biologist, Caltrans, District 3.

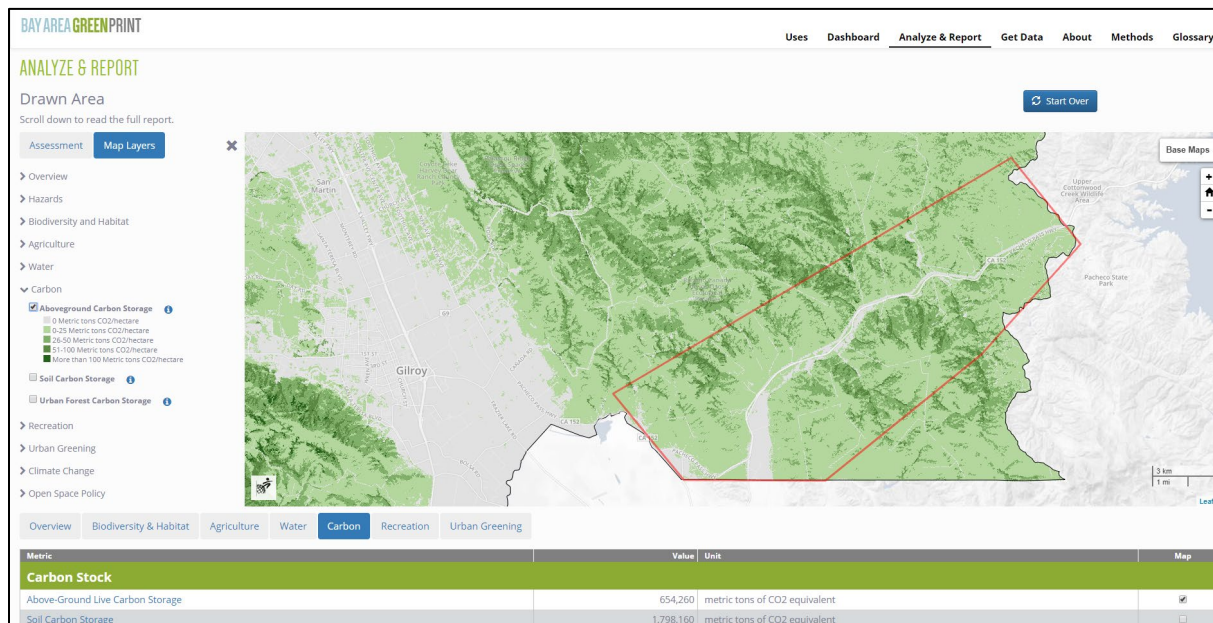
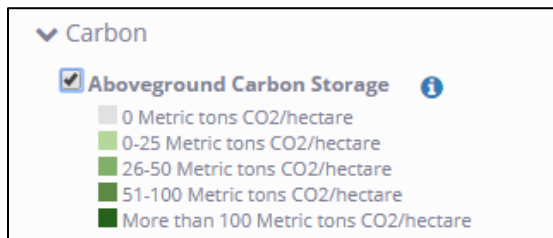
Figure 2. Above-ground carbon storage within the Study Area (red outline).
