**Pacheco Creek Restoration Project
Final Feasibility Study**

Project #4291-01

Santa Clara Valley Habitat Agency
535 Alkire Avenue, Suite 100
Morgan Hill, CA 95037

August 10, 2020

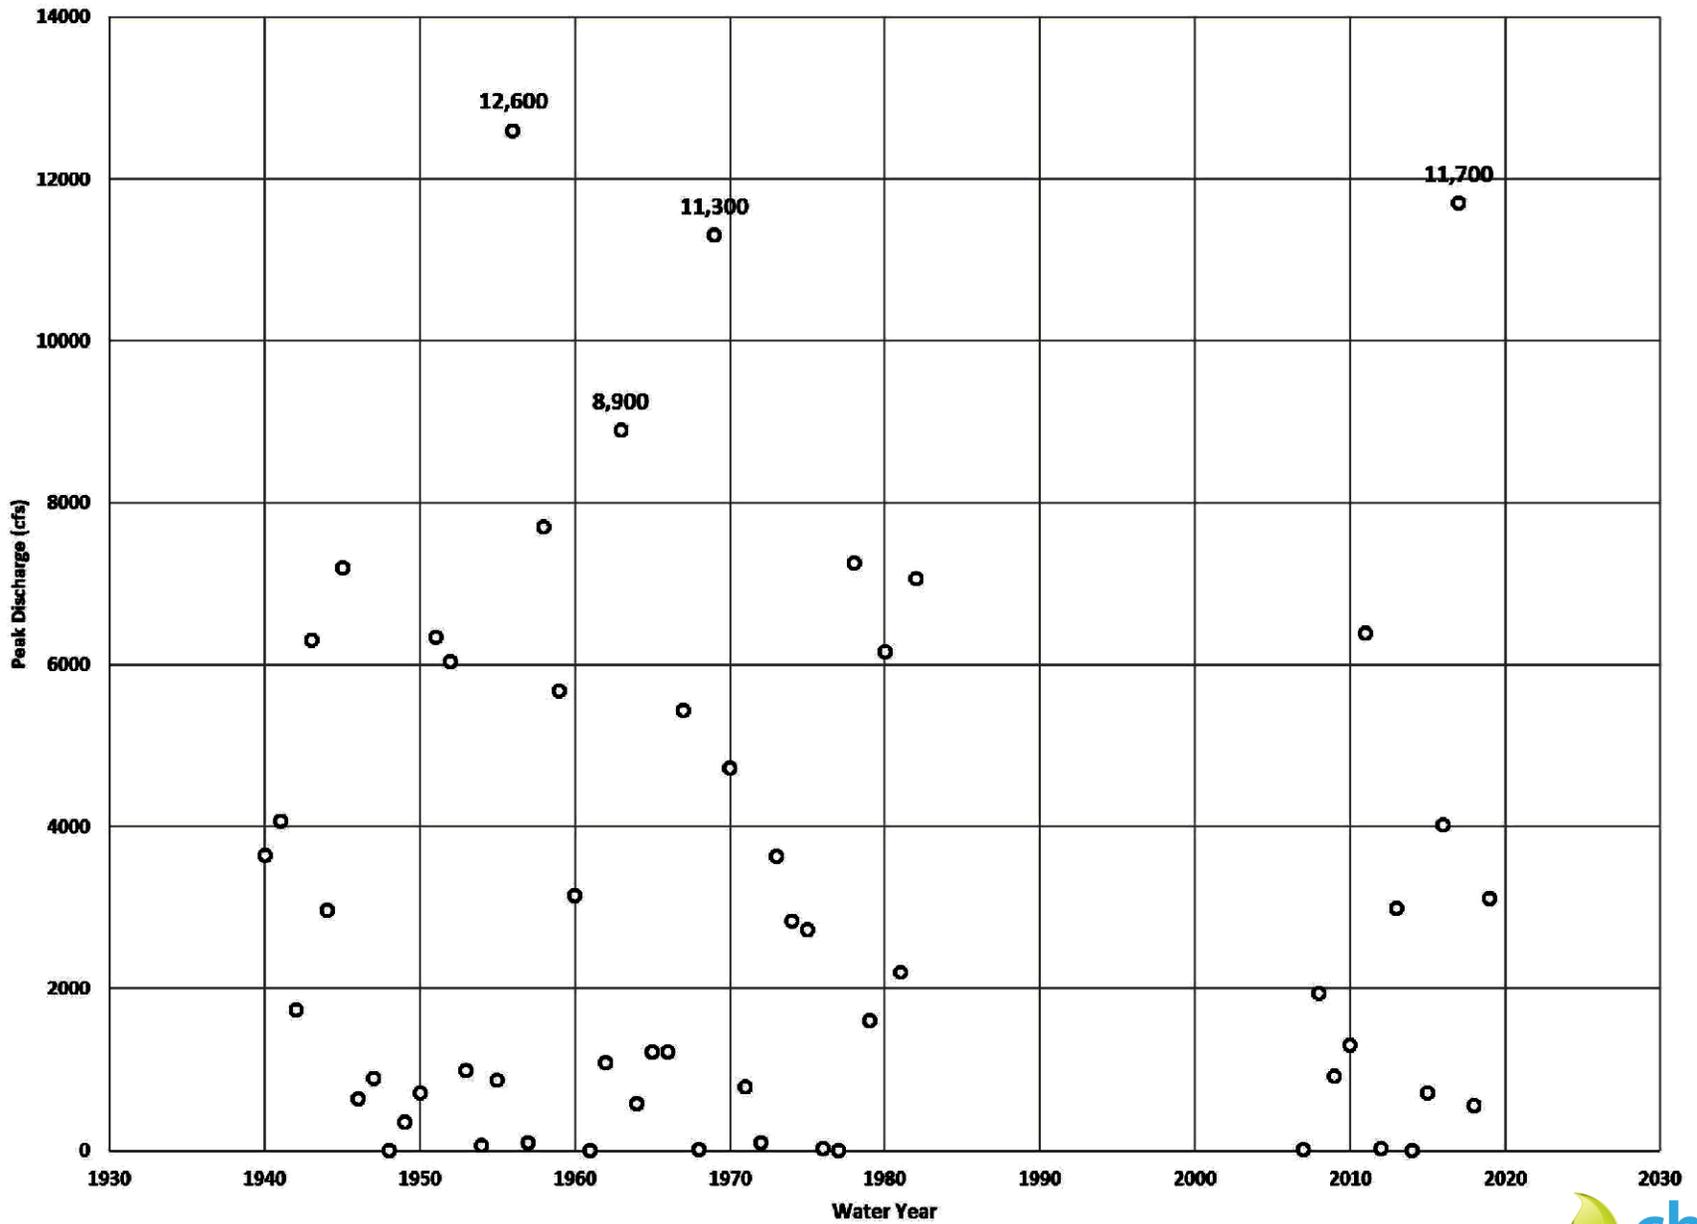
Figure 7. Annual Peak Streamflow Observed at USGS Gage 11153000

The variability in streamflow in this highly flashy system is evident in the instantaneous peak streamflow² observed each WY (Figure 7). Instantaneous peak flows for the period of occurred on December 23, 1955 (12,600 cfs), January 11, 2017 (11,700), and January 25, 1969 (11,300 cfs). One important note is that the second highest observed flow occurred recently in 2017. This flow resulted in geomorphic changes to the stream and floodplain discussed in subsequent sections. Annual peak flows of less than 2 cfs were also observed in four WYs. The difference between annual peak flows also illustrates the significant interannual variability of high flows in Pacheco Creek.

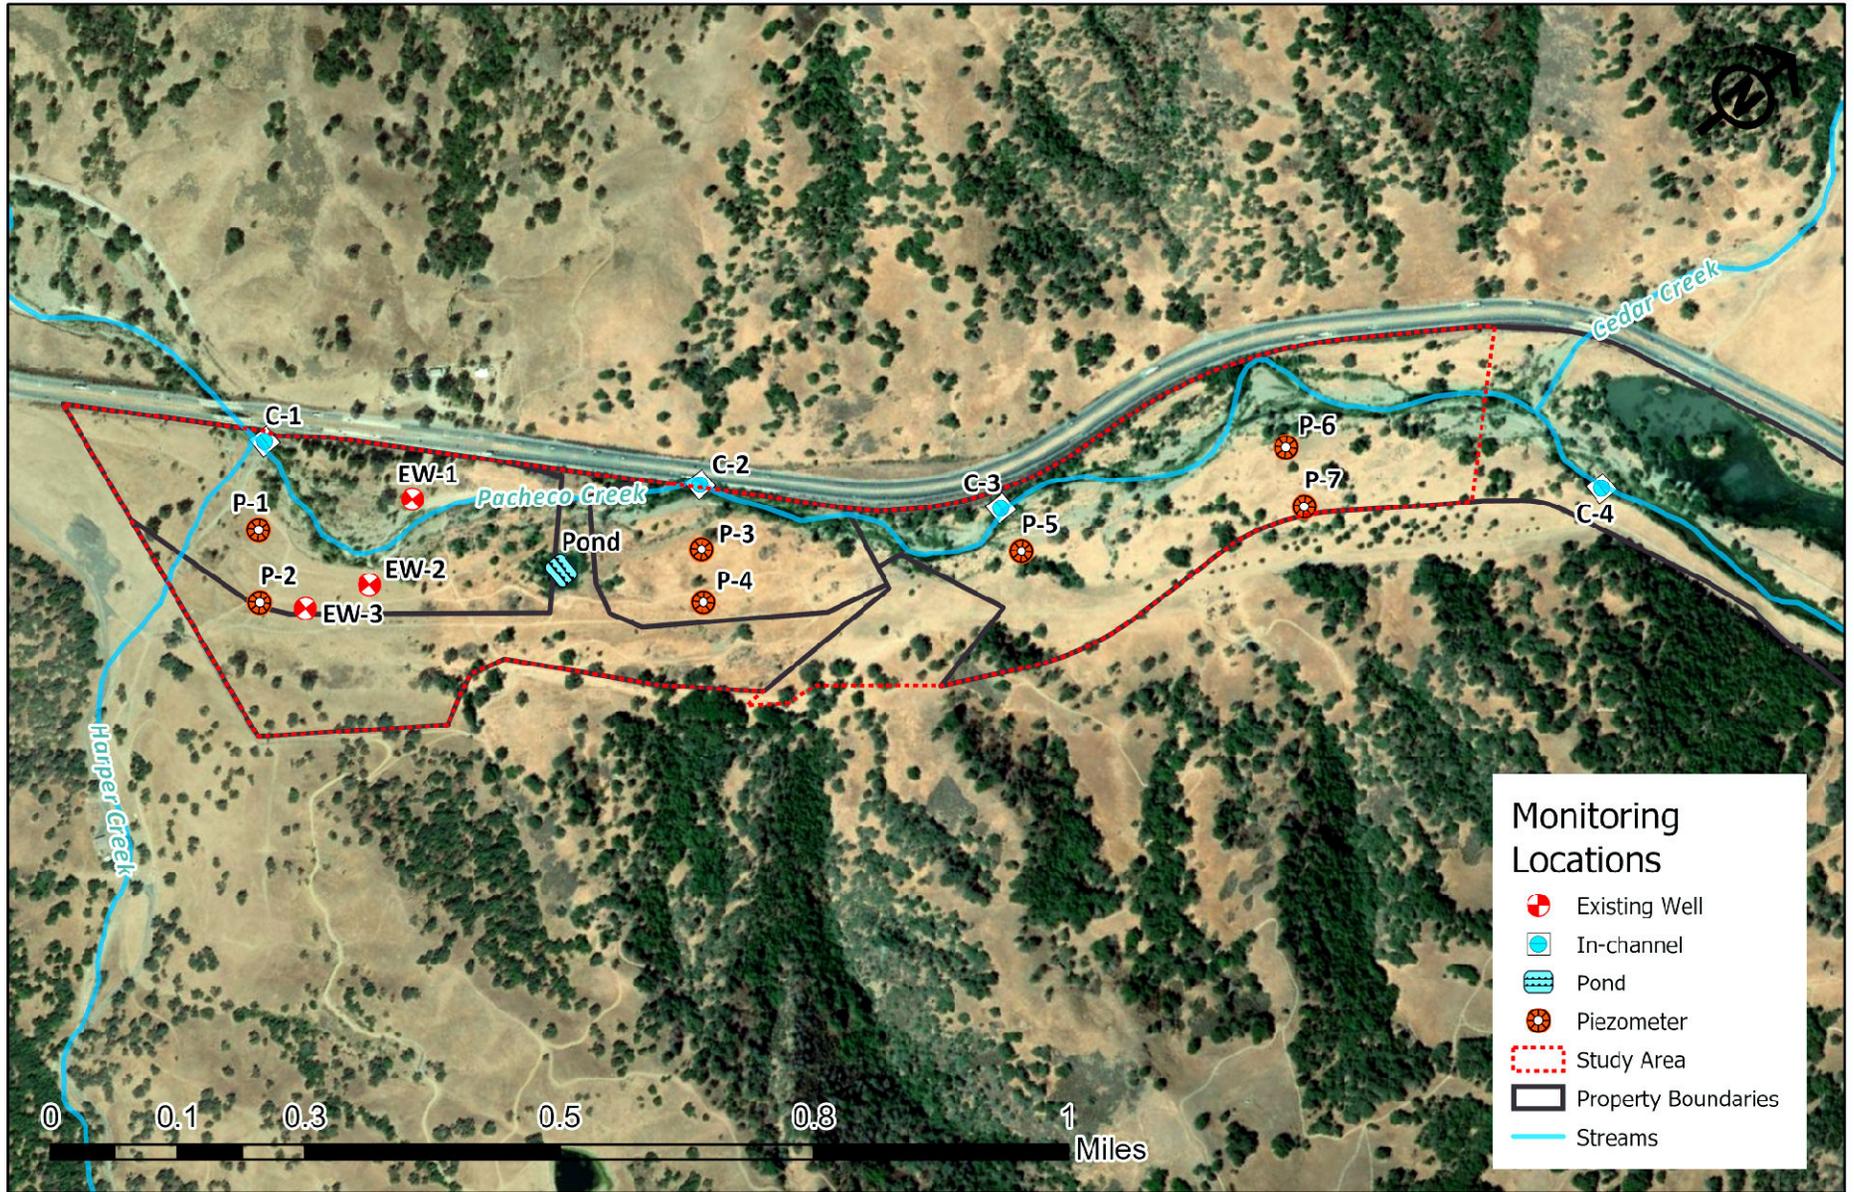
N:\Projects\42004291-01\Reports\Feasibility Study\Fig 10 Depth to Groundwater Created from WSE Data Collected March 26, 2020 and DEM.mxd

DTG—A DTG dataset was developed by differencing the March 26, 2020 WSE interpolated surface from the topographic surface developed by cbec as part of the hydraulic model development described in Appendix A (Figure 10). Much of the Pacheco Creek Reserve property is 7–10 ft above the estimated March 26, 2020 groundwater table, while the Ciraulo Property (at the upper end of the study area) is in closer proximity to the groundwater table with most areas within 3–7 ft of groundwater. The March 26, 2020 DTG is representative of conditions while there is surface water (~2 cfs measured at USGS gage) flowing in Pacheco Creek.

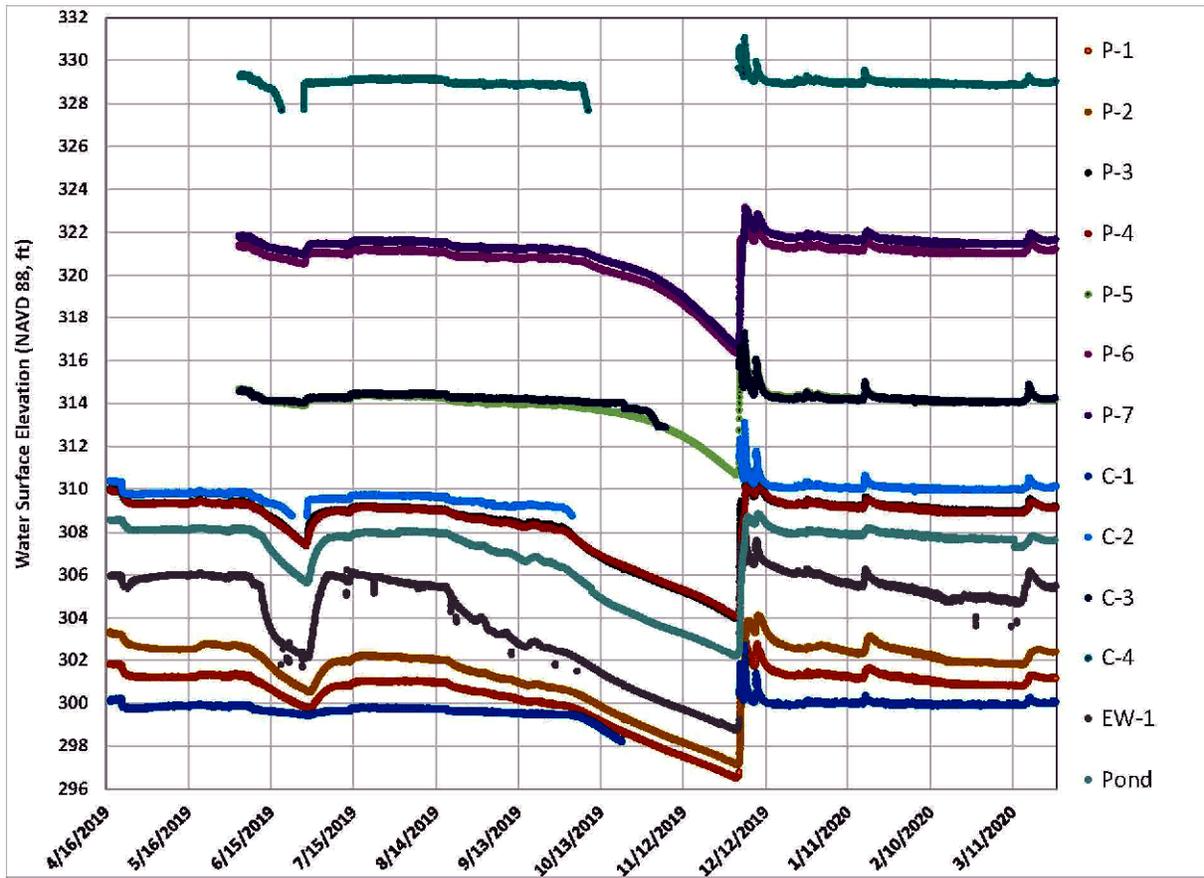
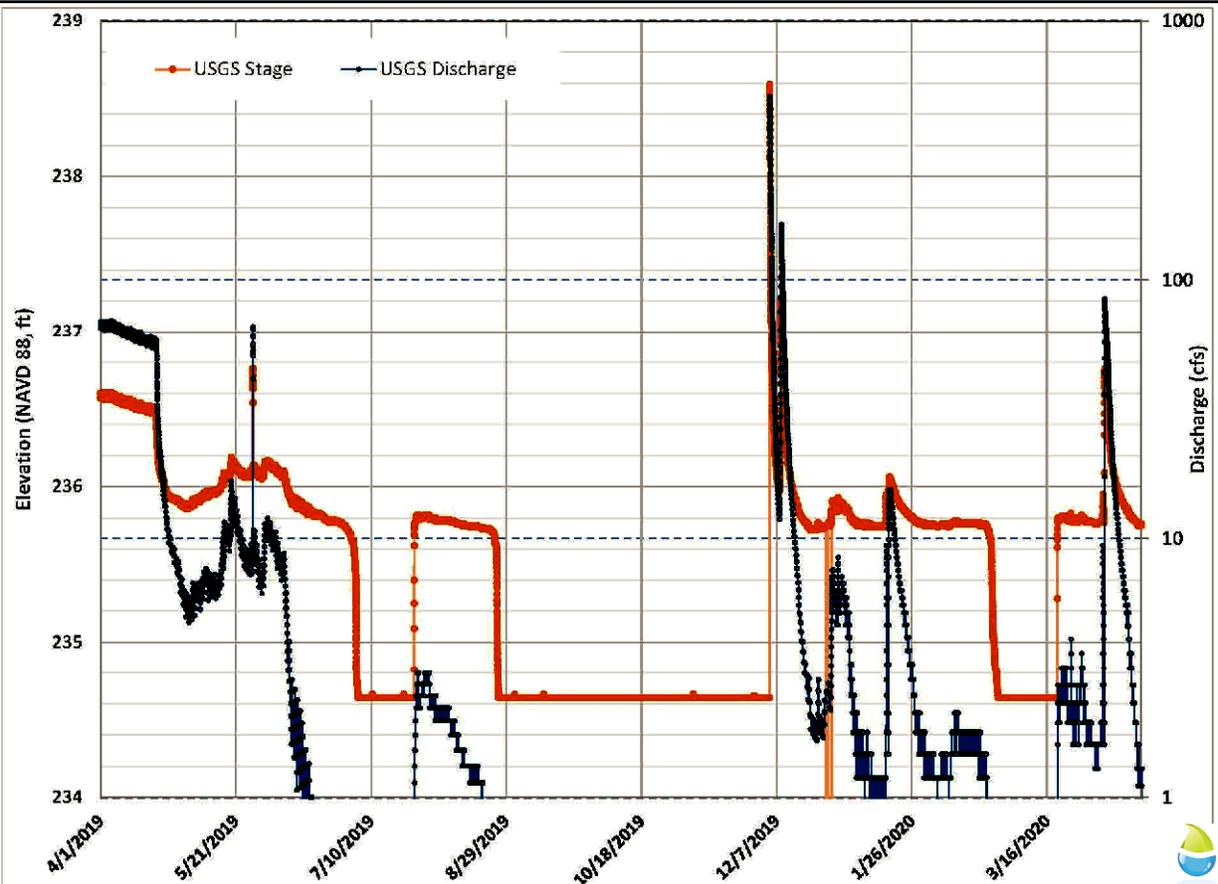
N:\Projects\4200\4291-01\Reports\Feasibility Study\Fig 12 Water Surface Elevation Records for Monitoring Network.mxd

Temporal Analysis of Groundwater and Streamflow—It is important to understand the response of groundwater to changes in streamflow, as this type of information is pertinent when considering how future releases from Pacheco Reservoir will affect the shallow alluvial aquifer (i.e., the groundwater elevation). Instruments P-1 through P-4, C-1, C-2, EW-1 and Pond were installed on April 17, 2019. At that time, flow in Pacheco Creek was still elevated (59 cfs) from winter storms. The remaining instruments (P-5, P-6, P-7, C-3, C-4) were installed on June 3, 2019 after the piezometers were constructed. The WSE time series for each instrument is displayed in Figure 12.

This reduction in streamflow can be observed in the project site with surface and groundwater levels beginning to decline on June 11 and starting to rebound by June 28 (Figure 12). Analysis of how quickly WSEs at each monitoring location rebounded when water was released from the reservoir is useful in order to understand the amount of water necessary to sustain a constant shallow groundwater level across the study area, and the duration that releases need to be sustained to achieve them. As the flow in Pacheco Creek dropped, the water level at two of the instream loggers (C-2, C-4) fell below the elevation of the loggers, as the stream likely went dry or nearly dry in those locations. The logger at C-1 was placed in a deeper pool and showed minimal elevation drop from the reduction of flow through the reach.

The groundwater elevation in most piezometers began rising within 24 hours of the levels observed in the instream monitoring locations and rebounded to nearly their previous level within 1 week. Sites P-1 and P-2 took the longest to rebound (12 days). This makes sense as the gradient for the groundwater table is steepest laterally across the piezometer transect in those locations. Pond, P-3, P-4, and EW-1 all took approximately 7 days to rebound. The upper sites, P-4, P-5, P-6, P-7, and C-3, all rebounded to nearly previous levels within 3 days. This indicates that upstream where the DTG is shallower in general, the aquifer responds more quickly to changes in Pacheco Creek flow. The recovery timing at each transect makes sense when the slope of the groundwater surface perpendicular to the valley slope is considered.

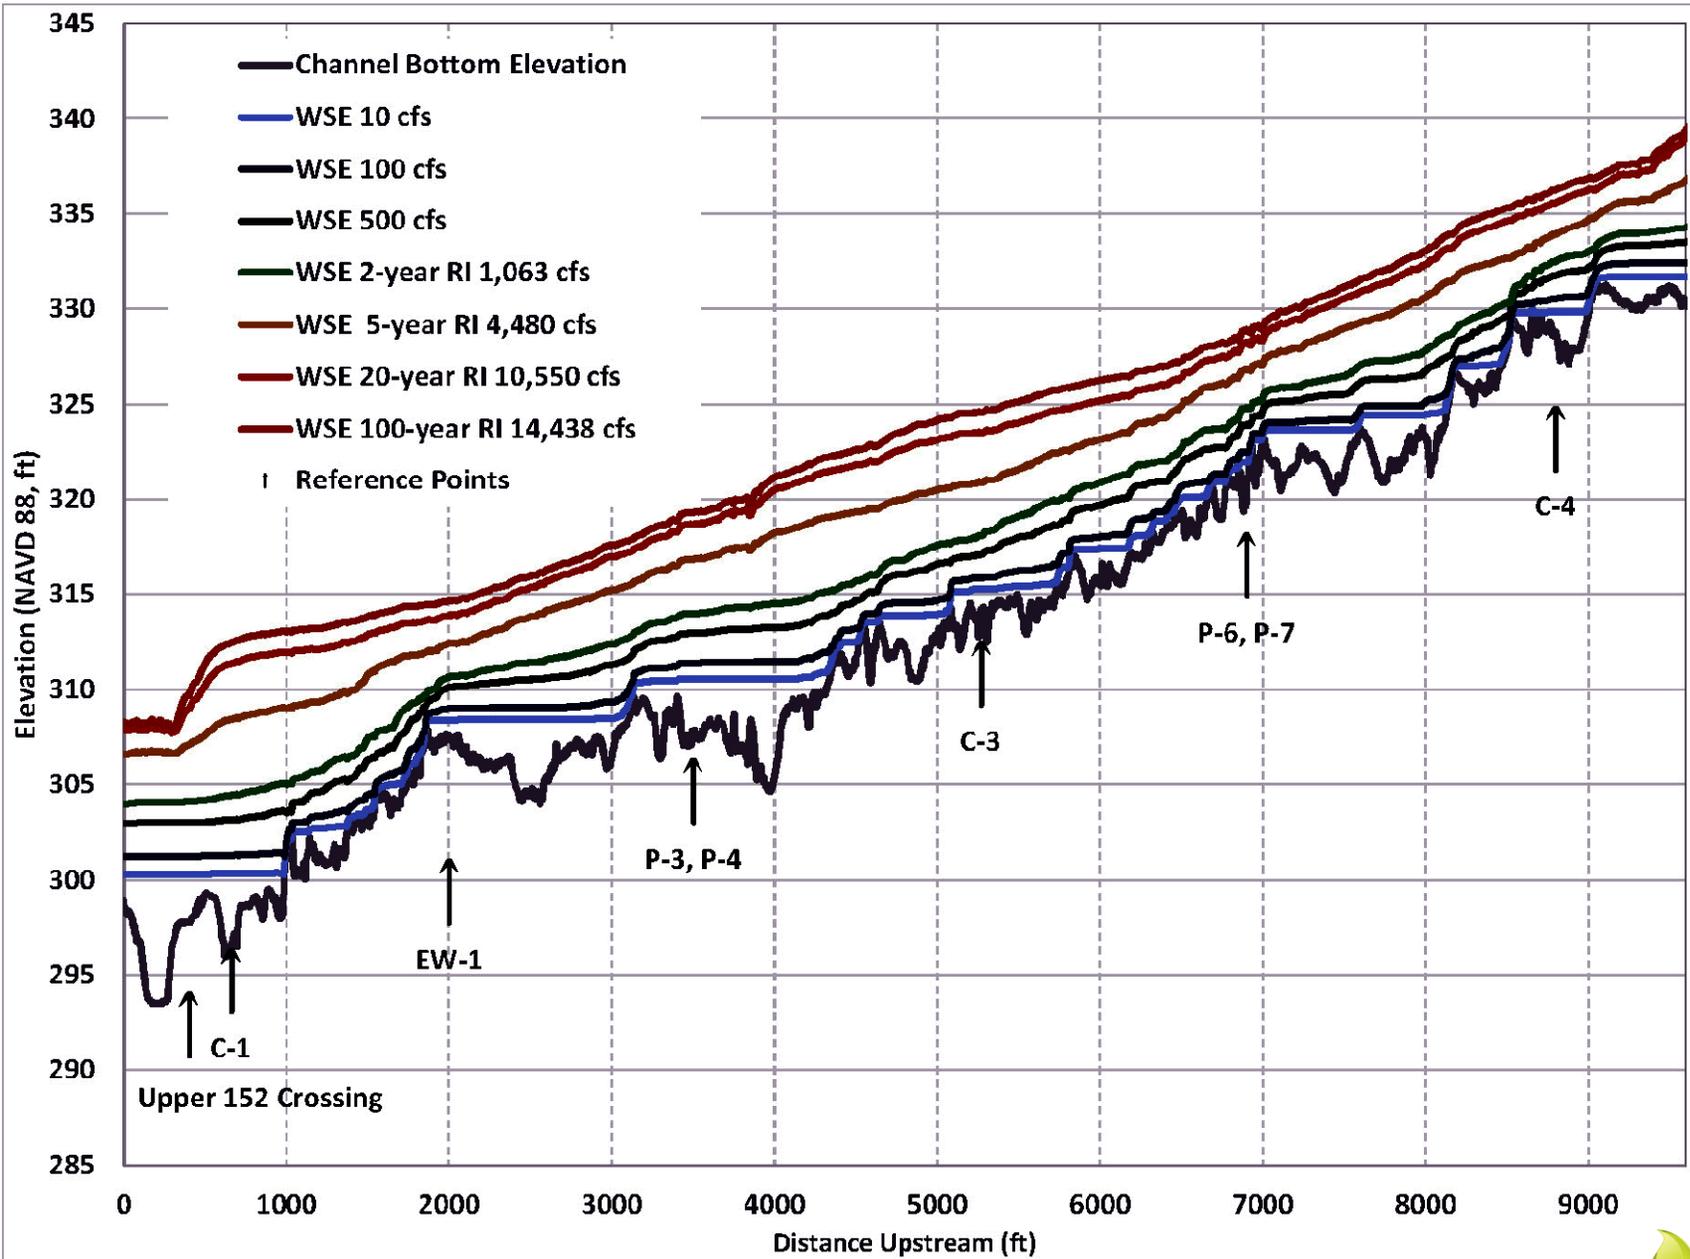
N:\Projects\42004\291-01\Reports\Feasibility Study\Fig 15 WSE Profile.mxd

Longitudinal profiles of WSE for the simulated flows also help characterize hydraulic conditions throughout the study area (Figure 15). At lower flows, WSEs are driven by local, in-channel topographic controls (i.e., riffle crests). At higher flows such as the 20- and 100-year recurrence interval events, larger valley-wide controls (i.e., limitations on flow conveyance capacity) such as the Highway 152 bridge and abutments become more apparent.

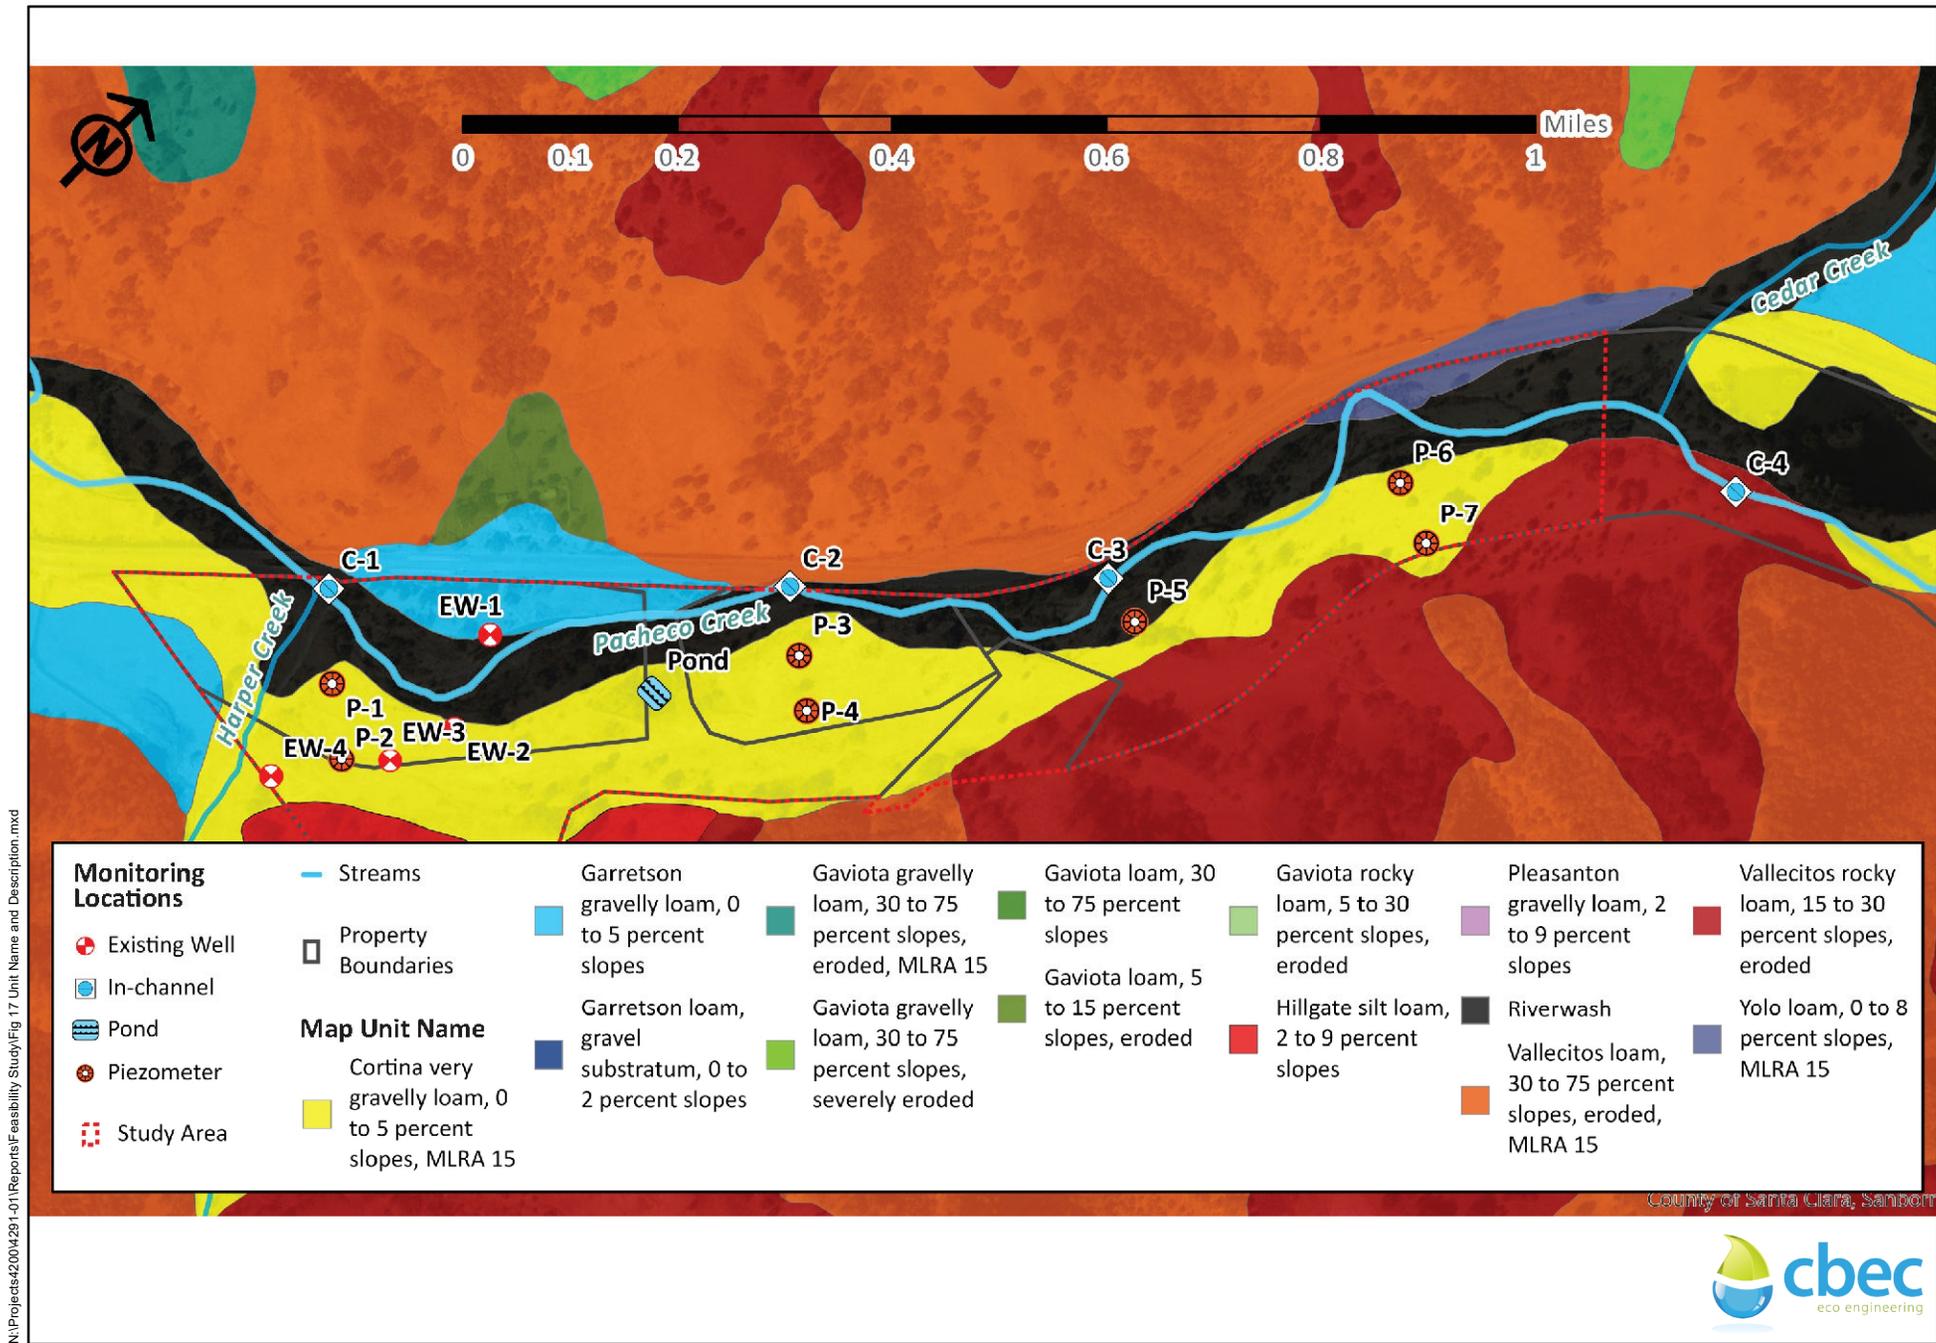
N:\Projects\4200\4291-01\Reports\Feasibility Study\Fig 17 Unit Name and Description.mxd

Soils within the study area are mostly composed of two map units: Cortina very gravelly loam and Riverwash (Figure 17). The unit displayed in yellow is the Cortina very gravelly loam, 0 to 5 percent slopes. This is an excessively well drained soil series on alluvial fans and floodplains. The map unit displayed in black is Riverwash, which generally refers to deep alluvial materials that were erratically deposited during flood events. SFEI noted that Riverwash is indicative of a multi-thread channel system, which extended across the entirety of the valley in the 1927 soil survey (SFEI 2008).

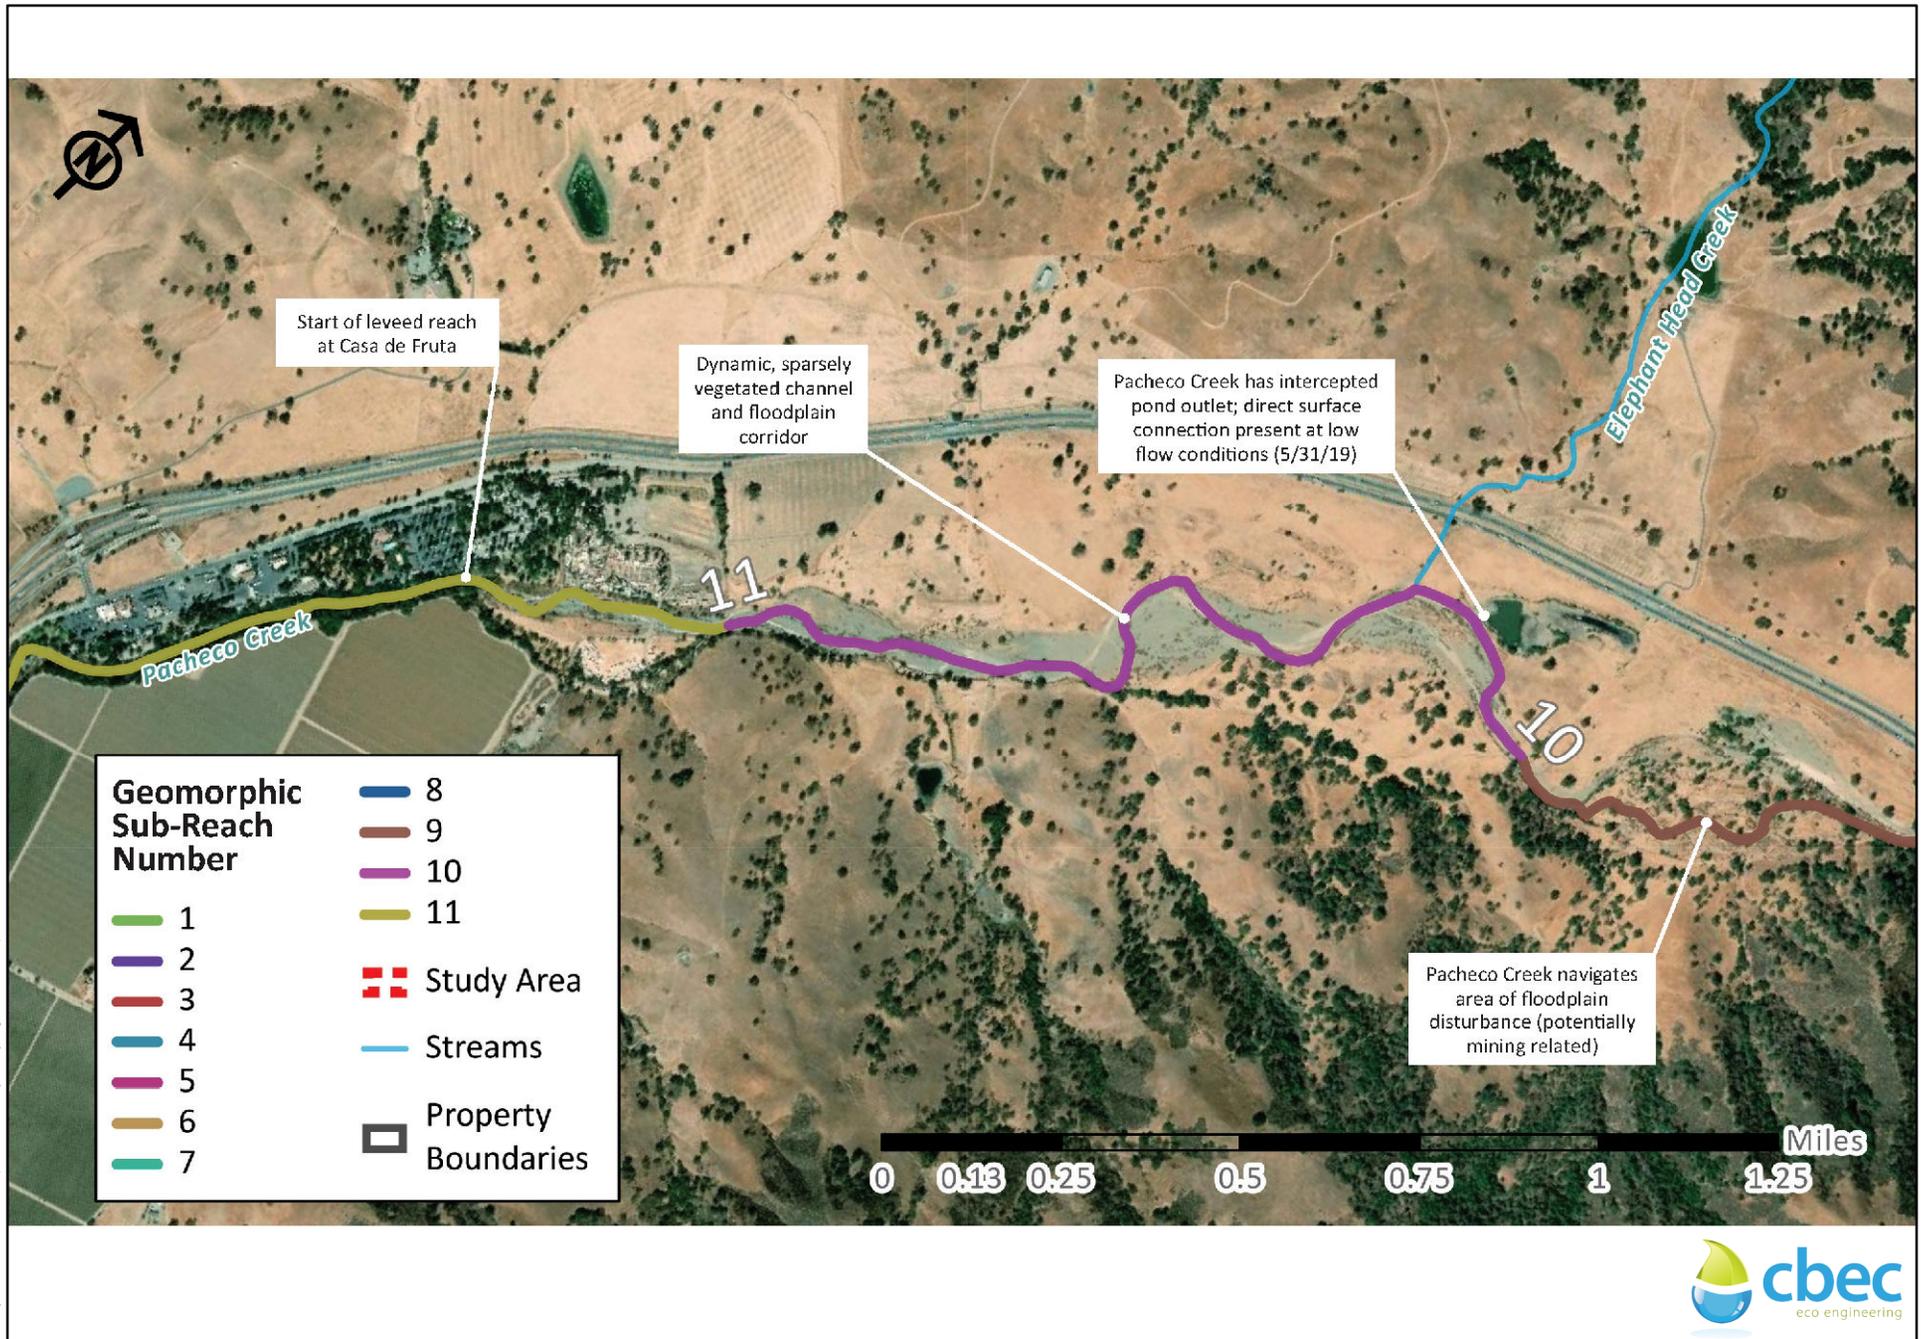
Figure 18d. Geomorphic Overview of the Larger Reconnaissance Reach - Plate 3

Continuing downstream, Pacheco Creek flows through a visibly disturbed floodplain area (potentially caused by mining that left behind tailings mounds) along the downstream end of sub-reach 9 (Figure 18d). The channel meanders through a maze of ridges or mounds studded with large sycamores. Sub-reach 10 is characterized by a broad and dynamic floodplain corridor with substantially less riparian vegetation establishment than present from sub-reach 5 through the upstream end of sub-reach 9. Along sub-reach 10, Pacheco Creek has also intercepted the outlet of a pond (likely a legacy gravel extraction area) and now has a direct surface connection with this feature during base flow conditions. As Pacheco Creek approaches Casa de Fruta along sub-reach 11, the active channel and floodplain corridor is dramatically reduced in width due to the construction of berms or levees along both creek banks (Figure 18d). The channel also appears to have been realigned and straightened. The combination of these factors greatly impairs natural physical processes and results in the most significant transition in the geomorphic character of Pacheco Creek along the larger reconnaissance reach.

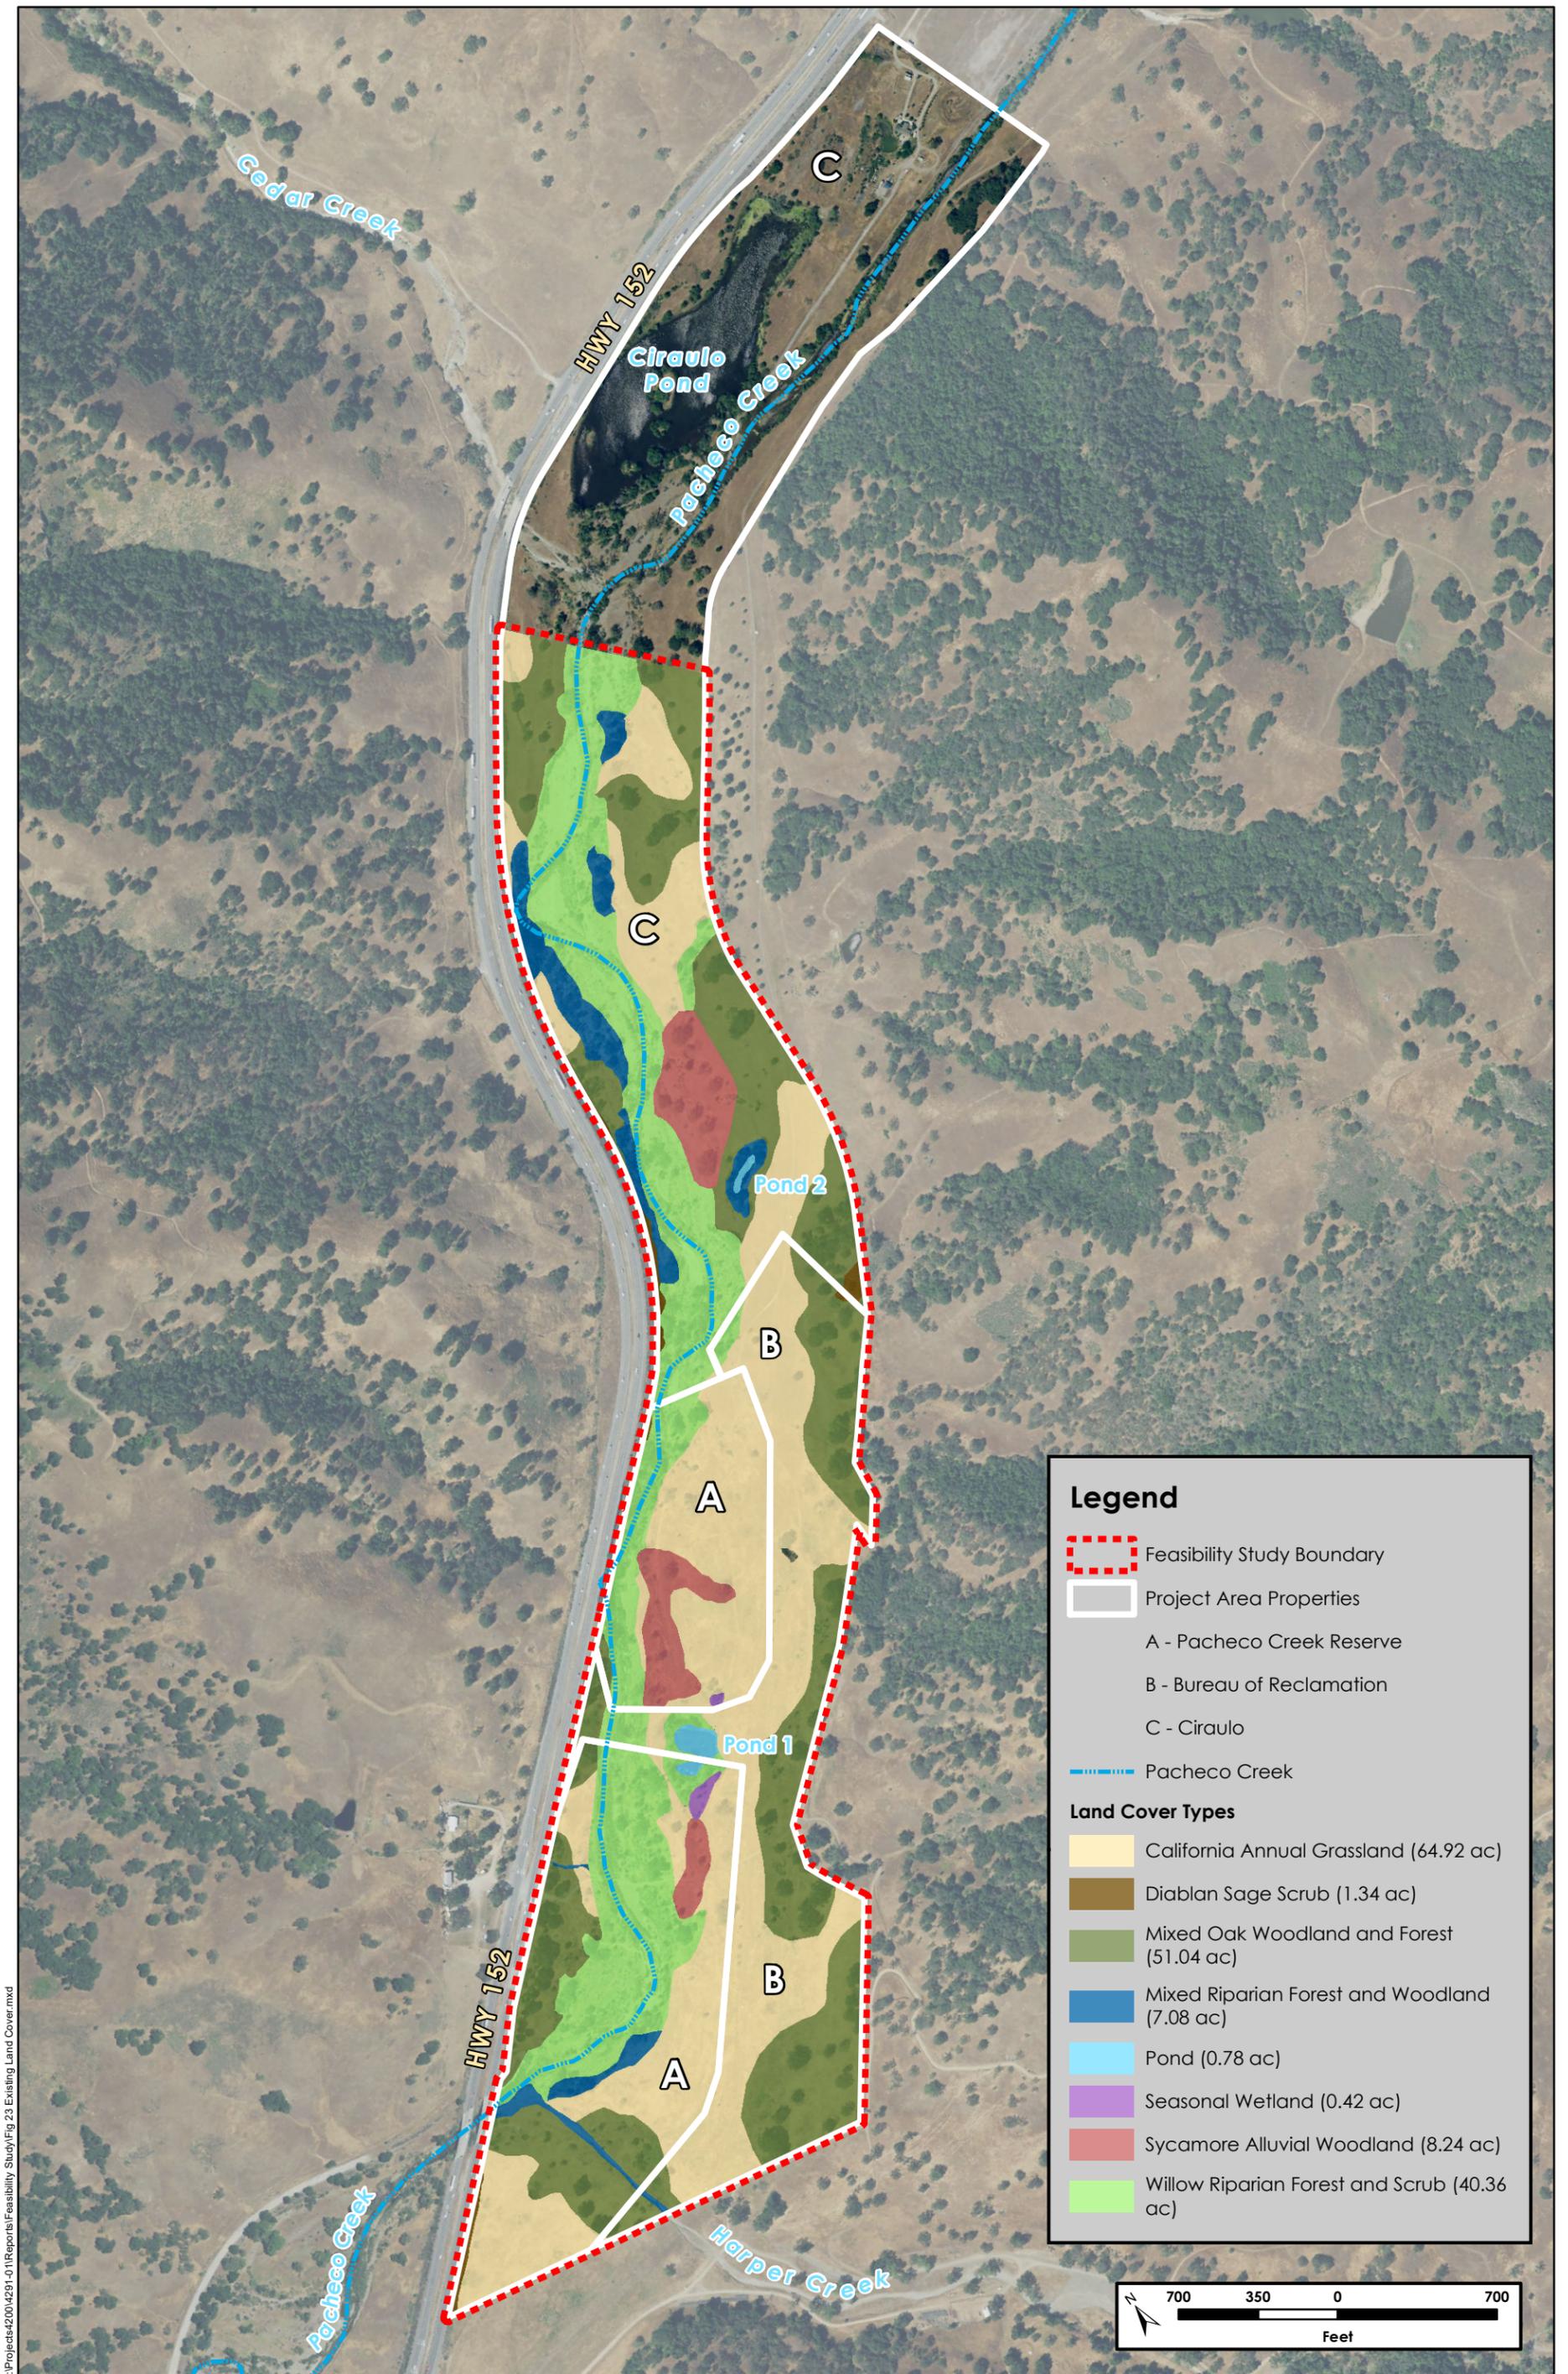
N:\Projects\4291-01\Reports\Feasibility Study\Fig 23 Existing Land Cover.mxd

California annual grassland covers most of the study area, predominately to the east of Pacheco Creek (Figure 23). Vegetation in this land cover type is dominated by non-native annual grass species such as ripgut brome (*Bromus diandrus*), soft brome (*Bromus hordeaceus*), and foxtail barley (*Hordeum murinum*). Nonnative invasive forbs are also present and include yellow star thistle (*Centaurea solstitialis*) and milk thistle (*Silybum marianum*). However, this land cover type also includes lesser amounts of native forbs, including various lupine species (*Lupinus* spp.), common gumplant (*Grindelia camporum*), California goldfields (*Lasthenia gracilis*), narrow leaved owl’s clover (*Castilleja attenuata*), and California golden violet (*Viola pendunculata*). Scattered, individual coast live oak (*Quercus agrifolia*) and valley oak (*Quercus lobata*) occur within areas mapped as California annual grassland.

This land cover type occurs sporadically throughout the study area, and is generally associated with the historical secondary channels of Pacheco Creek or with large excavated depressions in the California annual grassland (Figure 23). Vegetation varies amongst the marshes, but generally consists of an herbaceous layer of wire rush (*Juncus balticus*), common bog rush (*Juncus effusus*), tall cyperus (*Cyperus eragrostis*), or spike rush (*Eleocharis macrostachya*). These marshes also vary in overstory, with some being entirely herbaceous, while those is the historical channels having a shrub layer of mule fat or an overstory canopy of large red willows.

Two significant ponds were observed in the study area. The largest is located in the southern half of the study area, to the east of Pacheco Creek; this is denoted as Pond 1 in Figure 23. This pond has significant depth, and is likely perennial in most years. This pond was apparently excavated by a previous landowner within the California annual grassland sometime in the past; the original purpose of this pond is unknown. Another smaller pond occurs near the center of the study area, and is obscured on aerial imagery by overhanging tree canopy; this is denoted as Pond 2 in Figure 23. Pond 2 is substantially shallower than Pond 1. The origin of this pond is unknown, although it is within a historical channel and may have been natural scoured, however it may have been further excavated by a previous landowner to enhance the water source for cattle. We observed that there was no surface ponding in Pond 2 in July 2019.

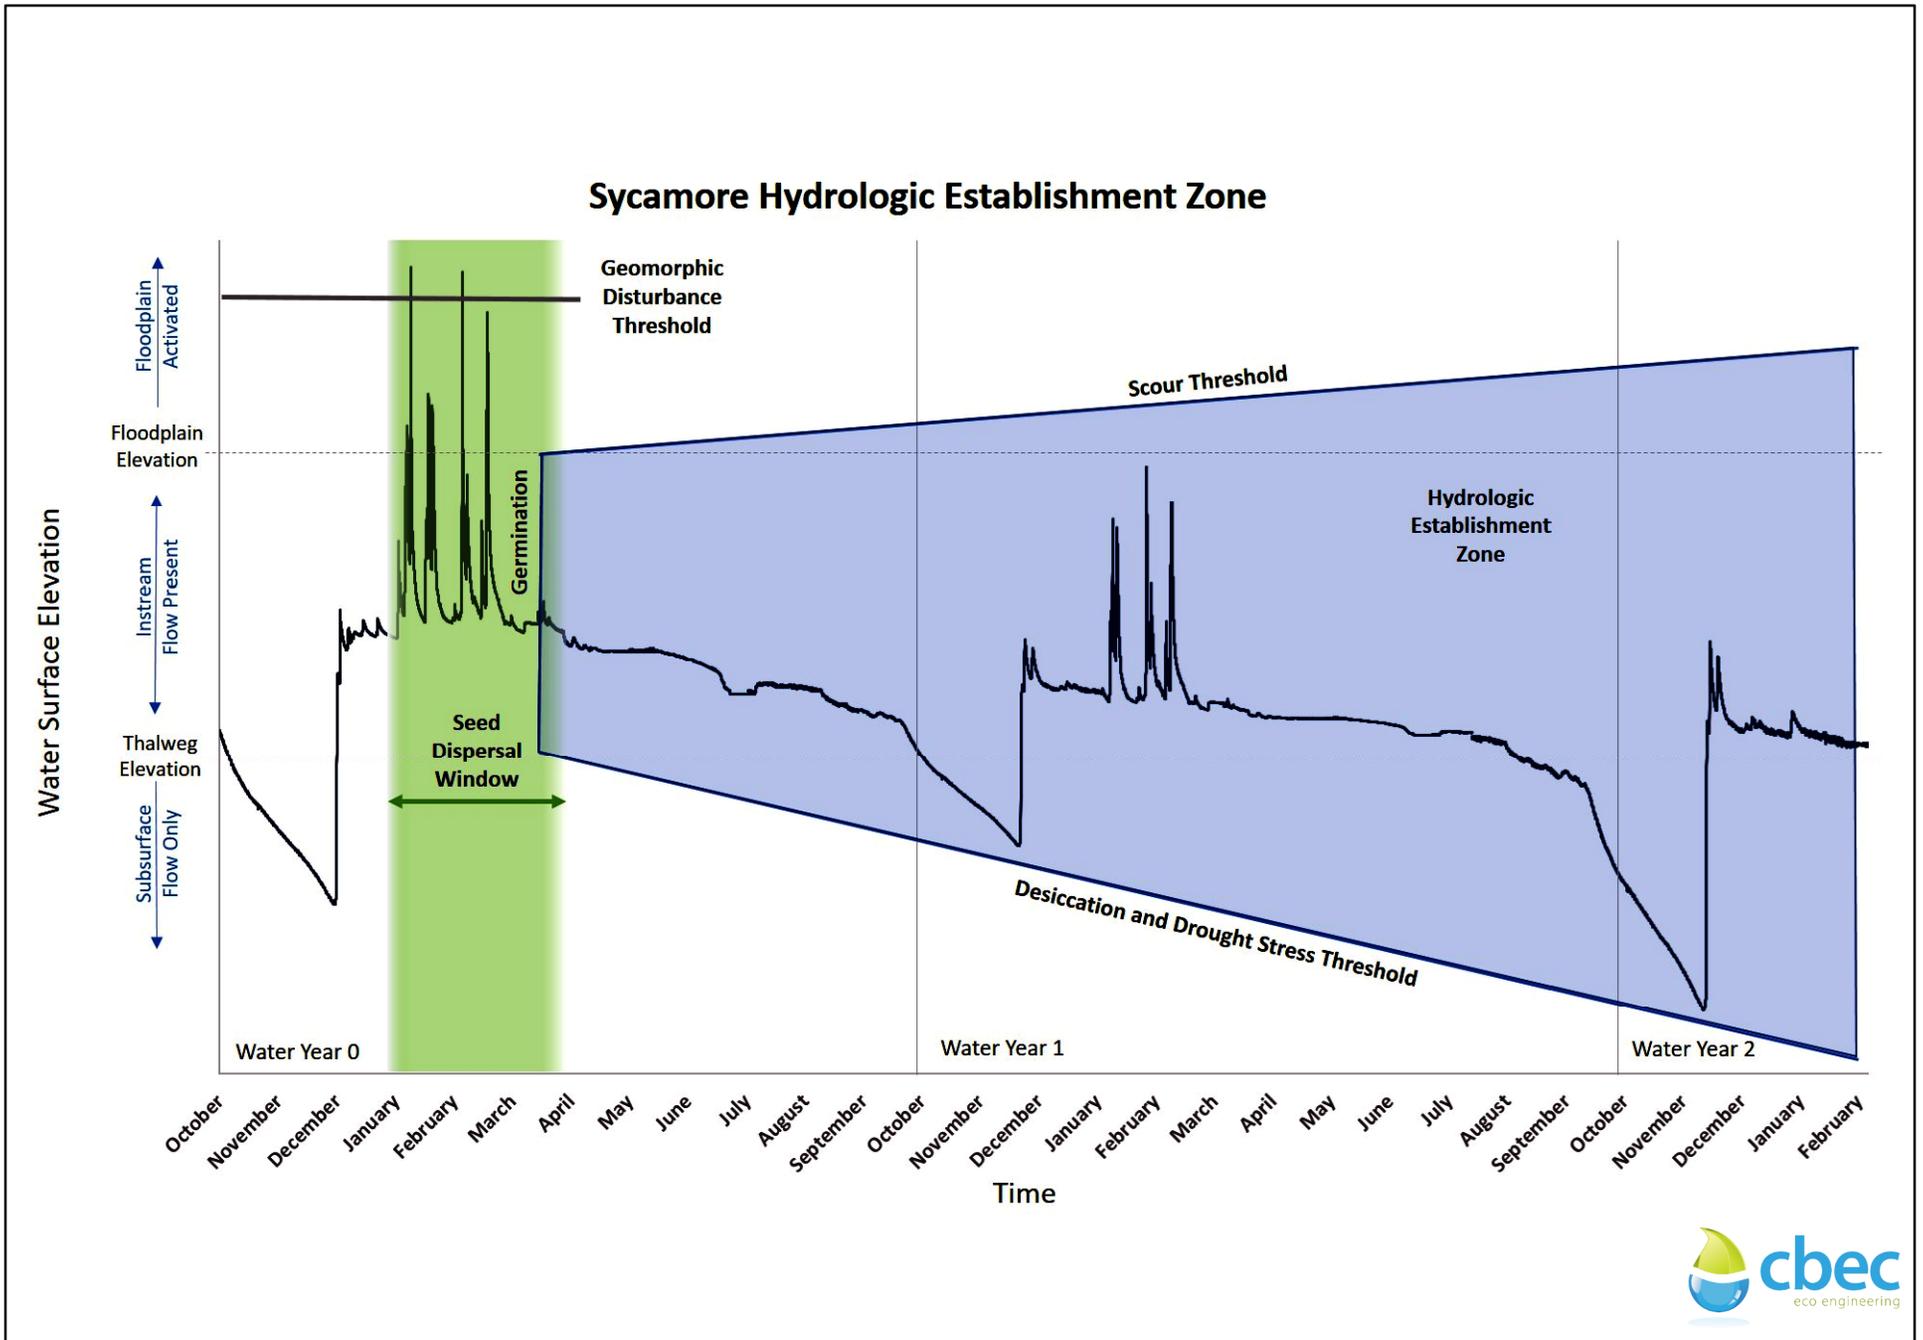
To illustrate the temporal hydrologic requirements for sycamore regeneration, we have adapted Mahoney & Rood's (1998) recruitment box model for cottonwoods for application to the California sycamore. The recruitment box for cottonwoods refers to the flow range that exists between higher magnitude flows that can scour new seedlings and lower flows that maintain required moisture for roots during the seed dispersal period. The recruitment box concept has been adapted for sycamores as a Sycamore Hydrologic Establishment Zone which extends for multiple years following germination (Figure 28). Water surface elevation (including groundwater level when flow goes sub-surface) has been substituted for streamflow in the y-axis to account for the intermittent nature of streamflow in sycamore-supporting streams.
