**Pacheco Creek Restoration Project
Final Feasibility Study**

Project #4291-01

Santa Clara Valley Habitat Agency
535 Alkire Avenue, Suite 100
Morgan Hill, CA 95037

August 10, 2020

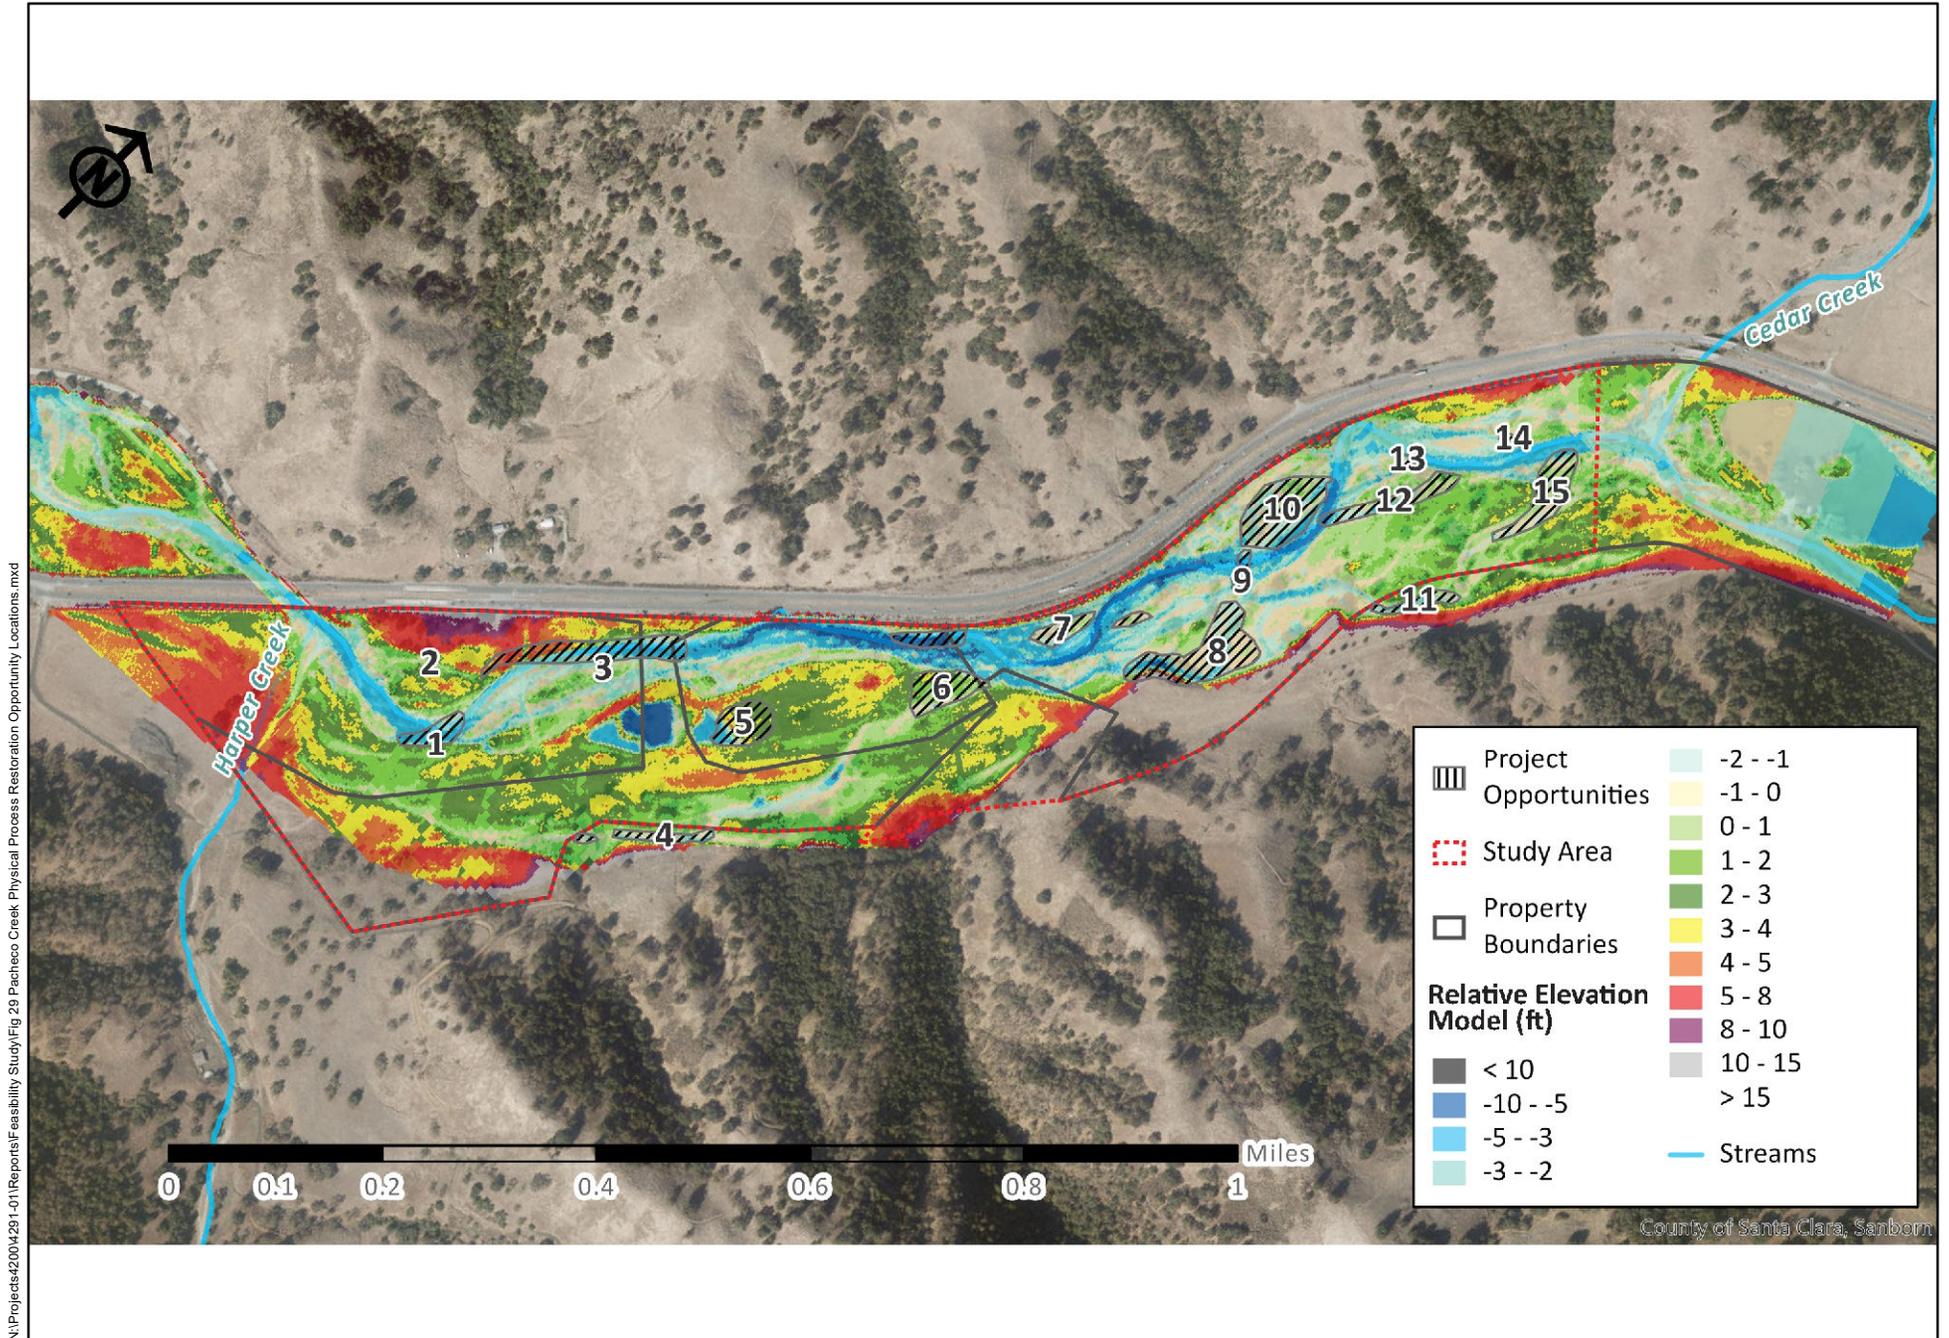
N:\Projects\42004\291-01\Reports\Feasibility Study\Fig 29 Pacheco Creek Physical Process Restoration Opportunity Locations.mxd

Our team considered each of these general restoration element categories and identified specific (e.g., spatially explicit) physical process restoration opportunities (Figure 29). These opportunities typically combine two or more restoration elements. Table 5 summarizes the restoration opportunities and constituent restoration elements; it also includes scoring across key restoration goals, rough order of magnitude cost implications and a prioritization score for each opportunity. Many of these opportunities are aimed at promoting conditions that support existing and proposed SAW areas and potentially natural sycamore regeneration. Some of these measures are also aimed at slowing or inhibiting potential future channel incision processes and the associated reduction in floodplain connectivity within the study area.

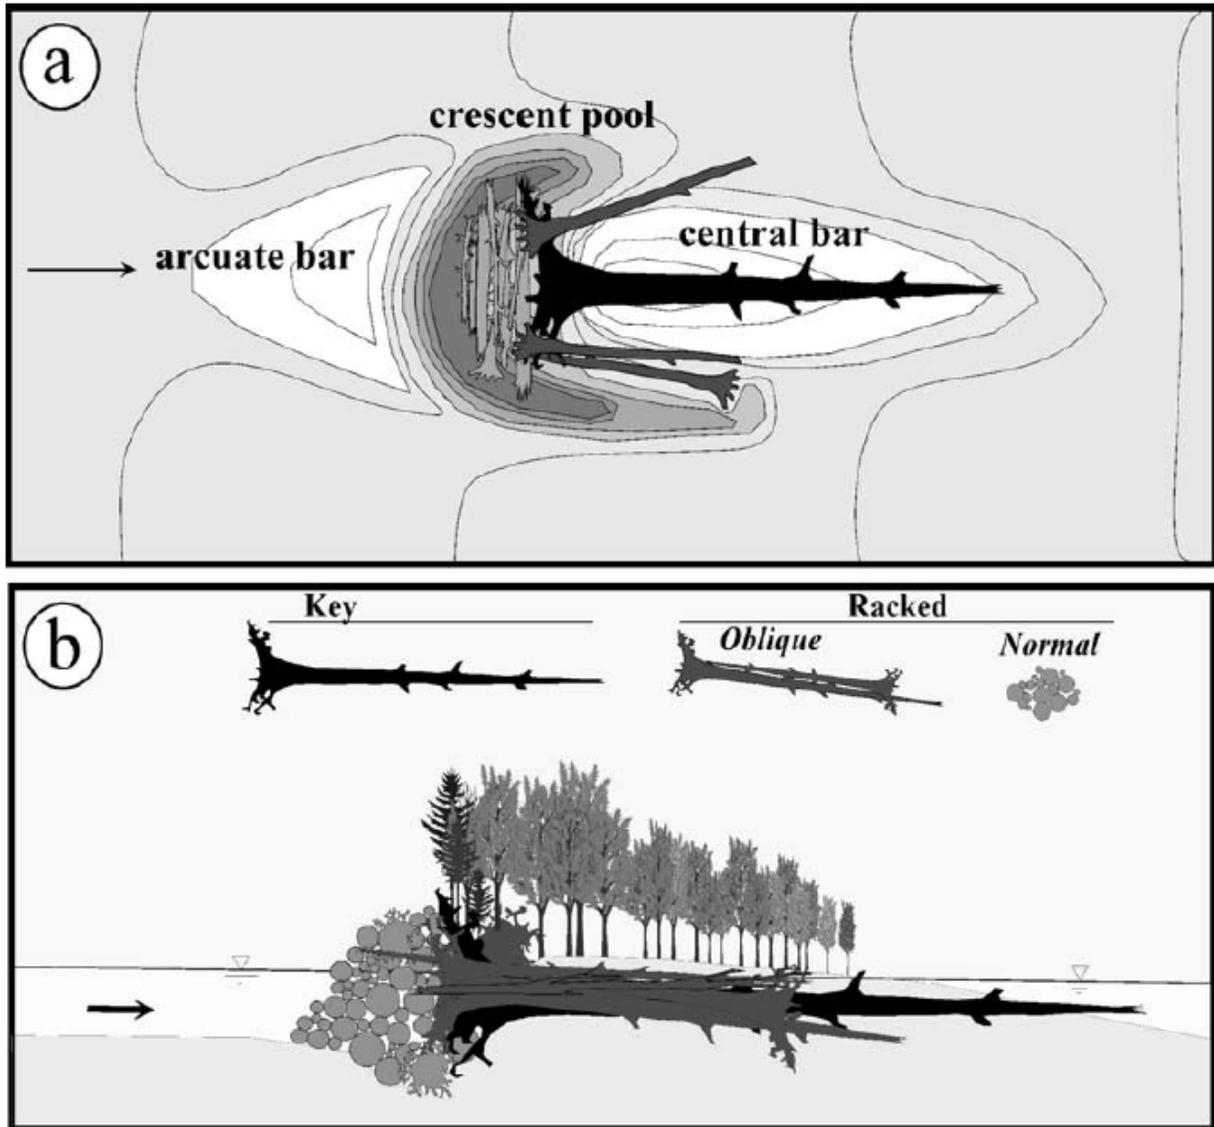
Fig. 6. (a) Planview illustration of basic structure of bar apex jams. Alluvial morphology associated with bar apex jams includes an upstream arcuate bar, a crescent pool adjacent to the jam, and a central bar downstream (Abbe and Montgomery, 1996). (b) Profile illustrating tree colonization along the axis of a bar apex jam commonly exhibiting a distinctive age sequence decreasing downstream from the key-member rootwad.
