## Wildlife Permeability and Hazards across Highway 152 Pacheco Pass: Establishing a Baseline to Inform Infrastructure and Restoration.

February 2020

PREPARED BY PATHWAYS FOR WILDLIFE FOR THE SANTA CLARA VALLEY  
HABITAT AGENCY.

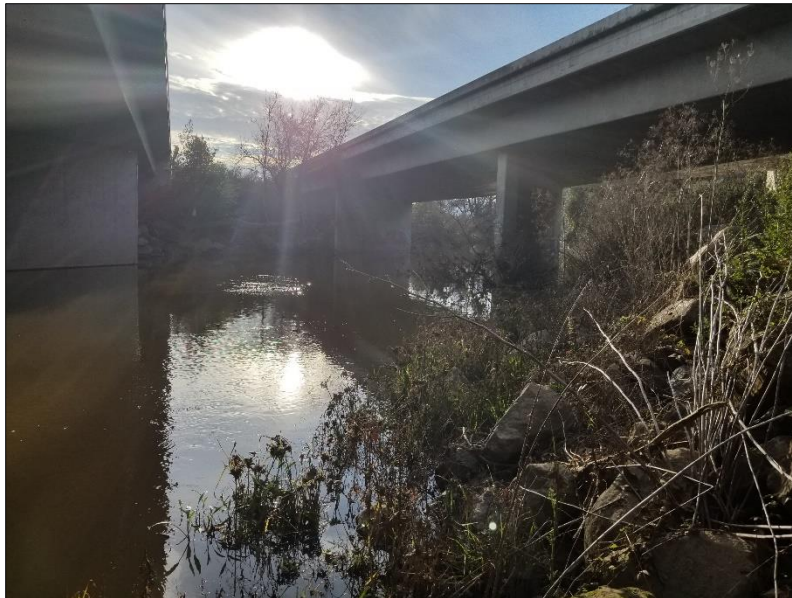
Figure 15. Pacheco Creek bridge flooded during February 2019.

During the winter season of the study, there were several storm events that caused the bridges and culverts to flood with water (Figures 15 & 16). Before the flooding events occurred, multiple species were recorded to consistently travel through the bridges and culverts during the months of August-December 2018 (Chart 3).

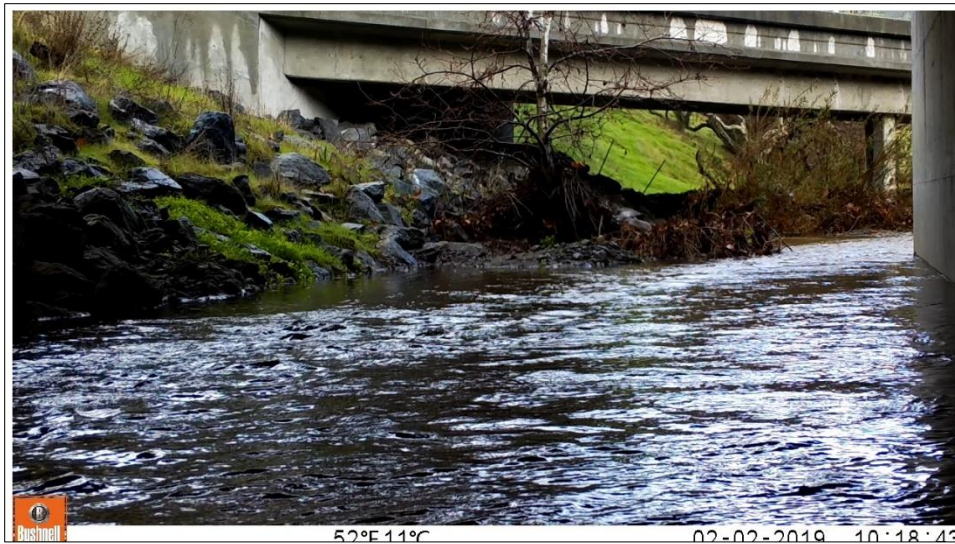
Figure 16. Cedar Creek bridge flooded during February 2019.

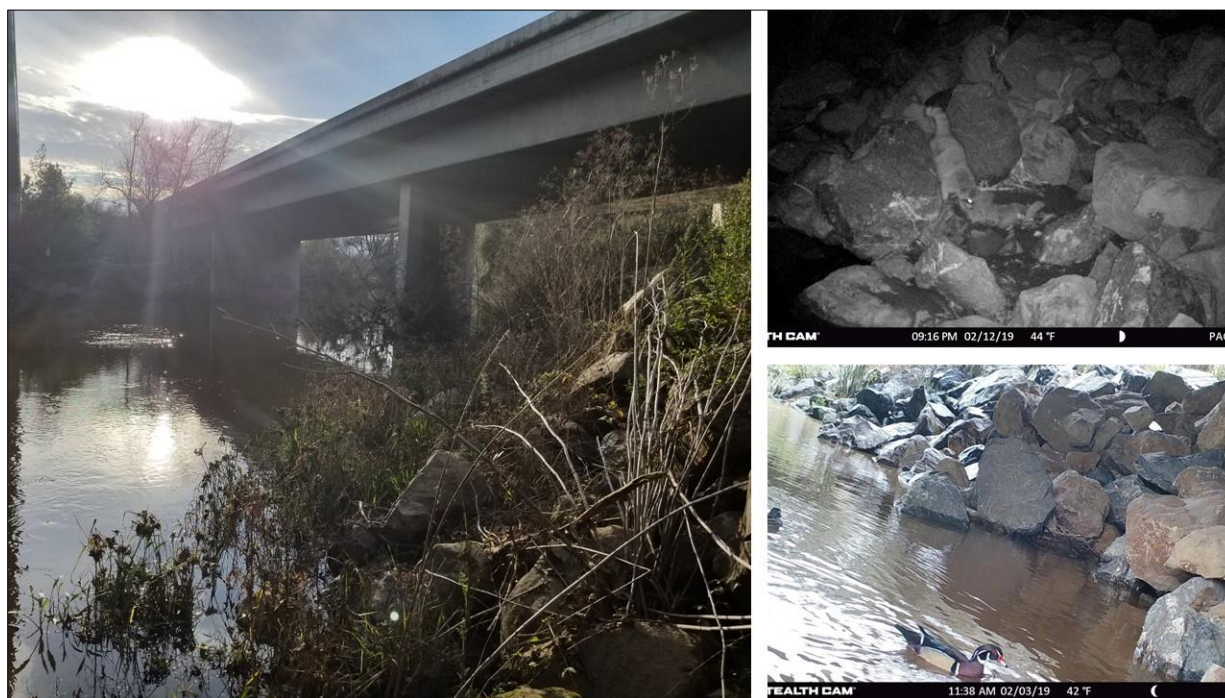
At the Pacheco Creek bridge, where multiple species had been recorded consistently traveling under the bridge, we recorded wood ducks (*Aix sponsa*) swimming by the camera (Figure 18). The only species we recorded during January and February traveling under the bridge were raccoons (Figure 18).

Figure 18. Pacheco Creek bridge in February 2019 and camera data.

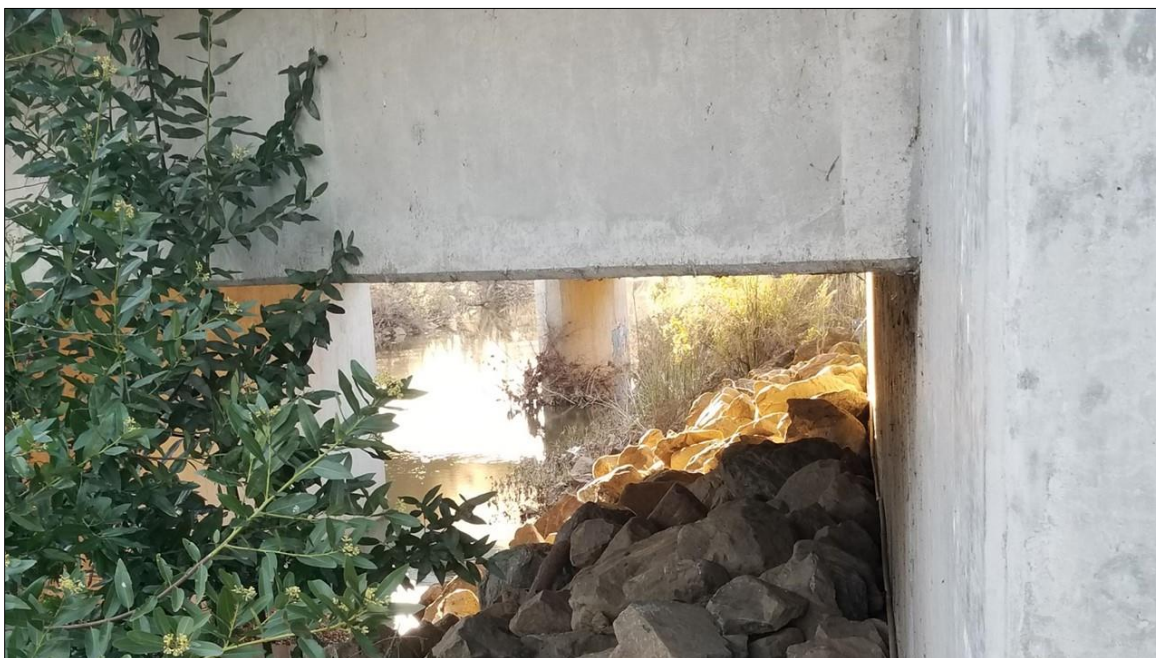
The east and west sides of the Pacheco Creek bridge are lined with large rip rap rocks (Figure 19). The rip rap [or RSP] makes it difficult for some wildlife species to travel under the bridge when the creek is full and inundates the bank below the RSP. The only species recorded traveling along the rip rap were raccoons and bobcats; both species are agile climbers, which allow them to navigate the large rip rap at the bridge abutments.

Figure 19. The east side of the Pacheco Creek bridge at the Pacheco Reserve.

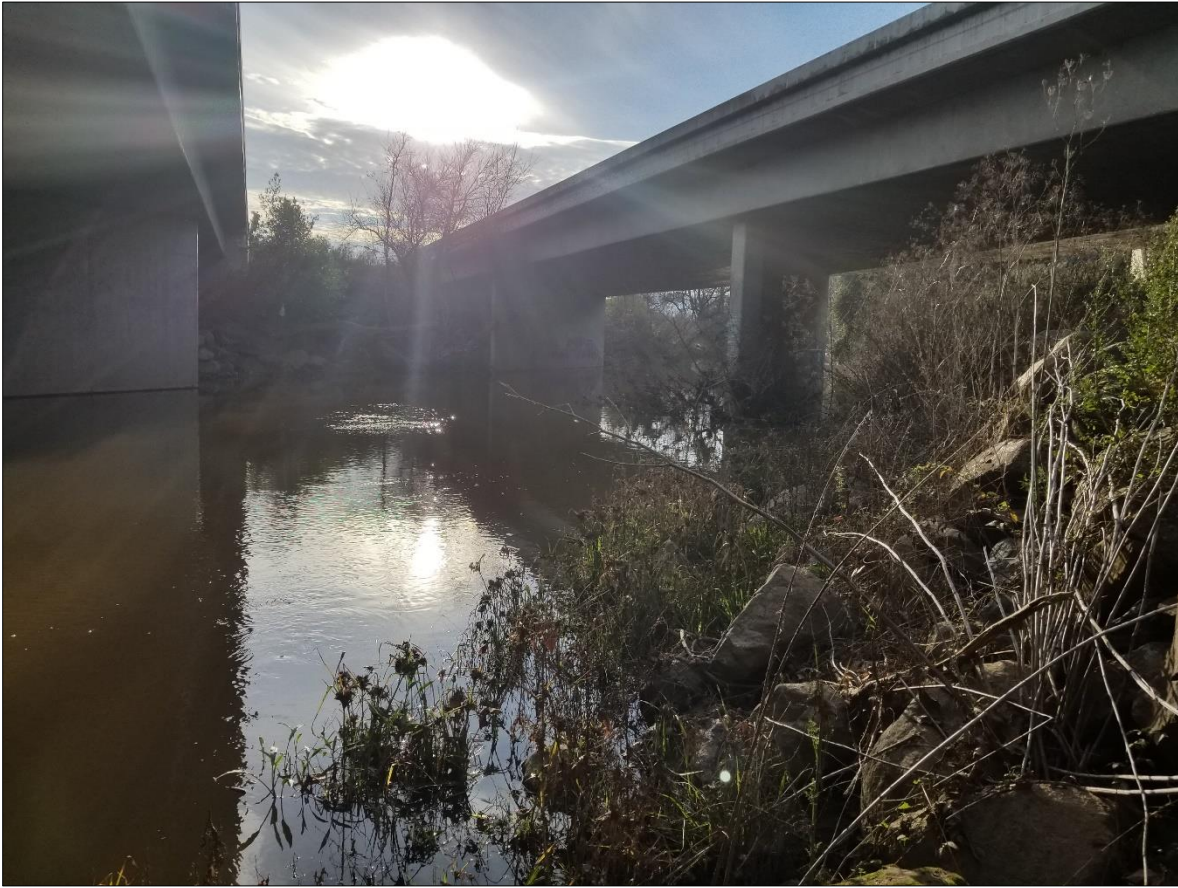
Wildlife passage during high flows could be improved by removing dead trees, dead shrubs, and dense invasive vegetation along the banks to increase bank width at higher slope areas and restoring with native vegetation. Both the east and west sides of the bridge have large amounts of dead tree and invasive vegetation build up that can restrict species movement through the bridge (Figure 21). By removing this debris, it would increase the amount of creek bank available for wildlife to traverse under the bridge. As with the RSP improvement, this project would engage the San Jose Conservation Corps to conduct the work.

Figure 21. The east side of the Pacheco Creek bridge.
