H. T. HARVEY & ASSOCIATES

Ecological Consultant

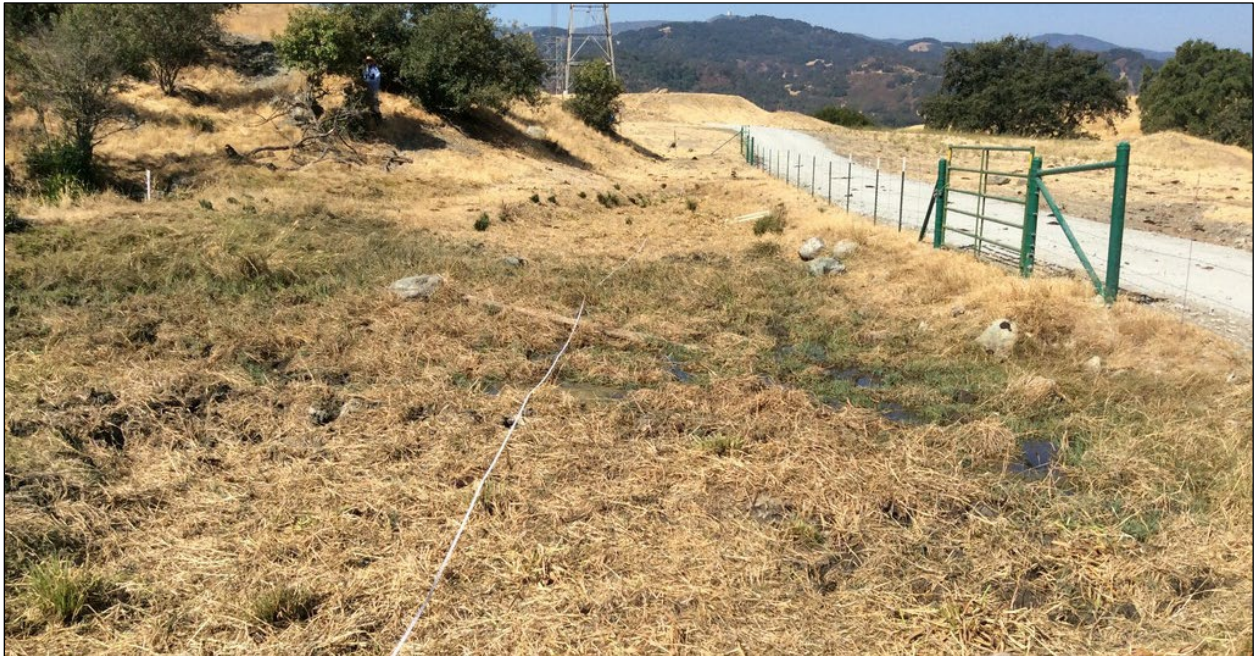
Photo 1. Year 1 Conditions at Photo Point 1a during Vegetation Monitoring at the Wetland Mitigation Site (August 8, 2017)

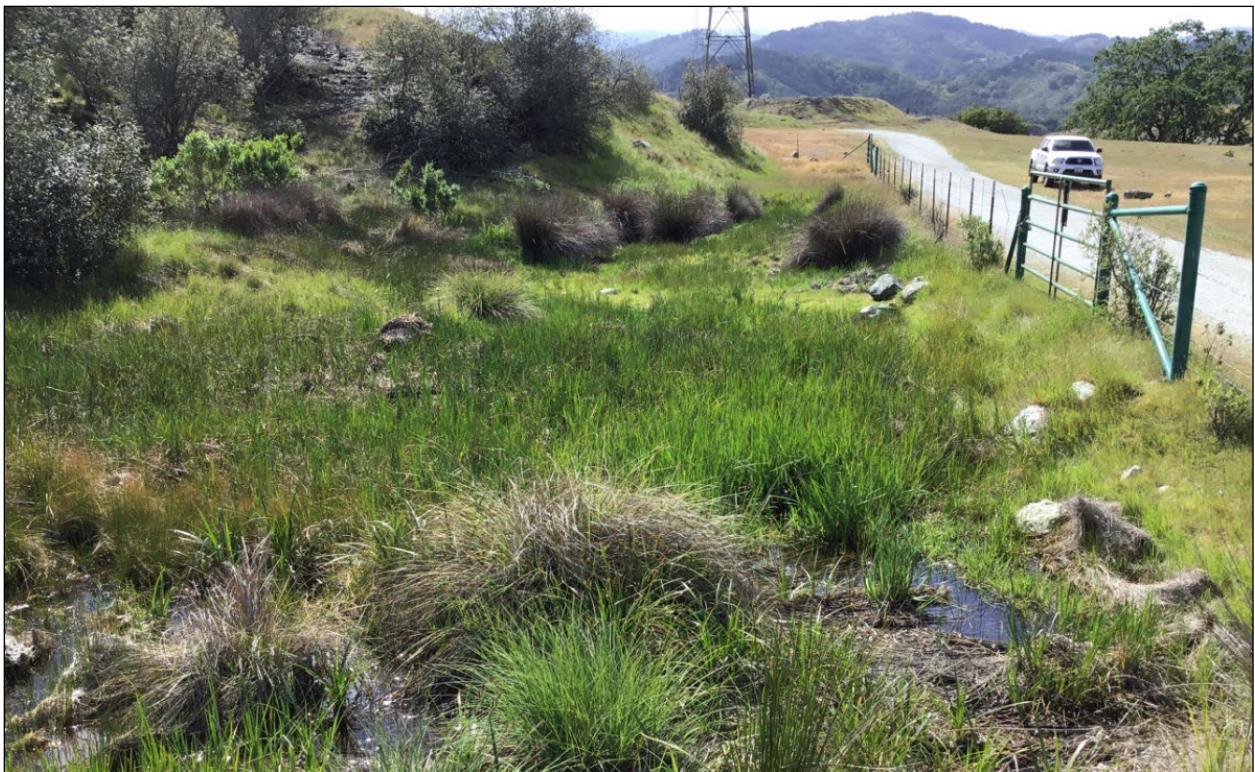
Photo 2. Year 6 Conditions at Photo Point 1a during Vegetation Monitoring at the Wetland Mitigation Site (March 29, 2022)

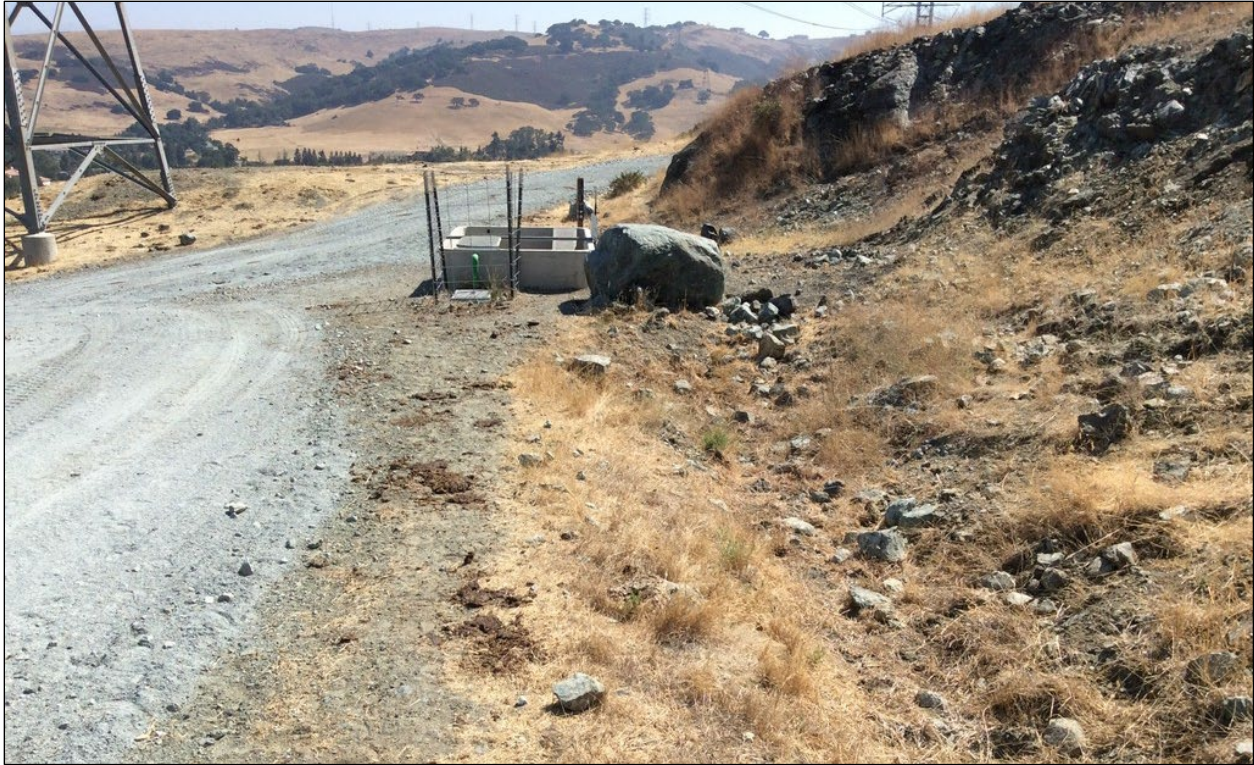
Photo 3. Year 1 Conditions at Photo Point 1b during Vegetation Monitoring at the Wetland Mitigation Site (August 8, 2017)

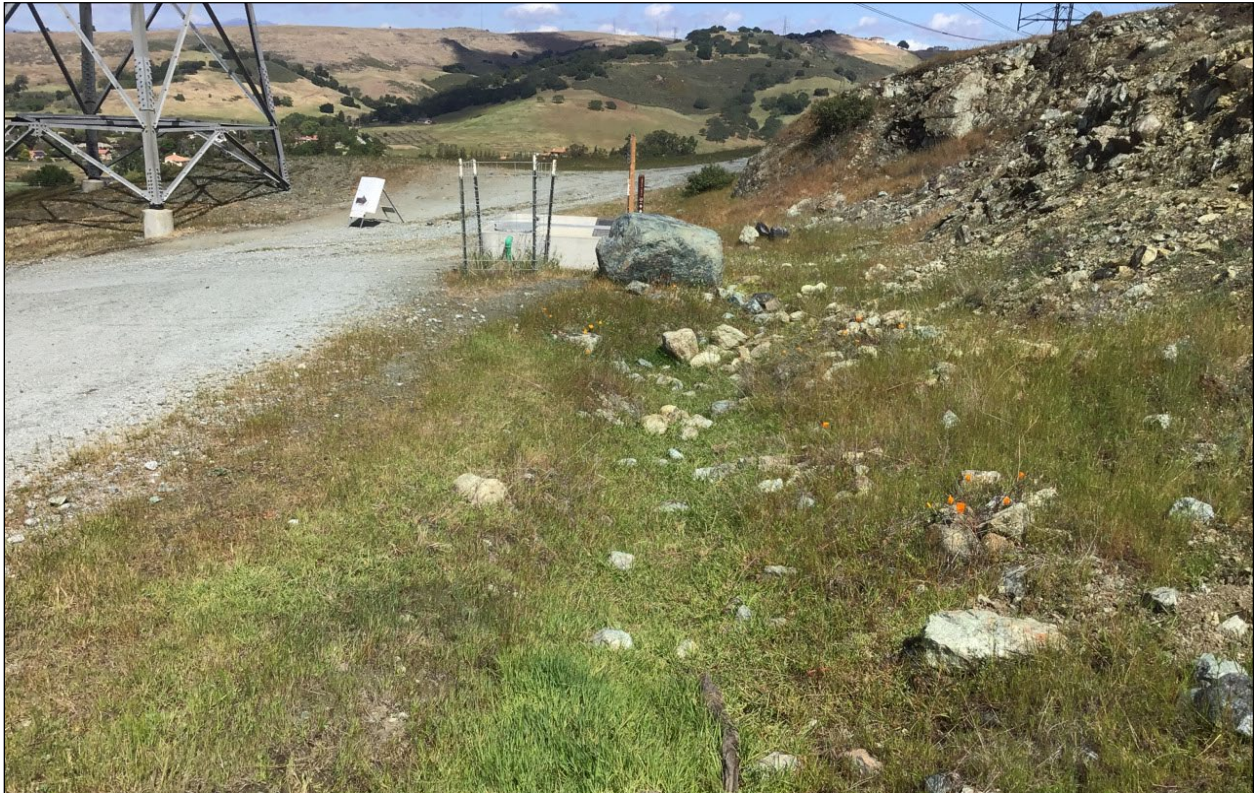
Photo 4. Year 6 Conditions Looking East from Photo Point 1b during Vegetation Monitoring at the Wetland Mitigation Site (March 29, 2022)

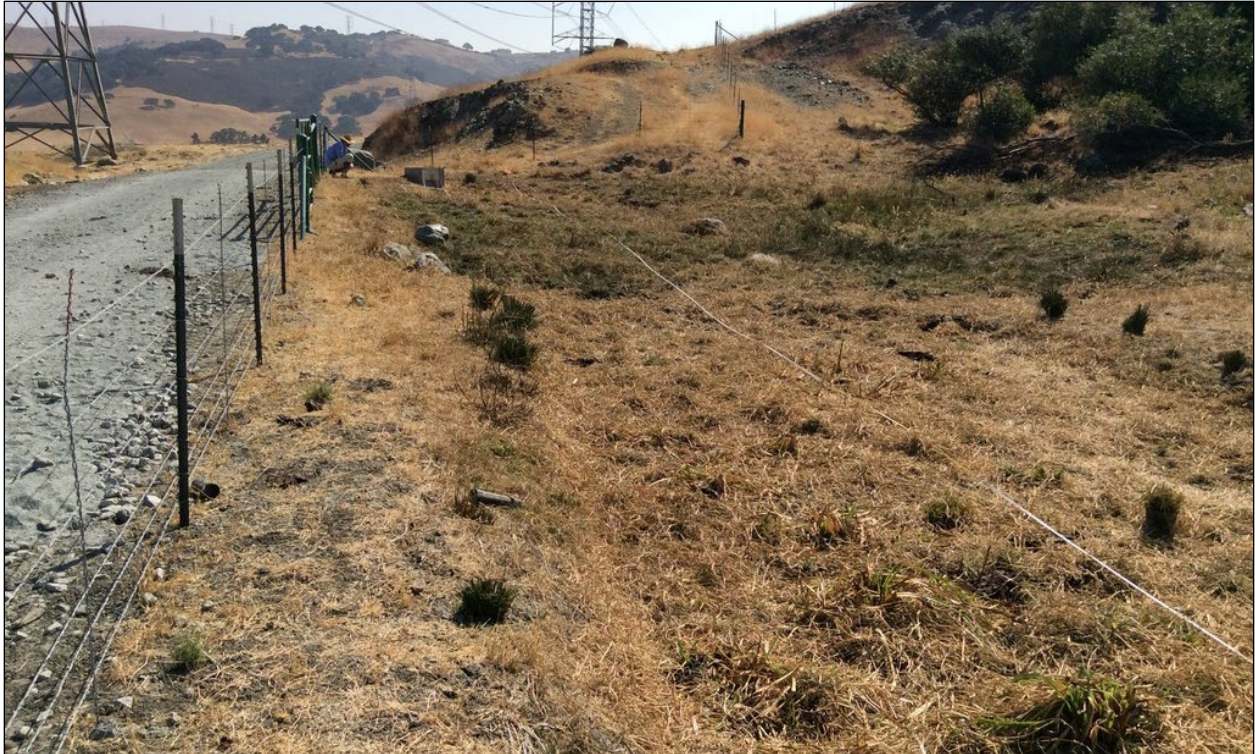
Photo 5. Year 1 Conditions at Photo Point 2 during Vegetation Monitoring at the Wetland Mitigation Site (August 8, 2017)

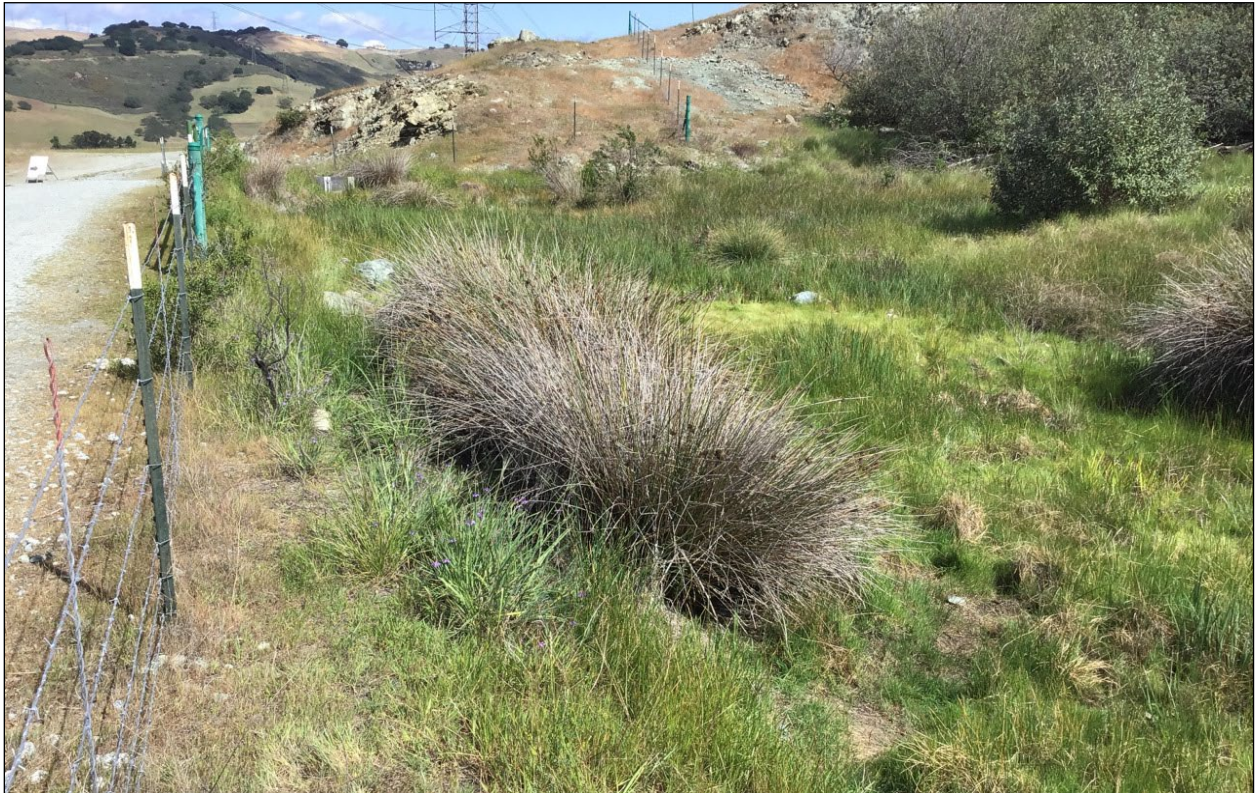
Photo 6. Year 6 Conditions at Photo Point 2 during Vegetation Monitoring at the Wetland Mitigation Site (March 29, 2022)

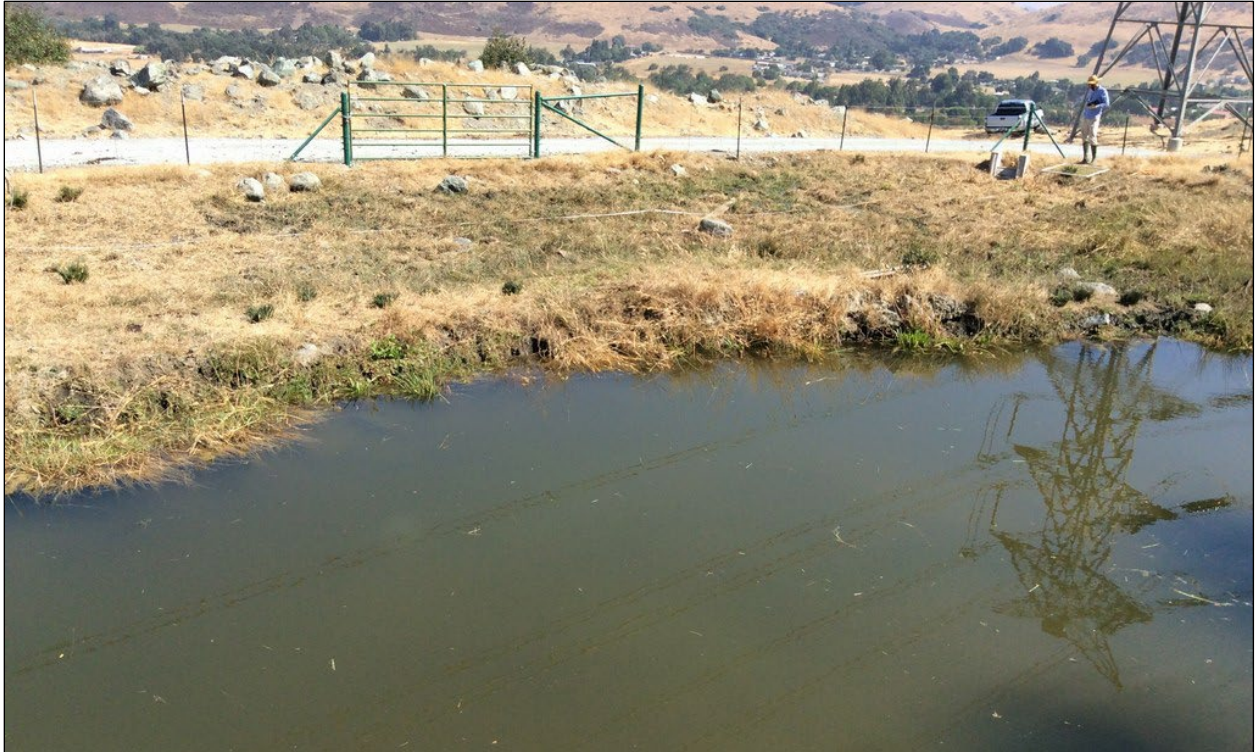
Photo 7. Year 1 Conditions at Photo Point 3 during Vegetation Monitoring at the Wetland Mitigation Site (August 8, 2017)

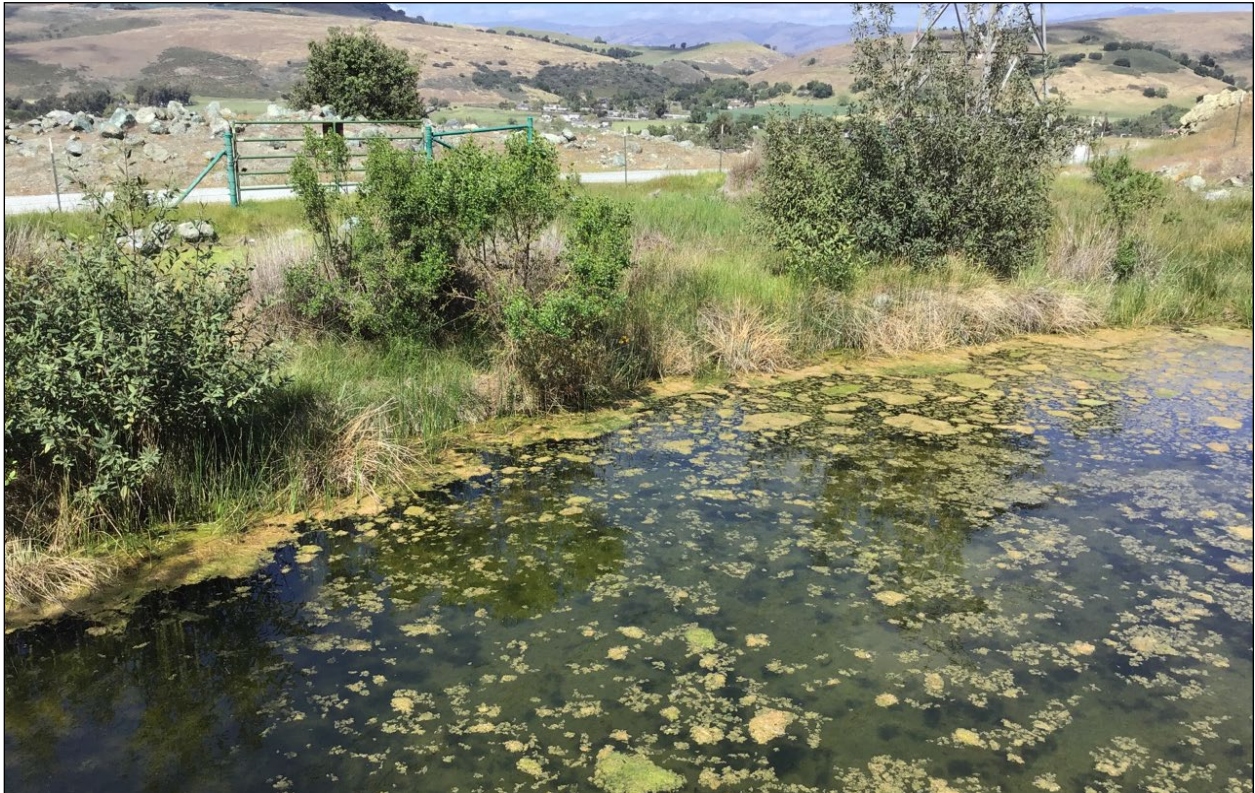
Photo 8. Year 6 Conditions at Photo Point 3 during Vegetation Monitoring at the Wetland Mitigation Site (March 29, 2022)

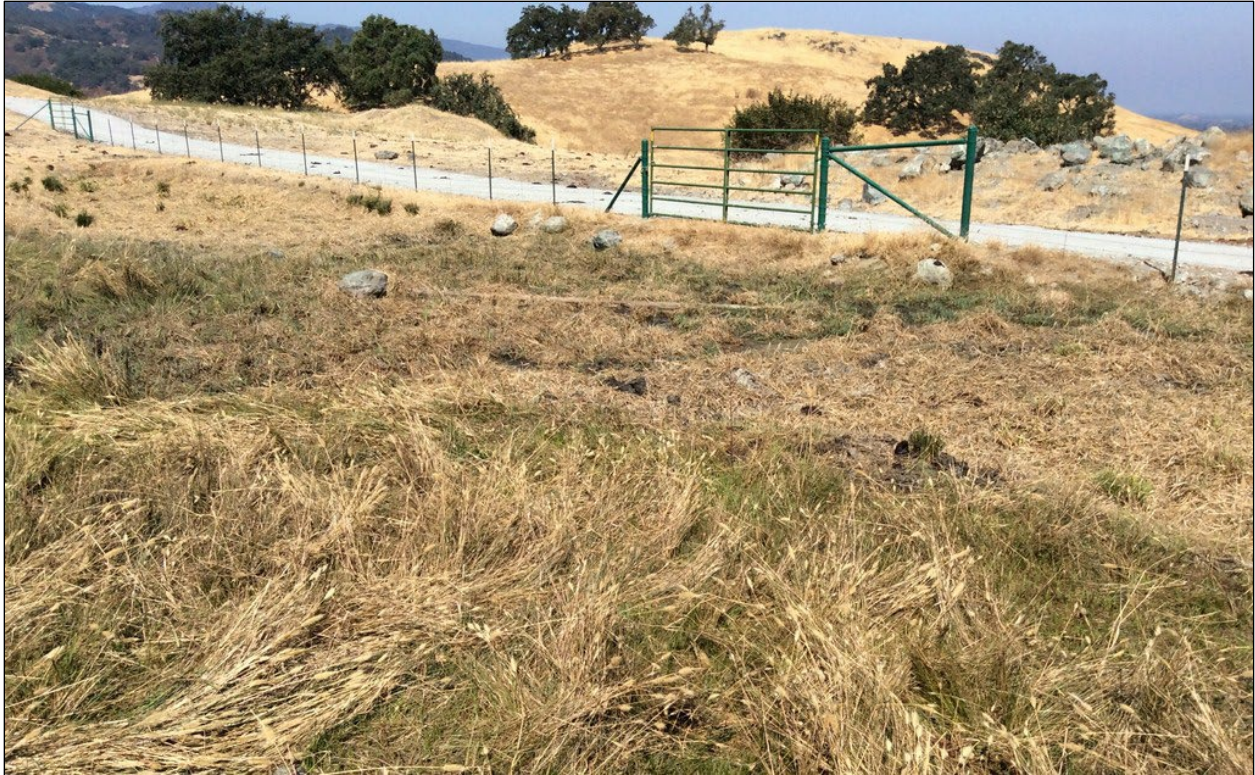
Photo 9. Year 1 Conditions at Photo Point 4 during Vegetation Monitoring at the Wetland Mitigation Site (August 8, 2017)

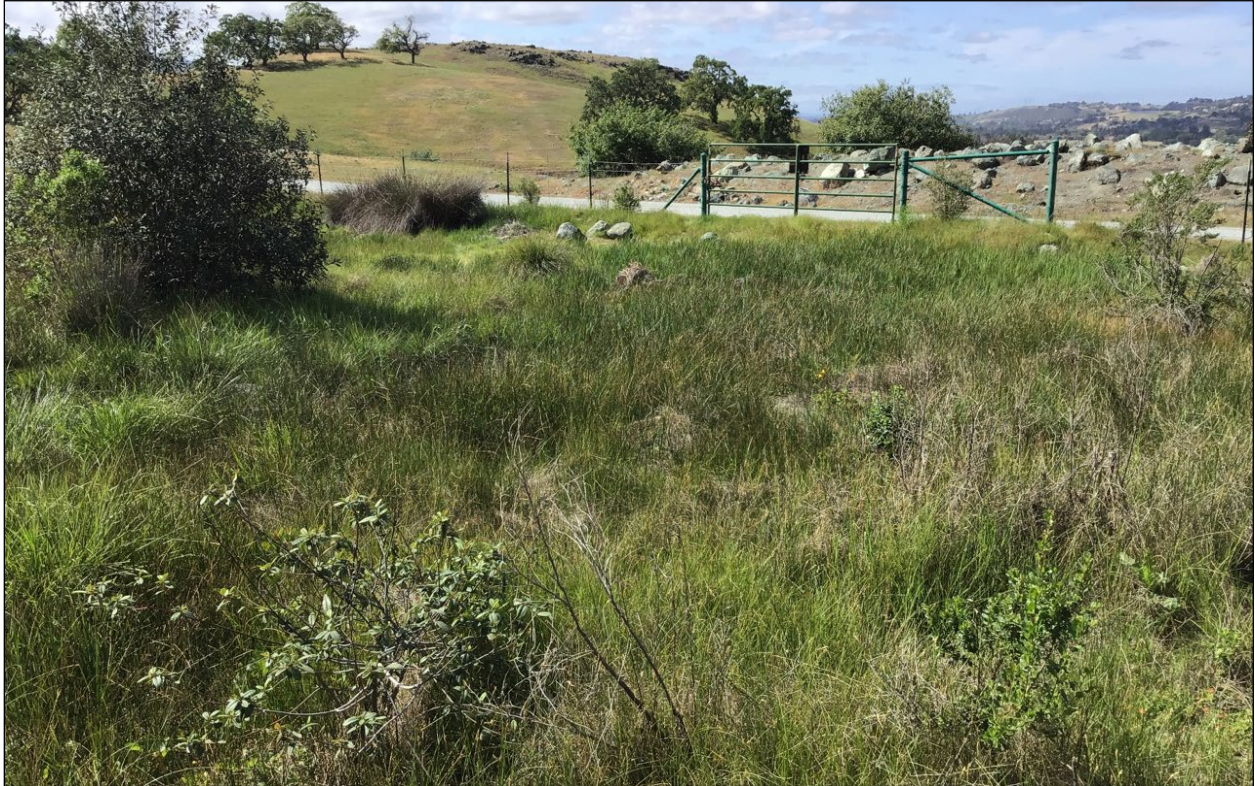
Photo 10. Year 6 Conditions at Photo Point 4 during Vegetation Monitoring at the Wetland Mitigation Site (March 29, 2022)

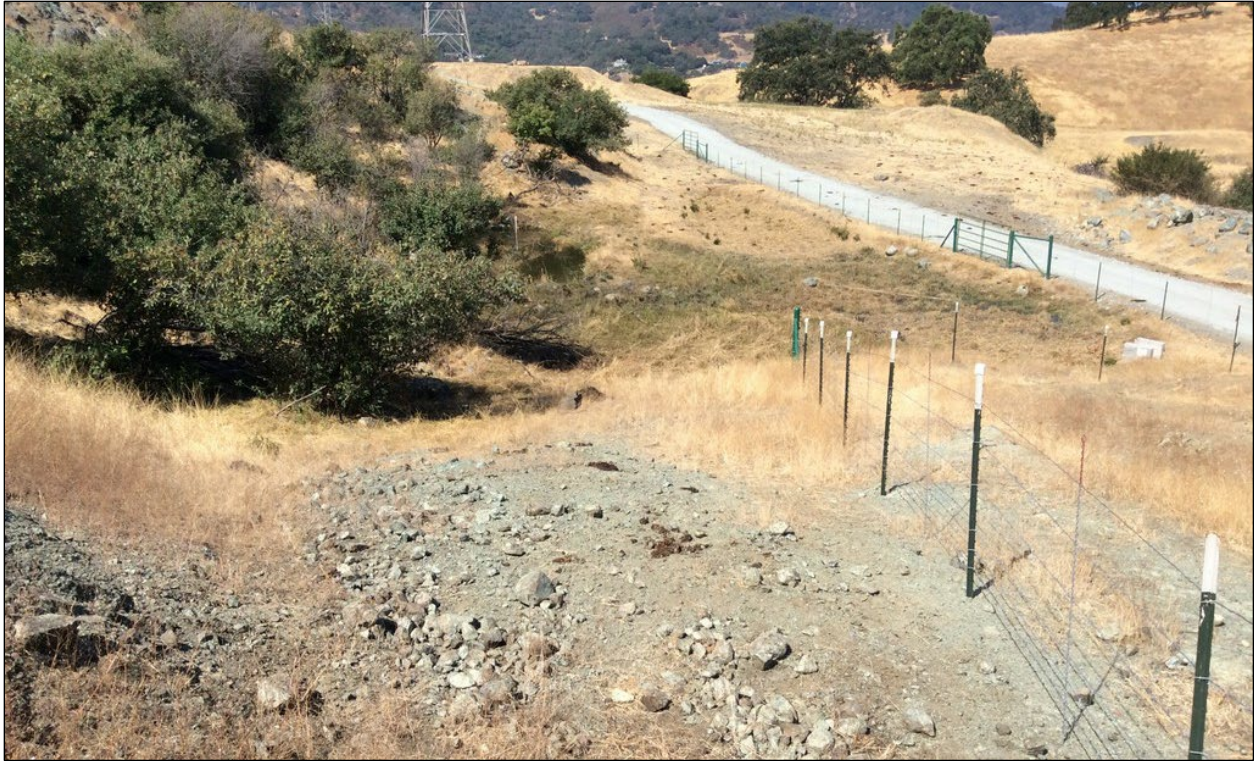
Photo 11. Year 1 Conditions at Photo Point 5 during Vegetation Monitoring at the Wetland Mitigation Site (August 8, 2017)

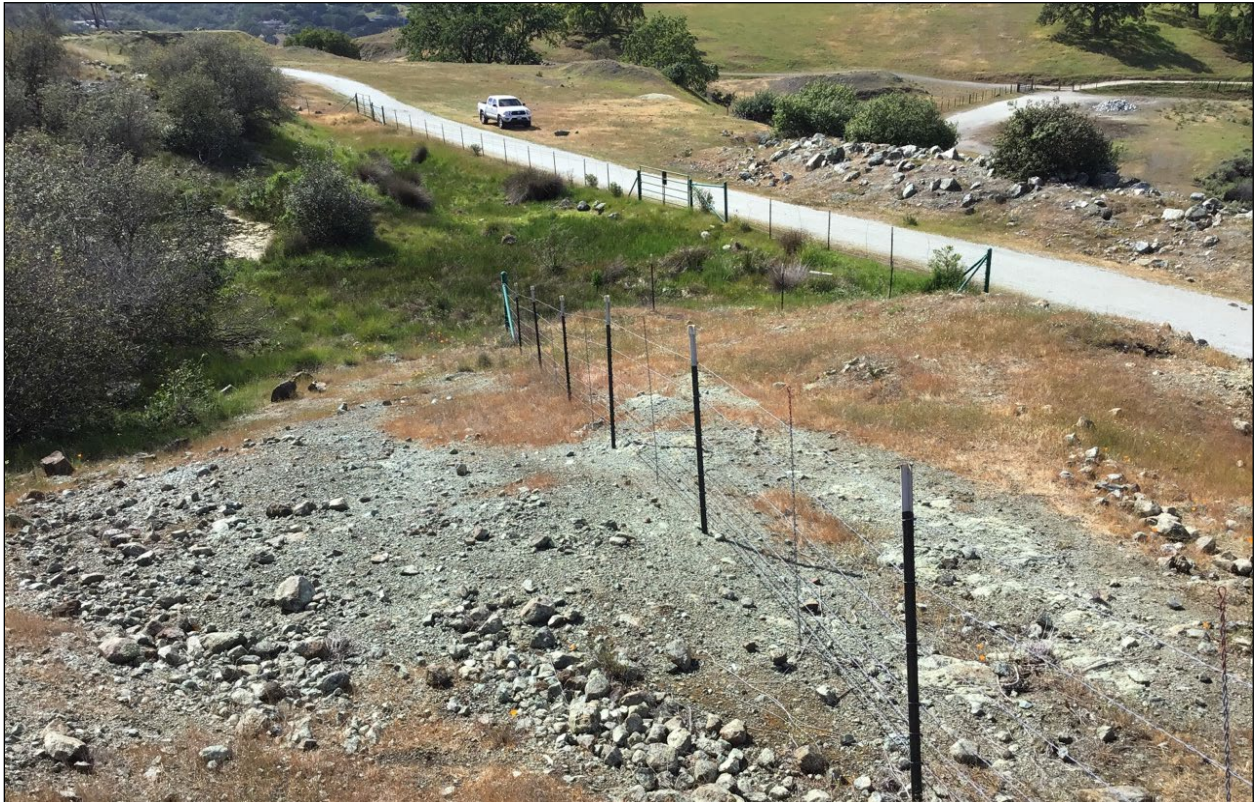
Photo 12. Year 6 Conditions at Photo Point 5 during Vegetation Monitoring at the Wetland Mitigation Site (March 29, 2022)

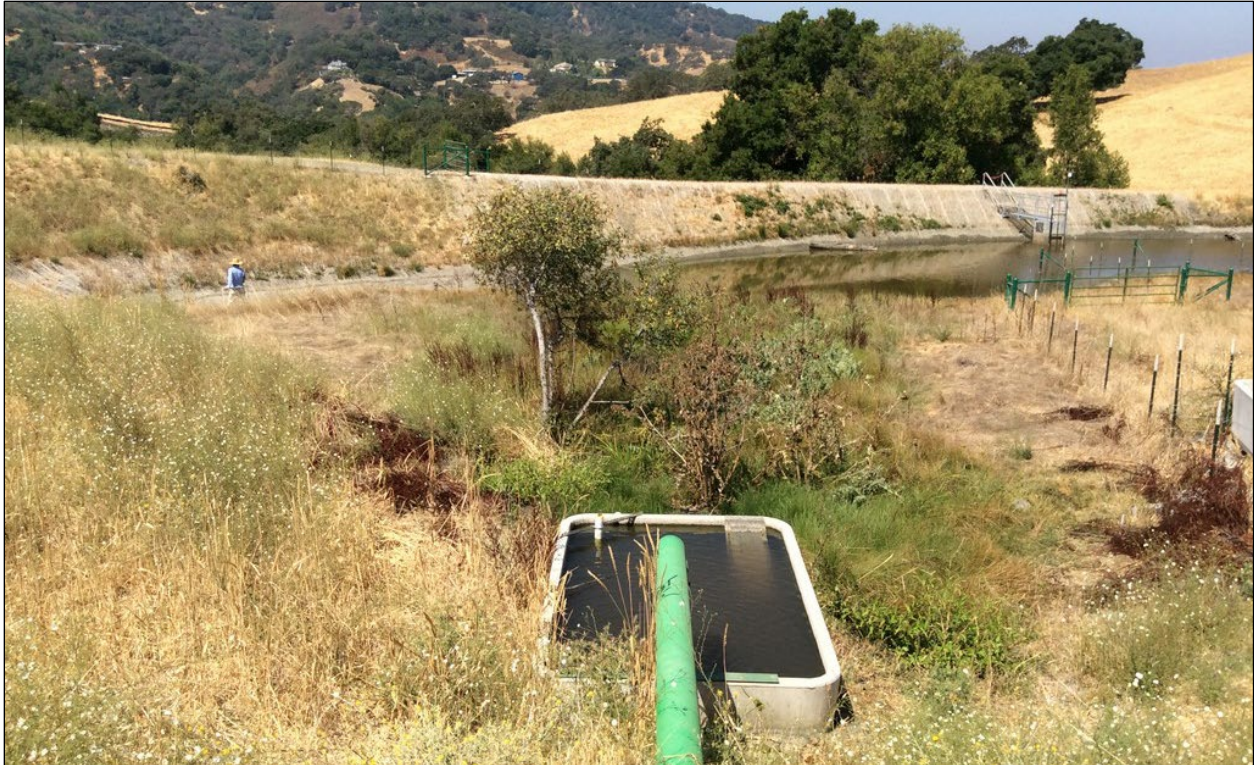
Photo 13. Year 1 Conditions at Photo Point 6 during Mt. Hamilton Thistle Abundance Monitoring at the Pond Mitigation Site (August 8, 2017)

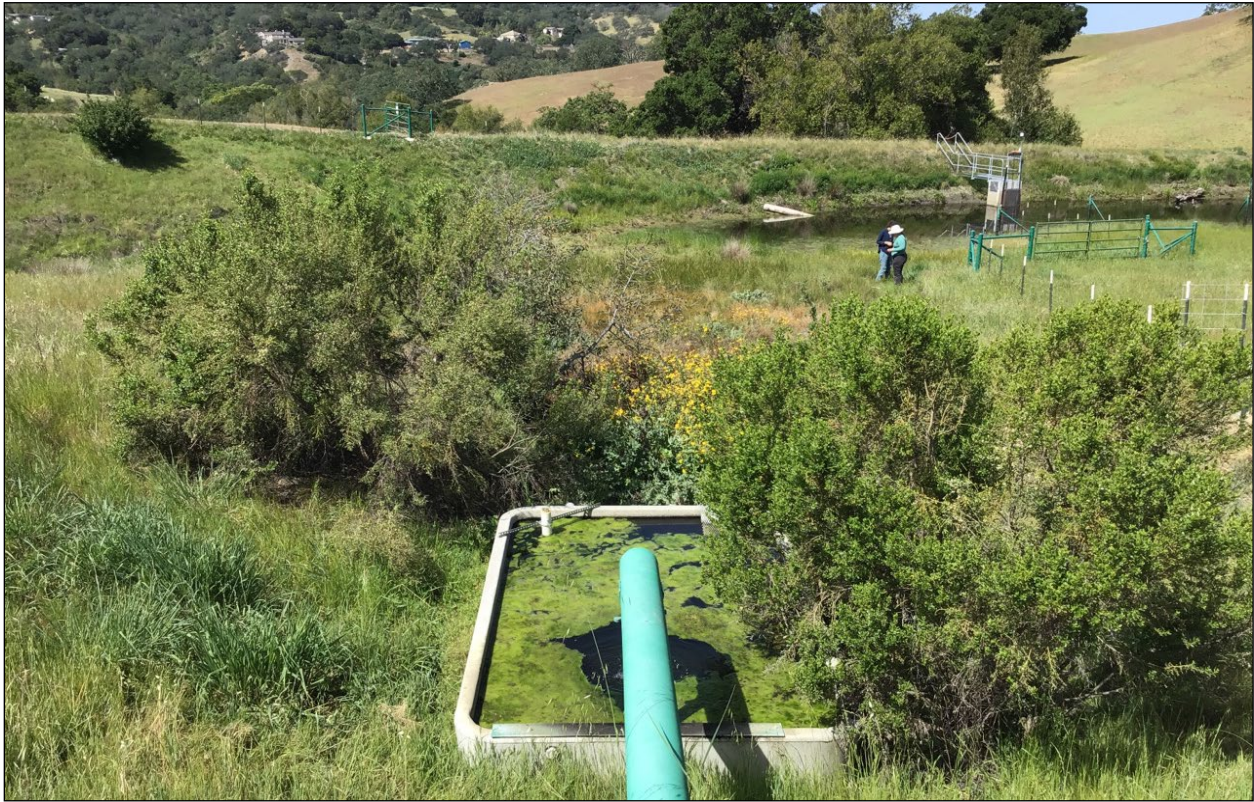
Photo 14. Year 6 Conditions at Photo Point 6 during Mt. Hamilton Thistle Abundance Monitoring at the Pond Mitigation Site (April 6, 2022)

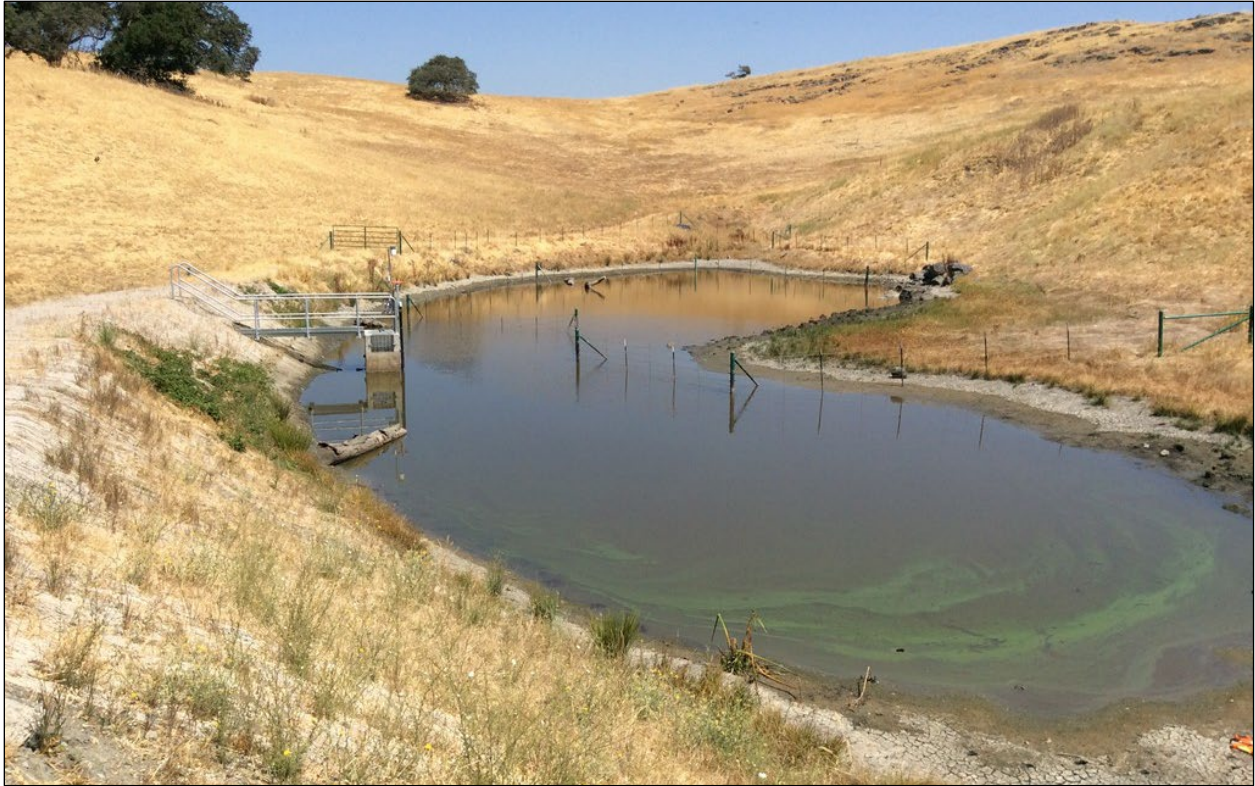
Photo 15. Year 1 Conditions at Photo Point 7a during Vegetation Monitoring at the Pond Mitigation Site (August 8, 2017)

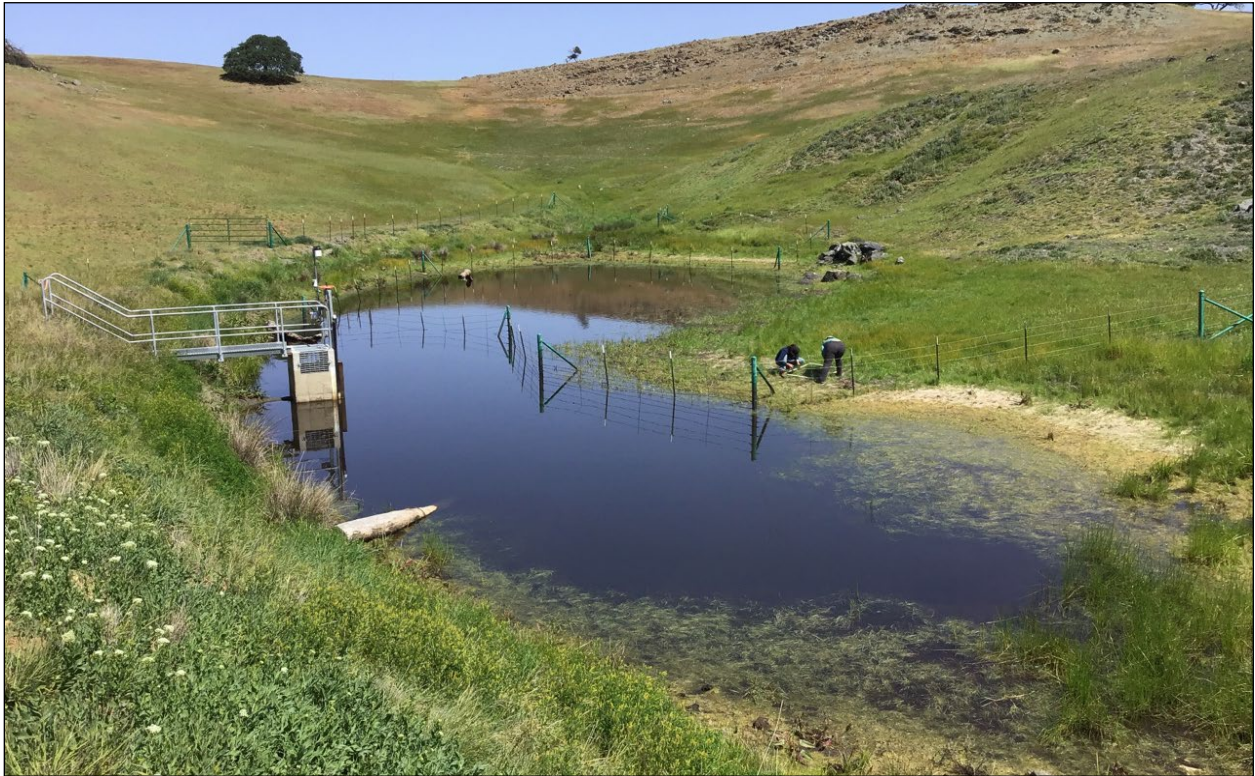
Photo 16. Year 6 Conditions at Photo Point 7a during Vegetation Monitoring at the Pond Mitigation Site (April 6, 2022)

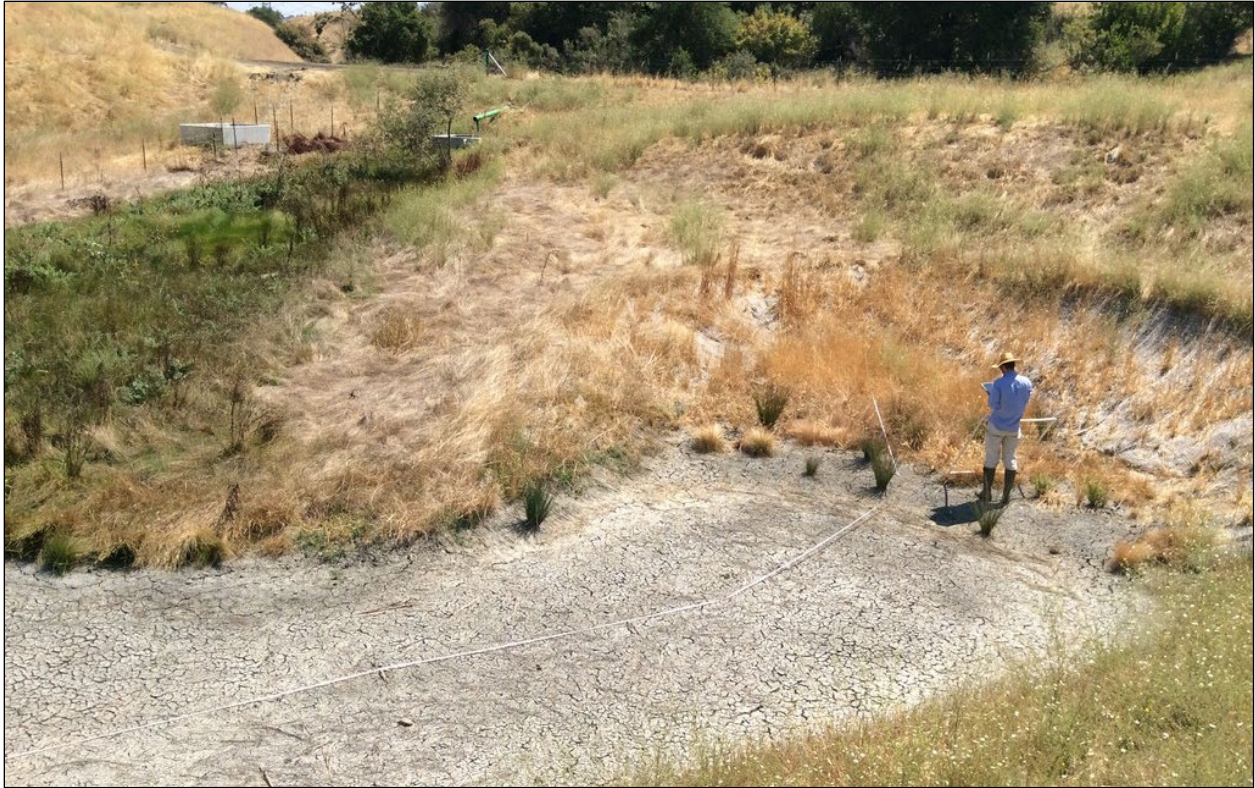
Photo 17. Year 1 Conditions at Photo Point 7b during Vegetation Monitoring, Showing the Wetland Establishment Area at the Pond Mitigation Site (August 8, 2017)

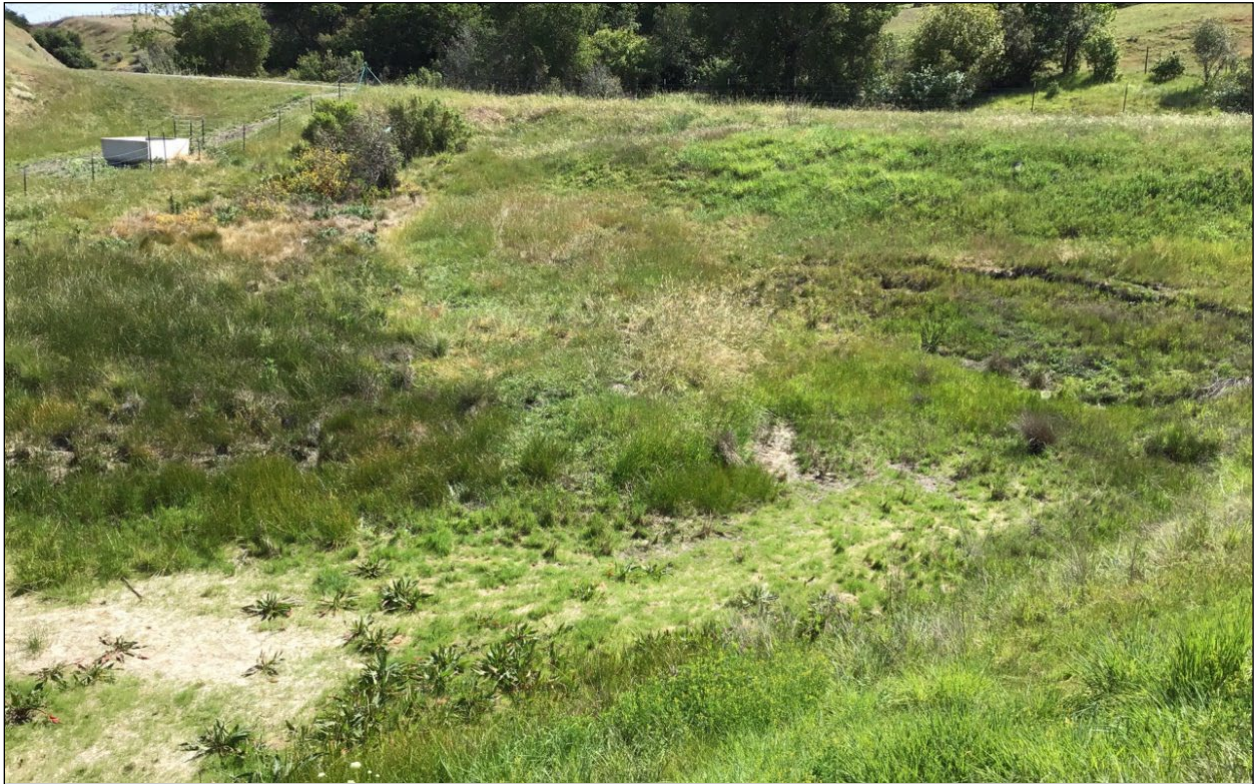
Photo 18. Year 6 Conditions at Photo Point 7b during Vegetation Monitoring, Showing the Wetland Establishment Area at the Pond Mitigation Site (April 6, 2022)

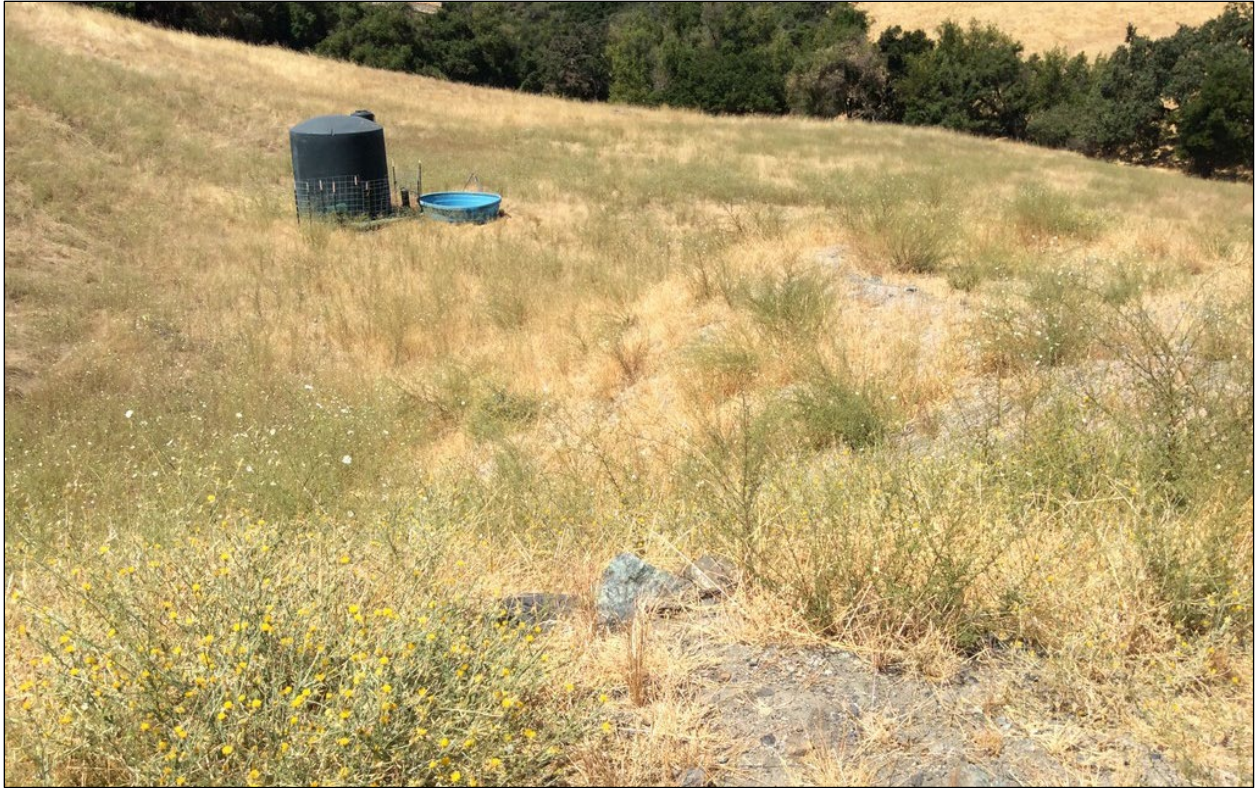
Photo 19. Year 1 Conditions at Photo Point 7c during Vegetation Monitoring at the Pond Mitigation Site (August 8, 2017)

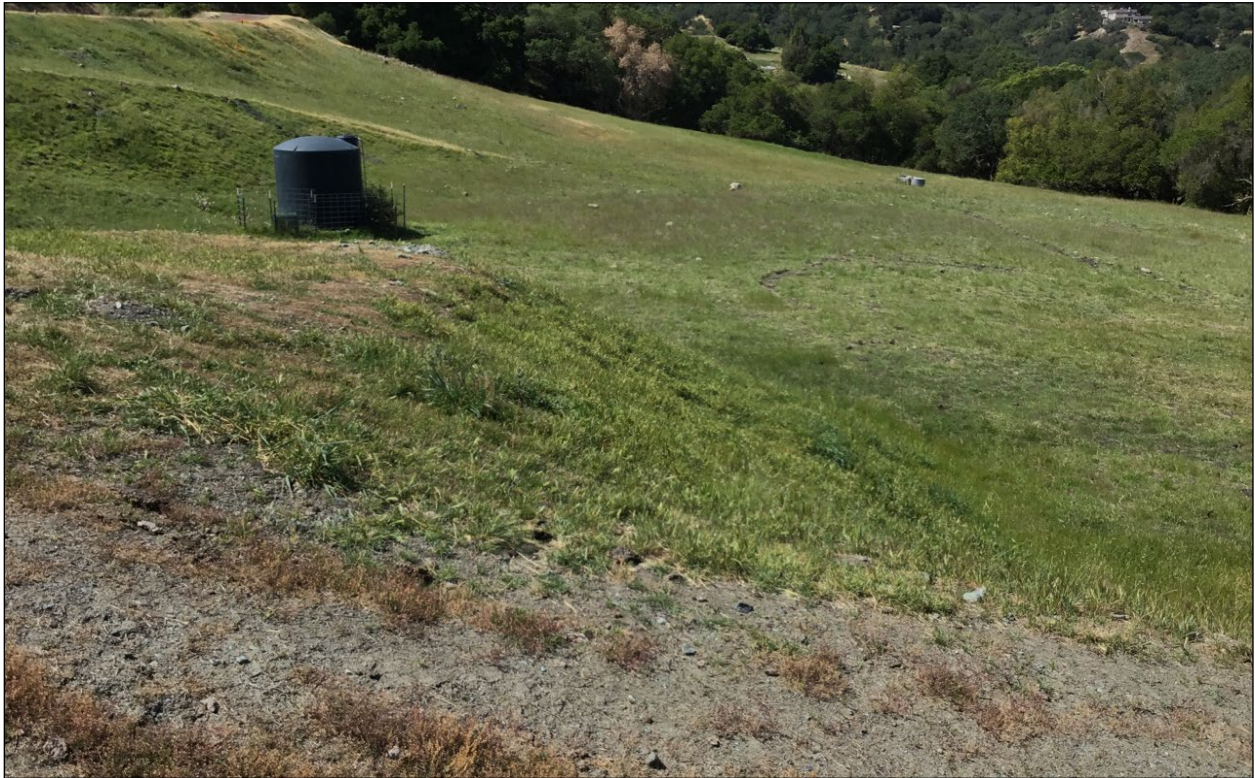
Photo 20. Year 6 Conditions at Photo Point 7c during Vegetation Monitoring at the Pond Mitigation Site (April 6, 2022)

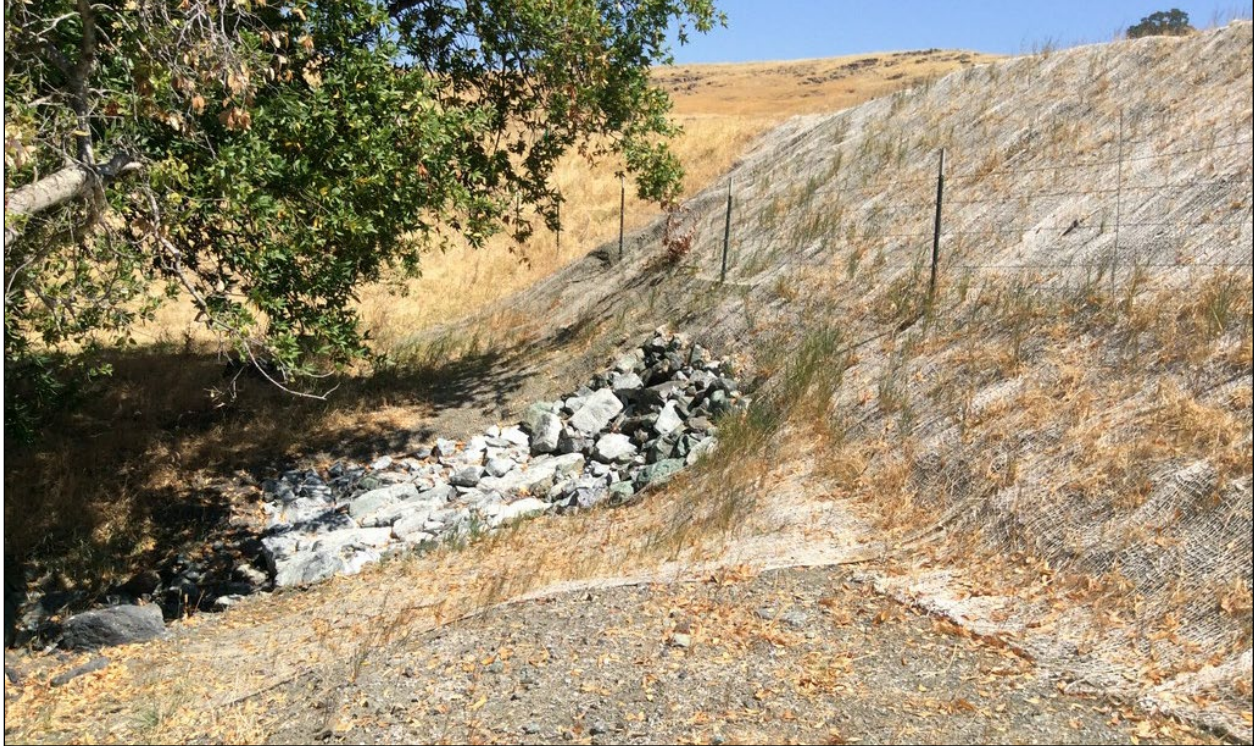
Photo 21. Year 1 Conditions at Photo Point 8 during Vegetation Monitoring at the Pond Mitigation Site (August 8, 2017)

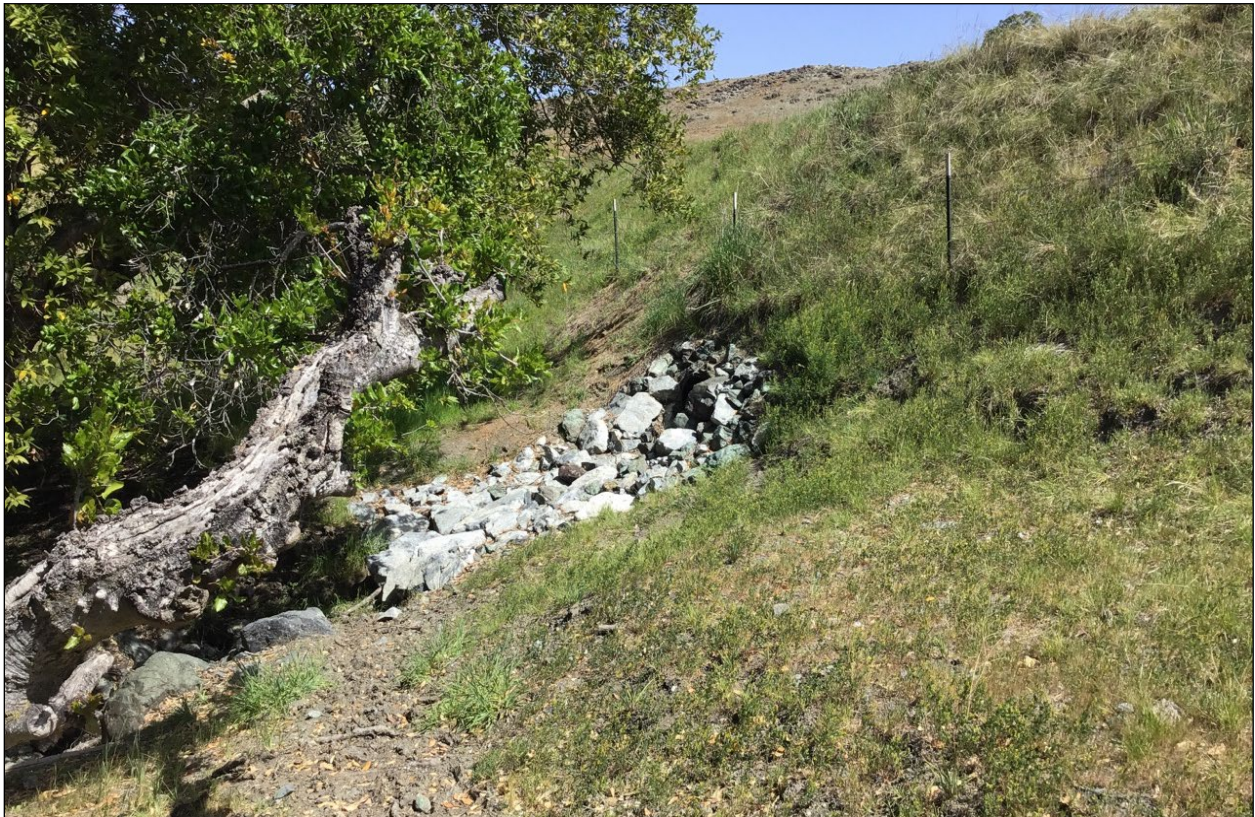
Photo 22. Year 6 Conditions at Photo Point 8 during Vegetation Monitoring at the Pond Mitigation Site (April 6, 2022)

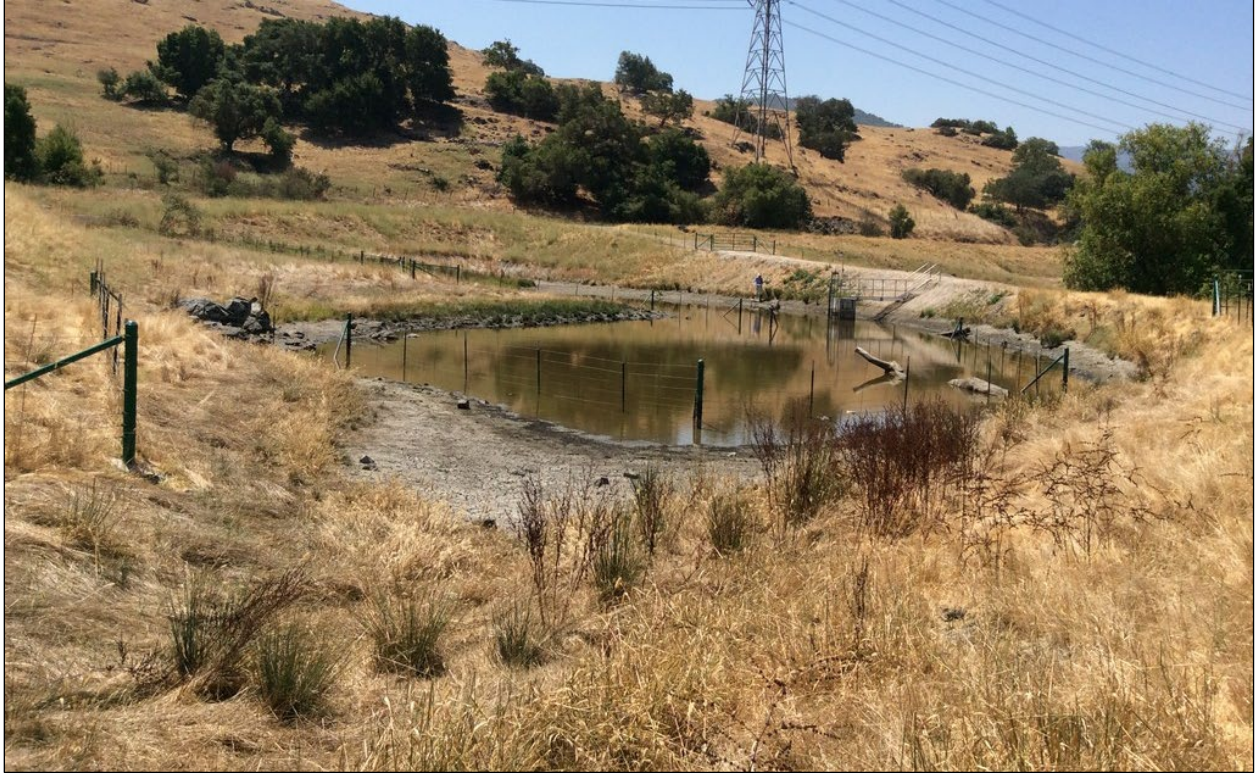
Photo 23. Year 1 Conditions at Photo Point 9 during Vegetation Monitoring at the Pond Mitigation Site (August 8, 2017)
