H. T. HARVEY & ASSOCIATES

Ecological Consultant

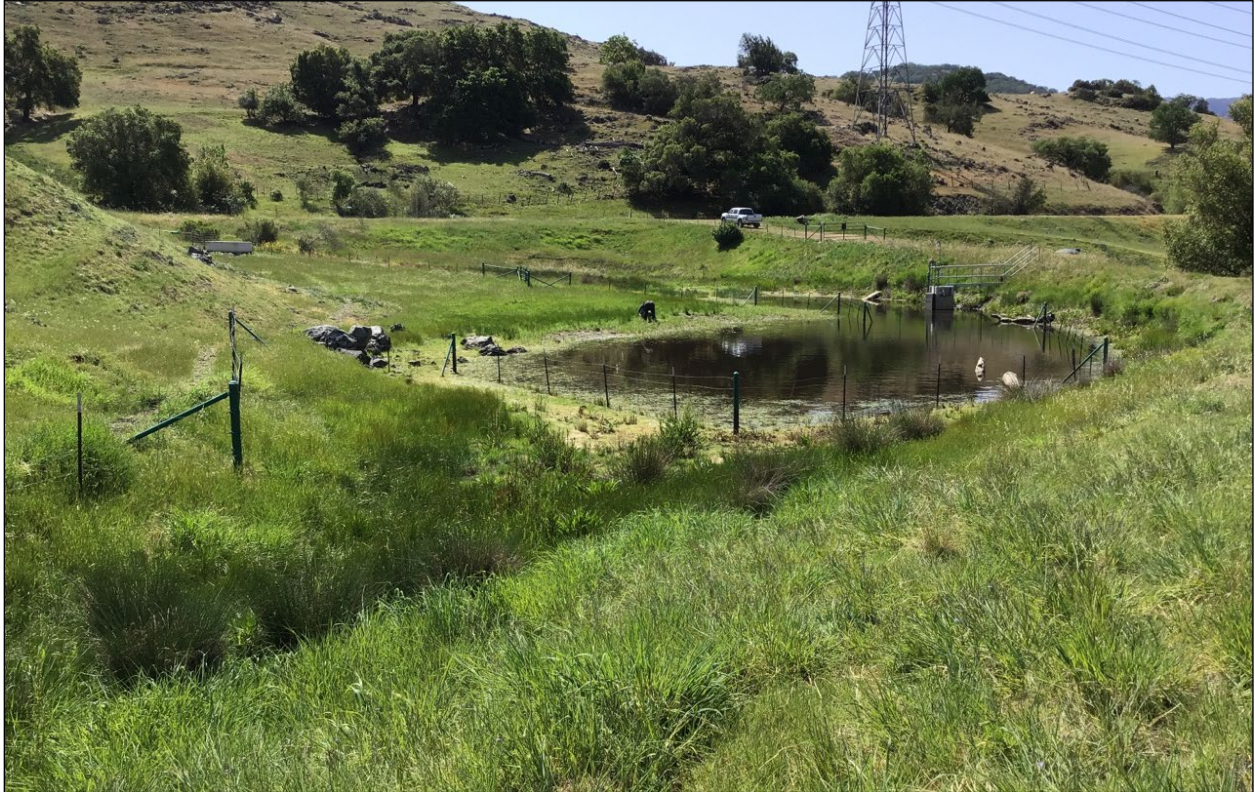
Photo 24. Year 6 Conditions at Photo Point 9 during Vegetation Monitoring at the Pond Mitigation Site (April 6, 2022)

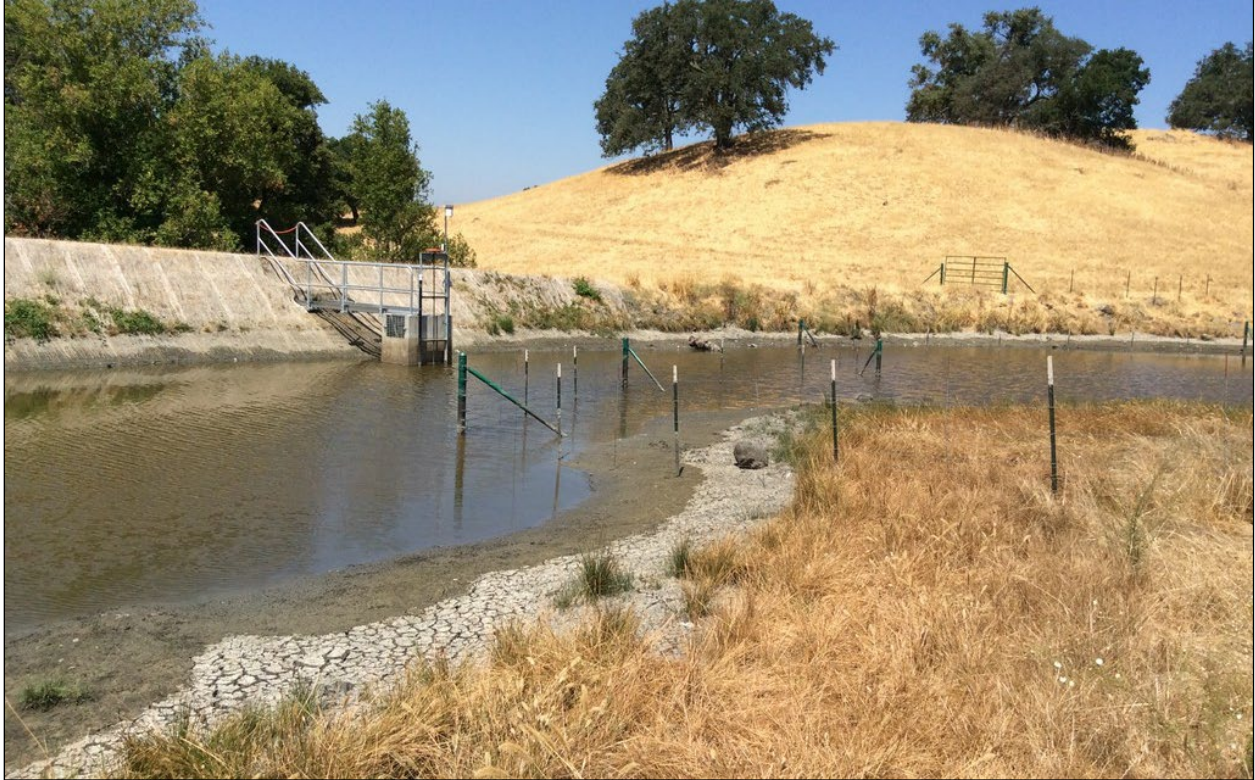
Photo 25. Year 1 Conditions at Photo Point 10 during Vegetation Monitoring at the Pond Mitigation Site (August 8, 2017)

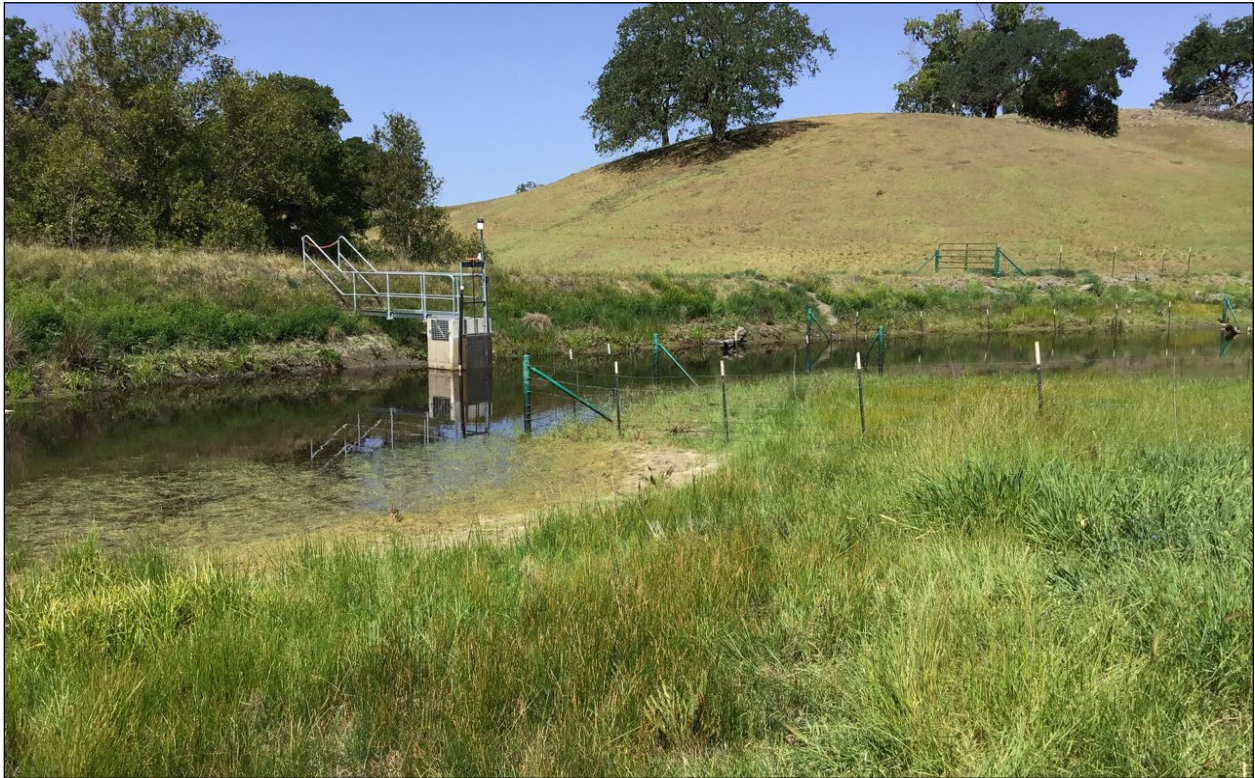
Photo 26. Year 6 Conditions at Photo Point 10 during Vegetation Monitoring at the Pond Mitigation Site (April 6, 2022)

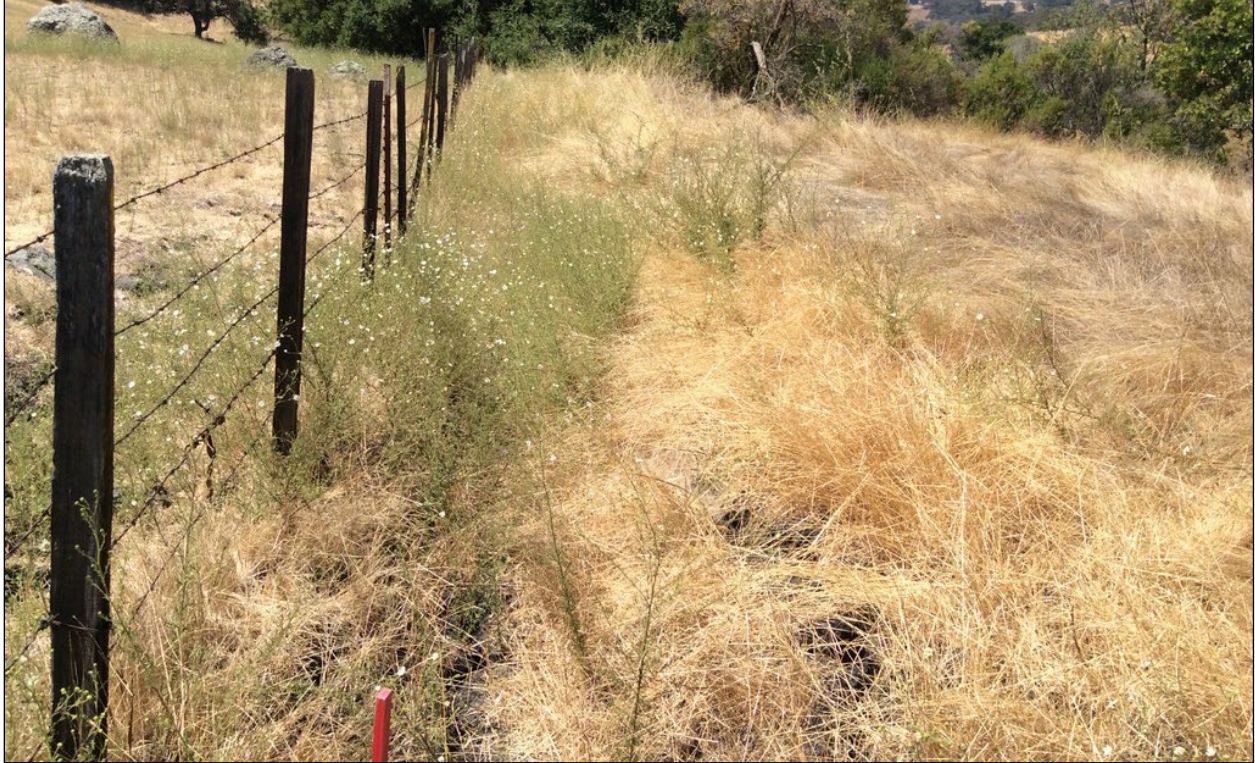
Photo 27. Year 1 Conditions at Photo Point 11 during Vegetation Monitoring, Where the Hillside Seep Collection Ditch was Enhanced in the Seep Collection Area (August 8, 2017)

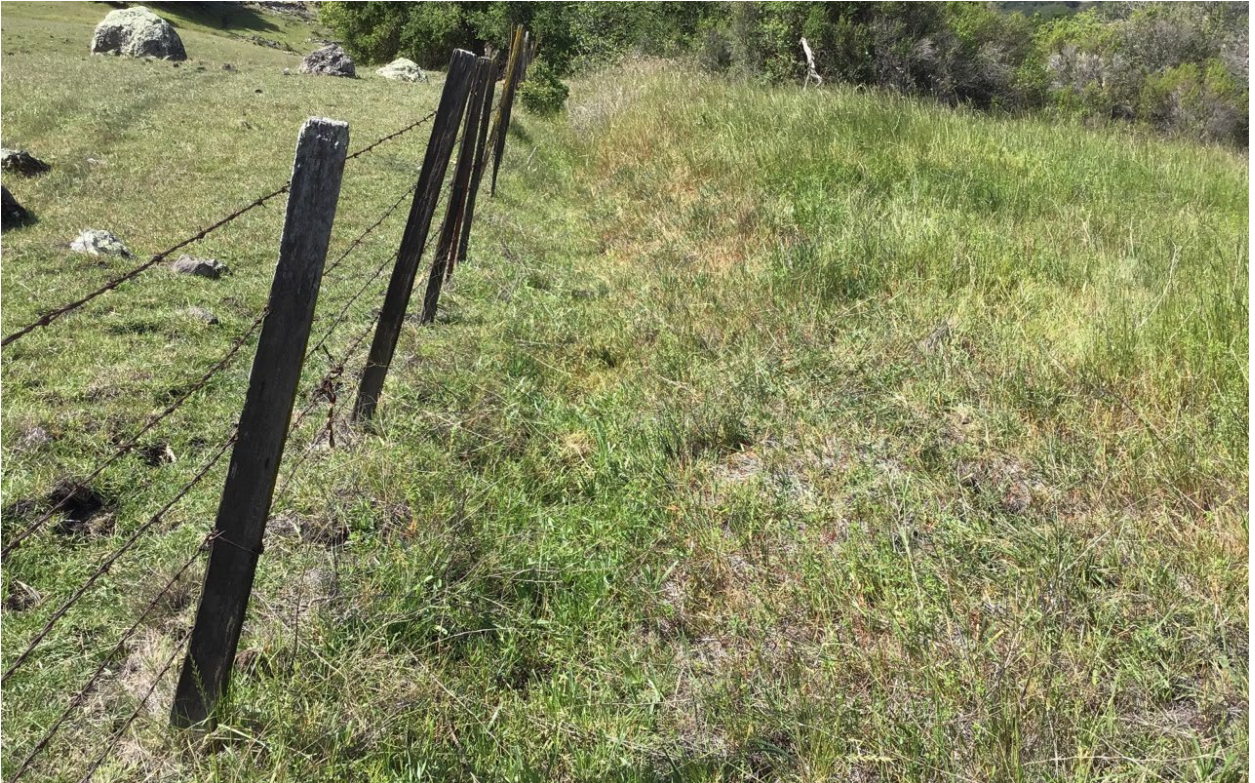
Photo 28. Year 6 Conditions at Photo Point 11 during Vegetation Monitoring, Where the Hillside Seep Collection Ditch was Enhanced in the Seep Collection Area (April 6, 2022)

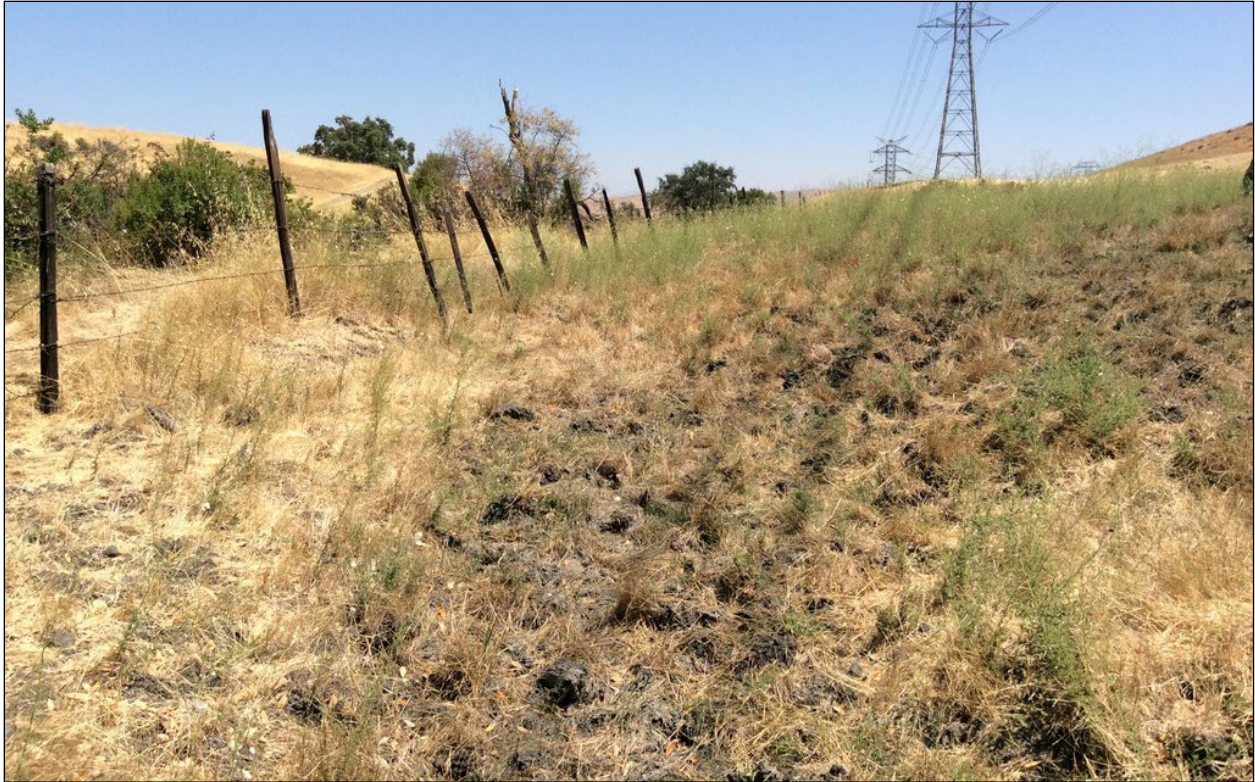
Photo 29. Year 1 Conditions at Photo Point 12 during Vegetation Monitoring, Where the Hillside Seep Collection Ditch was Enhanced in the Seep Collection Area (August 8, 2017)

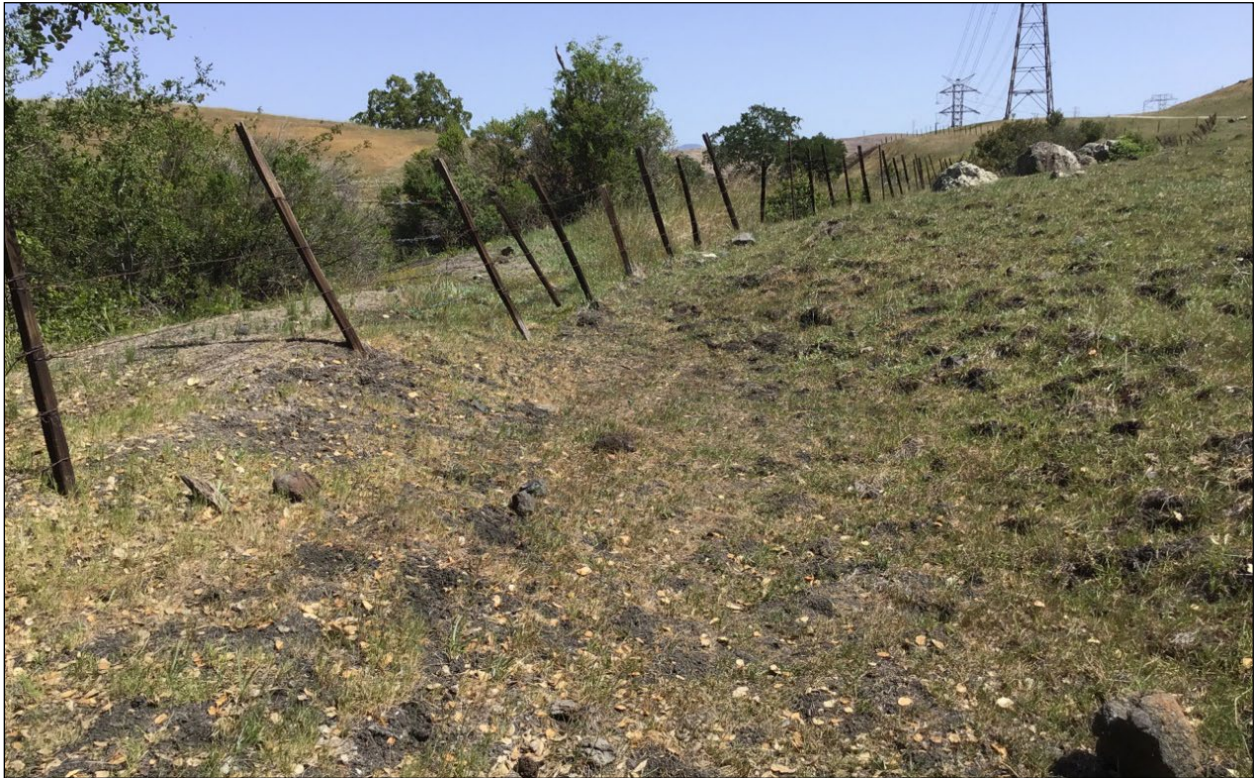
Photo 30. Year 6 Conditions at Photo Point 12 during Vegetation Monitoring, Where the Hillside Seep Collection Ditch was Enhanced in the Seep Collection Area (April 6, 2022)

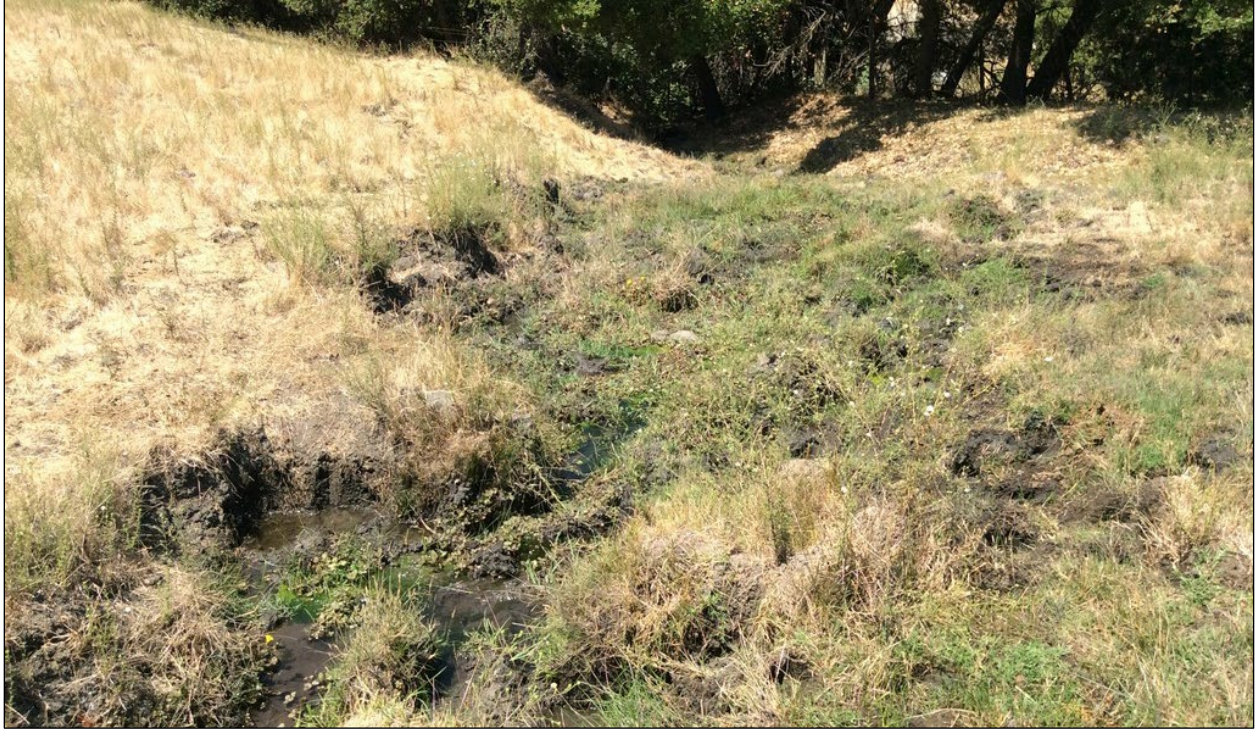
Photo 31. Year 1 Conditions at Photo Point 13 during Vegetation Monitoring, at an Existing Seep in the Seep Collection Area That Wasn't Disturbed during Construction (August 8, 2017)

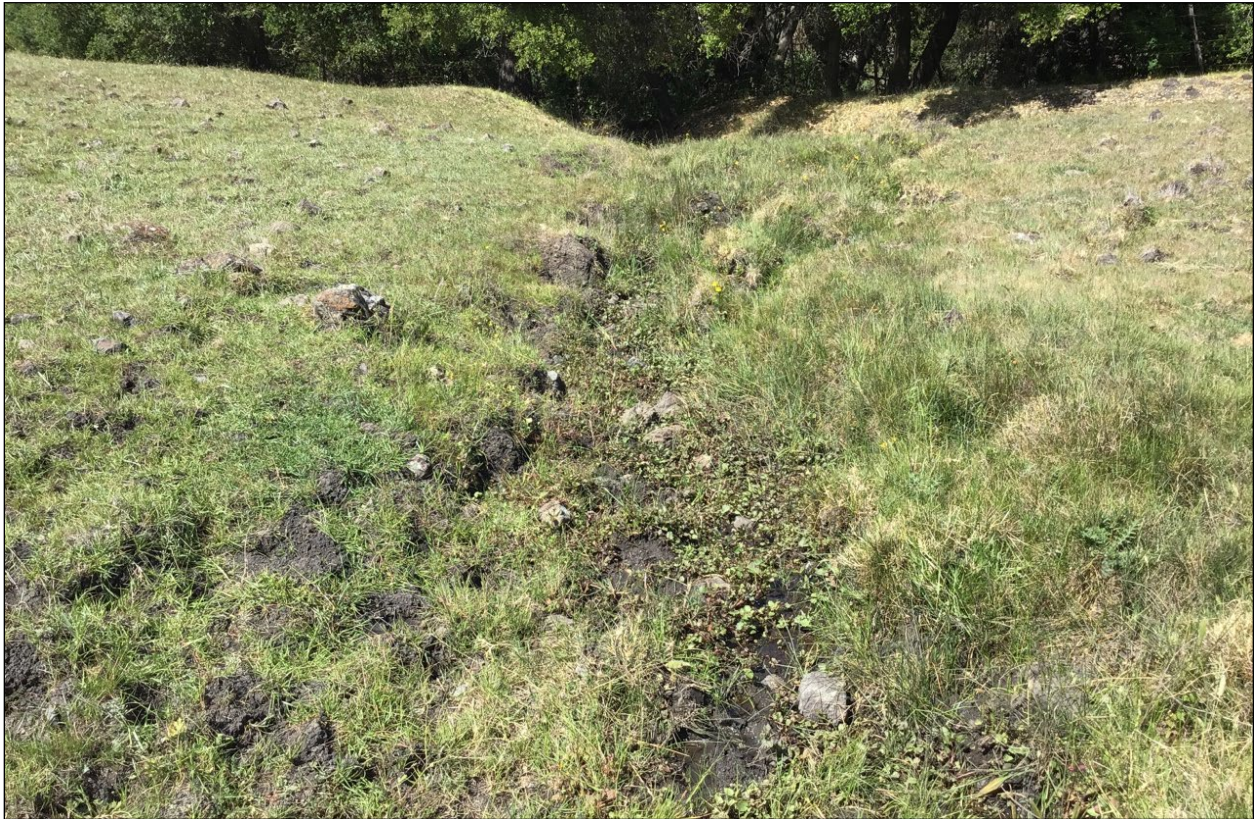
Photo 32. Year 6 Conditions at Photo Point 13 during Vegetation Monitoring, at an Existing Seep in the Seep Collection Area That Wasn't Disturbed during Construction (April 6, 2022)

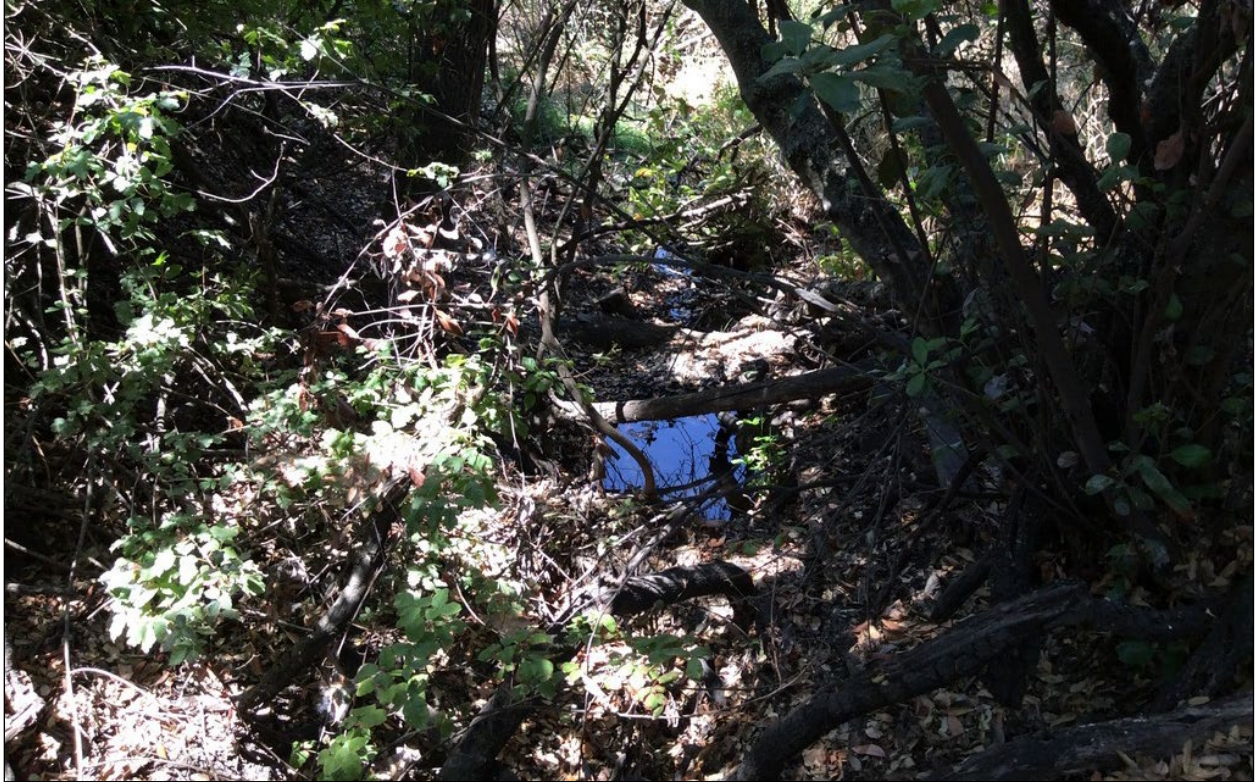
Photo 33. Year 1 Conditions at Photo Point 14 during Vegetation Monitoring, Where Debris Jams Were Installed in the Seep Collection Area (August 8, 2017)

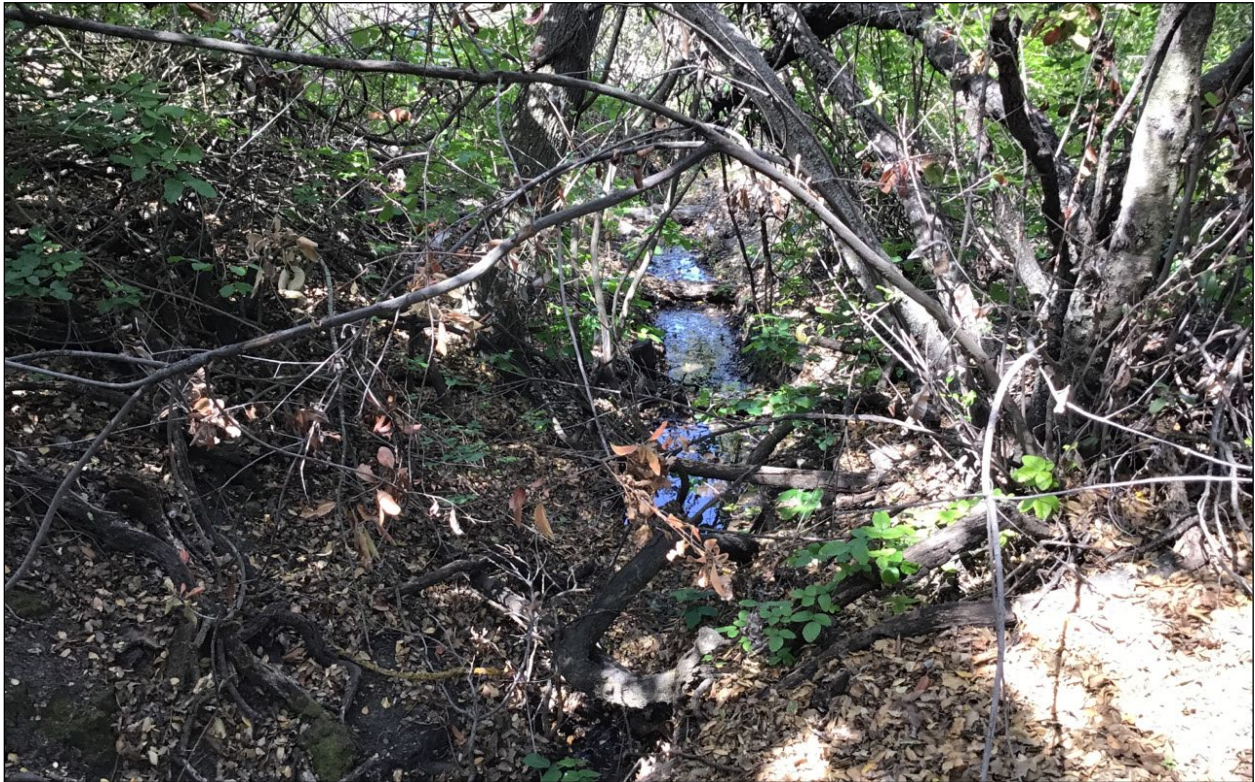
Photo 34. Year 6 Conditions at Photo Point 14 during Vegetation Monitoring, Where Debris Jams Were Installed in the Seep Collection Area (April 6, 2022)

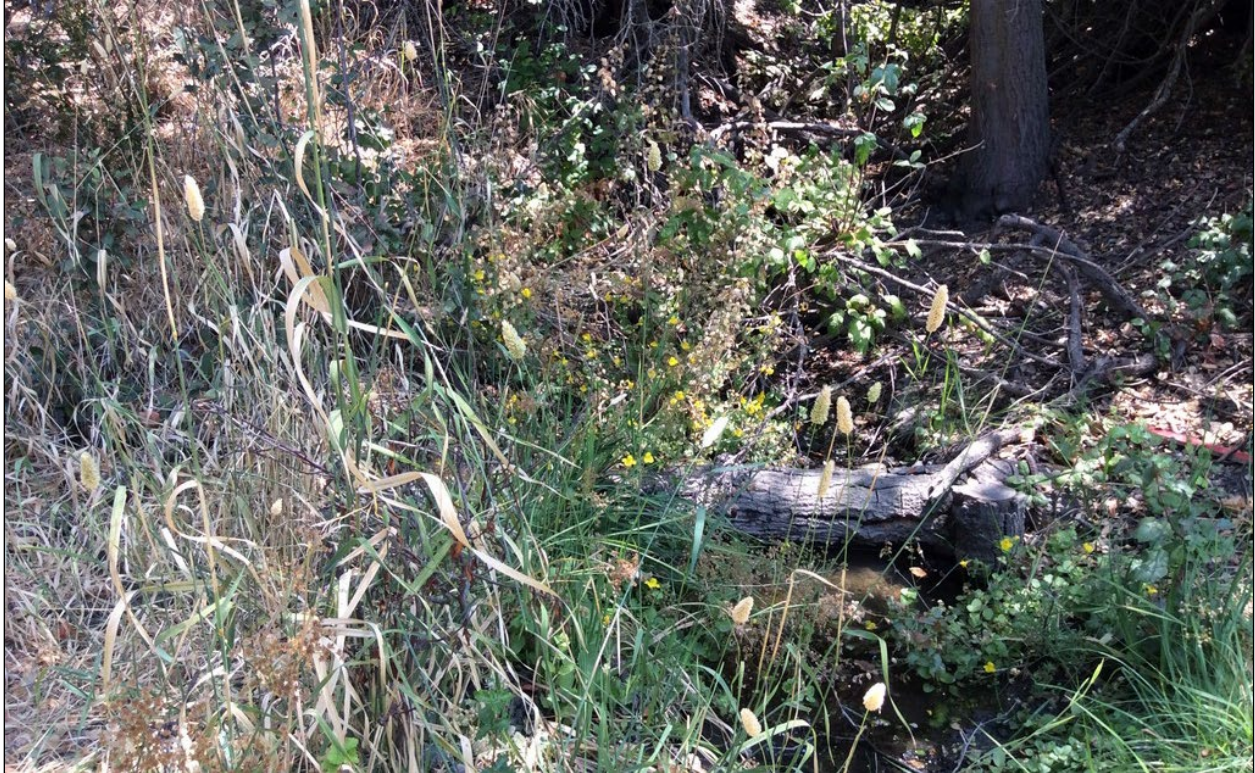
Photo 35. Year 1 Conditions at Photo Point 15 during Vegetation Monitoring, with a Log Debris Jam Installed in the Seep Collection Area (August 8, 2017)

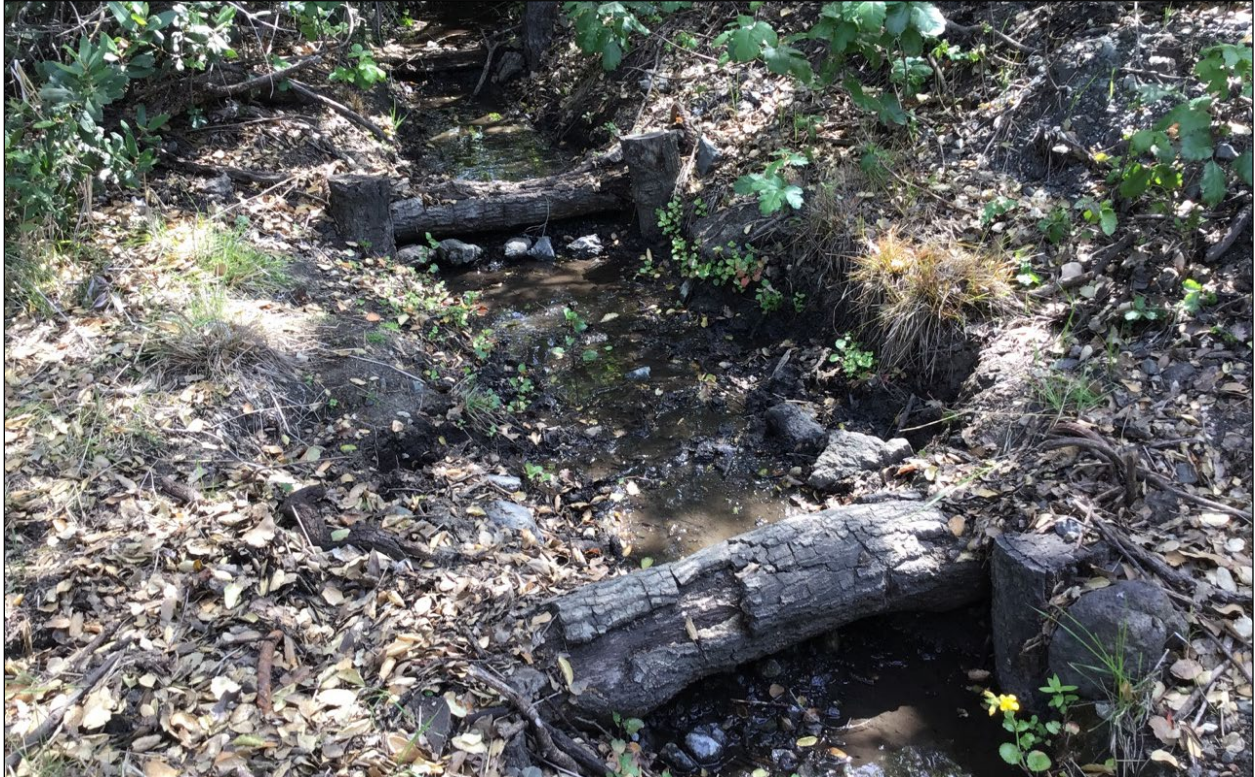
Photo 36. Year 6 Conditions at Photo Point 15 during Vegetation Monitoring, with a Log Debris Jam Installed in the Seep Collection Area (April 6, 2022)

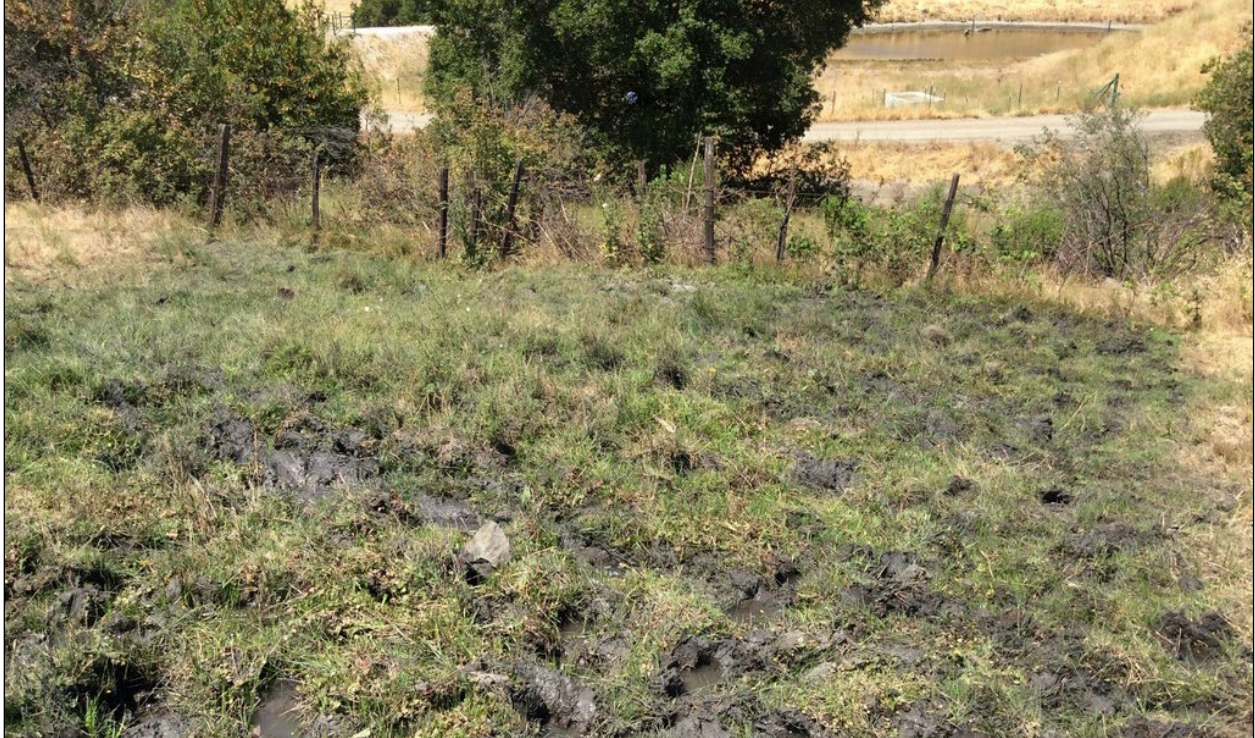
Photo 37. Year 1 Conditions at Photo Point 16 during Vegetation Monitoring, at an Existing Seep in the Seep Collection Area That Wasn't Disturbed during Construction (August 8, 2017)

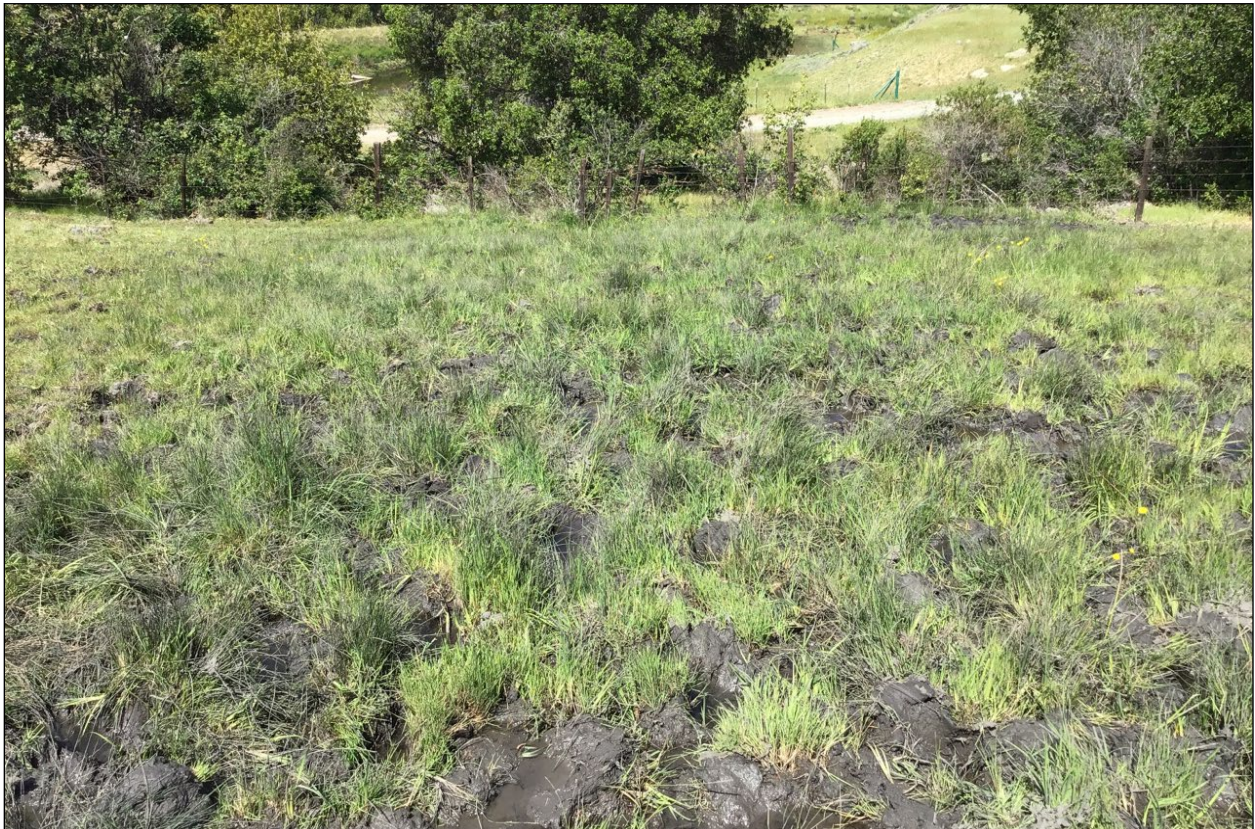
Photo 38. Year 6 Conditions at Photo Point 16 during Vegetation Monitoring, at an Existing Seep in the Seep Collection Area That Wasn't Disturbed during Construction (April 6, 2022)

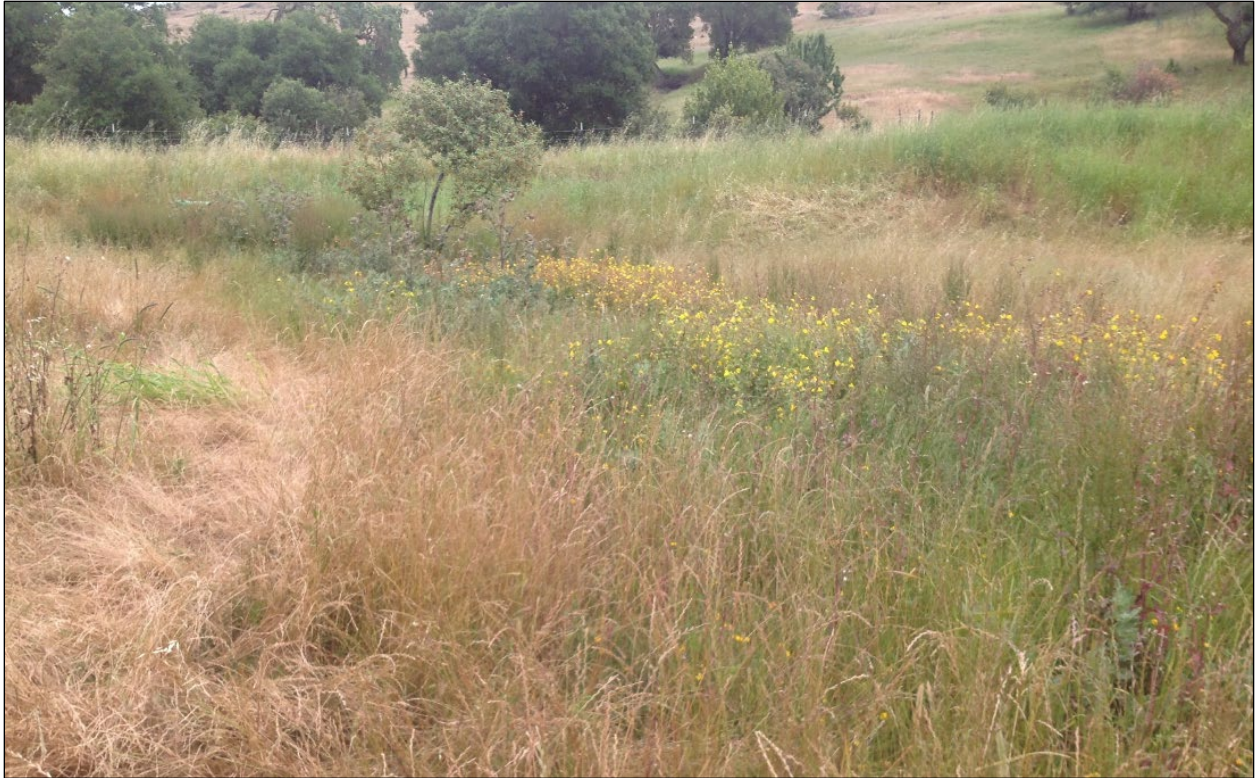
Photo 39. Year 1 Conditions at Photo Point 17 during Mt. Hamilton Thistle Abundance Monitoring at the Pond Mitigation Site (August 8, 2017)

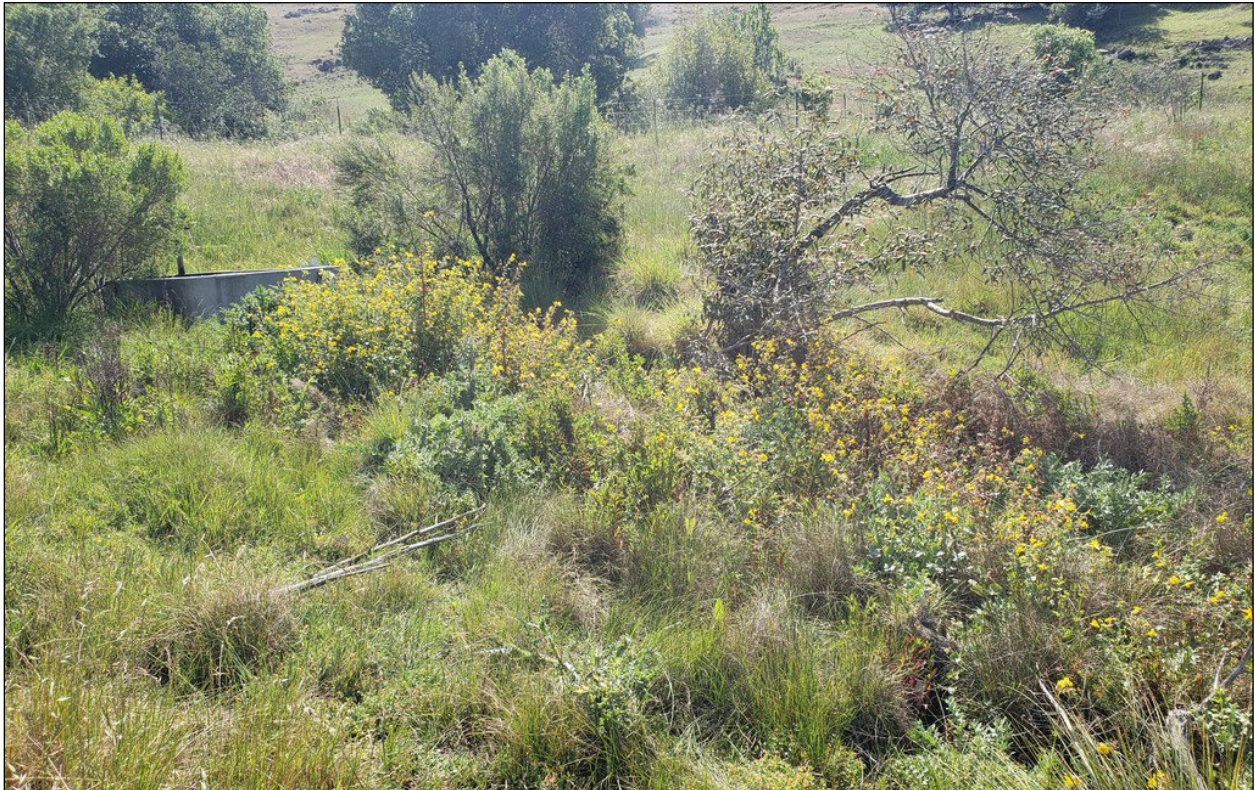
Photo 40. Year 6 Conditions at Photo Point 17 during Mt. Hamilton Thistle Abundance Monitoring at the Pond Mitigation Site (April 6, 2022)

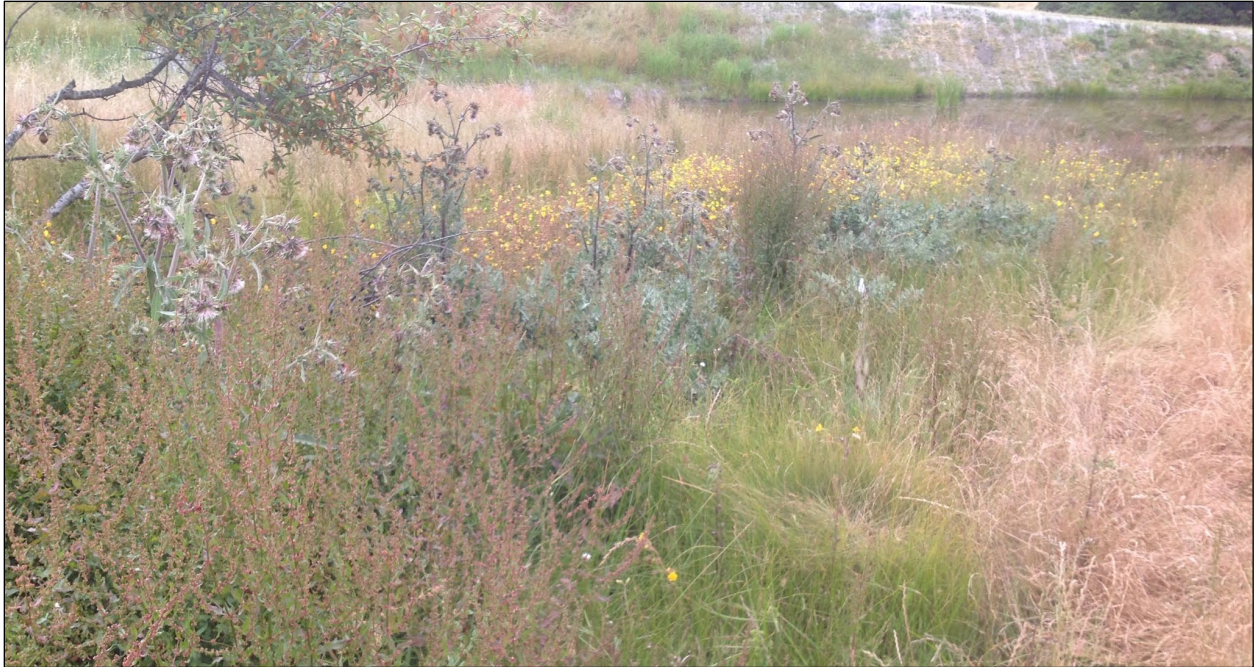
Photo 41. Year 1 Conditions at Photo Point 18 during Mt. Hamilton Thistle Abundance Monitoring at the Pond Mitigation Site (August 8, 2017)

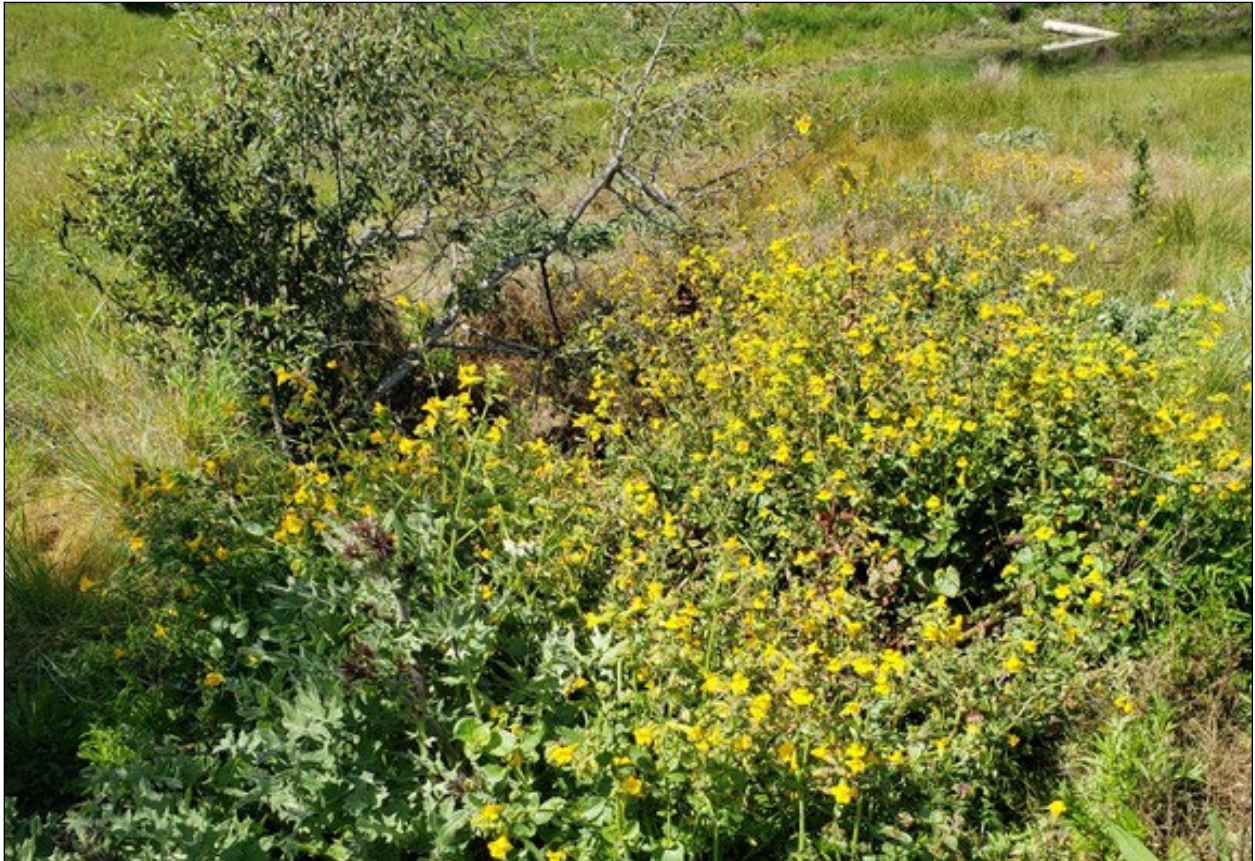
Photo 42. Year 6 Conditions at Photo Point 18 during Mt. Hamilton Thistle Abundance Monitoring at the Pond Mitigation Site (April 6, 2022)
