Coyote Ridge Ponds Restoration Project, Ponds CR1 and CR4- Year 3 Monitoring Report

January 15, 2023

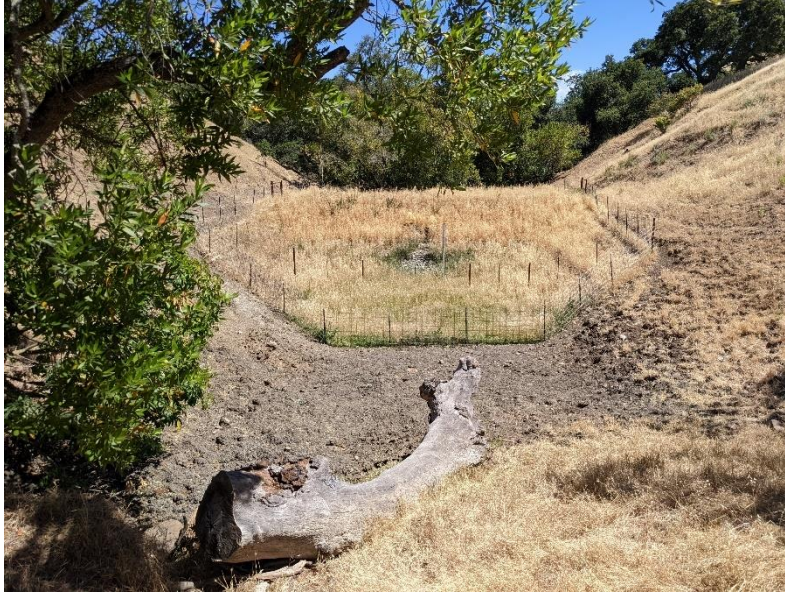
Photo 41. CR1 at water (1.1 ft) on April 18 (noted by others) but was completely dry by May 1 (noted by others) (June 16, 2022).

Water was observed in CR1 temporarily on January 14 (4.6-ft) but was dry again (6 weeks later) by March 3. 1.1-ft was observed on April 18, but the pond was dry again by May 1.

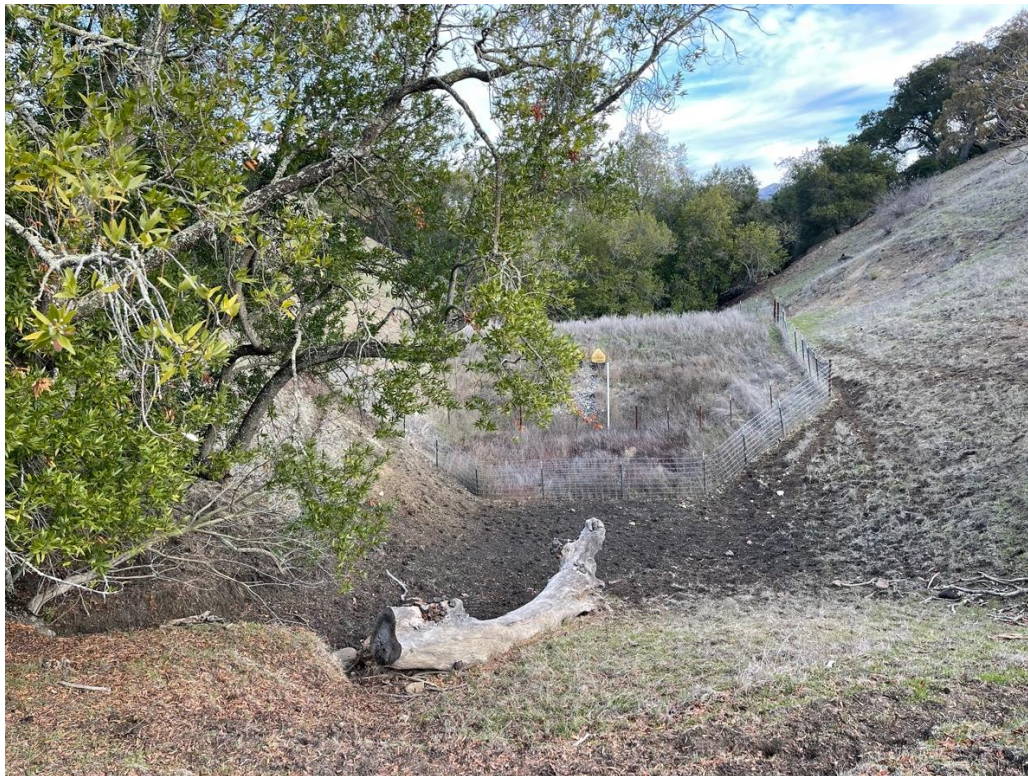
CR01

- UTC fence and gates have been replaced with cattle fences and gates. Nice to have a smooth wire along the bottom.
- Perimeter pond exclusion fences and gates – fences and gates intact, no obvious incursion by the cattle. Grazing evident outside the perimeter fence.
- Overflow pipes and debris guards – intact
- Berm conditions and integrity – good vegetation growth, no evidence of erosion
- Side slopes in and outside the perimeter fence – good vegetation growth, no evidence of erosion
- Water level and staff gauge – staff gauge intact, no measurable water
- Restoration pond vegetation – no planted pond vegetation observed
- Restoration hydroseed vegetation – good vegetation cover
- Observations, comments and recommendations – everything looked good, no problems except for the lack of sufficient rainfall. No recommendations.

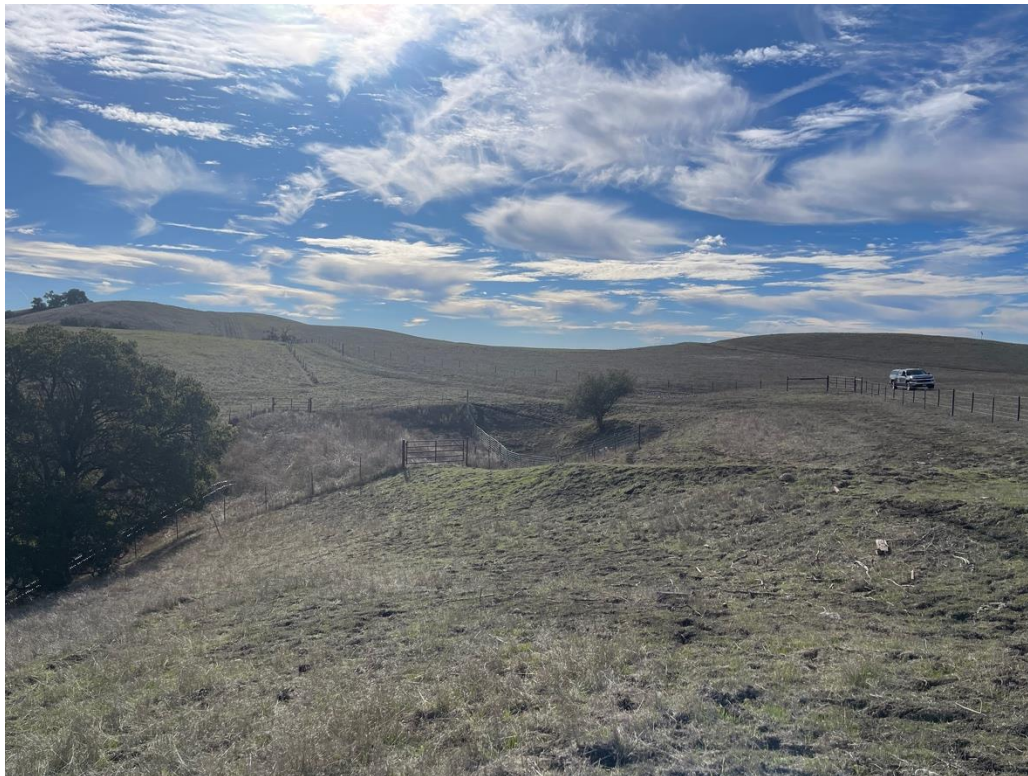
CR04

- UTC fence and gates have been replaced with cattle fences and gates. Nice to have a smooth wire along the bottom.

- Perimeter pond exclusion fences and gates - perimeter fences intact, no obvious incursion by the cattle. Grazing evident outside the perimeter fence.
- Overflow pipes and debris guards - intact
- Berm conditions and integrity - good vegetation growth, no evidence of erosion
- Side slopes in and outside the perimeter fence - good vegetation growth, no evidence of erosion
- Water level and staff gauge - staff gauge intact, no measurable water
- Restoration pond vegetation – about 30 *Juncus balticus* survived
- Restoration hydroseed vegetation - good vegetation cover
- Observations, comments, and recommendations –Everything looked good, no problems except for the lack of sufficient rainfall.

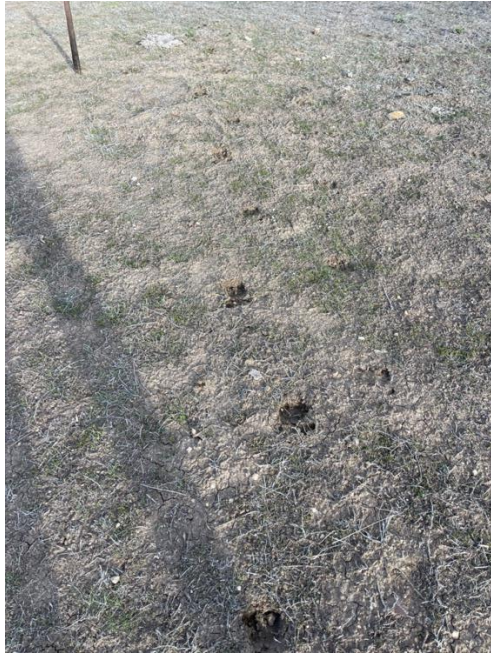
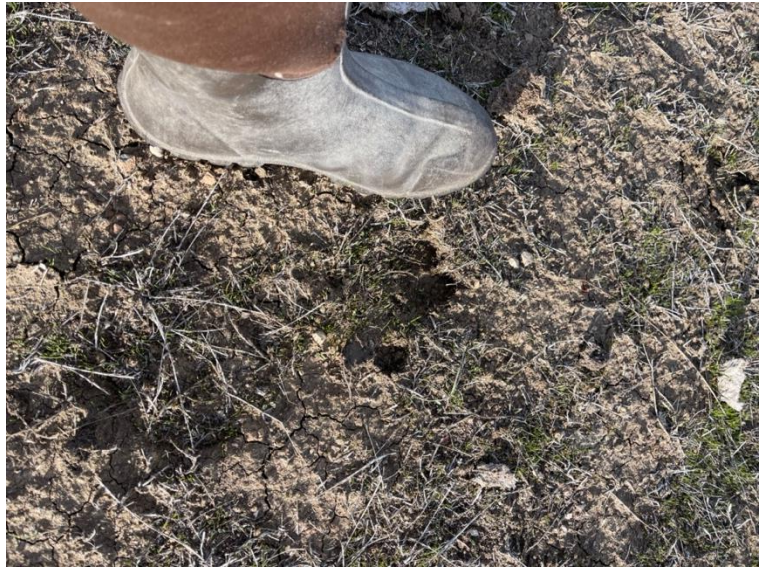
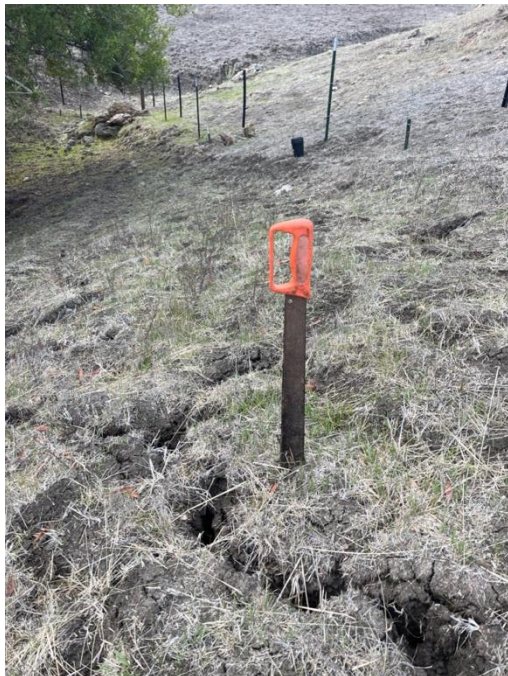
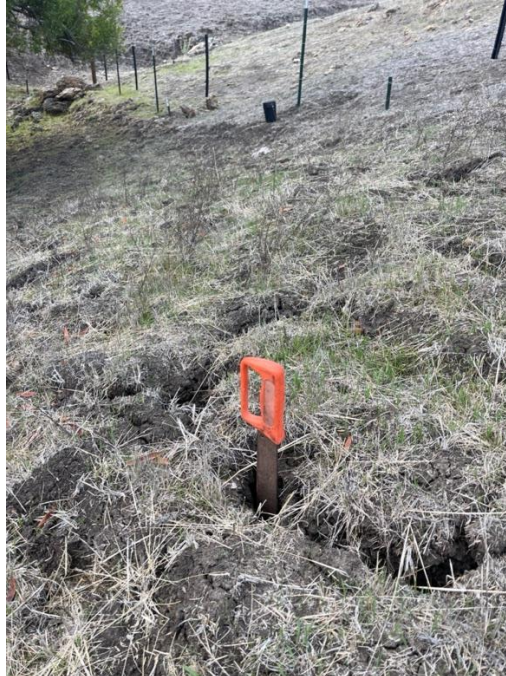
No evidence of any significant recent rain, no visible signs of overland flow. Some of the cracks in the clay soils were quite deep. The first set of pics are from Pond 1 area, the second from Pond 4
