# Coyote Valley US-101 Culvert Maintenance & PM 20.98 Fence Realignment and Jump-out

Ann Calnan – Valley Transportation Authority

Shawn Lockwood – Valley Water

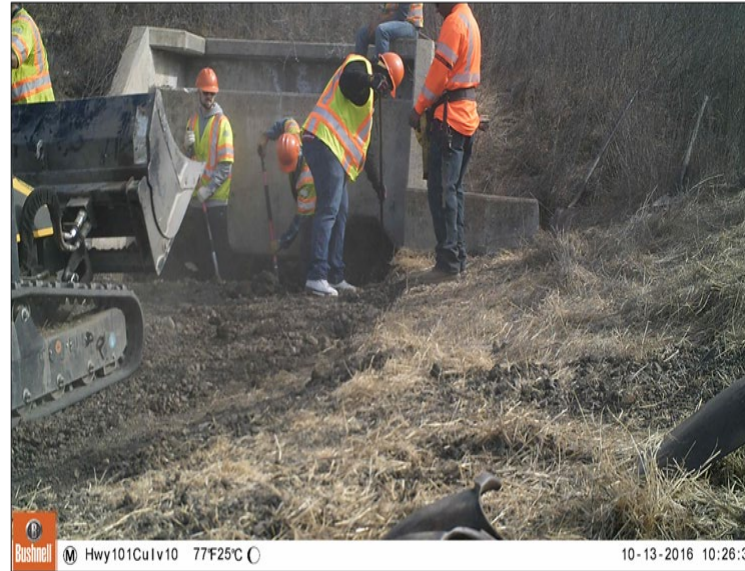
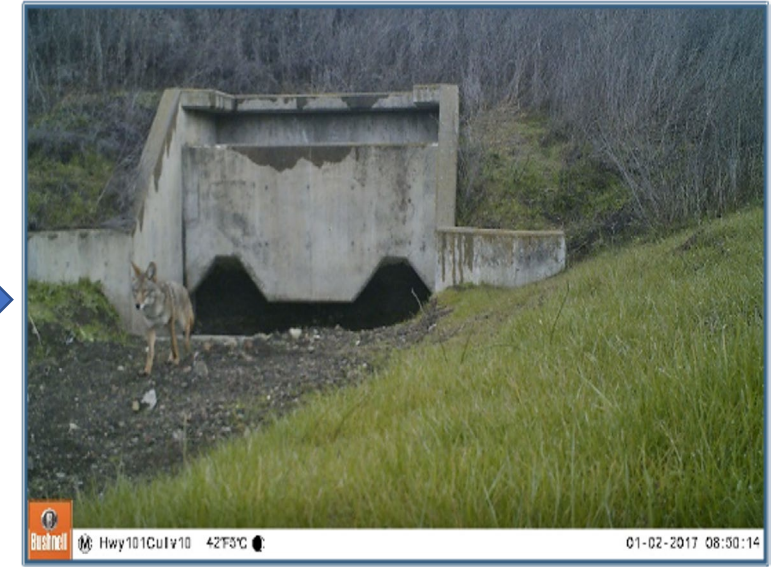
**PM 20.98**

SCCWCTWG worked with Caltrans to get blockages removed from two US-101 culverts, Post Mile (PM) 20.98 and PM 24.27.

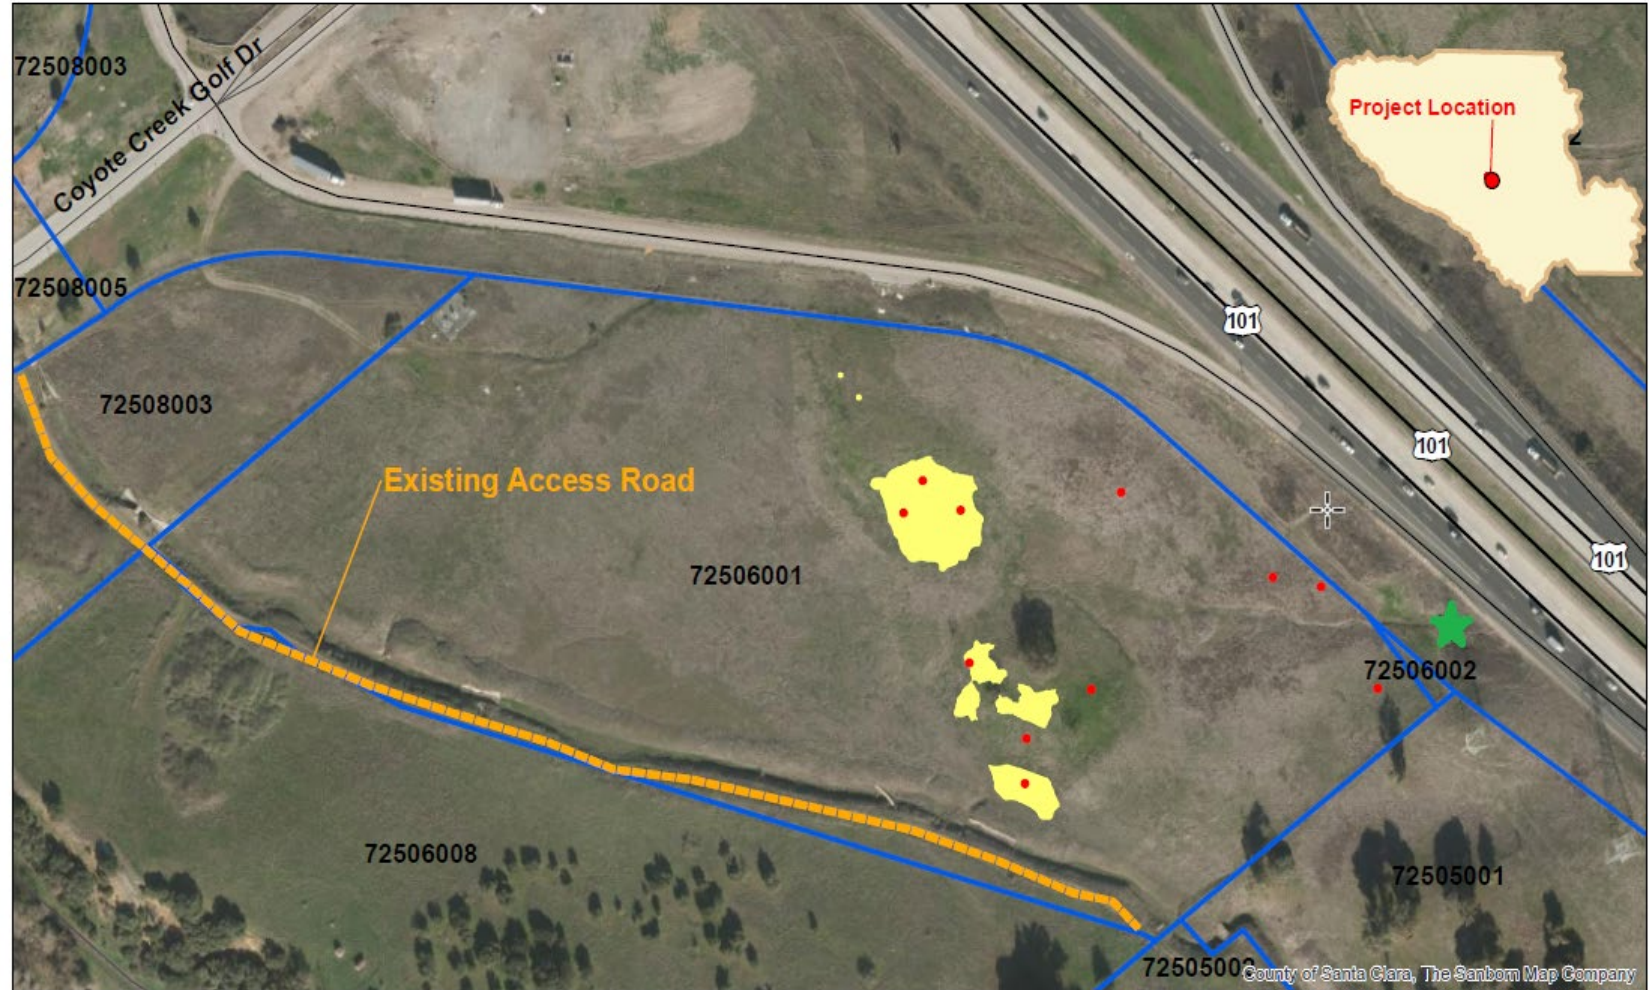
**Coyote Valley Wildlife Corridor  
Enhancements Project  
- PM 20.98 Culvert**

Valley Water initiated a Safe, Clean Water Priority D2 restoration site on Valley Water property at the west side of the PM 20.98 culvert.

PM 20.98 Culvert
-

Valley Oak Planting Basins (.001 acres)
-

Removal Areas - Herbaceous Invasives (0.5 acres)
-

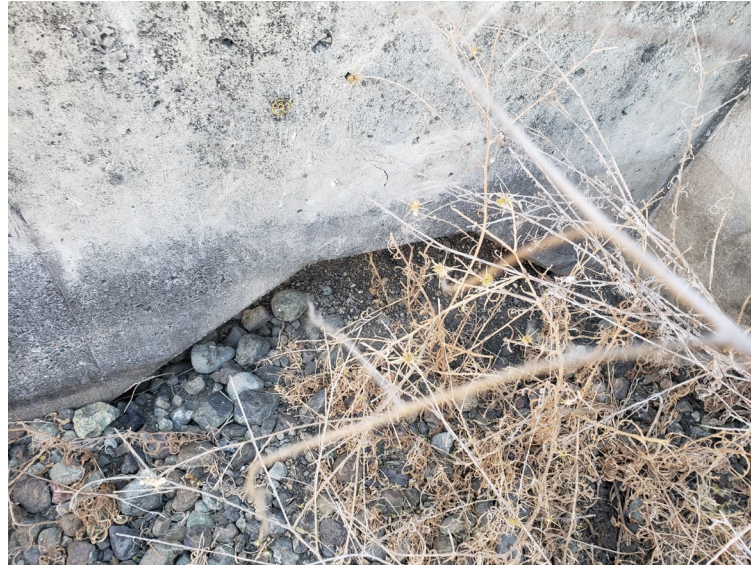
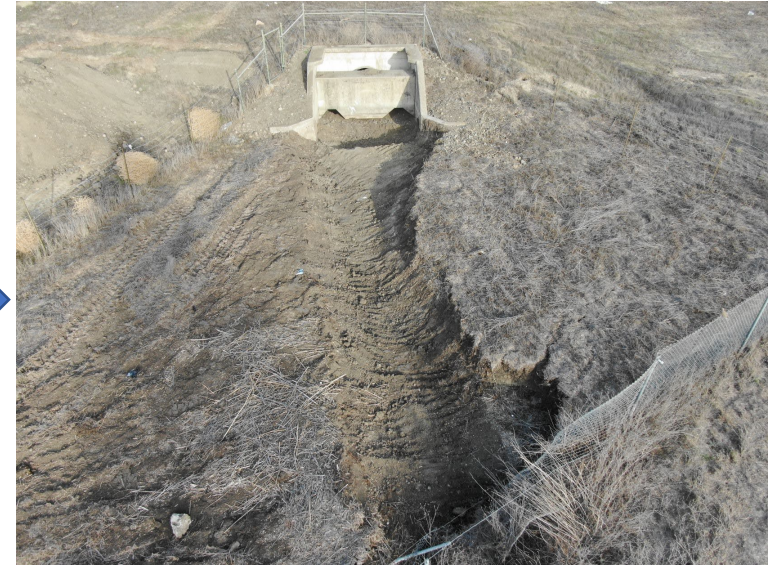
**PM 21.6**

Preventative maintenance was performed to clear the dissipator walls at the PM 21.6 and 21.8 culverts.

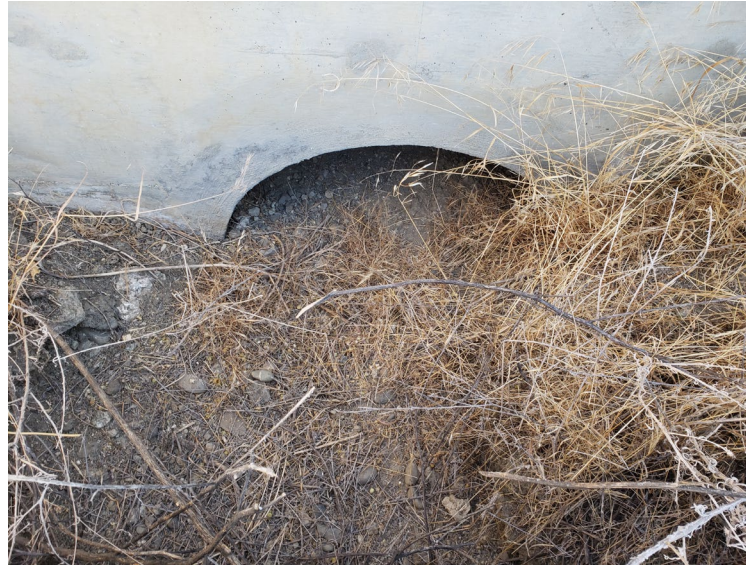
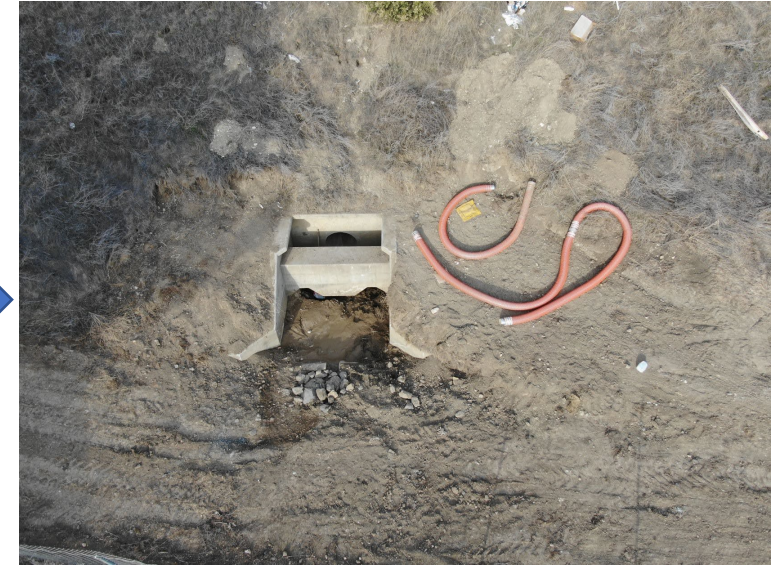
## PM 22.17

Maintenance was performed to clear both the dissipator wall and blockage on the west side of the PM 22.17 culvert.

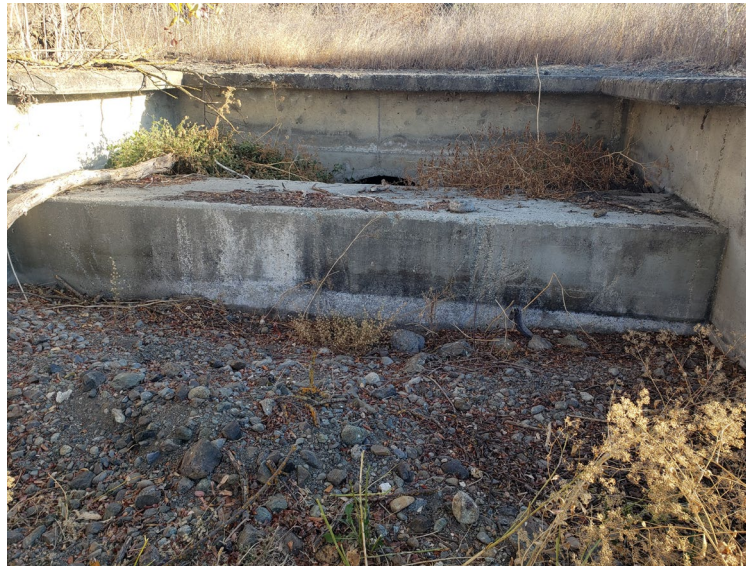
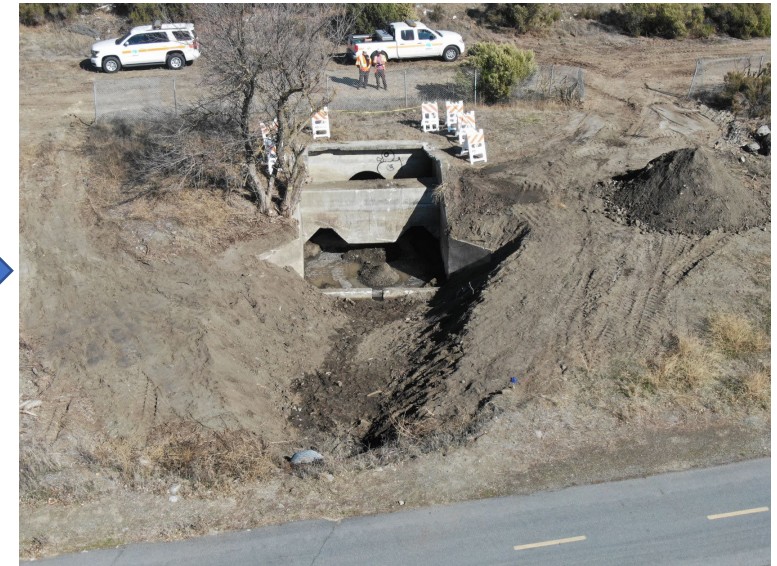
## PM 23.2

Maintenance was performed to clear the dissipator wall, but regular means were unsuccessful in clearing the PM 23.2 culvert due to the severity of the blockage. Next steps TBD.

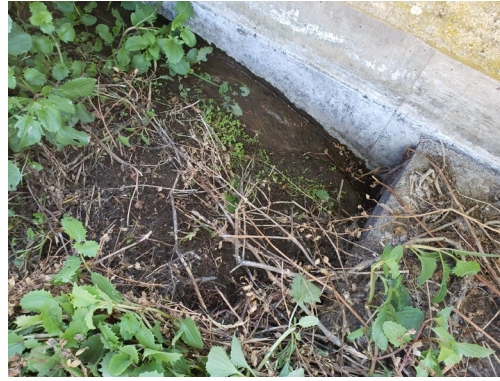
**PM 20.82**

Due to the severity of the blockages, the means and methods need to be determined before the permitting process can begin.

Maintenance will require 401/404 permits due to the presence of waters of the US/State (both other waters and wetlands).

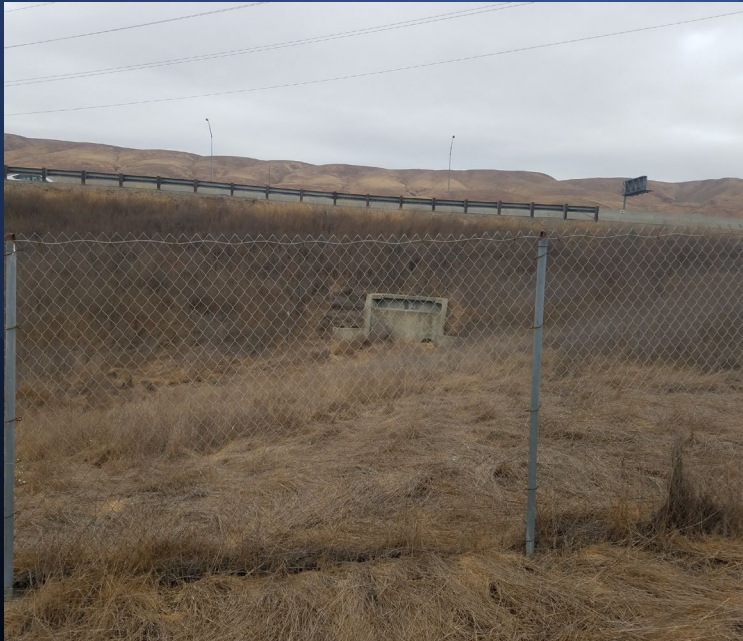
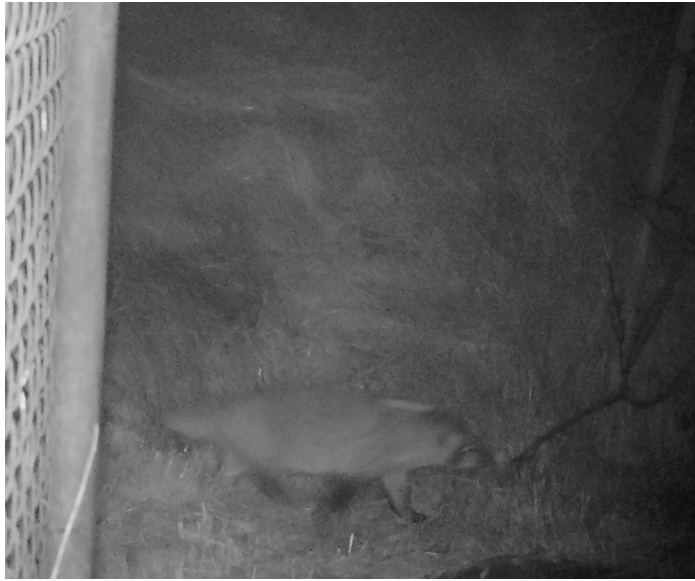
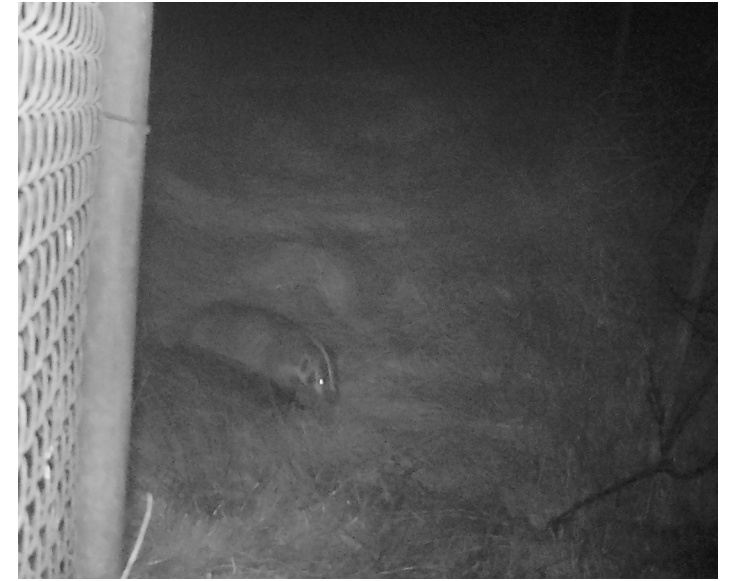
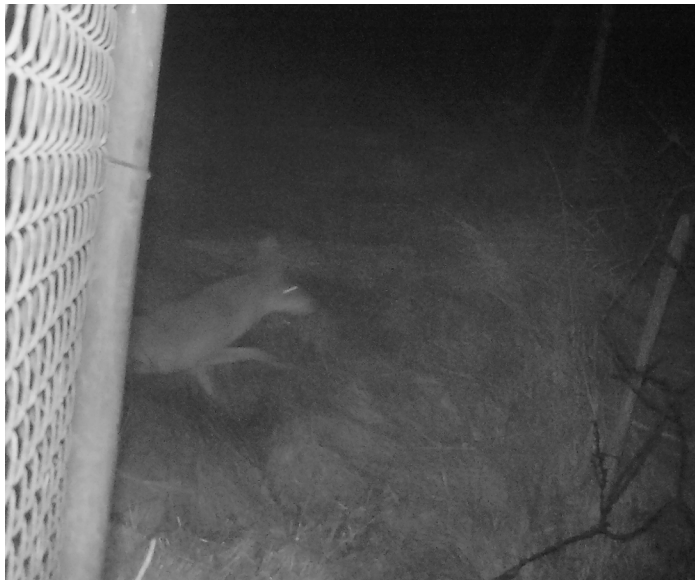
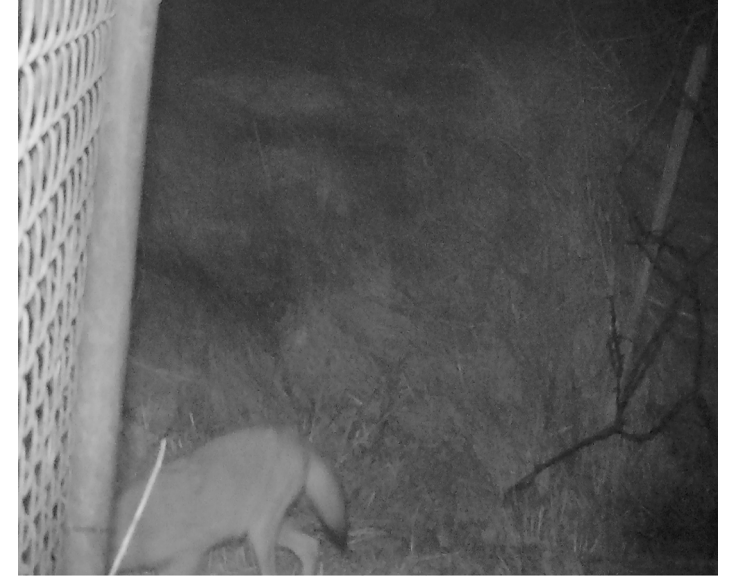
Fence Realignment Need

PM 20.98 Culvert Fence  
Realignment and Jump-out

2024: Valley Water will construct the jump-out using Safe, Clean Water Priority D2 funding. Caltrans will realign the fence and will maintain their new infrastructure in perpetuity.

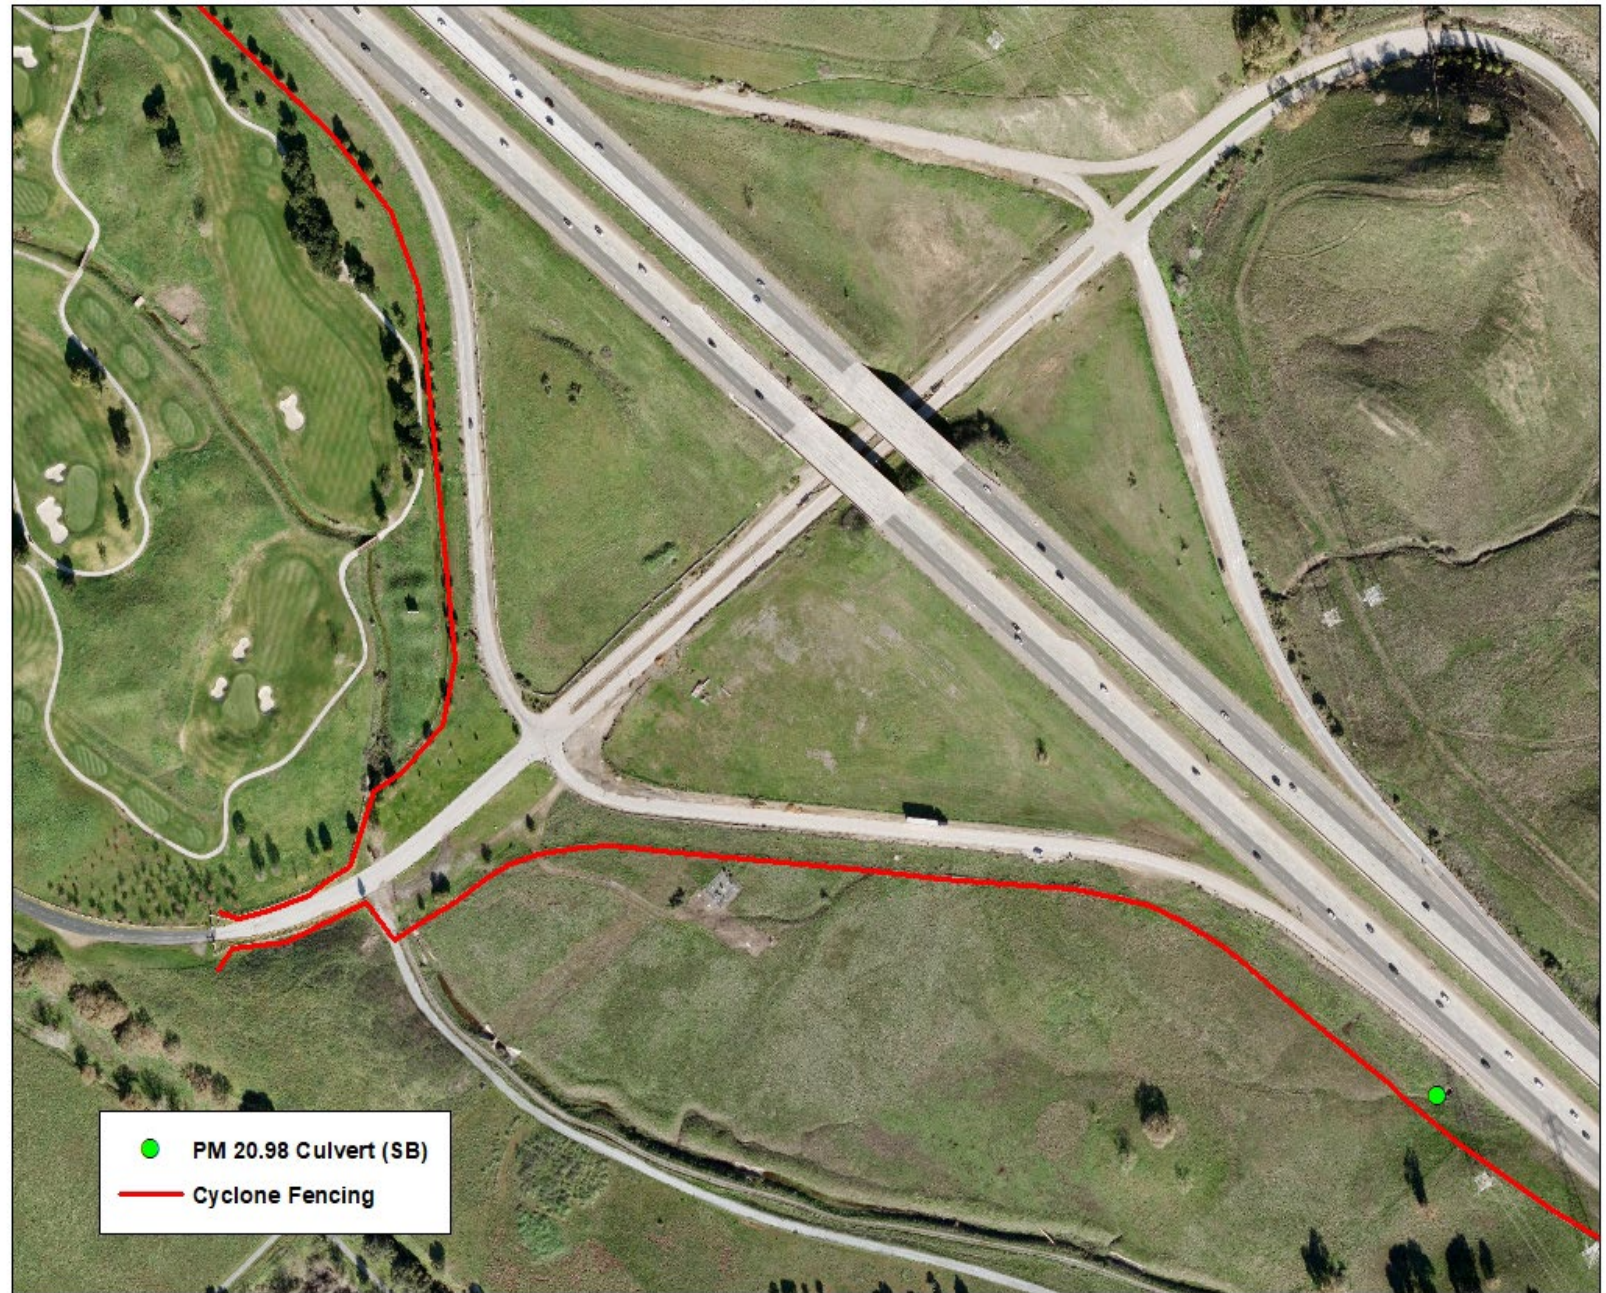
### Jump-out Need

## PM 20.98 Culvert Fence Realignment and Jump-out

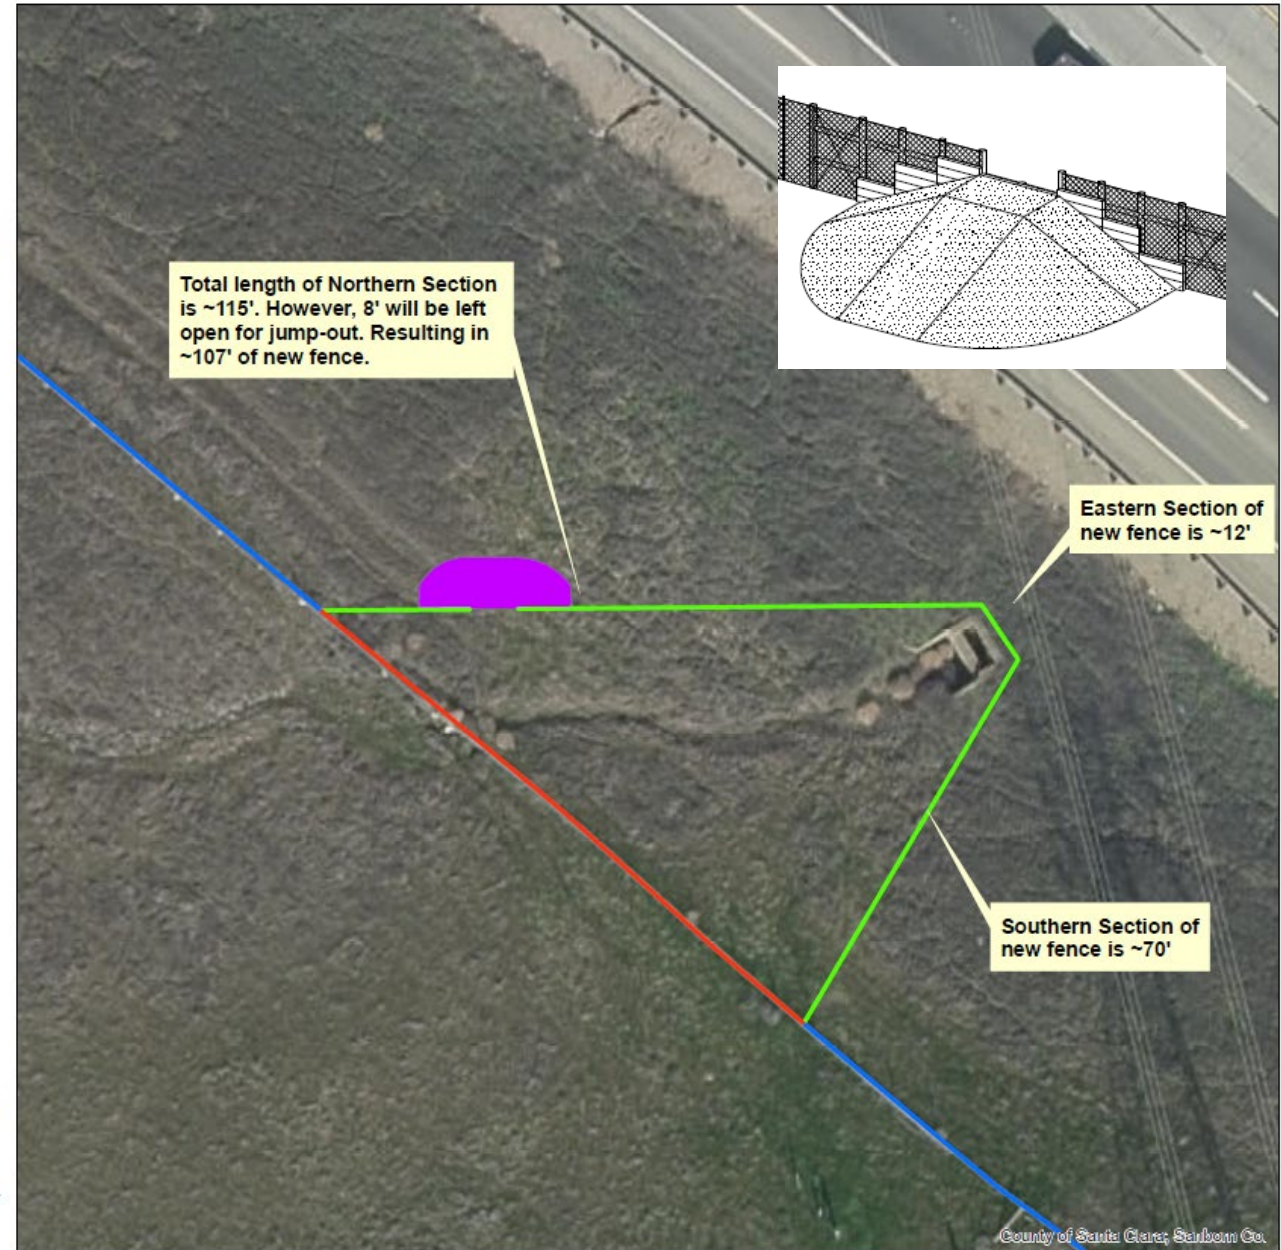
### Culvert PM 20.98 Fence Realignment & Jump-out Mockup

Jump-Out

New Cyclone  
Fence  
Realignment

Existing  
Cyclone Fence  
to Remove

Existing  
Cyclone Fence  
to Stay
