Project No. 3753-08

**Subject: Calero County Park and Wetland Restoration Project—Year 7 (2023)
Supplemental Vegetation and Hydrology Monitoring**

Year 7 (2023) Supplemental Vegetation and Hydrology Monitoring Memorandum (3753-08)
December 2023

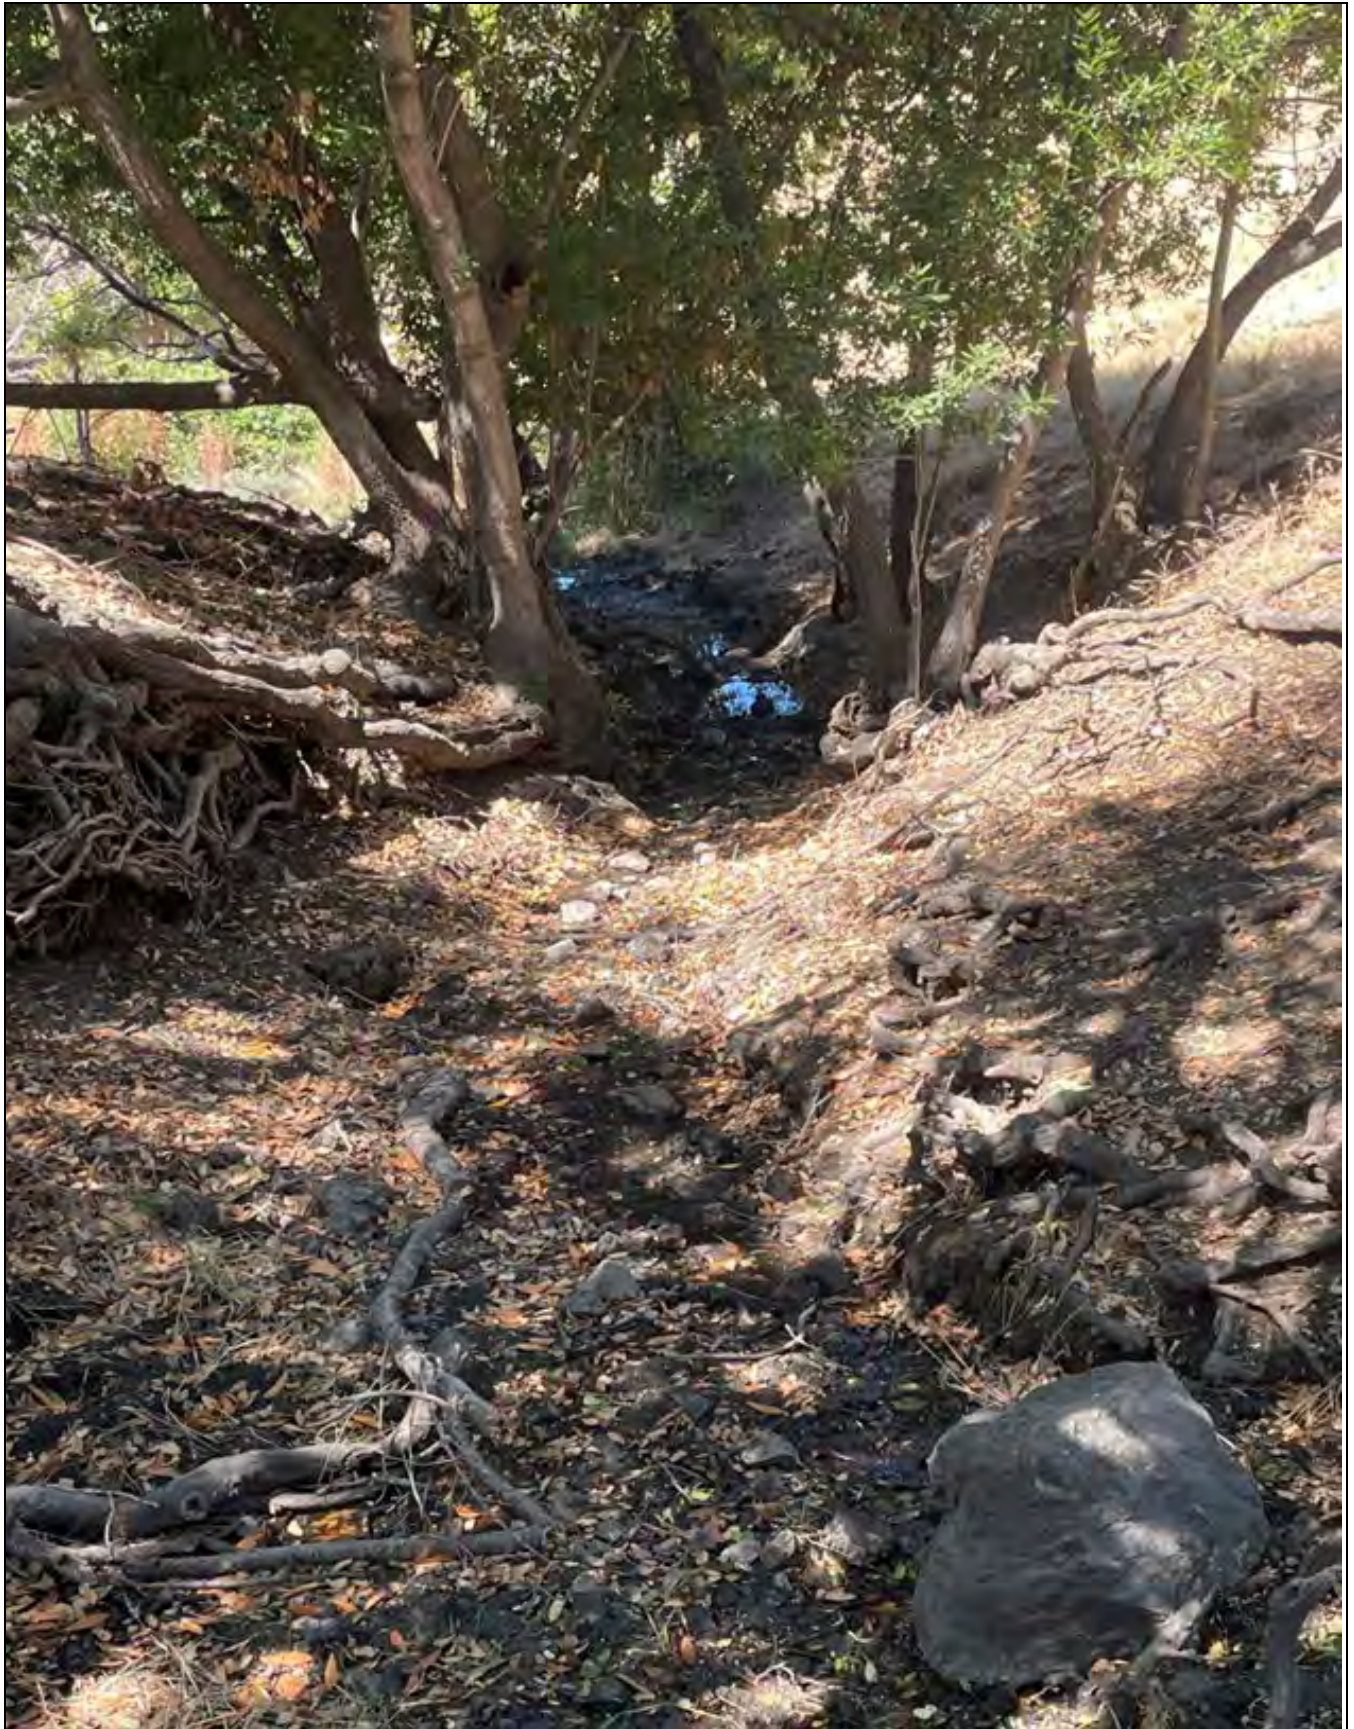
Figure 1

A clog at the seep spring box was removed on August 2, 2023, prior to the August 16th site visit, which improved seep flow into the pond trough but did not produce any standing water in the pond by the August 16th monitoring date (Note: puddling was observed in the bottom of the pond in mid-November 2023 by Habitat Agency staff). There was some dampness noted at the very bottom of the pond which had previously been dry (according to HT Harvey). Immediately downstream of the pond at creek grade, the bed of the creek was also damp with some puddling of water present (Figure 1). With a newly restored seep inflow, this would suggest that seep inflows to the pond were potentially flowing below the pond.

Upon further inspection of the seep spring box, a cow carcass was found upstream of the log weirs. The cow carcass has since been removed from the seep flow line and a fence was built surrounding the upstream seep areas to keep cattle out during the wet season in the future with the goals of enhancing the upstream wetland seeps, reducing sedimentation, and reducing blockage formation at the intake pipe (N. Hale, personal communication, December 19, 2023).

Notes: Taken 08/16/2023

- More frequent maintenance of the seep intake pipe to ensure minimal sedimentation resulting in blockage cutting off inflow to the pond from the spring box.
- Inspect the pond outlet structure gate seals and grout for possible leaks.

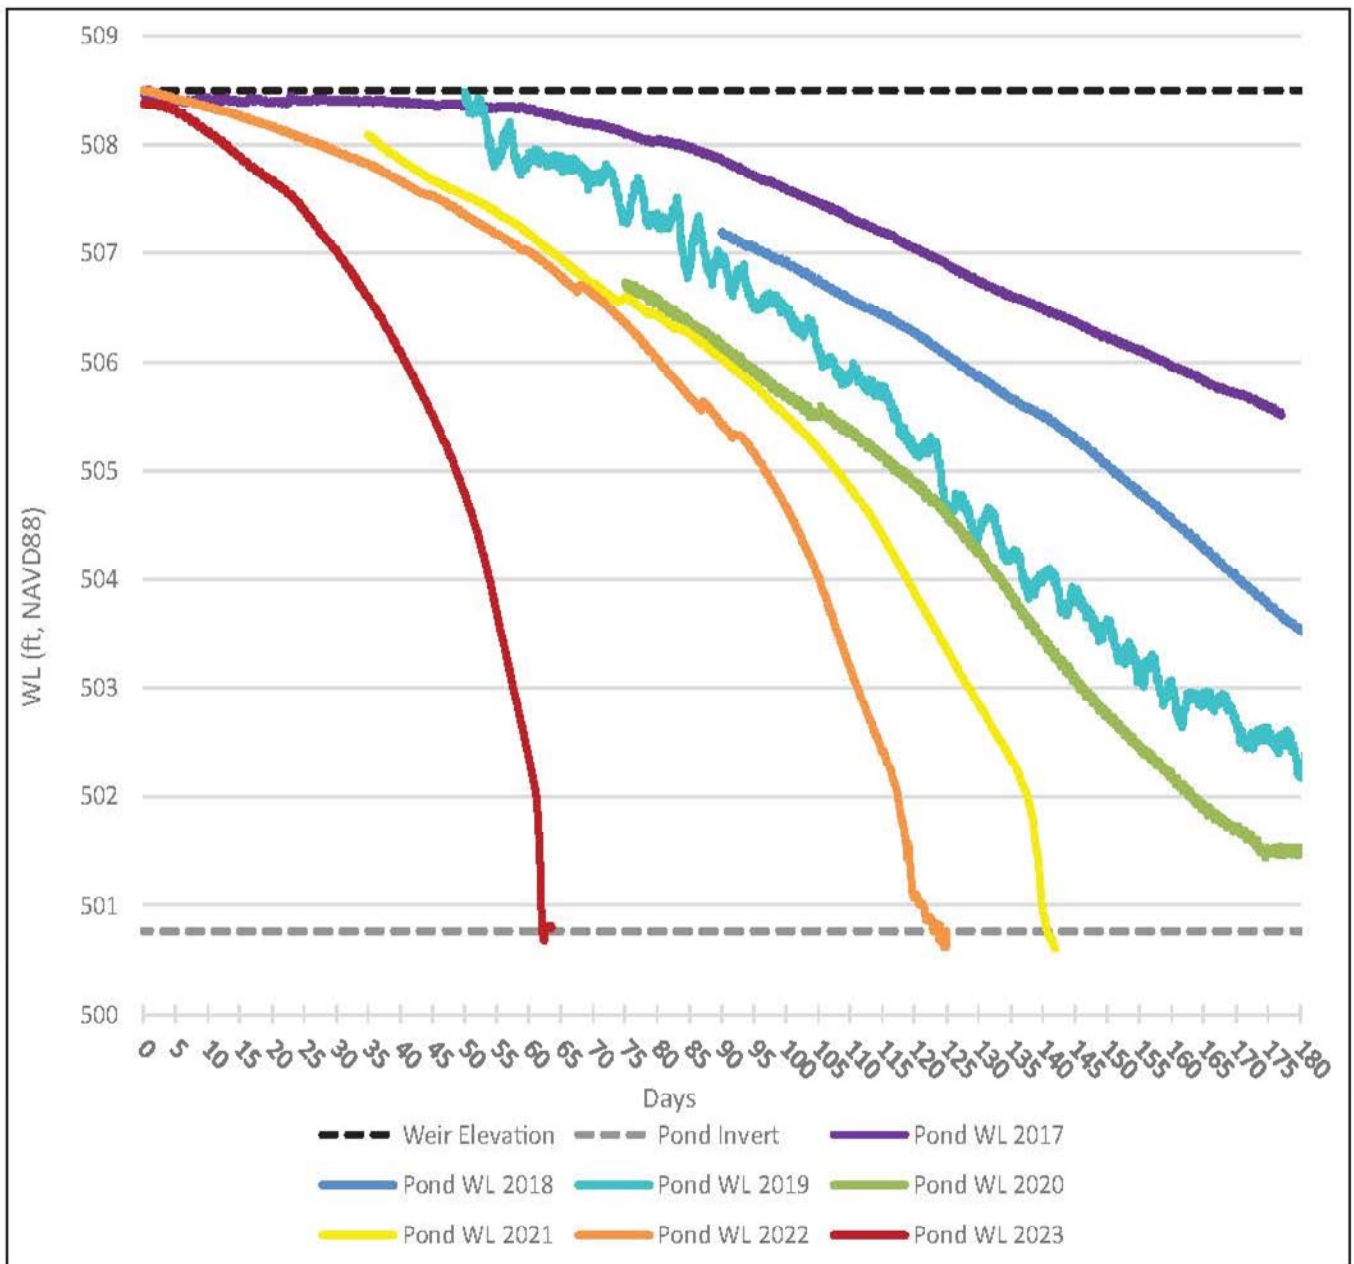
<i>Calero Mitigation Site Supplemental Analysis</i>	
		Pond Water Level Drawdown Rate Comparison	
		Project No. 15-1030-5	Created By: AH
			Figure 2

Pond water level drawdown rates have increased every year since the start of the monitoring period. WY 2023 experienced the quickest drawdown rate despite being a very wet year with more rain than any previous monitoring year. The water budget model analysis of the pond shows that seep flow input and percolation losses are the most important variables contributing to the pond's Spring/Summer hydrologic regime. Observed differences in the pond's water levels and the observed data for the first five years of the project (WY 2017-2021) are in large part explained by changes in estimates of seep flow due to climate extremes, blockages in the seep spring box not allowing for sustained inflow to the pond, but also a significant increase in losses which are assumed to be percolation losses through the bottom of the pond. The percolation losses in the two most recent WYs are even worse despite WY 2023 being the wettest year on record. Early rains and runoff in WYs 2022 and 2023 were not retained in the pond per the water budget model, resulting in lower initial observed pond water levels. Additionally, the pond lost water faster in these two WYs compared to the previous four WYs by nearly double the rate. Potential contributions to the quickening of pond water level drawdown rates include, but are not limited to: 1) compromised bentonite layer in the pond bottom, 2) seepage via cracks or under the bentonite layer, 3) piping through the pond embankment, 4) ground squirrel burrowing activity lower down on the embankment (though there are no observations to date), 5) seepage around the outlet structure, and/or 6) leaks in the outlet structure gate or mounting plate.

WY	Date WSE dropped below weir elevation	Obs. dry date	Precipitation class
2017	3/21/2017	9/19/2017	Wet
2018	04/07/2018 (highest WL 507.19)	8/26/2018	Very Dry
2019	4/12/2019	8/30/2019	Wet
2020	4/17/2020 (highest WL 506.73 ft)	7/26/2020	Very Dry
2021	01/20/2021 (highest WL 508.09 ft)	5/15/2021	Very Dry
2022	1/19/2022	5/25/2022	Very Dry
2023	4/12/2023	7/10/2023	Very Wet

To gain a better understanding for why the pond losses are increasing with each passing year, future monitoring of the project site is highly recommended, to include:

- Continued gage data monitoring and subsequent water budget analysis to compare yearly data trends.
- More frequent monitoring visits, especially immediately after rain events during WY 2024 to observe conditions in real-time, especially early in the season as the pond is filling but also after the pond has filled and is drawing down for the season.
- Supplemental flow monitoring in the creek below the pond to understand flow rates and volumes, especially early in the season as the pond is filling but also after the pond has filled and is drawing down for the season.

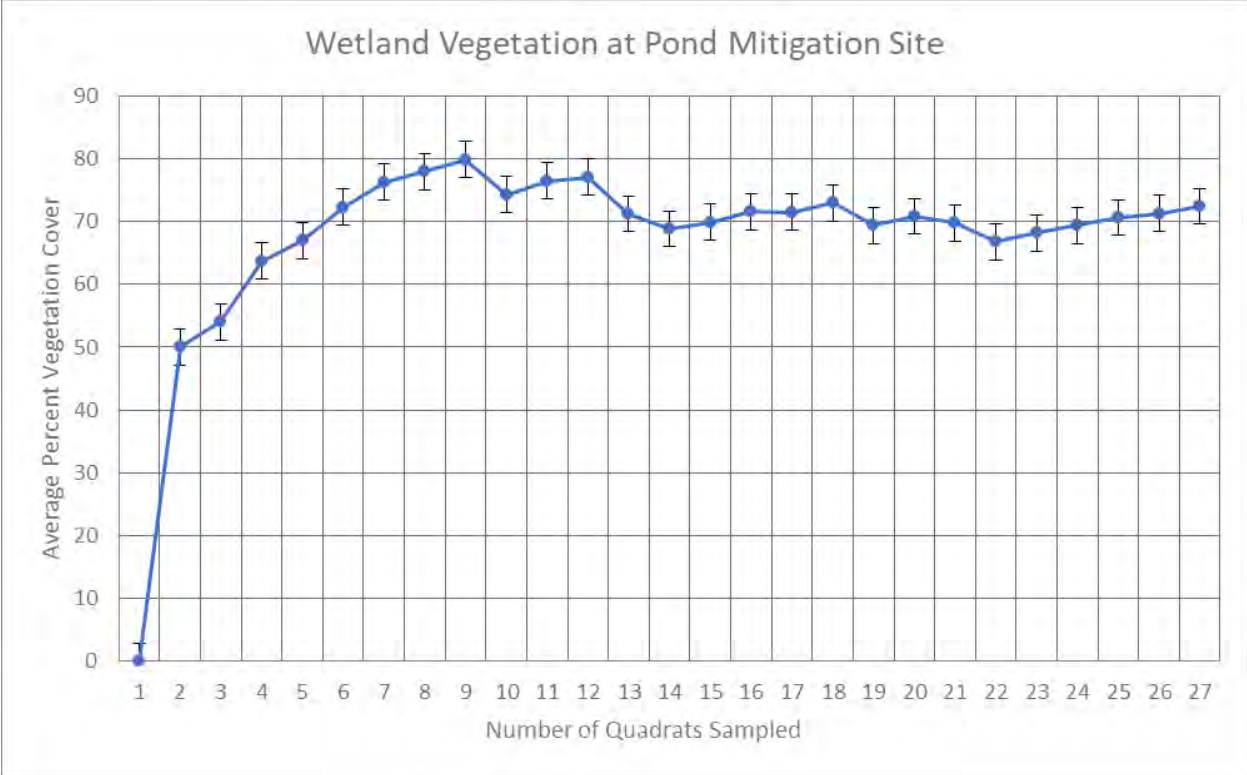
Figure C-1. Species Accumulation Curve for the Pond Mitigation Site in Year 7

Upland species cover was low and the area was dominated by cover of wetland species. Creeping spike rush (*Eleocharis macrostachya*, OBL) provided the most cover (40.8%), followed by bog rush (*Juncus effusus*, FACW) and two toothed sedge (*Carex serratodens*, FACW), which provided 13.9% and 5.6% cover, respectively. Complete vegetation monitoring results, including species accumulation curves, are provided in Appendix C.

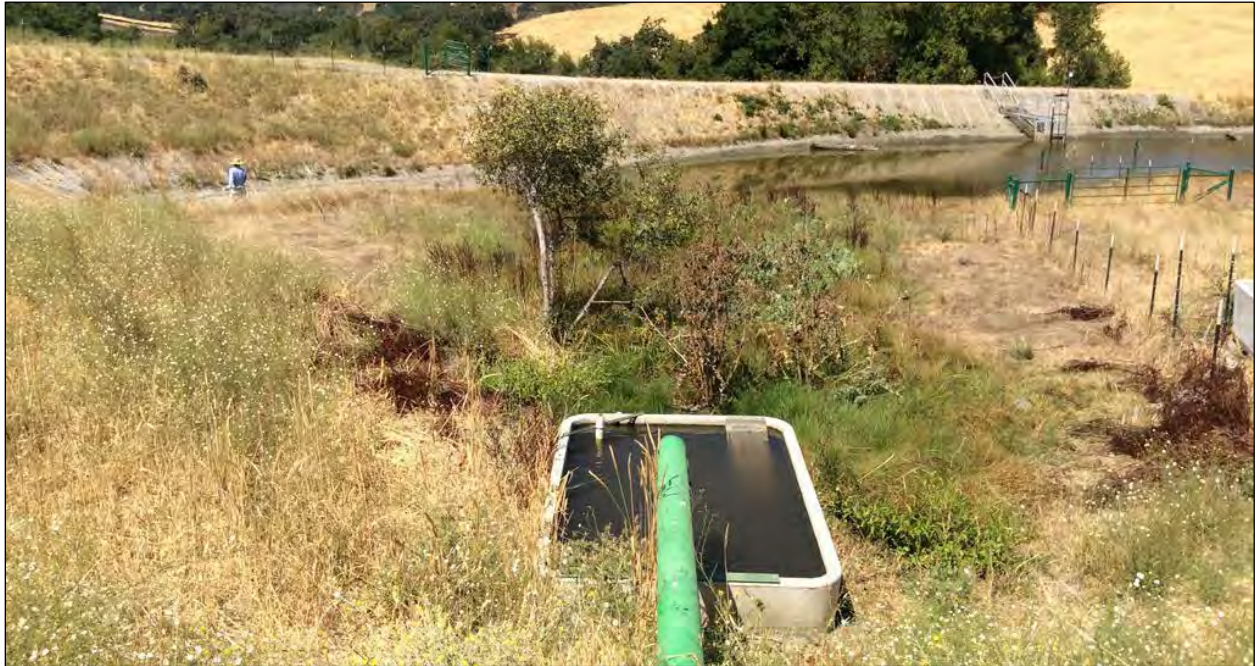
Photo 1. Year 1 Conditions at Photo Point 6 during Mt. Hamilton Thistle Abundance Monitoring at the Pond Mitigation Site (August 8, 2017)

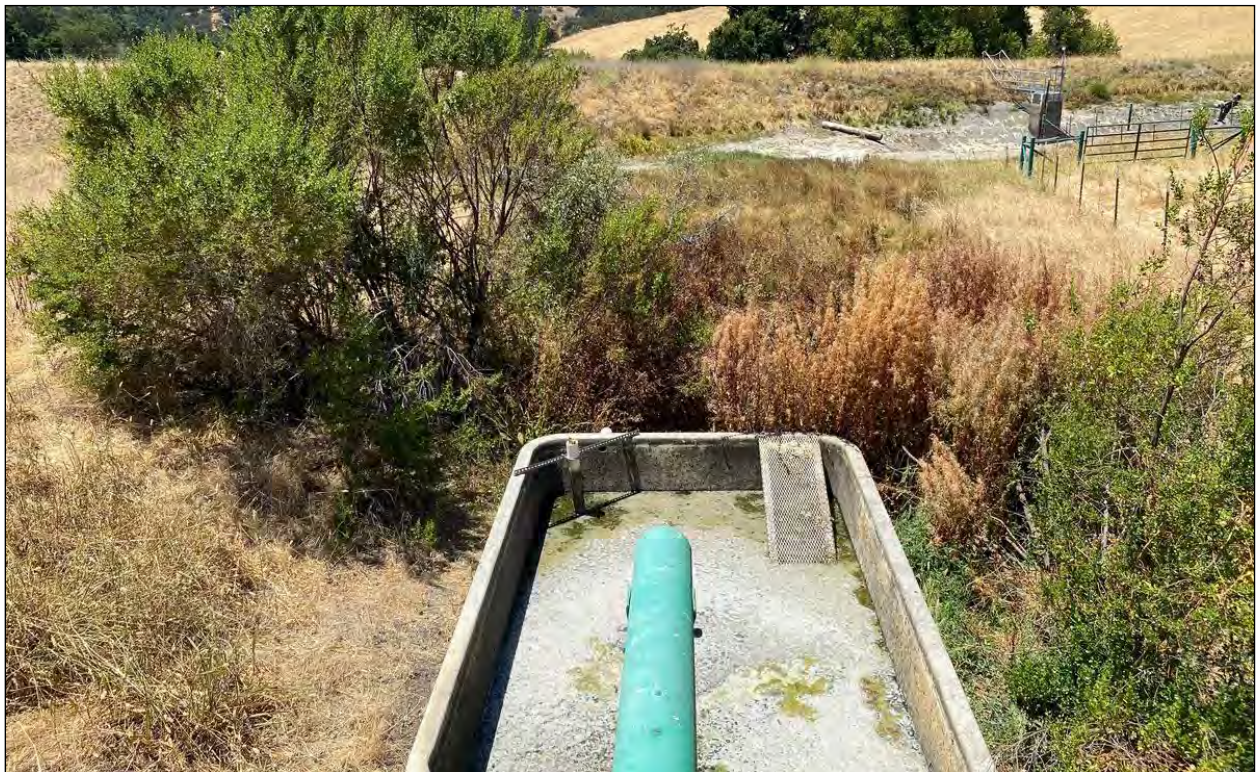
A summary of the results of Mt. Hamilton thistle abundance monitoring in Years 1-7 is presented in Table 2. The population abundance shows a declining trend beginning in Year 4 and continuing through Year 7, although the number of flowering individuals has remained approximately consistent. Percent cover in Year 7 was very low relative to prior monitoring years, although this was likely attributable to the time of year in which monitoring was conducted (July, vs. May-June in Years 1-6). Second-year plants were in various stages of senescence, indicating some cover had already been lost. Health and vigor of individuals in the population was good. Most flowering individuals had begun to drop their seed at the time of monitoring. Photodocumentation of the Mt. Hamilton thistle population is included in Section D.

Photo 2. Year 7 Conditions at Photo Point 6 during Mt. Hamilton Thistle Abundance Monitoring at the Pond Mitigation Site (July 17, 2023)

- Coordinating with two AIR-Accredited (i.e., Accreditation to Improve Restoration and Native Plant Nursery Stock Cleanliness) nurseries to contract grow seedlings from seed collected on-site, to be installed in the late winter or early spring of 2023/2024

- Trimming and clearing of competing native herbaceous vegetation in the Mt. Hamilton thistle population area, to mimic the effects of cattle grazing and reduce competition with the Mt. Hamilton thistle

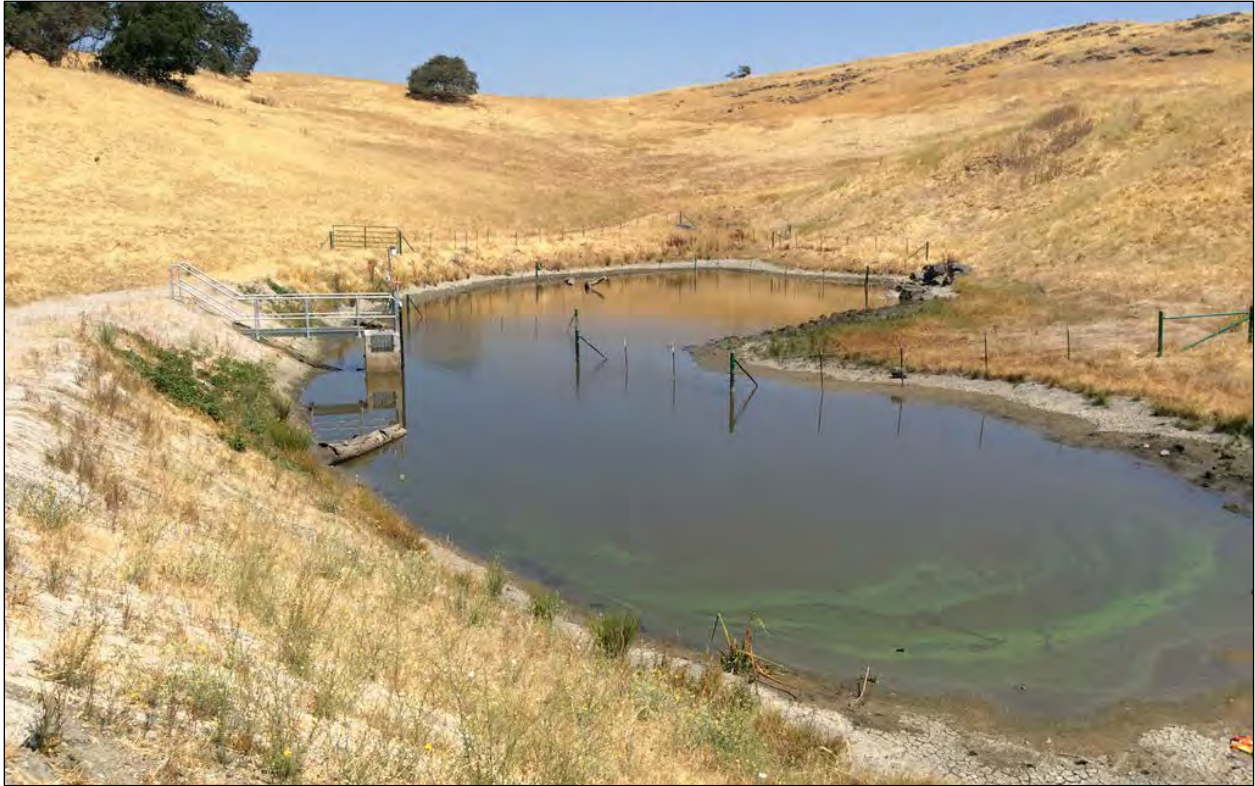
Photo 3. Year 1 Conditions at Photo Point 7a during Vegetation Monitoring at the Pond Mitigation Site (August 8, 2017)

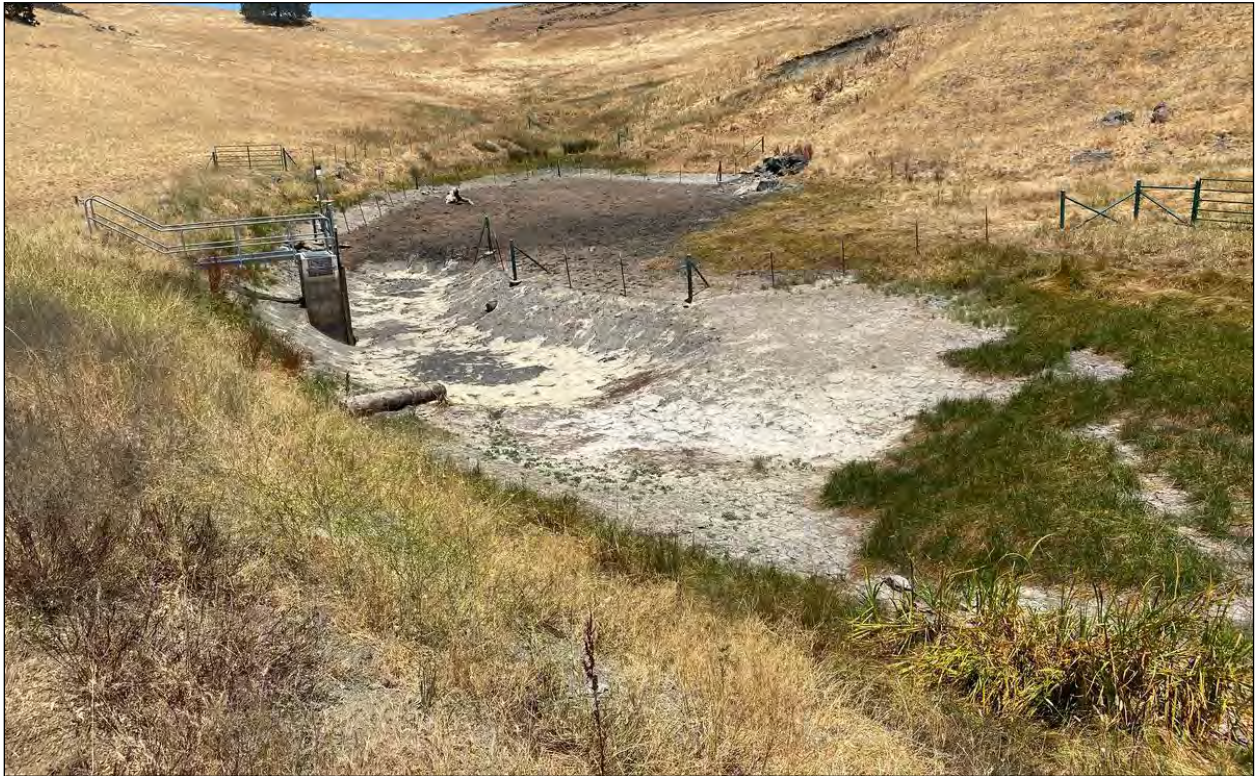
The average percent cover of wetland vegetation was 72.4% at the pond mitigation site, which exceeds the final success criterion of 70%. This is an increase over previous monitoring years, likely in response to the high precipitation in the winter of 2022/2023, in contrast to the historically dry conditions in the prior three

Photo 4. Year 7 Conditions at Photo Point 7a during Vegetation Monitoring at the Pond Mitigation Site (July 17, 2023)

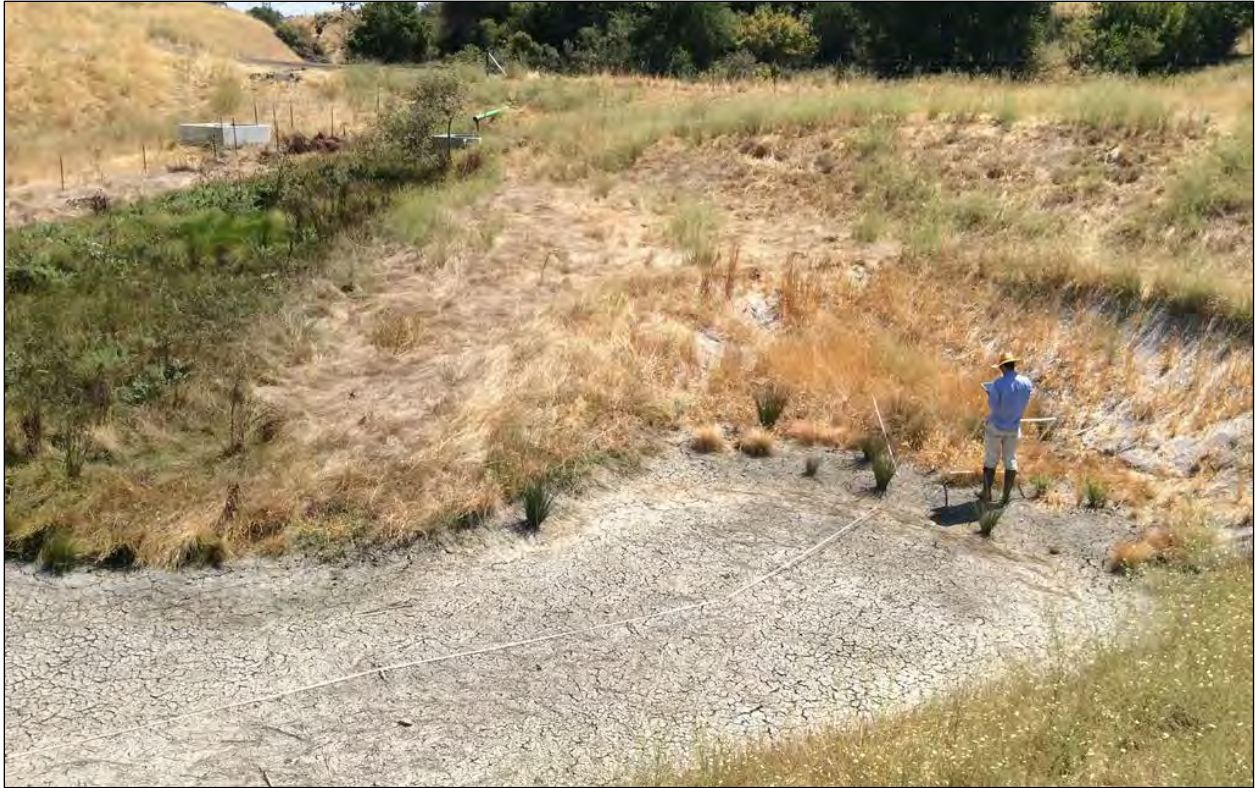
Photo 5. Year 1 Conditions at Photo Point 7b during Vegetation Monitoring, Showing the Wetland Establishment Area at the Pond Mitigation Site (August 8, 2017)

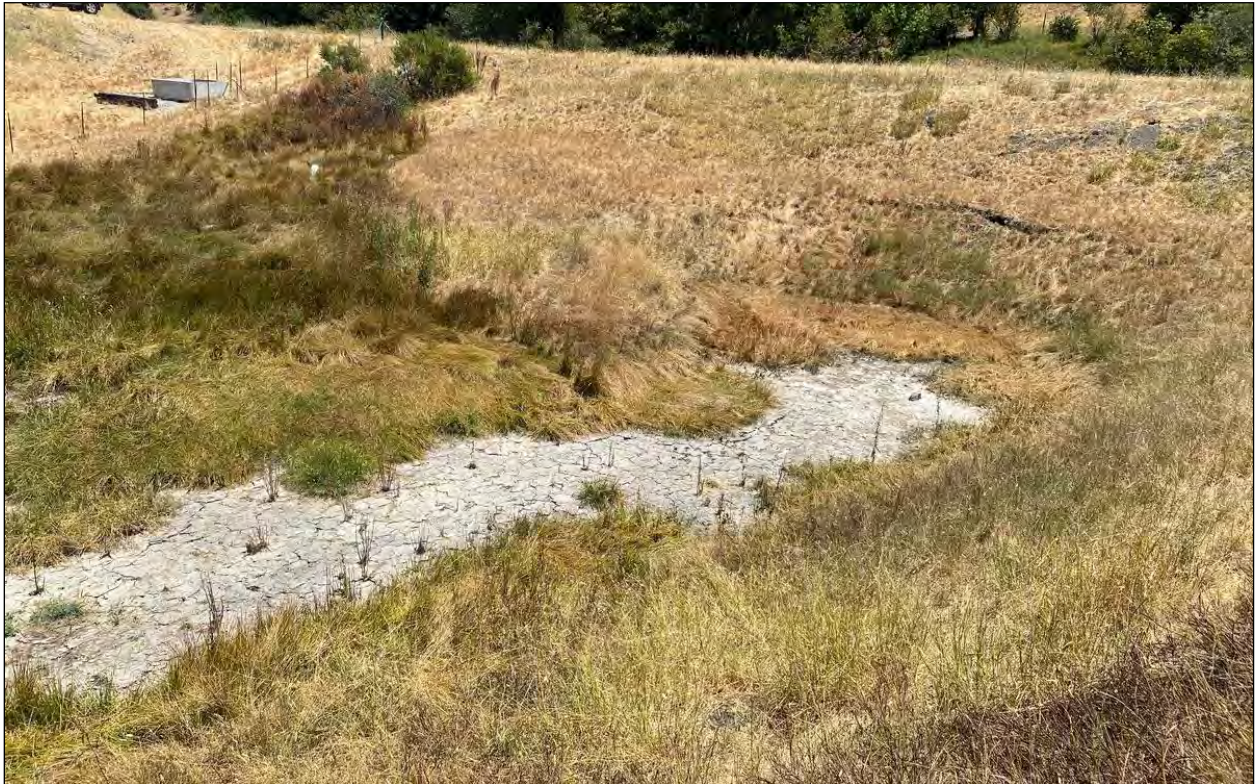
Photo 6. Year 7 Conditions at Photo Point 7b during Vegetation Monitoring, Showing the Wetland Establishment Area at the Pond Mitigation Site (July 17, 2023)

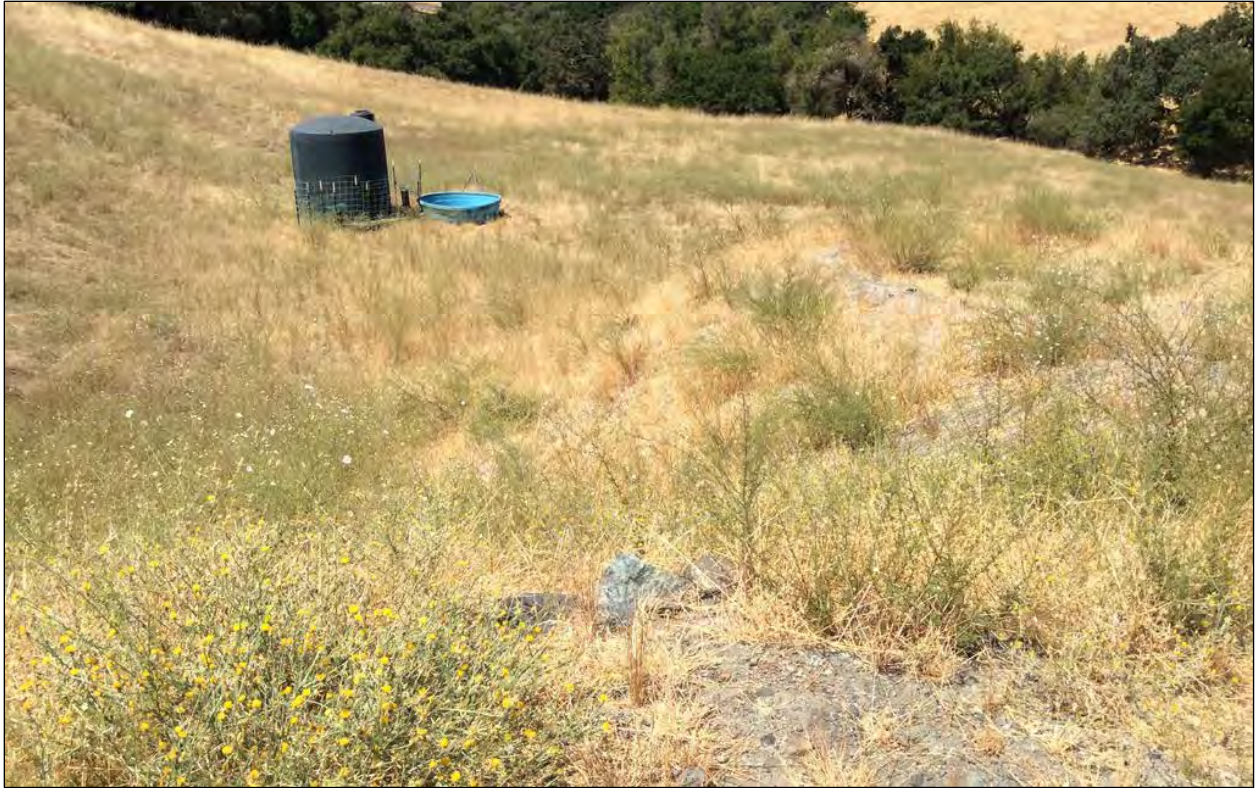
Photo 7. Year 1 Conditions at Photo Point 7c during Vegetation Monitoring at the Pond Mitigation Site (August 8, 2017)

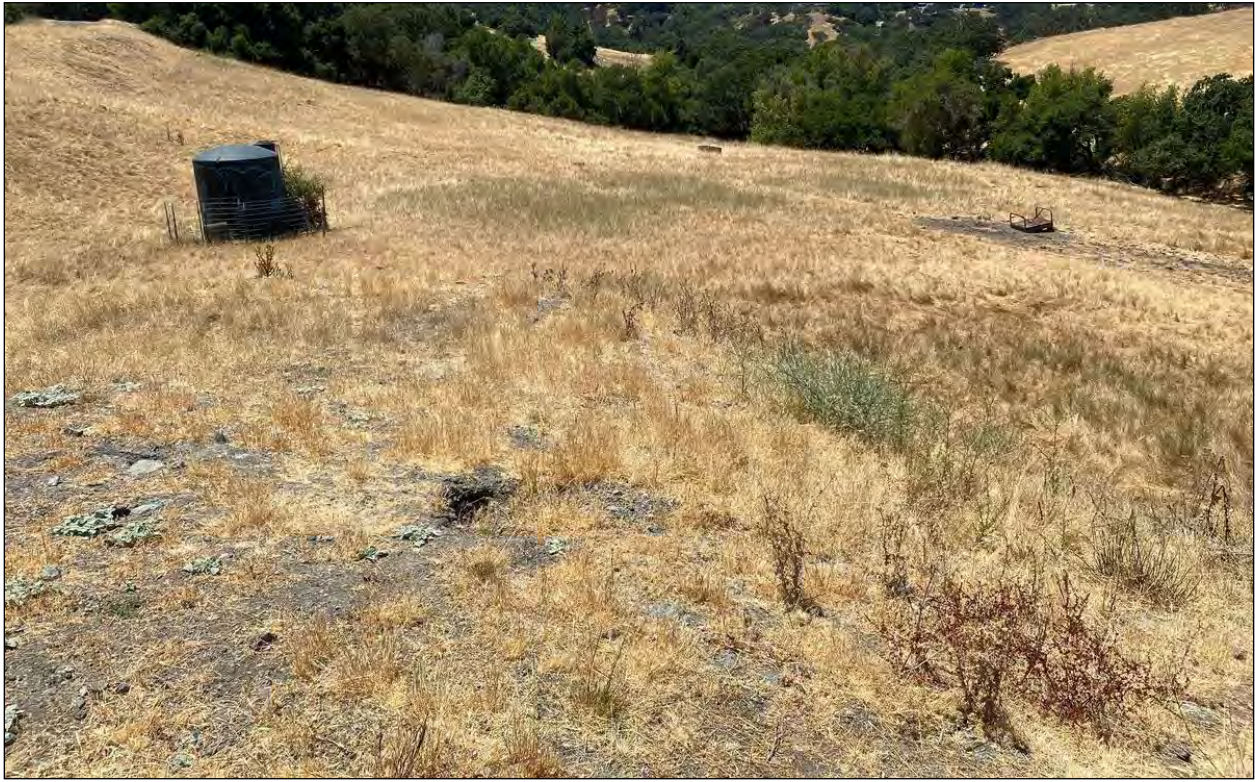
Photo 8. Year 7 Conditions at Photo Point 7c during Vegetation Monitoring at the Pond Mitigation Site (July 17, 2023)

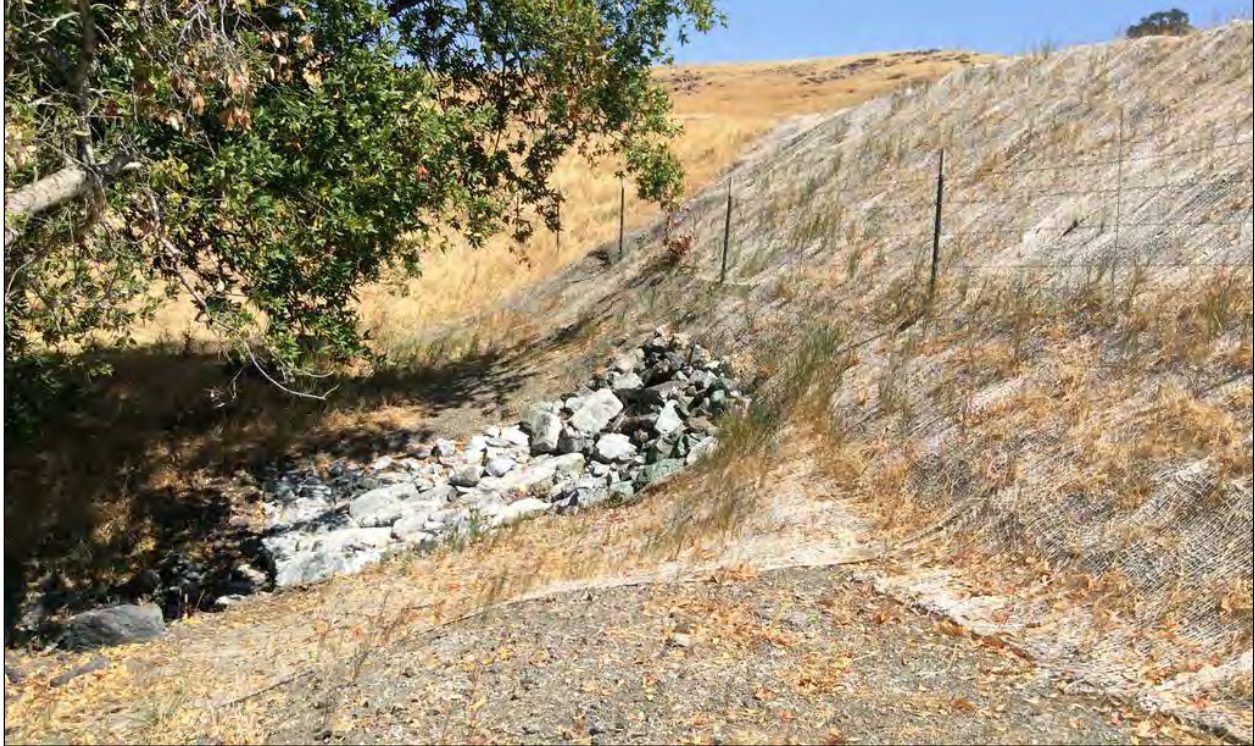
Photo 9. Year 1 Conditions at Photo Point 8 during Vegetation Monitoring at the Pond Mitigation Site (August 8, 2017)

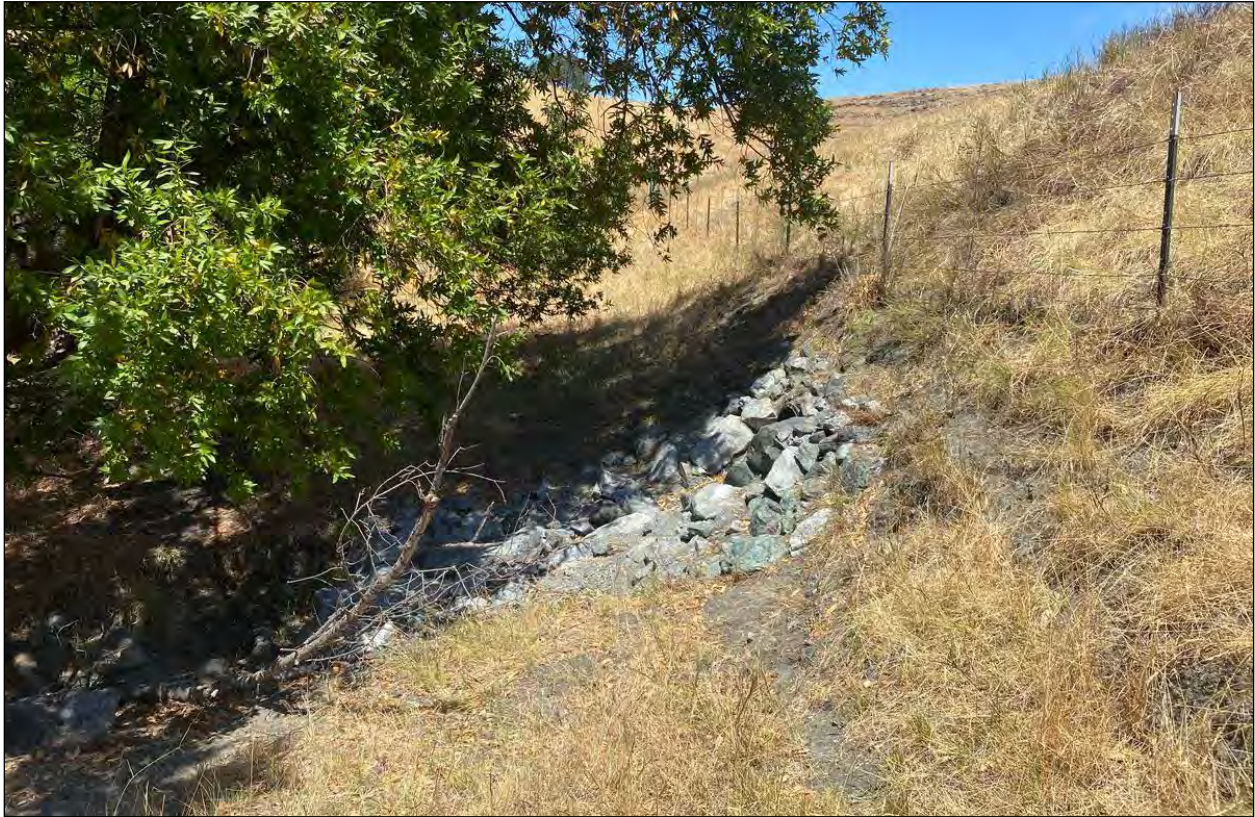
Photo 10. Year 7 Conditions at Photo Point 8 during Vegetation Monitoring at the Pond Mitigation Site (July 17, 2023)

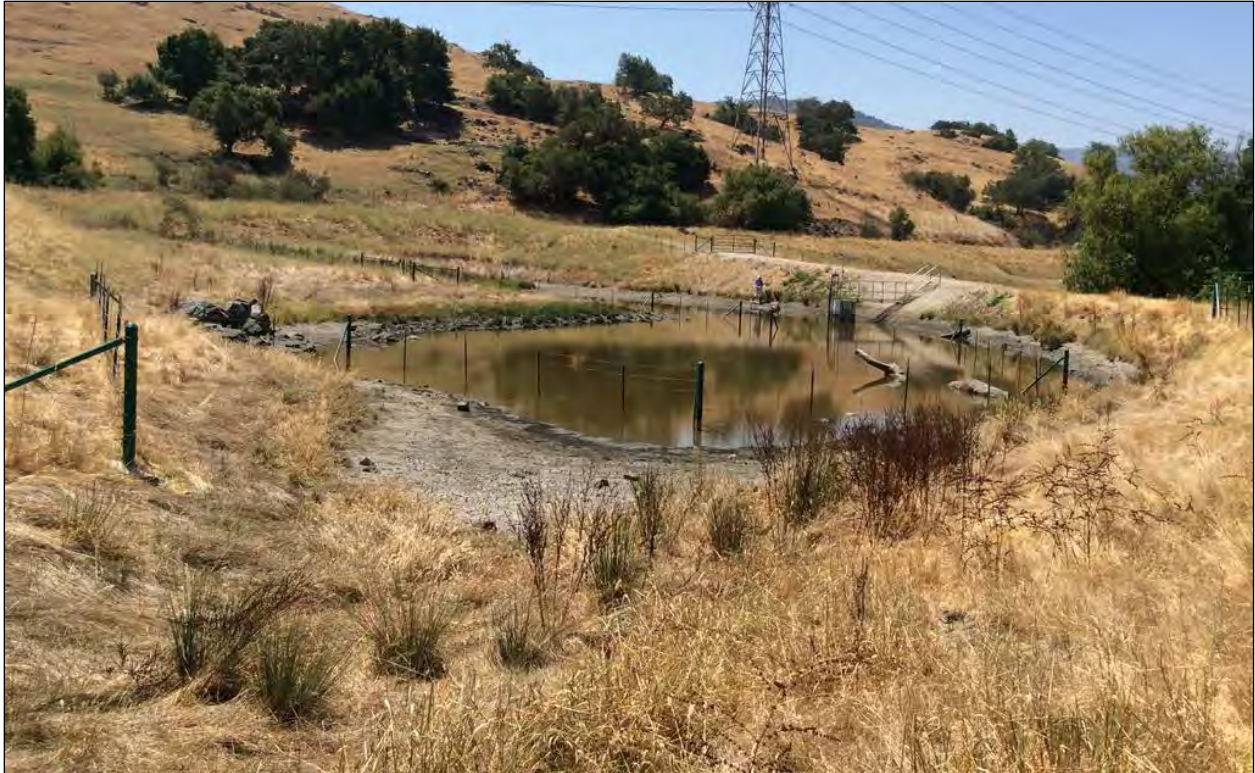
Photo 11. Year 1 Conditions at Photo Point 9 during Vegetation Monitoring at the Pond Mitigation Site (August 8, 2017)

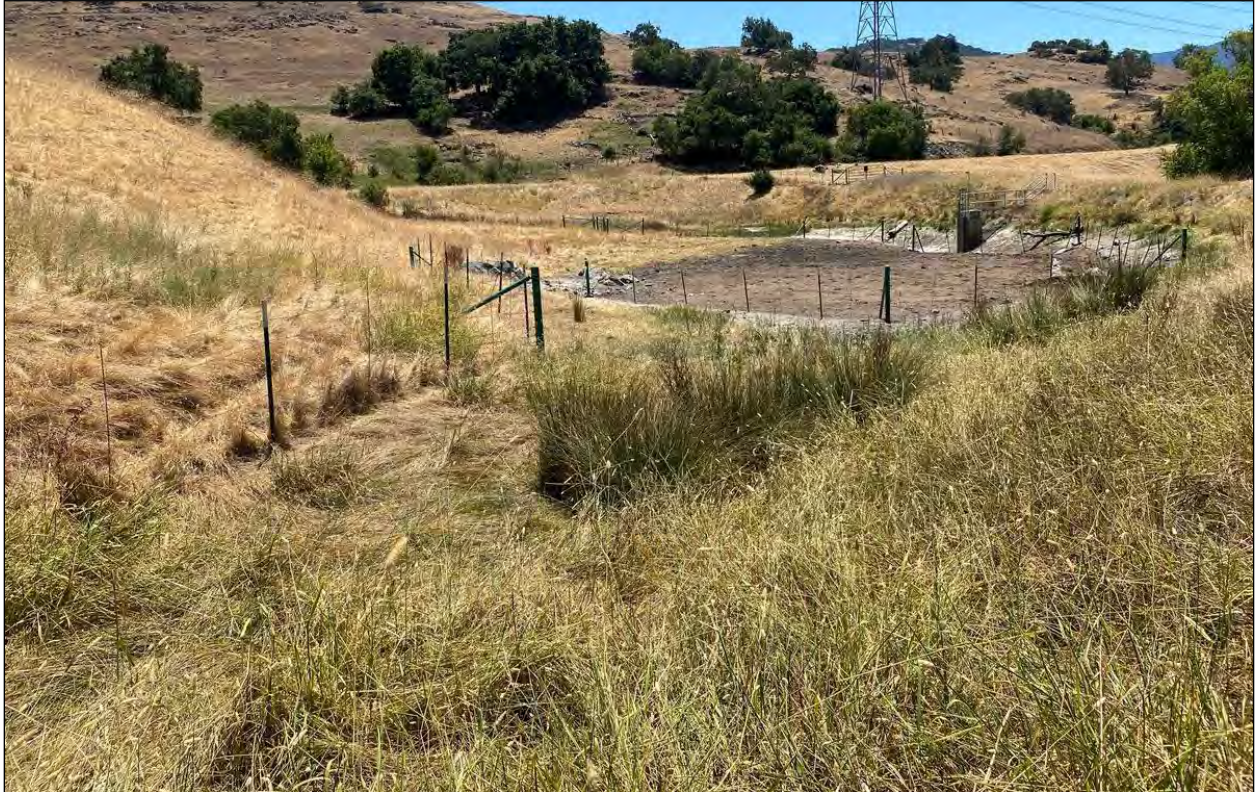
Photo 12. Year 7 Conditions at Photo Point 9 during Vegetation Monitoring at the Pond Mitigation Site (July 17, 2023)

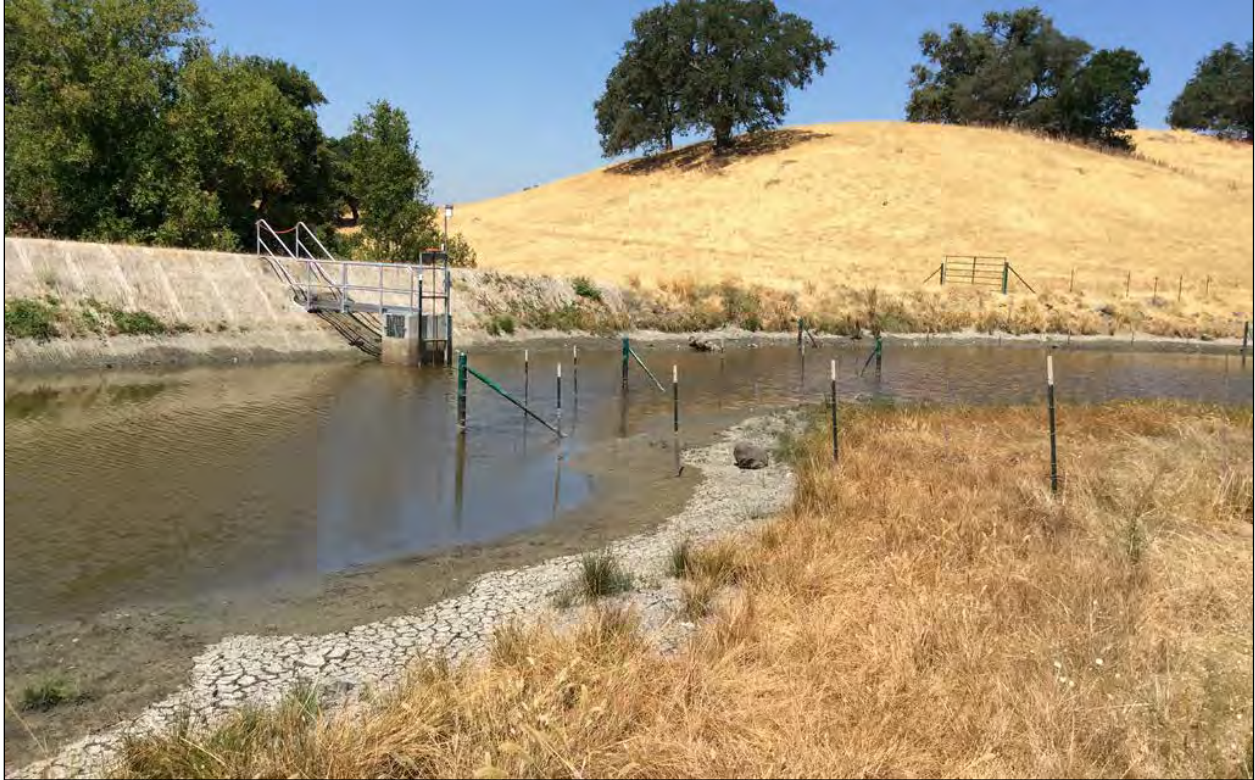
Photo 131. Year 1 Conditions at Photo Point 10 during Vegetation Monitoring at the Pond Mitigation Site (August 8, 2017)

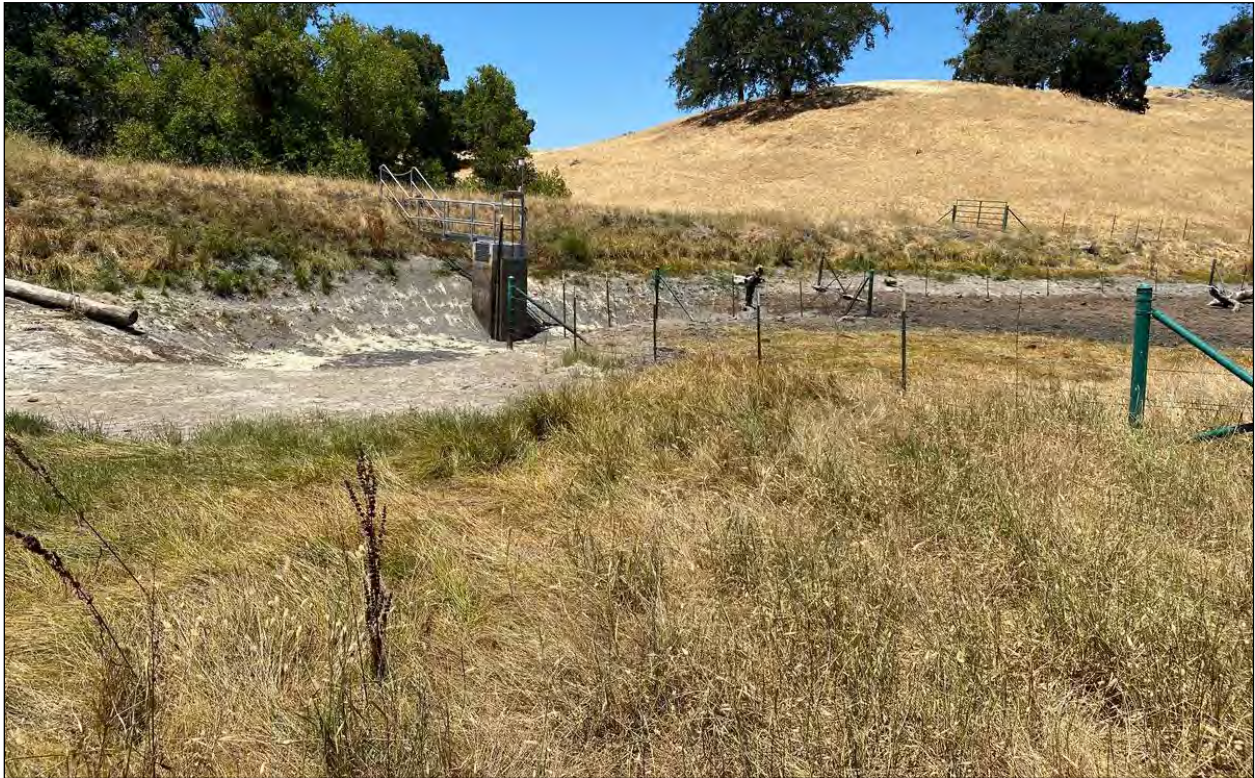
Photo 14. Year 7 Conditions at Photo Point 10 during Vegetation Monitoring at the Pond Mitigation Site (July 17, 2023)

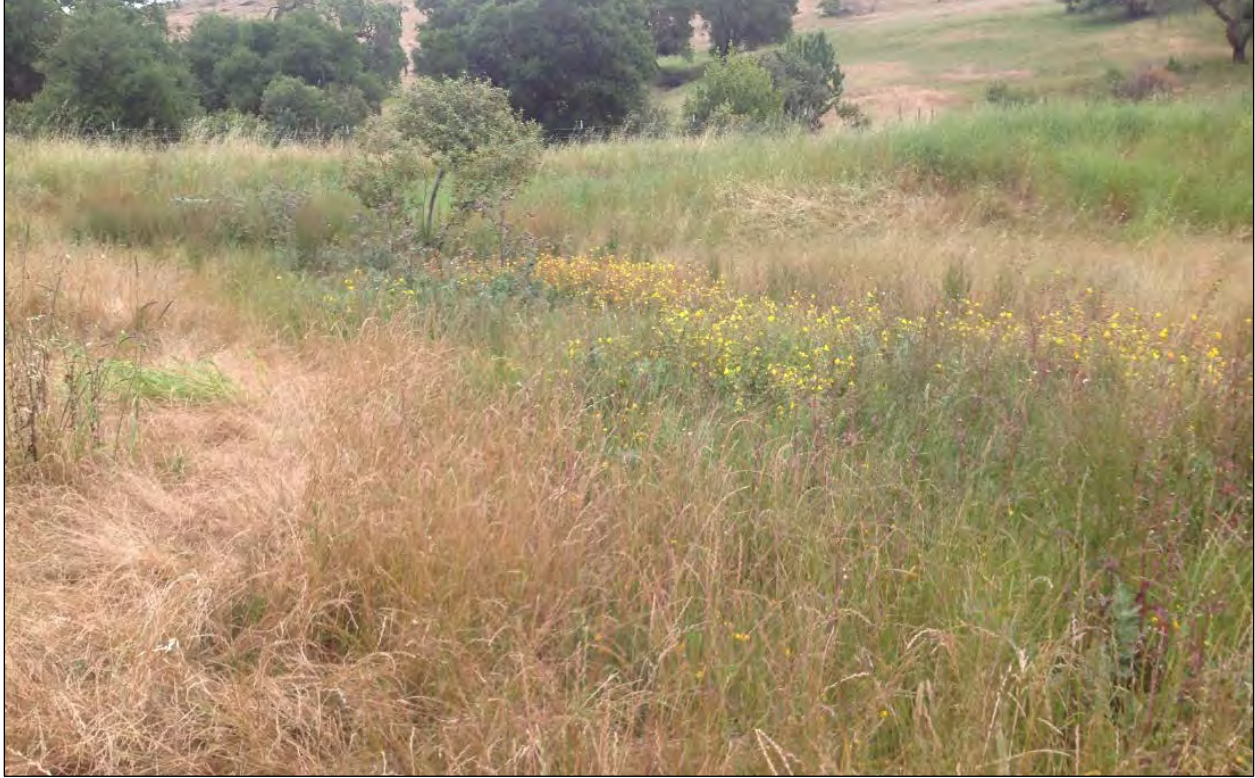
Photo 15. Year 1 Conditions at Photo Point 17 during Mt. Hamilton Thistle Abundance Monitoring at the Pond Mitigation Site (August 8, 2017)

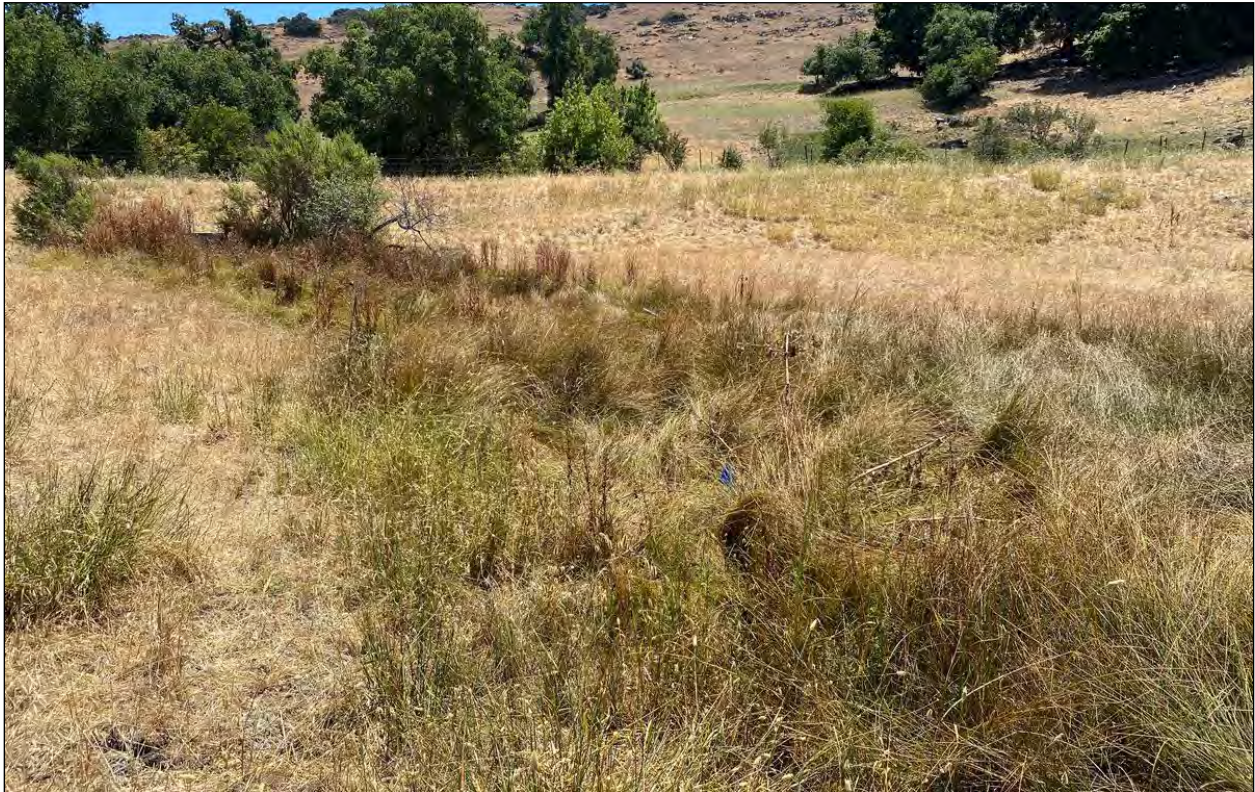
Photo 16. Year 7 Conditions at Photo Point 17 during Mt. Hamilton Thistle Abundance Monitoring at the Pond Mitigation Site (July 17, 2023)
