Project No. 3753-08

**Subject: Calero County Park and Wetland Restoration Project—Year 7 (2023)
Supplemental Vegetation and Hydrology Monitoring**

Year 7 (2023) Supplemental Vegetation and Hydrology Monitoring Memorandum (3753-08)
December 2023

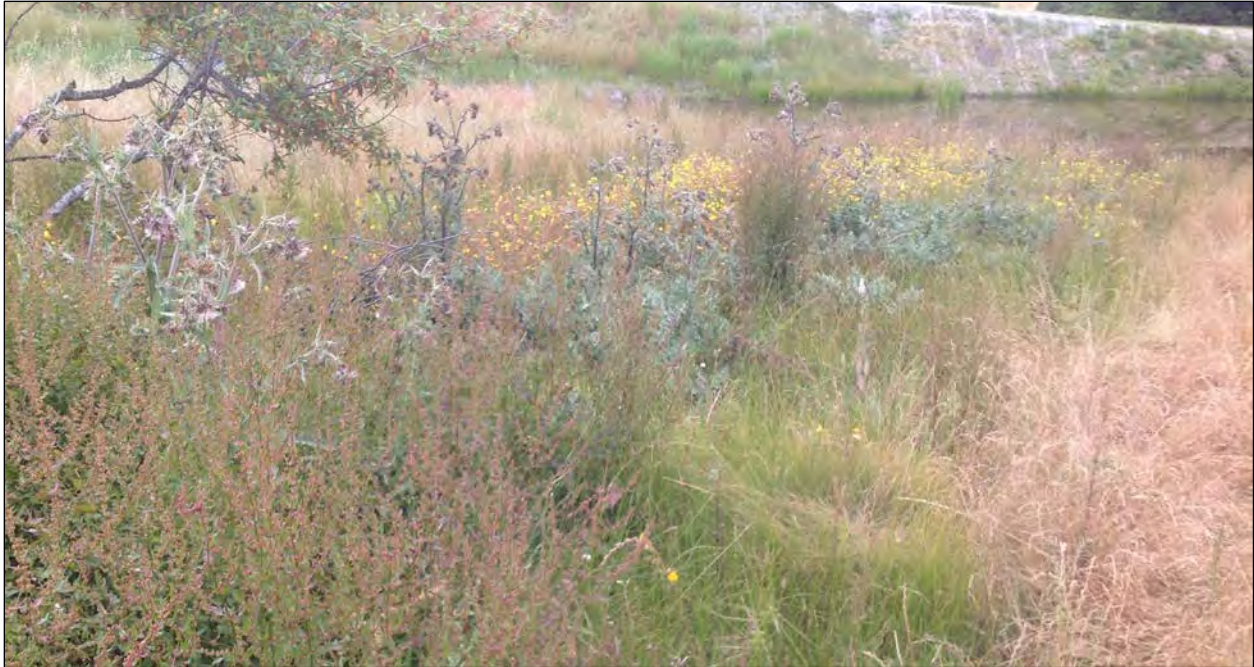
Photo 17. Year 1 Conditions at Photo Point 18 during Mt. Hamilton Thistle Abundance Monitoring at the Pond Mitigation Site (August 8, 2017)

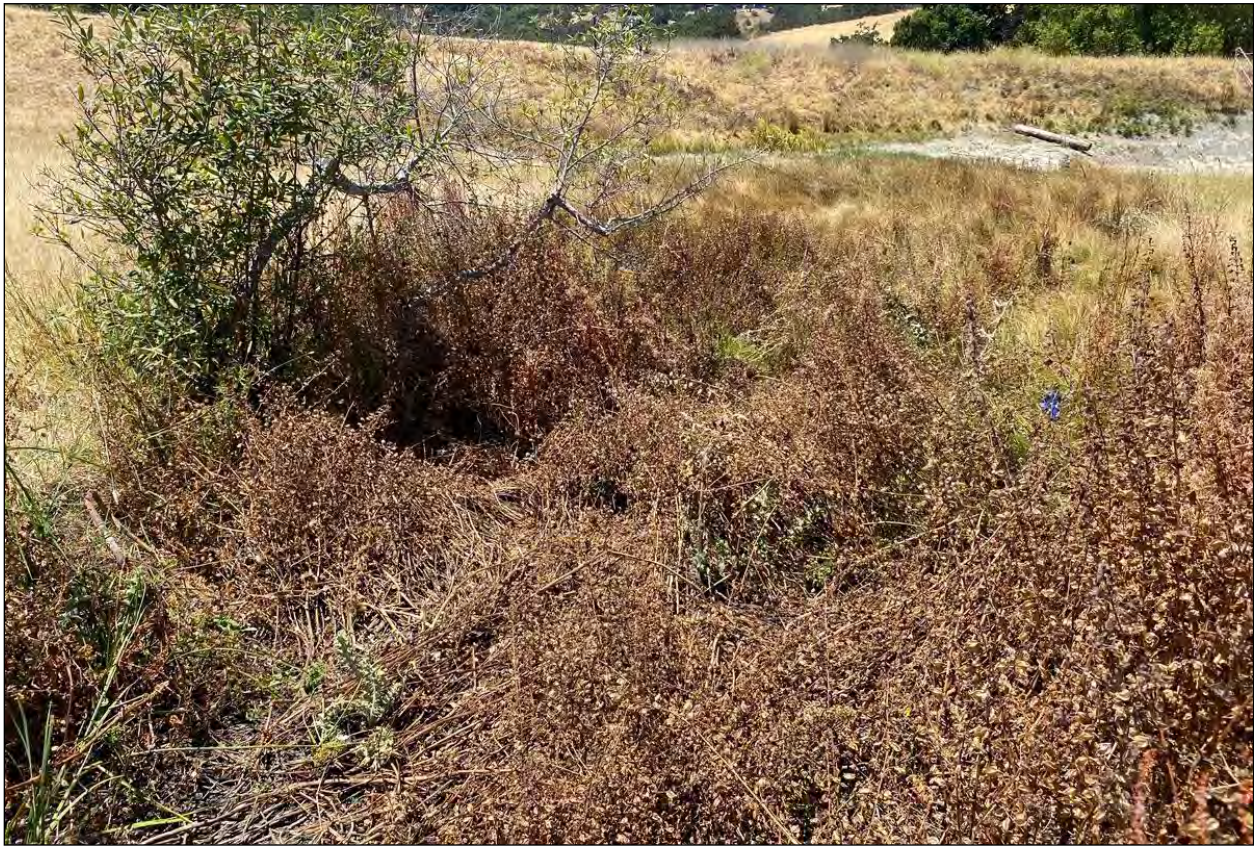
Photo 18. Year 7 Conditions at Photo Point 18 during Mt. Hamilton Thistle Abundance Monitoring at the Pond Mitigation Site (July 17, 2023)
