Coyote Ridge Ponds  
Restoration Project,  
Ponds CR1 and CR4-  
Year 4 Monitoring  
Report

February 16, 2024

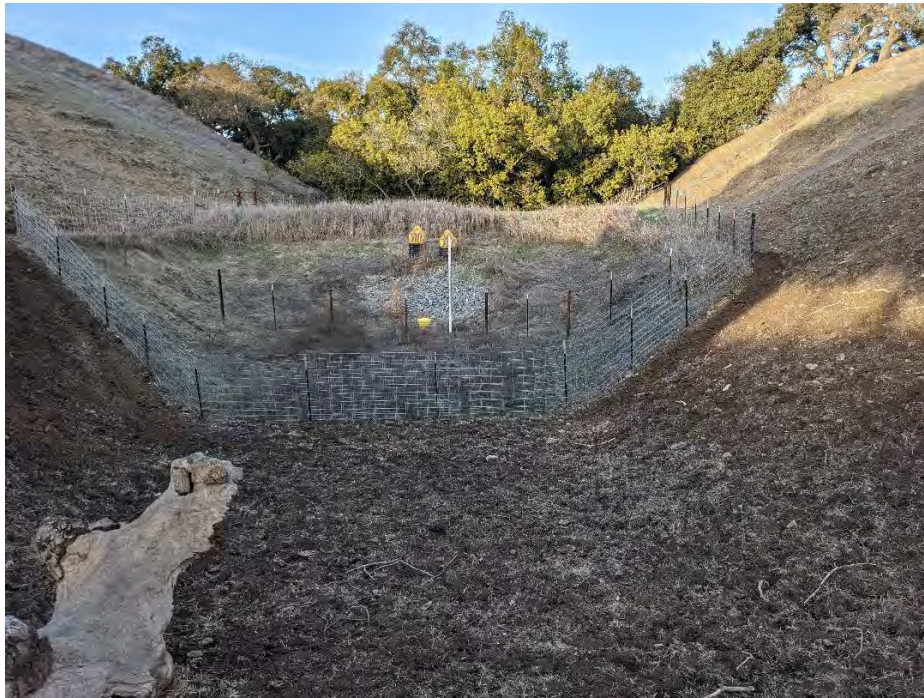
Photo 37. Completely Dry Pond Bed at CR1 (December 29, 2020)

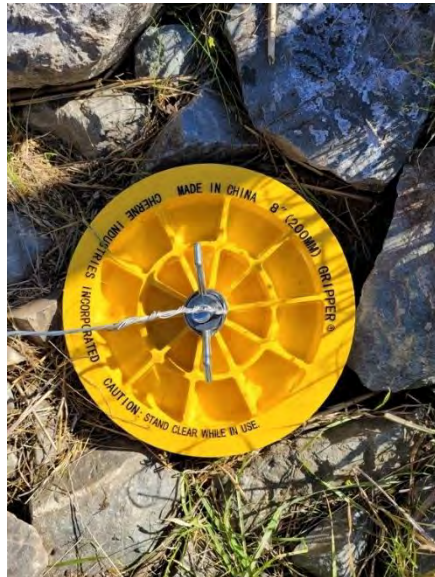
Photo 33. Removeable caps, added to the quick drain pipes to prevent leakage (photo provided by SCVHA, November 30, 2021)

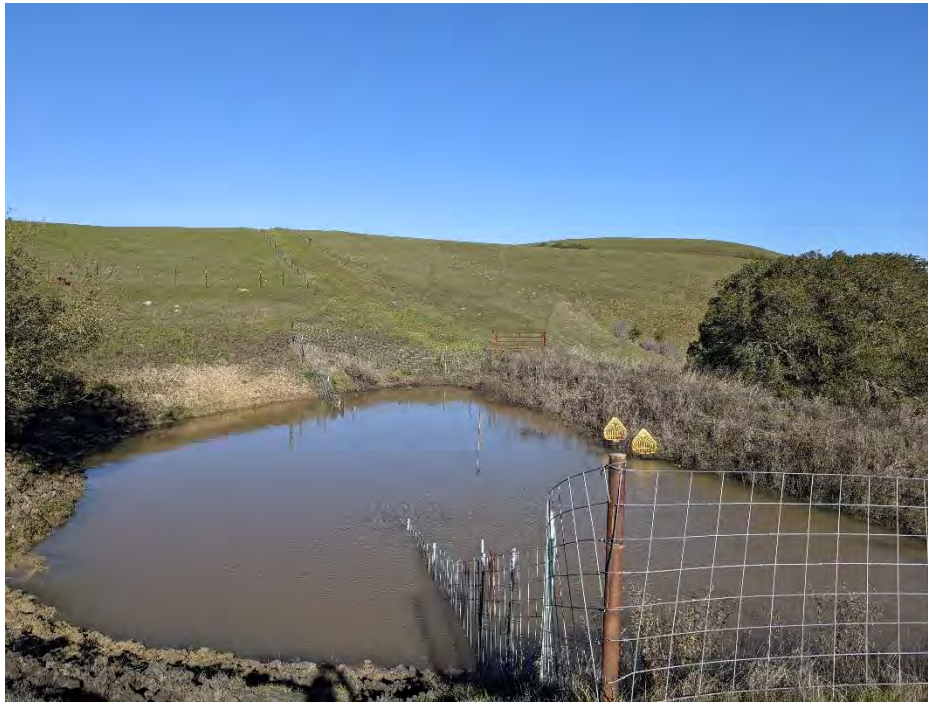
Photo 44. Pond filled with >12-inches of rainfall in November – January (January 30, 2023)

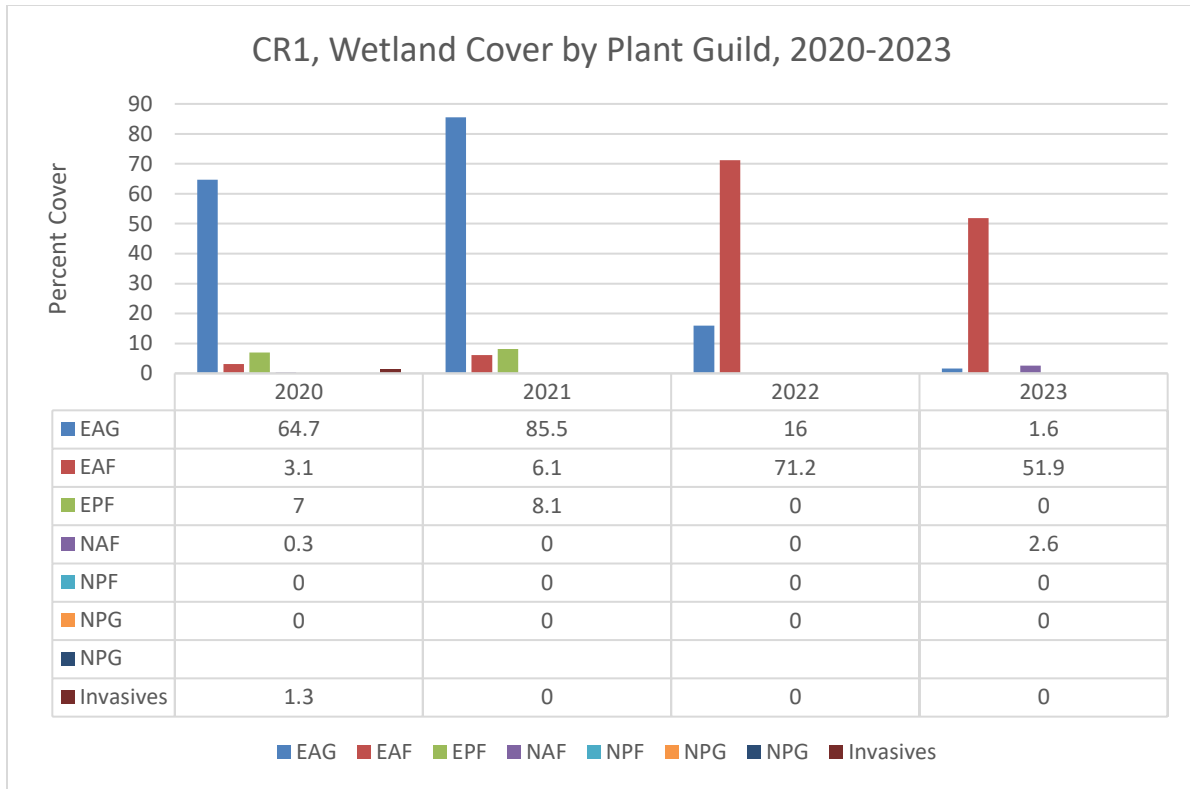
Figure A-7. CR1, Wetland Quadrats, Plant Cover, by Guild, 2020-2023

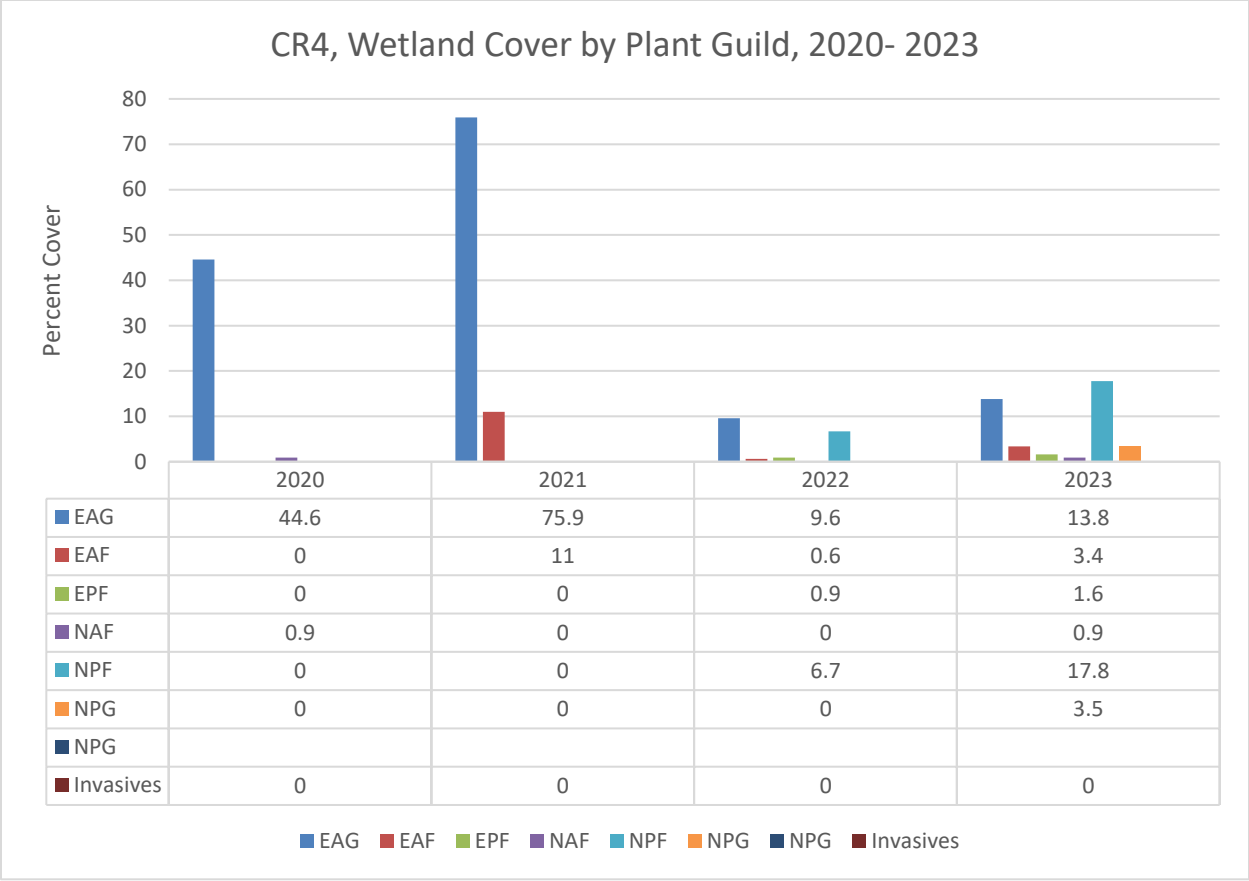
Figure A-12. CR4, Wetland Quadrats, Plant Cover, by Guild, 2020-2023

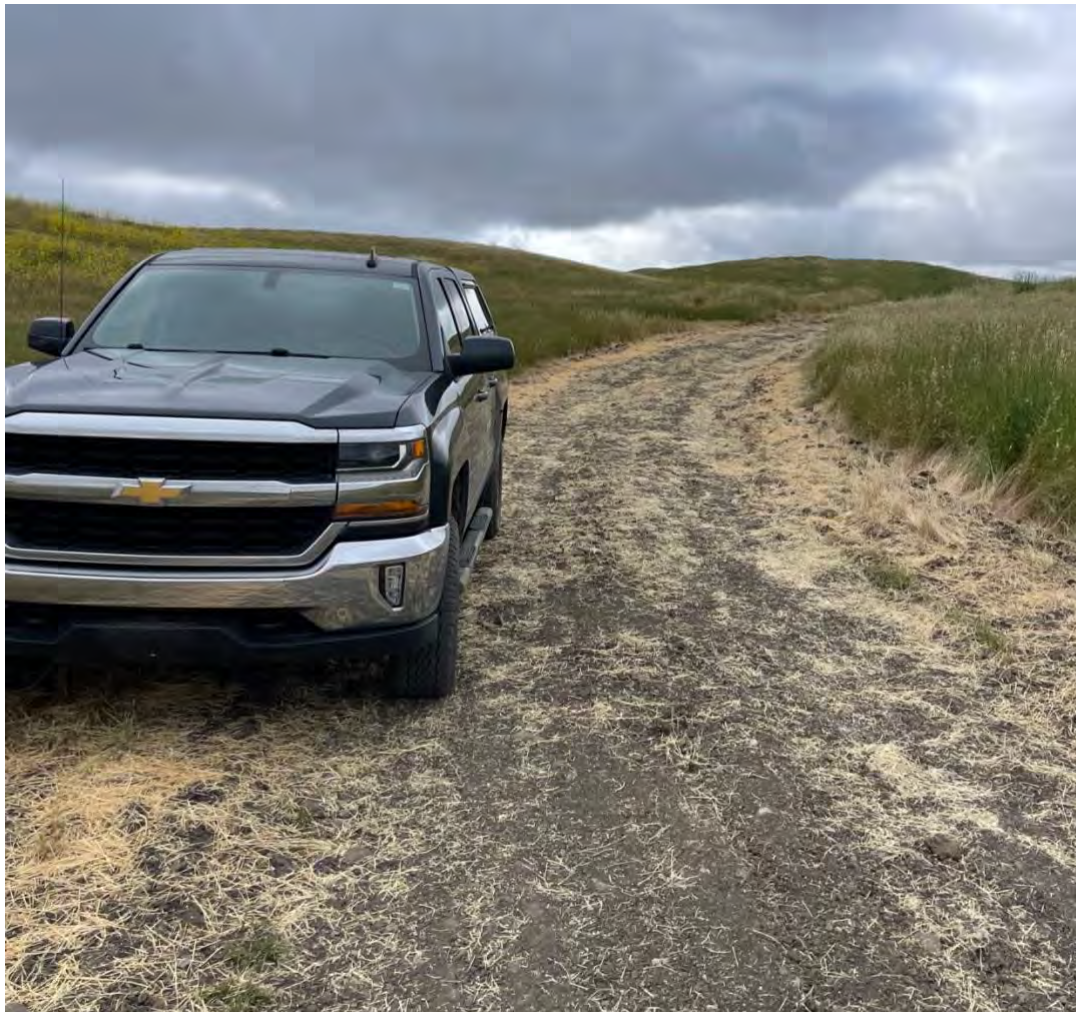
## Metcalf Road Entry gate to Staging Area

The main gate and the next cattle gate were intact and operational. The entry road was eroded as usual, some minor road work. No wildlife observed. This pic is by the old staging area.

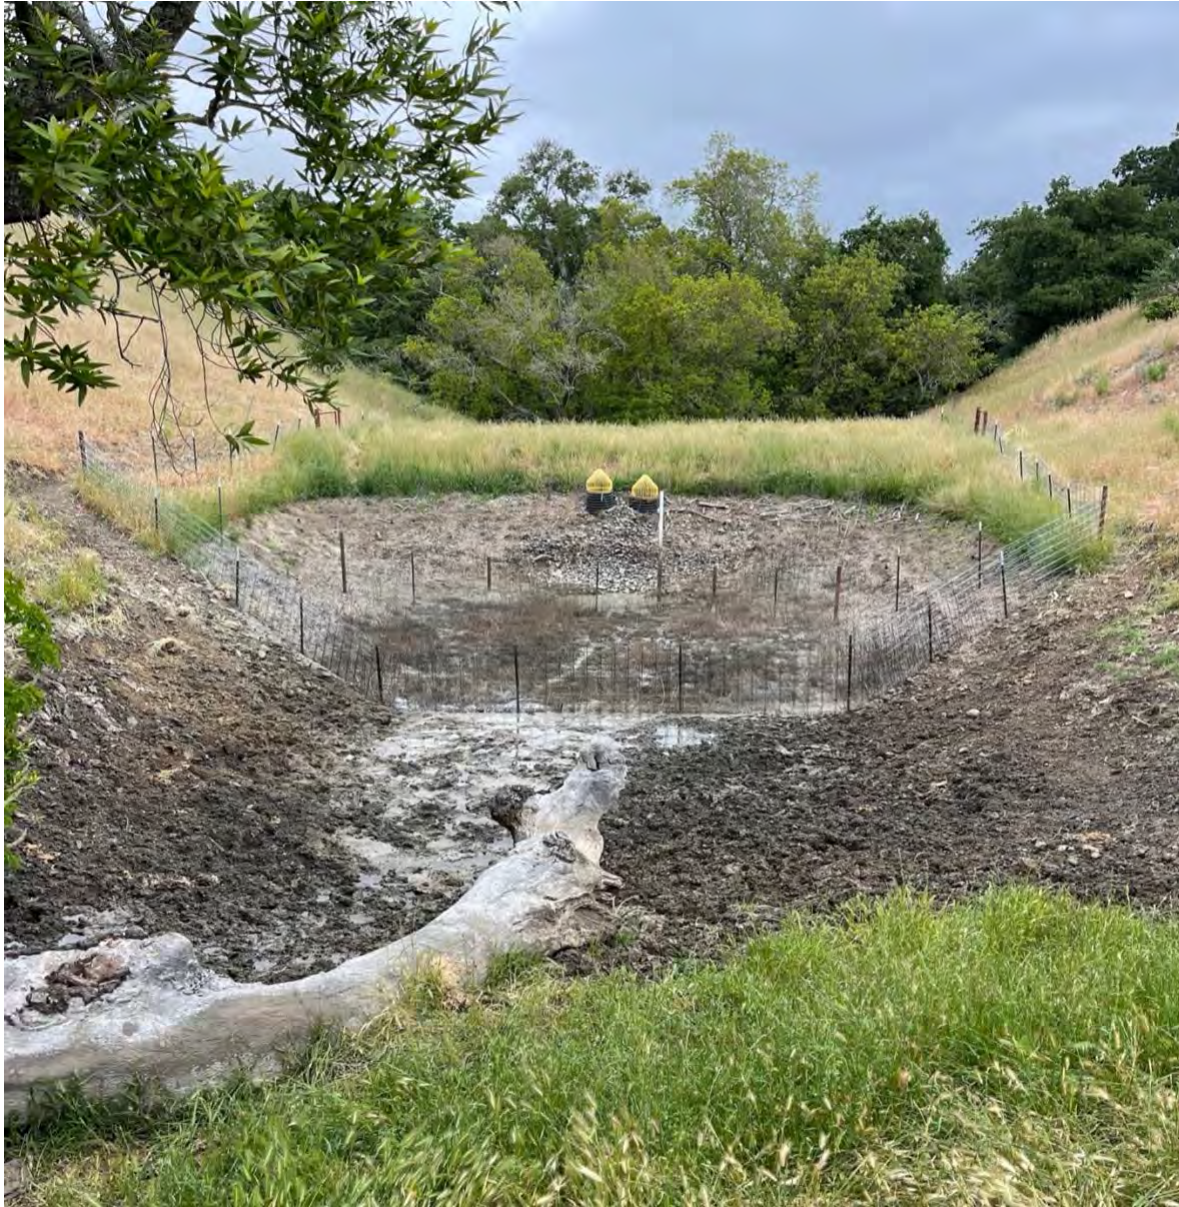
## CR01

- The cattle fence and gate are intact.
- Perimeter pond exclusion fences and gates – fences and gates intact, no obvious incursion by the cattle. Grazing evident outside the perimeter fence.
- Overflow pipes and debris guards – intact
- Berm conditions and integrity – good vegetation growth, no evidence of erosion

- Side slopes in and outside the perimeter fence – good vegetation growth, no evidence of erosion
- Water level and staff gauge – staff gauge intact, no measurable water
- Observations, comments, and recommendations – pond was full at some point this winter, currently empty. No recommendations.

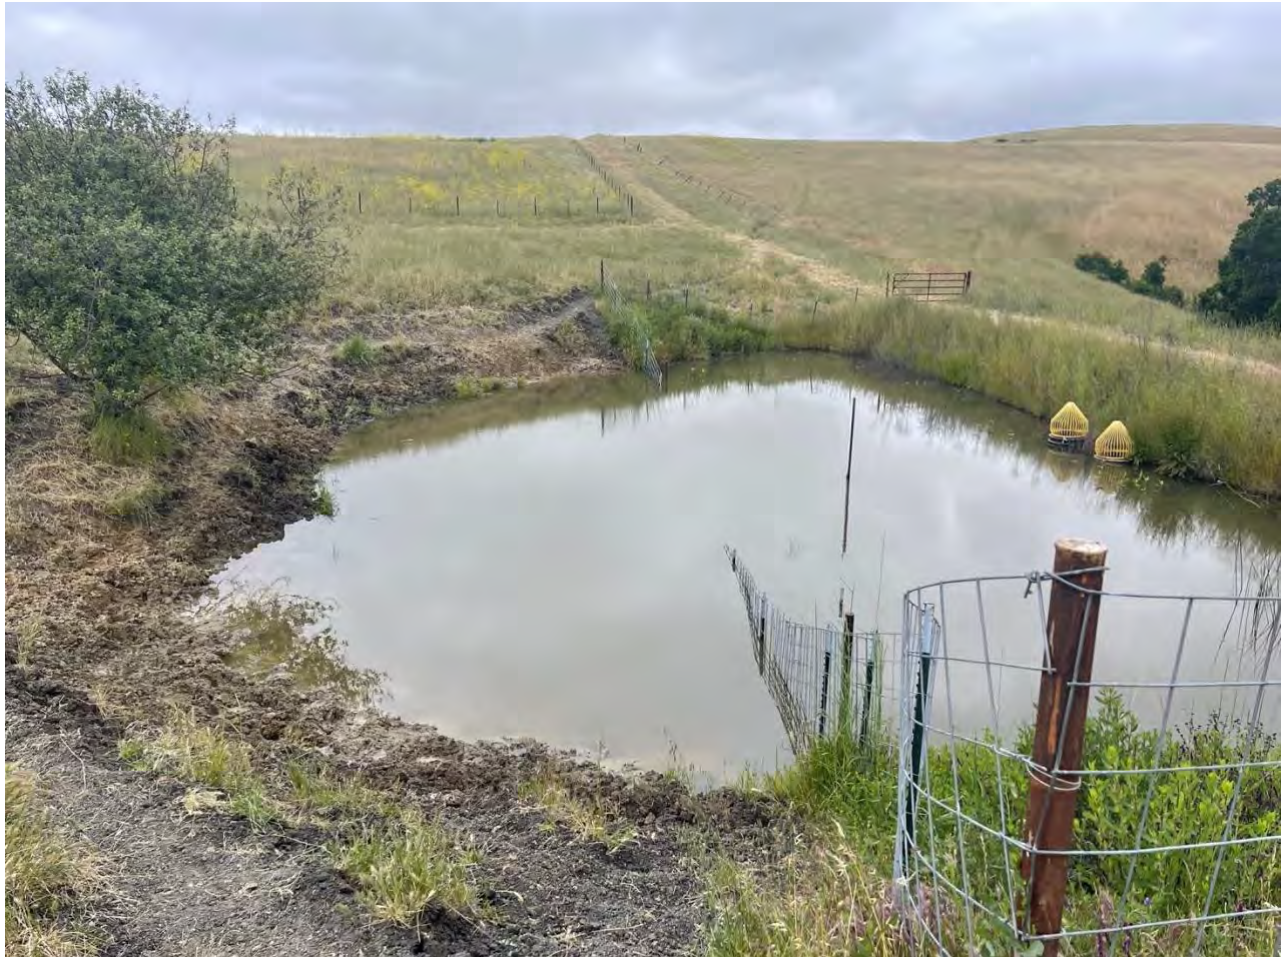
## CR04

- Cattle fence and gates intact.
- Perimeter pond exclusion fences and gates - perimeter fences intact, no obvious incursion by the cattle. Grazing evident outside the perimeter fence.
- Overflow pipes and debris guards - intact
- Berm conditions and integrity - good vegetation growth, no evidence of erosion
- Side slopes in and outside the perimeter fence - good vegetation growth, no evidence of erosion

- Water level and staff gauge - staff gauge intact, pond is full
  - Restoration pond vegetation – good vegetation coverage
- Observations, comments, and recommendations – everything looked good, no observable issues. No recommendations. 44
