H. T. HARVEY & ASSOCIATES

**Pacheco Creek Restoration Project
Year 1 (2024) Annual Monitoring Report**

Project 4291-04

January 13, 2025

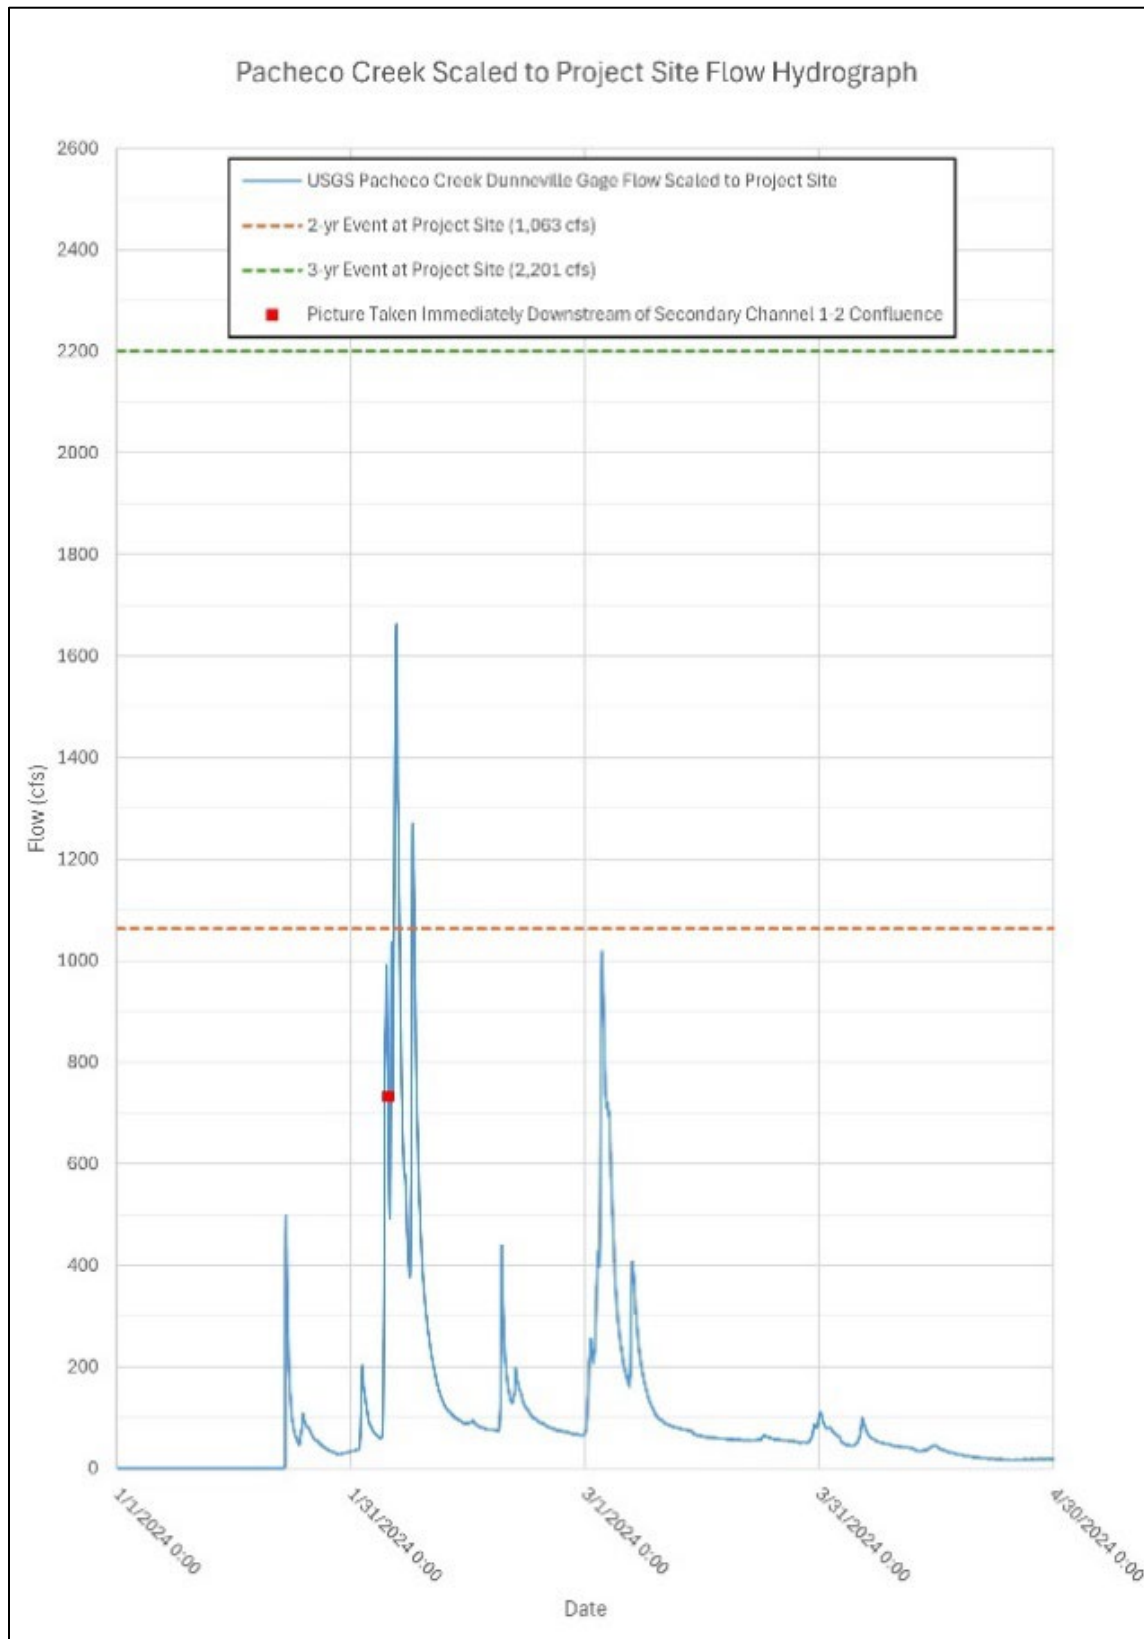
Figure 6. Pacheco Creek Hydrograph Scaled to the Project Site

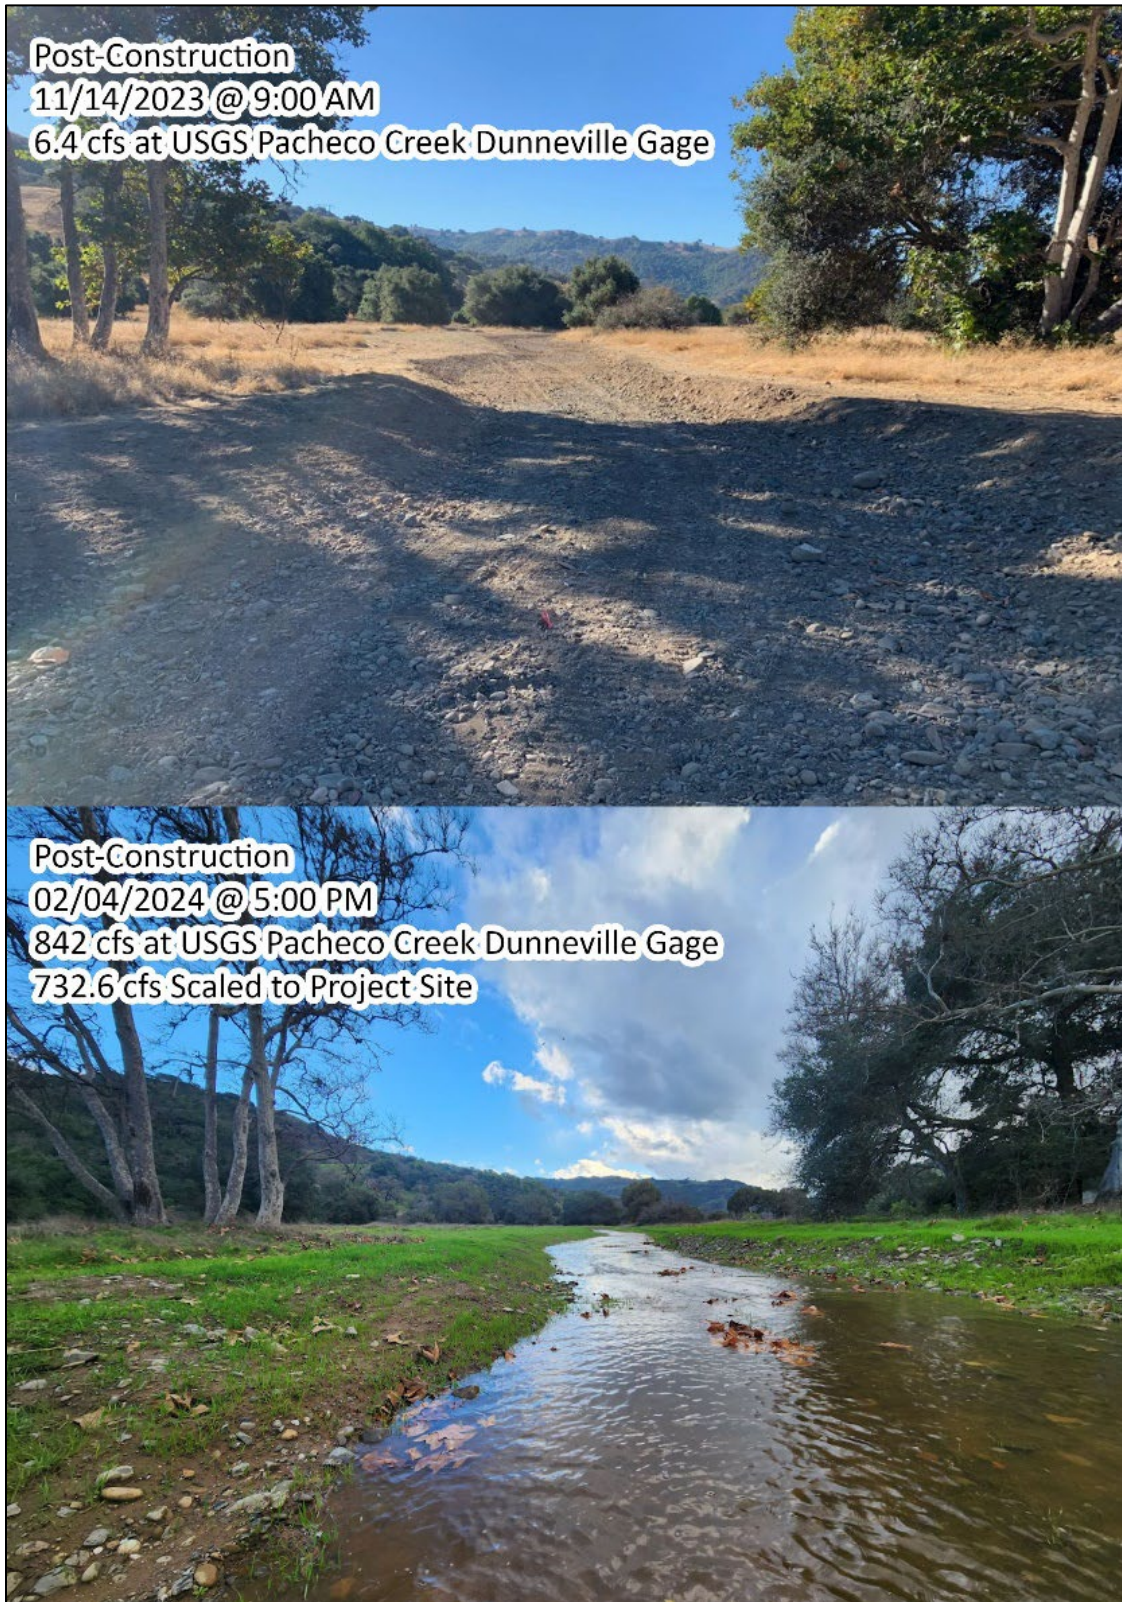
A visual assessment of the project site was conducted when discharge in Pacheco Creek was elevated, and inundation of the secondary channel network was directly observed (Figure 7). A majority of the secondary channel network was inundated during the site visit, but flows remained within the banks of the channels and significant floodplain inundation was not observed. The secondary channel network is performing hydrologically as expected.

Figure 7. Visual Comparison of the Primary Secondary Channel under Different Discharge Conditions

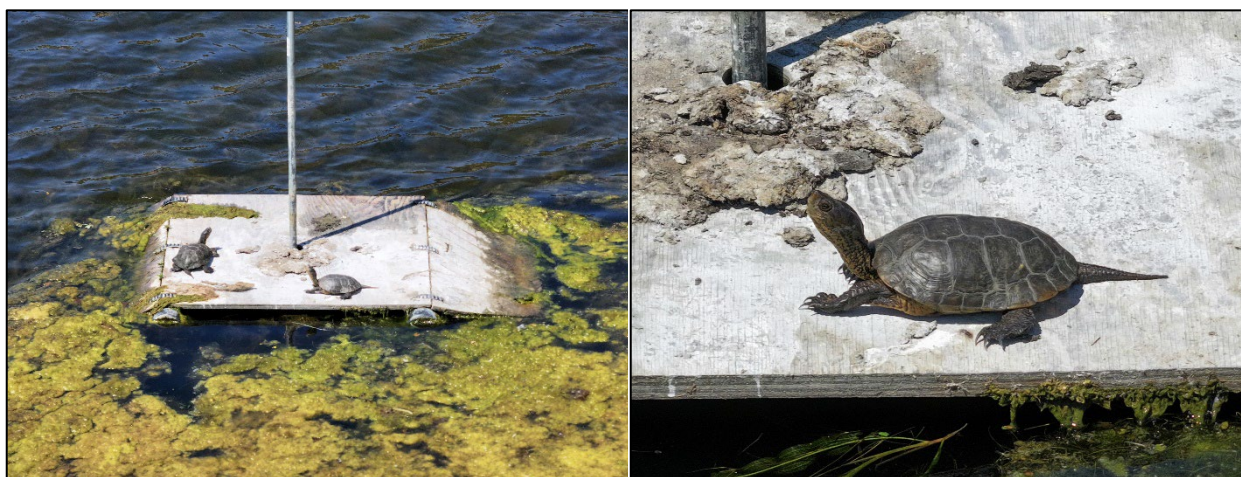
Northwestern Pond Turtle—The site provides suitable northwestern pond turtle habitat. Northwestern pond turtles were observed at Pond 1 during Year 1 monitoring (Table 15). Habitat Agency ecologist Nathan Hale observed this species basking on PALS material in the mainstem of Pacheco Creek on April 12, 2024. Habitat resource manager Triangle, Barry Baba, documented two Northwestern pond turtles utilizing one of the pond basking structures in Pond 3 on August 5, 2024 (Figure 9).

Figure 9. Northwestern pond turtles utilizing basking structures in Pond 3 on August 5, 2024.

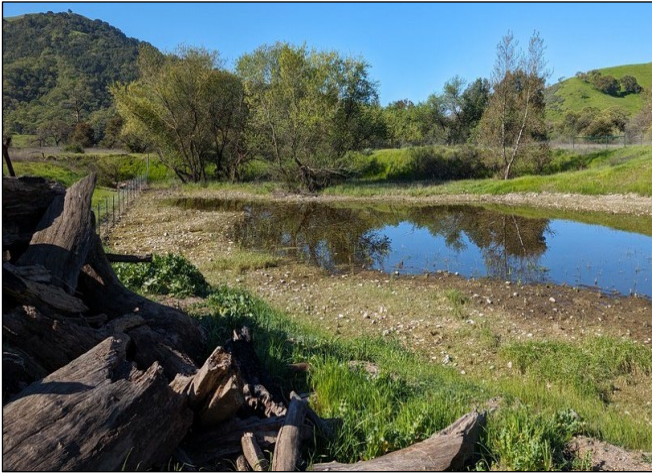
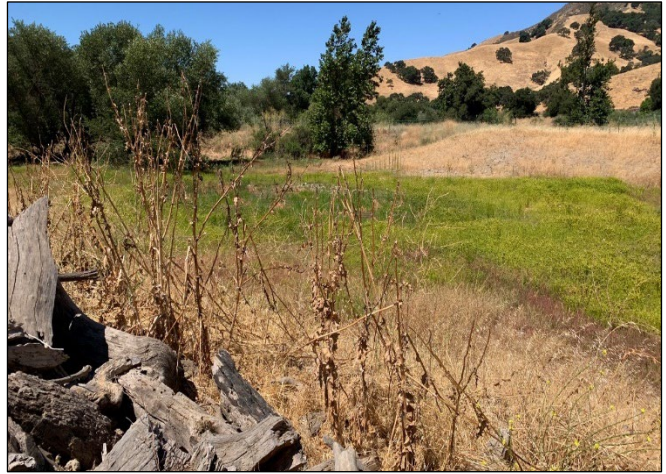
Photopoint 1. As-Built Conditions Looking Southwest, Showing Seasonal Wetland on March 20, 2024 (Left) and in Year 1 monitoring on July 17, 2024 (Right).

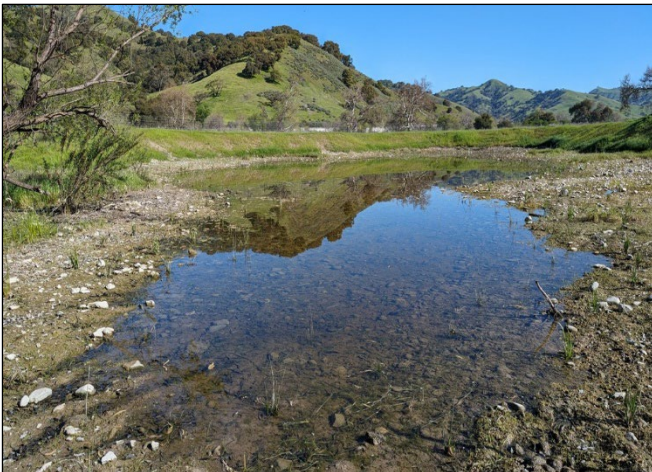
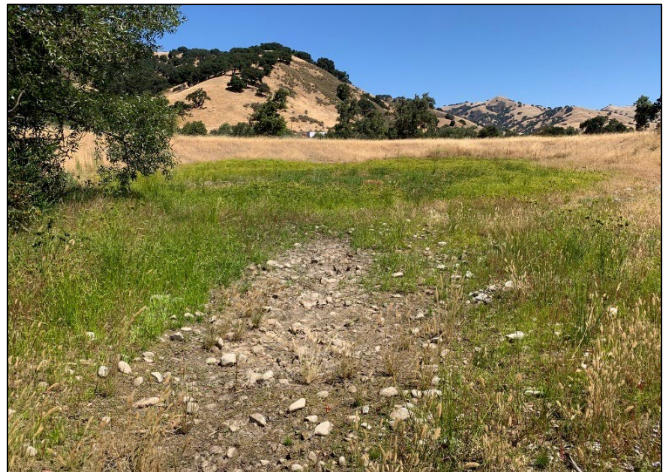
Photopoint 2. As-Built Conditions Looking North, Showing Seasonal Wetland on March 20, 2024 (Left) and in Year 1 monitoring on July 17, 2024 (Right).

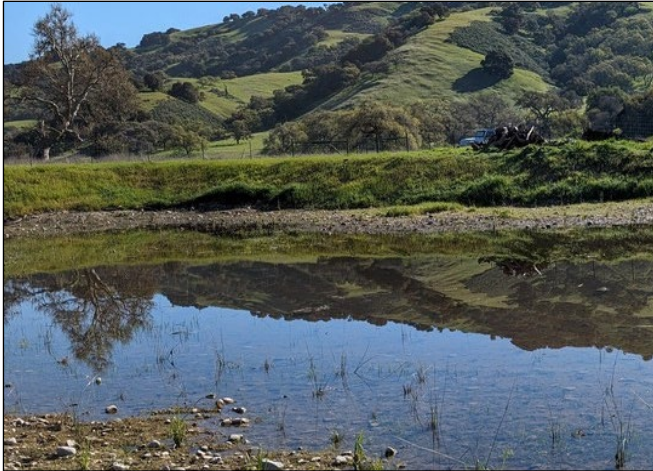
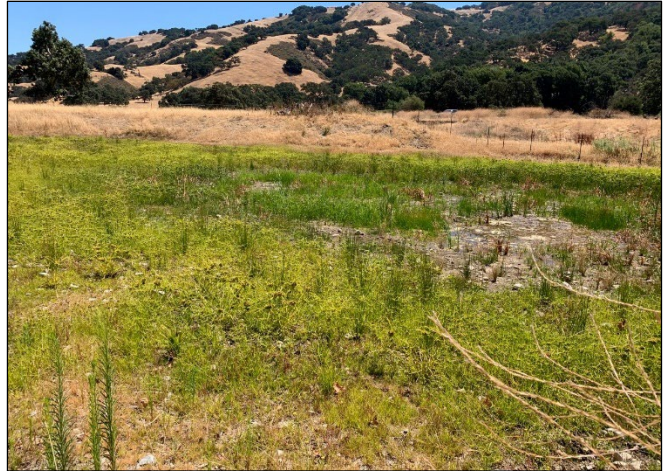
Photopoint 3. As-Built Conditions Looking Northeast, Showing Seasonal Wetland on March 20, 2024 (Left) and in Year 1 monitoring on July 17, 2024 (Right).

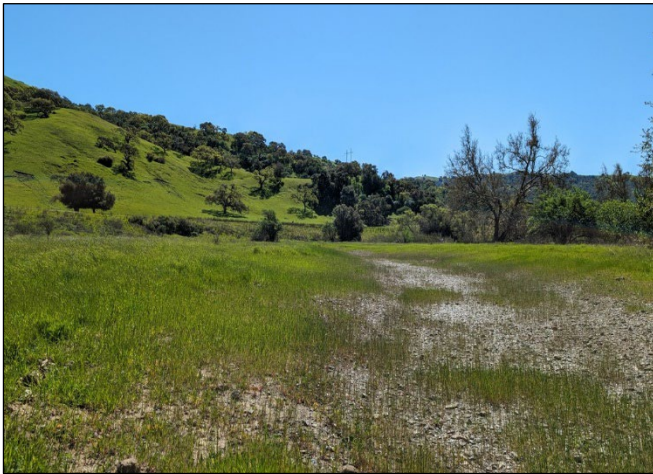
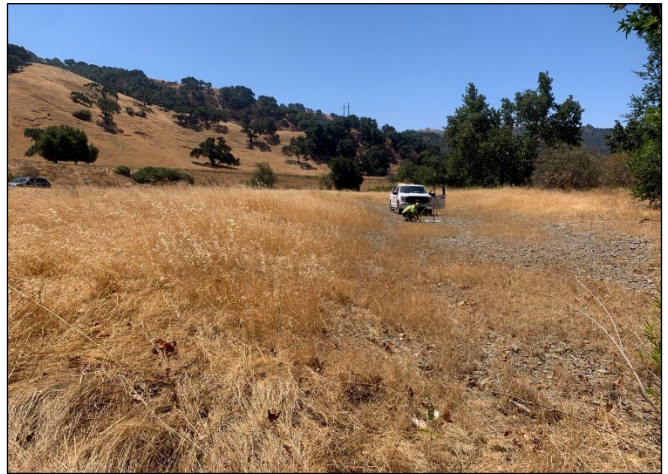
Photopoint 4. As-Built Conditions Looking South, Showing Graded Secondary Channel 6 on March 20, 2024 (Left) and in Year 1 monitoring on August 6, 2024 (Right).

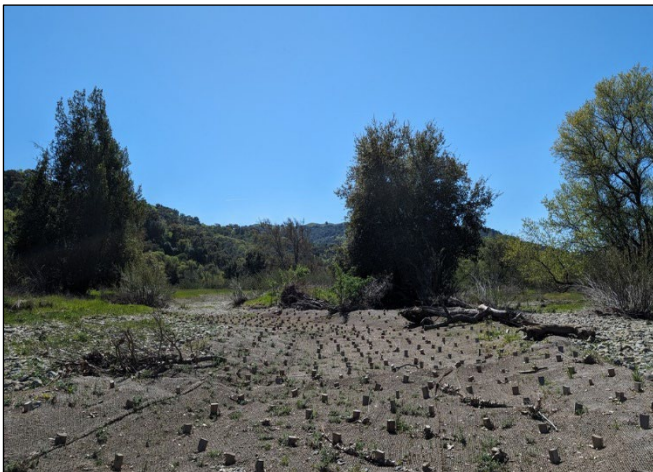
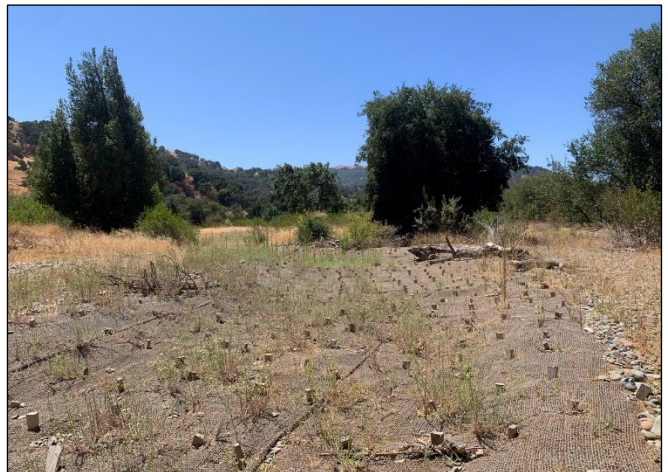
Photopoint 5. As-Built Conditions Looking South, Showing Graded Secondary Channel 7 on March 20, 2024 (Left) and in Year 1 monitoring on August 6, 2024 (Right).

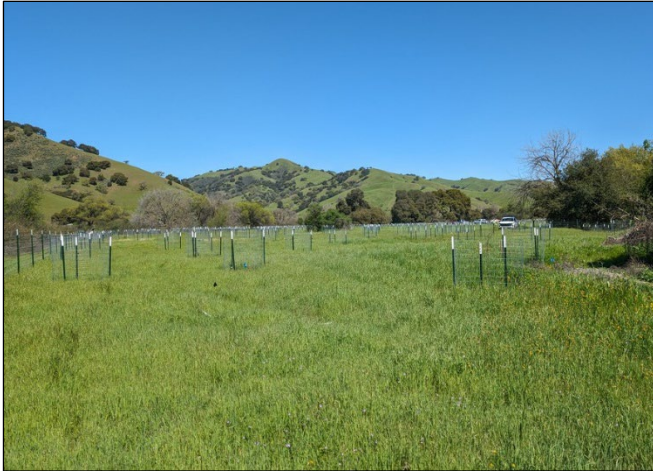
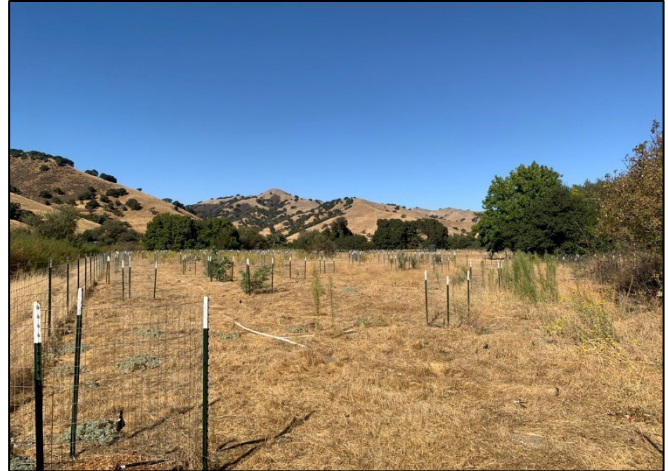
Photopoint 6. As-Built Conditions Looking North, Showing SAW 1 From Southernmost Corner on March 20, 2024 (Left) and in Year 1 monitoring on September 27, 2024 (Right).

- Install replacement plants in the SAW habitat restoration areas.** The project’s MMP requires replacement of all dead plants in Year 2. Replanting to 100% of initial planting numbers in SAW habitat restoration areas will facilitate rapid establishment of the target habitats and increase the likelihood that the site will achieve the performance and final success criteria by Year 10 (2033). In addition, as documented in the project’s Biological As-built Report, fewer sycamore plantings were installed than planned in the MMP due to low percent survival of sycamore propagules in the nurseries. During nursery propagation there was extremely low establishment of sycamore scions in the nursery from genetically pure branch stakes, despite two seasons of collection and growing of plantings at two different nurseries. It is hypothesized that the source trees were experiencing drought stress at the time branch cuttings were taken in 2021-2023 for the nursery production, and that this may have decreased the creation of seedlings from cuttings and reduced the vigor of resultant seedlings. Therefore, additional sycamores, which have been grown from genetically pure branch stakes at Grassroots Ecology nursery throughout 2024, should be installed concurrent with replacement planting to achieve the target quantities of sycamores. The spatial layout of each missing sycamore was placed by project restoration ecologists during the 2023 planting. Replacement plants should coincide with the locations of dead/failed conspecific tree and shrubs to the extent feasible.

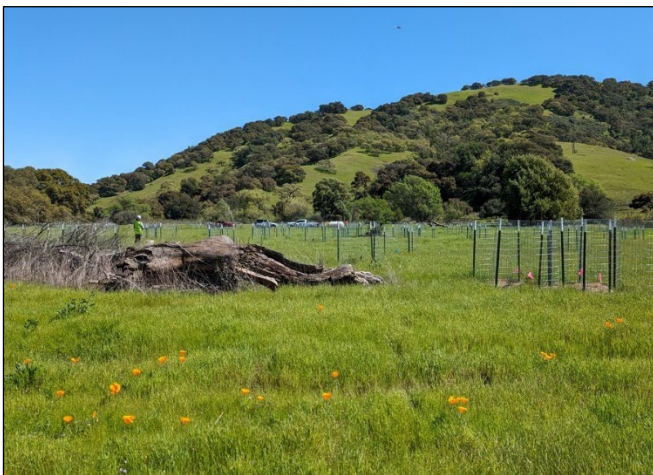
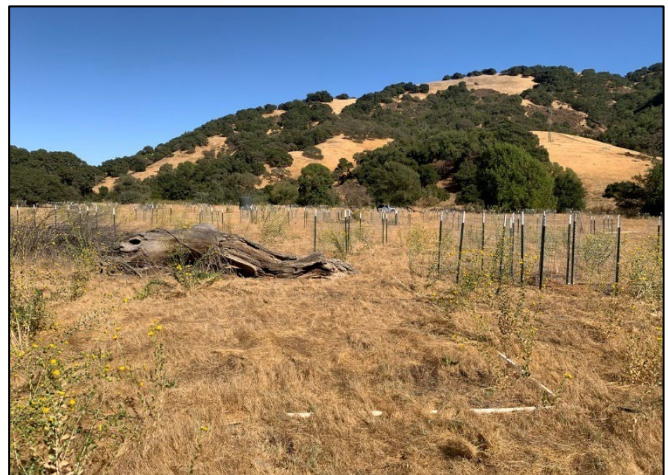
Photopoint 7. As-Built Conditions Looking East, Showing SAW 1 From West Fence Line on March 20, 2024 (Left) and in Year 1 monitoring on September 27, 2024 (Right).

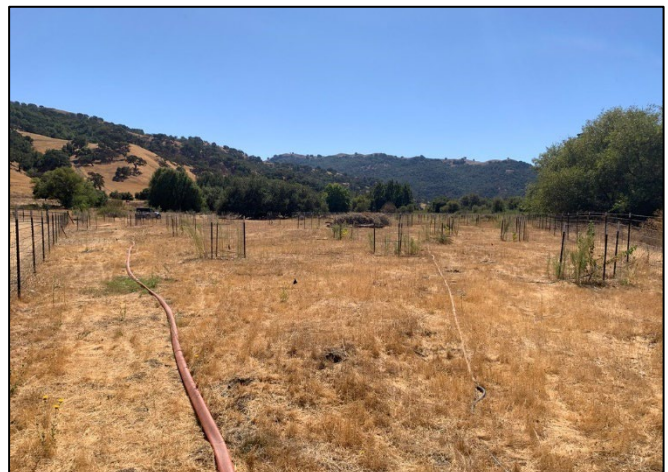
Photopoint 8. As-Built Conditions Looking South, Showing SAW 1 From Northwest Corner on March 20, 2024 (Left) and in Year 1 monitoring on September 27, 2024 (Right).

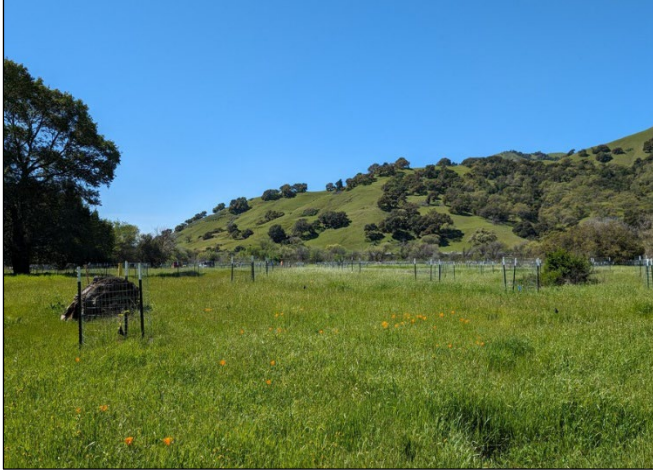
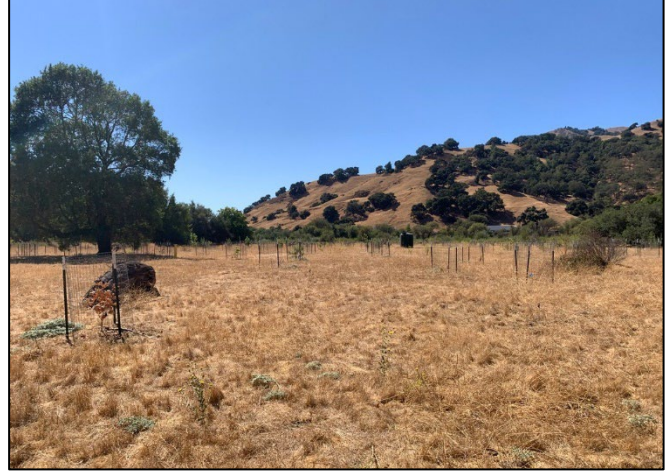
Photopoint 9. As-Built Conditions Looking West, Showing SAW 1 From Northeast Corner on March 20, 2024 (Left) and in Year 1 monitoring on September 27, 2024 (Right).

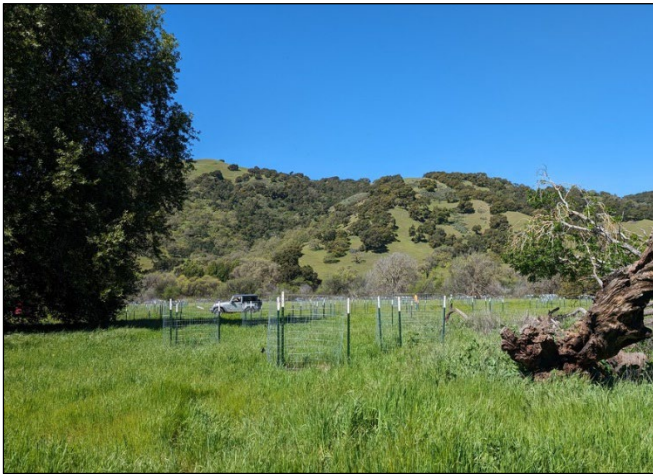
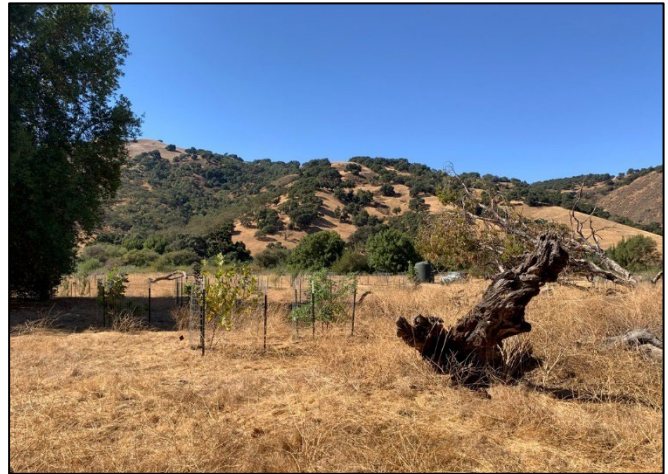
Photopoint 10. As-Built Conditions Looking North, Showing SAW 1 From Southeast Corner on March 20, 2024 (Left) and in Year 1 monitoring on September 27, 2024 (Right).

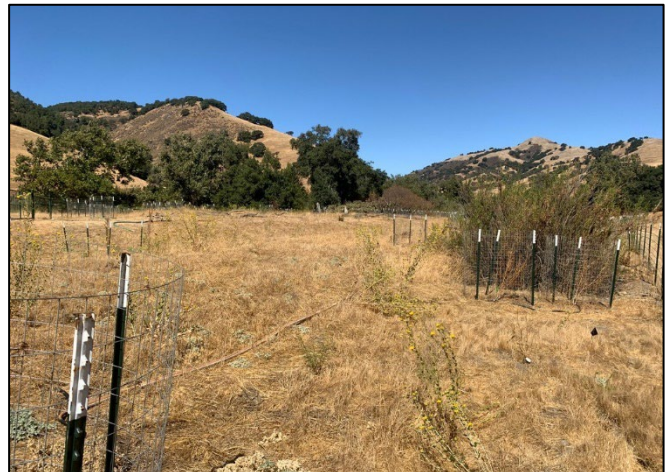
Photopoint 11. As-Built Conditions Looking North, Showing SAW 2 From Southeast Corner on March 20, 2024 (Left) and in Year 1 monitoring on September 27, 2024 (Right).

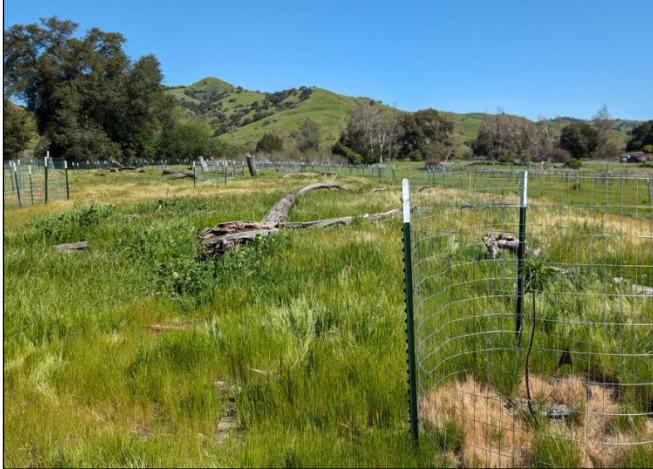
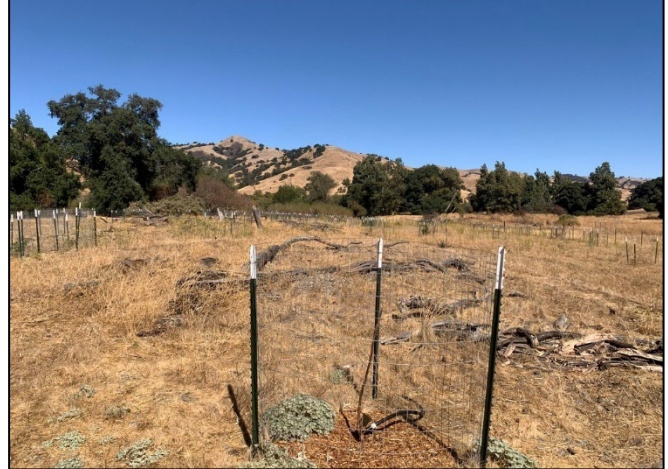
Photopoint 12. As-Built Conditions Looking North, Showing SAW 2 From Southern Fenceline on March 20, 2024 (Left) and in Year 1 monitoring on September 27, 2024 (Right).

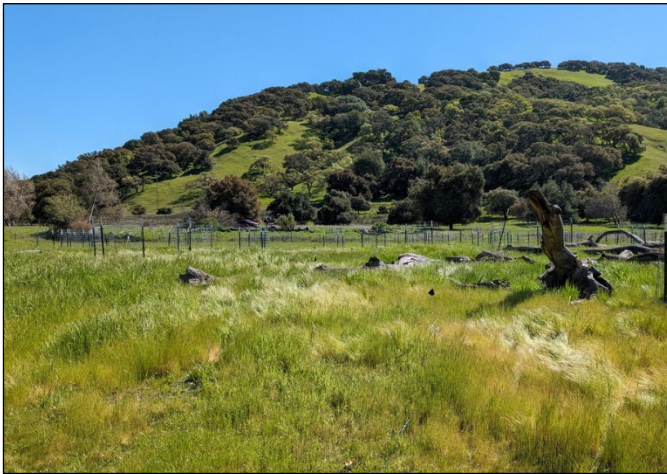
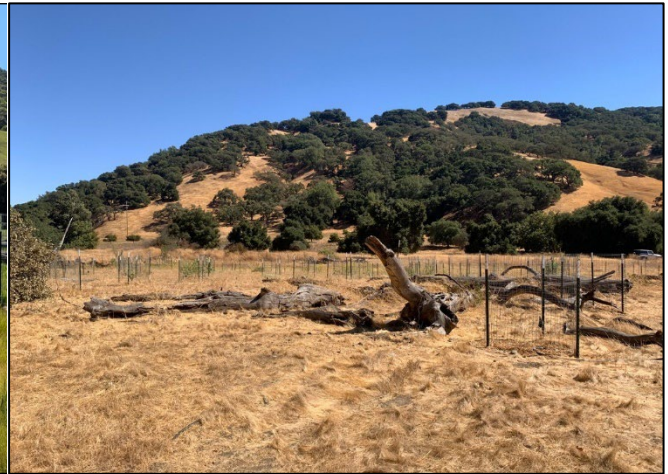
Photopoint 13. As-Built Conditions Looking East, Showing SAW 2 From Western Fenceline on March 20, 2024 (Left) and in Year 1 monitoring on September 27, 2024 (Right).

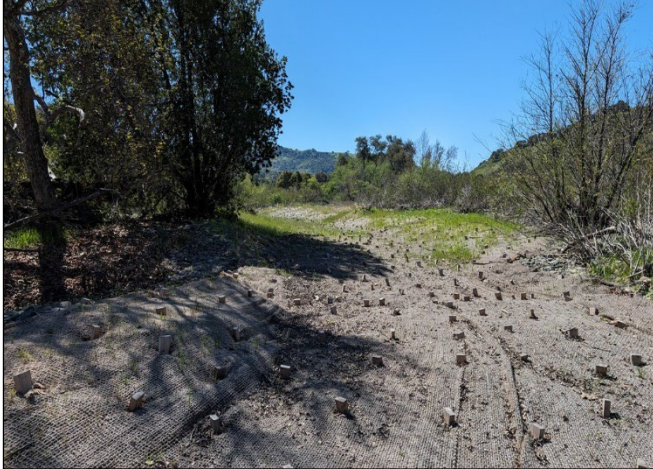
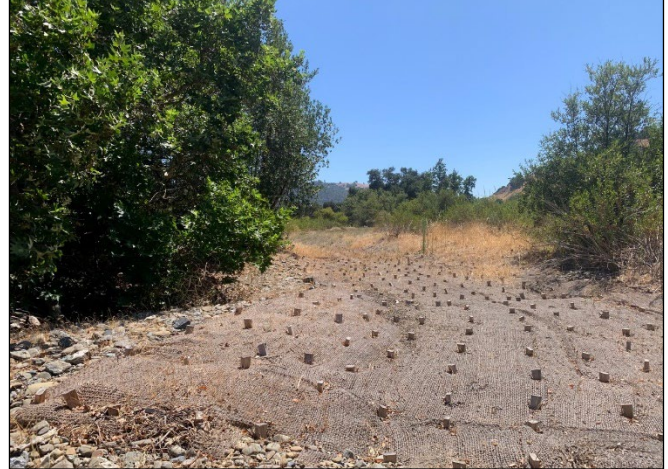
Photopoint 15. As-Built Conditions Looking South, Showing Graded Secondary Channel 4 on March 20, 2024 (Left) and in Year 1 monitoring on August 8, 2024 (Right).

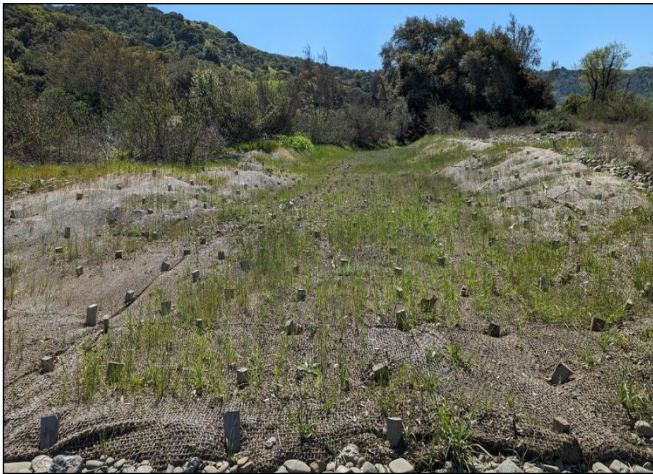
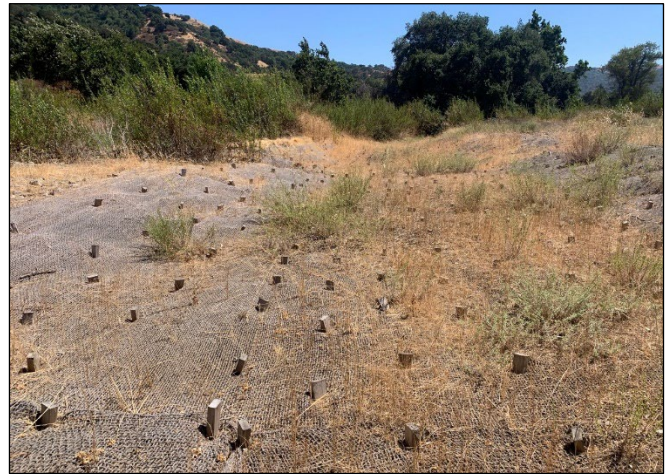
Photopoint 16. As-Built Conditions Looking South, Showing Graded Secondary Channel 3 on March 20, 2024 (Left) and in Year 1 monitoring on August 8, 2024 (Right).

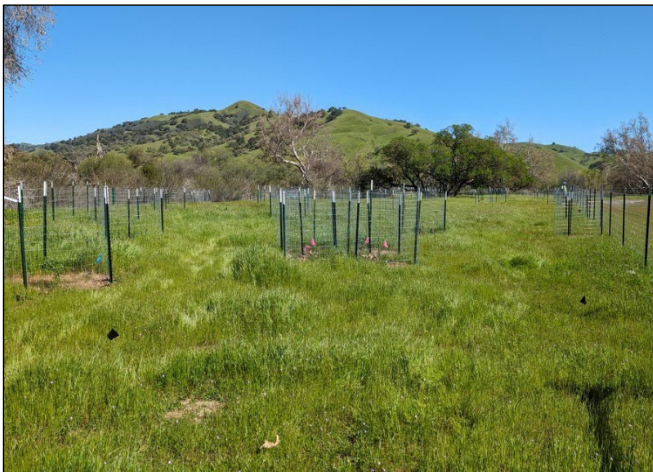
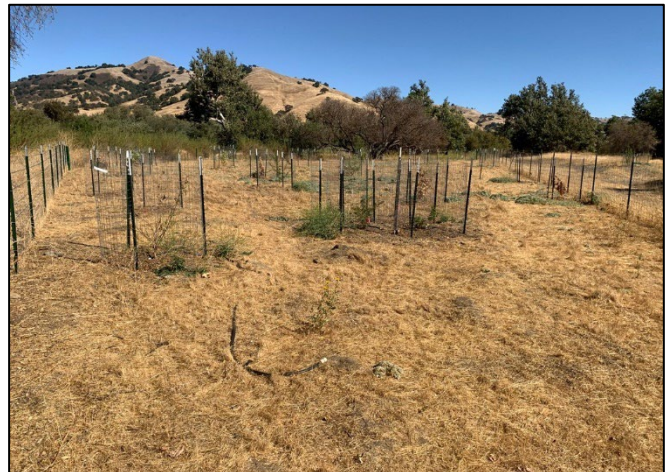
Photopoint 17. As-Built Conditions Looking Northeast, Showing SAW 3 From Southern Corner on March 20, 2024 (Left) and in Year 1 monitoring on September 27, 2024 (Right).

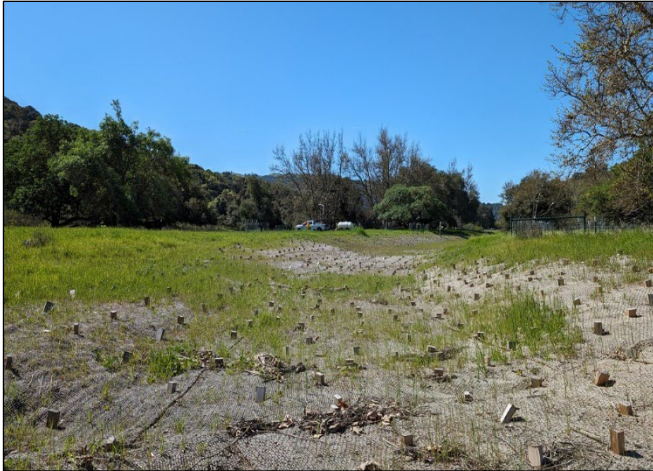
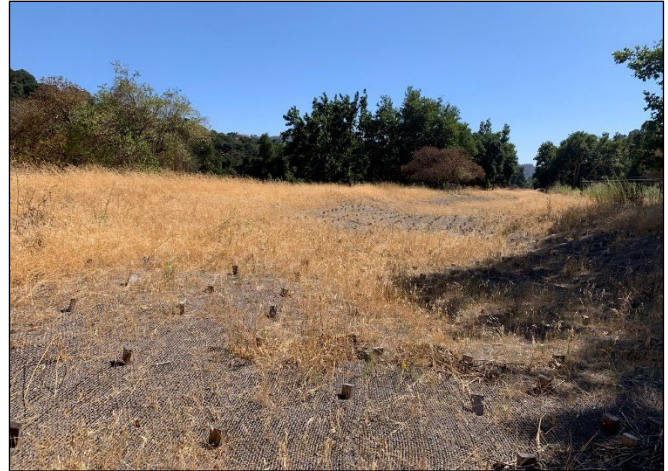
Photopoint 18. As-Built Conditions Looking Southwest, Showing Graded Secondary Channel 2 through SAW 3 on March 20, 2024 (Left) and in Year 1 monitoring on August 8, 2024 (Right).

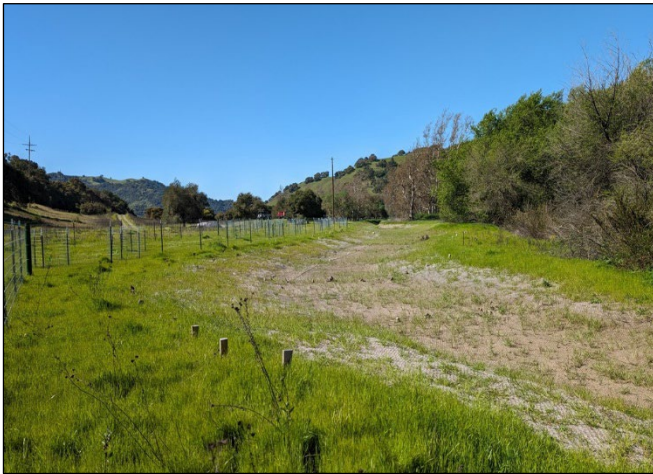
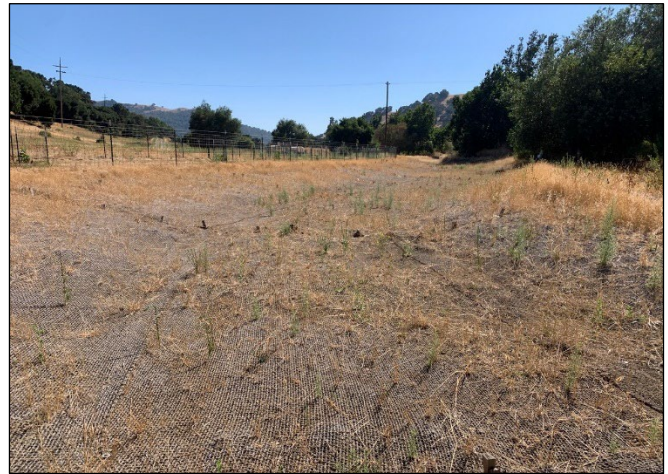
Photopoint 19. As-Built Conditions Looking Southwest, Showing Graded Secondary Channel 1 Adjacent to SAW 4 on March 20, 2024 (Left) and in Year 1 monitoring on August 8, 2024 (Right).

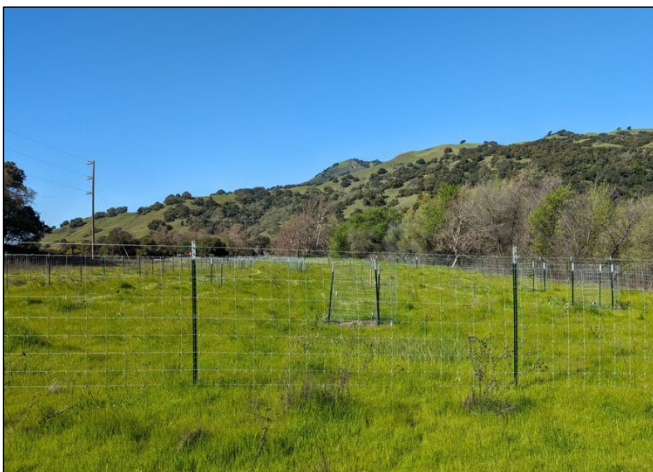
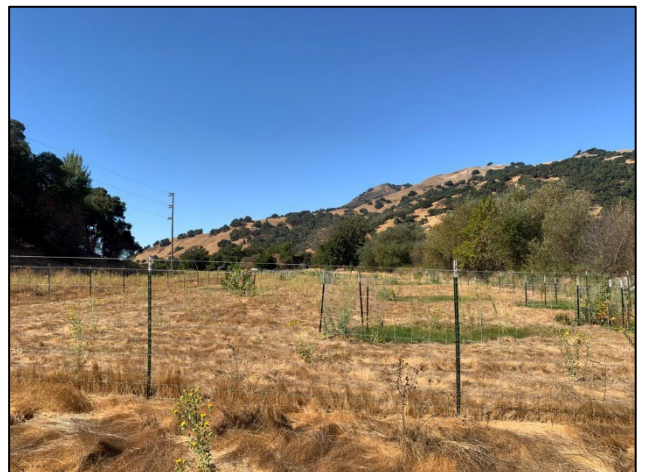
Photopoint 20. As-Built Conditions Looking Southwest, Showing SAW 4 From Outside Northeast Fenceline on March 20, 2024 (Left) and in Year 1 monitoring on September 27, 2024 (Right).

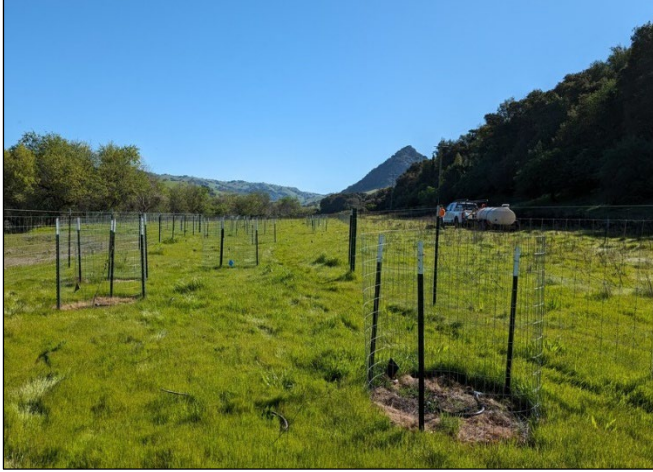
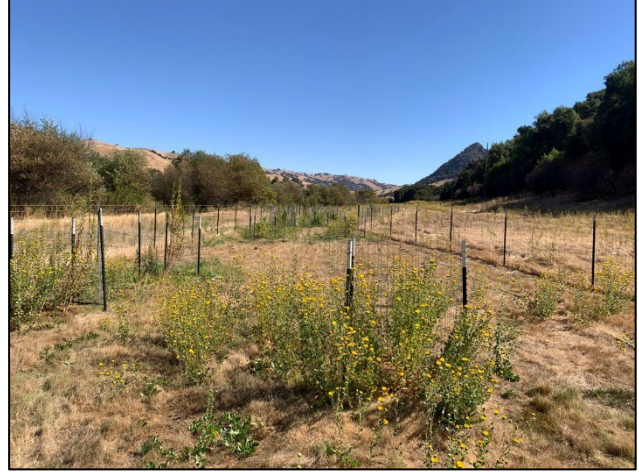
Photopoint 21. As-Built Conditions Looking Northeast, Showing SAW 4 From Southwest Corner on March 20, 2024 (Left) and in Year 1 monitoring on September 27, 2024 (Right).

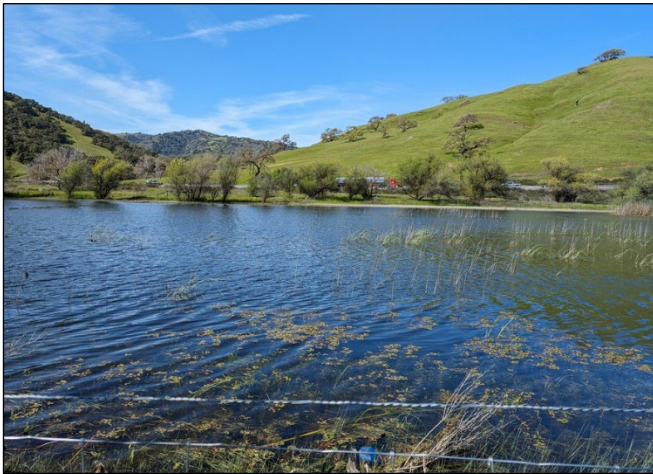
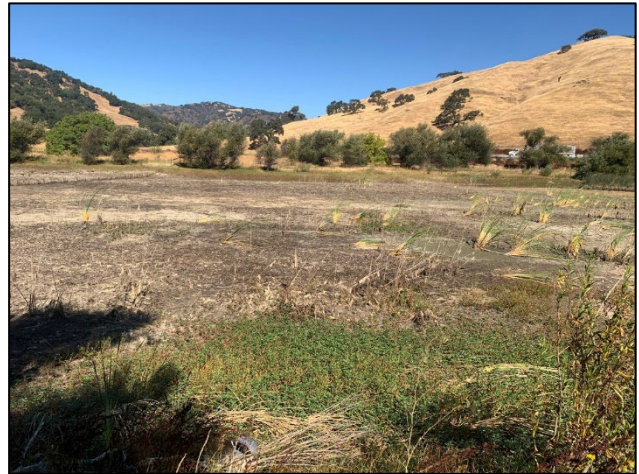
Photopoint 22. As-Built Conditions Looking North, Showing Pond 3 From Southeast Bank Outside Fenceline on March 20, 2024 (Left) and in Year 1 monitoring on September 27, 2024 (Right).

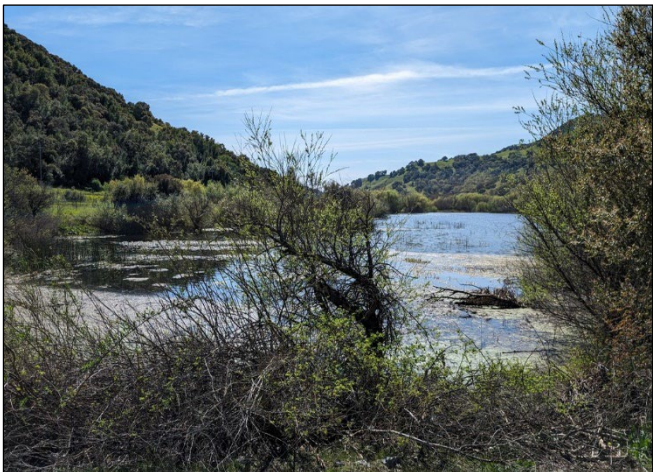
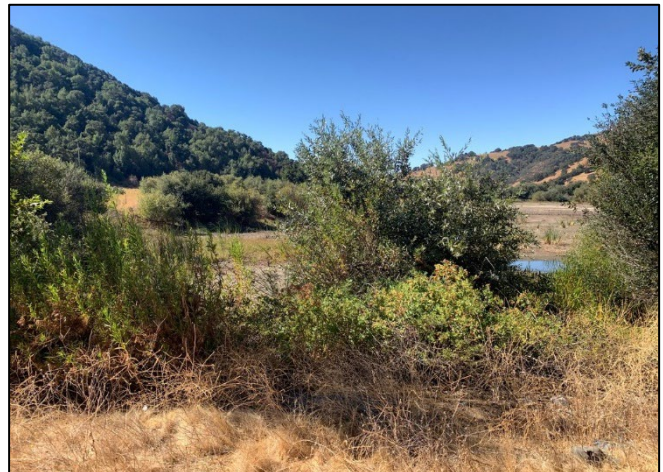
Photopoint 23. As-Built Conditions Looking West, Showing Pond 3 From Bank Inside Fenceline on March 20, 2024 (Left) and in Year 1 monitoring on September 27, 2024 (Right).

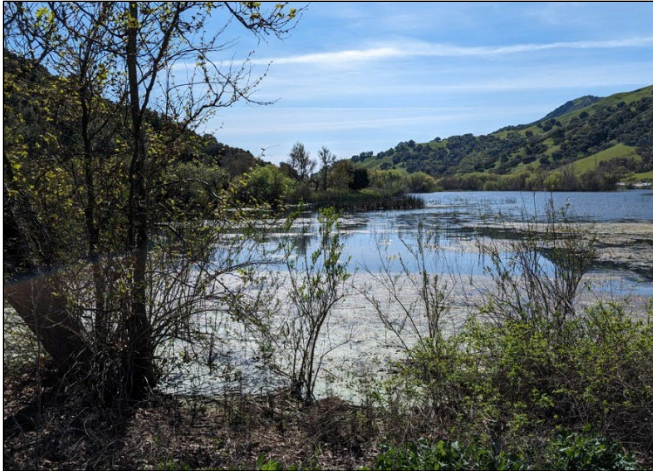
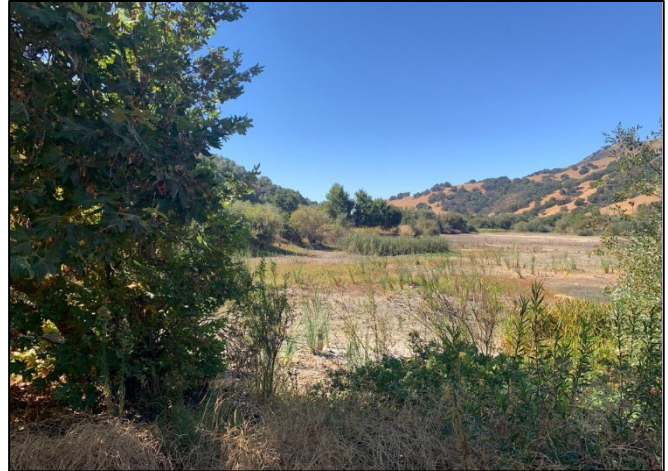
Photopoint 23. As-Built Conditions Looking West, Showing Pond 3 From Bank Inside Fenceline, on March 20, 2024 (Left) and in Year 1 monitoring on September 27, 2024 (Right).

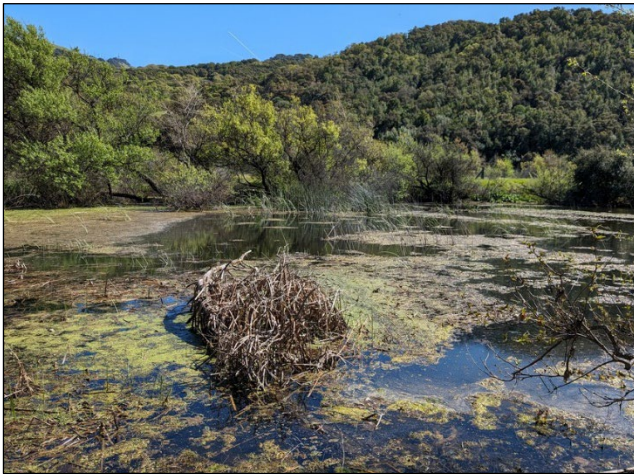
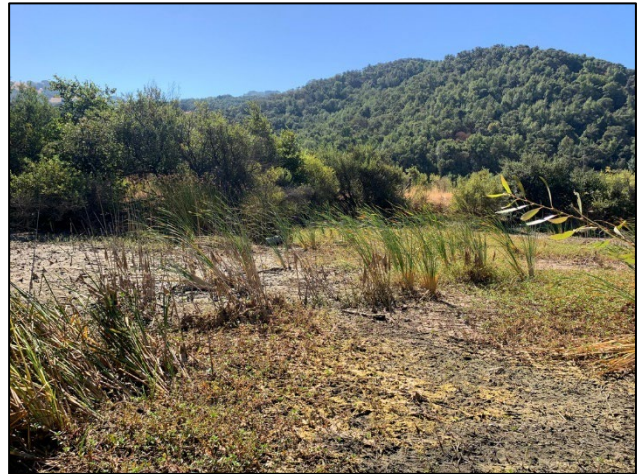
Photopoint 23. As-Built Conditions Looking Southeast, Showing Pond 3 From Peninsula Inside Fenceline on March 20, 2024 (Left) and in Year 1 monitoring on September 27, 2024 (Right).

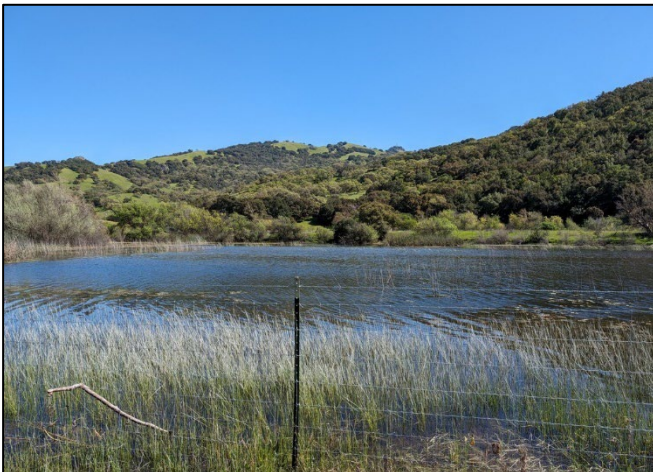
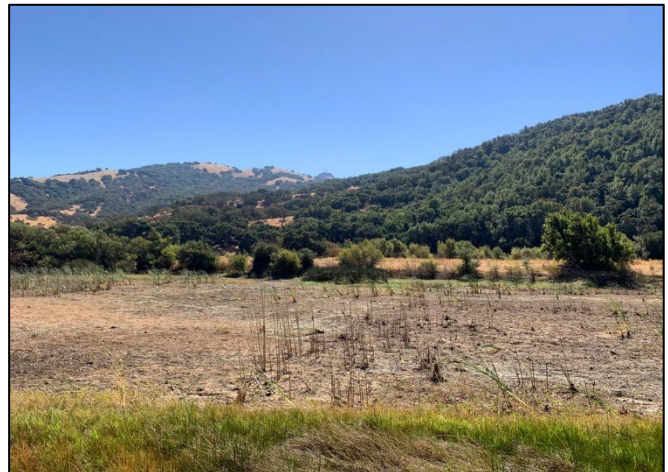
Photopoint 24. As-Built Conditions Looking Southeast, Showing Pond 3 From Northwest Bank outside of Fenceline on March 20, 2024 (Left) and in Year 1 monitoring on September 27, 2024 (Right).
