**Figure 1. Coyote Ridge CR1 and CR4 Sites Vicinity Map**  
**Coyote Ridge Ponds Restoration Project, Ponds CR1 and CR4**  
**Year 5 Monitoring Report**  
**January 2025**

# Coyote Ridge Property Stock Pond Habitat Restoration

Inspection date: April 29, 2024 12:30 pm

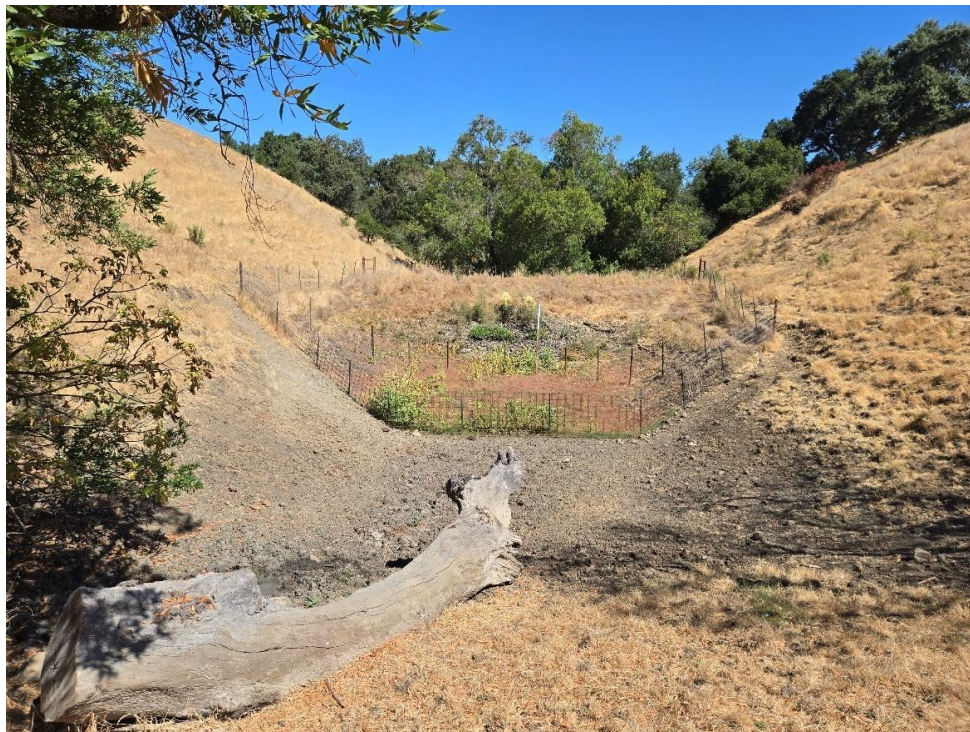
**Photo 65. Pond is completely dry (June 2024)**

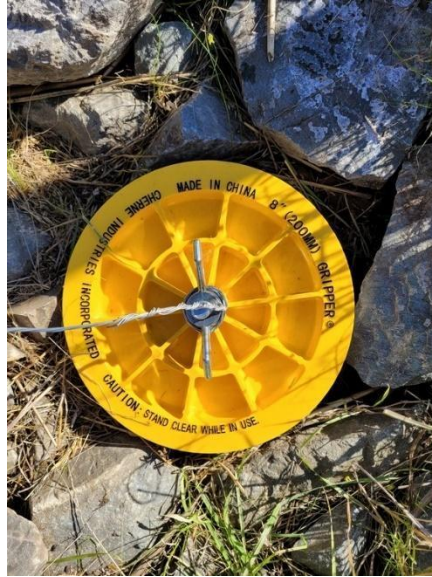
**Photo 69. No water at CR4 due to open drain valve (photo provided by SCVHA, February 10, 2021)**

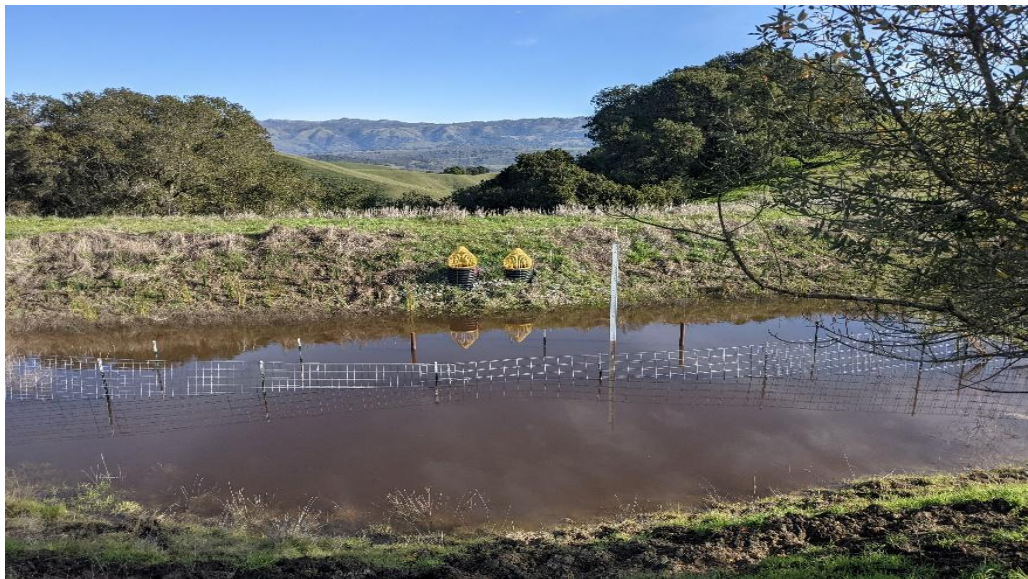
**Photo 70. Removable caps, added to the quick drain pipes to prevent leakage (photo provided by SCVHA, November 30, 2021)**

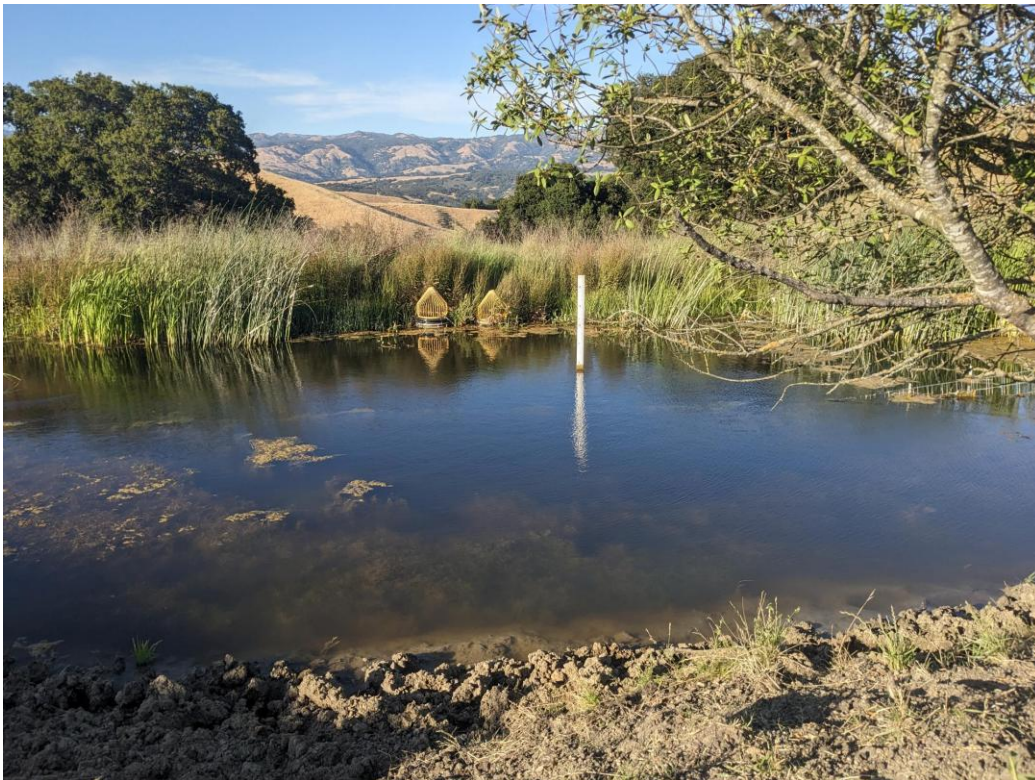
**Photo 76. Pond did not dry during the summer and retained 3.1 ft of water (November 2, 2023)**

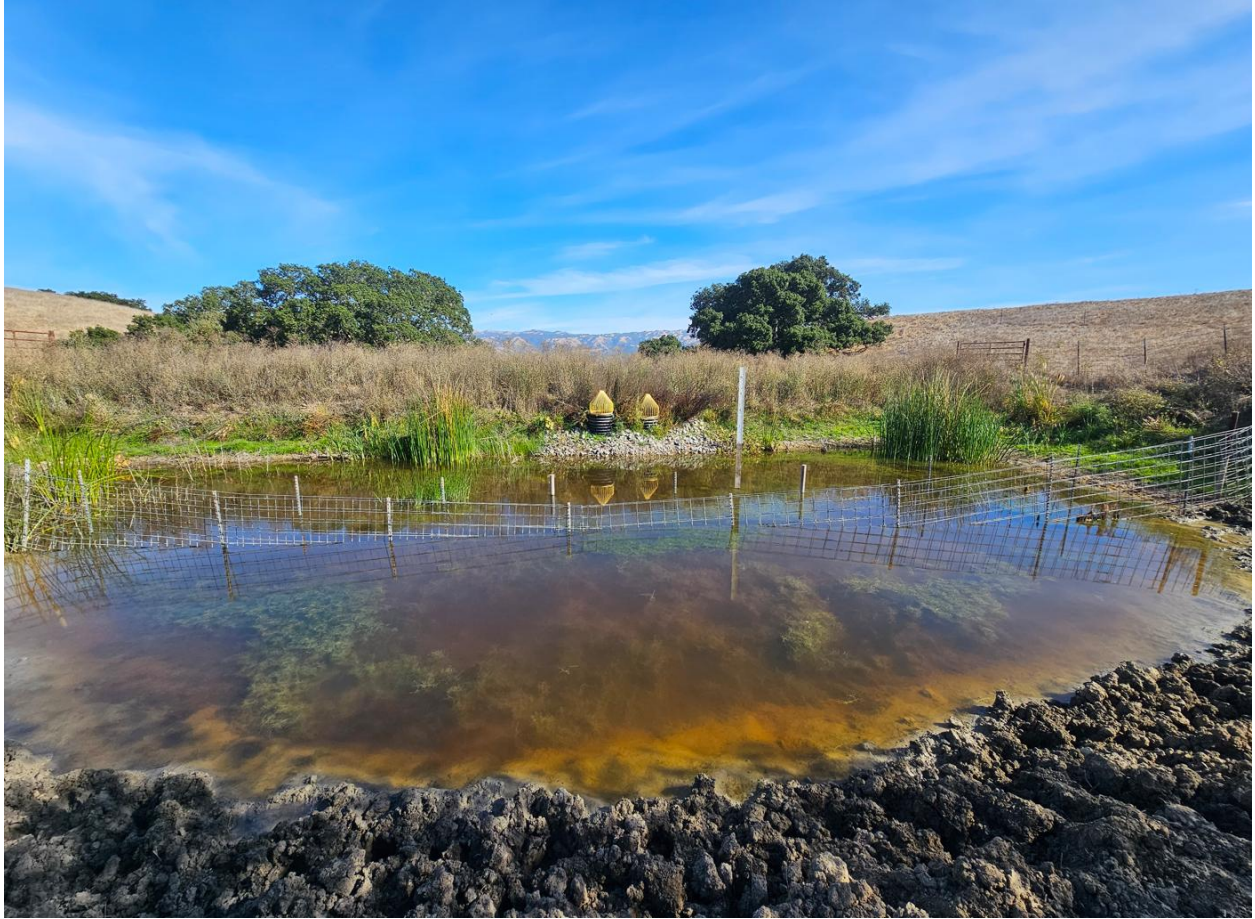
**Photo 79. Pond did not dry during summer months and retained 2.8 ft of water (September 5, 2024)**

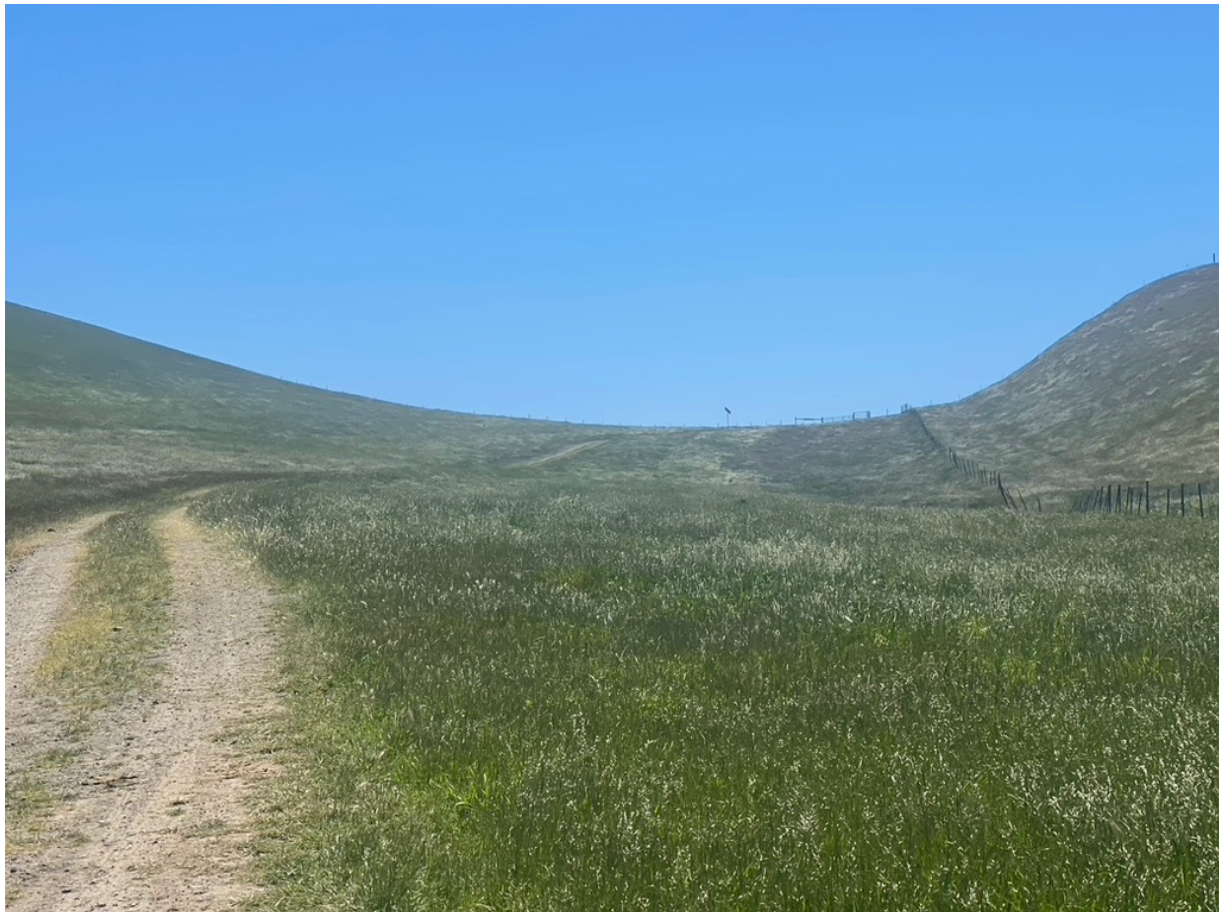
## Metcalf Road Entry gate to Staging Area

The main gate and the next cattle gate were intact and operational. The entry road was eroded in the usual places. No wildlife observed.

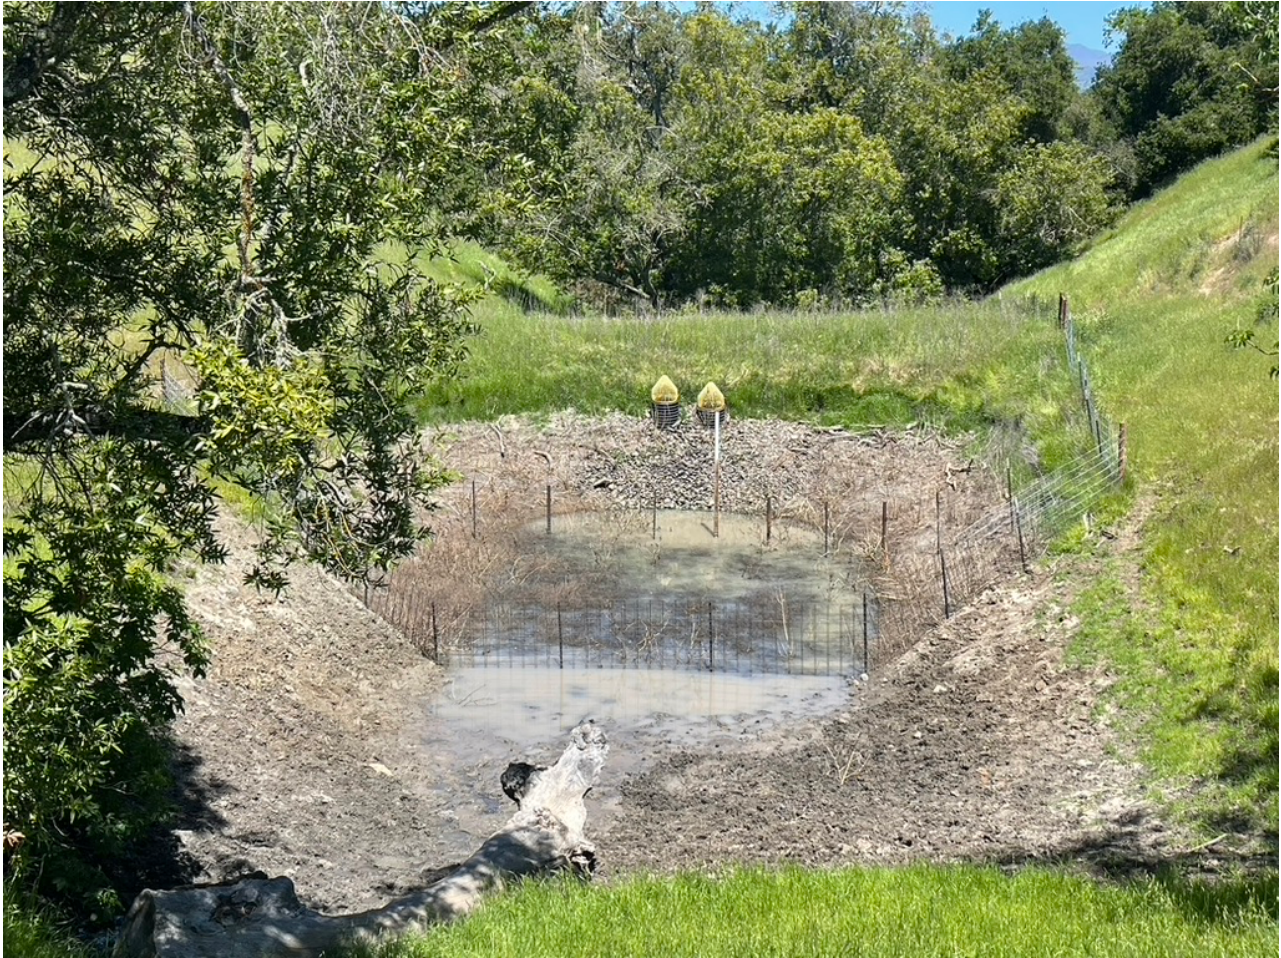
## CR01

- The cattle fence and gate are intact.
- Perimeter pond exclusion fences and gates – fences and gates intact, no obvious incursion by the cattle. Grazing evident outside the perimeter fence.
- Overflow pipes and debris guards – intact
- Berm conditions and integrity – good vegetation growth, no evidence of erosion
- Side slopes in and outside the perimeter fence – good vegetation growth, no evidence of erosion
- Water level and staff gauge – staff gauge intact, hard to read, less than one foot water
- Observations, comments, and recommendations – No recommendations

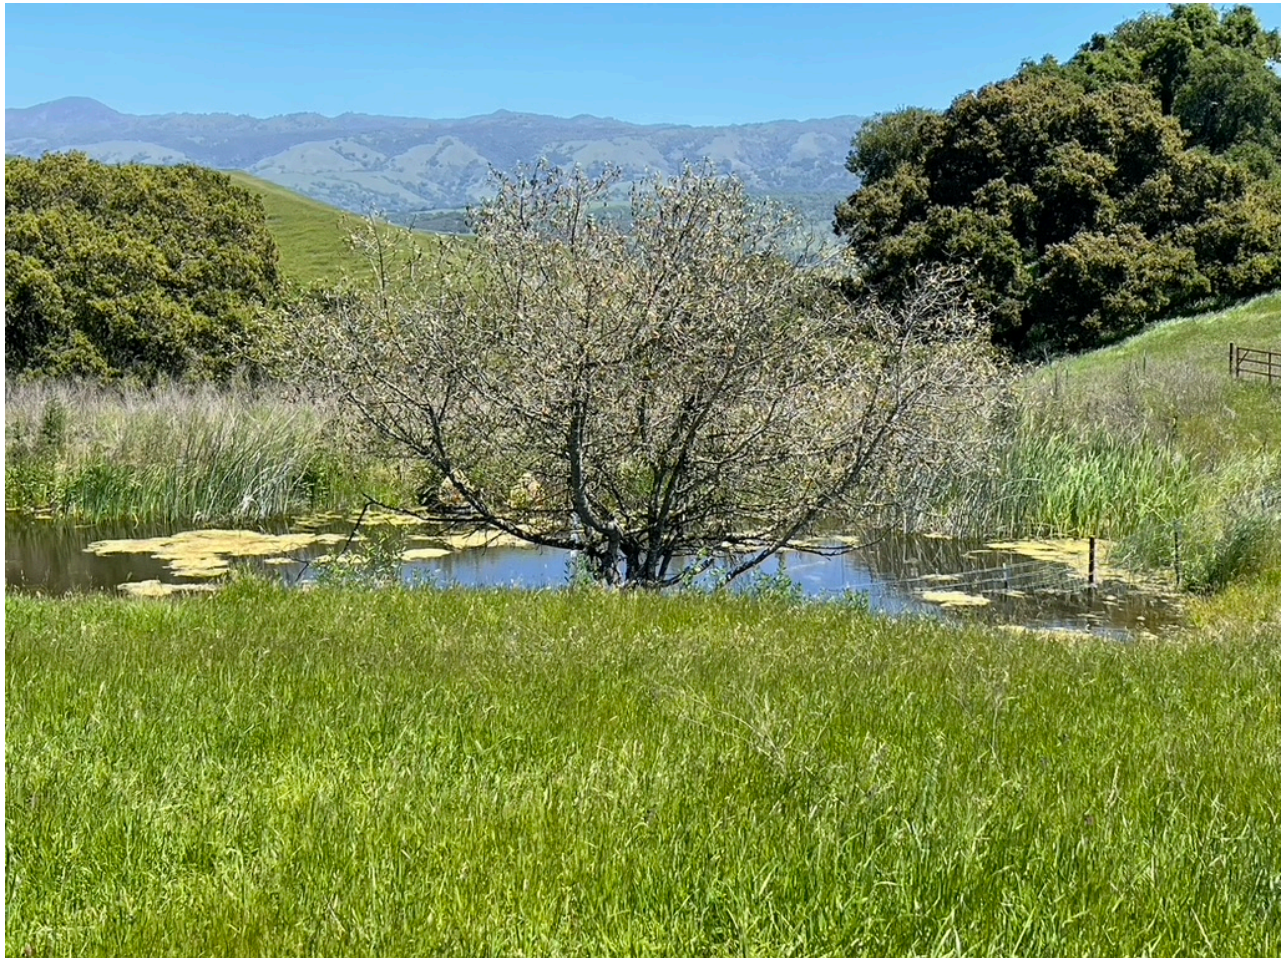
## CR04

- Cattle fence and gates intact.
  - Perimeter pond exclusion fences and gates - perimeter fences intact, no obvious incursion by the cattle. Grazing evident outside the perimeter fence.
  - Overflow pipes and debris guards - intact
  - Berm conditions and integrity - good vegetation growth, no evidence of erosion
  - Side slopes in and outside the perimeter fence - good vegetation growth, no evidence of erosion
  - Water level and staff gauge - staff gauge intact, pond is full. 6' foot.
  - Good vegetation coverage
- Observations, comments, and recommendations – everything looked good, no observable issues. No recommendations.
