**Calero County Park Pond and Wetland  
Restoration Project—  
Year 5 (2021) Monitoring Report**

**Project # 3753-07**

January 3, 2022

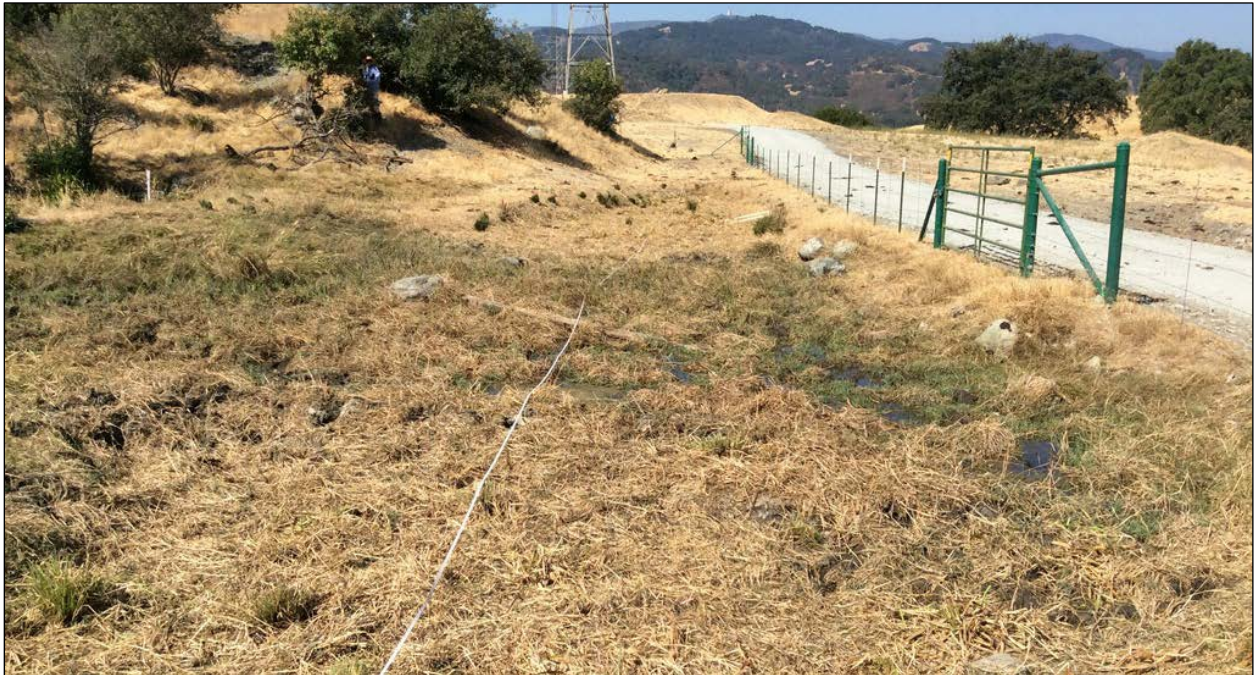
**Photo 1. Year 1 Conditions at Photo Point 1a during Vegetation Monitoring at the Wetland Mitigation Site (August 8, 2017)**

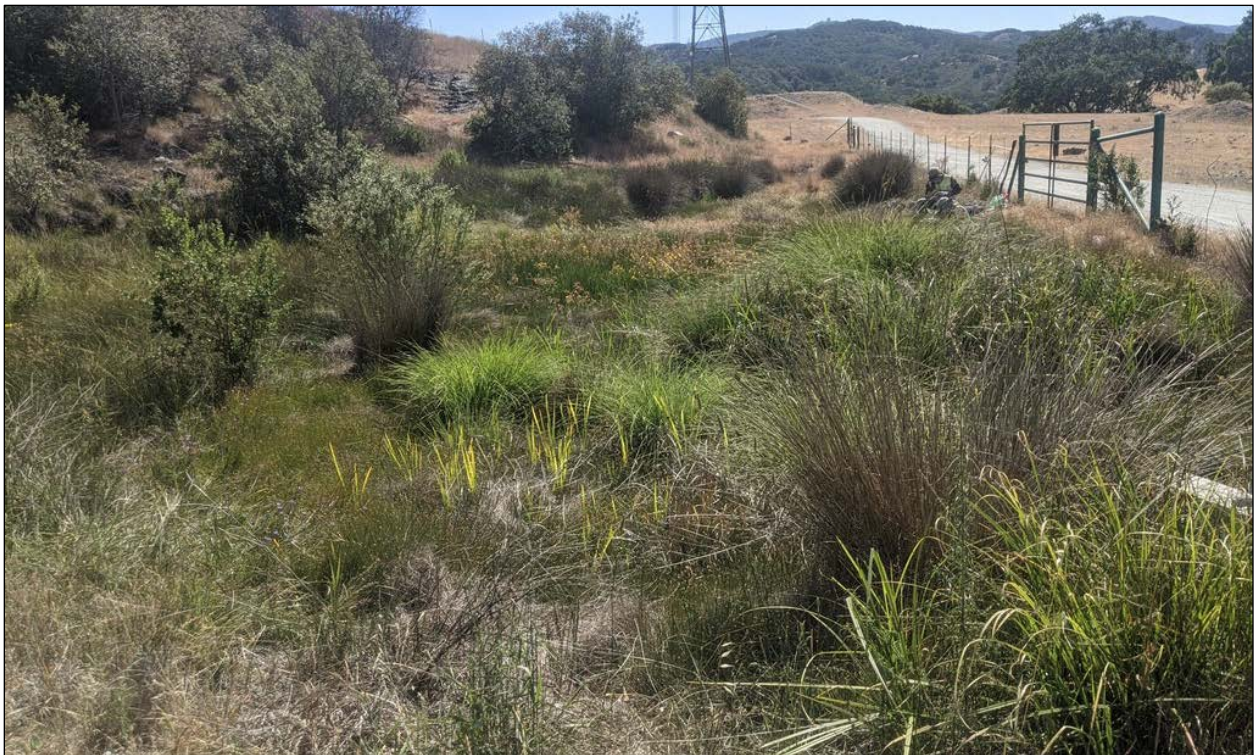
**Photo 2. Year 5 Conditions at Photo Point 1a during Vegetation Monitoring at the Wetland Mitigation Site (May 20, 2021)**

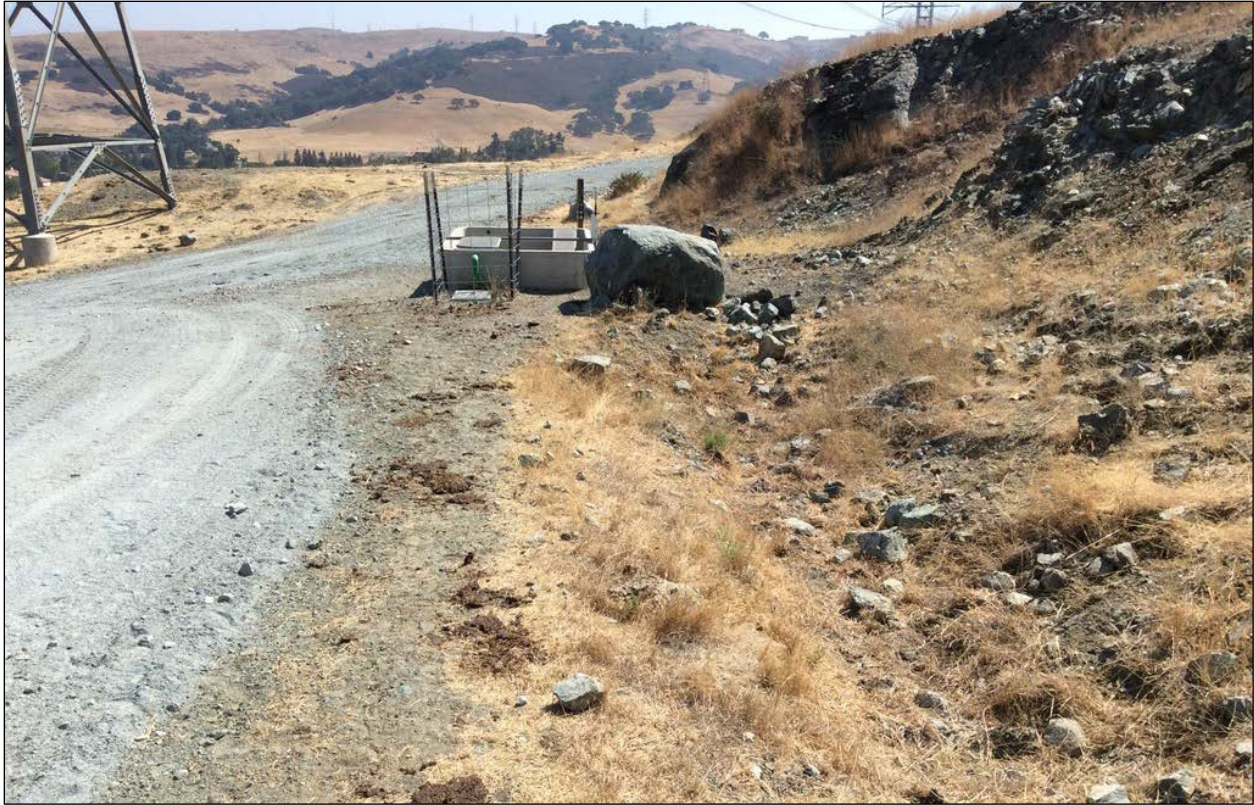
**Photo 3. Year 1 Conditions at Photo Point 1b during Vegetation Monitoring at the Wetland Mitigation Site (August 8, 2017)**

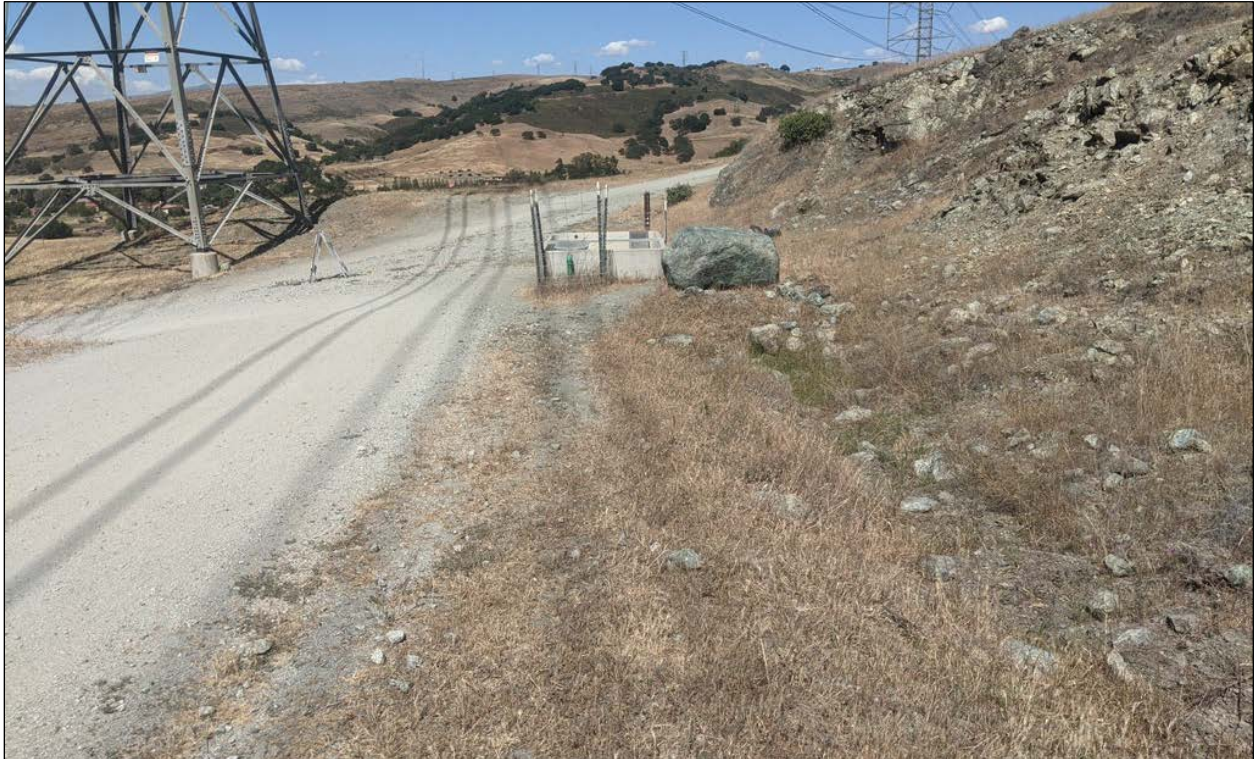
**Photo 4. Year 5 Conditions Looking East from Photo Point 1b during Vegetation Monitoring at the Wetland Mitigation Site (May 20, 2021)**

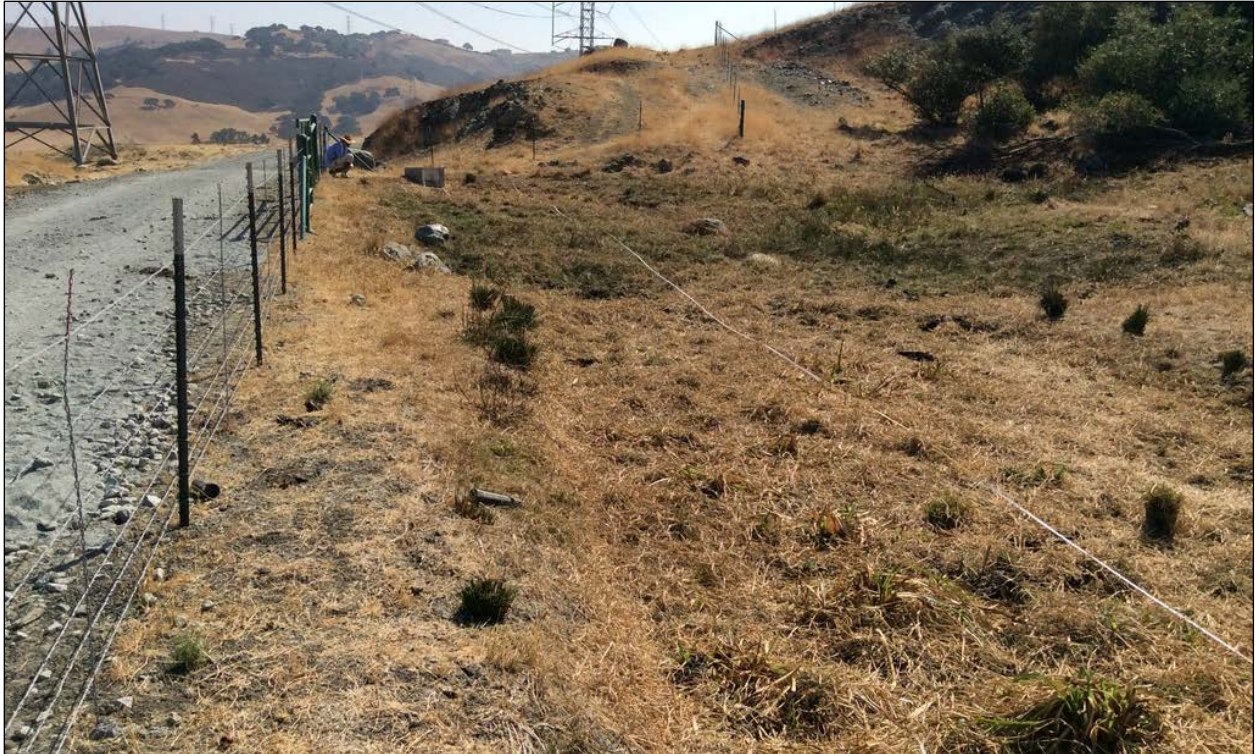
**Photo 5. Year 1 Conditions at Photo Point 2 during Vegetation Monitoring at the Wetland Mitigation Site (August 8, 2017)**

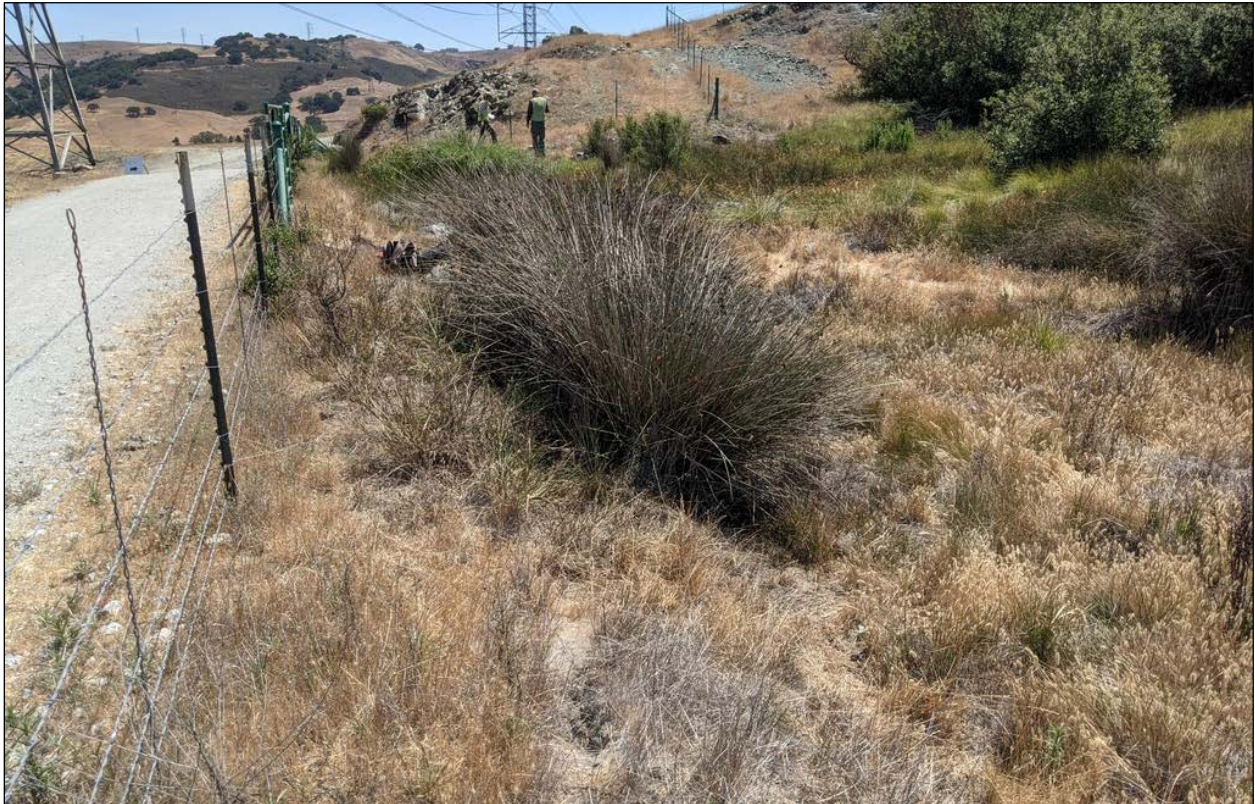
**Photo 6. Year 5 Conditions at Photo Point 2 during Vegetation Monitoring at the Wetland Mitigation Site (June 2, 2021)**

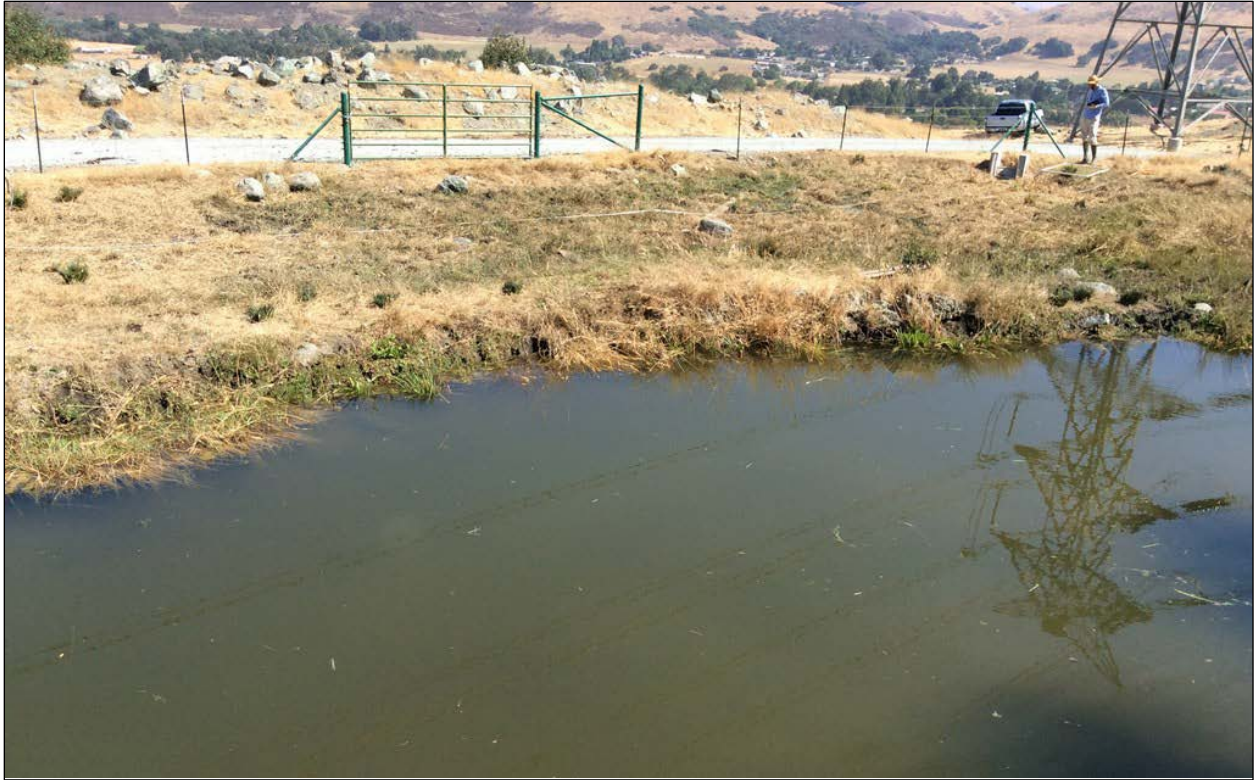
**Photo 7. Year 1 Conditions at Photo Point 3 during Vegetation Monitoring at the Wetland Mitigation Site (August 8, 2017)**

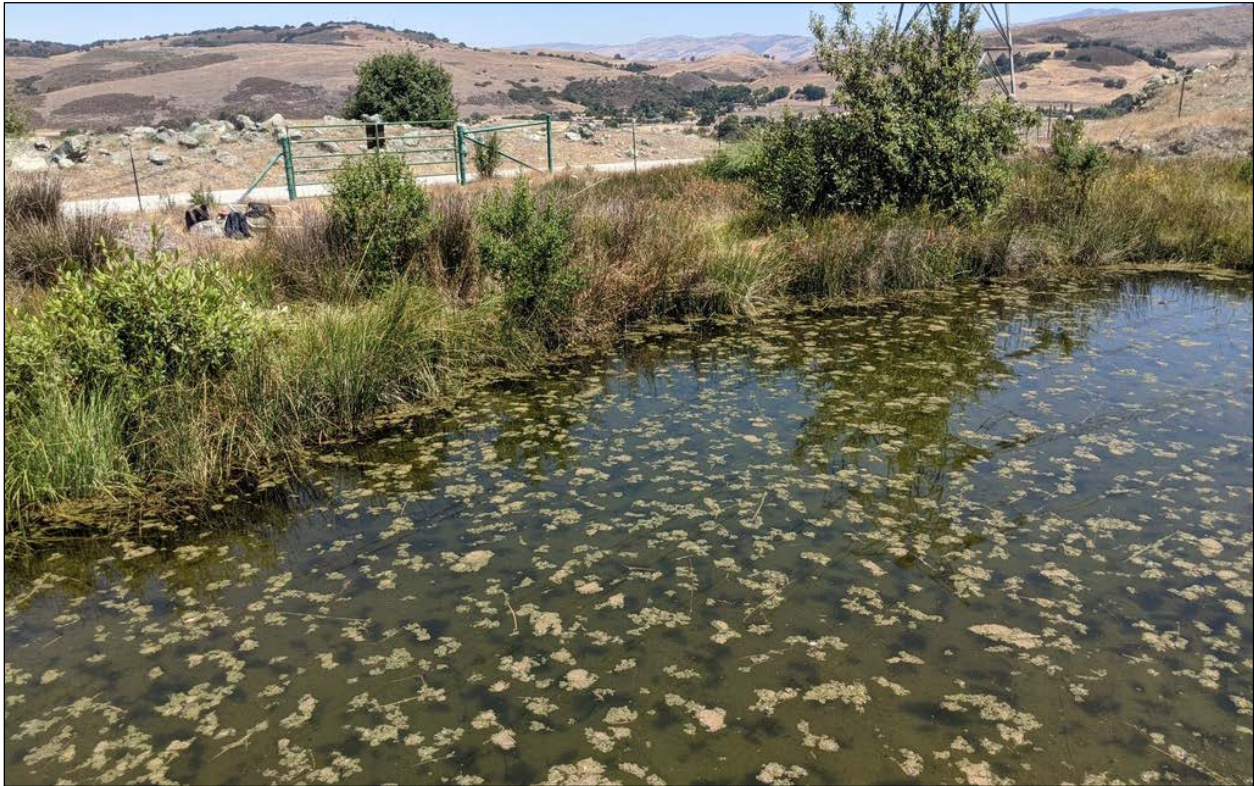
**Photo 8. Year 5 Conditions at Photo Point 3 during Vegetation Monitoring at the Wetland Mitigation Site (June 2, 2021)**

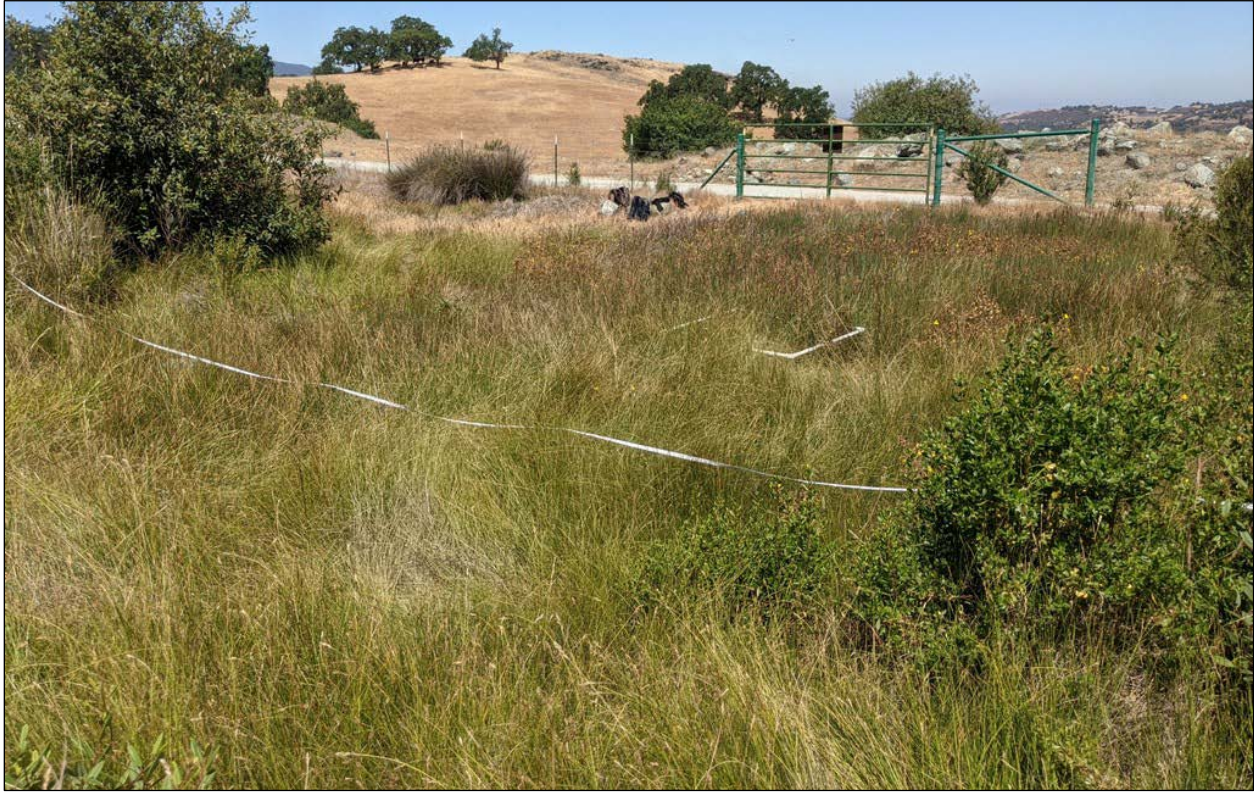
**Photo 10. Year 5 Conditions at Photo Point 4 during Vegetation Monitoring at the Wetland Mitigation Site (June 2, 2021)**

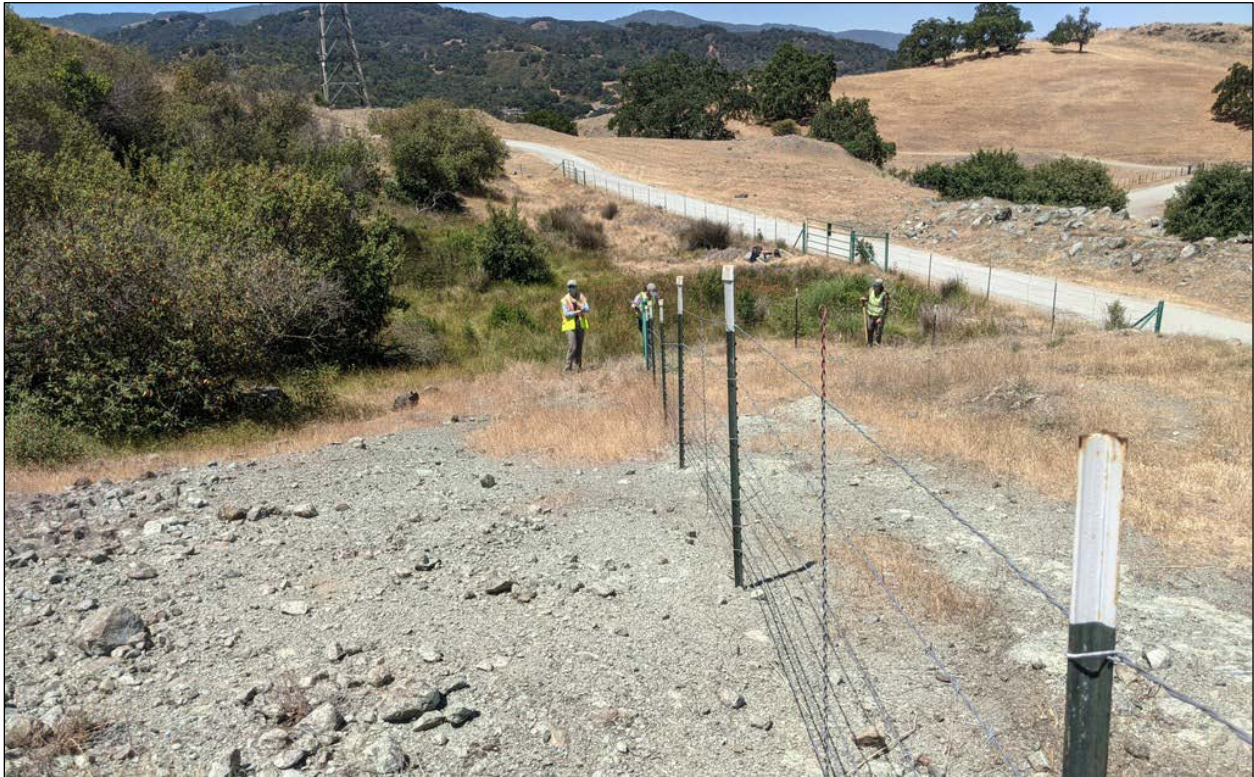
**Photo 12. Year 5 Conditions at Photo Point 5 during Vegetation Monitoring at the Wetland Mitigation Site (June 2, 2021)**

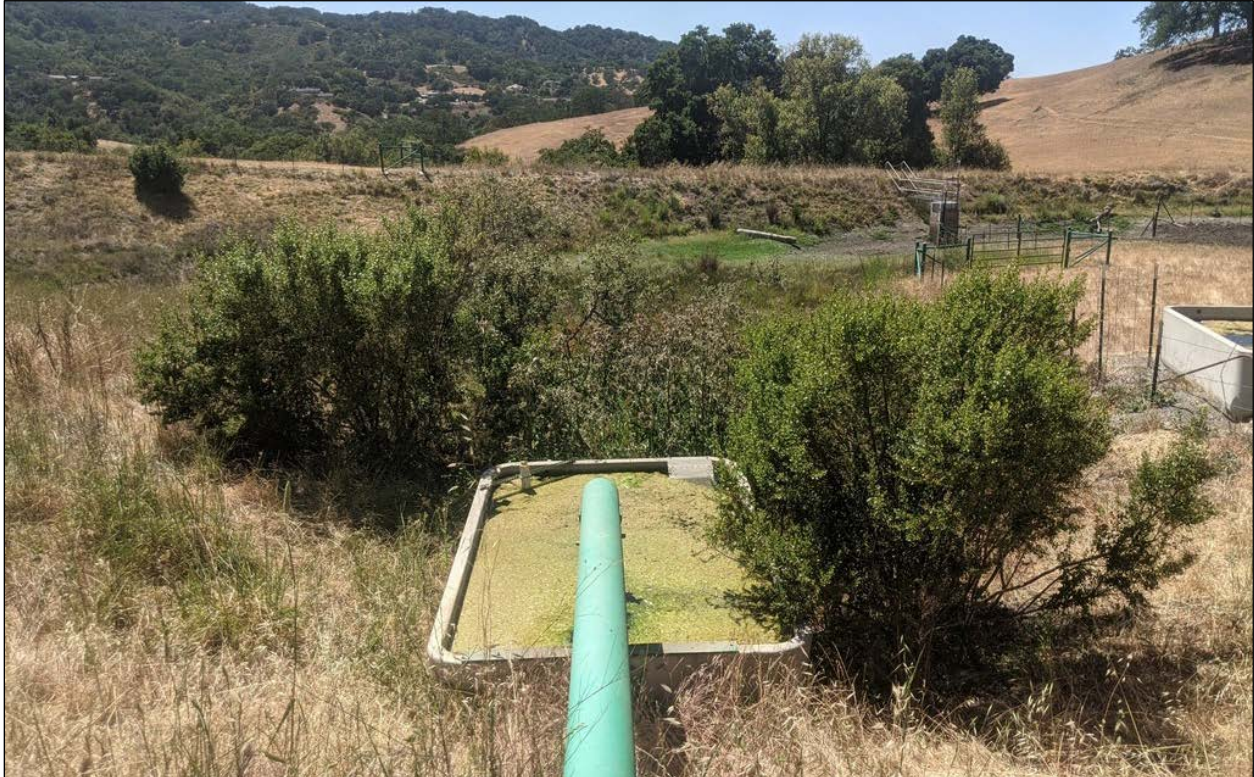
**Photo 14. Year 5 Conditions at Photo Point 6 during Mt. Hamilton Thistle Abundance Monitoring at the Pond Mitigation Site (May 20, 2021)**

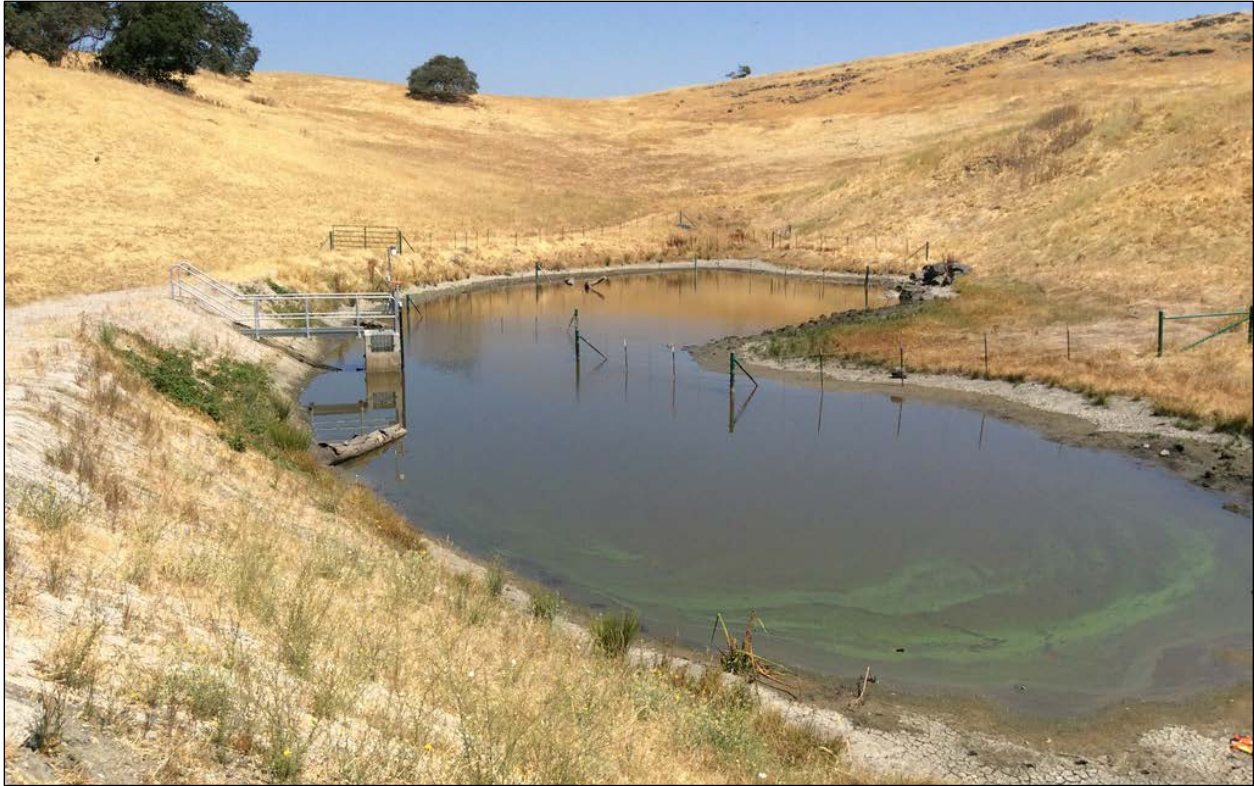
**Photo 15. Year 1 Conditions at Photo Point 7a during Vegetation Monitoring at the Pond Mitigation Site (August 8, 2017)**

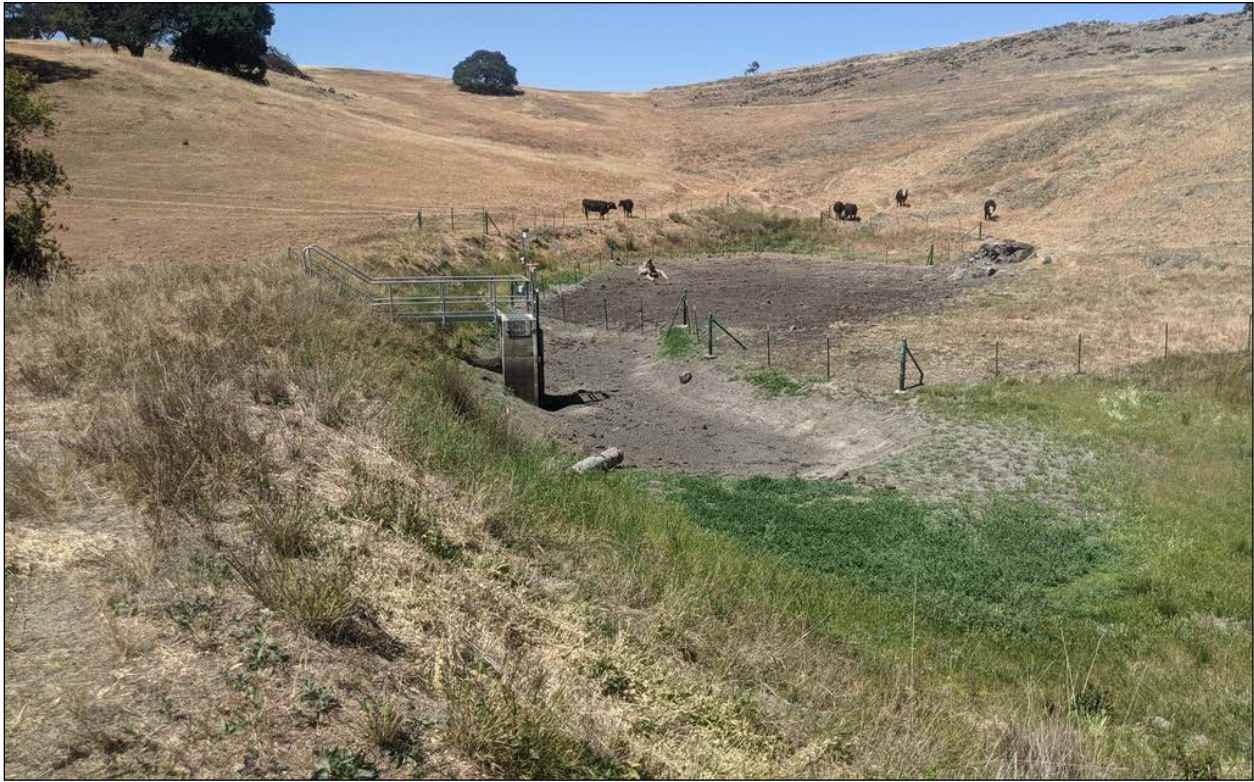
**Photo 16. Year 5 Conditions at Photo Point 7a during Vegetation Monitoring at the Pond Mitigation Site (May 20, 2021)**

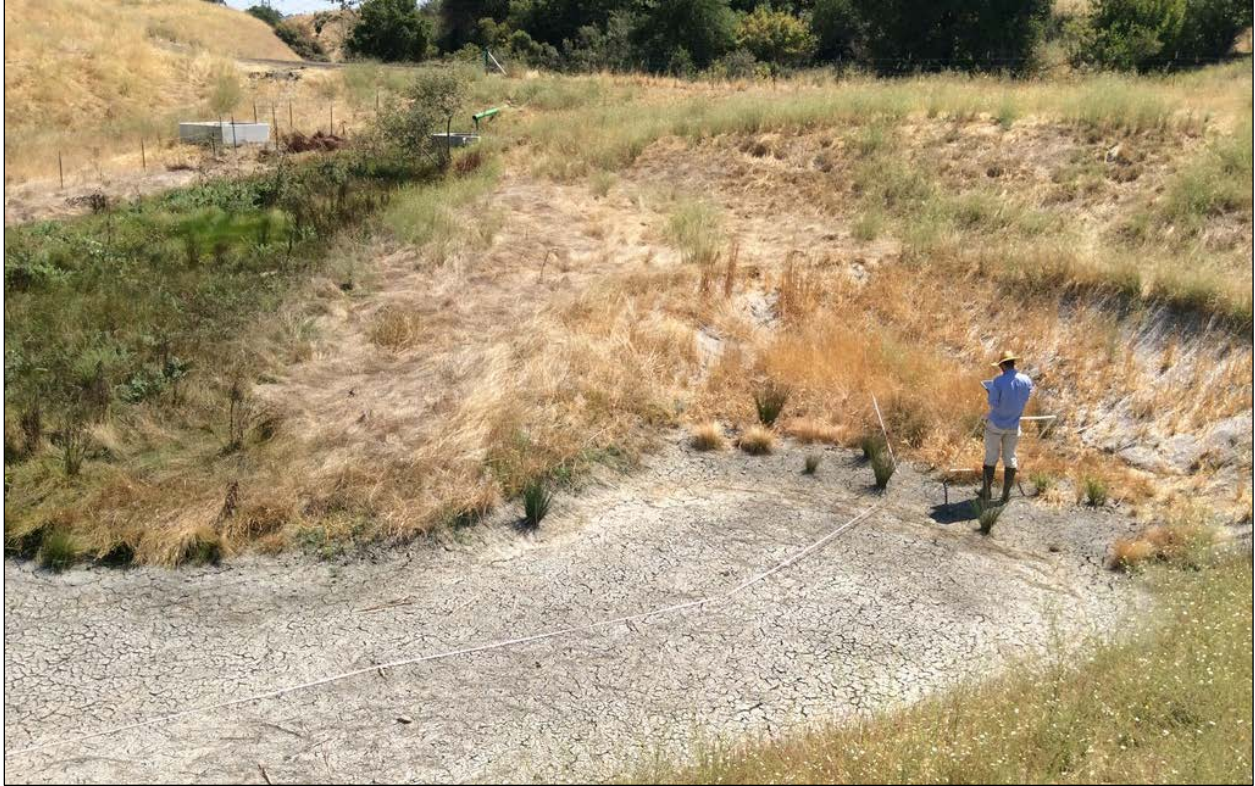
**Photo 17. Year 1 Conditions at Photo Point 7b during Vegetation Monitoring, Showing the Wetland Establishment Area at the Pond Mitigation Site (August 8, 2017)**

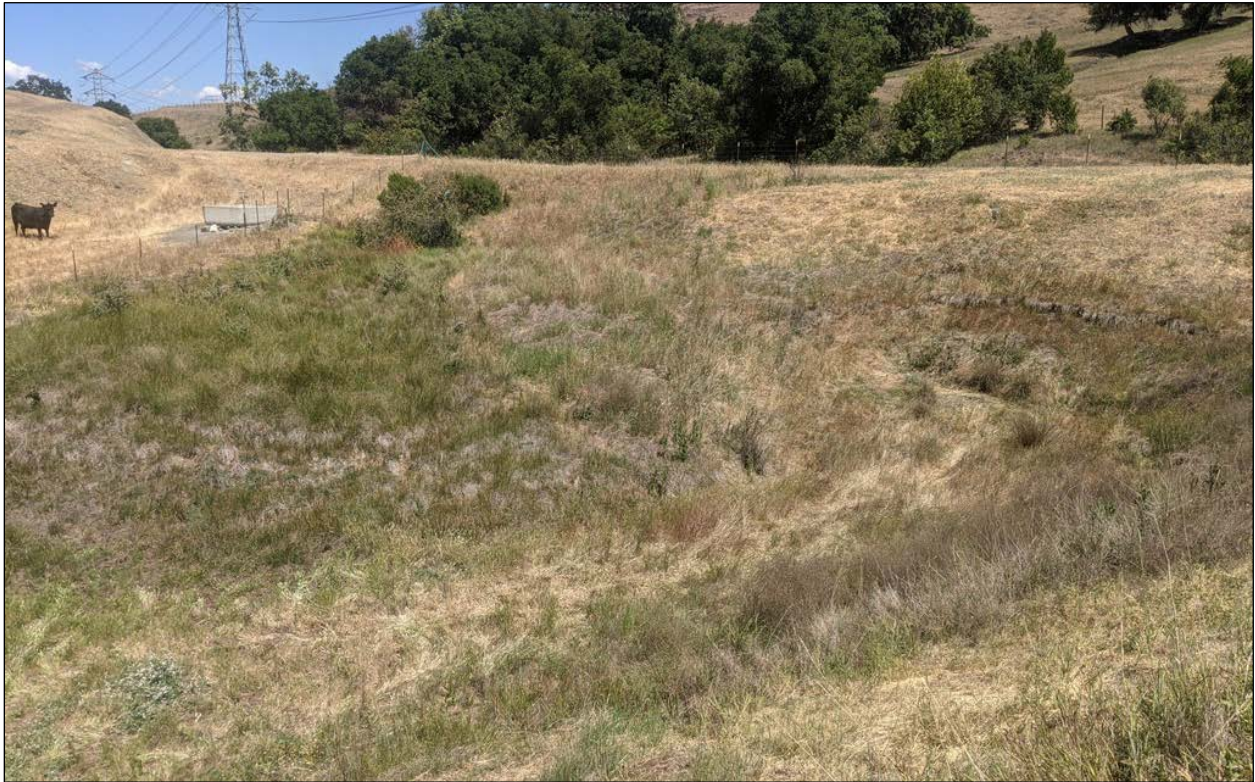
**Photo 18. Year 5 Conditions at Photo Point 7b during Vegetation Monitoring, Showing the Wetland Establishment Area at the Pond Mitigation Site (May 20, 2021)**

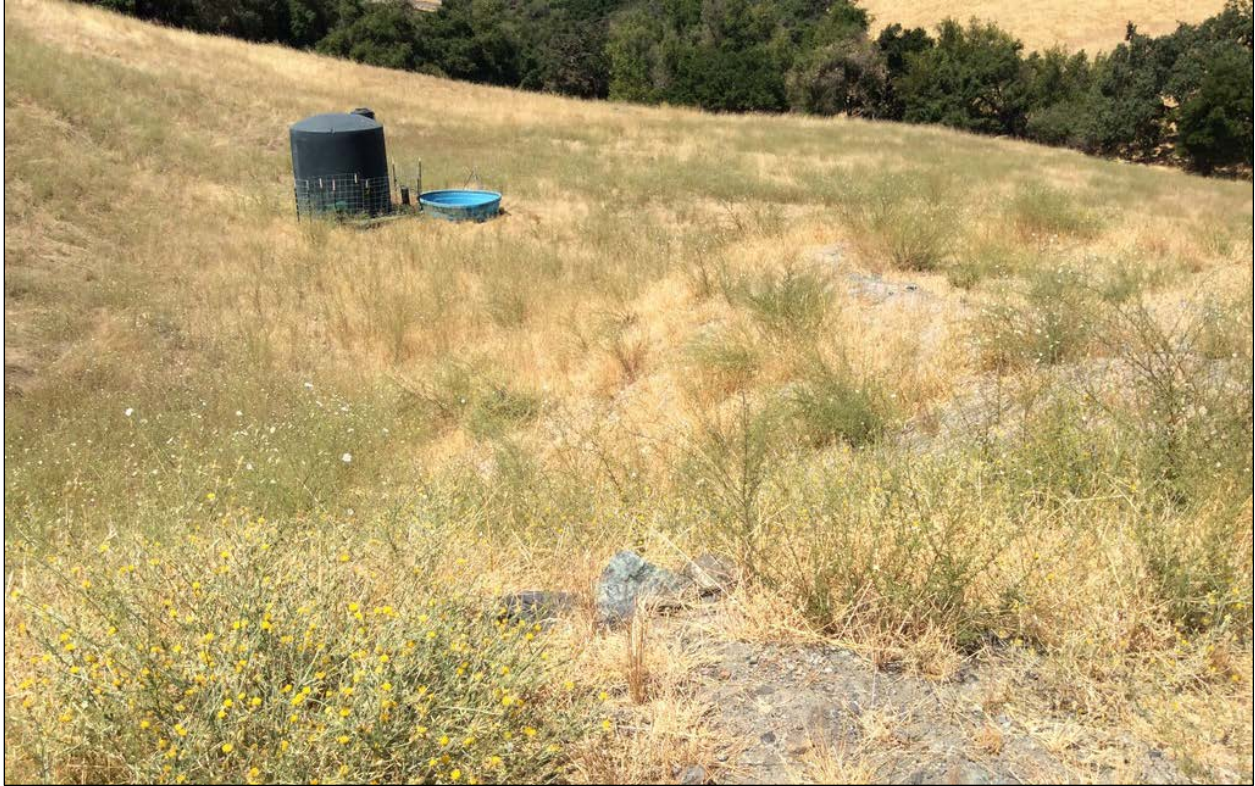
**Photo 19. Year 1 Conditions at Photo Point 7c during Vegetation Monitoring at the Pond Mitigation Site (August 8, 2017)**

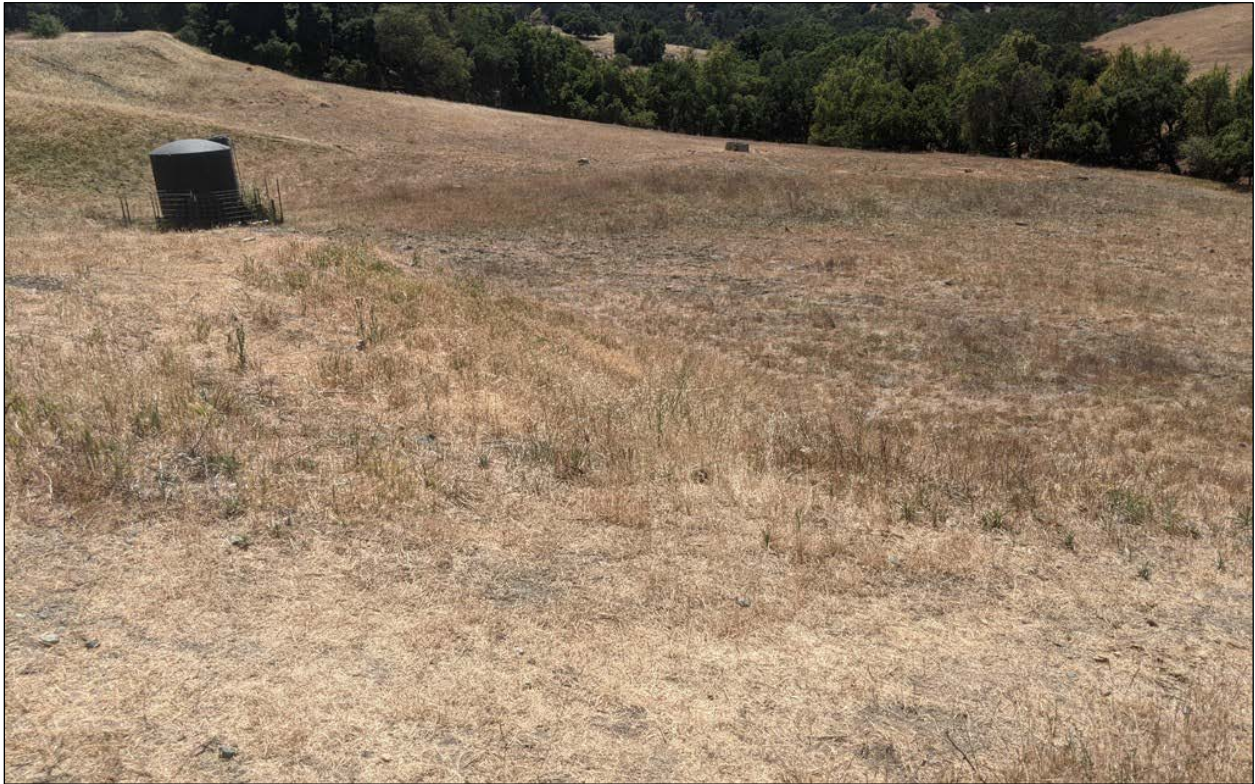
**Photo 20. Year 5 Conditions at Photo Point 7c during Vegetation Monitoring at the Pond Mitigation Site (May 20, 2021)**

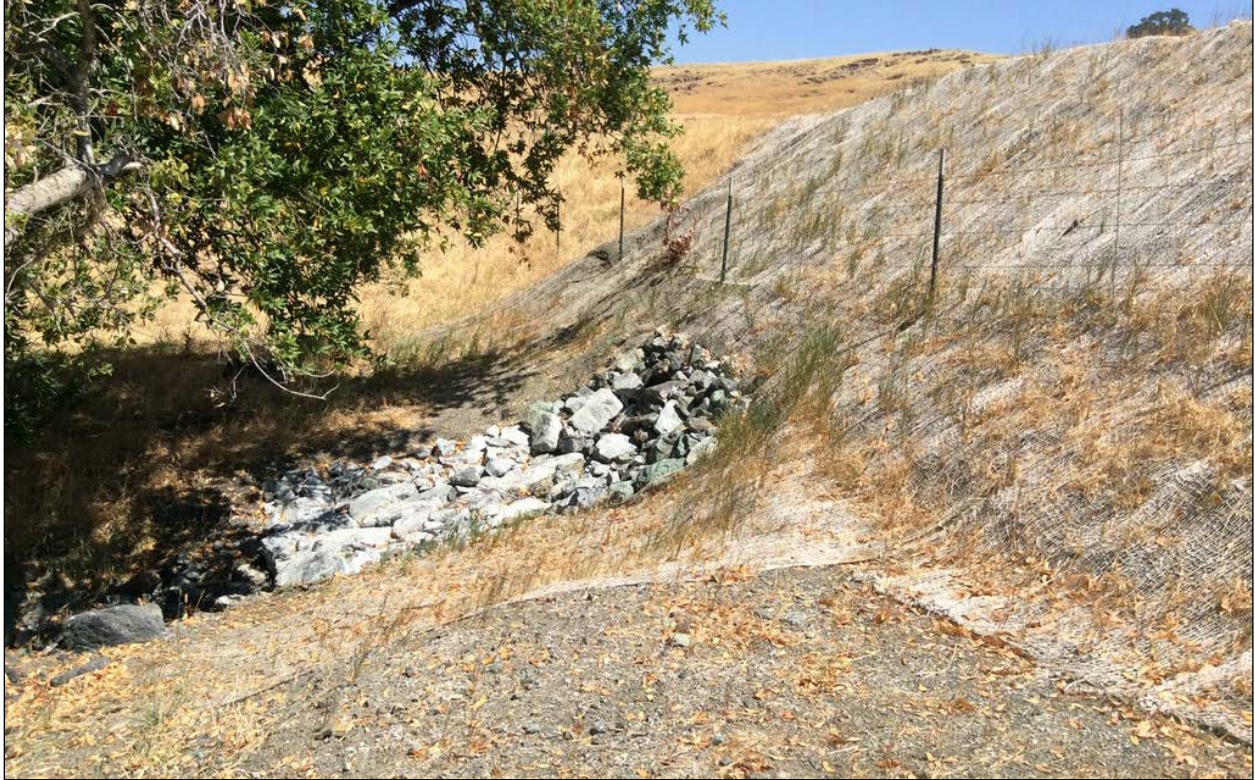
**Photo 21. Year 1 Conditions at Photo Point 8 during Vegetation Monitoring at the Pond Mitigation Site (August 8, 2017)**

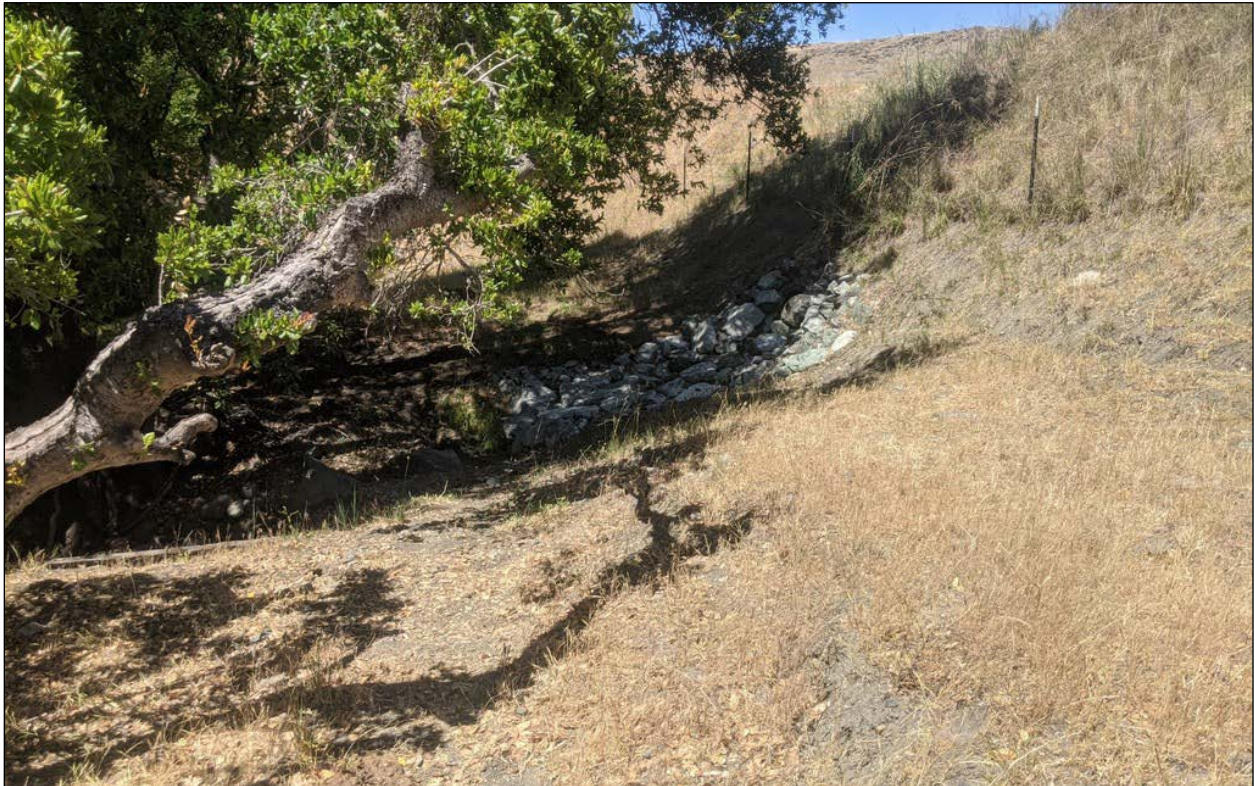
**Photo 22. Year 5 Conditions at Photo Point 8 during Vegetation Monitoring at the Pond Mitigation Site (May 20, 2021)**

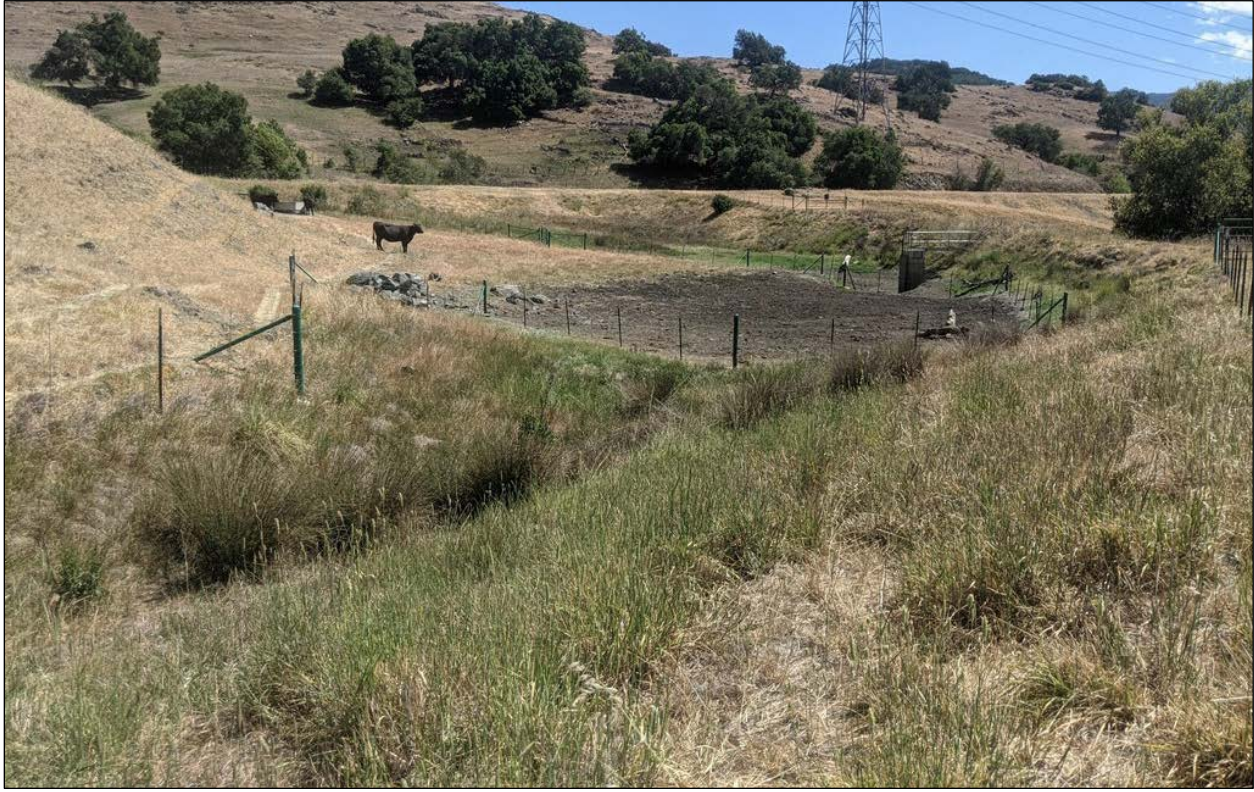
**Photo 24. Year 5 Conditions at Photo Point 9 during Vegetation Monitoring at the Pond Mitigation Site (May 20, 2021)**

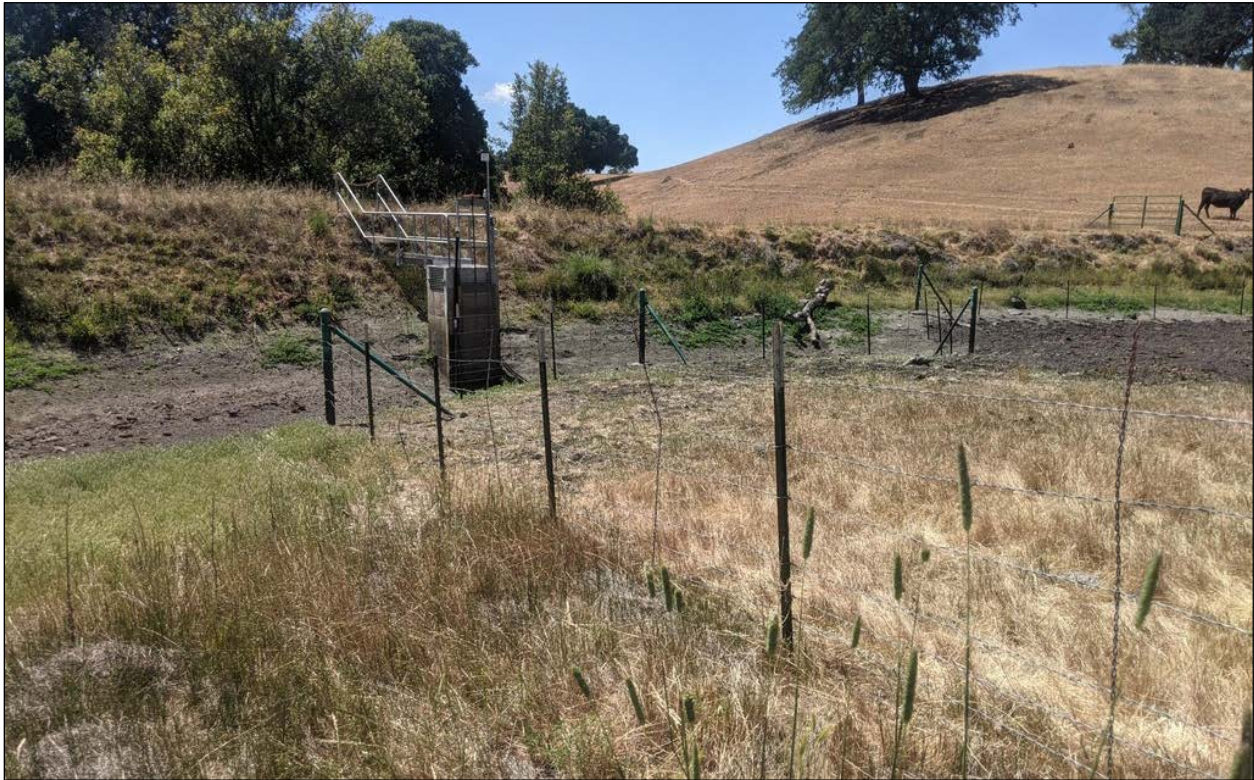
**Photo 26. Year 5 Conditions at Photo Point 10 during Vegetation Monitoring at the Pond Mitigation Site (May 20, 2021)**

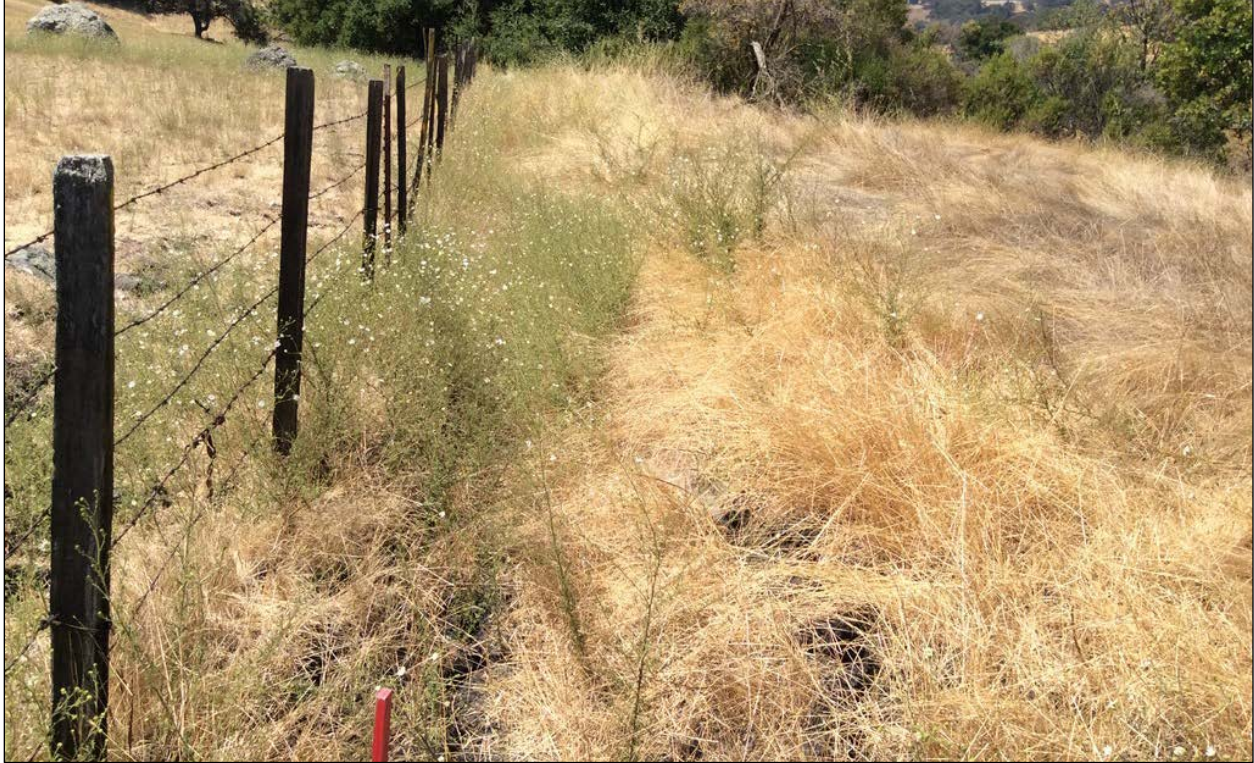
**Photo 27. Year 1 Conditions at Photo Point 11 during Vegetation Monitoring, Where the Hillside Seep Collection Ditch was Enhanced in the Seep Collection Area (August 8, 2017)**

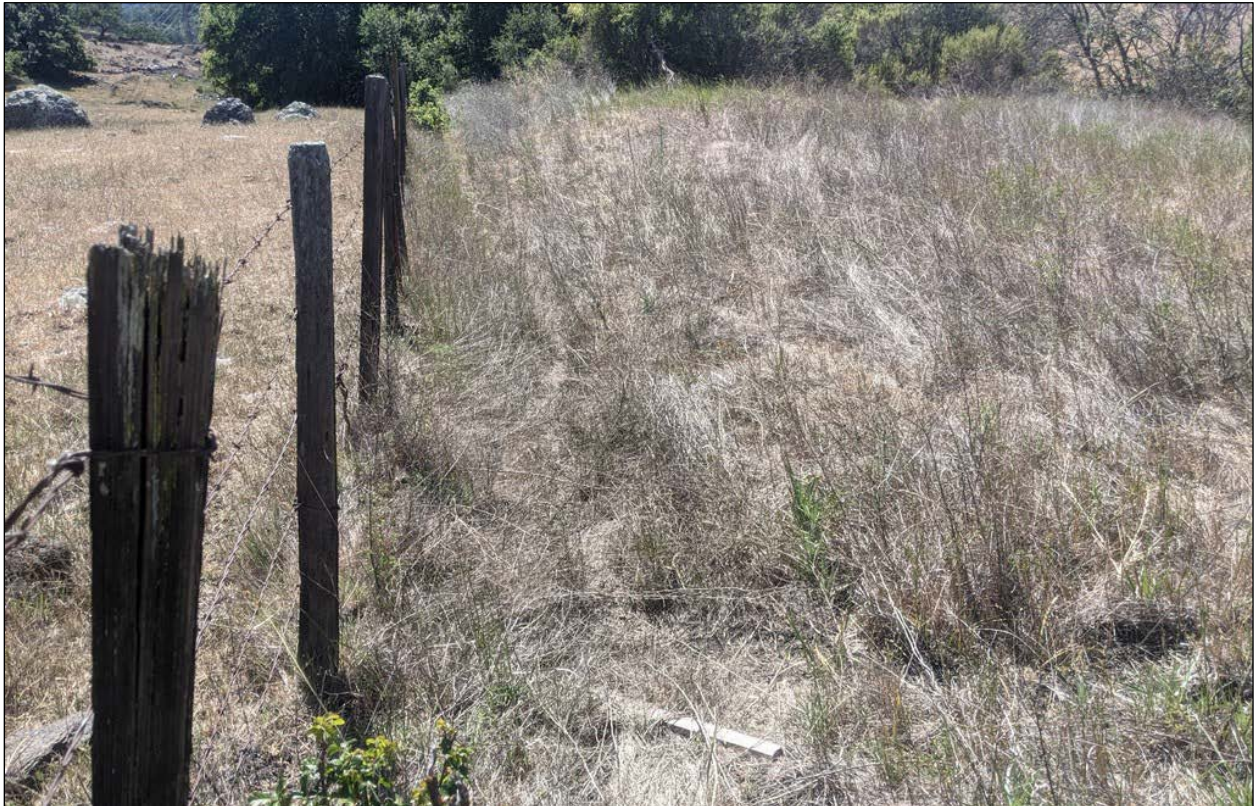
**Photo 28. Year 5 Conditions at Photo Point 11 during Vegetation Monitoring, Where the Hillside Seep Collection Ditch was Enhanced in the Seep Collection Area (May 20, 2021)**
