**Calero County Park Pond and Wetland  
Restoration Project—  
Year 5 (2021) Monitoring Report**

**Project # 3753-07**

January 3, 2022

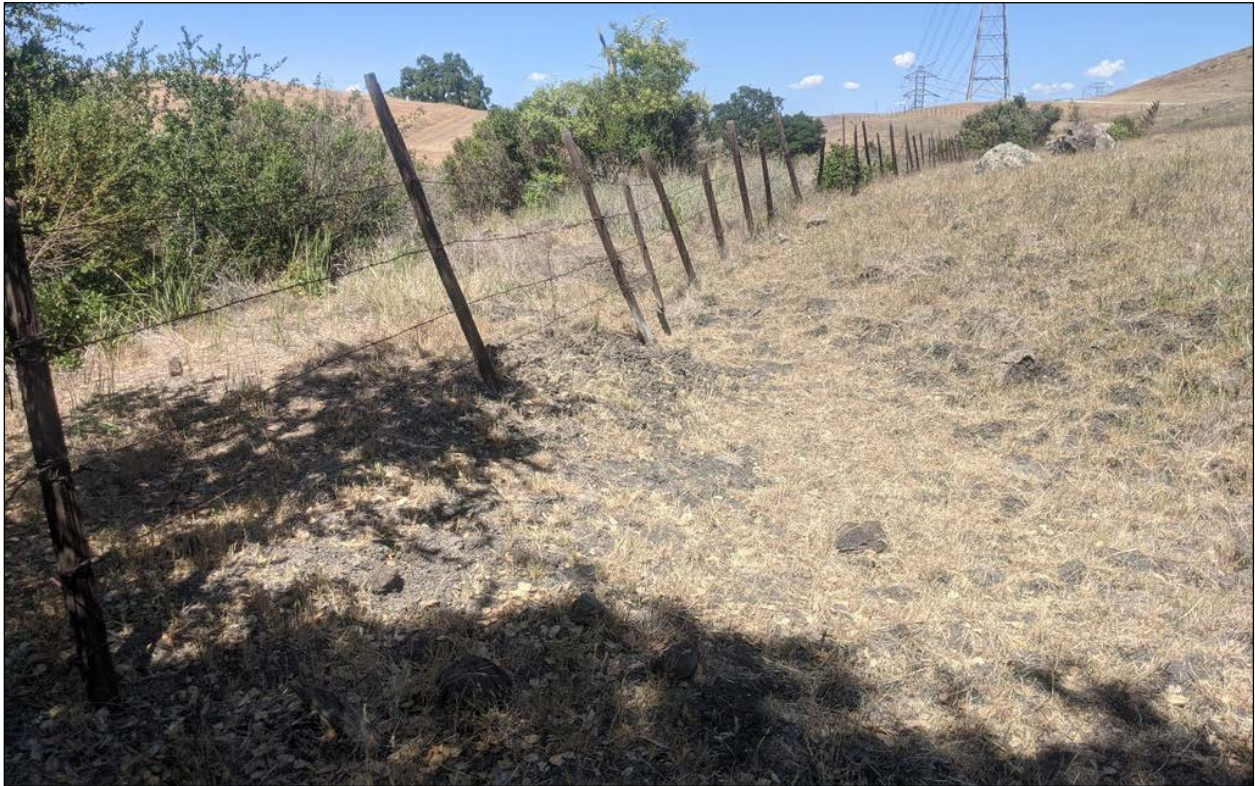
**Photo 30. Year 5 Conditions at Photo Point 12 during Vegetation Monitoring, Where the Hillside Seep Collection Ditch was Enhanced in the Seep Collection Area (May 20, 2021)**

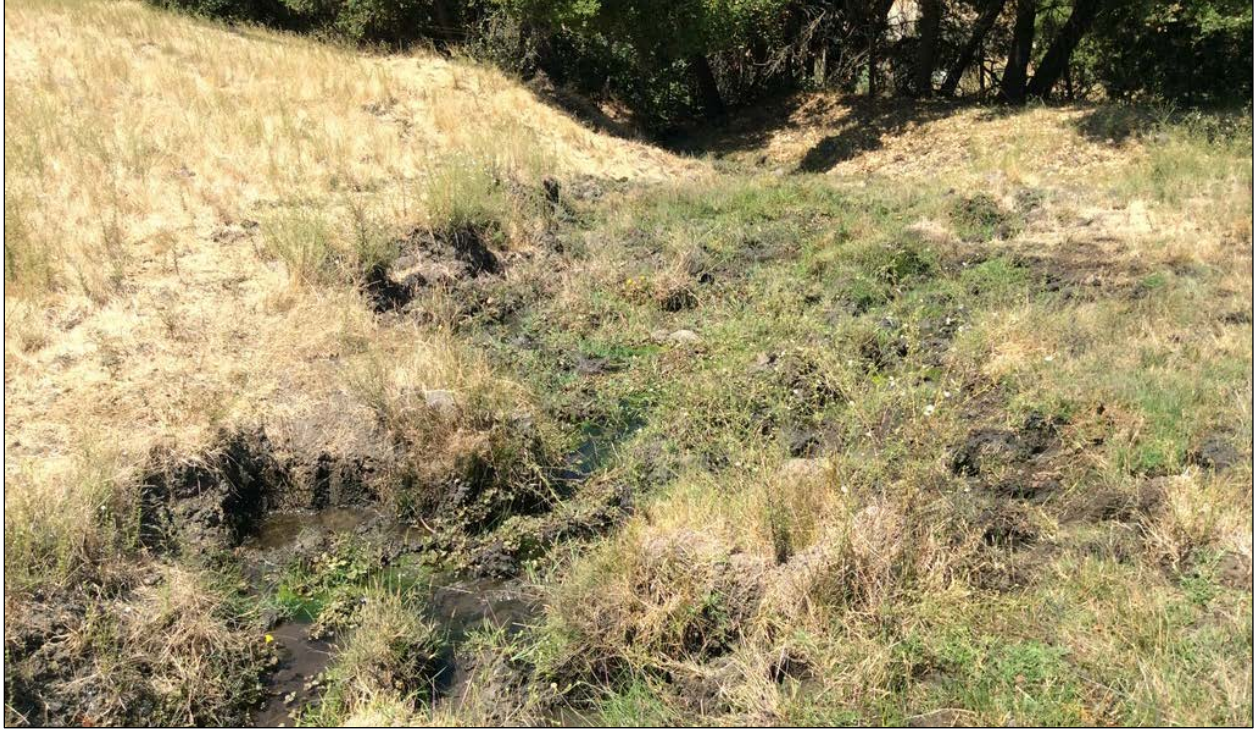
**Photo 31. Year 1 Conditions at Photo Point 13 during Vegetation Monitoring, at an Existing Seep in the Seep Collection Area That Wasn't Disturbed during Construction (August 8, 2017)**

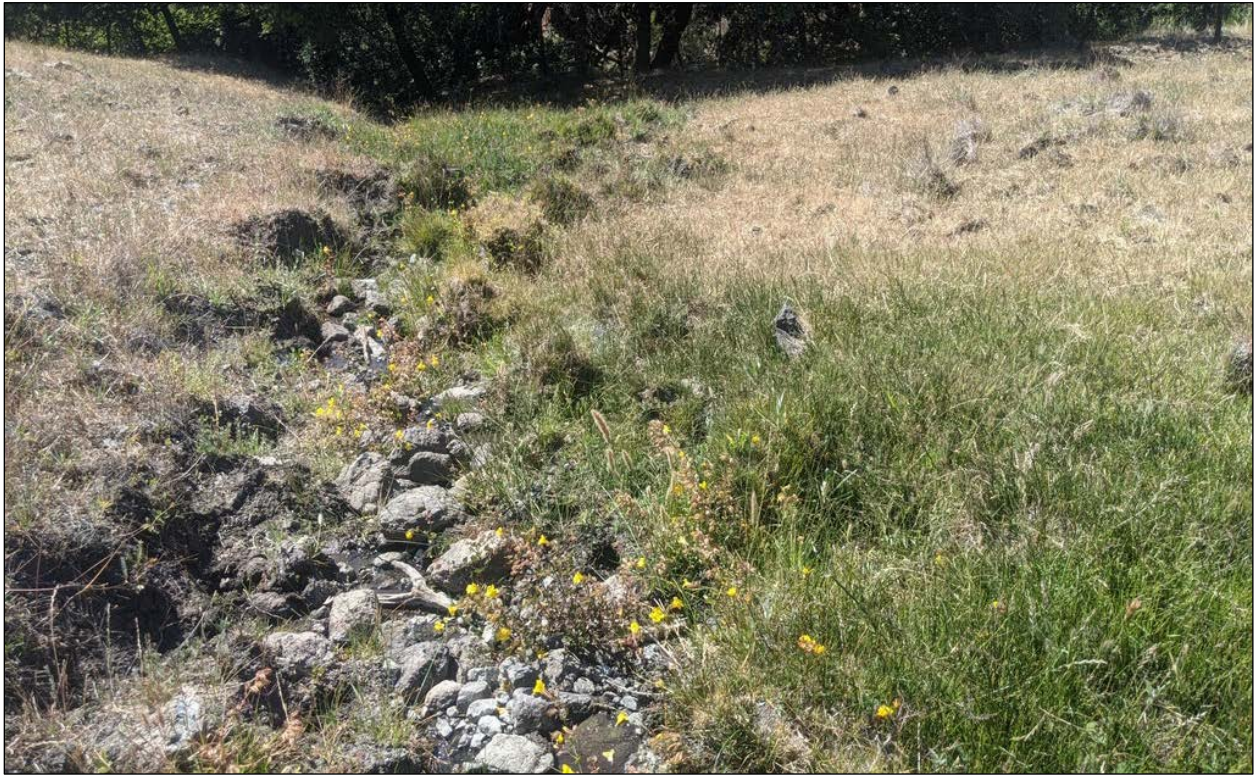
**Photo 32. Year 5 Conditions at Photo Point 13 during Vegetation Monitoring, at an Existing Seep in the Seep Collection Area That Wasn't Disturbed during Construction (May 20, 2021)**

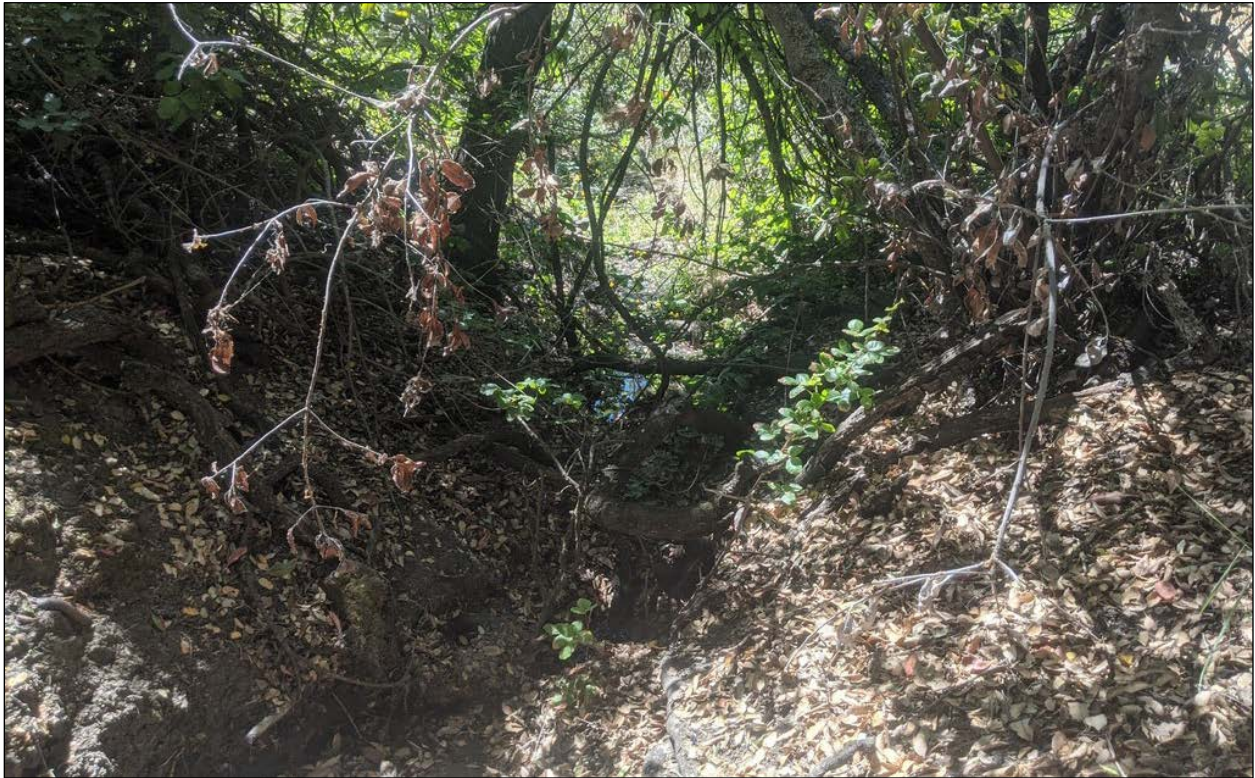
**Photo 34. Year 5 Conditions at Photo Point 14 during Vegetation Monitoring, Where Debris Jams Were Installed in the Seep Collection Area (May 20, 2021)**

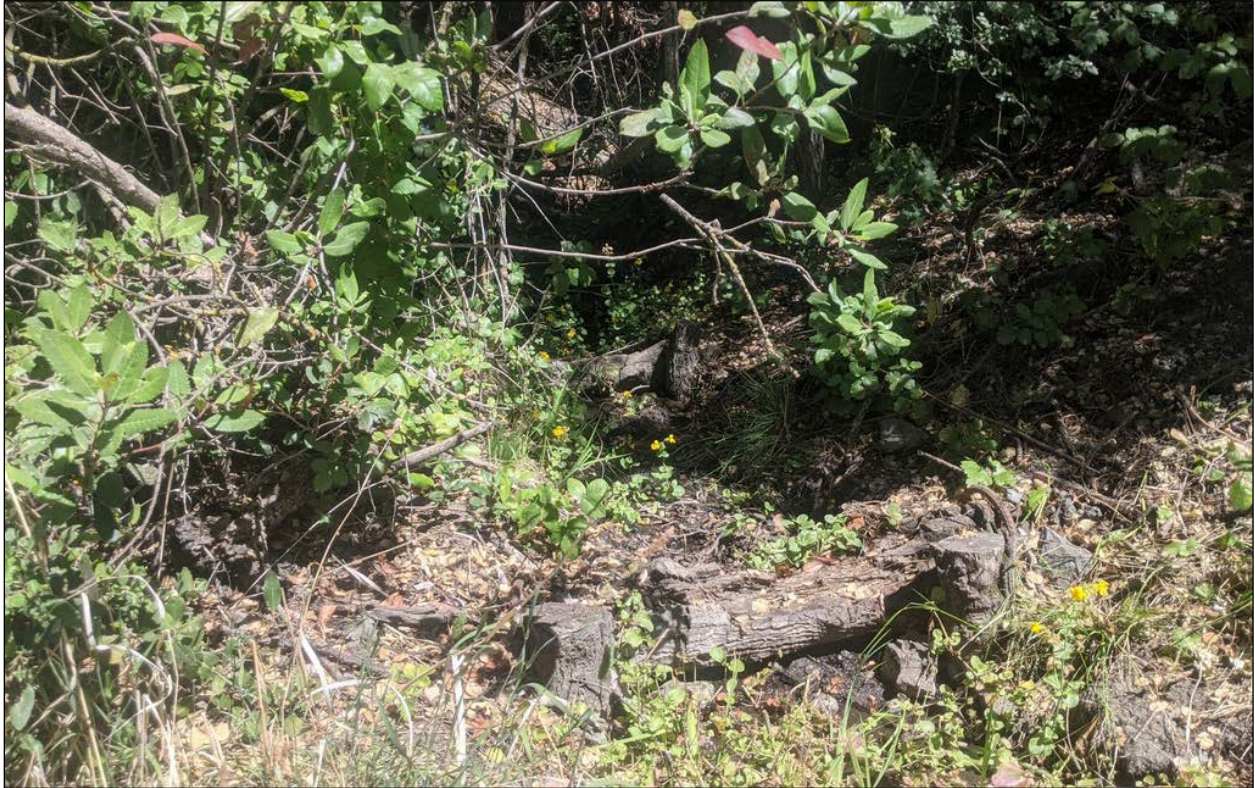
**Photo 36. Year 5 Conditions at Photo Point 15 during Vegetation Monitoring, with a Log Debris Jam Installed in the Seep Collection Area (May 20, 2021)**

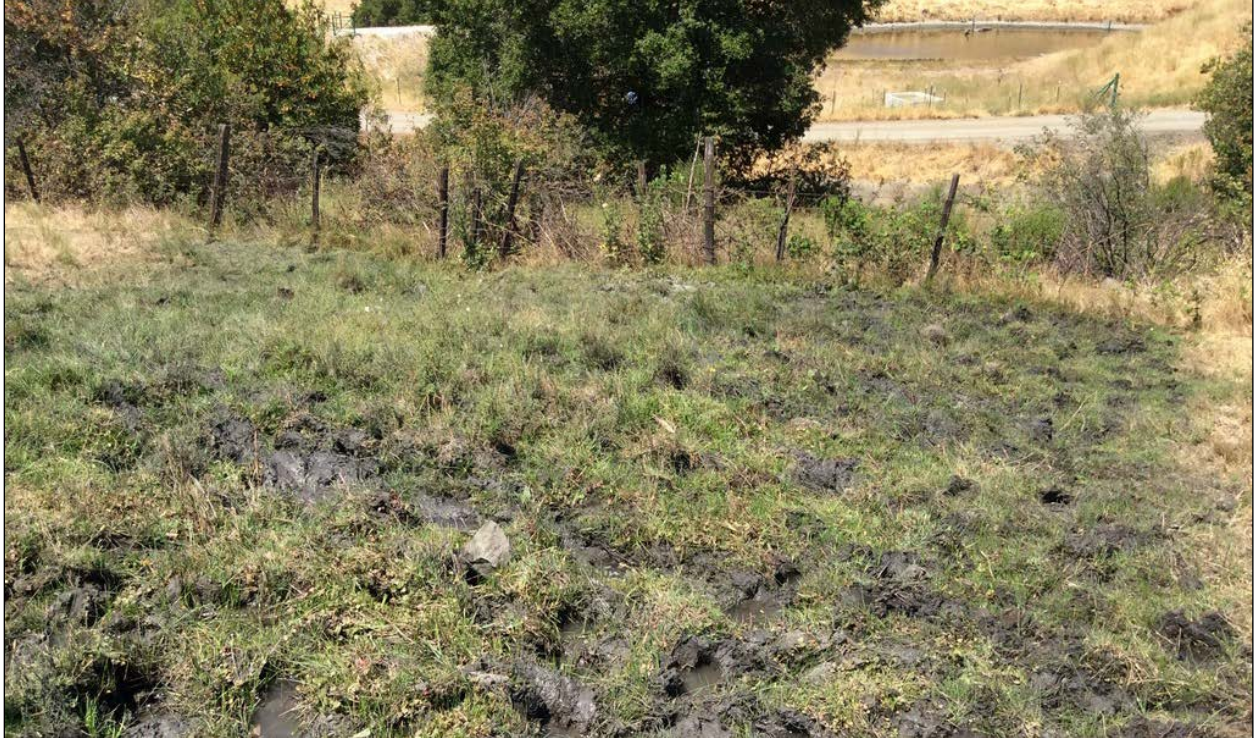
**Photo 37. Year 1 Conditions at Photo Point 16 during Vegetation Monitoring, at an Existing Seep in the Seep Collection Area That Wasn't Disturbed during Construction (August 8, 2017)**

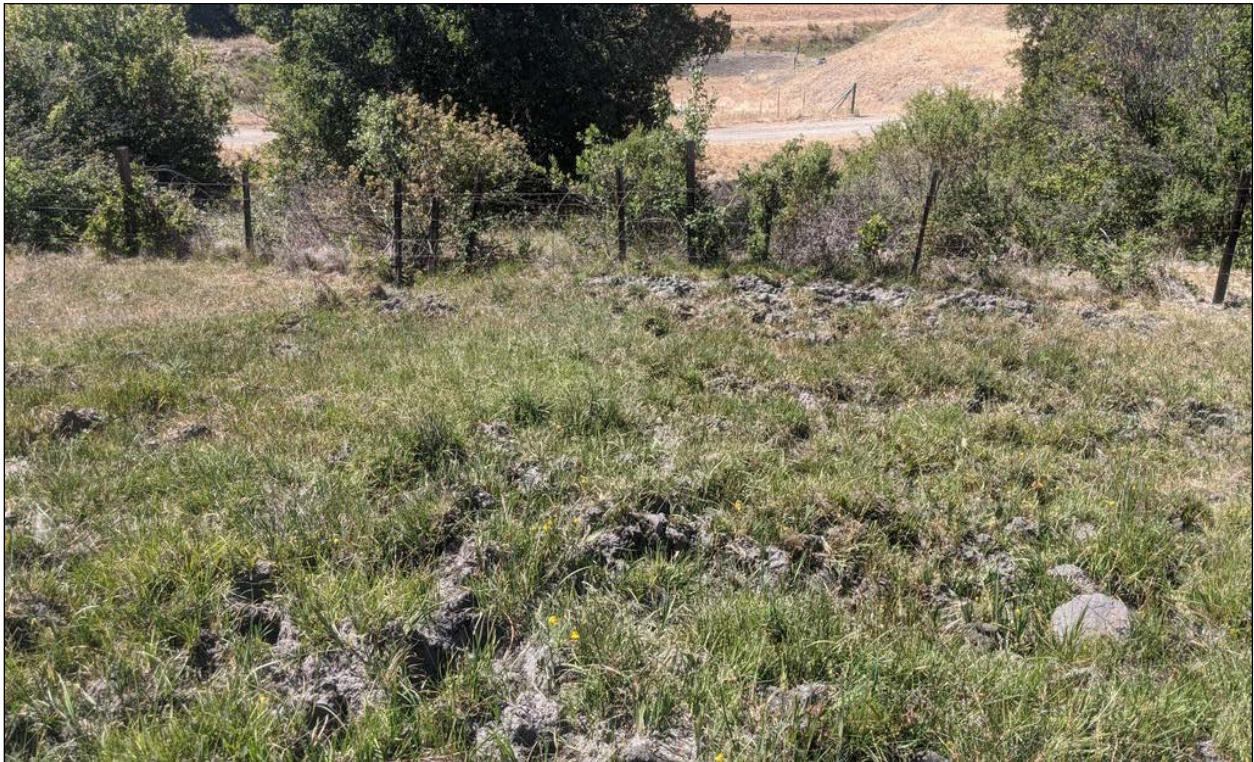
**Photo 38. Year 5 Conditions at Photo Point 16 during Vegetation Monitoring, at an Existing Seep in the Seep Collection Area That Wasn't Disturbed during Construction (May 20, 2021)**

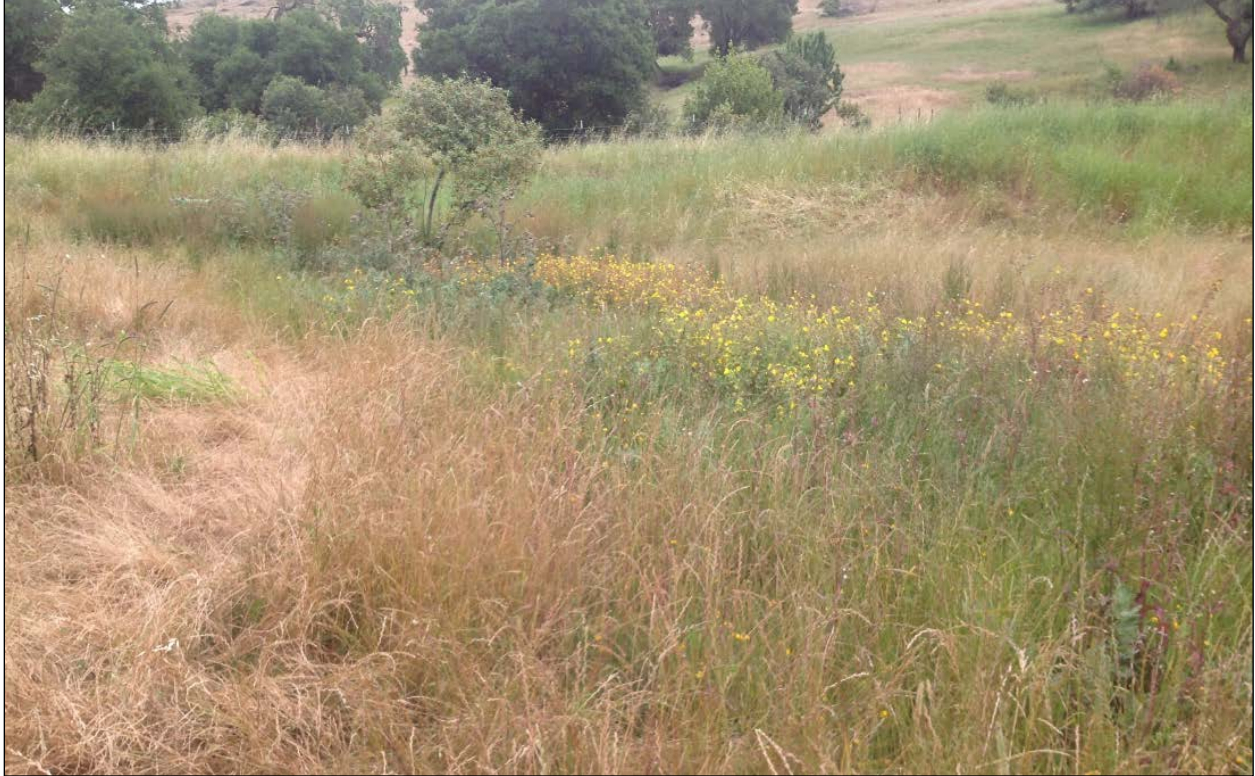
**Photo 39. Year 1 Conditions at Photo Point 17 during Mt. Hamilton Thistle Abundance Monitoring at the Pond Mitigation Site (August 8, 2017)**

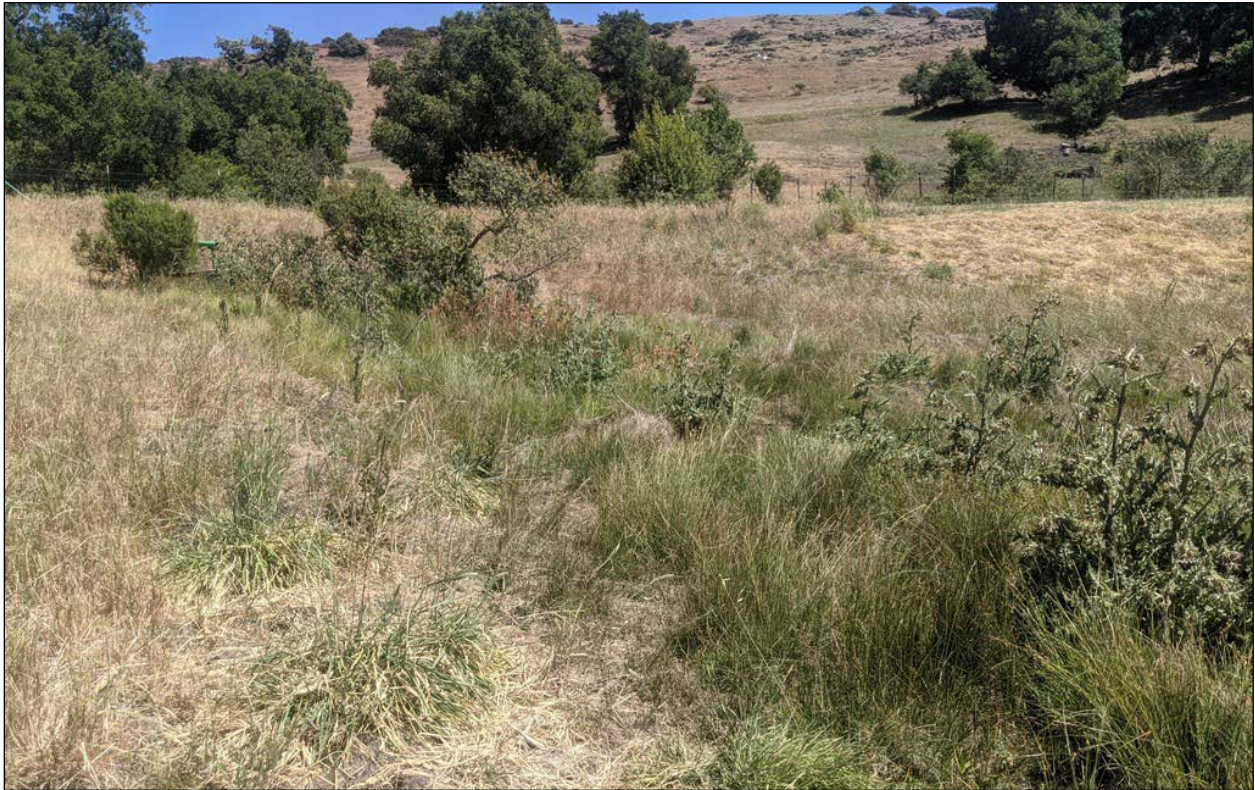
**Photo 40. Year 5 Conditions at Photo Point 17 during Mt. Hamilton Thistle Abundance Monitoring at the Pond Mitigation Site (May 20, 2021)**

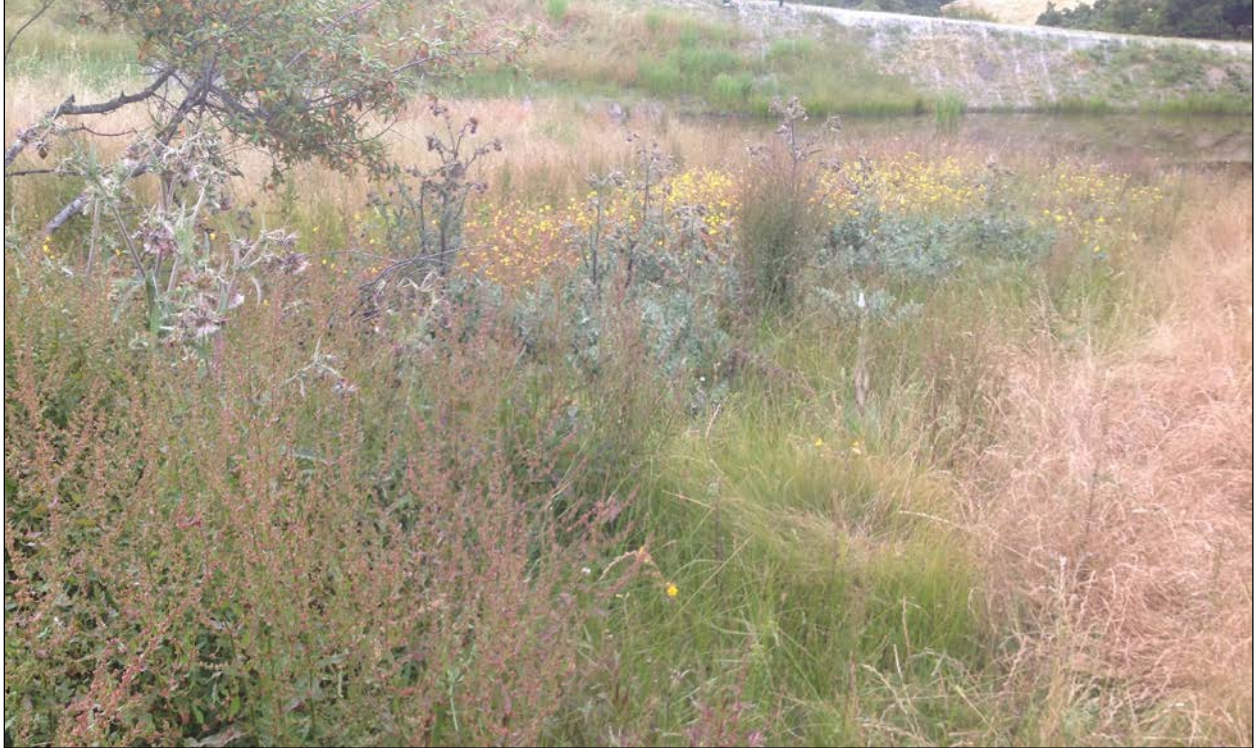
**Photo 41. Year 1 Conditions at Photo Point 18 during Mt. Hamilton Thistle Abundance Monitoring at the Pond Mitigation Site (Note flowering Mt. Hamilton Thistle Individuals; August 8, 2017)**

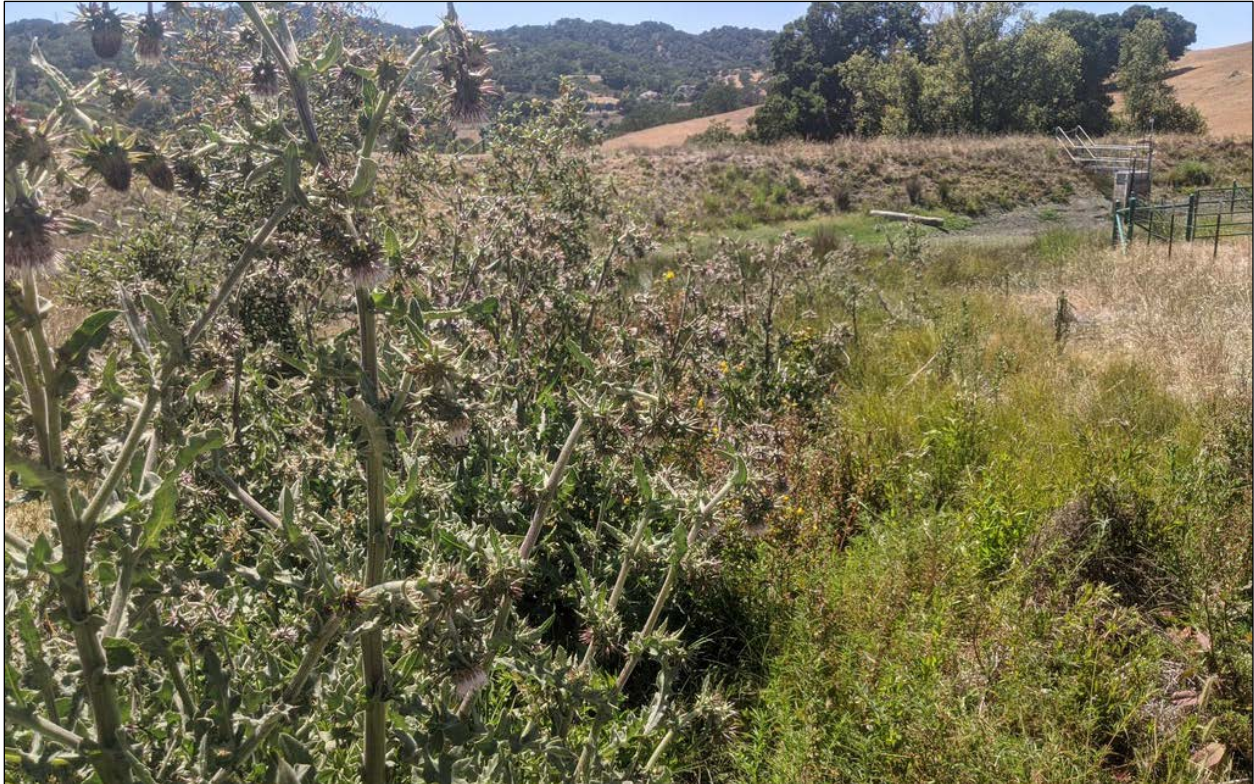
**Photo 42. Year 5 Conditions at Photo Point 18 during Mt. Hamilton Thistle Abundance Monitoring at the Pond Mitigation Site (May 20, 2021)**

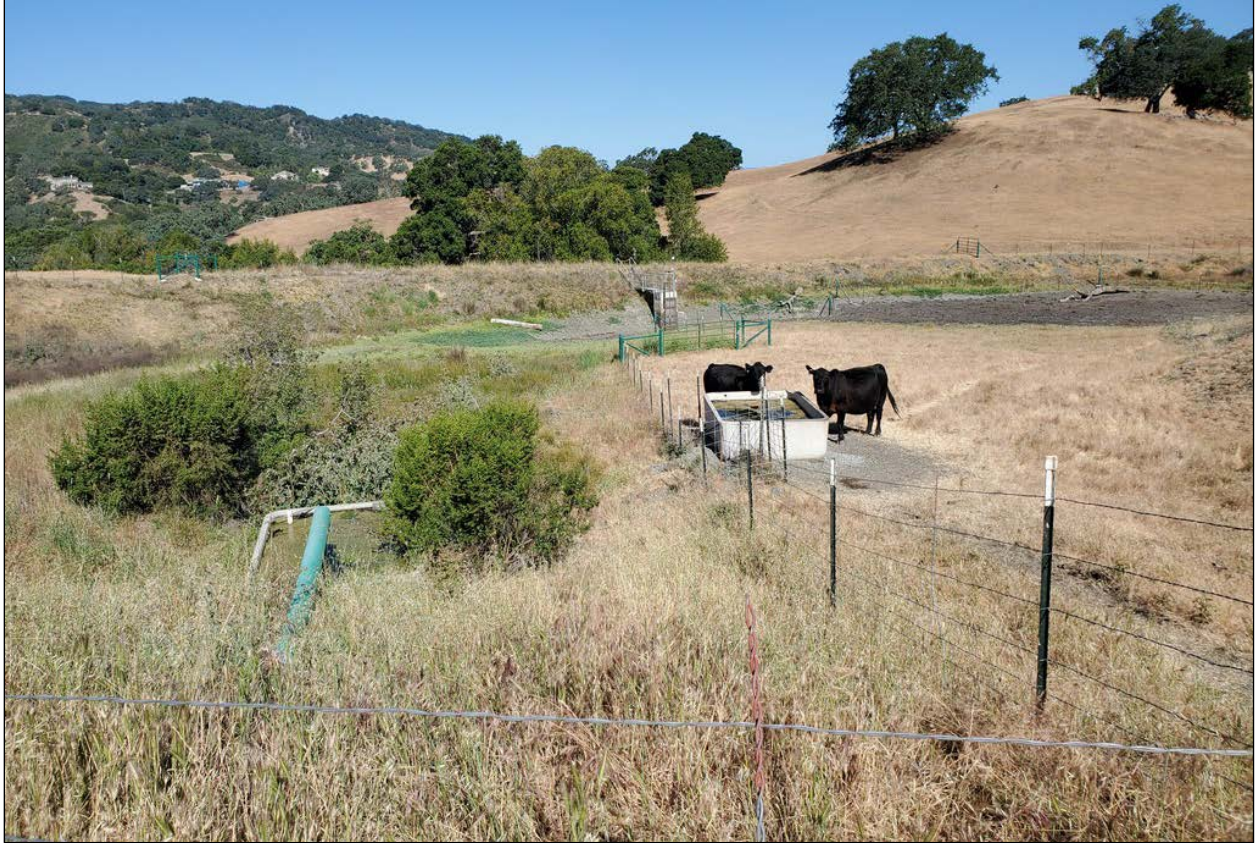
Photo 43. Cattle Using Water Trough near the Mt. Hamilton Thistle Population (May 20, 2021)

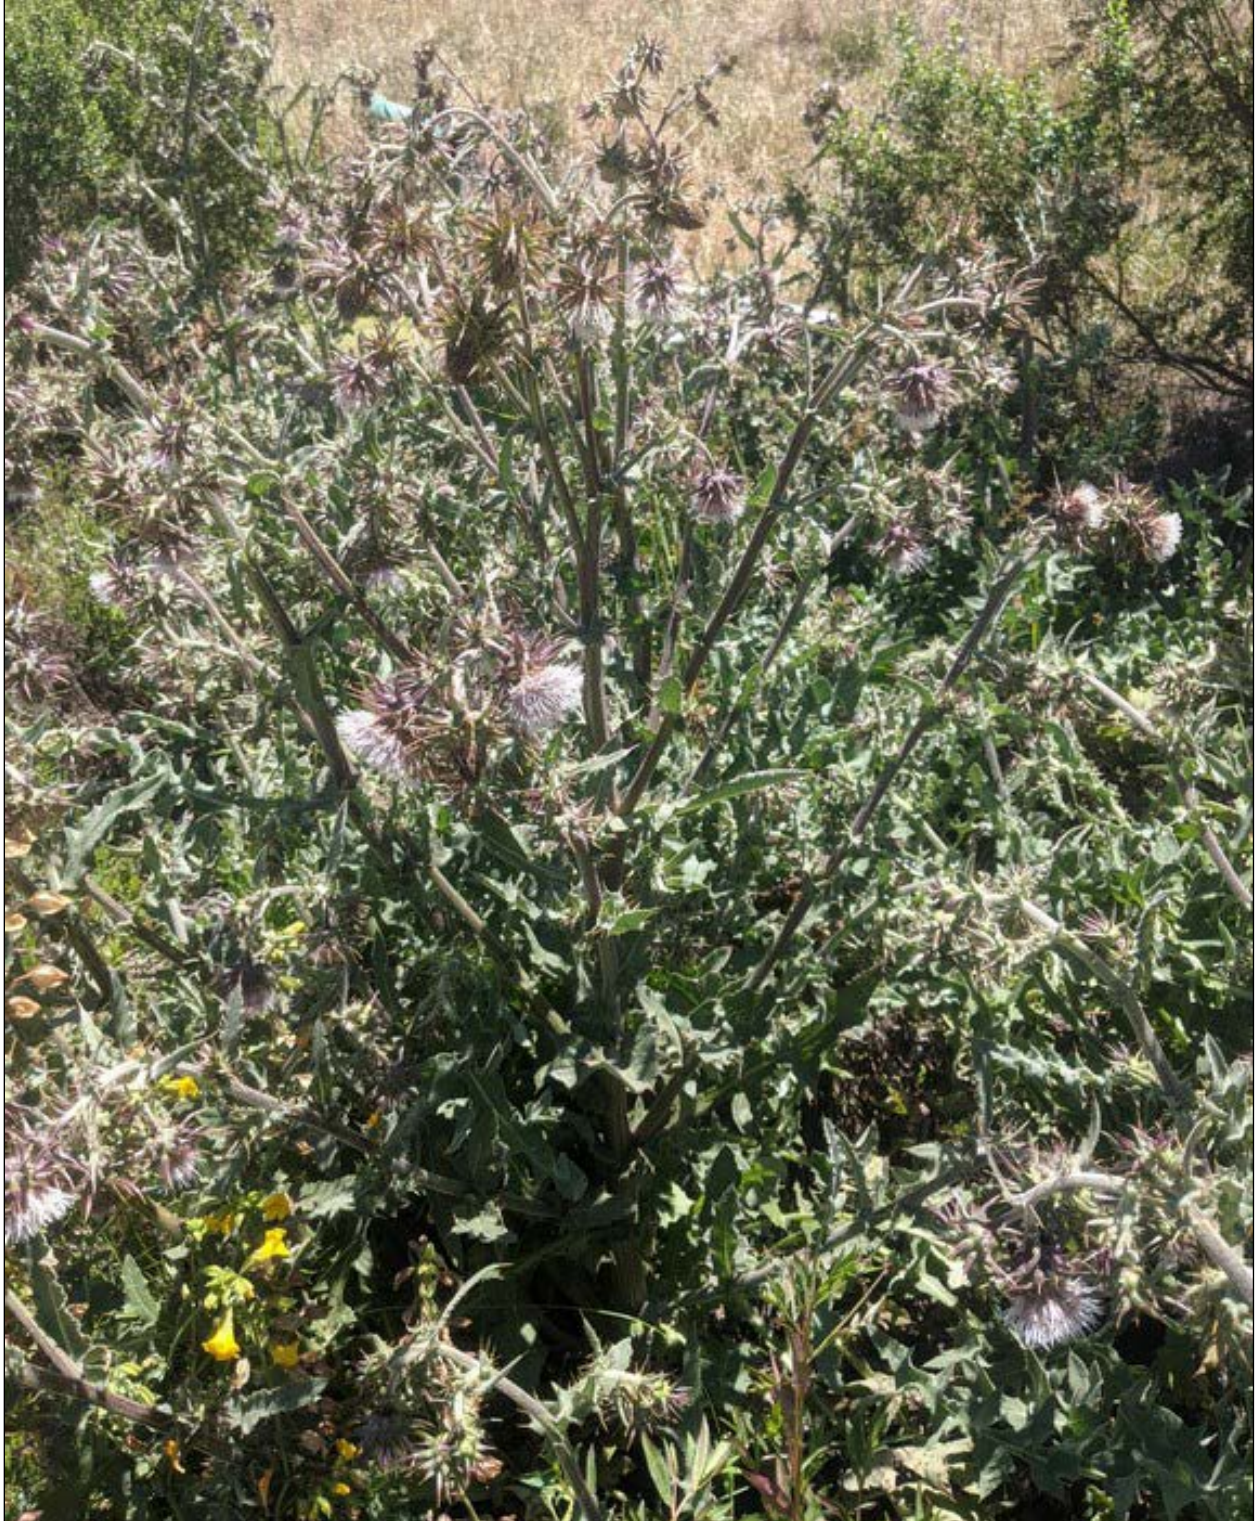
Photo 44. Mt. Hamilton Thistle in Flower (May 20, 2021)

The abundance of Mt. Hamilton thistle in the seep wetland population at the pond mitigation site decreased from 96 individuals in Year 4 to 69 individuals in Year 5. Forty-two individuals were flowering during Year 5 monitoring (Section D, Photo 44) and others were in bud. The Mt. Hamilton thistle population decreased by 0.02 acre between Year 4 and Year 5 and encompassed approximately 0.03 acre (Section E; Figure 3). Within the Mt. Hamilton thistle population extent, Mt. Hamilton thistle average percent cover decreased from 37.0% in Year 4 to 25.3% in Year 5. Overall health and vigor of individuals in the population was good. The majority of plants were large, mature individuals, and approximately 10% of the population were seedlings. No Mt. Hamilton thistle were observed at the wetland mitigation site during Year 5 monitoring. Photodocumentation of the Mt. Hamilton thistle population is included in Section D.

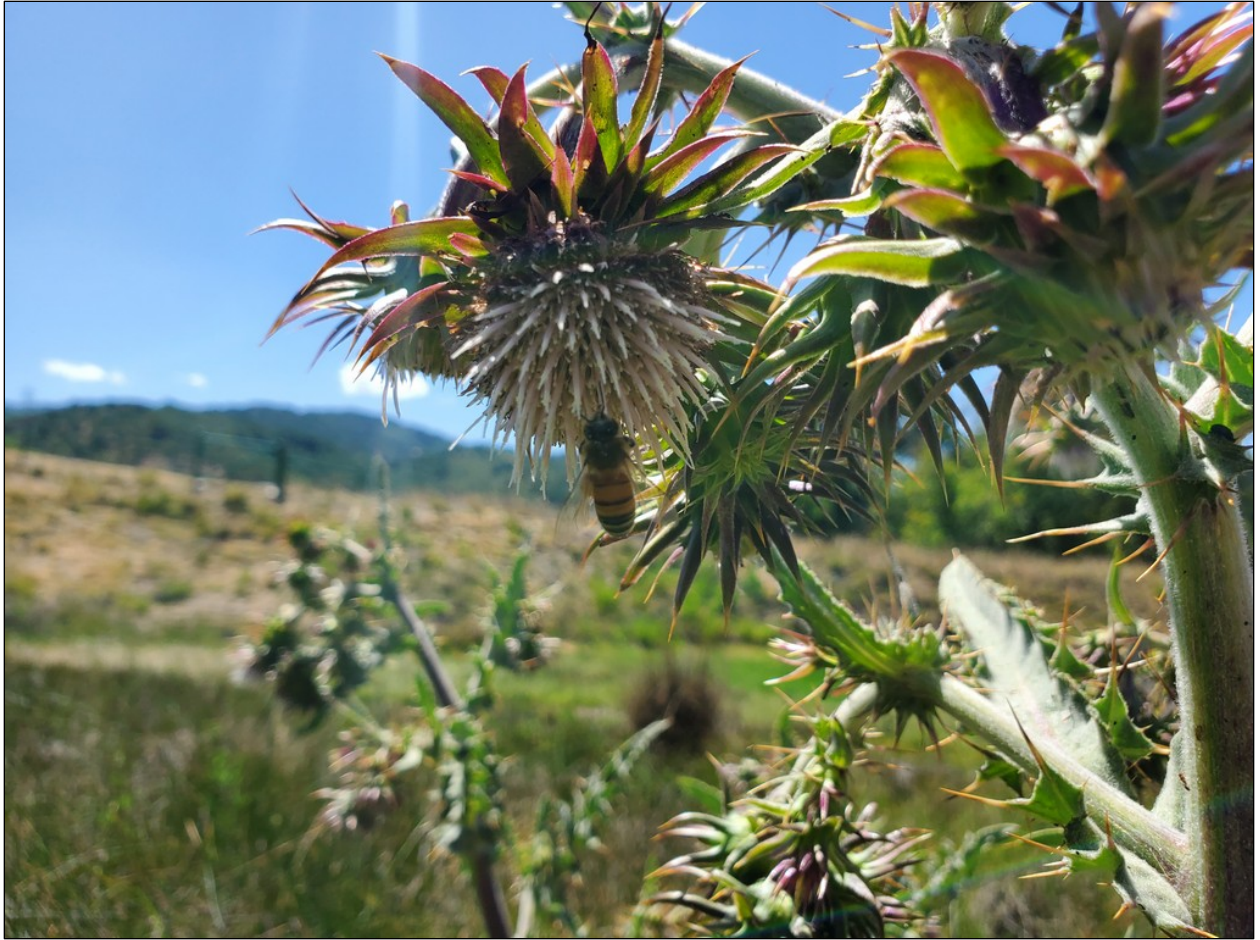
Photo 45. Mt. Hamilton Thistle Flower Head with a Bee (May 20, 2021)

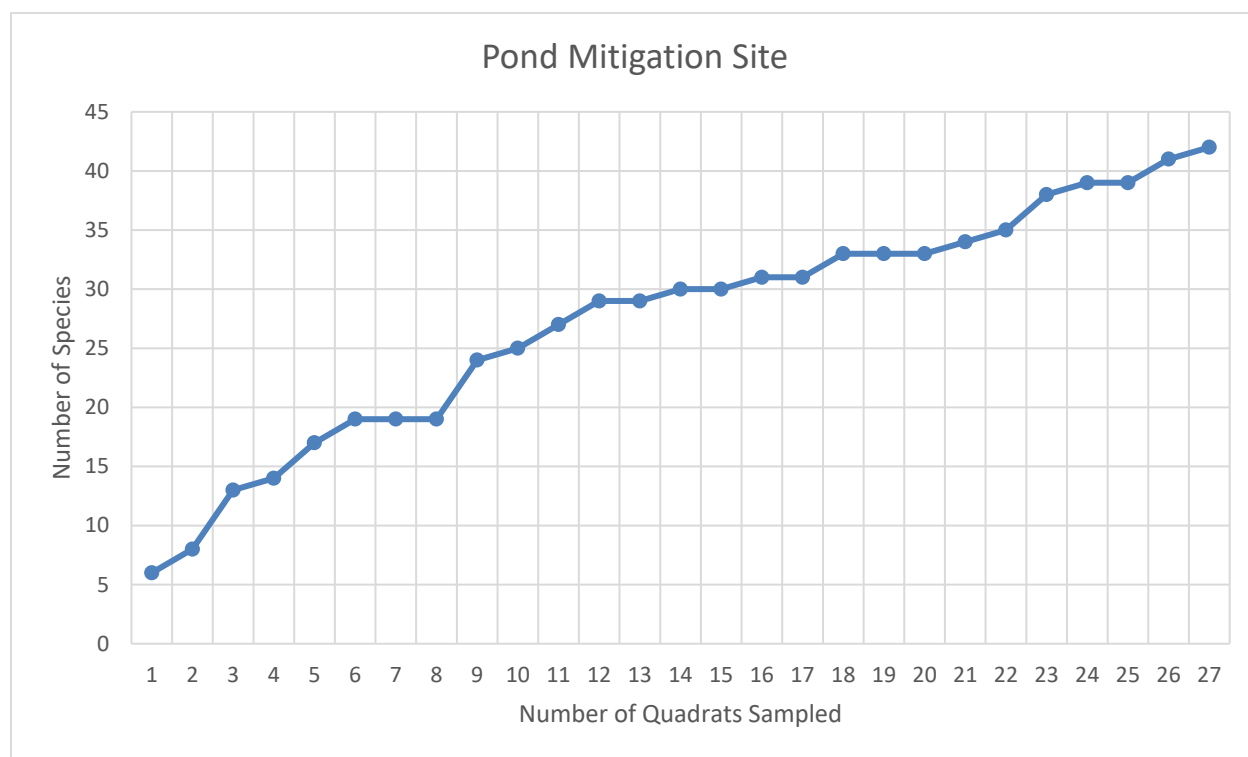
Figure A-1. Species Accumulation Curve for the Pond Mitigation Site

Sampling intensity was determined to be sufficient for the pond and wetland mitigation sites by verifying that the average cover values were stable relative to the number of samples collected (Kershaw 1973). We concluded that the sampling effort was representative of the site and sufficient based on the stable average cover and low level of standard error in our results.

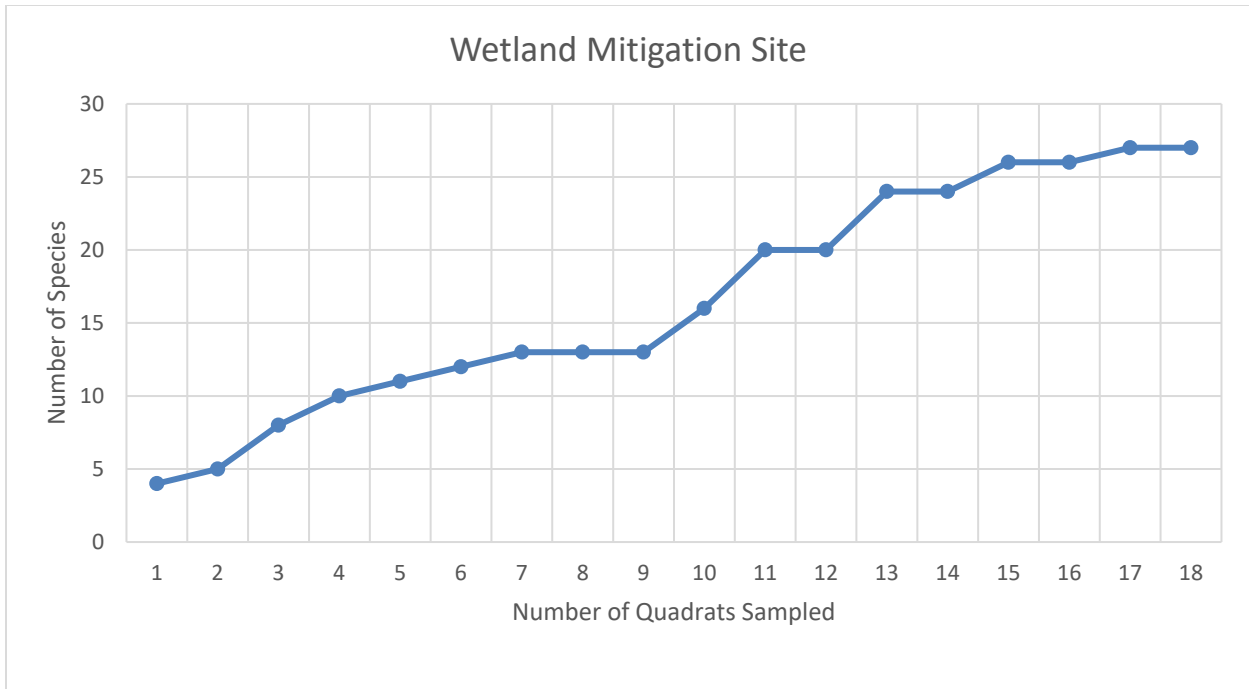
Figure A-2. Species Accumulation Curve for the Wetland Mitigation Site

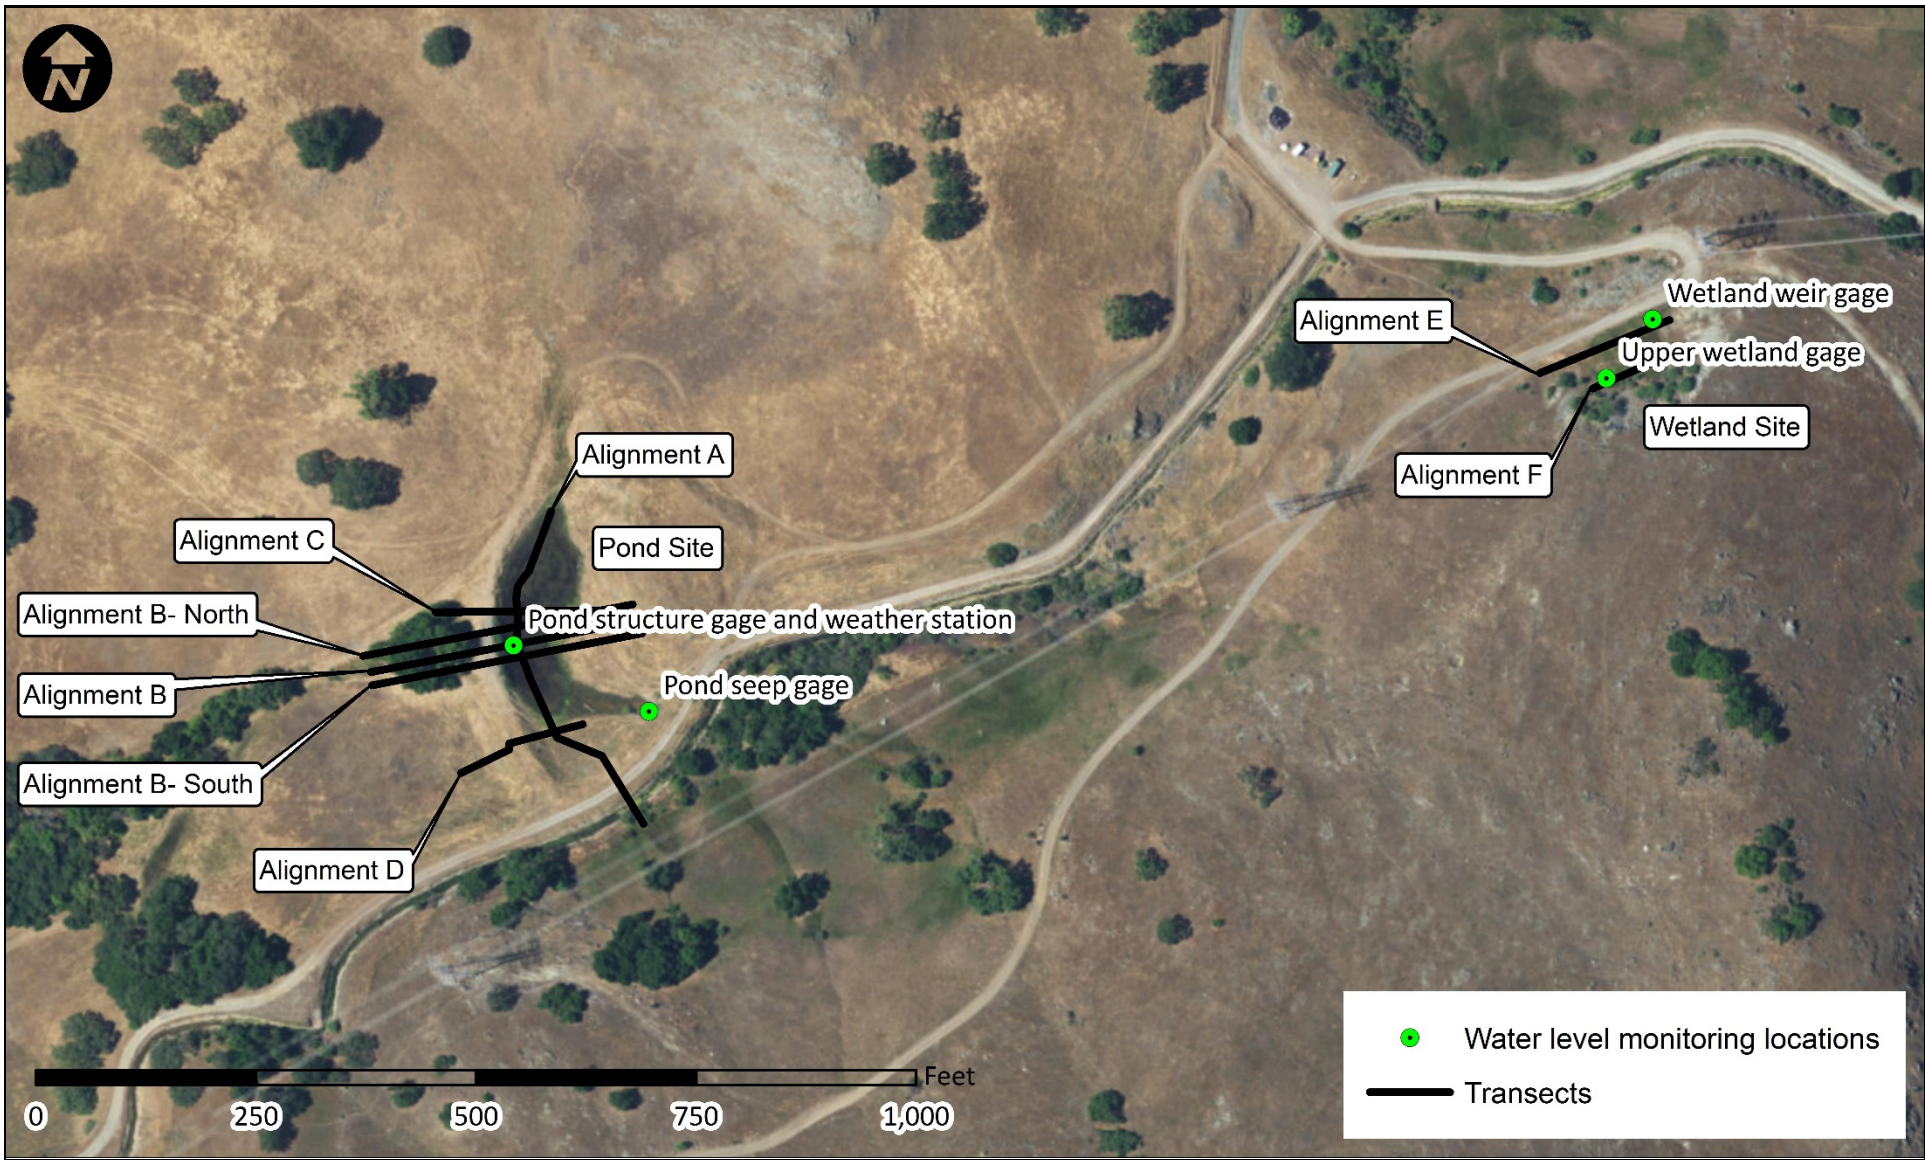
Fig2\_PondWaterLevels\_Year5\_20211014\_i1.docx  
11/19/2021

In Year 5, the pond site reached a maximum water level of 508.1 ft on January 30, 2021, which is below the full capacity elevation of 508.5 ft (Figure 2). The peak elevation was in response to the only major precipitation event of the year and receded without interruption until going dry on May 15, 2021. The seep flow remained directed toward the pond the entire year, but most of the water was likely intercepted by cattle drinking at the trough. The pond trough gage shows that the elevation fluctuations induced by cattle watering habits began as access to the pond diminished and the waterline receded out of their reach beyond the fenced-off section. This was the most notable period of cattle consumption of seep flows since the project construction.

During Year 1 (cbec, 2017), the pond maintained maximum capacity of 508.5 ft from January through early May when above normal (i.e., wet WY) precipitation and seep flows were contributing to the pond (Figure 2). The pond water levels drew down at a consistent rate starting in mid-May through mid-September, which correlates to the dry season when the seep inflow decreases. By September 19, 2017, the pond was emptied to manage for invasive species (crayfish and bullfrogs).

In Year 3, the pond maintained maximum capacity from January through mid-April when above normal (i.e., wet WY) precipitation and seep flows were contributing to the pond (Figure 2). The pond water levels drew down at a consistent rate starting in early May through early September, which correlates to the dry season when the seep inflow decreases. On September 9, 2019, seep flow was completely diverted away from the pond to the water storage tank, which caused a slightly sharper drop in water level. Then, on October 30, 2019, the pond was emptied to manage for invasive species (crayfish and bullfrogs).

In Year 4, the pond never reached maximum capacity, but the maximum water level was observed on April 7, 2020 at 506.9 ft (Figure 2). This peak occurred at the only time of the year when the seep flow

Regarding hydrologic performance standards, the pond exceeded a target water depth of at least two feet (i.e., 4.8 feet) through the end of August in Year 1. In Year 2, the water depth fell below the hydrologic performance standard. The pond did not fill to capacity and did not meet the two-foot water depth target for the end of August. As shown by Figure 2, there was an increase in the draw down rate of the pond water level at the beginning of June that corresponds to the period of time that the rancher started pumping from the water trough to water cattle. In addition to this increase in draw down rate, the fact that Year 2 was a very dry WY or well below normal (average) conditions largely contributed to not meeting the two-foot water depth target at the end of August. Year 3 did meet the hydrologic performance standard (i.e., 2.49 ft on August 31, 2019). As shown by Figure 2, there was an increase in the draw down rate of the pond water level at the end of June that corresponds to the period of time that the rancher started pumping from the water trough to water cattle. Years 4 and 5 did not meet the hydrologic performance standards because they were both very dry WYs or well below normal (average) conditions. This is due to both water years having the lowest recorded rainfall total in the last 30 years.

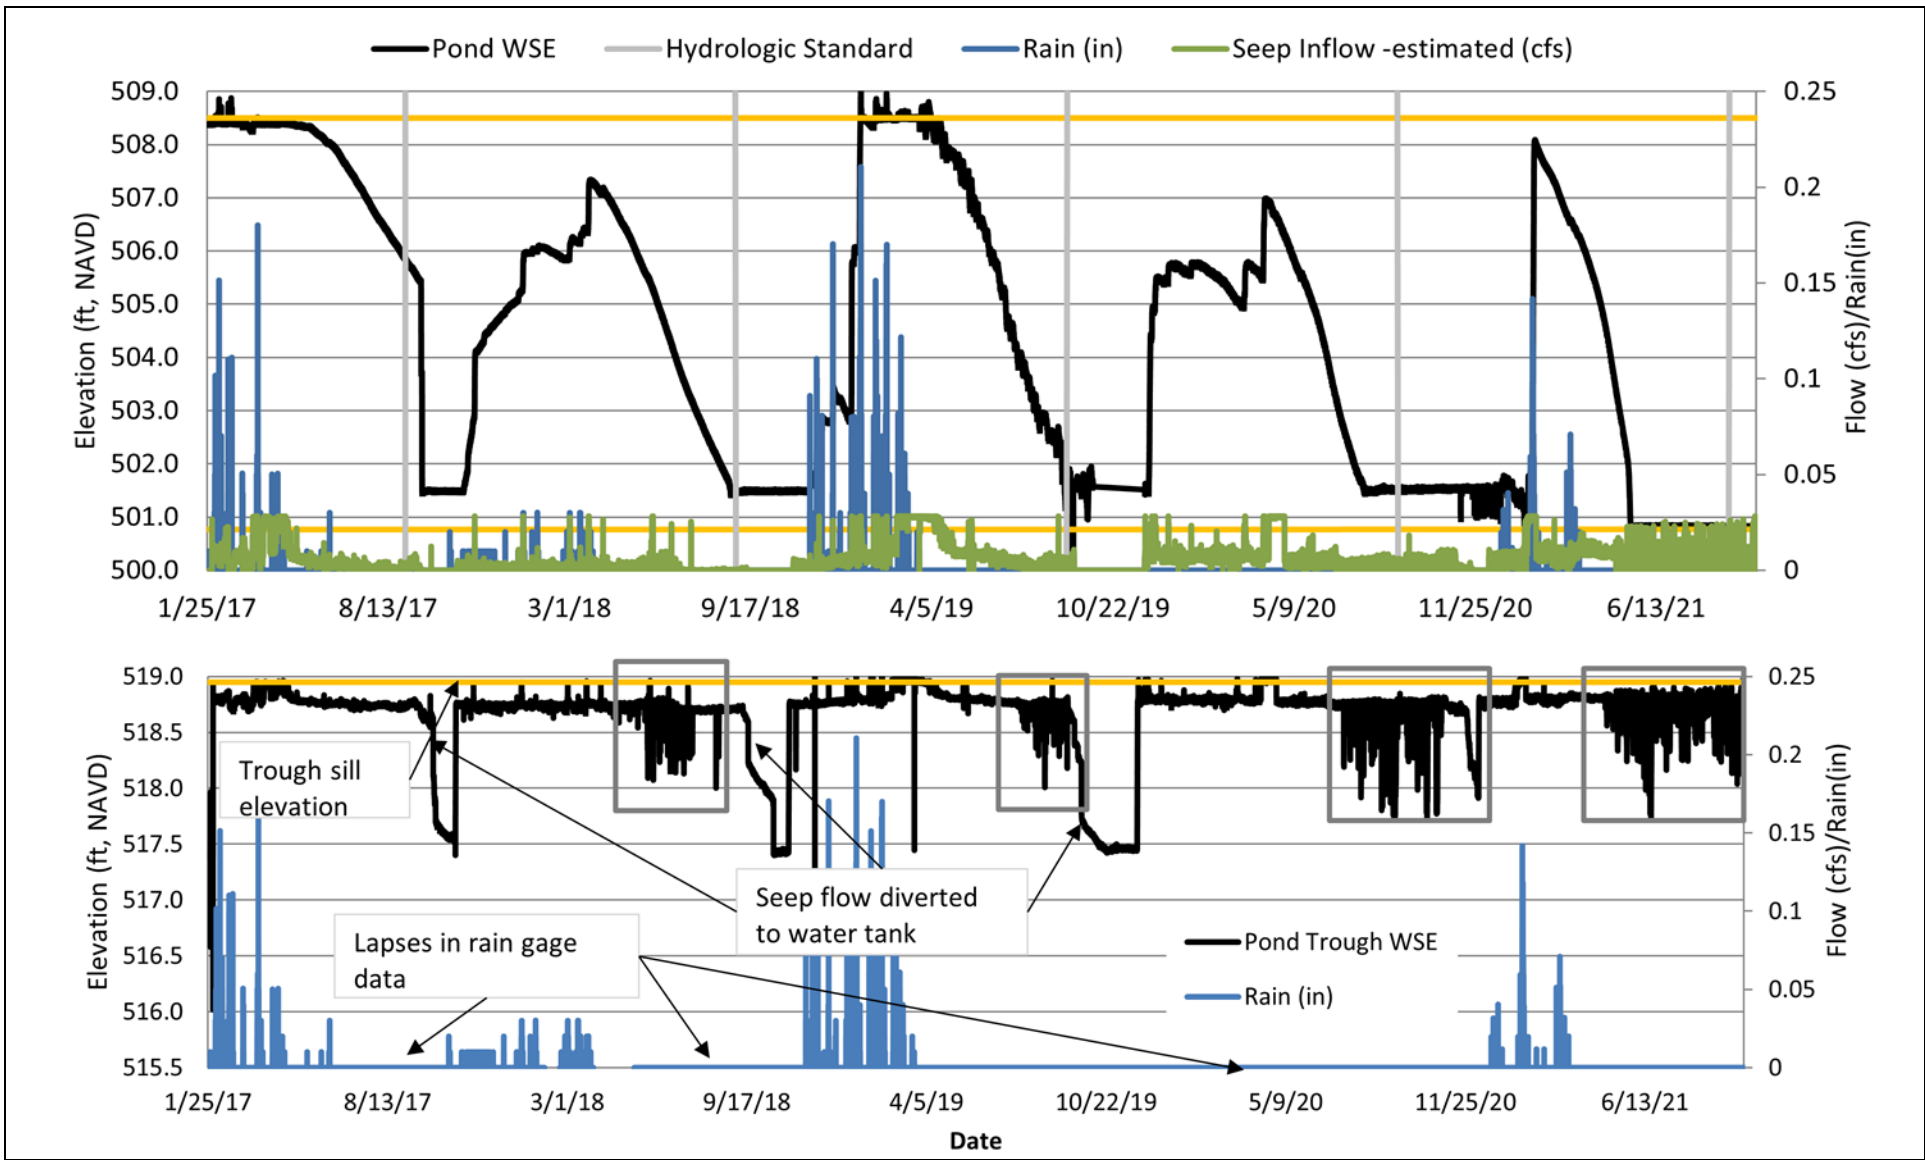
Notes: Gray boxes denote periods where cattle used the trough as a water source. Seep inflows are estimated using rating curve established by measuring trough water levels and outflows. When the trough was full the highest recorded seep inflow was 0.028 cfs. In reality, seep inflows can be greater than 0.028 cfs when the trough capacity is exceeded.
