**Calero County Park Pond and Wetland  
Restoration Project—  
Year 5 (2021) Monitoring Report**

**Project # 3753-07**

January 3, 2022

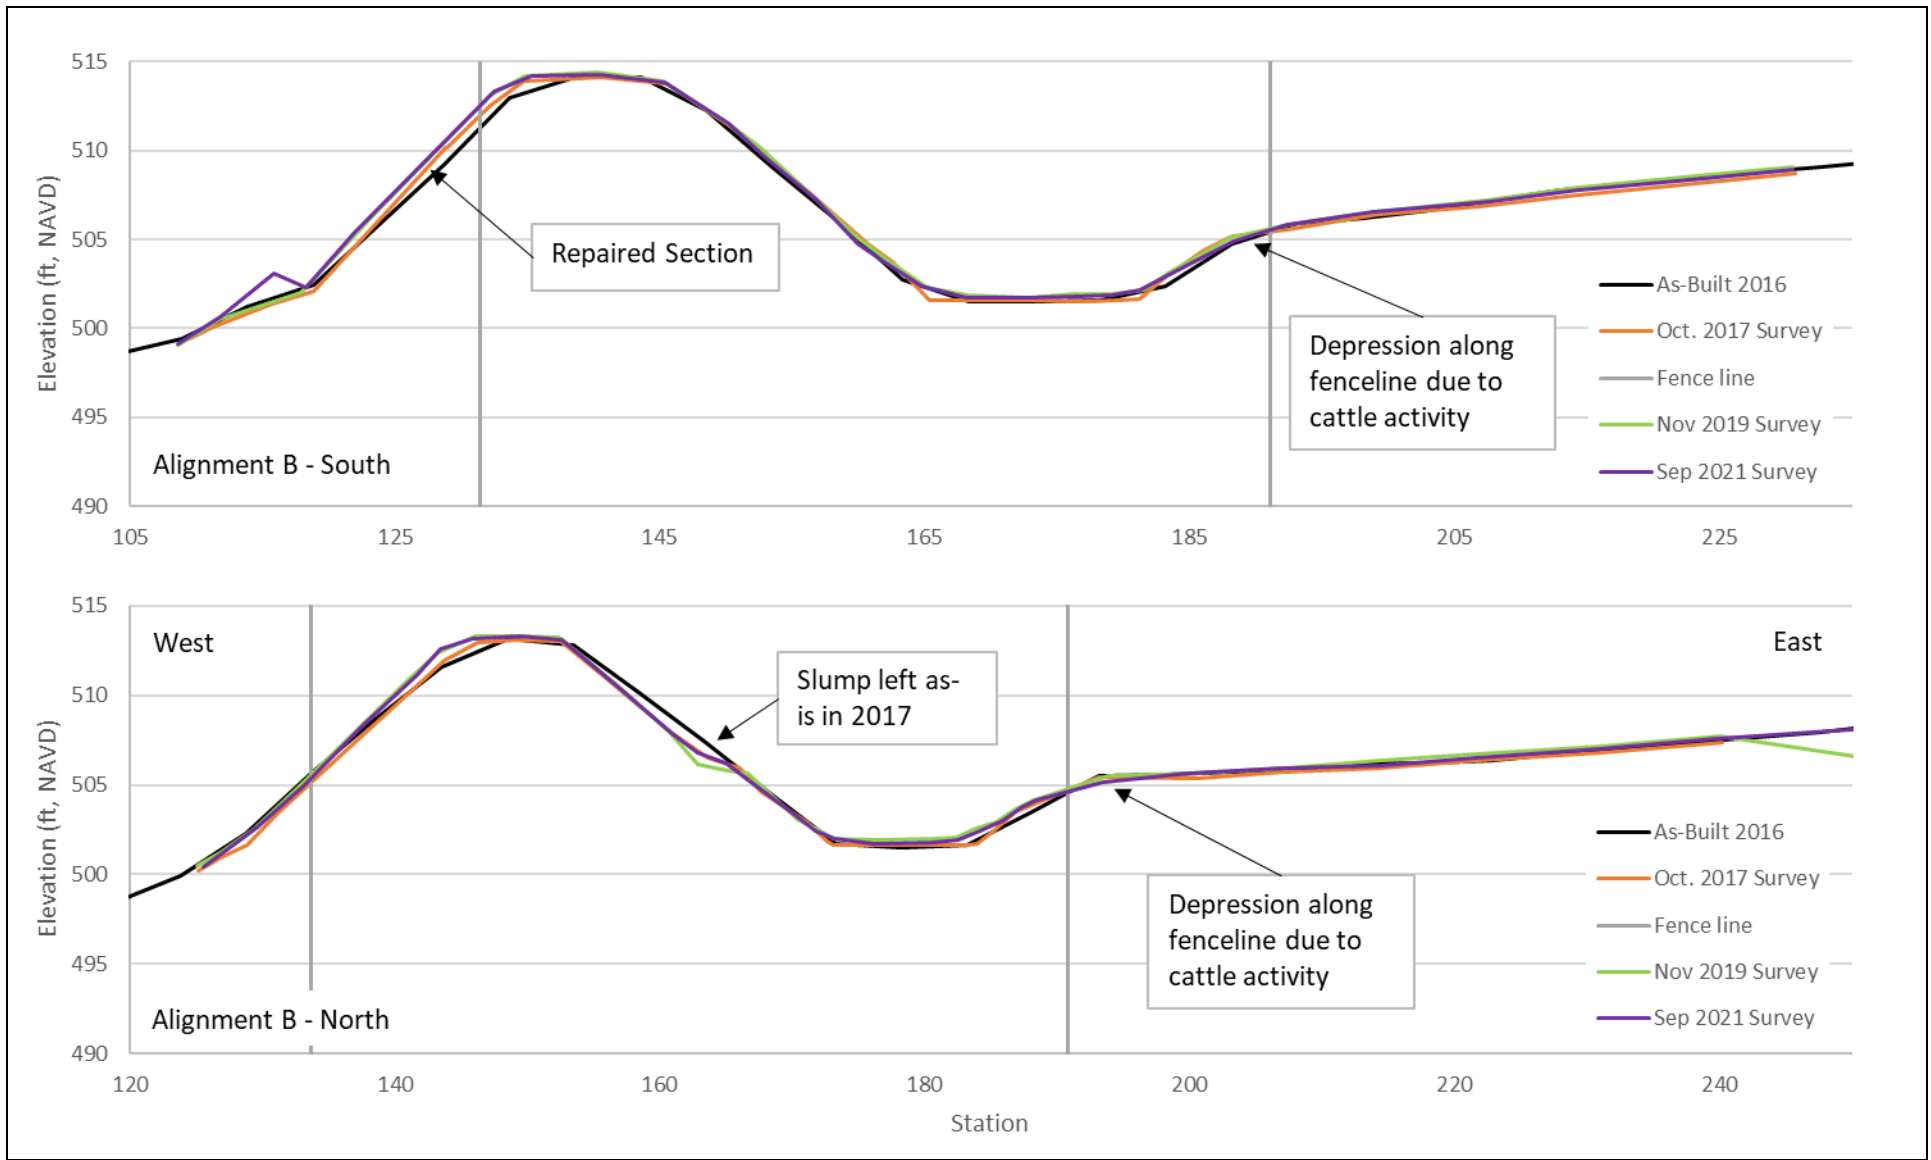
**Figure 5**

Notes: As-built elevations (black line) derived from as-built surface. Minor bank slump on Alignment B – North at station 165.

Little to no geomorphic changes were observed during Year 5 monitoring. Minor changes observed during monitoring included the lowering of the top of bank of the lower section of the pond compared to the 2019 survey. This is apparently due to additional cattle trampling during the very dry year, as cattle sought additional water, which left the soils more vulnerable. Additionally, soil cracks were observed at the top of bank in the lower wetland of the wetland mitigation site. The cracks were found to be only an aesthetic issue and do not compromise the ability of the lower wetland to hold water.

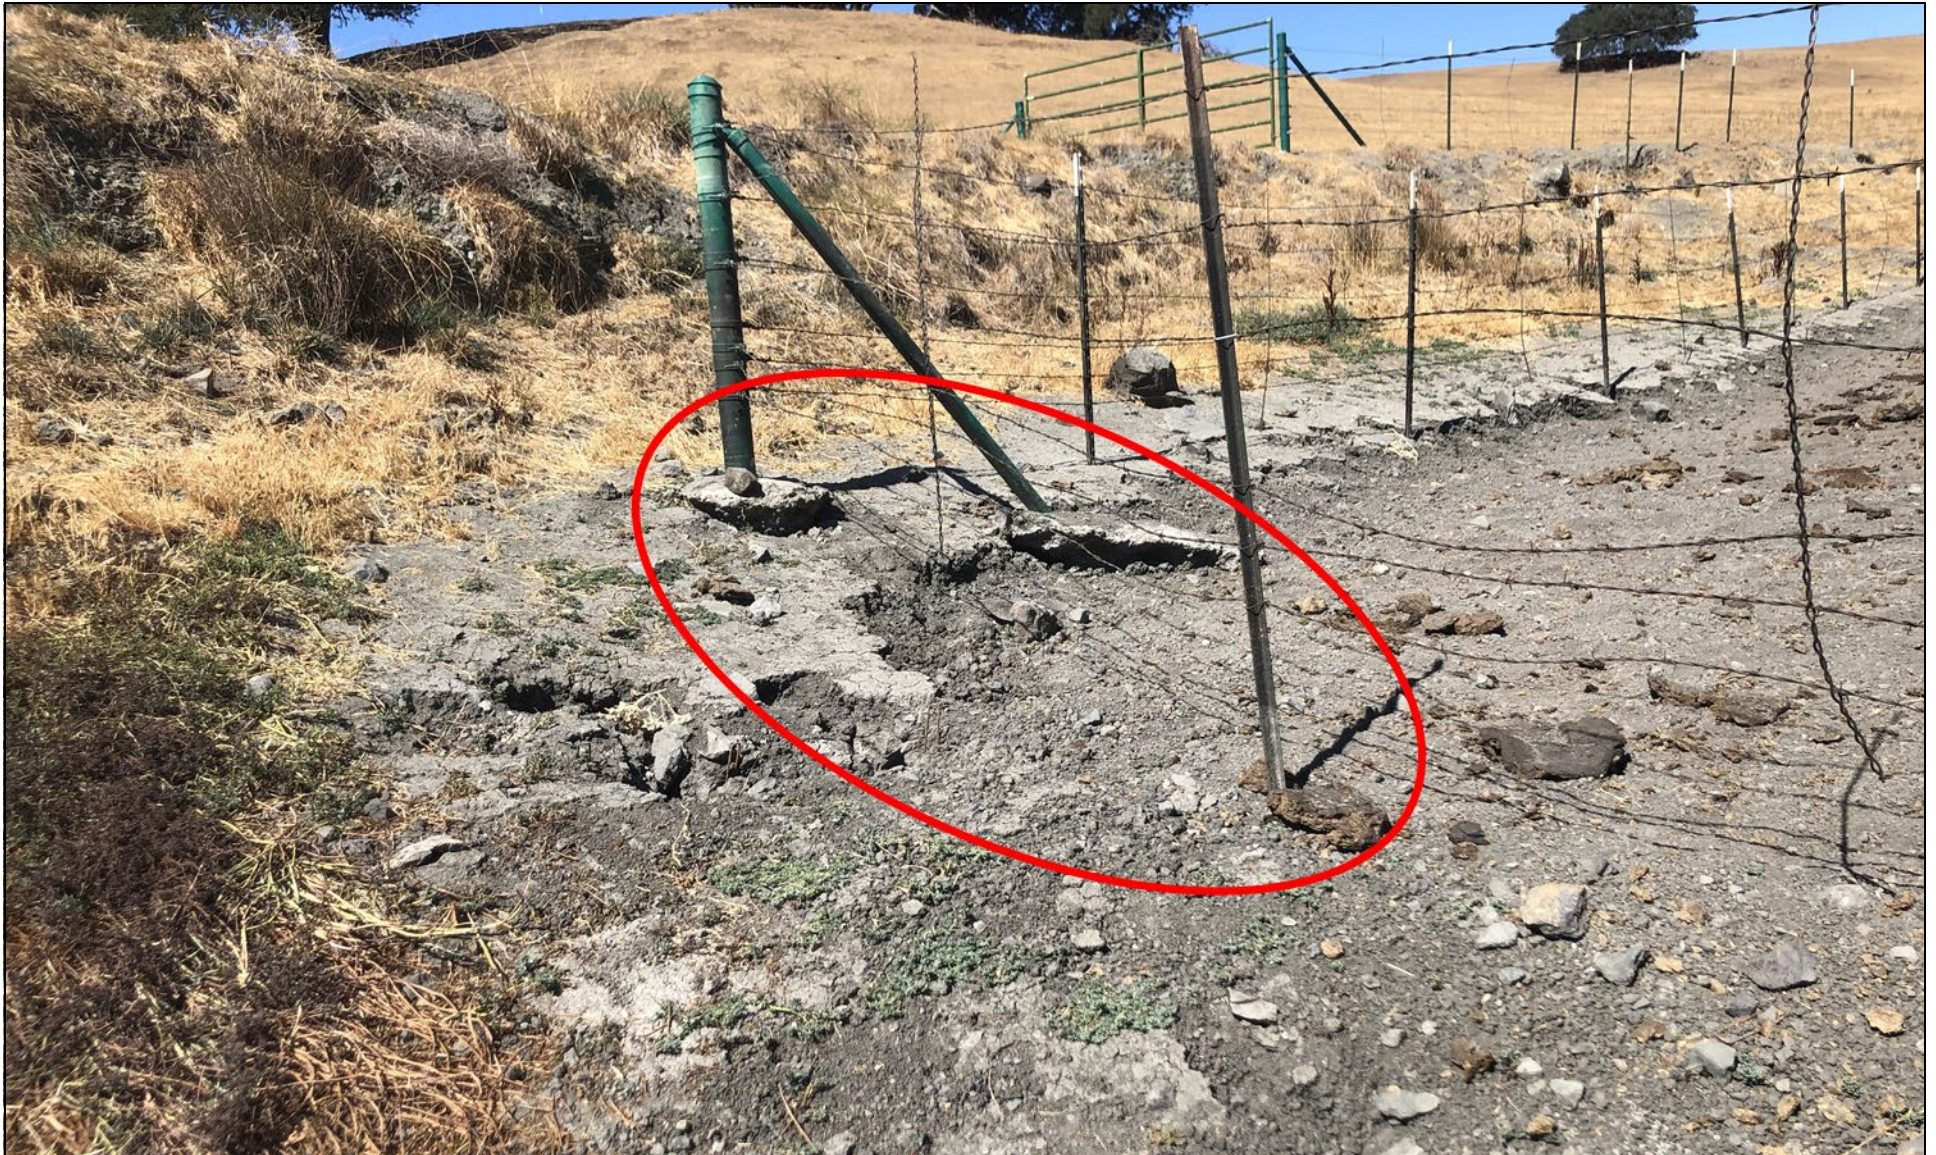
**Figure 8**

Calero Mitigation Site Monitoring  
**Fence line damage**

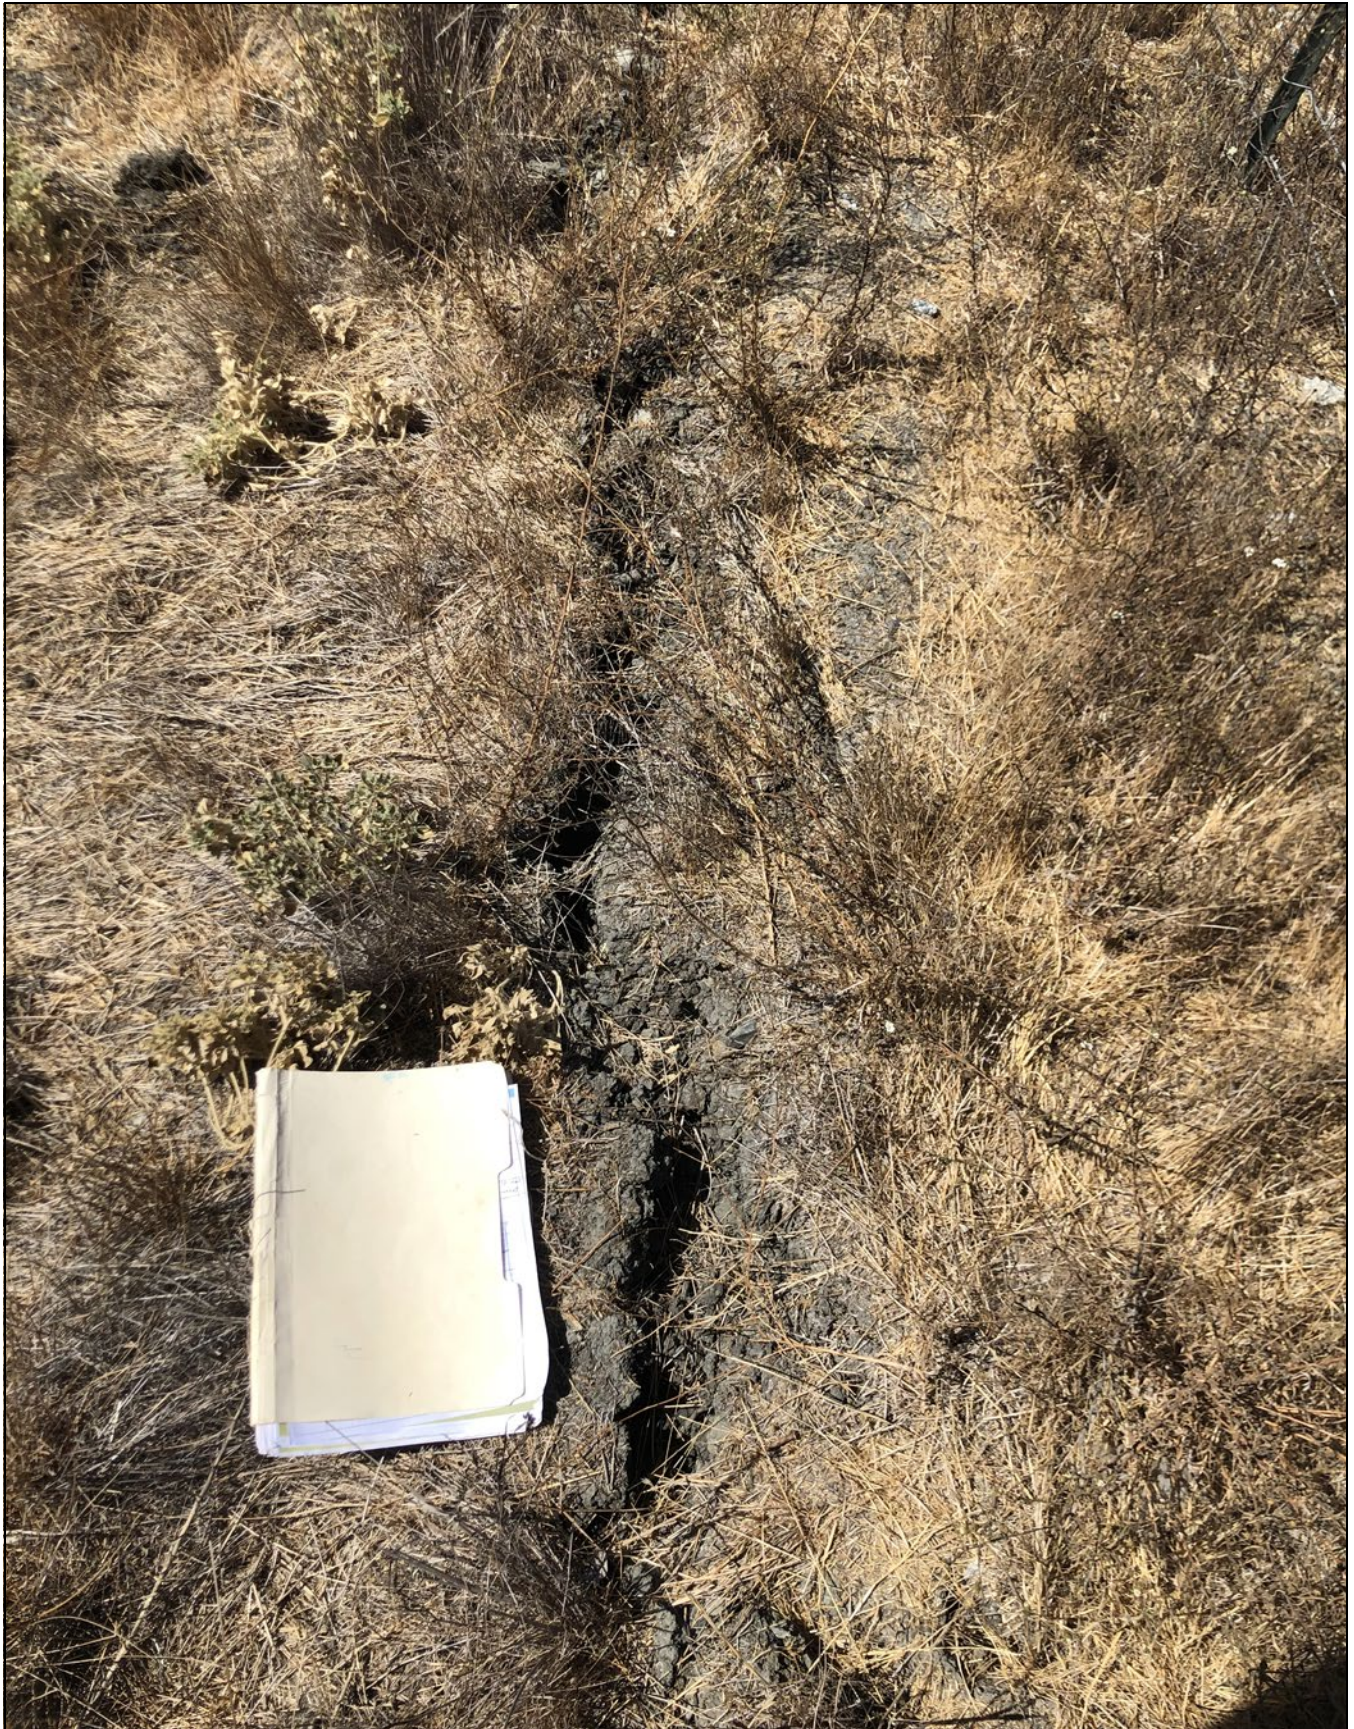
<i>Calero Mitigation Site Monitoring</i> <b>Lower Wetland crack</b>	
Project No. 15-1030-5		Created By: GD	<b>Figure 8</b>
