Project No. 3753-08

Subject: Calero County Park Pond and Wetland Restoration Project—Year 8 (2024)
Supplemental Vegetation and Hydrology Monitoring

Year 8 (2024) Supplemental Vegetation and Hydrology Monitoring Memorandum (3753-08)
February 2025

Calero County Park and Wetland Restoration Project

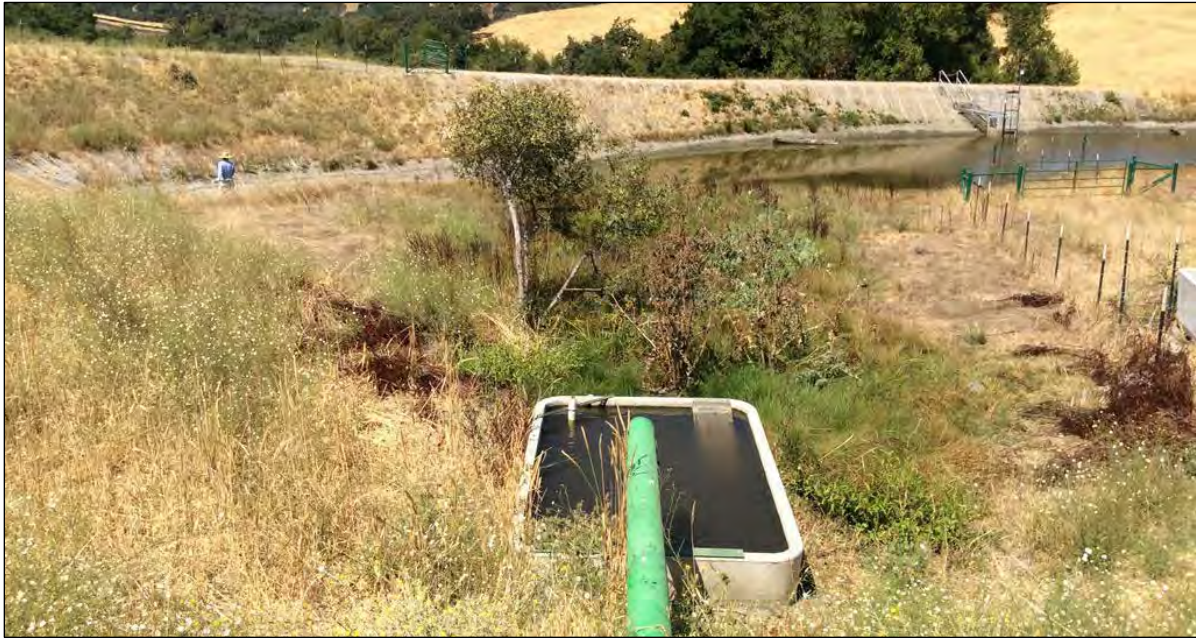
Photo 1. Year 1 Conditions at Photo Point 6 during Mt. Hamilton Thistle Abundance Monitoring at the Pond Mitigation Site (August 8, 2017)

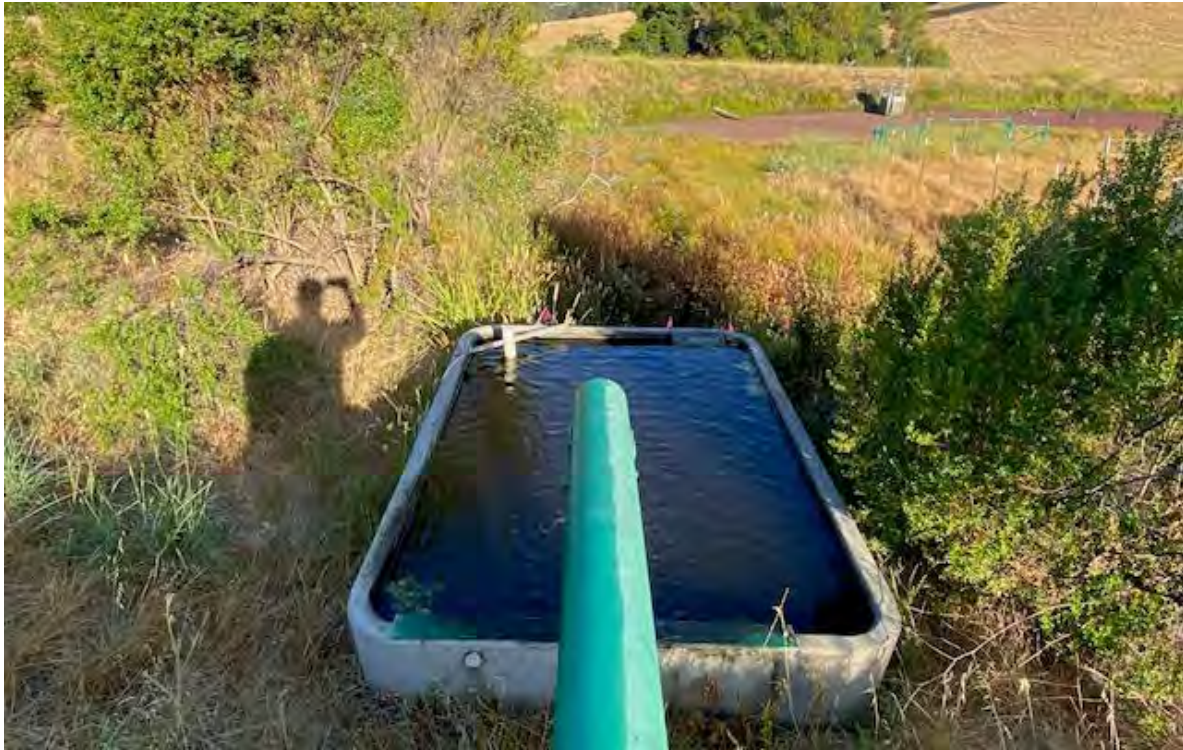
Photo 2. Year 8 Conditions at Photo Point 6 during Mt. Hamilton Thistle Abundance Monitoring at the Pond Mitigation Site (June 11, 2024)

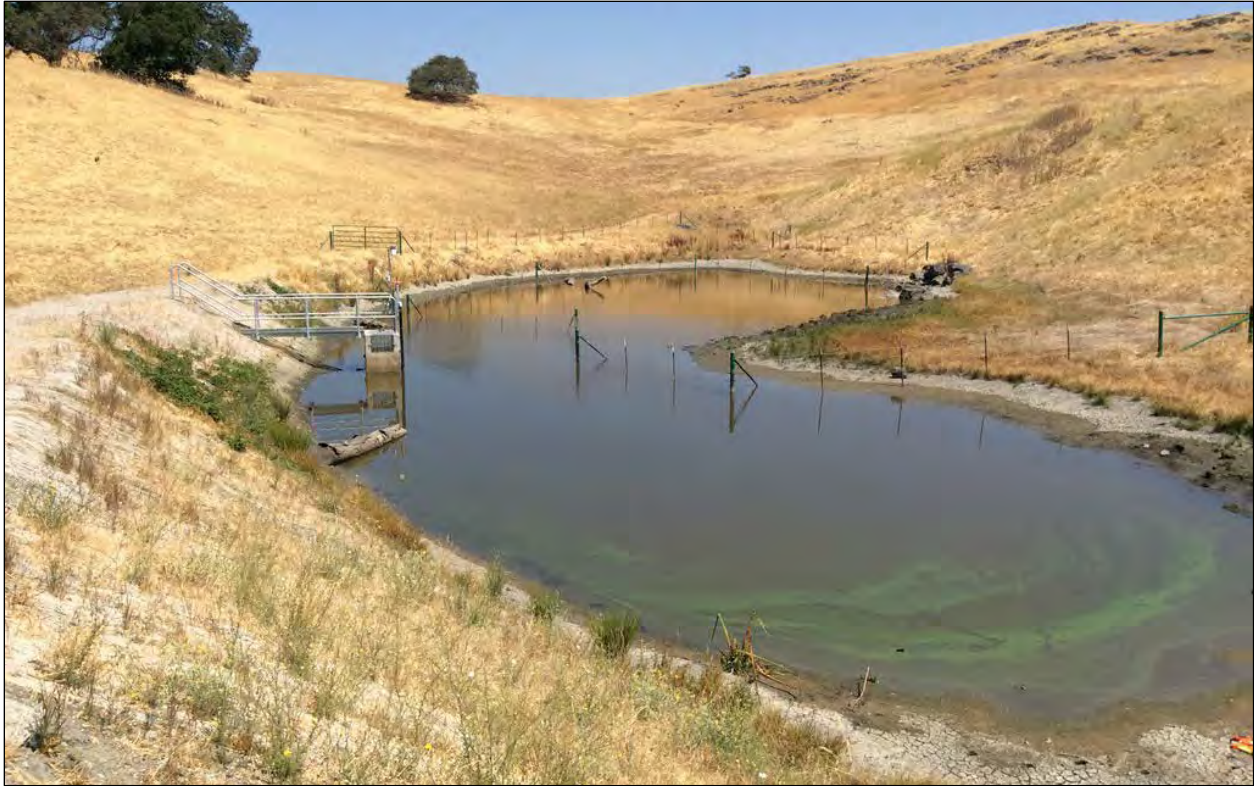
Photo 3. Year 1 Conditions at Photo Point 7a during Vegetation Monitoring at the Pond Mitigation Site (August 8, 2017)

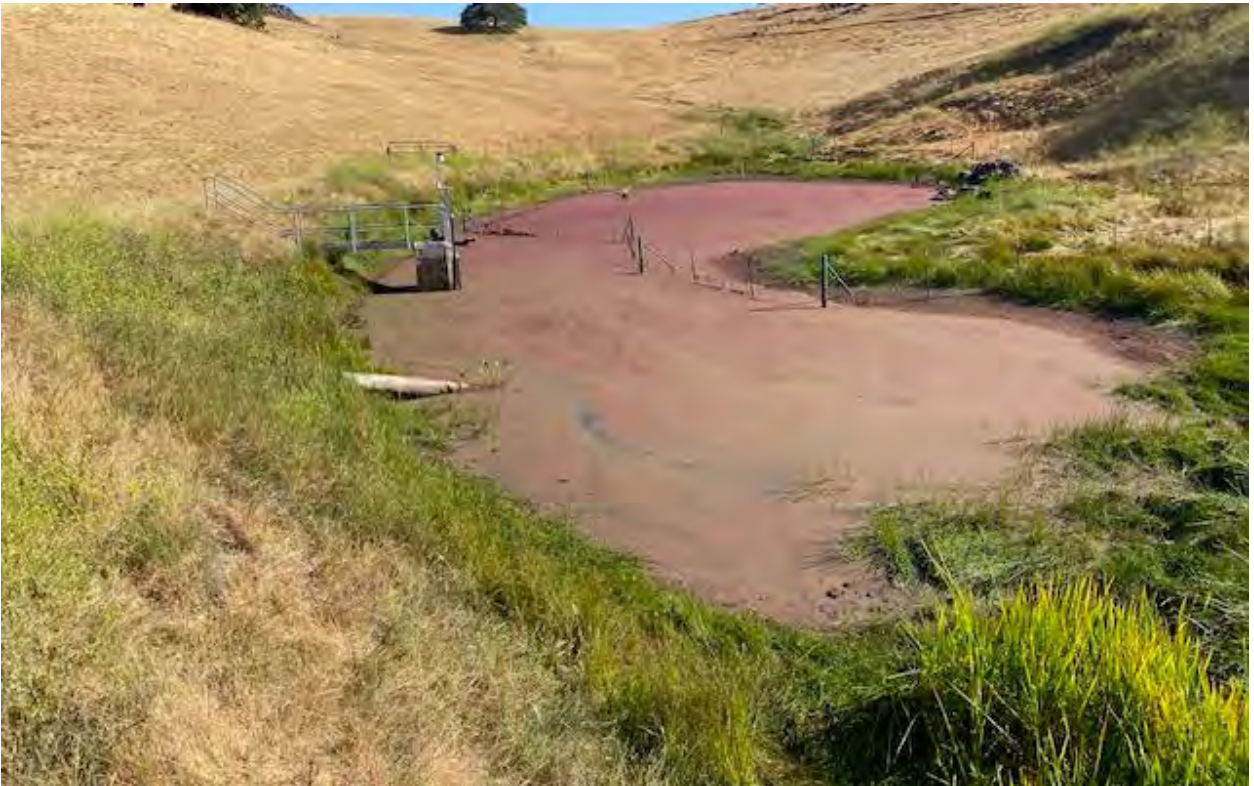
Photo 4. Year 8 Conditions at Photo Point 7a during Vegetation Monitoring at the Pond Mitigation Site (June 11, 2024)

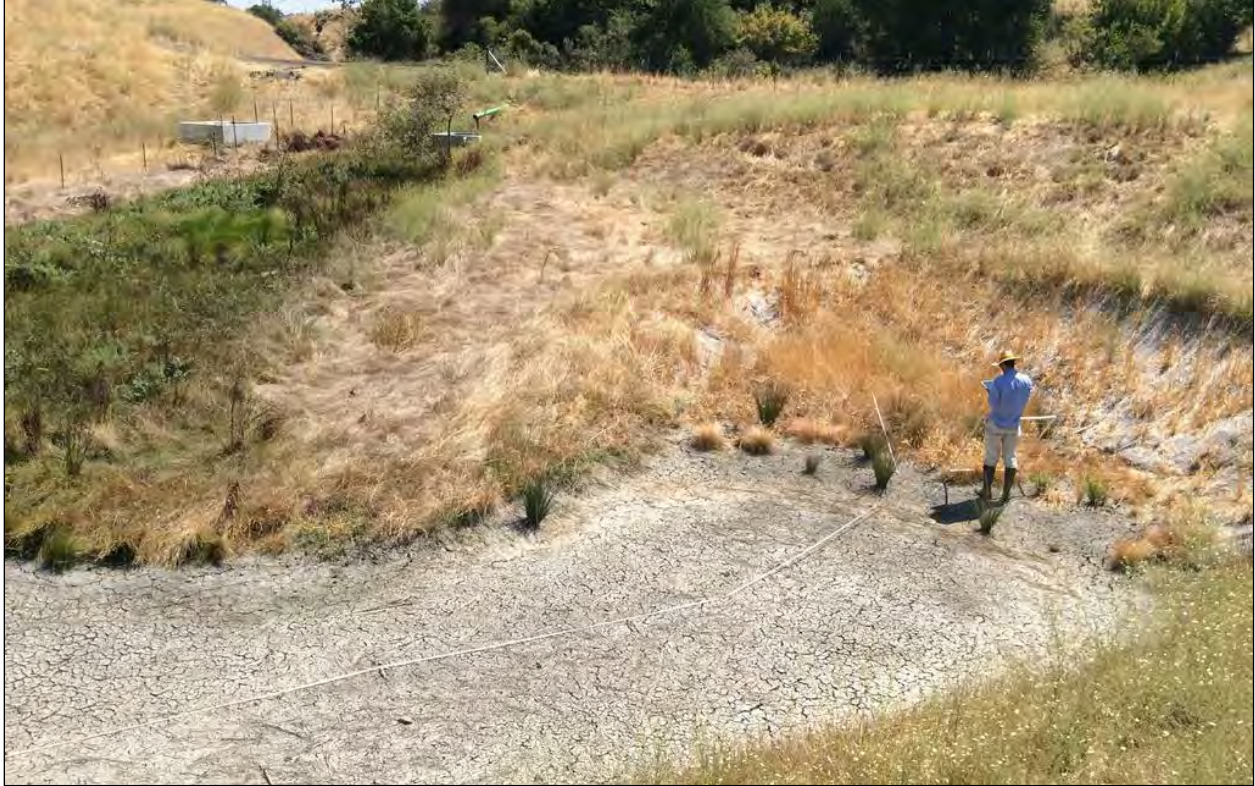
Photo 5. Year 1 Conditions at Photo Point 7b during Vegetation Monitoring, Showing the Wetland Establishment Area at the Pond Mitigation Site (August 8, 2017)

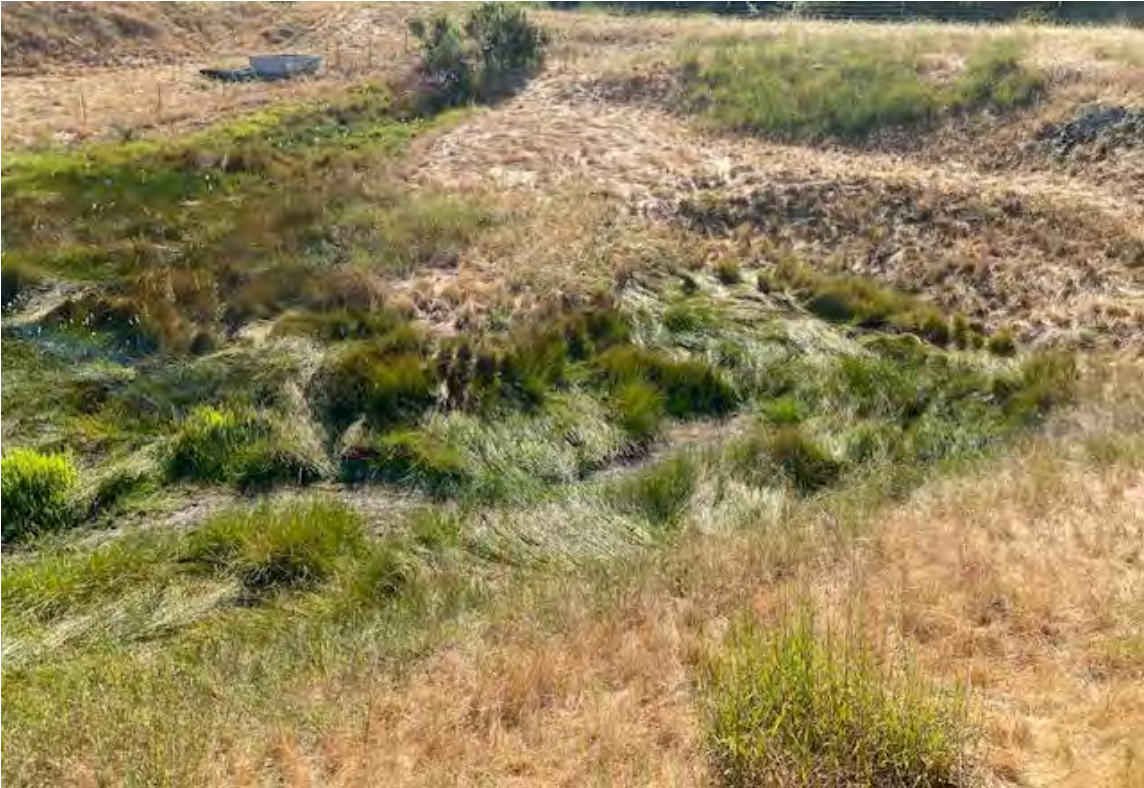
Photo 6. Year 8 Conditions at Photo Point 7b during Vegetation Monitoring, Showing the Wetland Establishment Area at the Pond Mitigation Site (June 11, 2024)

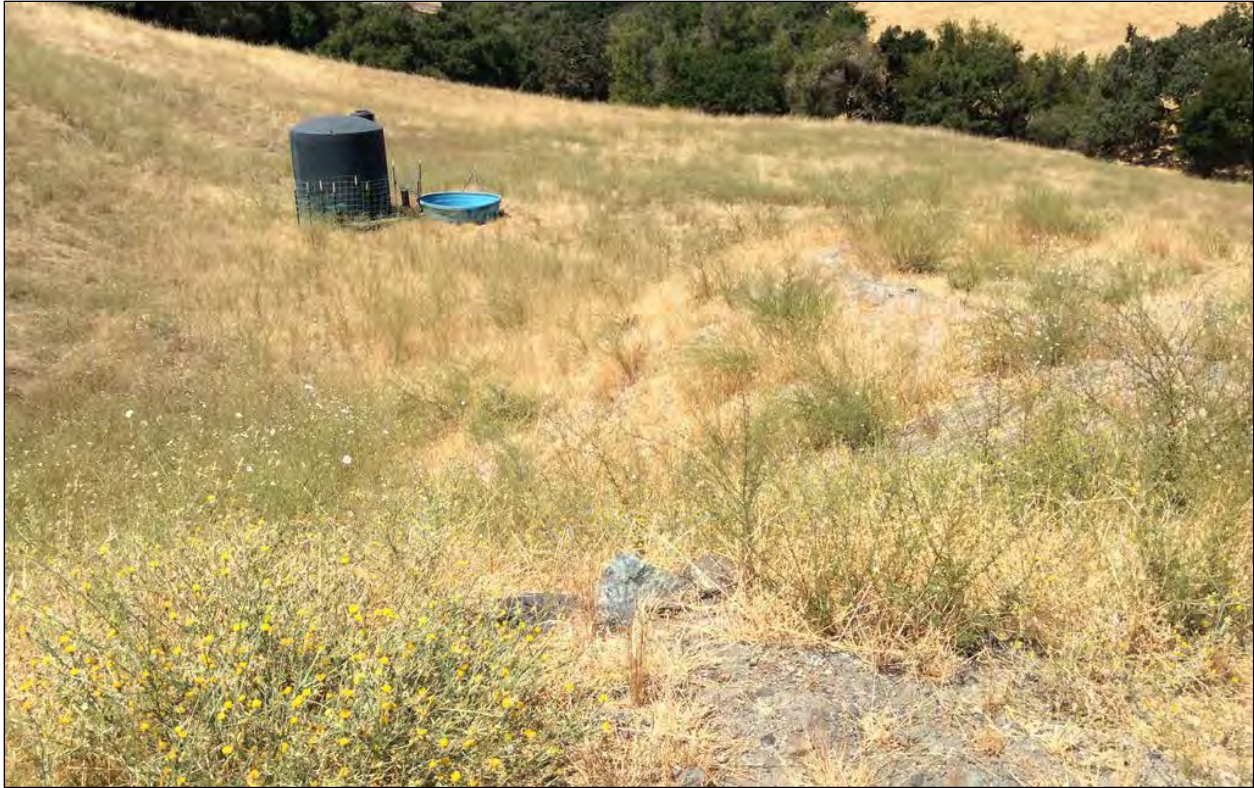
Photo 7. Year 1 Conditions at Photo Point 7c during Vegetation Monitoring at the Pond Mitigation Site (August 8, 2017)

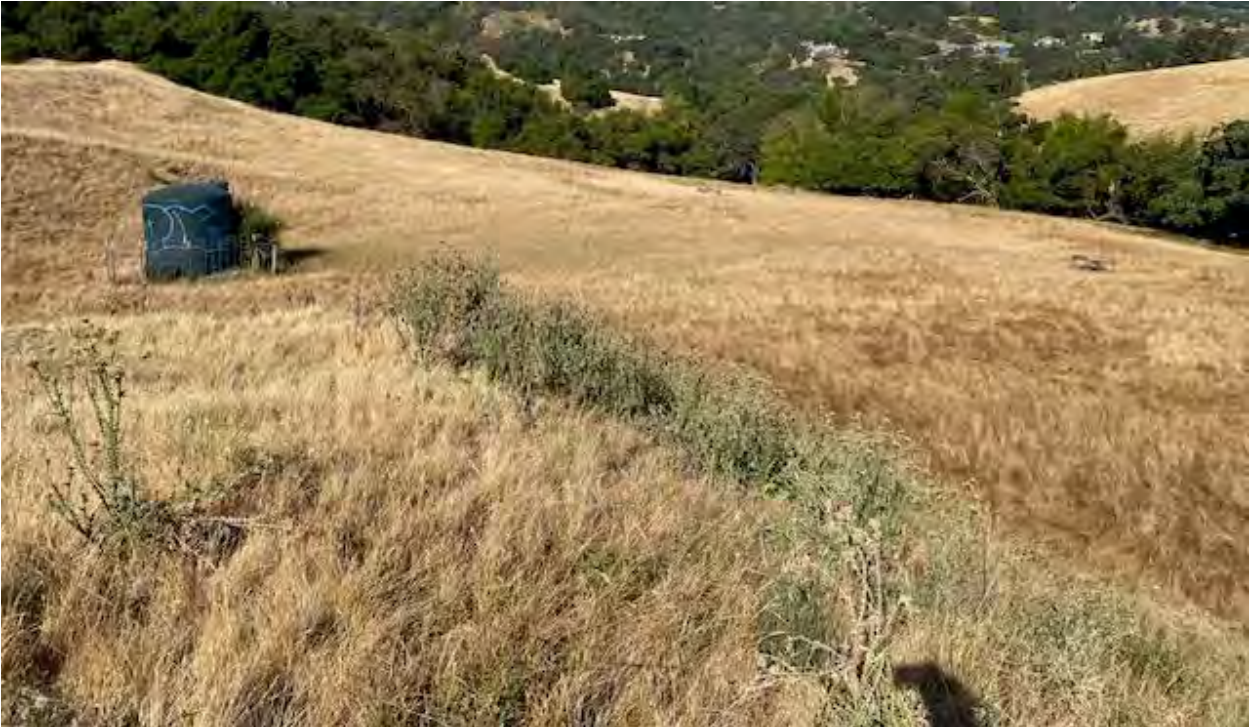
Photo 8. Year 8 Conditions at Photo Point 7c during Vegetation Monitoring at the Pond Mitigation Site (June 11, 2024)

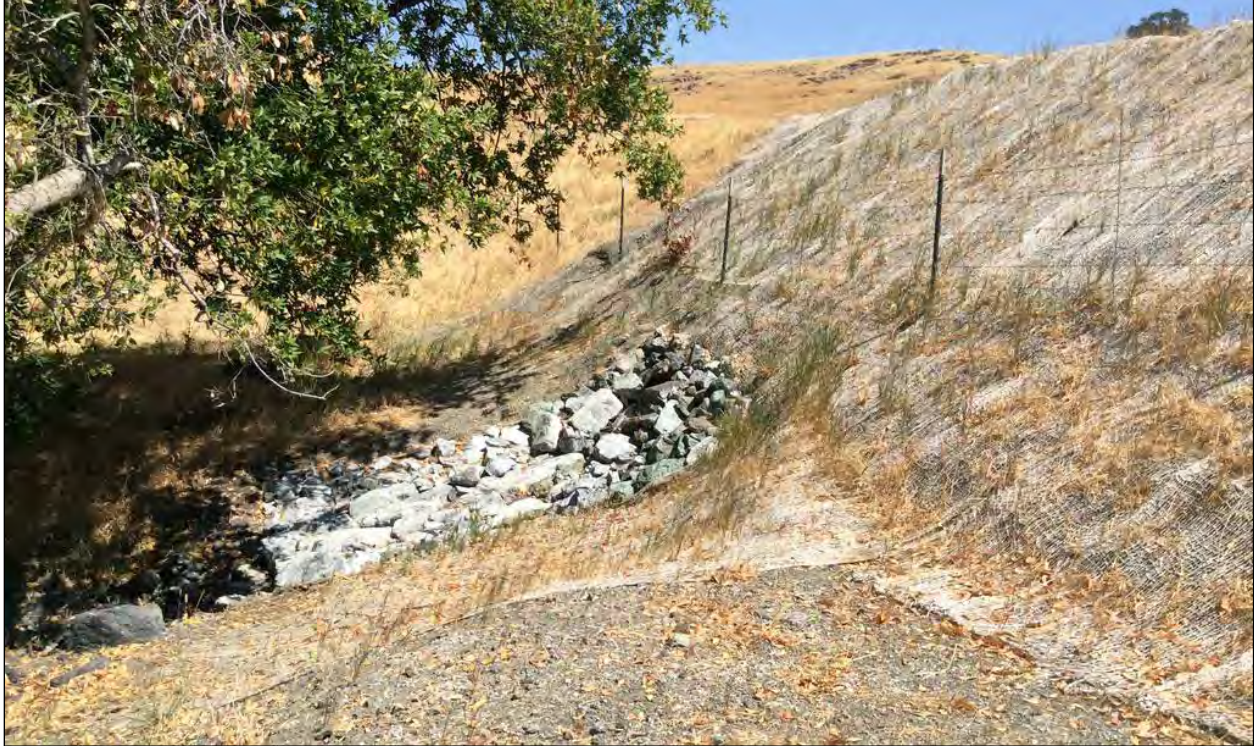
Photo 9. Year 1 Conditions at Photo Point 8 during Vegetation Monitoring at the Pond Mitigation Site (August 8, 2017)

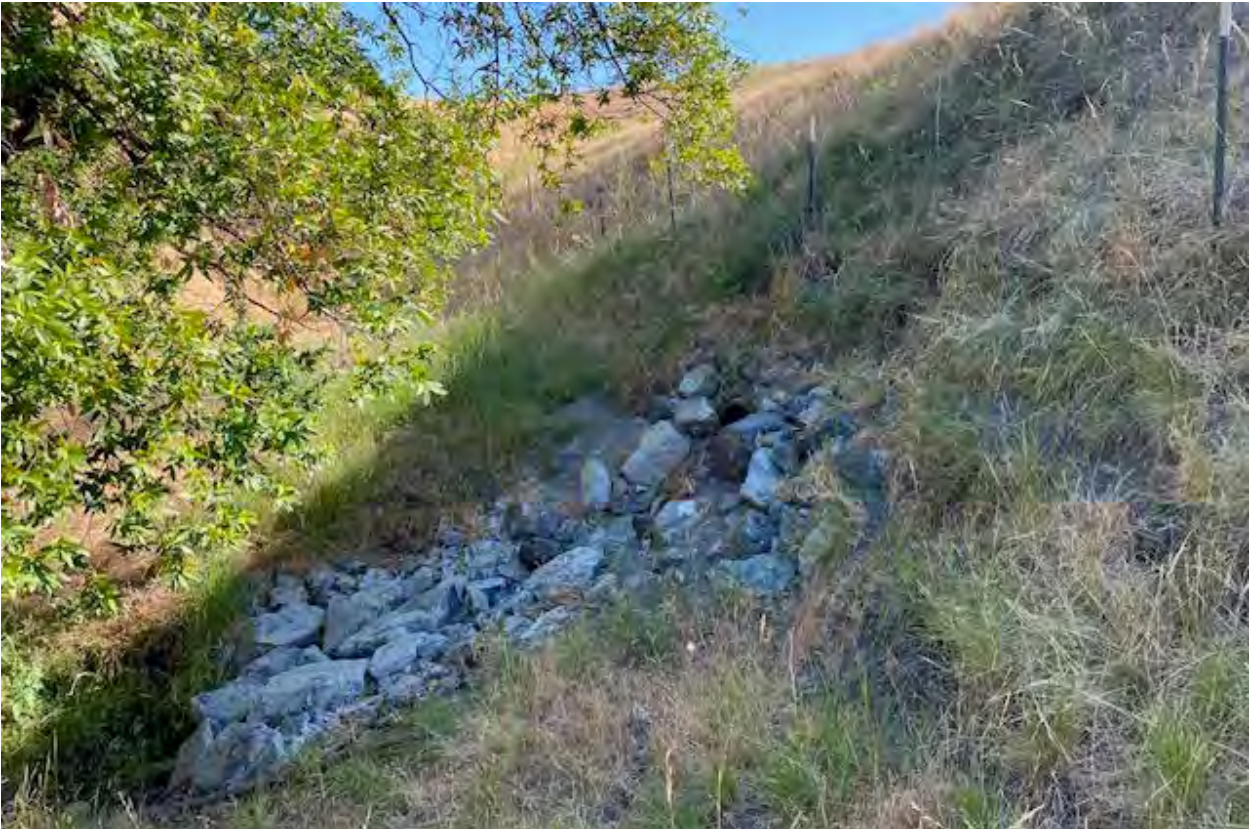
Photo 10. Year 8 Conditions at Photo Point 8 during Vegetation Monitoring at the Pond Mitigation Site (June 11, 2024)

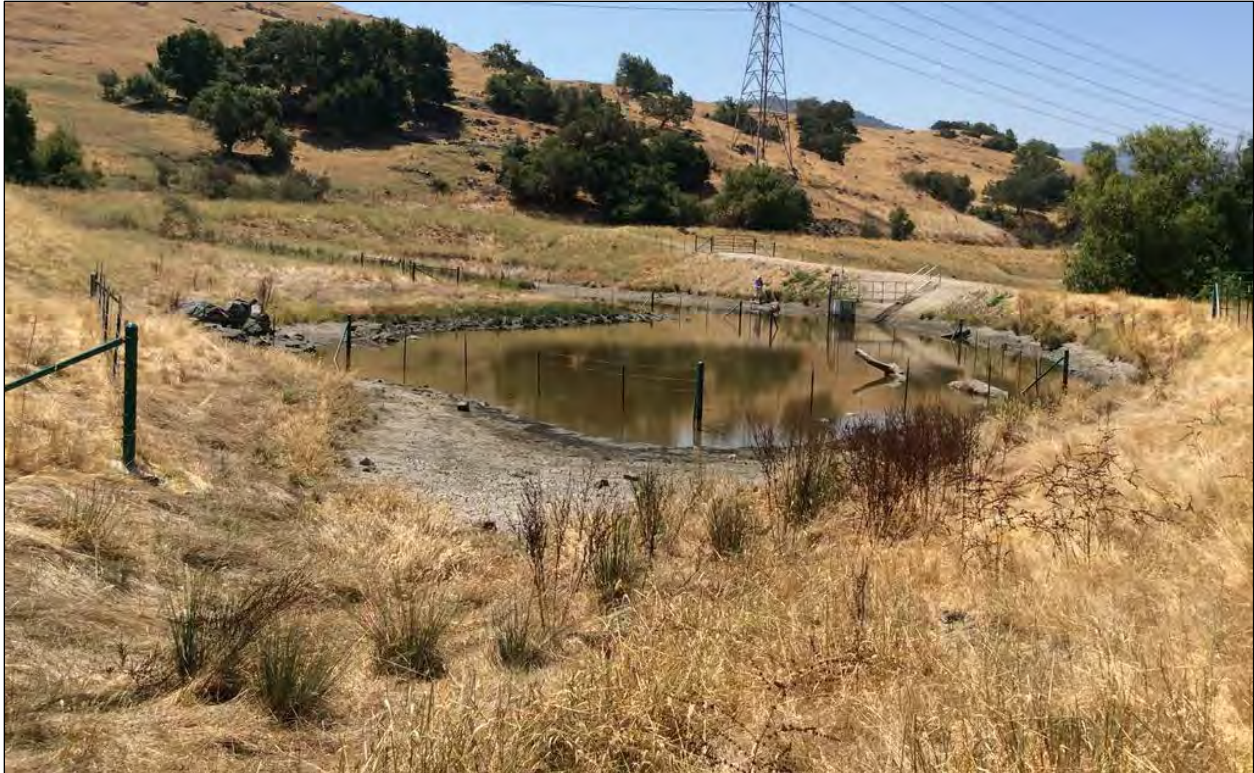
Photo 11. Year 1 Conditions at Photo Point 9 during Vegetation Monitoring at the Pond Mitigation Site (August 8, 2017)

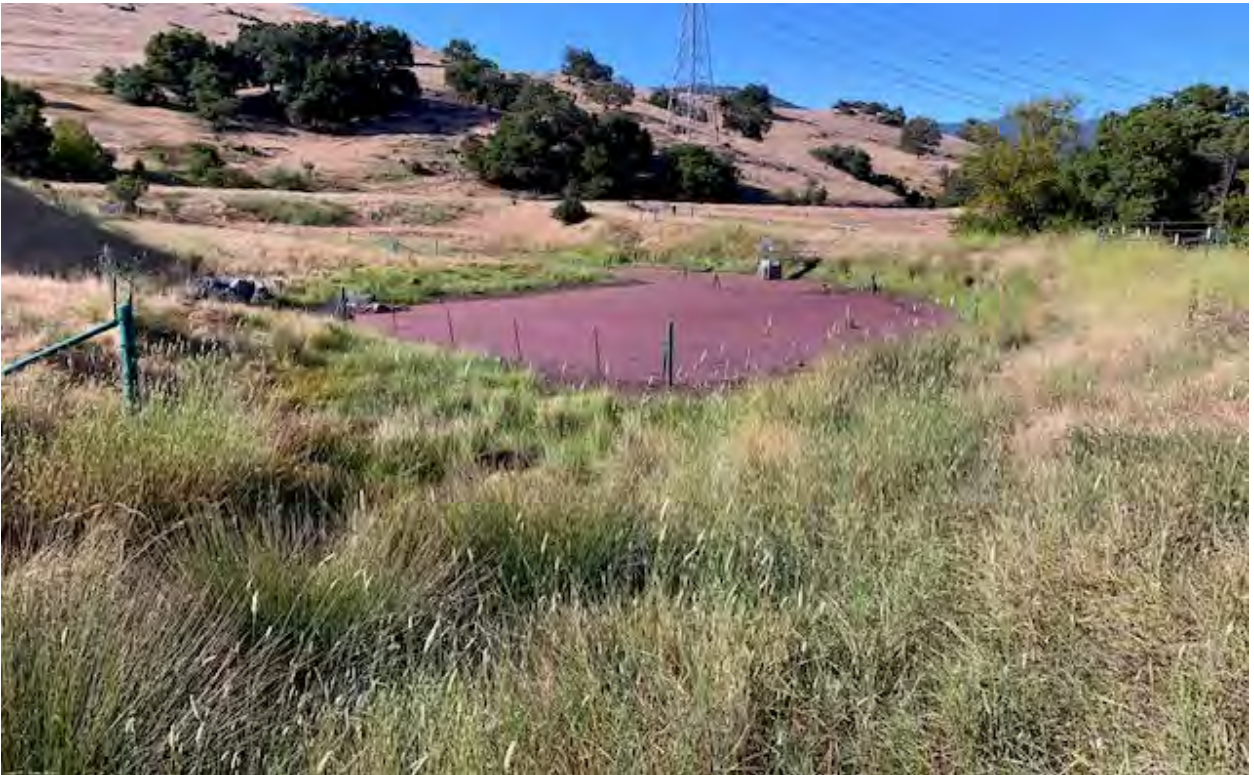
Photo 12. Year 8 Conditions at Photo Point 9 during Vegetation Monitoring at the Pond Mitigation Site (June 11, 2024)

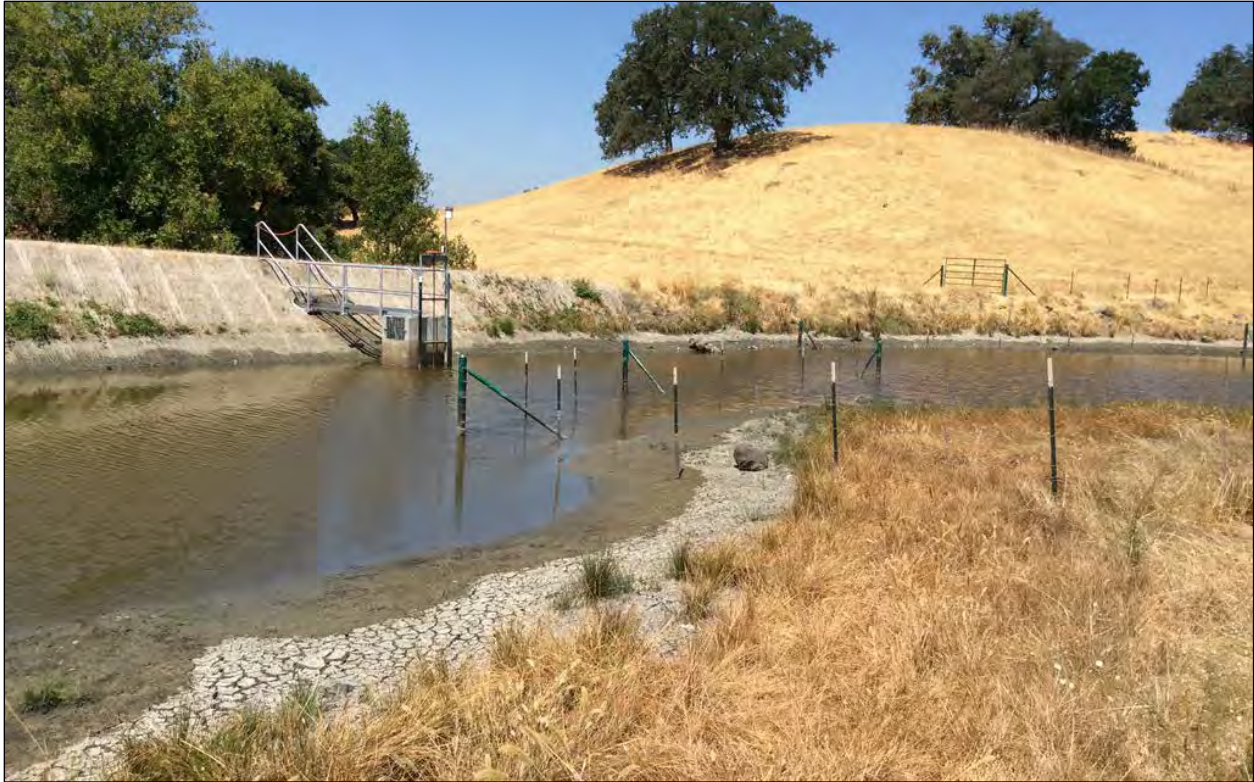
Photo 131. Year 1 Conditions at Photo Point 10 during Vegetation Monitoring at the Pond Mitigation Site (August 8, 2017)

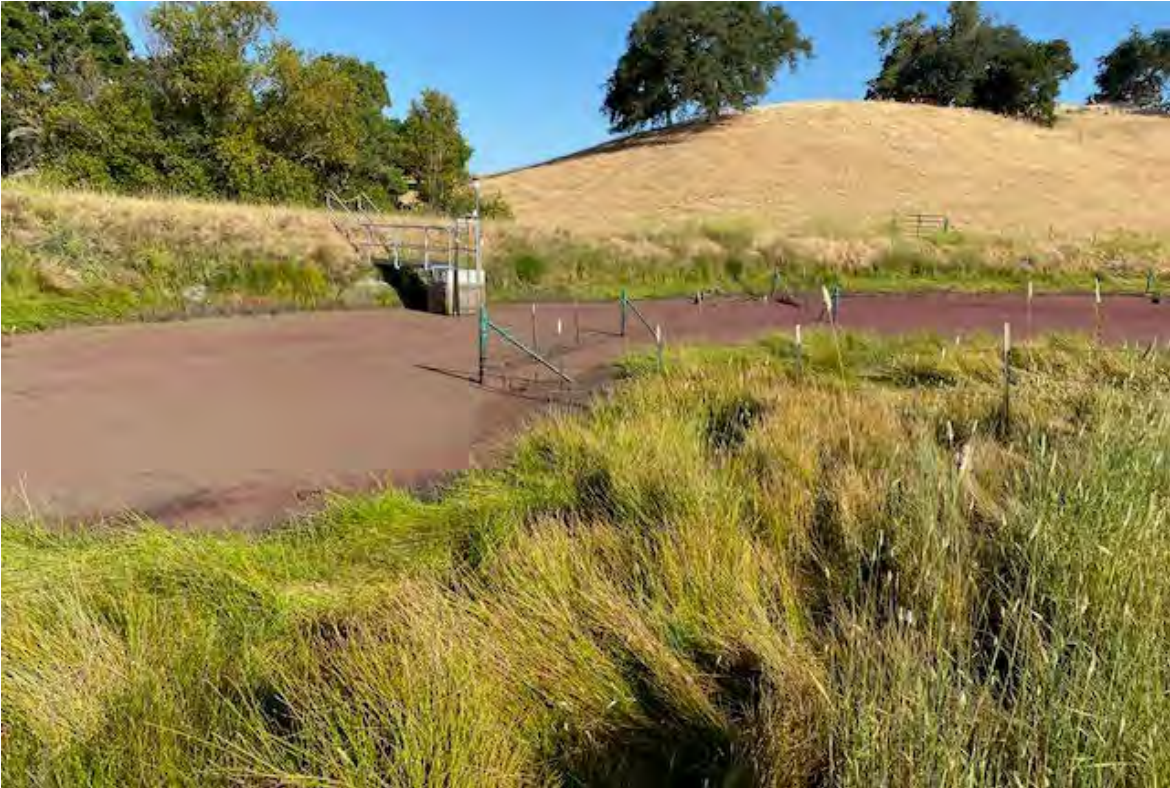
Photo 14. Year 8 Conditions at Photo Point 10 during Vegetation Monitoring at the Pond Mitigation Site (June 11, 2024)

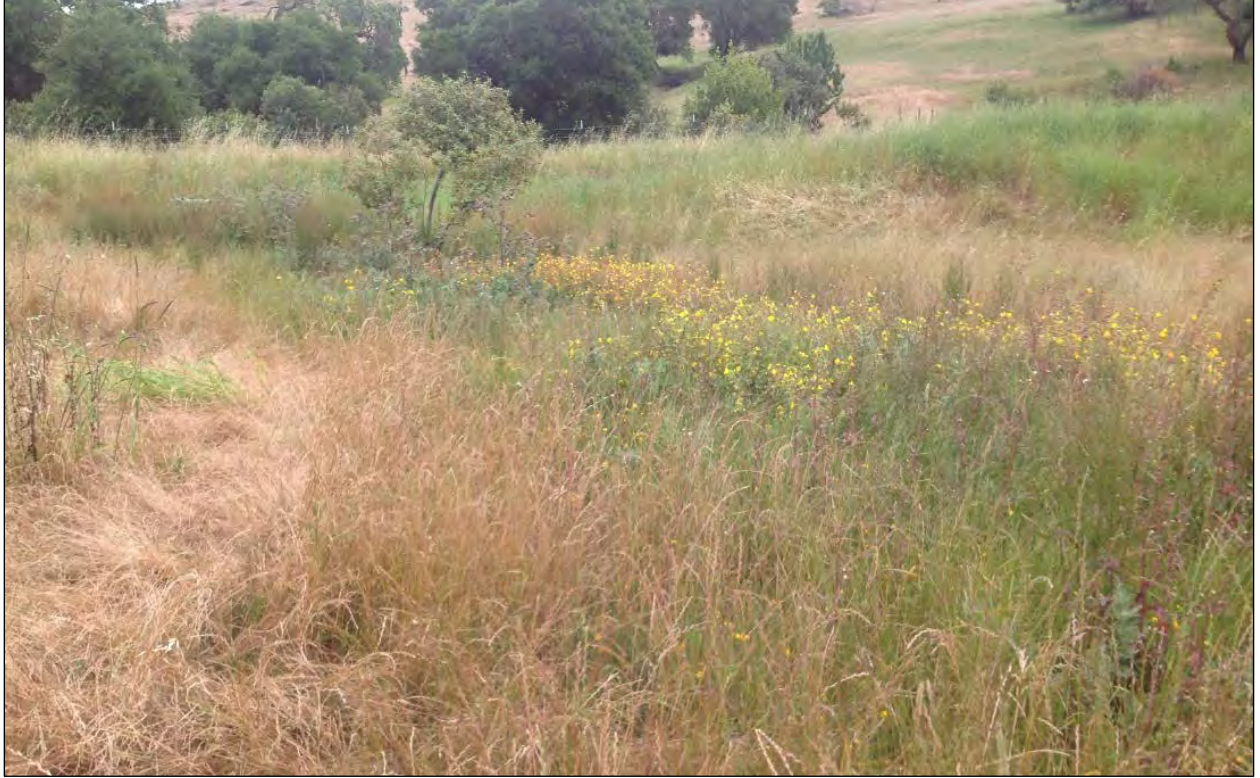
Photo 15. Year 1 Conditions at Photo Point 17 during Mt. Hamilton Thistle Abundance Monitoring at the Pond Mitigation Site (August 8, 2017)

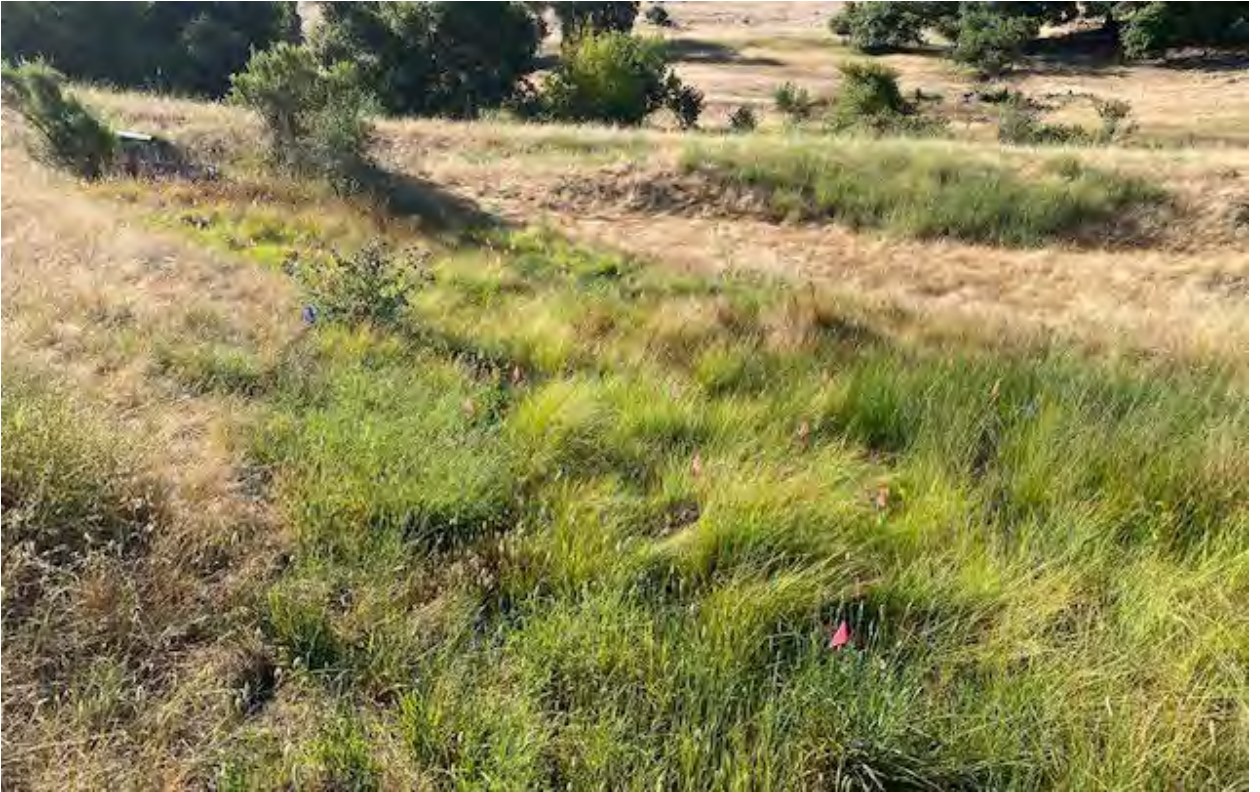
Photo 16. Year 8 Conditions at Photo Point 17 during Mt. Hamilton Thistle Abundance Monitoring at the Pond Mitigation Site (June 11, 2024)

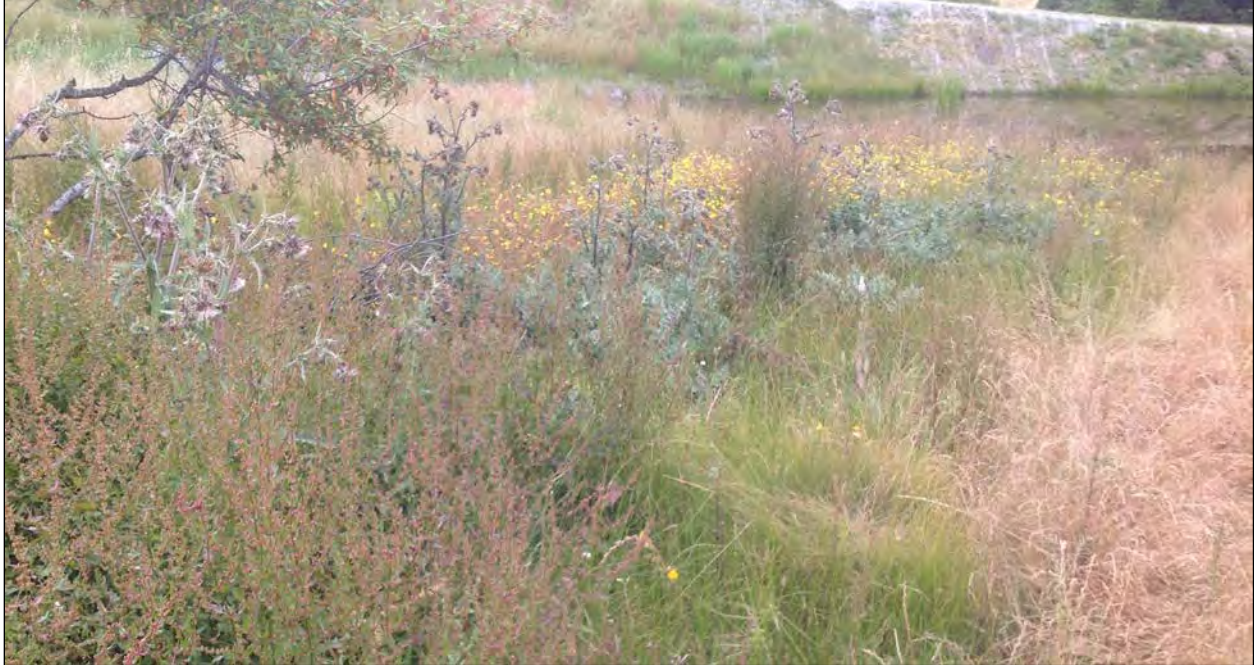
Photo 17. Year 1 Conditions at Photo Point 18 during Mt. Hamilton Thistle Abundance Monitoring at the Pond Mitigation Site (August 8, 2017)

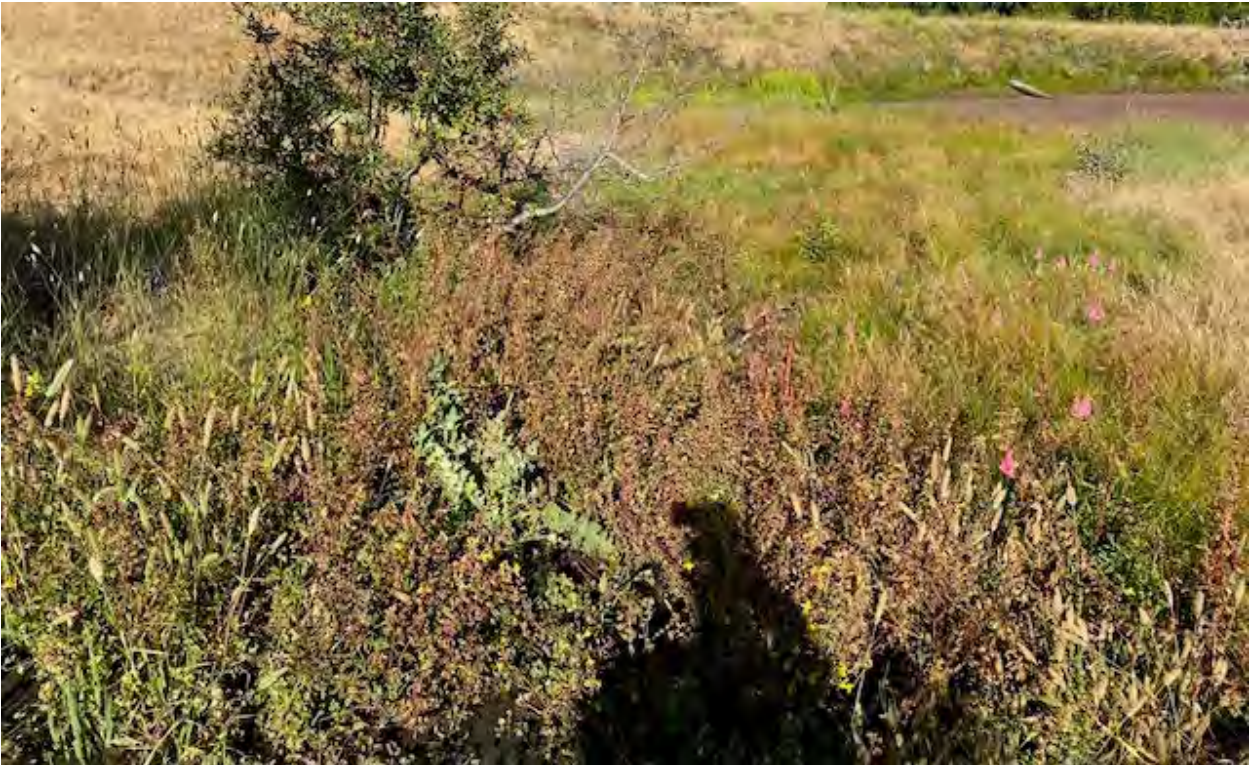
Photo 18. Year 8 Conditions at Photo Point 18 during Mt. Hamilton Thistle Abundance Monitoring at the Pond Mitigation Site (June 11, 2024)

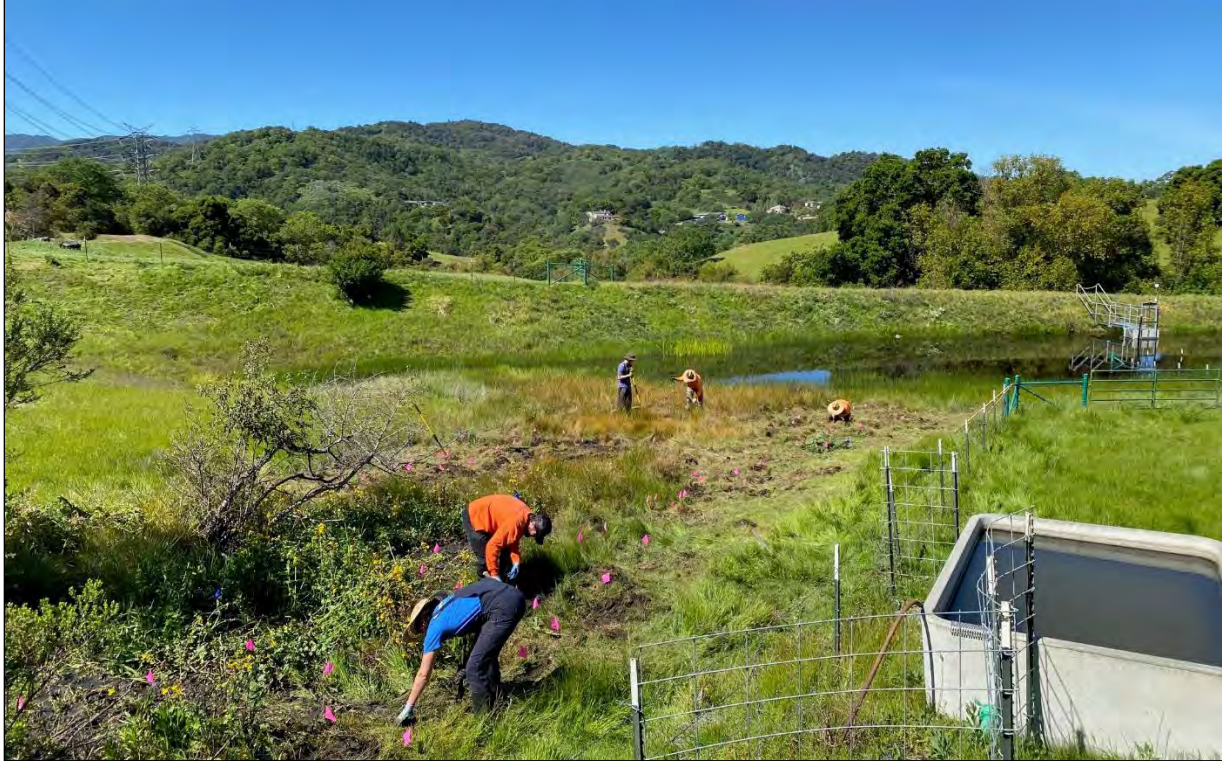
Photo 192. Plant Installation During Year 8 Mt. Hamilton Thistle Planting at the Pond Mitigation Site (April 9, 2024)

- Prior to installing seedlings, treated dense native herbaceous vegetation in the area with a simulated “cattle grazing event”, to reduce competition for the seedlings and improve conditions for recruitment and germination of Mt. Hamilton thistle seeds. Specifically, vegetation was removed in patches with hand tools—i.e., shovels, trowels, rakes, and a weed whip—to reveal bare ground throughout the area, including in areas where seedlings were to be installed. In addition, heavy trampling by crews was simulated during vegetation treatment and planting to emulate cattle footprints, creating small pockets where water can pool. Photos of the site during and after simulated disturbance and seedling installation can be found in Appendix A (Photos 19-23).

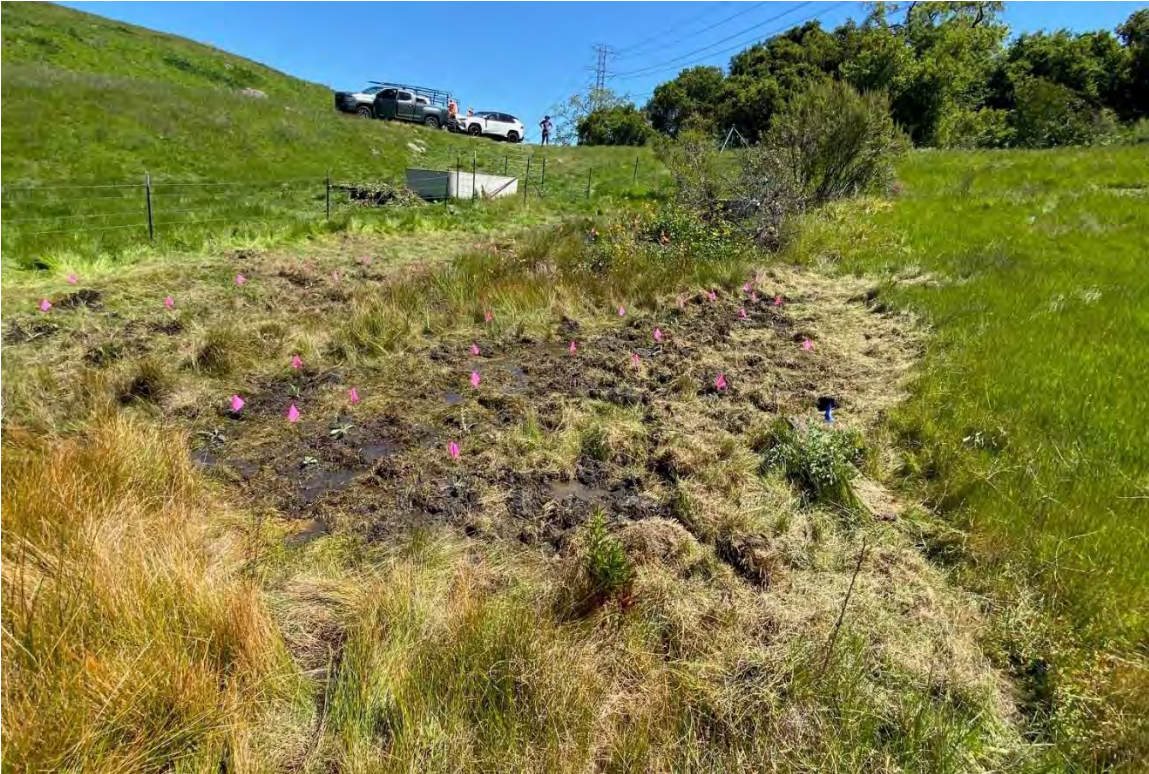
Photo 20. Seep at Pond Mitigation Site Following Vegetation Removal, Ground Disturbance, and Plant Installation During Year 8 Mt. Hamilton Thistle Planting (Flags Indicate Seedlings) (April 9, 2024)

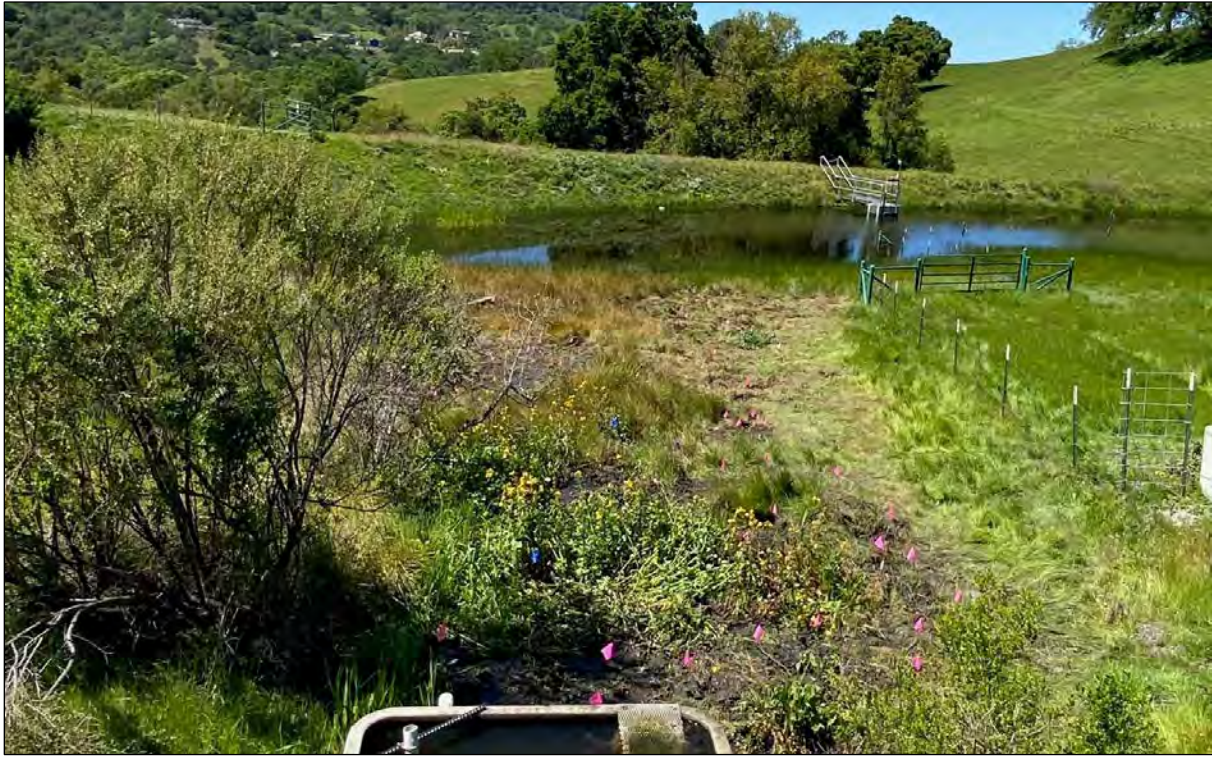
Photo 21. Seep at Pond Mitigation Site Following Vegetation Removal, Ground Disturbance, and Plant Installation During Year 8 Mt. Hamilton Thistle Planting (Flags Indicate Seedlings) (April 9, 2024)

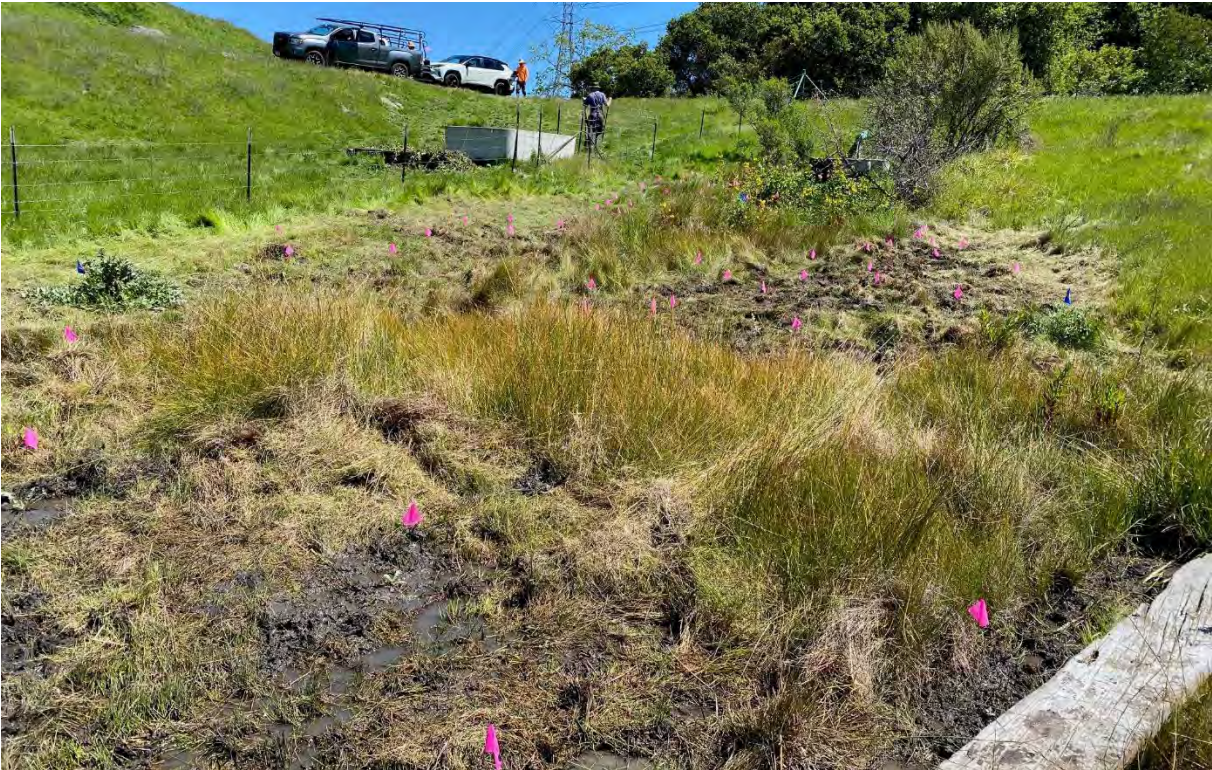
Photo 22. Year 8 Mt. Hamilton Thistle Seedlings at the Pond Mitigation Site (April 9, 2024)

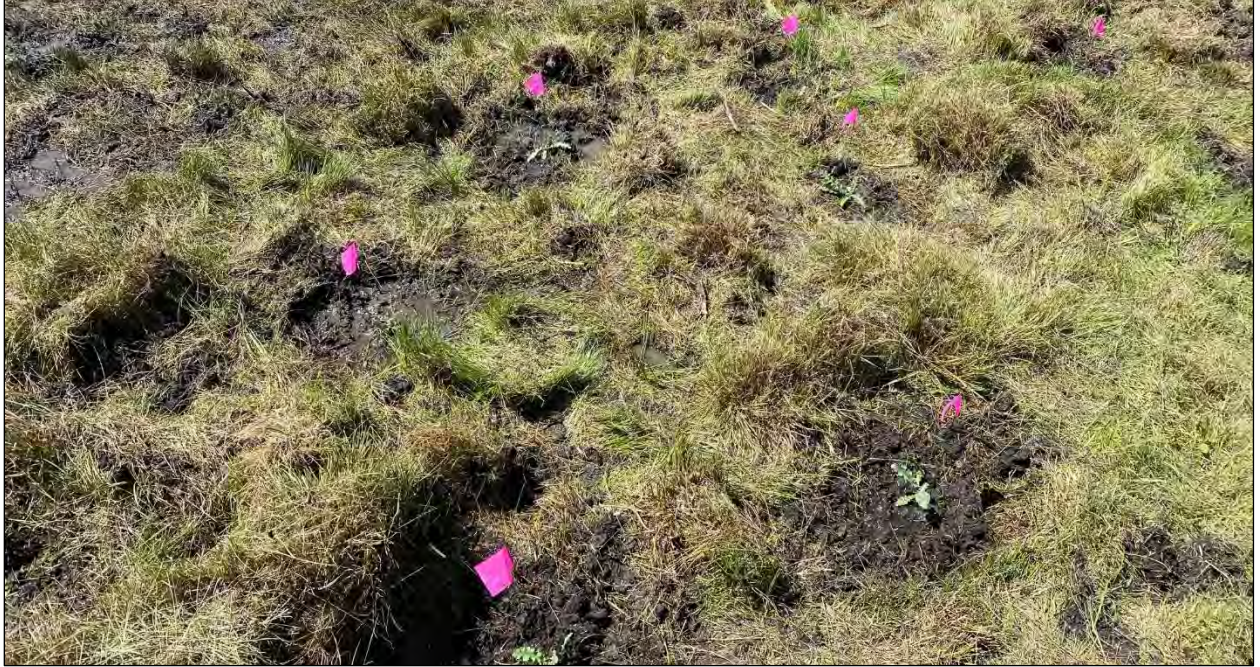
Photo 23. Year 8 Mt. Hamilton Thistle Seedlings at the Pond Mitigation Site (April 9, 2024)
