Project No. 3753-08

Subject: Calero County Park Pond and Wetland Restoration Project—Year 8 (2024)
Supplemental Vegetation and Hydrology Monitoring

Year 8 (2024) Supplemental Vegetation and Hydrology Monitoring Memorandum (3753-08)
February 2025

Calero County Park and Wetland Restoration Project

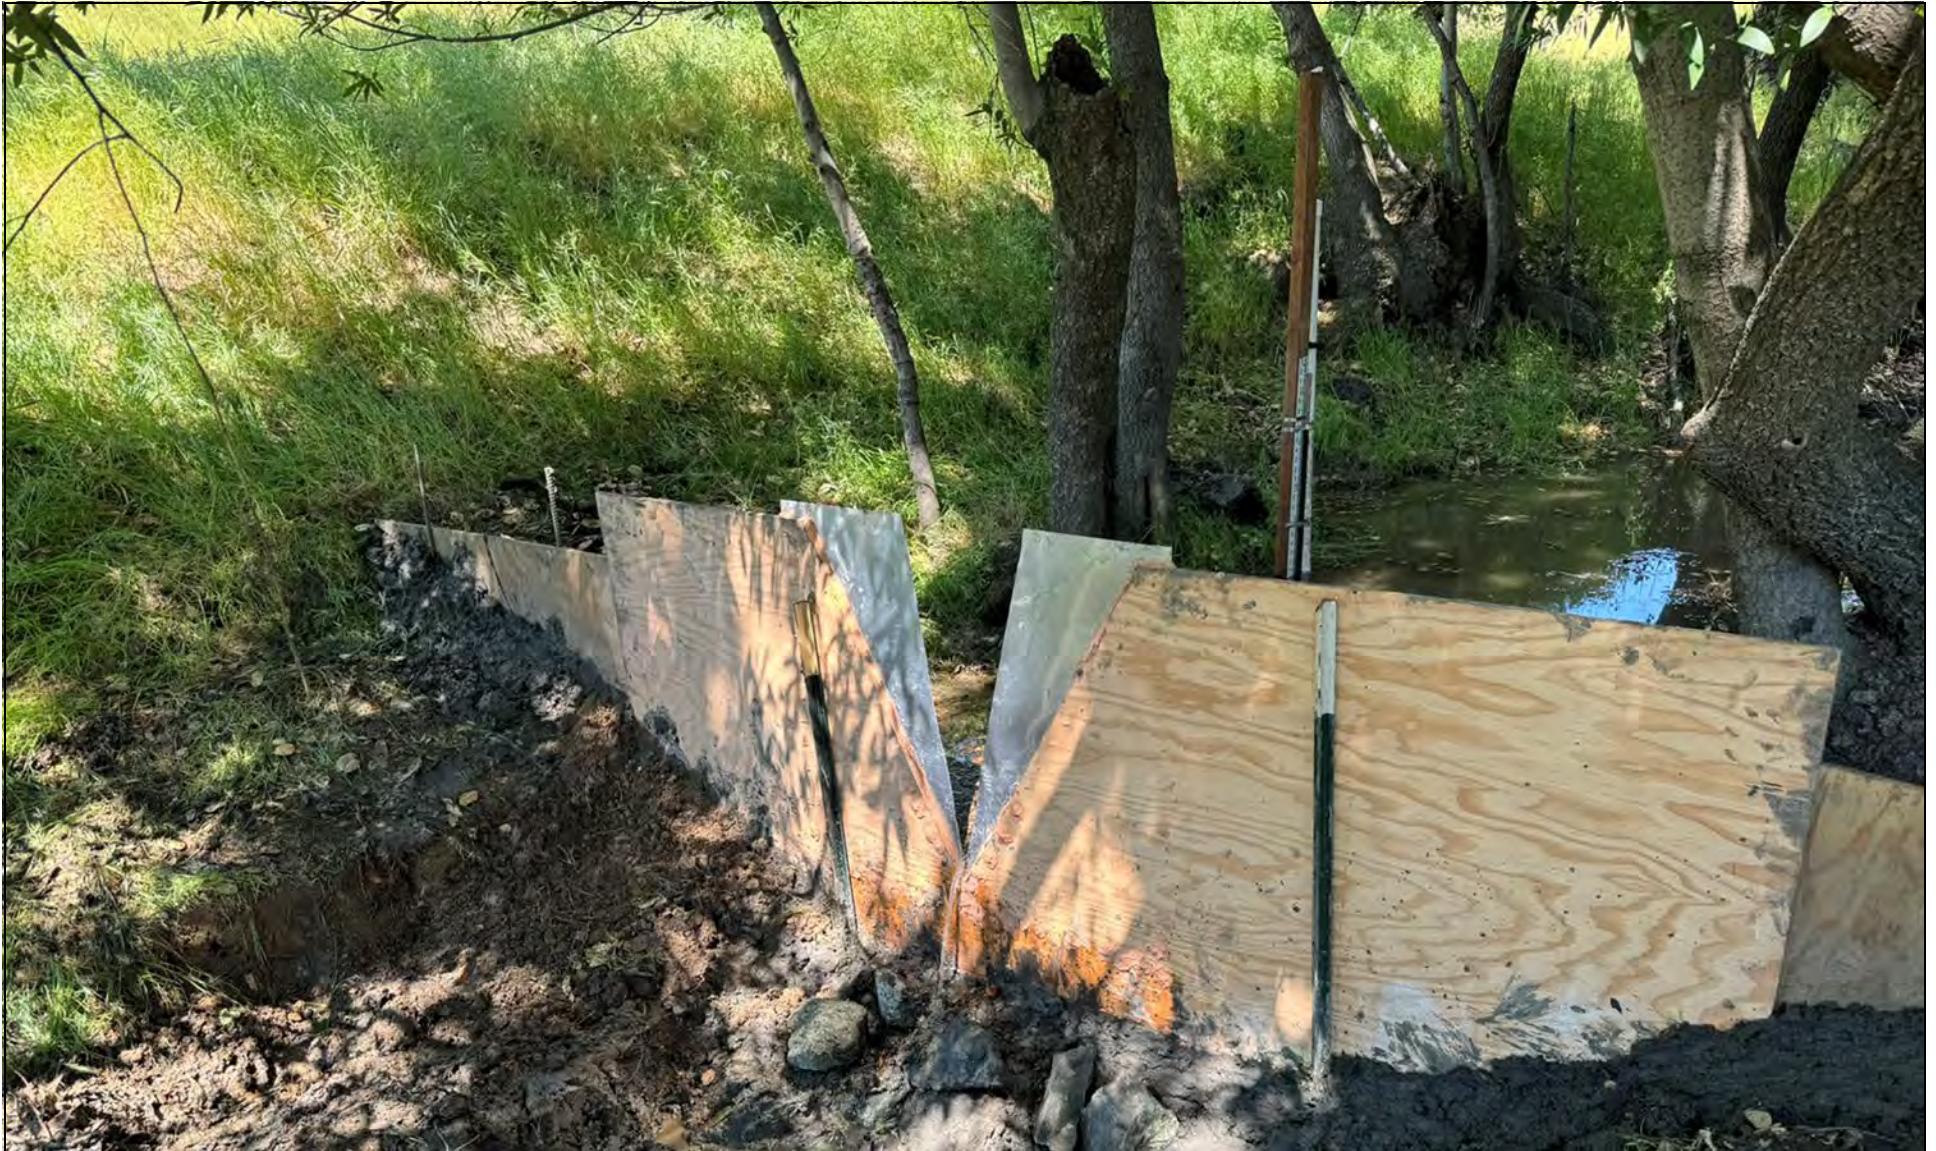
Figure 1

Notes: Photo taken on 05/03/2024 during weir install. Staff plate and gage housing is seen in the background.

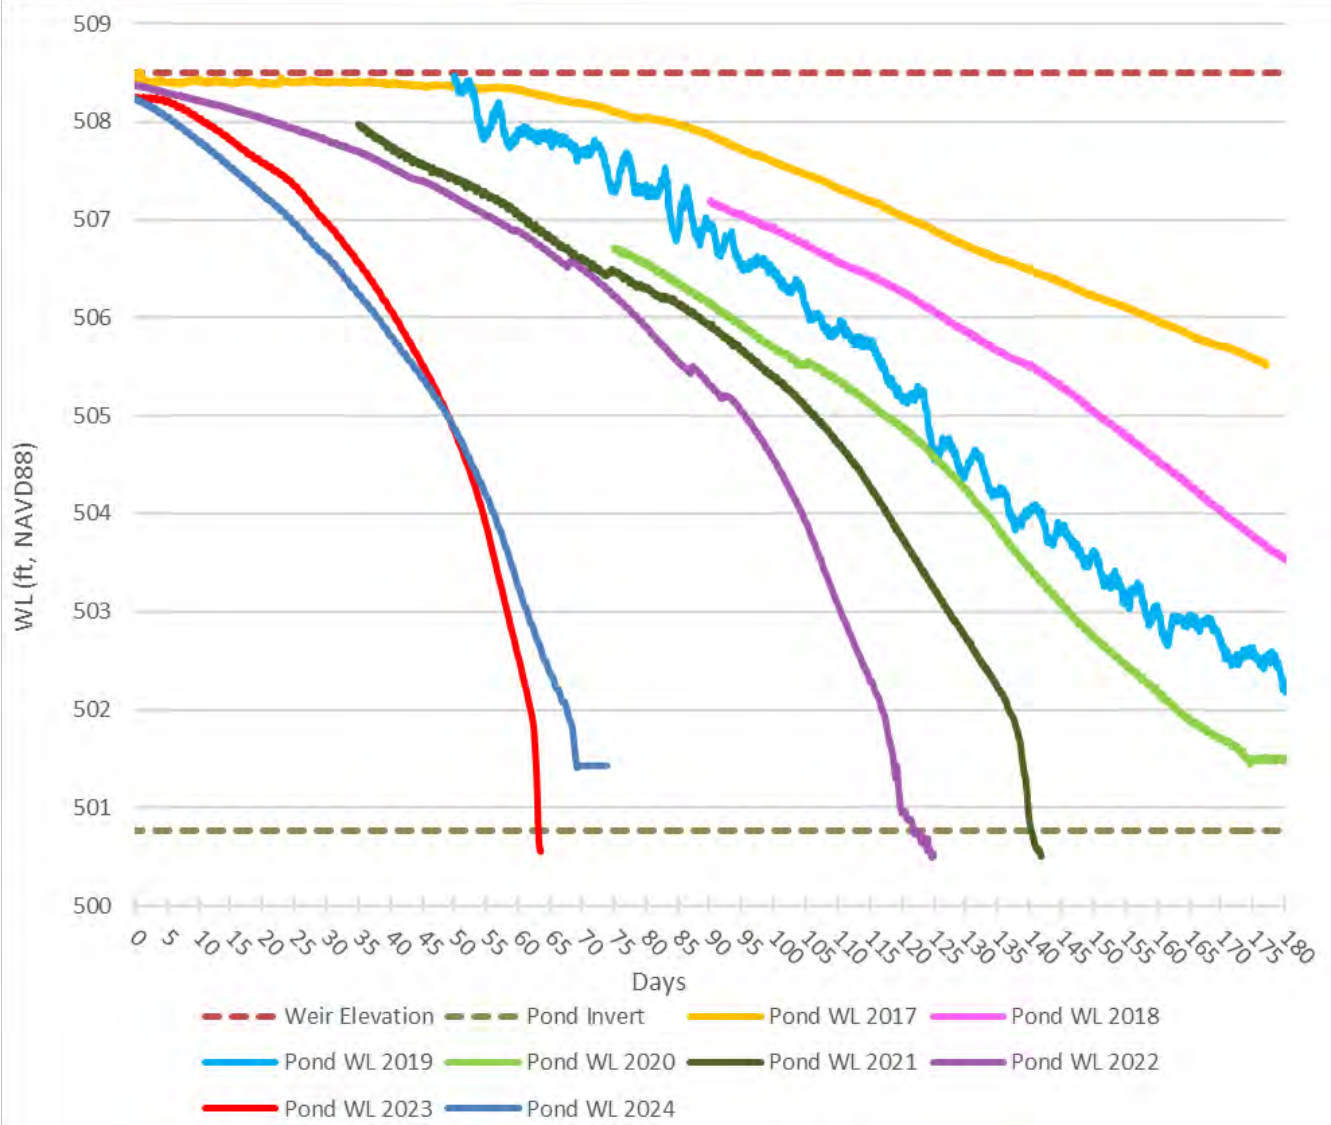
Calero Mitigation Site Monitoring	
		Pond water level recession	
	Project No. 15-1030-5	Created By: AH	Figure 3

WY	Date WL dropped below weir elevation	Dry date	Precipitation Class
2017	03/21/2017	9/19/2017	Wet
2018	04/07/2018 (highest WL 507.19)	8/26/2018	Very Dry
2019	4/12/2019	8/30/2019	Wet
2020	04/17/2020 (highest WL 506.73 ft)	7/26/2020	Very Dry
2021	01/20/2021 (highest WL 508.09 ft)	5/15/2021	Very Dry
2022	01/19/2022	5/25/2022	Dry
2023	04/12/2023	7/10/2023	Very Wet
2024	05/04/2024	7/16/2024	Dry

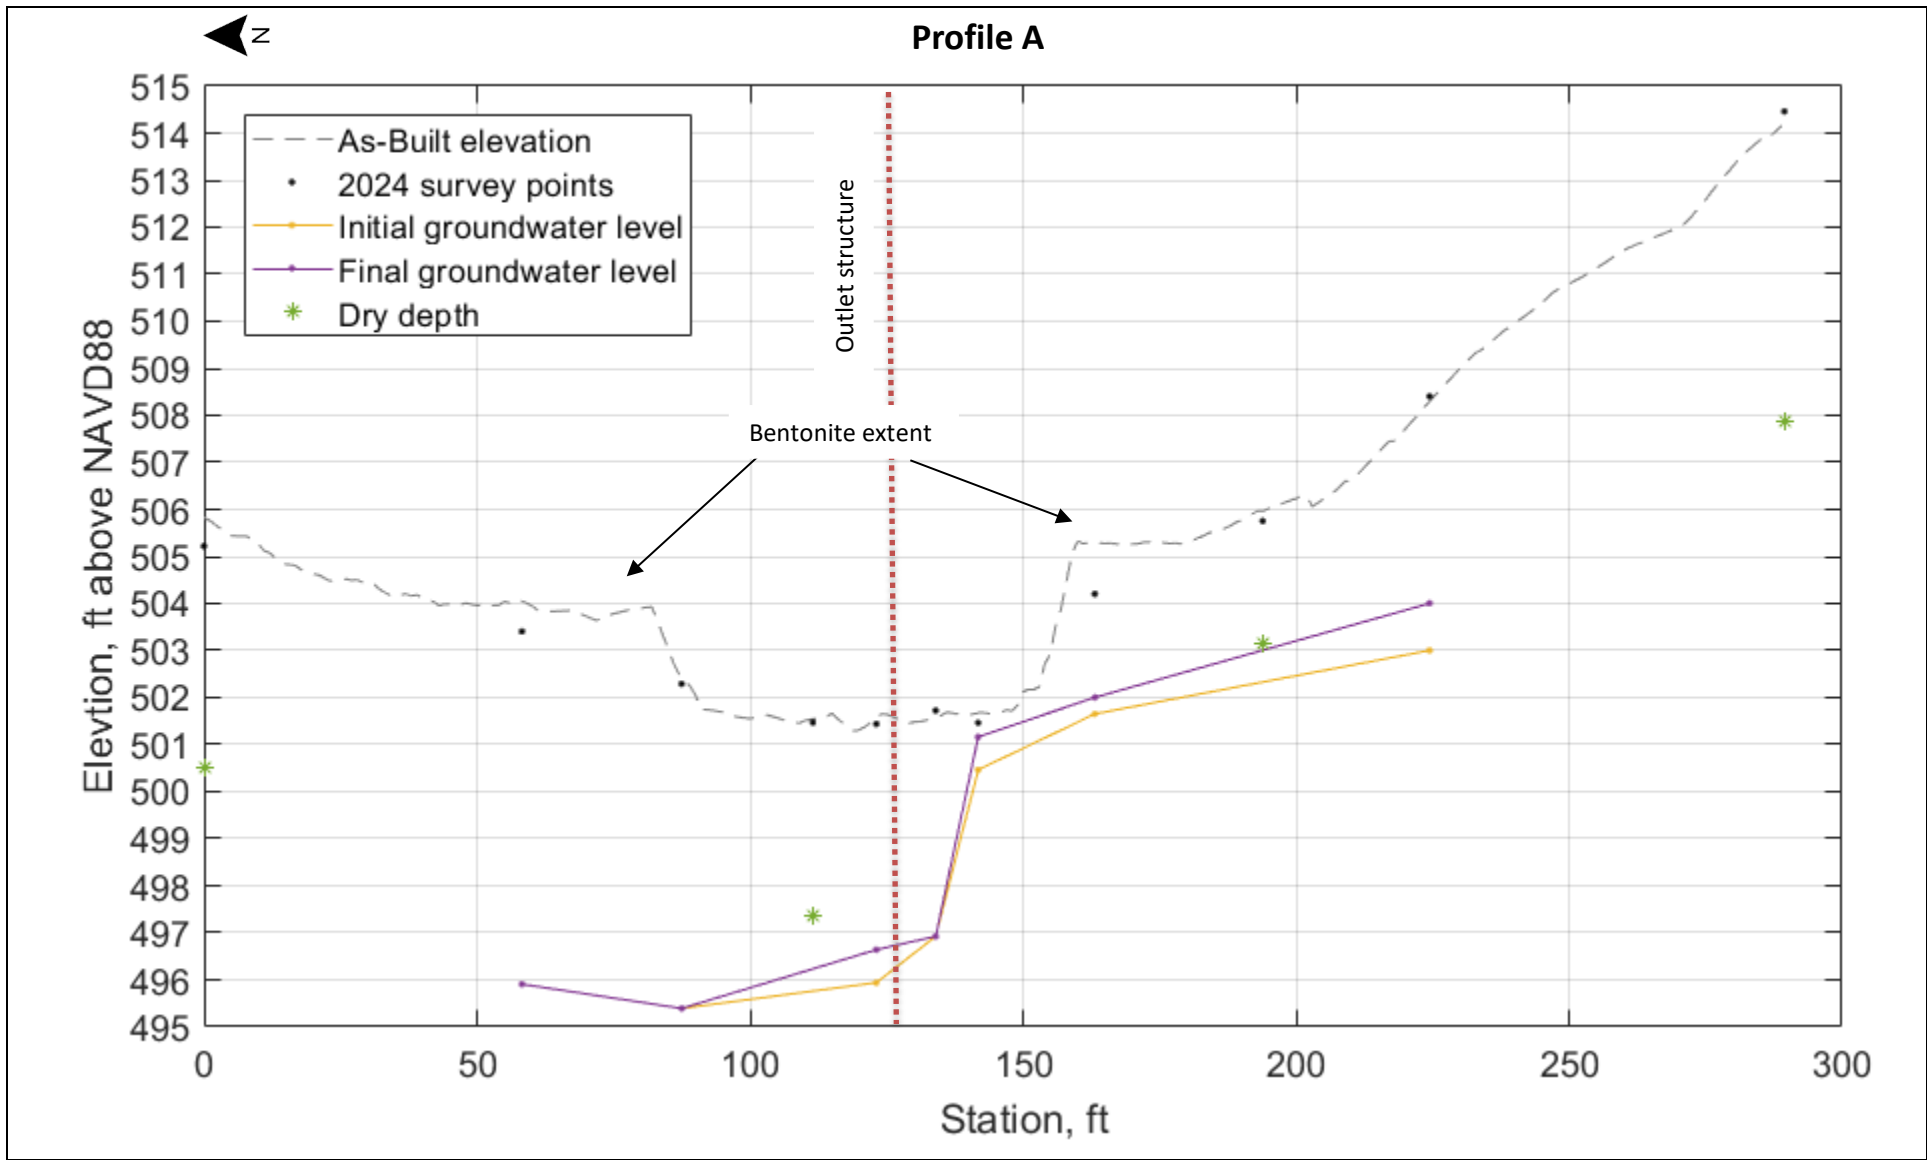
Project No. 15-1030-5	Created By: AH	Figure 5
-----------------------	----------------	-----------------

Calero Mitigation Site Monitoring
Groundwater Profile A

In consideration that weir flows below the pond were higher than seep flows into the pond, a site visit was made on October 17, 2024 to take groundwater depth measurements to better understand subsurface conditions. A hand auger was used to drill holes at points along the length of the pond. Data collected were used to create a groundwater surface elevation profile from the seep trough to the pond outlet and through the remainder of the pond.

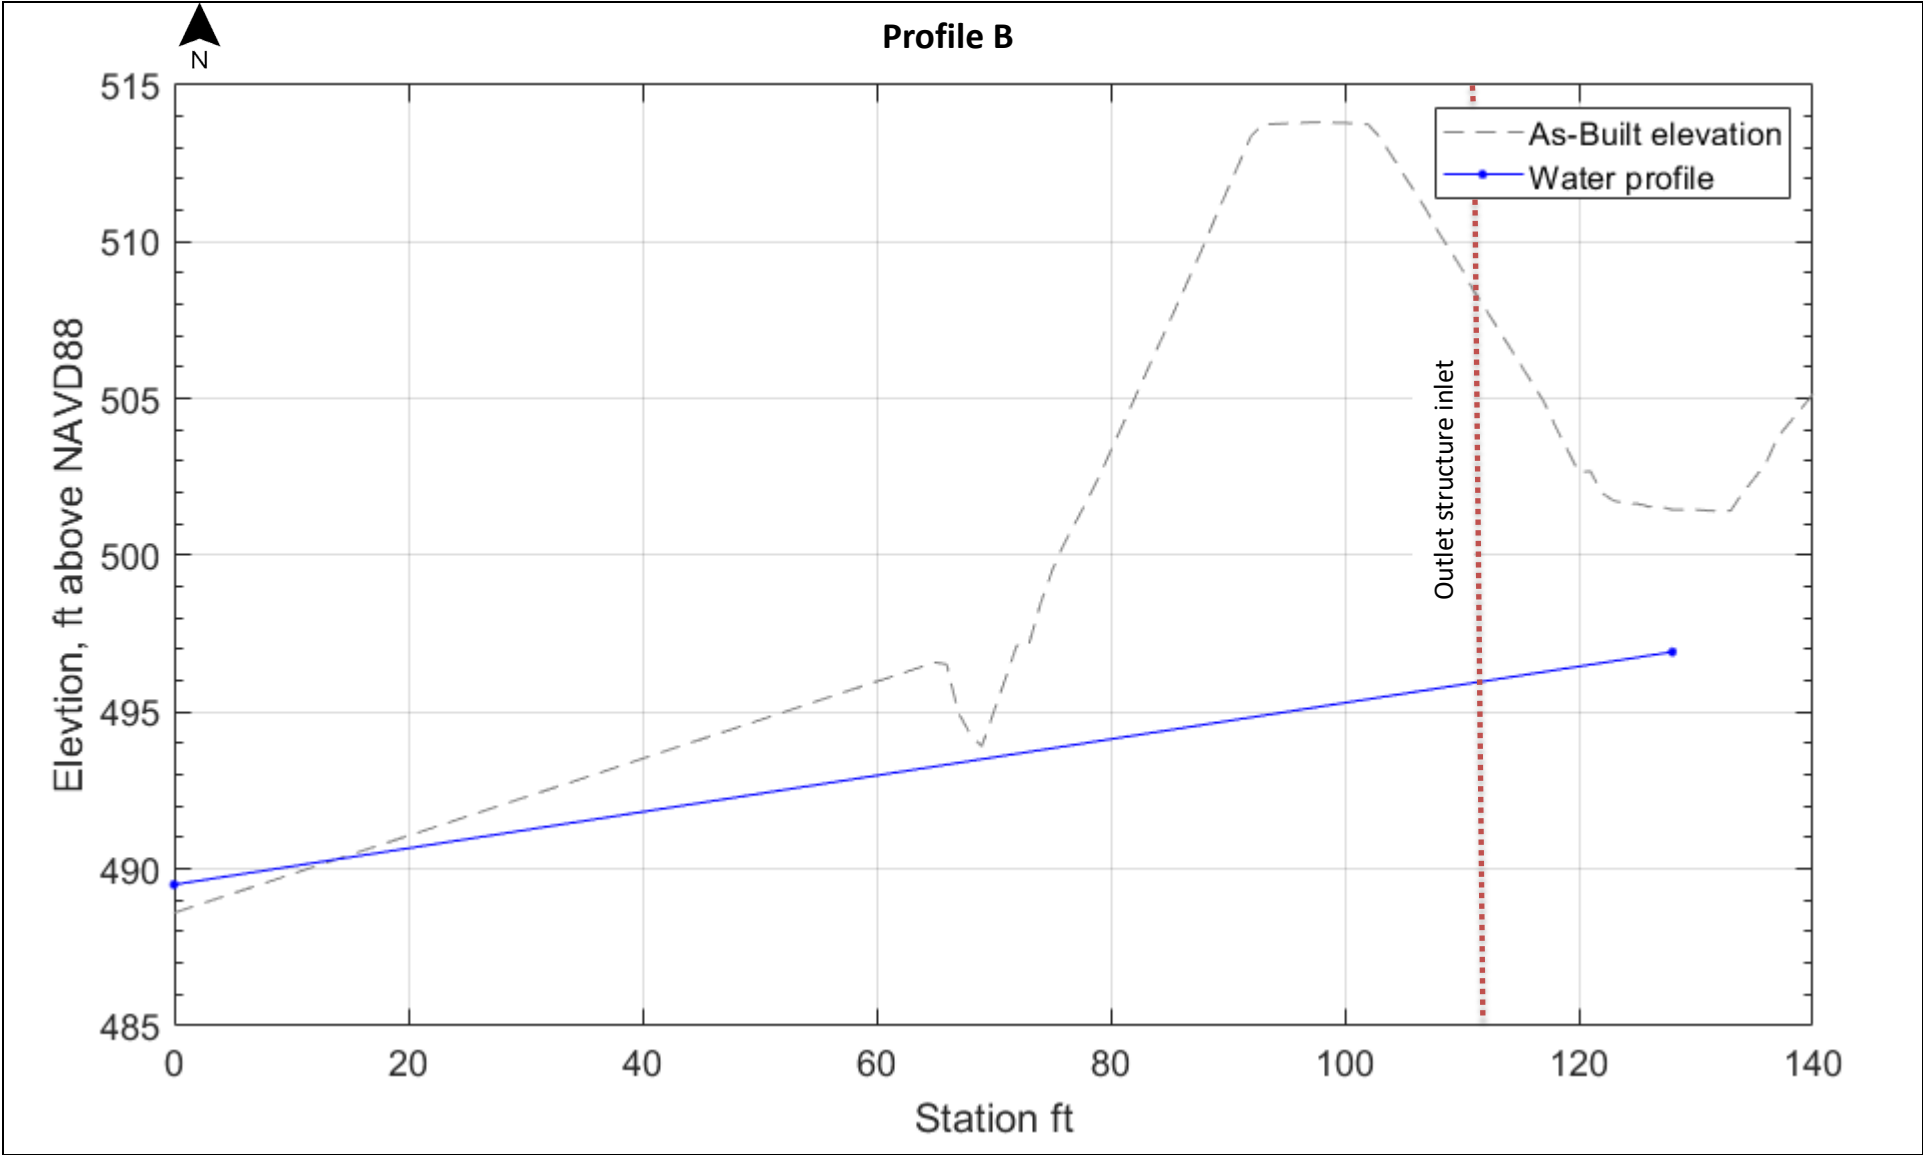
Project No. 15-1030-5	Created By: AH	Figure 6
-----------------------	----------------	-----------------

Calero Mitigation Site Monitoring
Groundwater Profile B

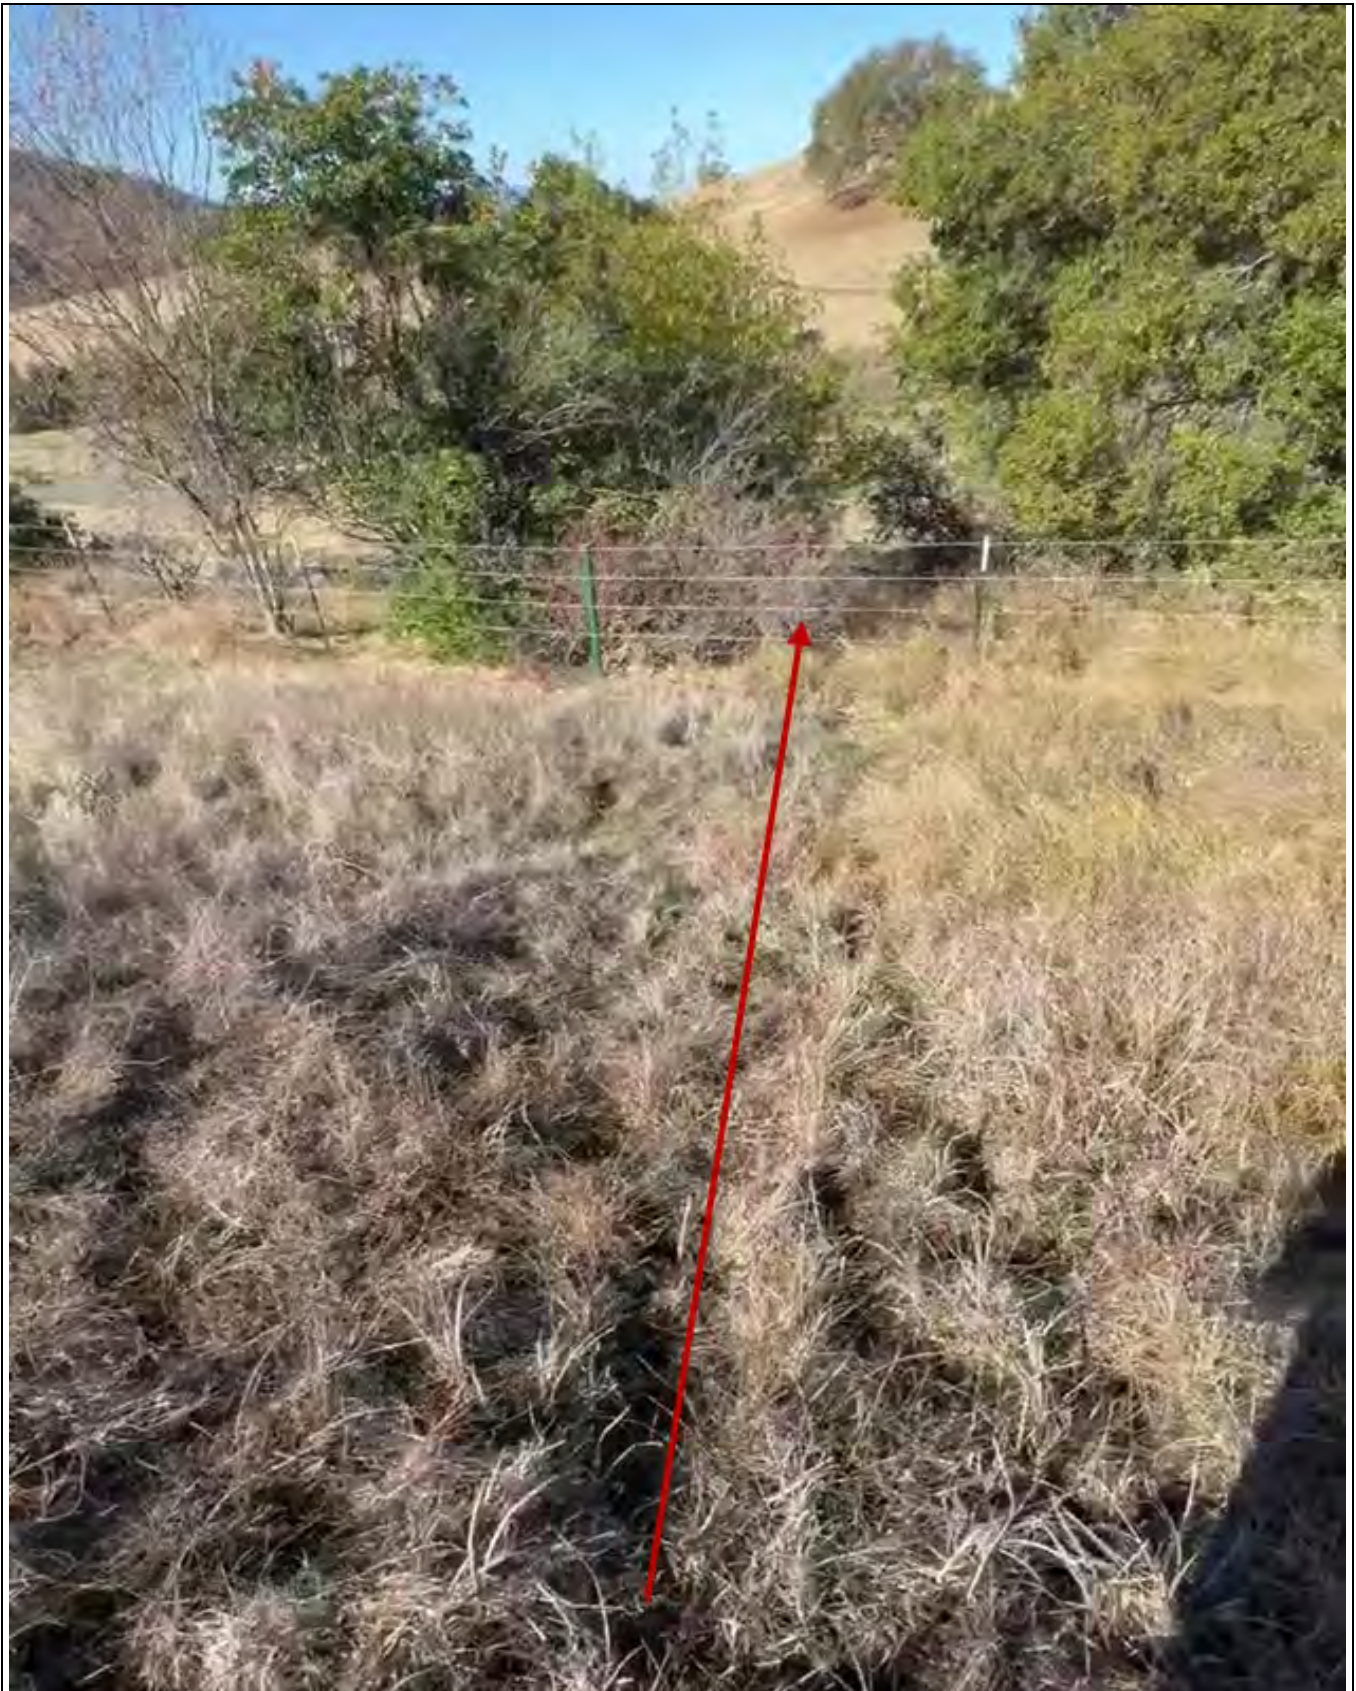
Calero Mitigation Site Monitoring
Seep 4 flow split
Figure 8

Notes:
See photo point #1 in
Figure 2 for location and
direction

A site visit was made on 11/14/2024 by the Habitat Agency to observe the adjacent upstream watershed and contributing seeps. It was noted that Seep 4 (Figure 2) was partially blocked by debris and partially redirected to the Almaden-Calero Canal. It is unknown when this blockage and flow split may have occurred, but it has likely contributed to loss in seep flows to the pond via the existing ditch. An additional investigation was made by cbec on 11/27/2024 to further investigate the seep collection system as partially informed by historical imagery. Based on review of 1968 aerial imagery (Figure 7), additional features that were investigated included a relic ditch running adjacent to the existing fence line east of Seep 1, and a relic ditch connecting Seeps 4 and 5. The flow split at Seep 4, near the fence line, was confirmed (Figure 8). The relic and defunct surface ditch connecting Seeps 4 and 5 was also identified (Figure 9). The relic and defunct surface drainage east of Seep 1 (Figure 10) was also investigated and is largely defunct due to multiple headcuts redirecting flows to the Almaden-Calero Canal.

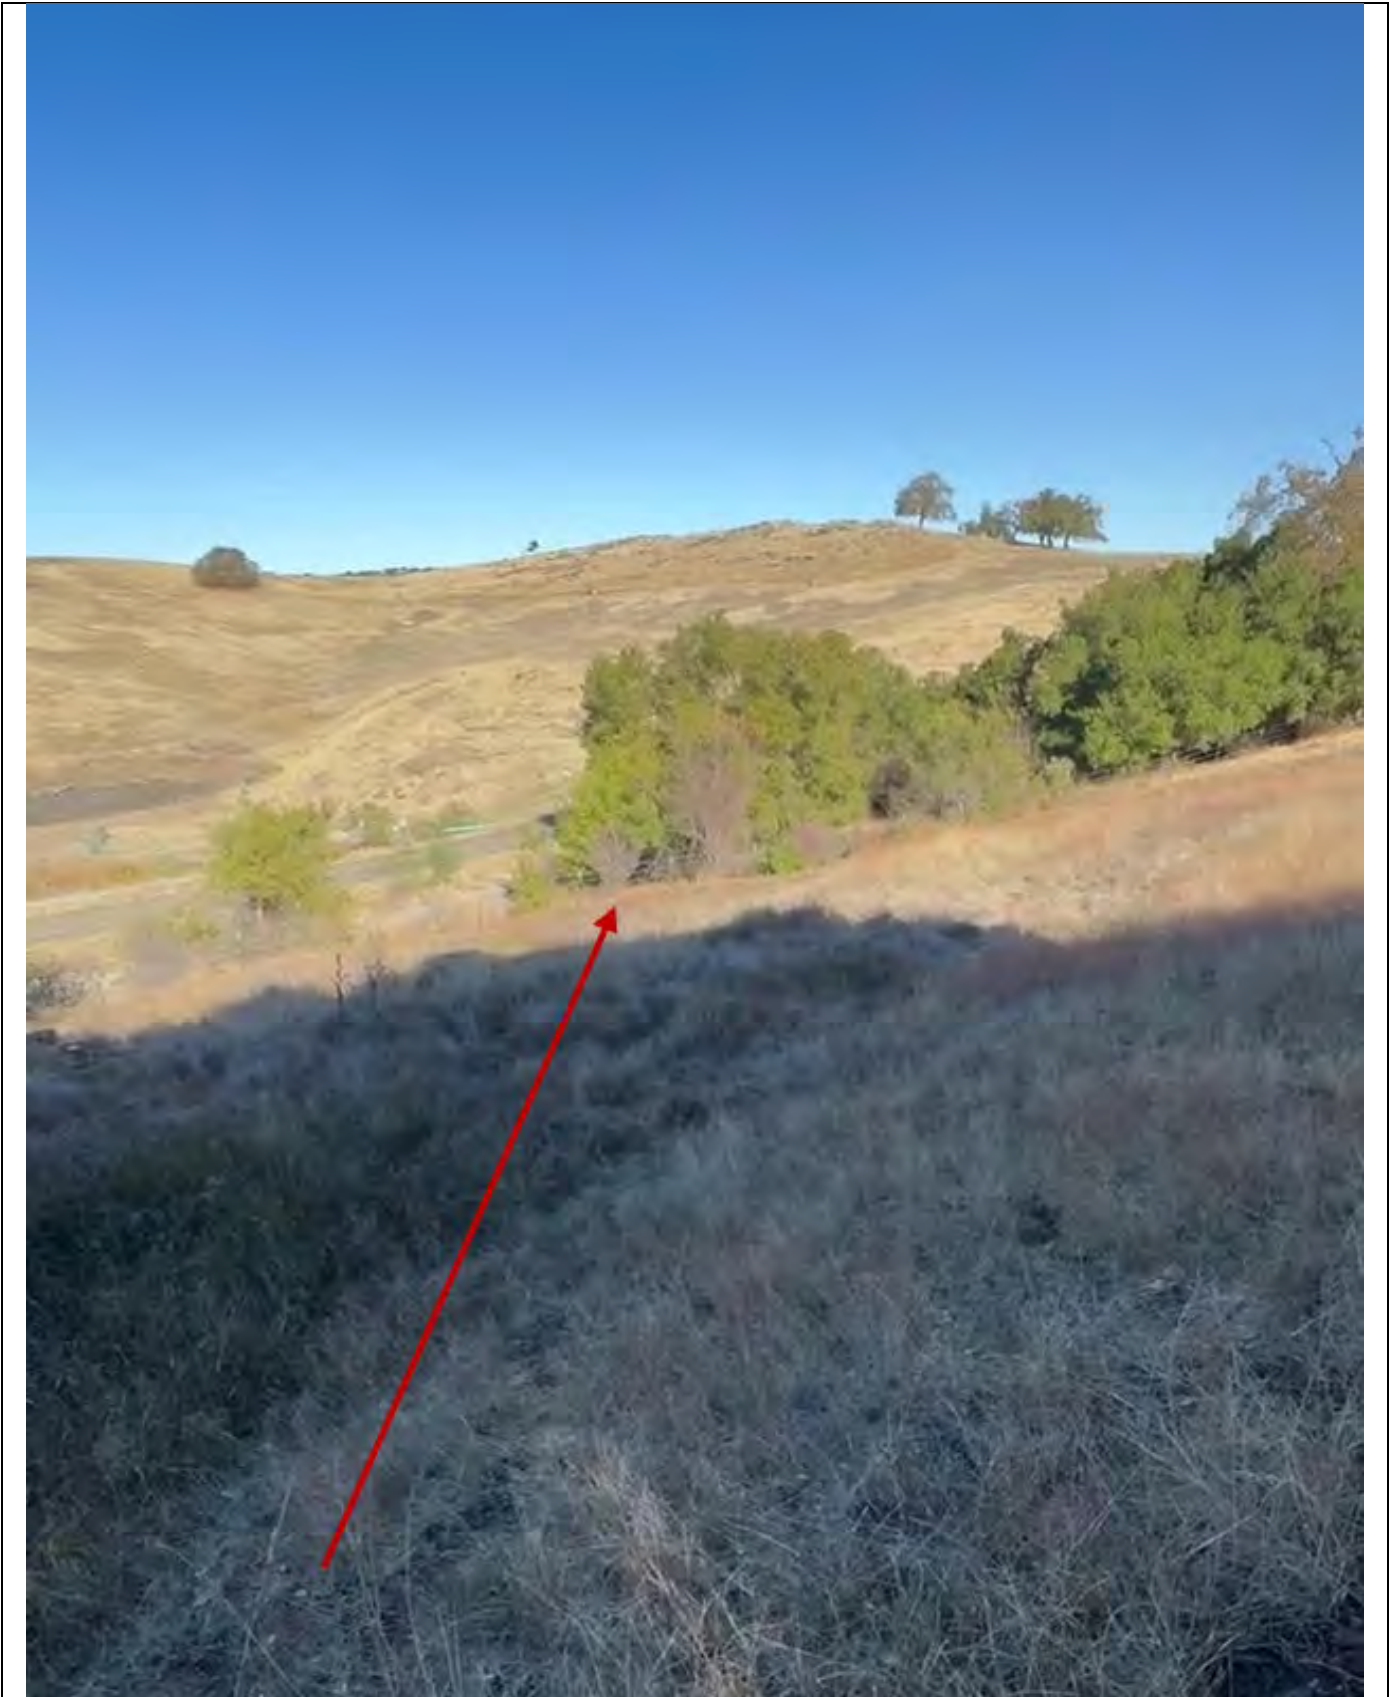
Calero Mitigation Site Monitoring
Relic surface ditch
Figure 9

Notes:
See photo point #3 in
Figure 2 for location and
direction

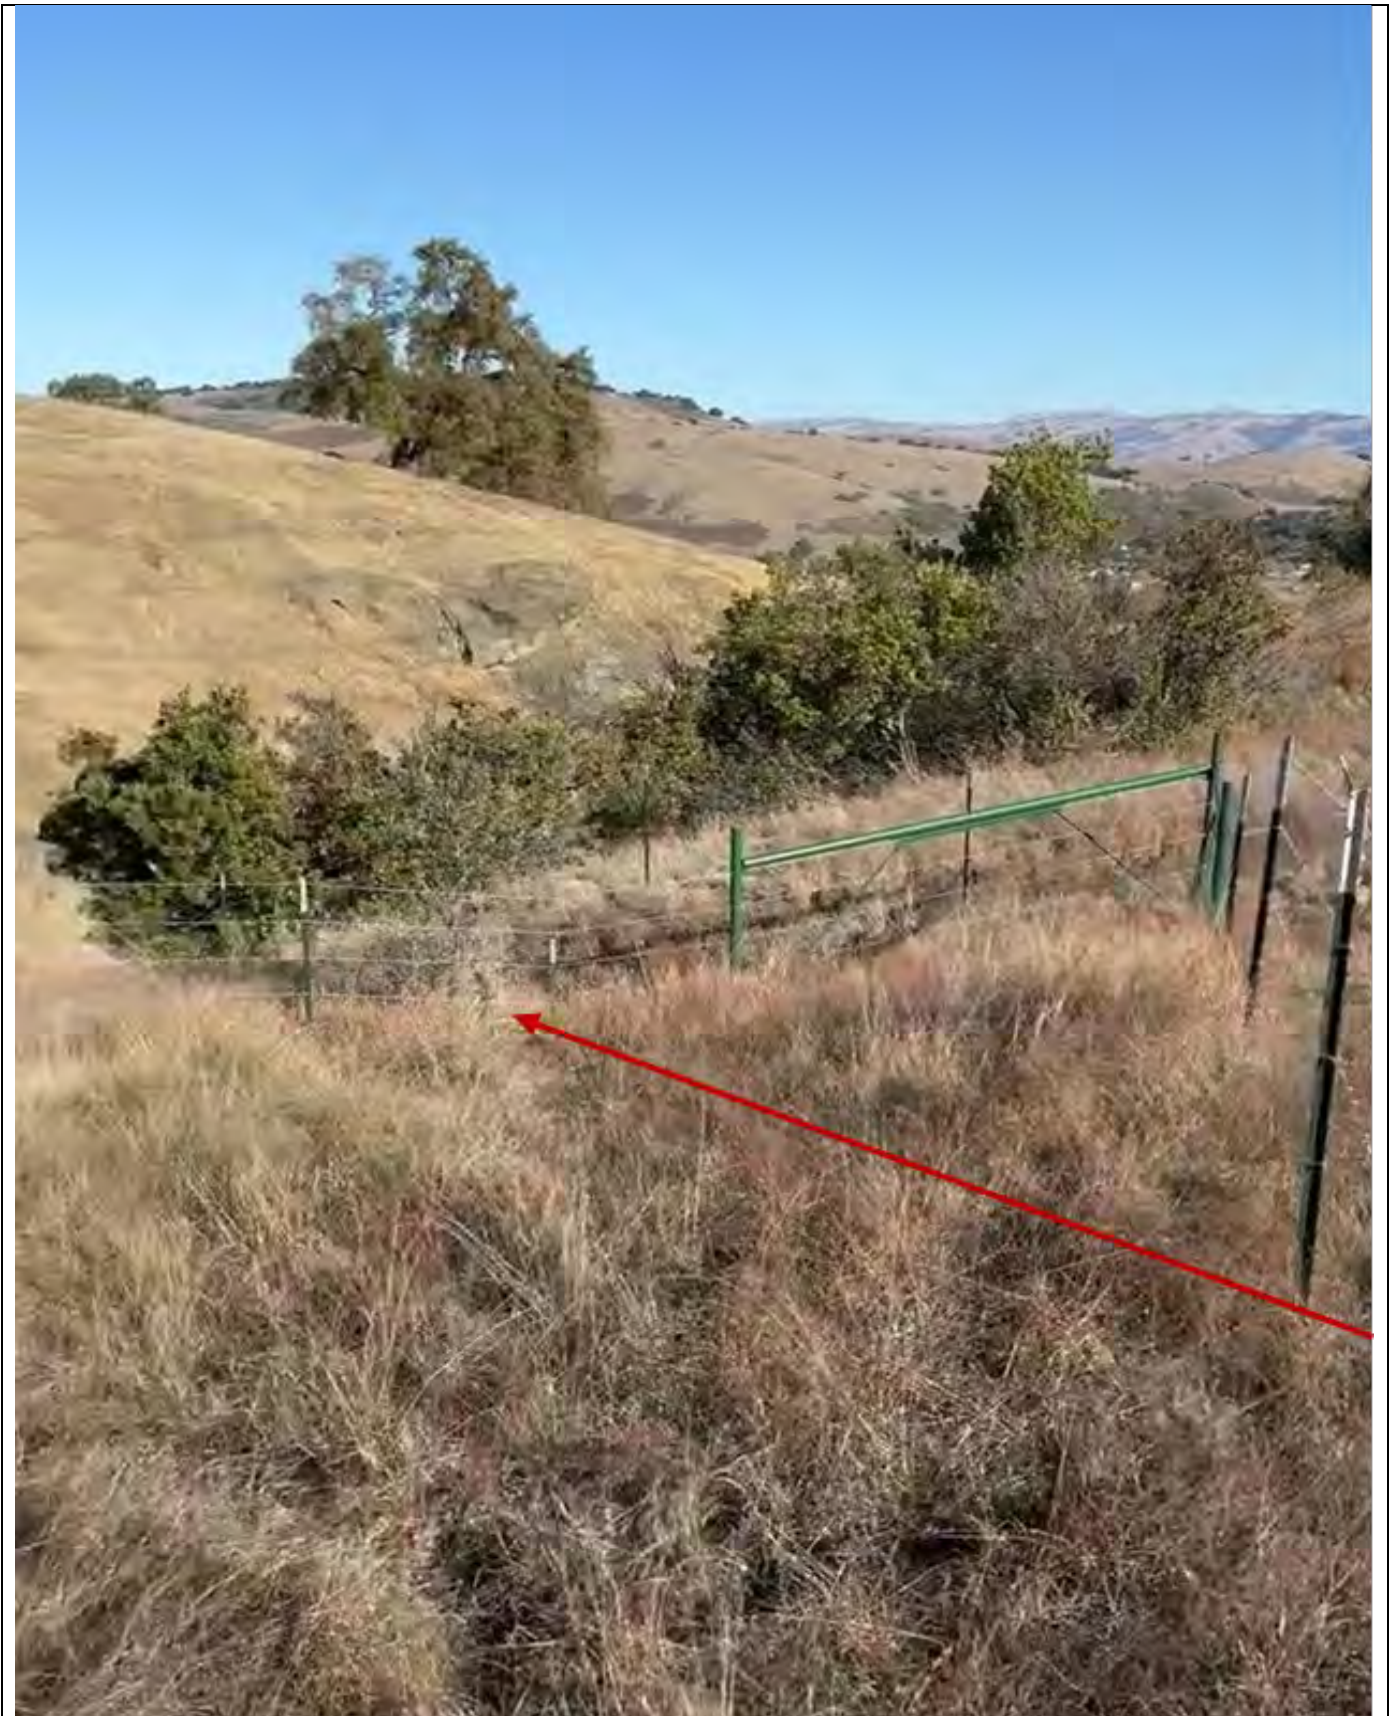
Calero Mitigation Site Monitoring
Relic surface drainage feature
Figure 10

Notes:
See photo point #3 in
Figure 2 for location and
direction

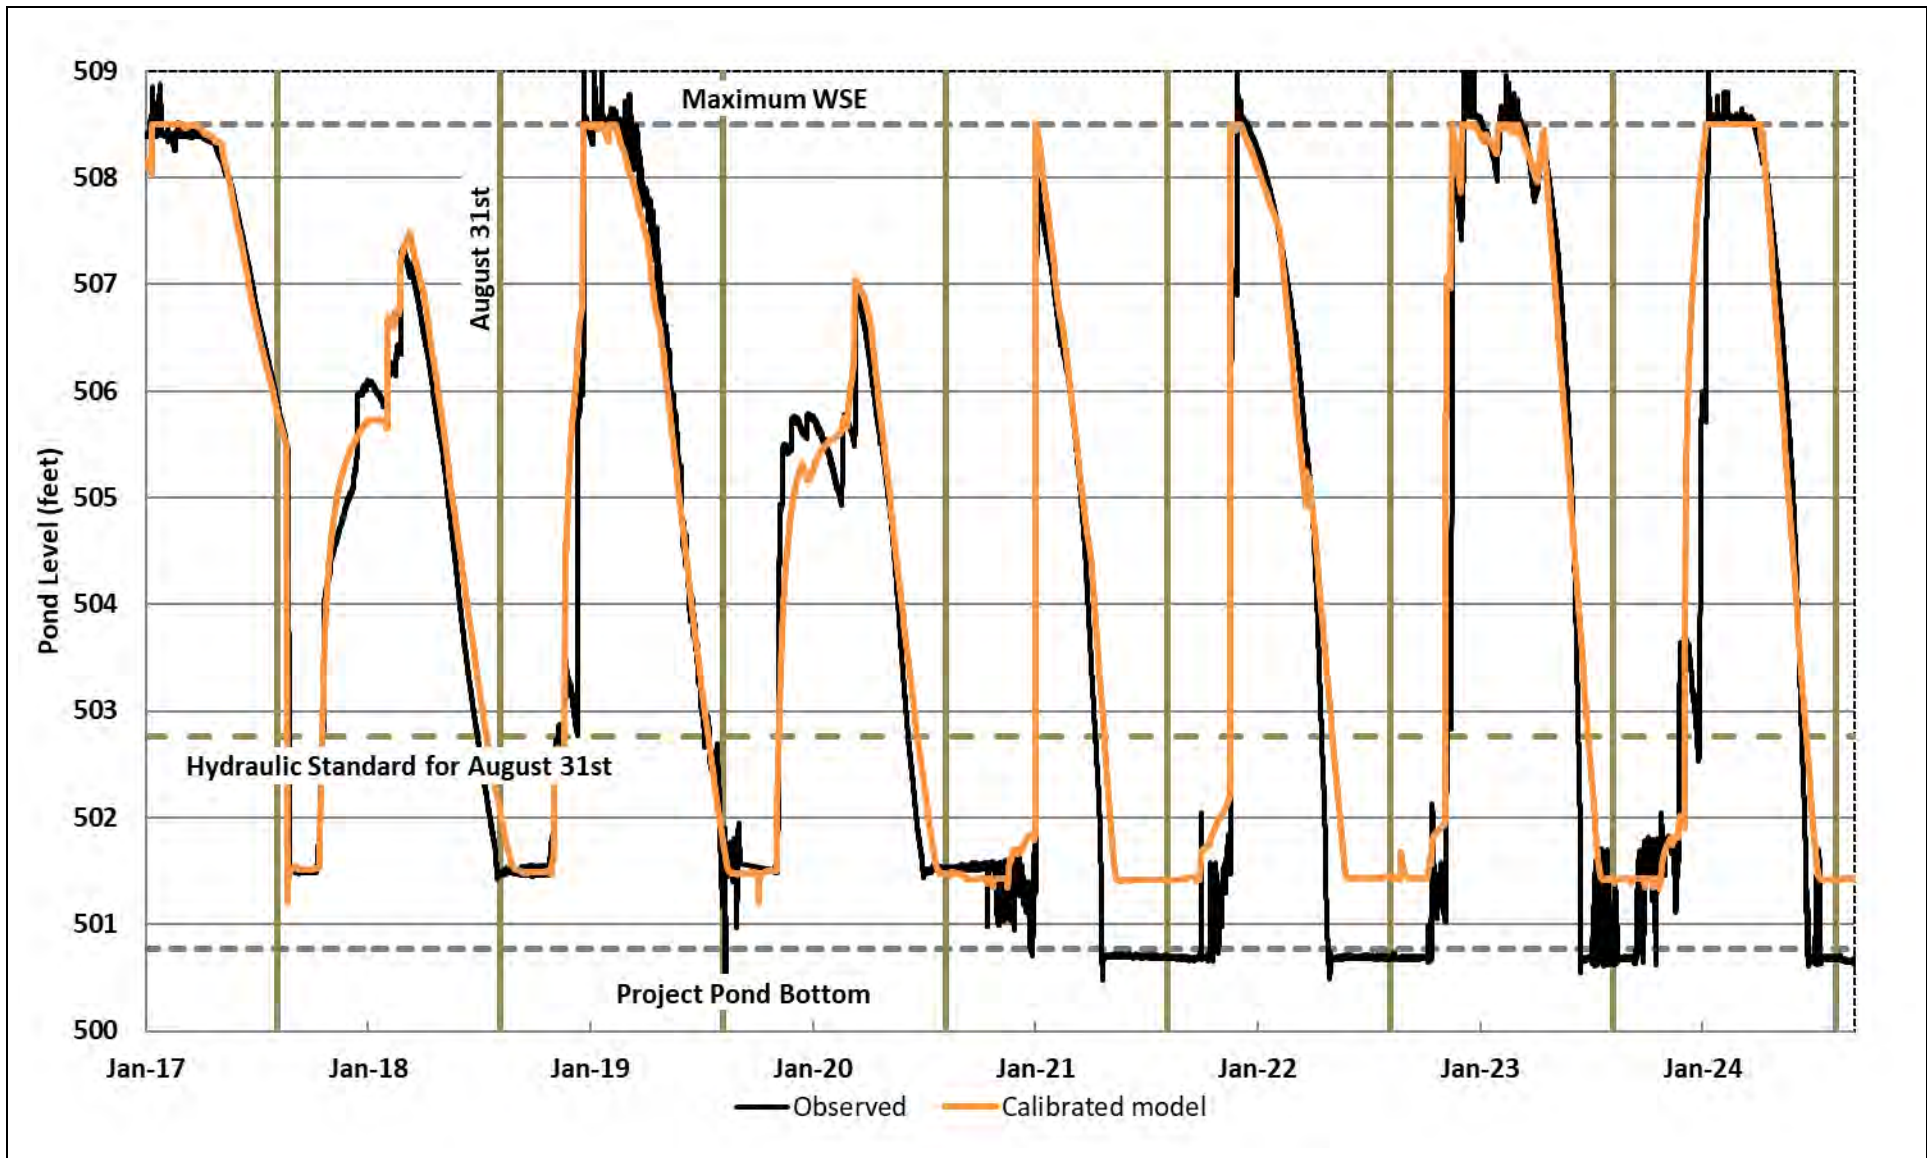
Figure 14

Notes:
 The pressure transducer was originally set at 501.5 ft. This was changed to 500.77 ft in December 2020 when a telemetered station was installed.

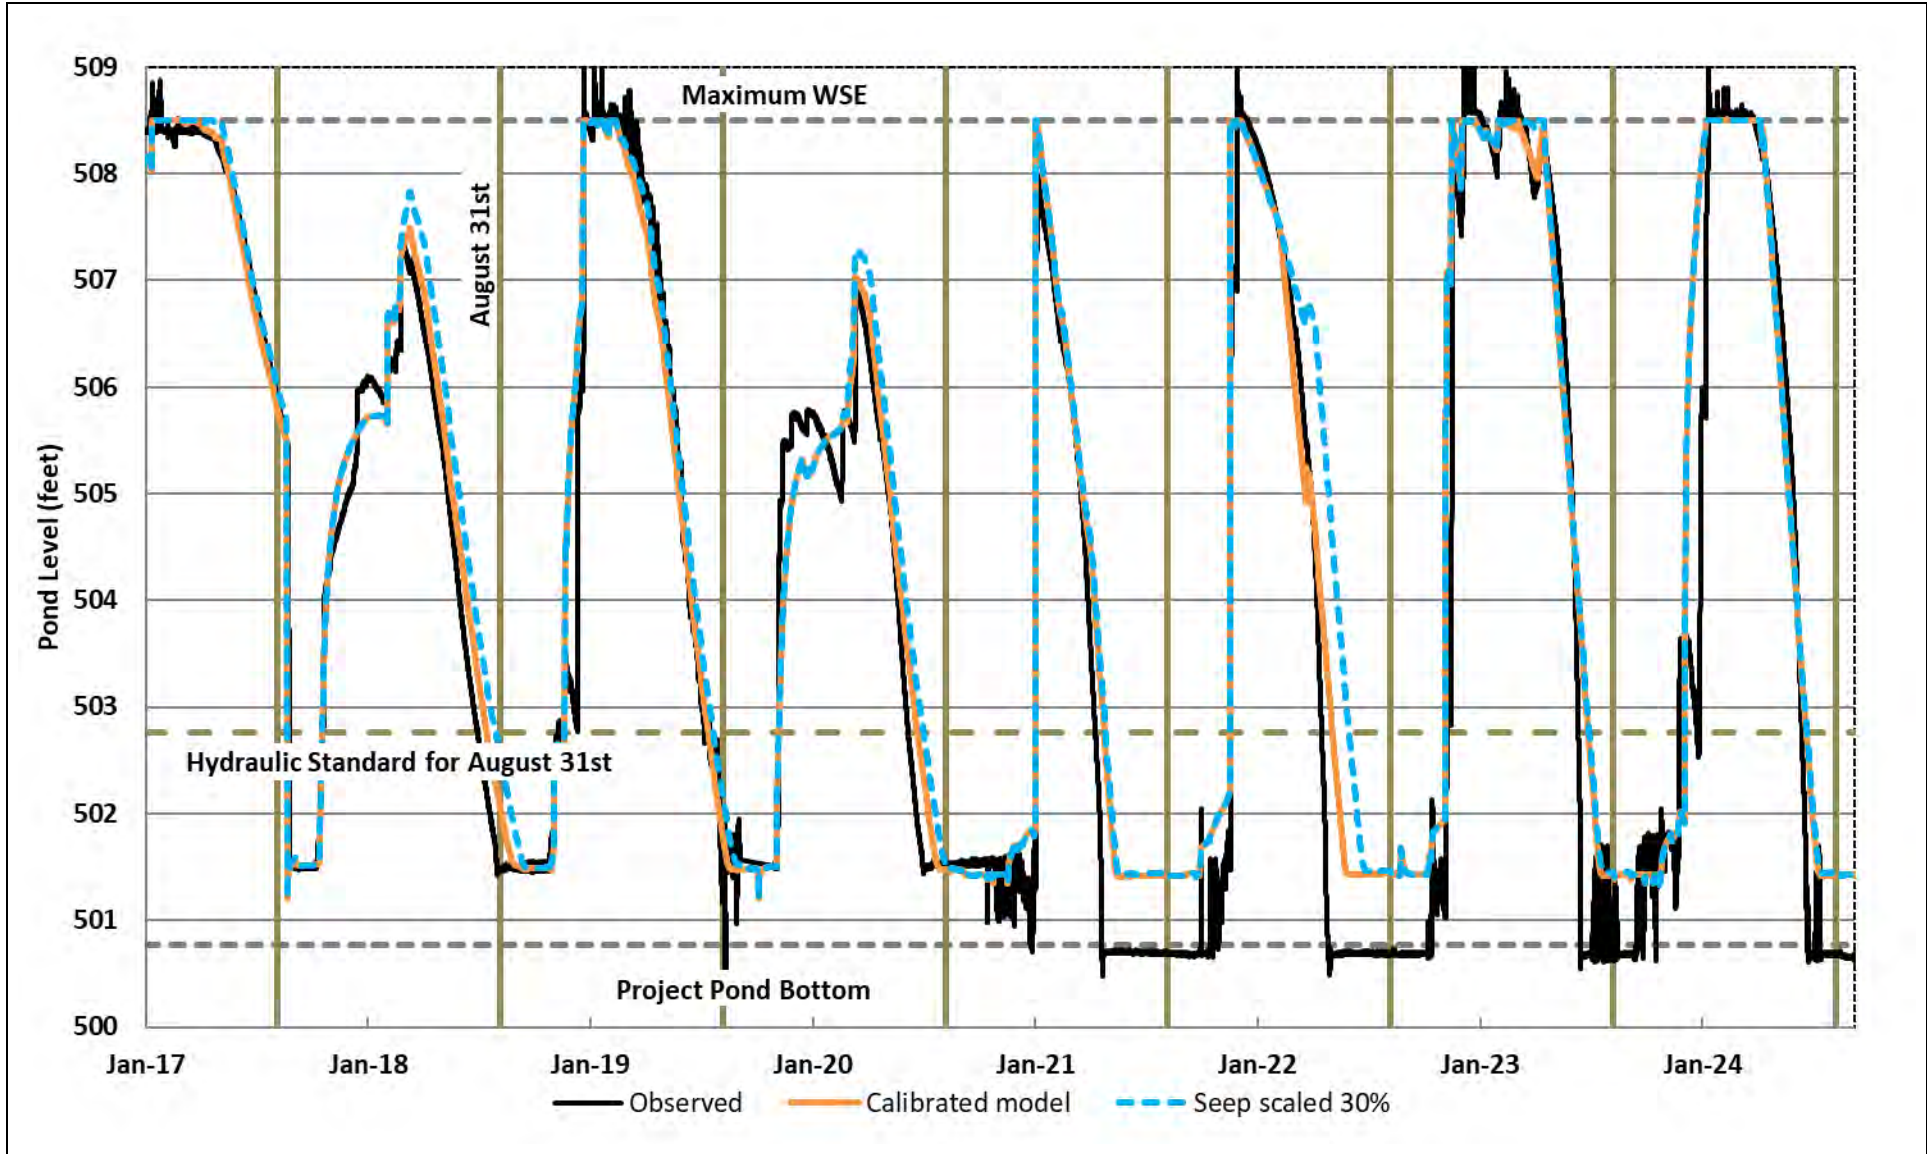
Project No. 15-1030-5	Created By: AH	Figure 15
-----------------------	----------------	------------------

Calero Mitigation Site Monitoring
Water budget model sensitivity
