Project No. 3753-08

Subject: Calero County Park Pond and Wetland Restoration Project—Year 8 (2024)
Supplemental Vegetation and Hydrology Monitoring

Year 8 (2024) Supplemental Vegetation and Hydrology Monitoring Memorandum (3753-08)
February 2025

Calero County Park and Wetland Restoration Project

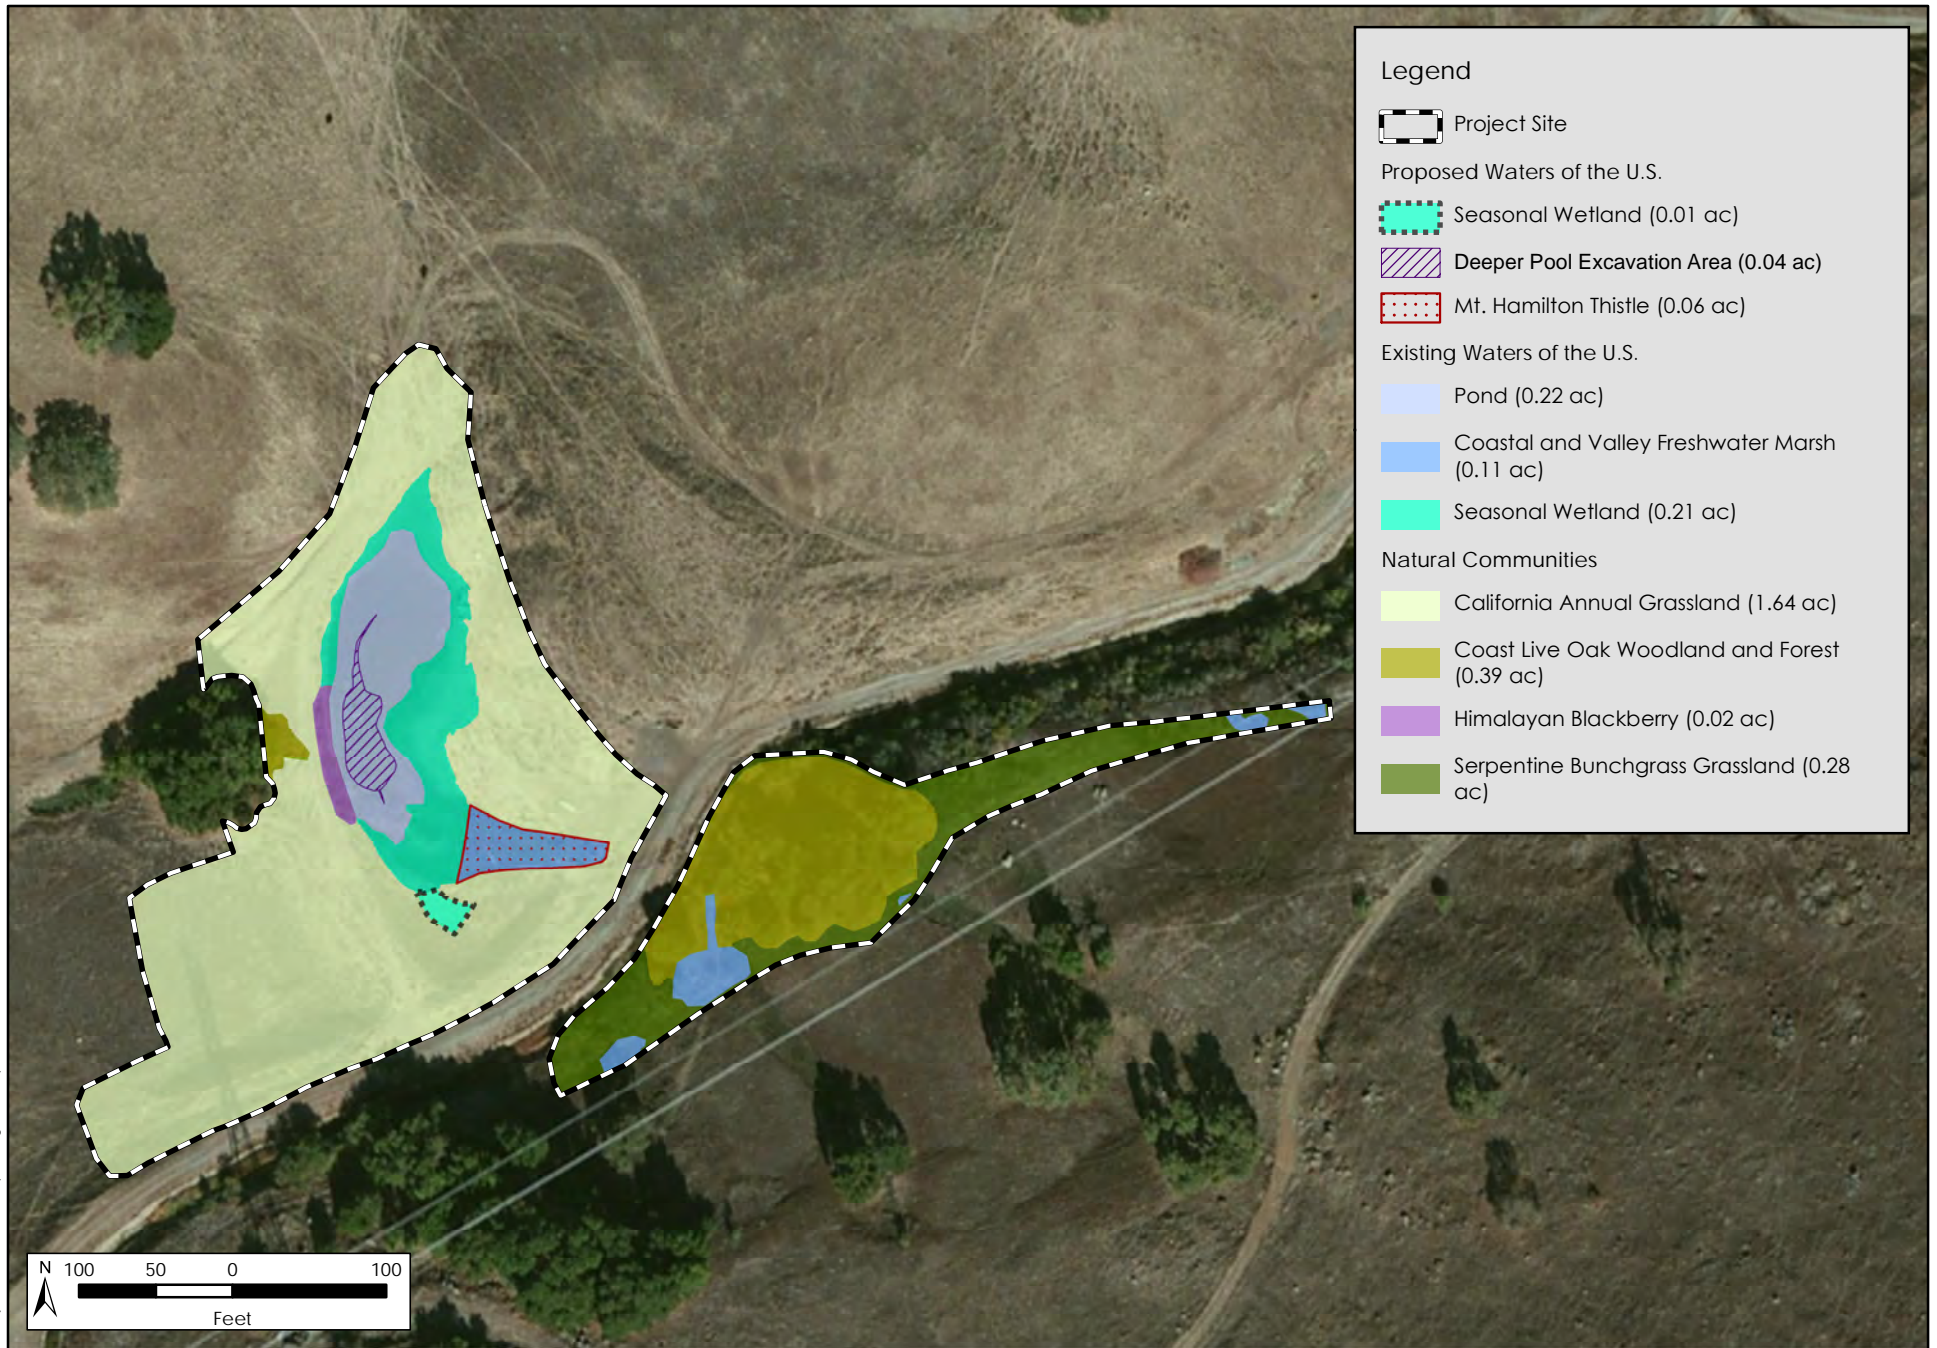
Figure 6. Proposed Waters of the U.S. at the Pond Mitigation Site
Long-term Management Plan for Permittee-Responsible Mitigation (3753-02)
Calero County Park Pond and Wetland Restoration Project
July 2016

A total of 0.54 acre of waters of the U.S. is currently present at the pond mitigation site (Figure 5). Restoration activities will result in the establishment of an additional 0.01 acre of waters of the U.S. and the restoration of higher-quality aquatic habitat function to 0.16 acre of currently degraded waters of the U.S. Following construction, 0.55 acre of waters of the U.S. will be present at the pond mitigation site (Figure 6).
