# Coyote Valley Linkage Assessment Study Final Report

PATHWAYS FOR WILDLIFE, TANYA DIAMOND AND  
AHIGA ROGER SNYDER

CALIFORNIA DEPARTMENT OF FISH  
AND WILDLIFE

MARCH 1, 2016

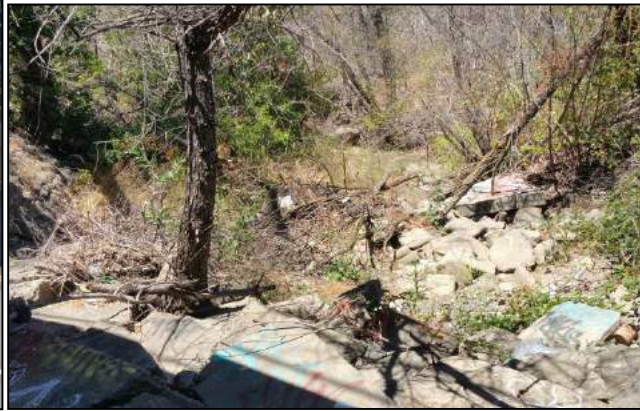
Figure 21: Debris at Monterey Road Culvert.

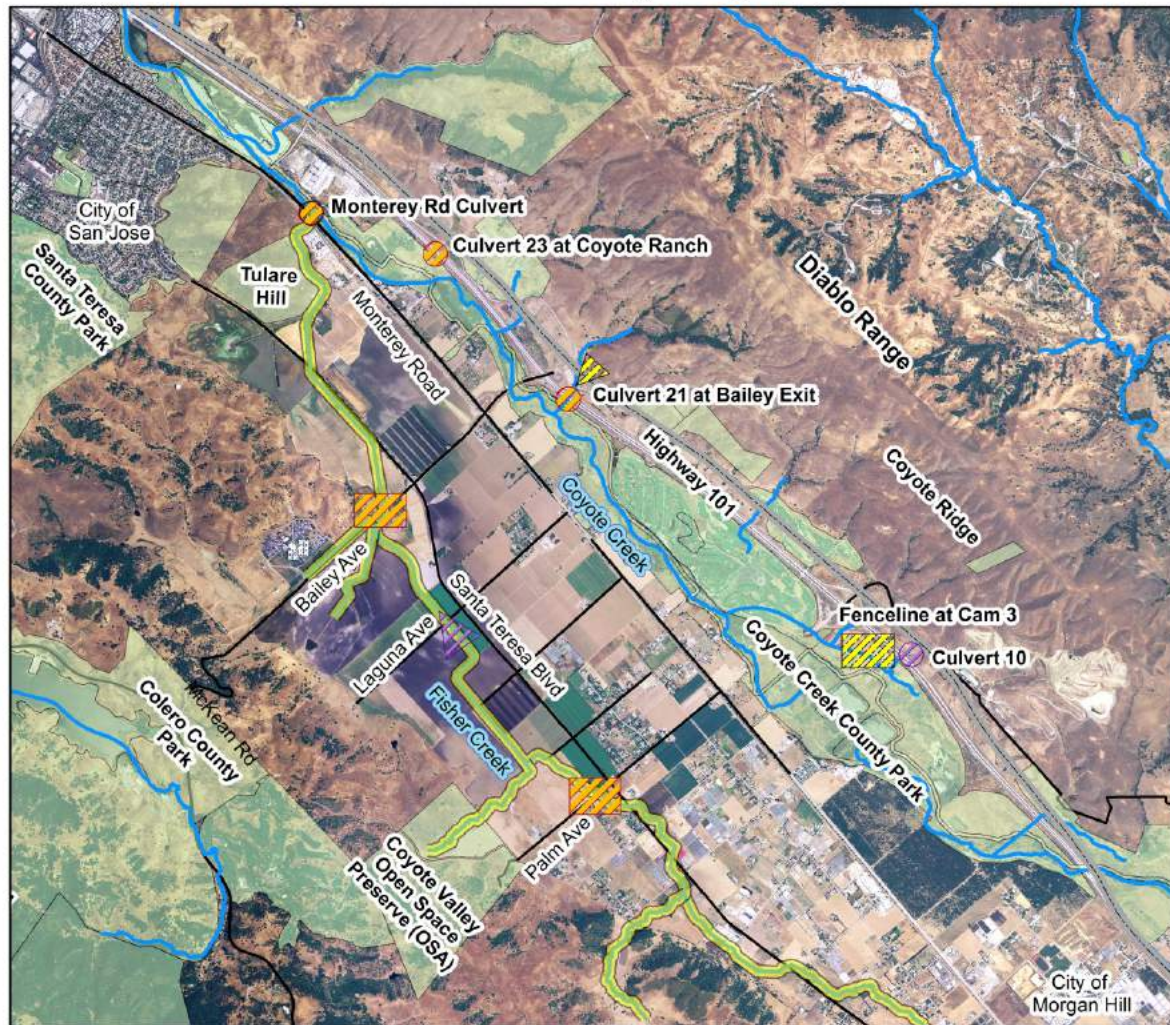
## Wildlife Connectivity Design with Permeability Improvements

through the landscape (Figure 22). This map also prioritizes barrier removal based on the impacts they are causing such as roadkill rates correlated at sites with blocked or inhibited crossing structures, in which animals have no choice but to cross over the road. Rankings were also based on high use areas by wildlife to lower use. High & Secondary Priority Recommendations, colored coded as orange (high priority) and yellow (secondary priority) in Figure 21:

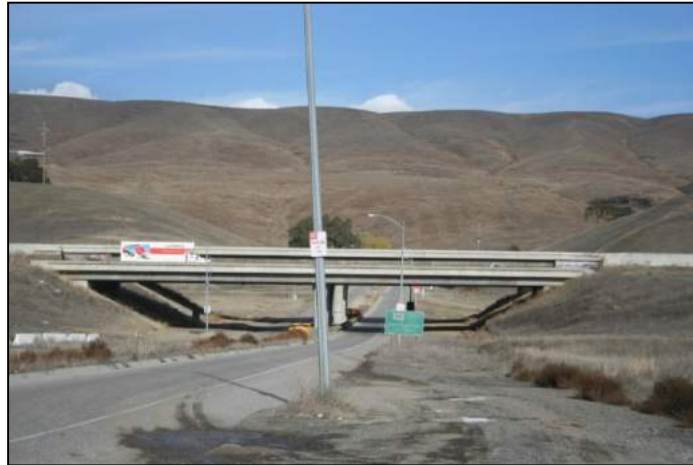
Figure 42: Highway 101 Golf Course Drive Underpass.

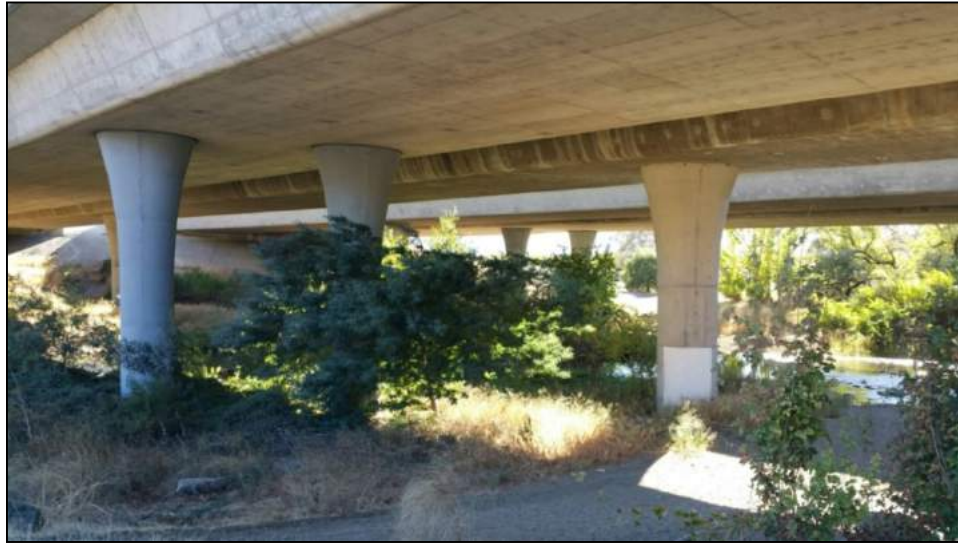
Figure 49: Highway 101 Coyote Creek Underpass.

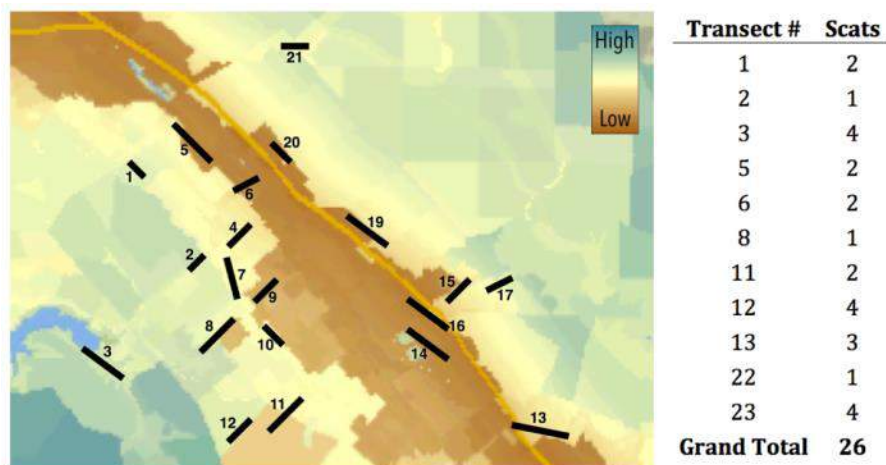
**Figure 5.** Map of transect locations and count of scats collected at each transect across Coyote Valley, CA.

Transects were walked on multiple separate occasions between the dates August 14, 2015 and September 7, 2015. For each sampling event, all available ground squirrel scats were collected outside burrows using sterile tweezers and placed in a 2 ml screw-cap tube containing DET solution (20% DMSO, 0.25 m EDTA, 100 mM Tris, pH 7.5 and NaCl to saturation) per Seutin et al. Tubes were kept frozen at -20°C until processing.
