**Calero County Park Pond and Wetland  
Restoration Project—  
Year 4 (2020) Monitoring Report**

**Project # 3753-07**

December 30 2020

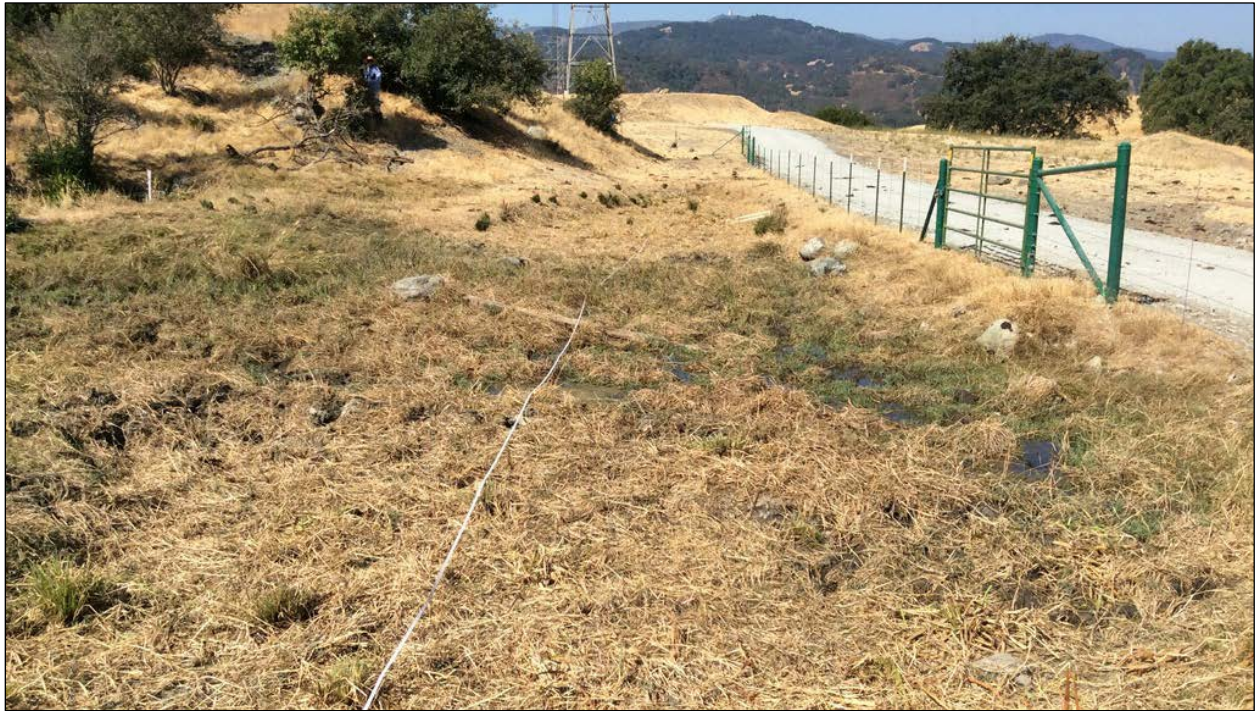
**Photo 1. Year 1 Conditions at Photo Point 1a during Vegetation Monitoring at the Wetland Mitigation Site (August 8, 2017)**

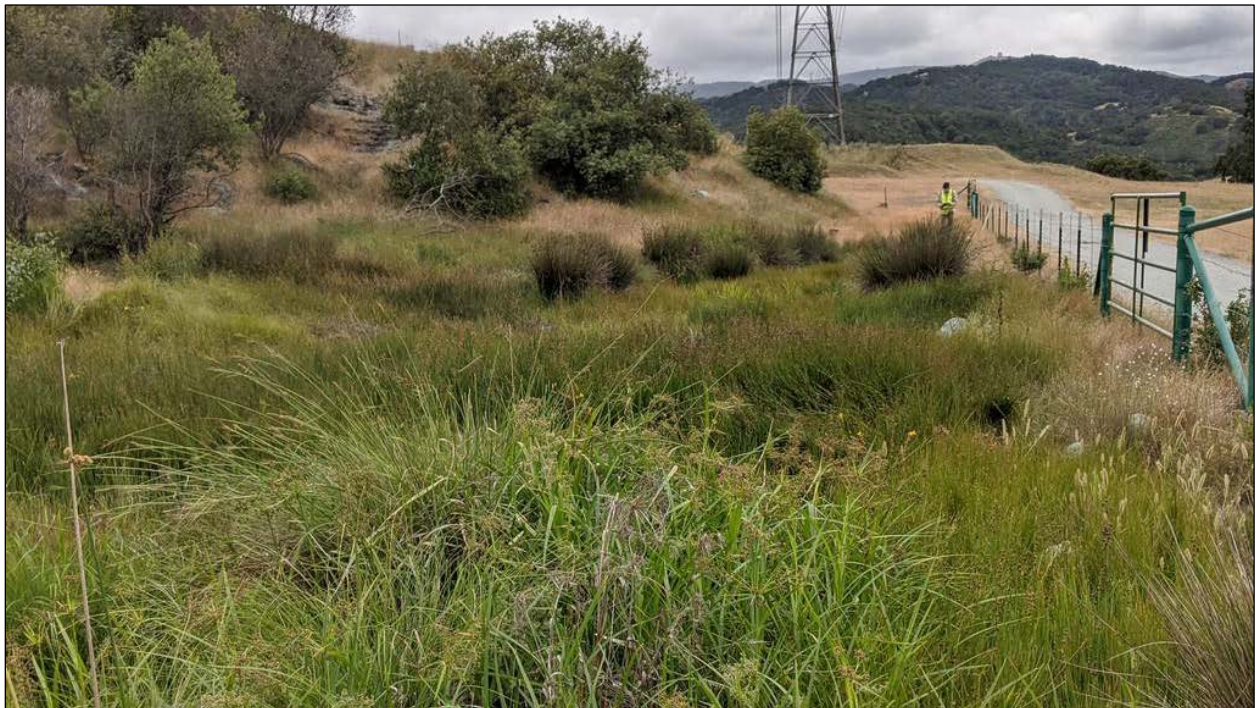
**Photo 2. Year 4 Conditions at Photo Point 1a during Vegetation Monitoring at the Wetland Mitigation Site (May 13, 2020)**

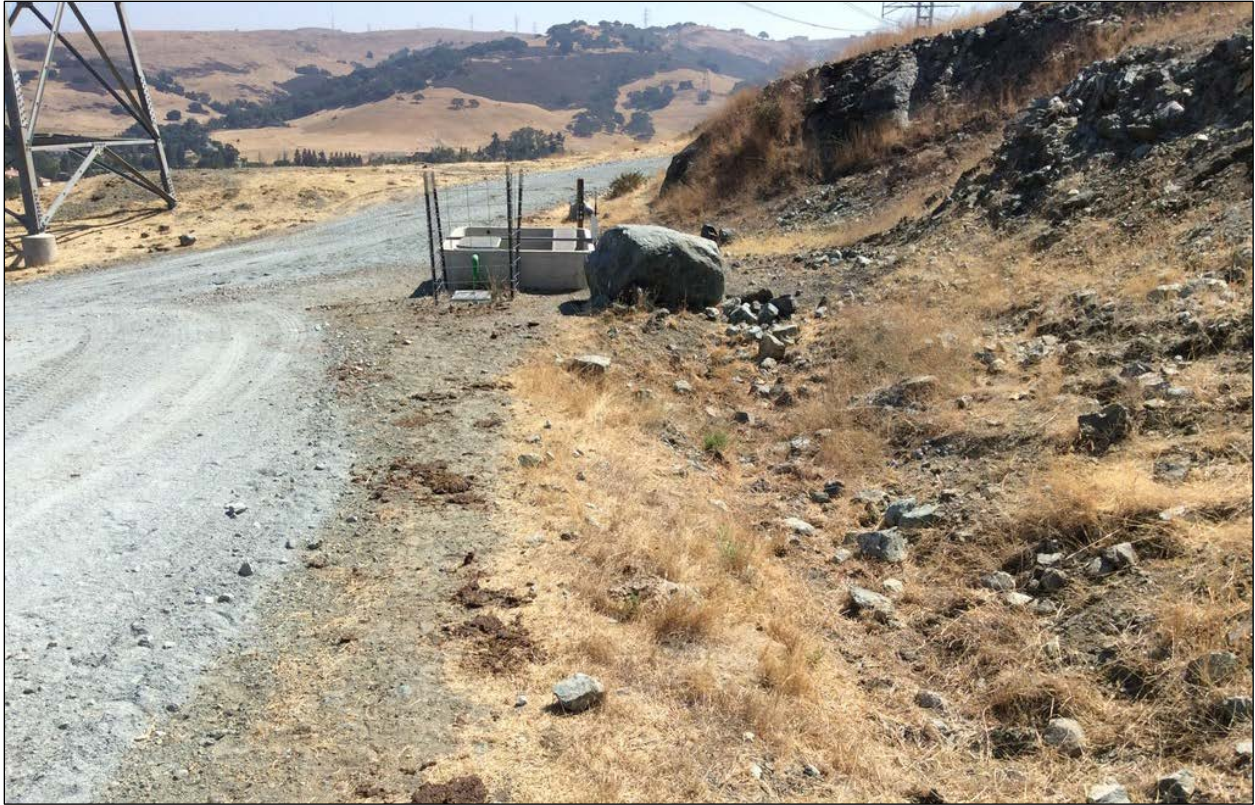
**Photo 3. Year 1 Conditions at Photo Point 1b during Vegetation Monitoring at the Wetland Mitigation Site (August 8, 2017)**

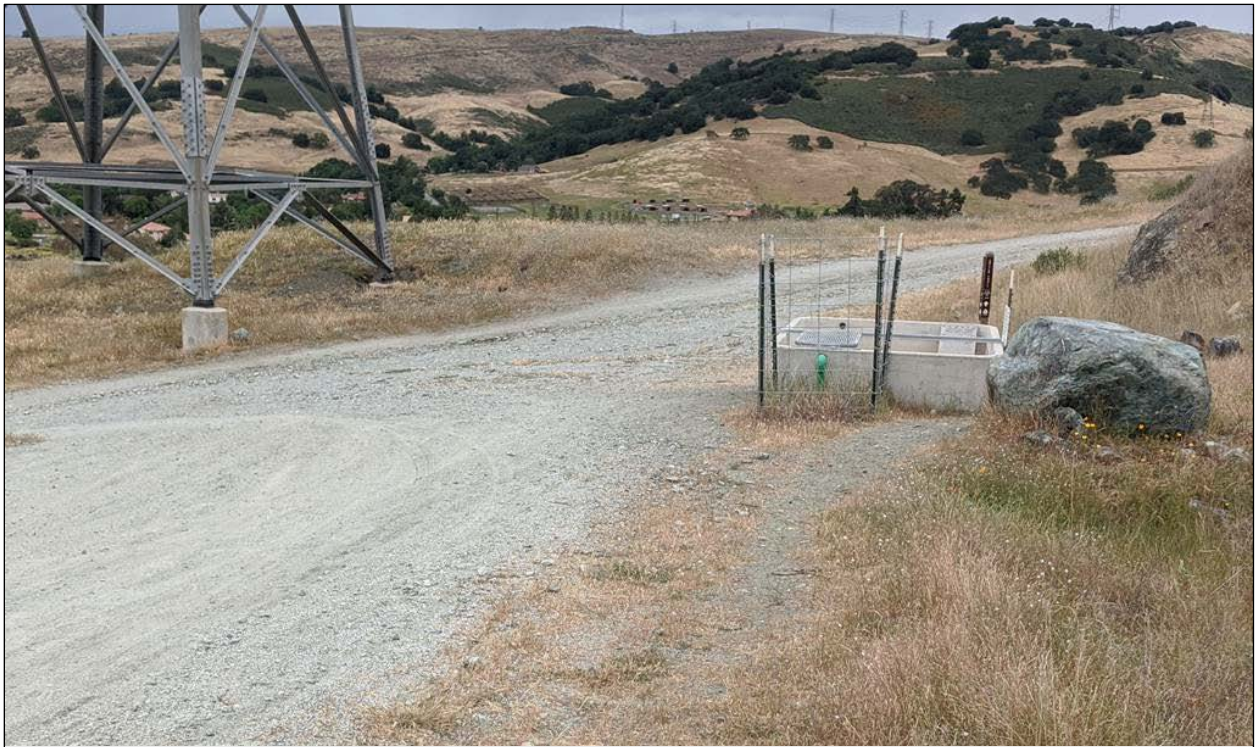
**Photo 4. Year 4 Conditions Looking East from Photo Point 1b during Vegetation Monitoring at the Wetland Mitigation Site (May 13, 2020)**

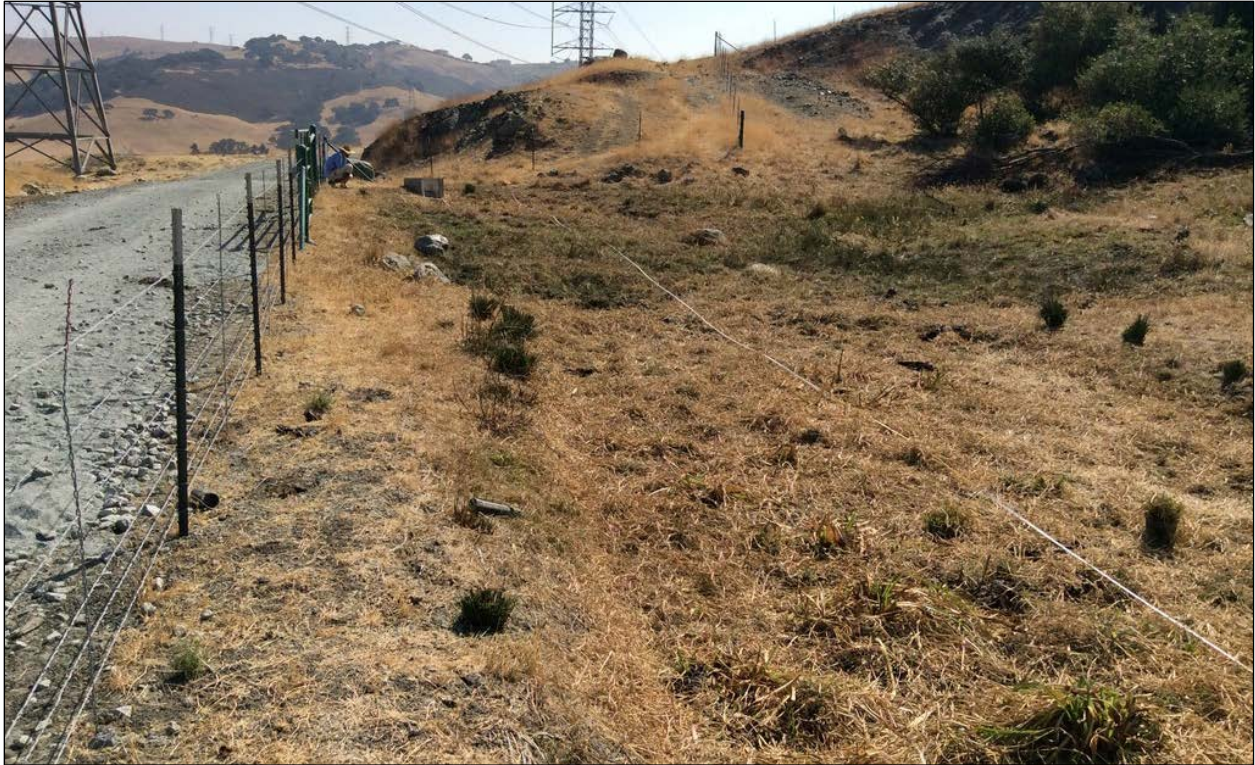
**Photo 5. Year 1 Conditions at Photo Point 2 during Vegetation Monitoring at the Wetland Mitigation Site (August 8, 2017)**

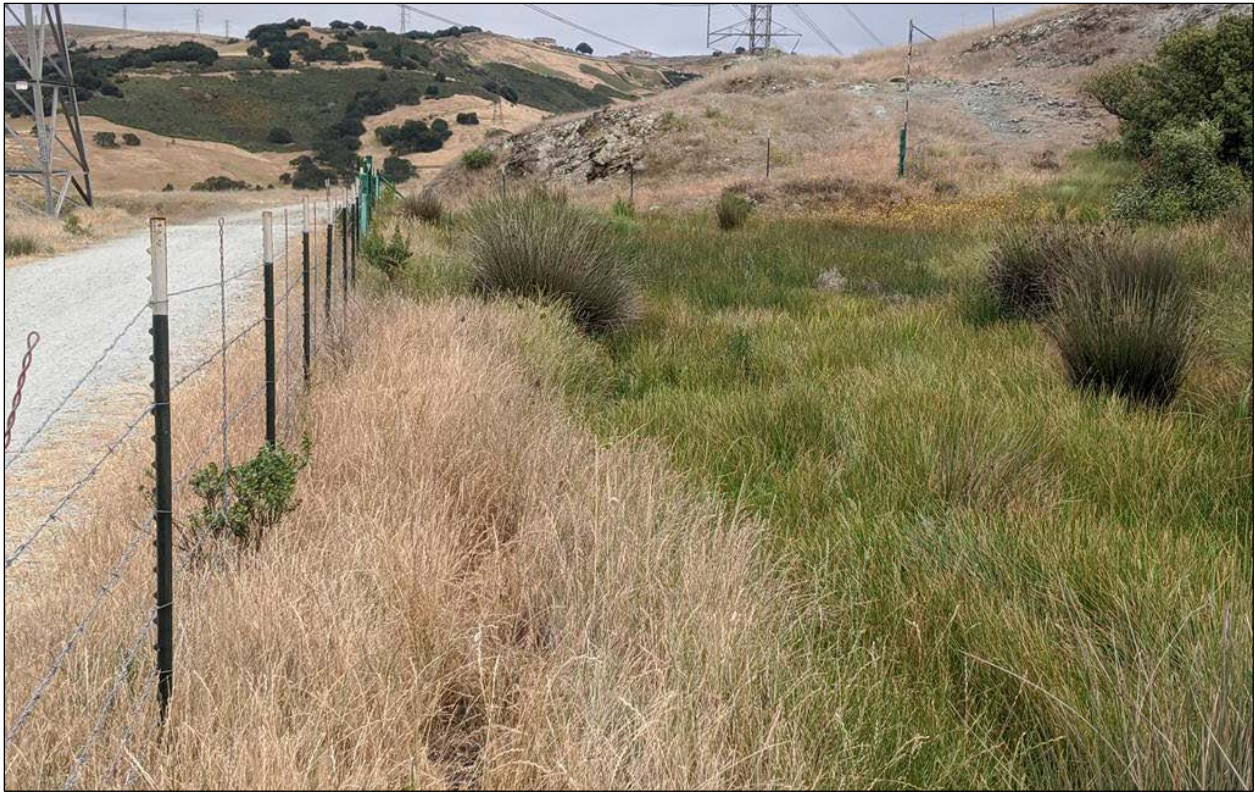
**Photo 6. Year 4 conditions at Photo Point 2 during Vegetation Monitoring at the Wetland Mitigation Site (May 13, 2020)**

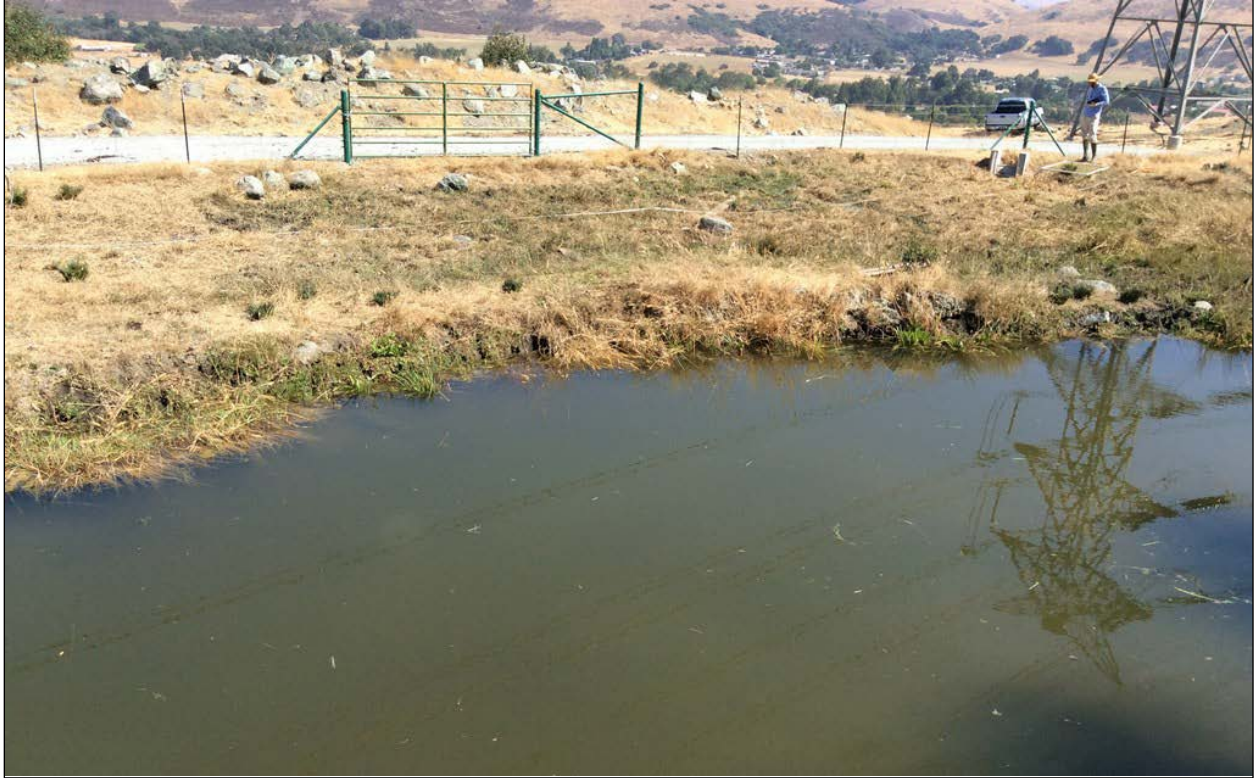
**Photo 7. Year 1 Conditions at Photo Point 3 during Vegetation Monitoring at the Wetland Mitigation Site (August 8, 2017)**

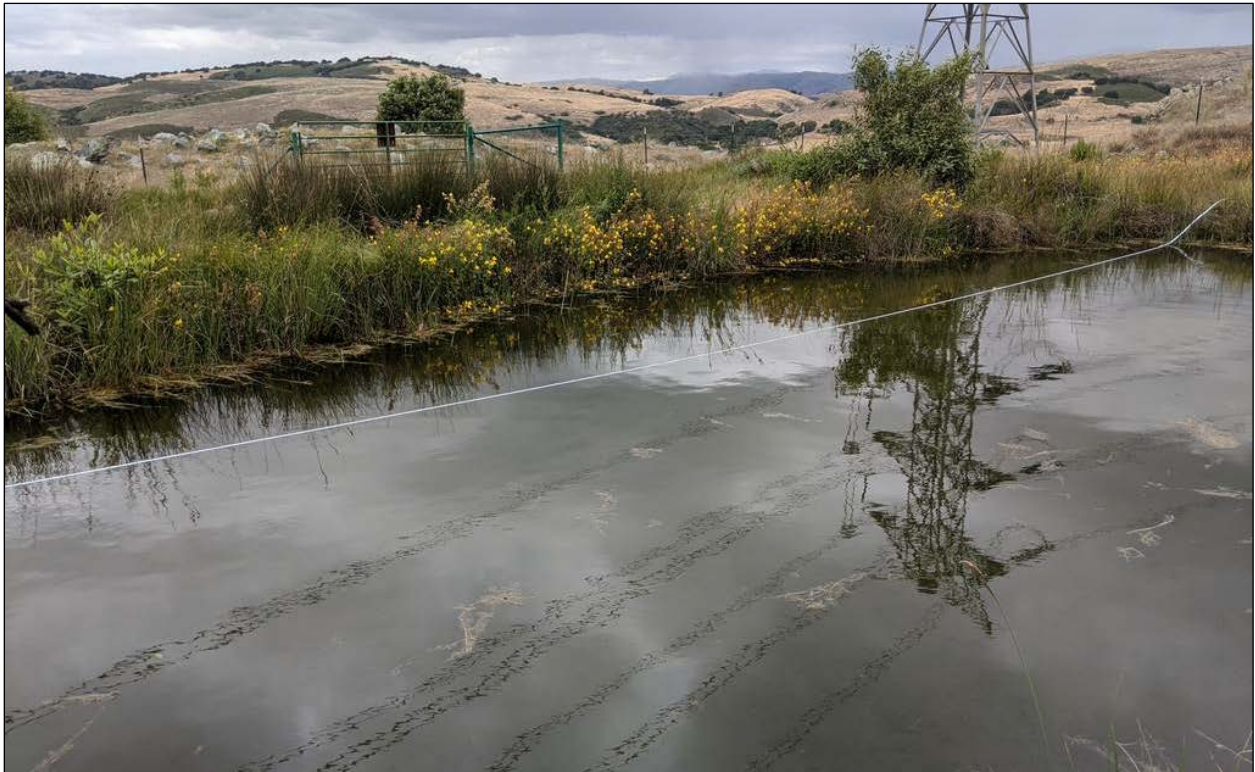
**Photo 8. Year 4 Conditions at Photo Point 3 during Vegetation Monitoring at the Wetland Mitigation Site (May 13, 2020)**

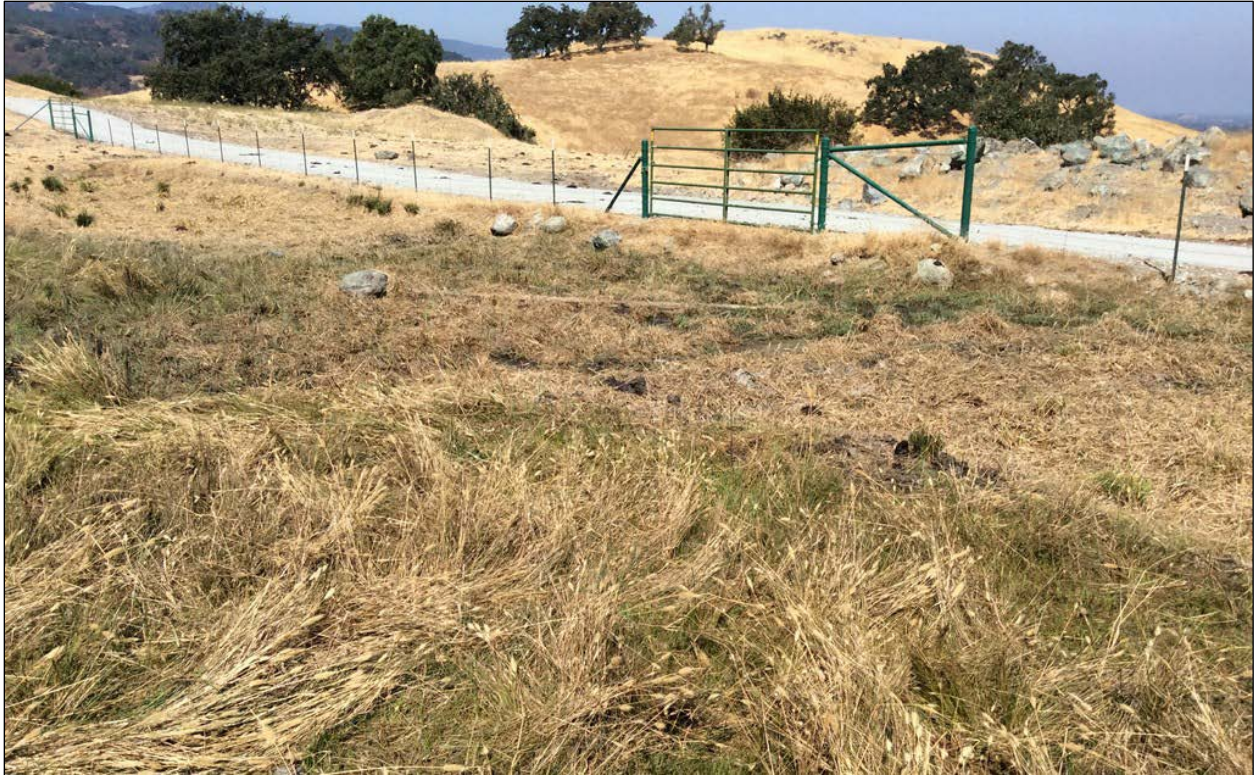
**Photo 9. Year 1 Conditions at Photo Point 4 during Vegetation Monitoring at the Wetland Mitigation Site (August 8, 2017)**

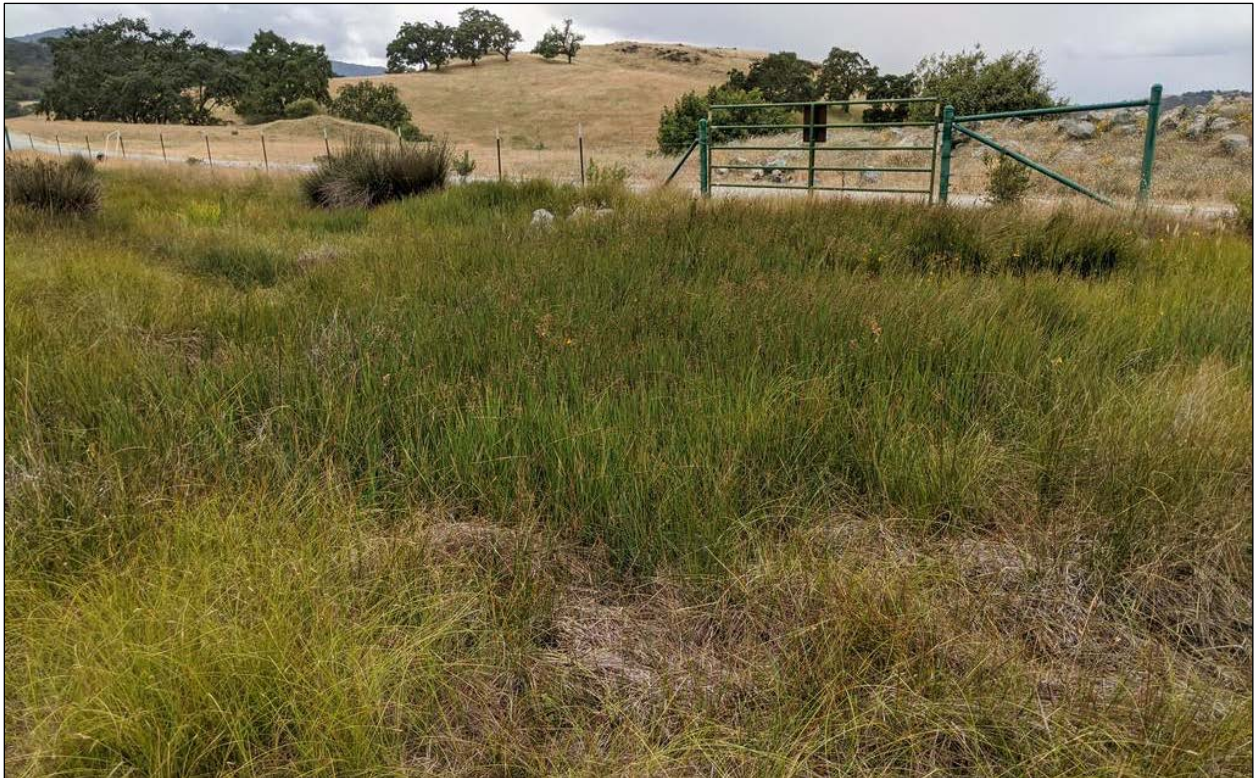
**Photo 10. Year 4 Conditions at Photo Point 4 during Vegetation Monitoring at the Wetland Mitigation Site (May 13, 2020)**

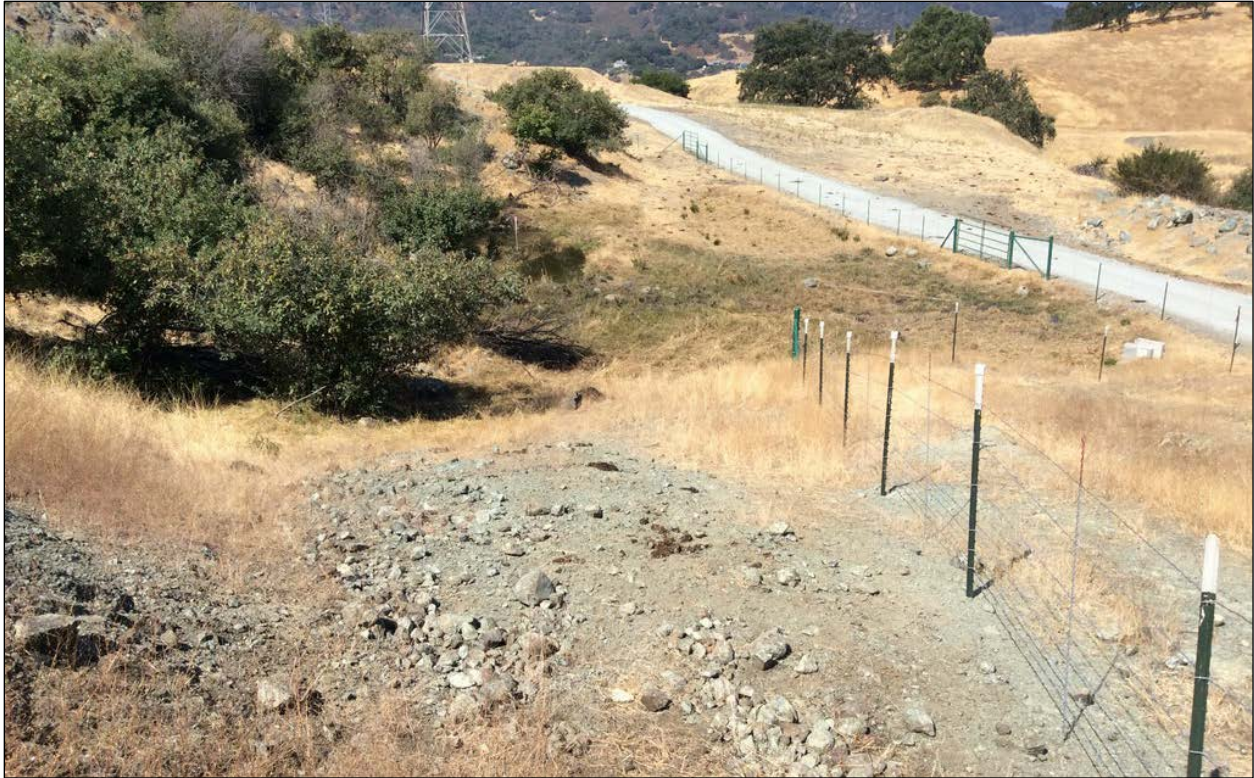
**Photo 11. Year 1 Conditions at Photo Point 5 during Vegetation Monitoring at the Wetland Mitigation Site (August 8, 2017)**

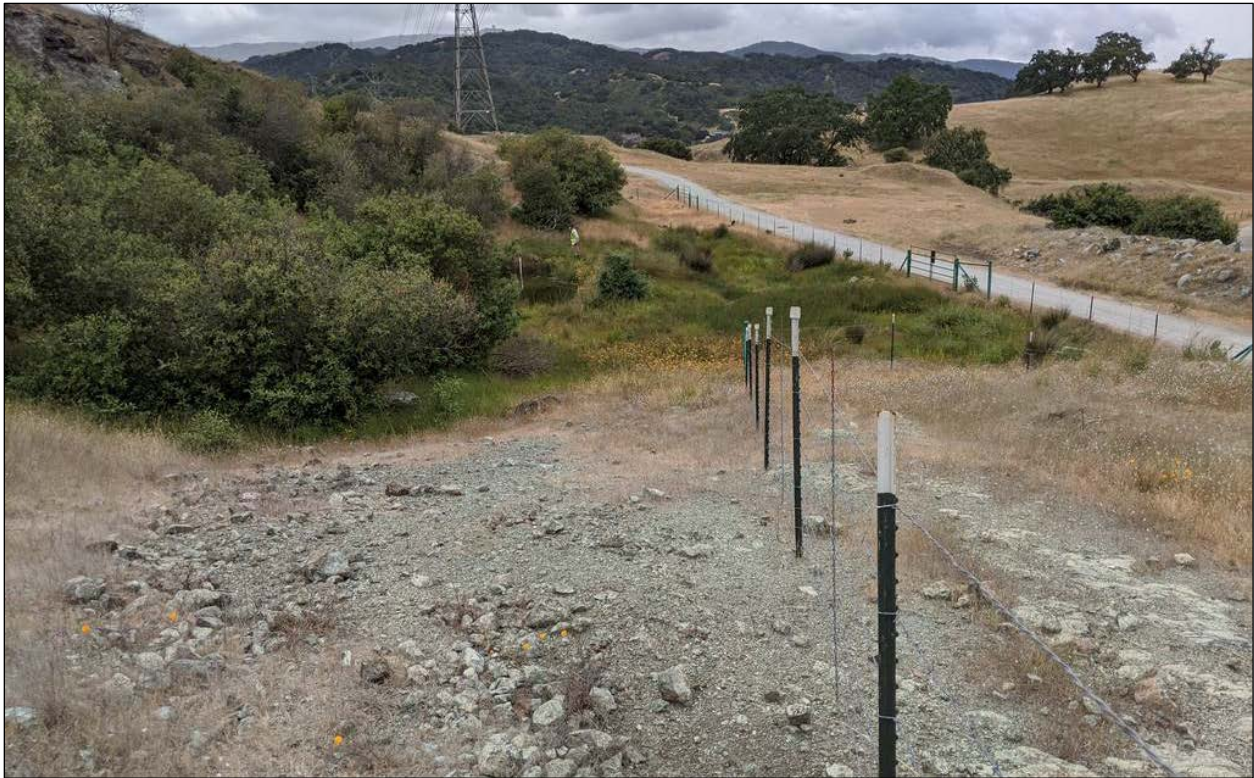
**Photo 12. Year 4 Conditions at Photo Point 5 during Vegetation Monitoring at the Wetland Mitigation Site (May 13, 2020)**

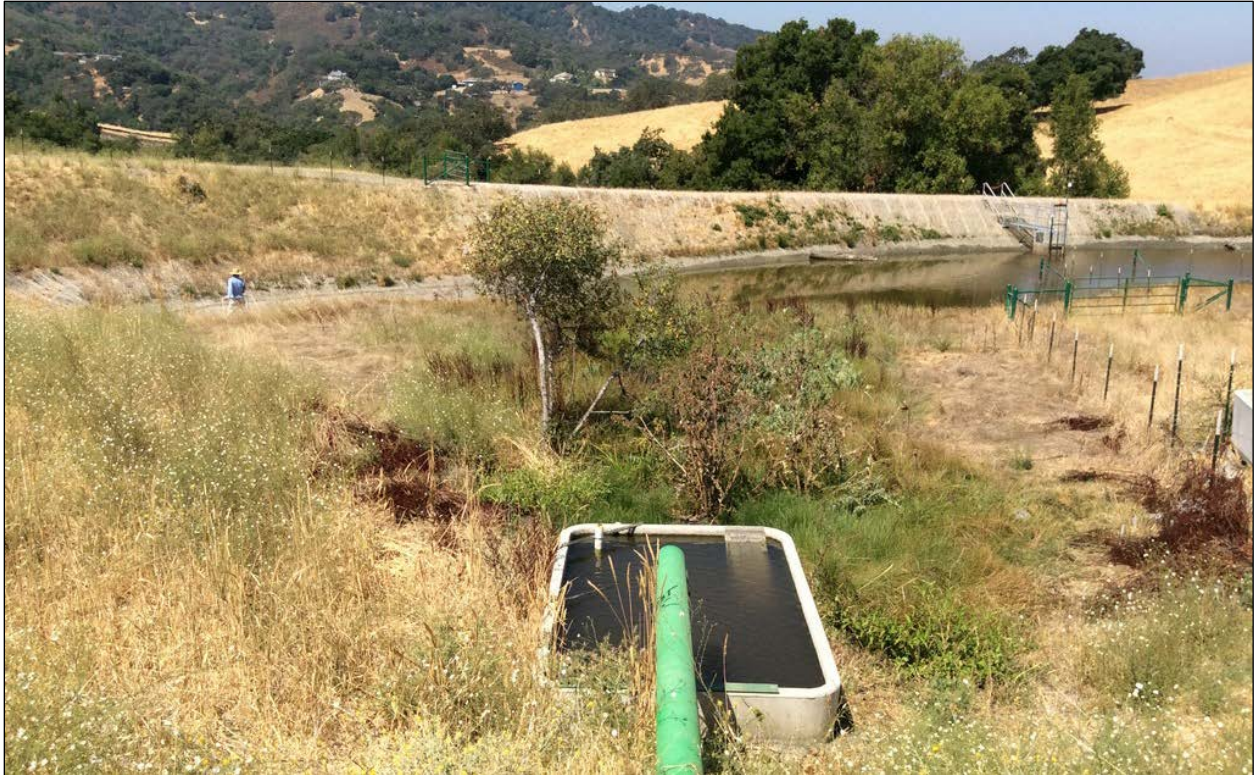
**Photo 13. Year 1 Conditions at Photo Point 6 during Mt. Hamilton Thistle Abundance Monitoring at the Pond Mitigation Site (August 8, 2017)**

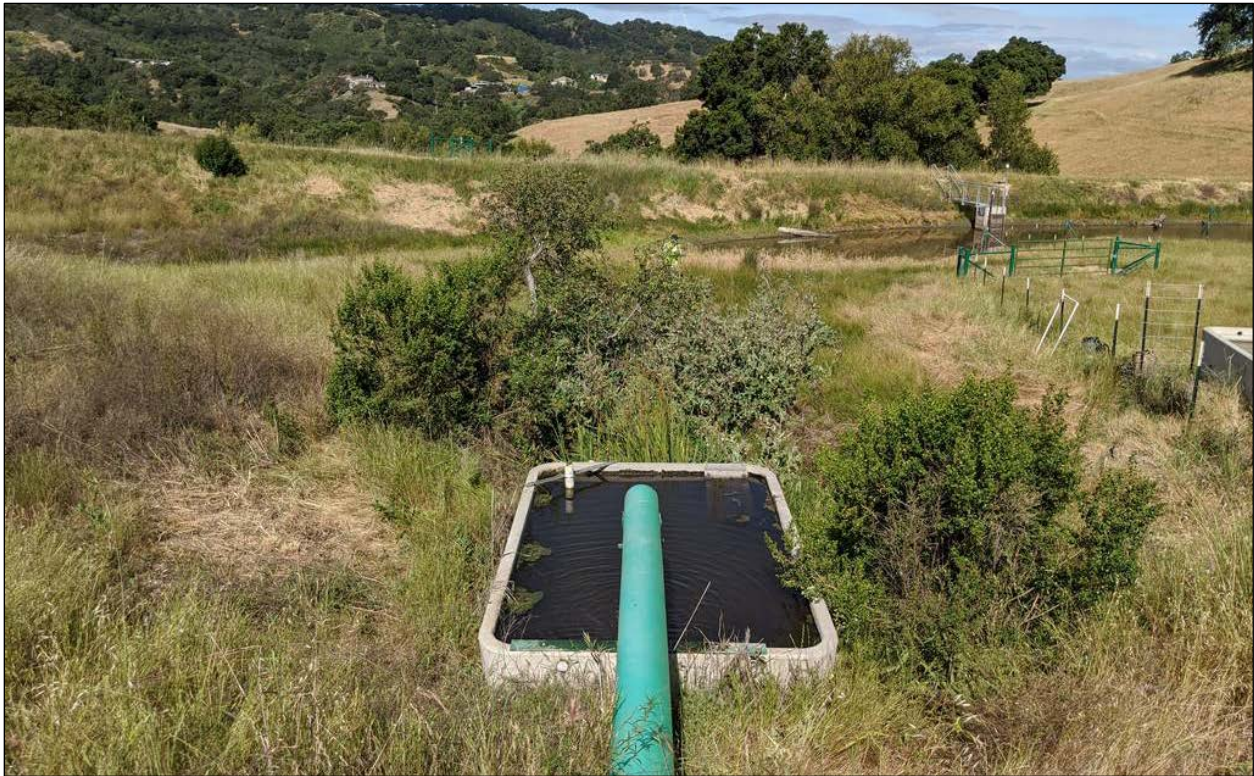
**Photo 14. Year 4 Conditions at Photo Point 6 during Mt. Hamilton Thistle Abundance Monitoring at the Pond Mitigation Site (May 13, 2020)**

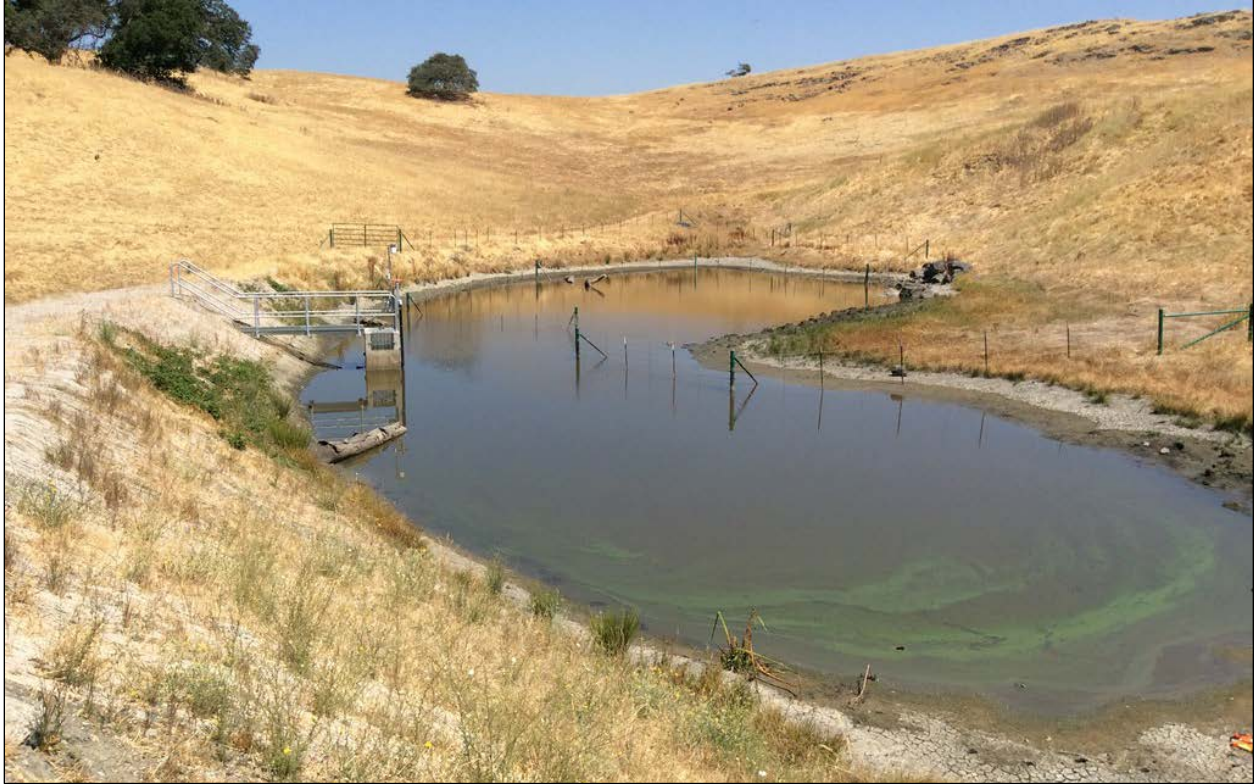
**Photo 15. Year 1 Conditions at Photo Point 7a during Vegetation Monitoring at the Pond Mitigation Site (August 8, 2017)**

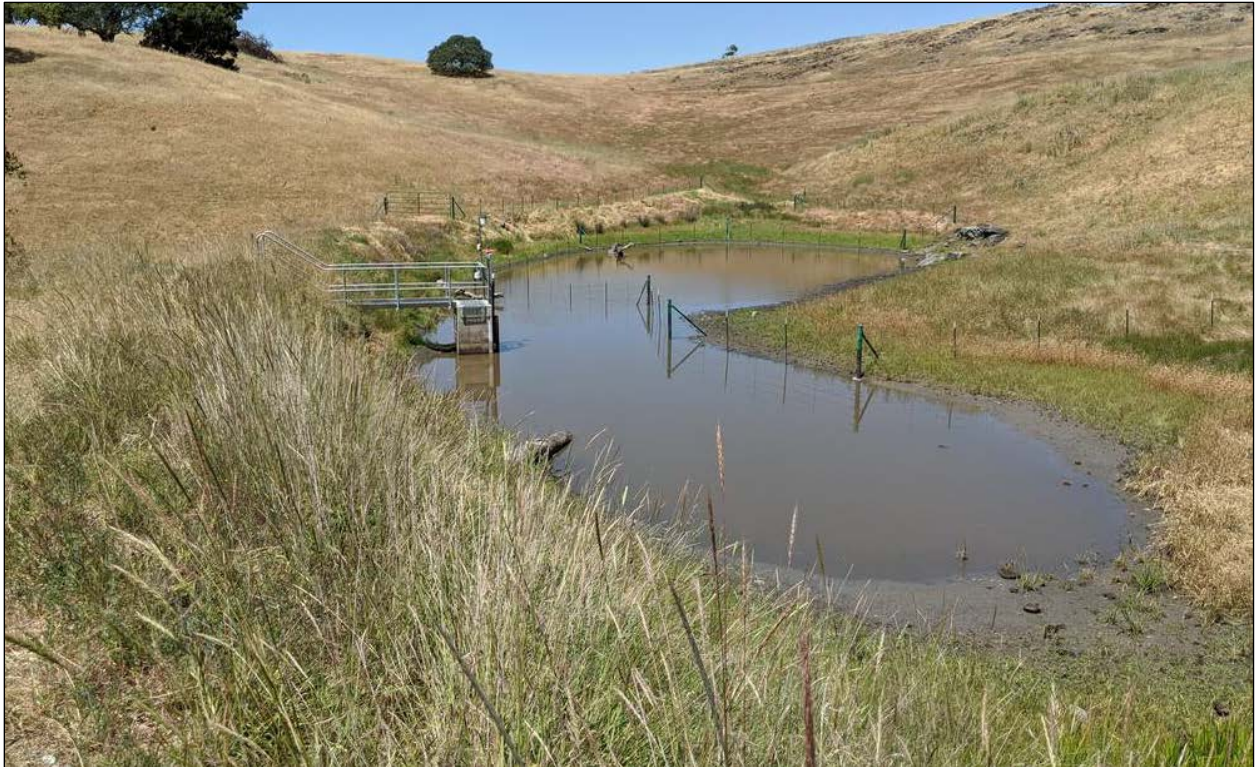
**Photo 16. Year 4 Conditions at Photo Point 7a during Vegetation Monitoring at the Pond Mitigation Site (May 20, 2020)**

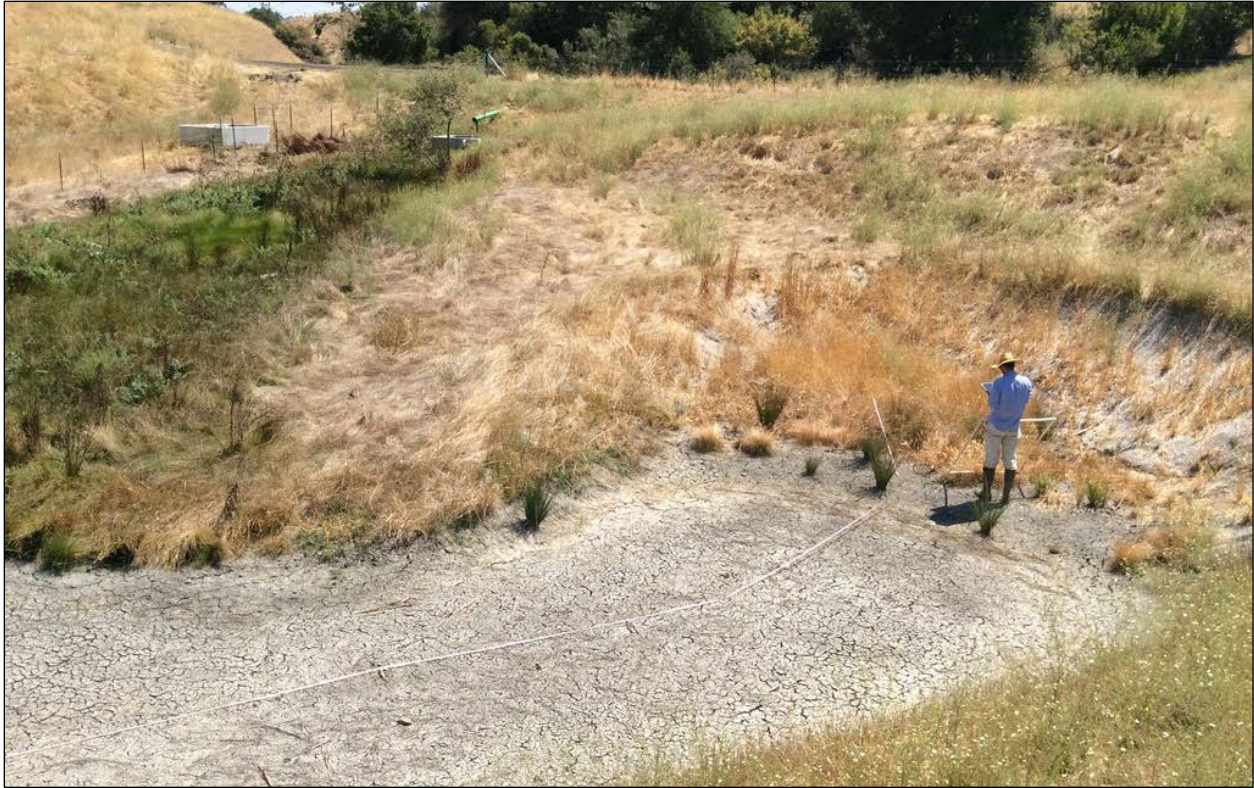
**Photo 17. Year 1 Conditions at Photo Point 7b during Vegetation Monitoring, Showing the Wetland Establishment Area at the Pond Mitigation Site (August 8, 2017)**

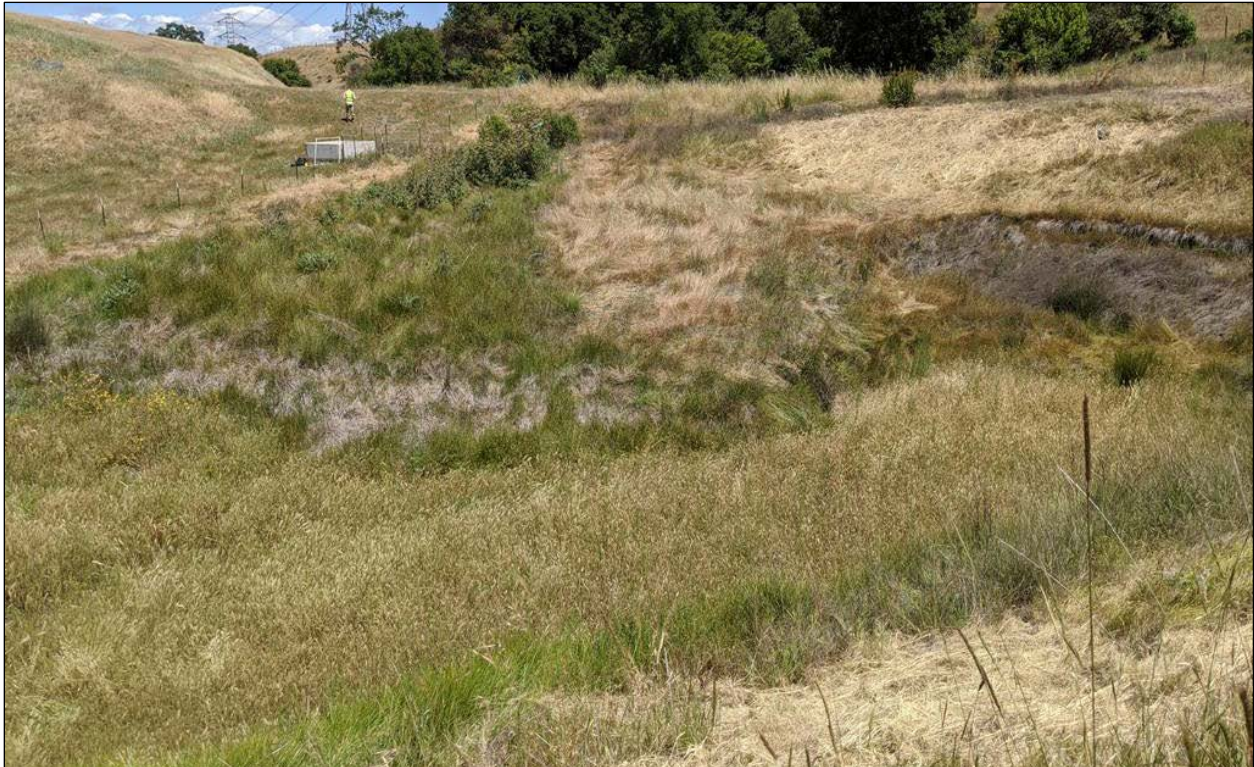
**Photo 18. Year 4 Conditions at Photo Point 7b during Vegetation Monitoring, Showing the Wetland Establishment Area at the Pond Mitigation Site (May 20, 2020)**

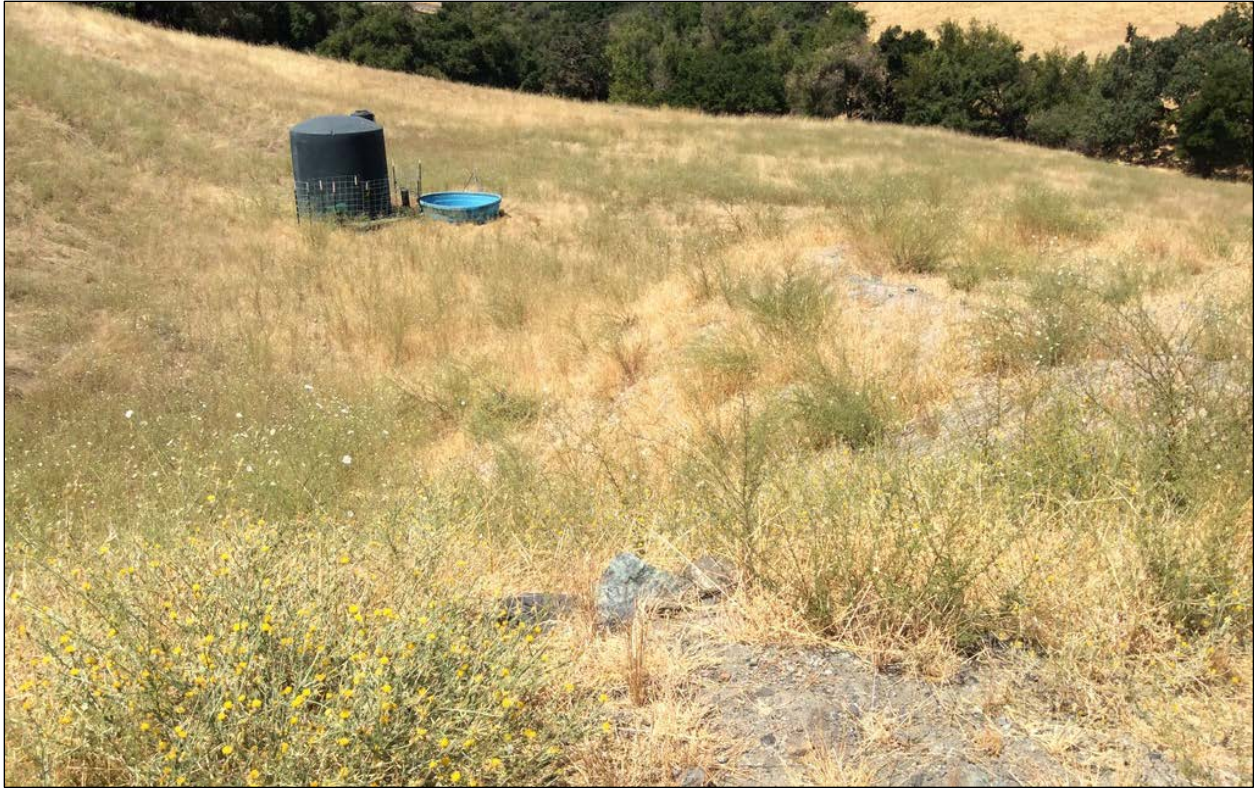
**Photo 19. Year 1 Conditions at Photo Point 7c during Vegetation Monitoring at the Pond Mitigation Site (August 8, 2017)**

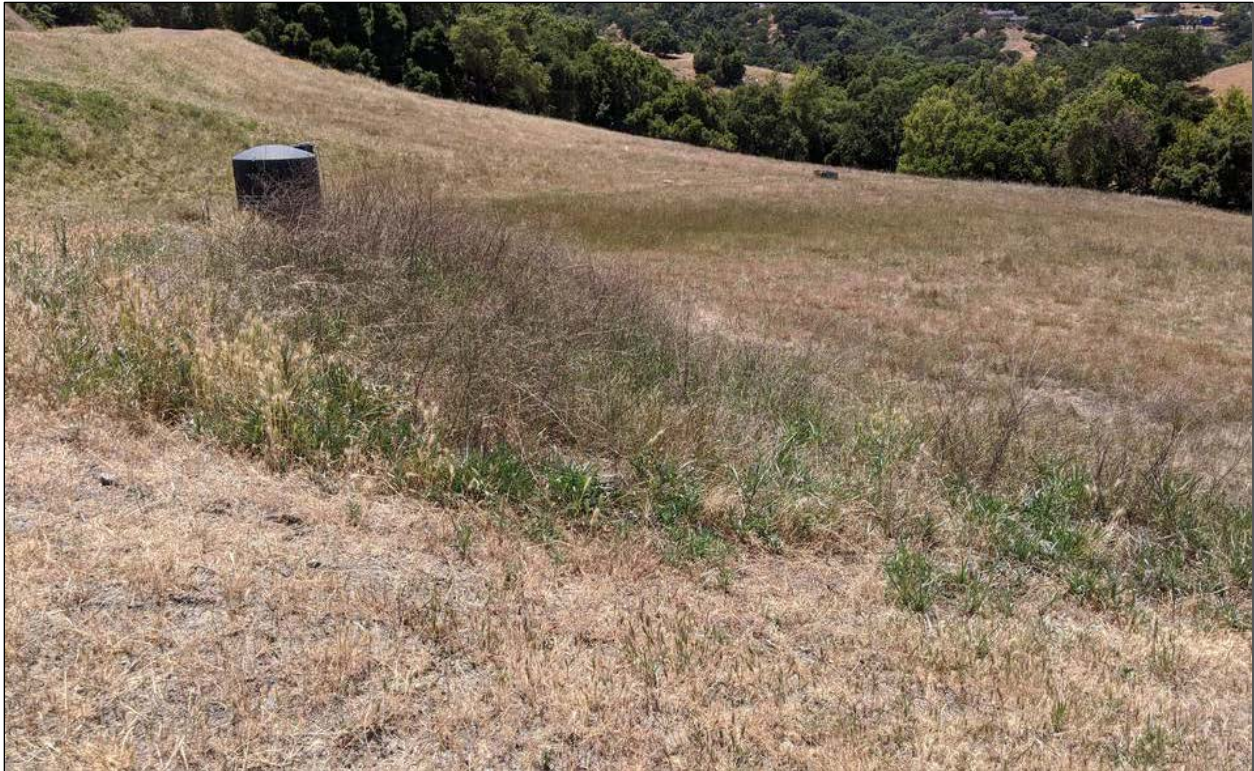
**Photo 20. Year 4 Conditions at Photo Point 7c during Vegetation Monitoring at the Pond Mitigation Site (May 20, 2020)**

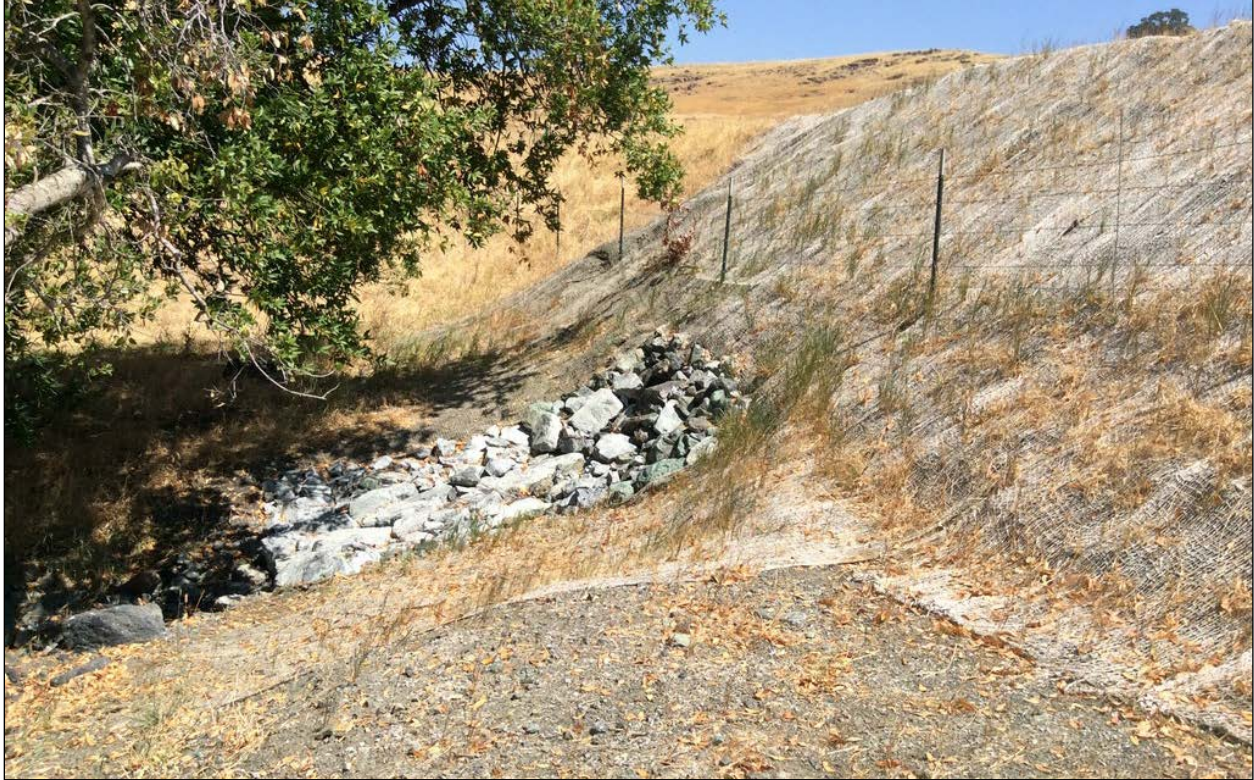
**Photo 21. Year 1 Conditions at Photo Point 8 during Vegetation Monitoring at the Pond Mitigation Site (August 8, 2017)**

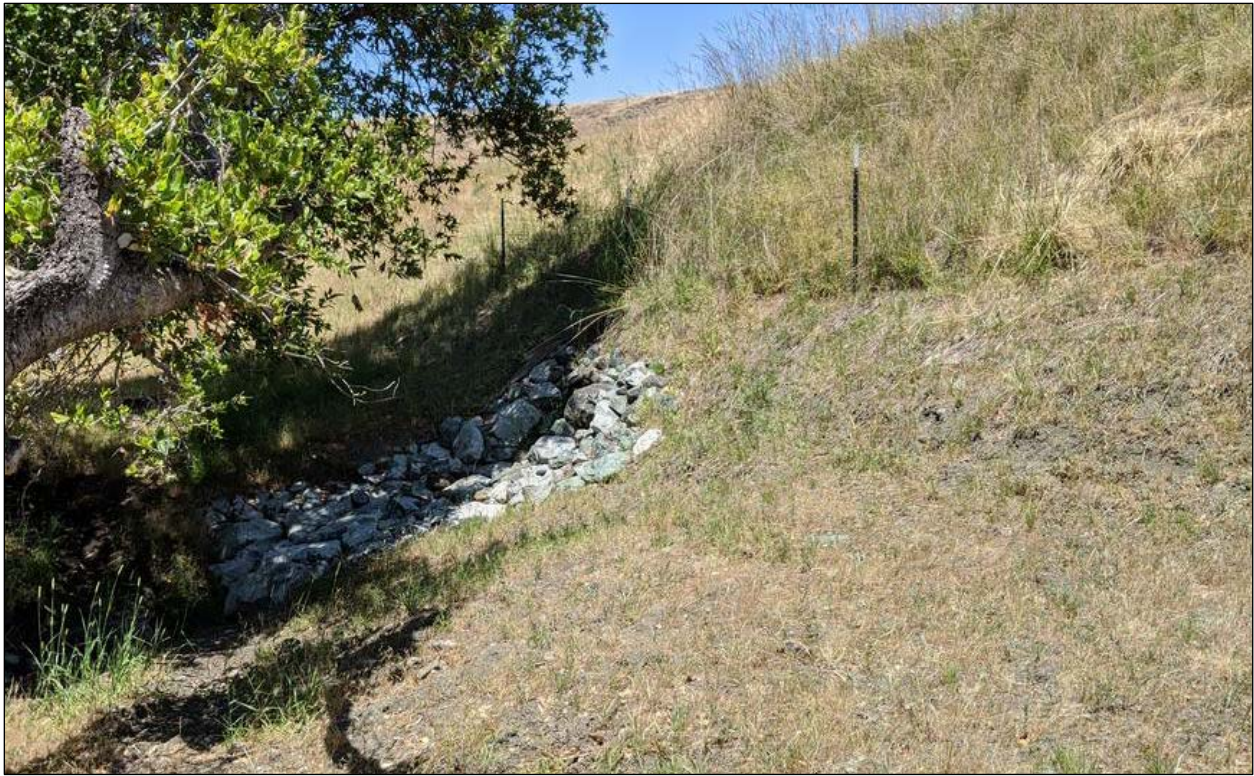
**Photo 22. Year 4 Conditions at Photo Point 8 during Vegetation Monitoring at the Pond Mitigation Site (May 20, 2020)**

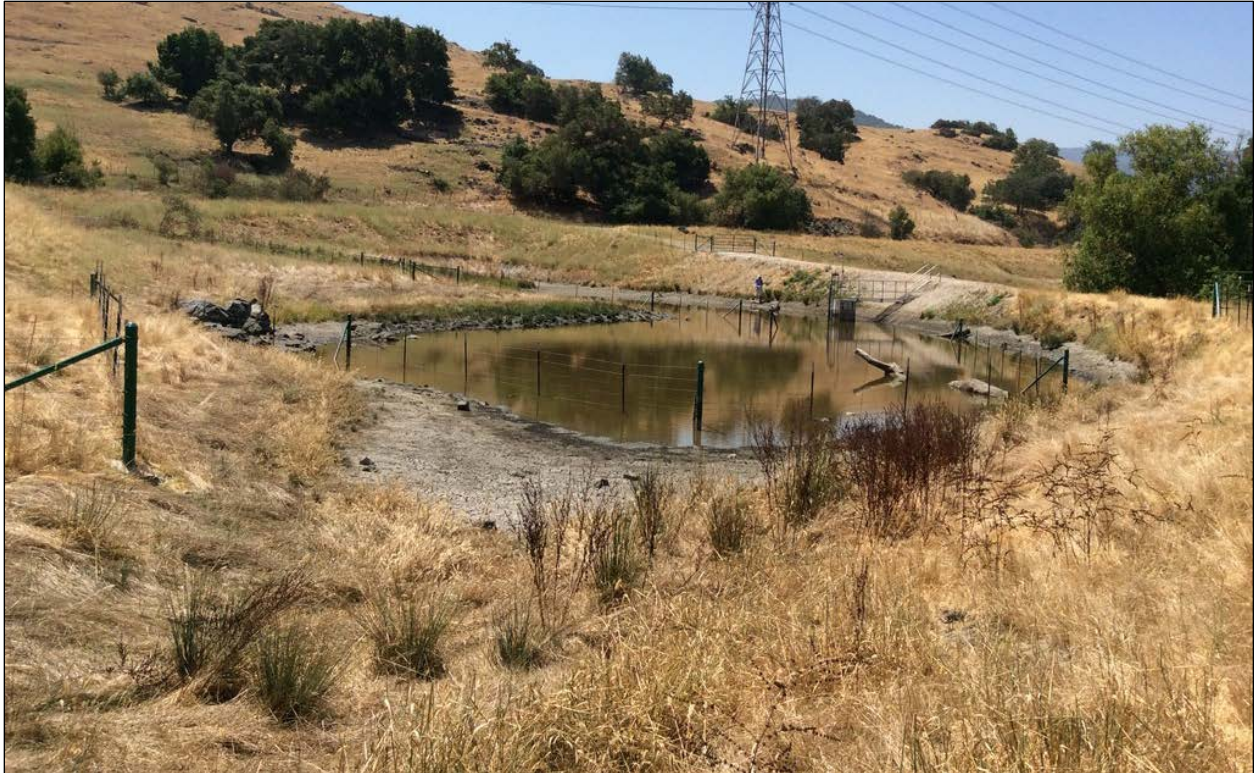
**Photo 23. Year 1 Conditions at Photo Point 9 during Vegetation Monitoring at the Pond Mitigation Site (August 8, 2017)**
