**Calero County Park Pond and Wetland  
Restoration Project—  
Year 4 (2020) Monitoring Report**

**Project # 3753-07**

December 30 2020

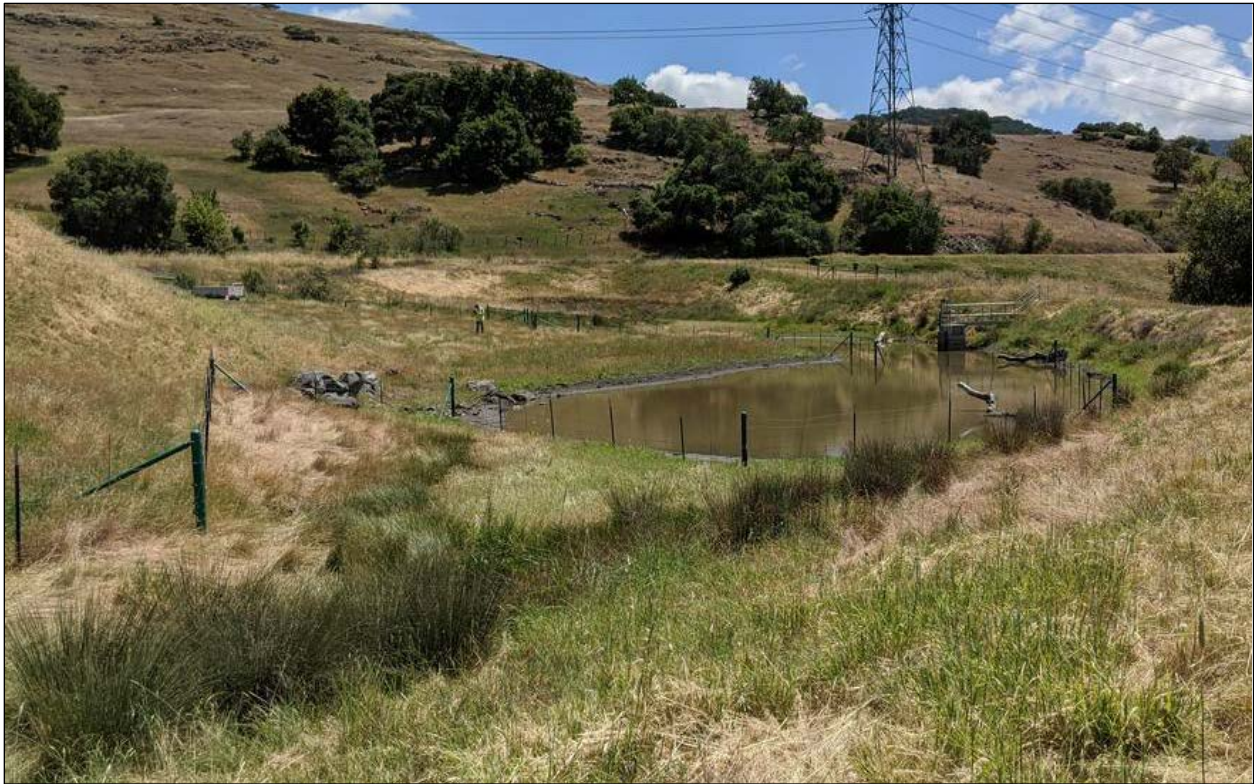
**Photo 24. Year 4 Conditions at Photo Point 9 during Vegetation Monitoring at the Pond Mitigation Site (May 20, 2020)**

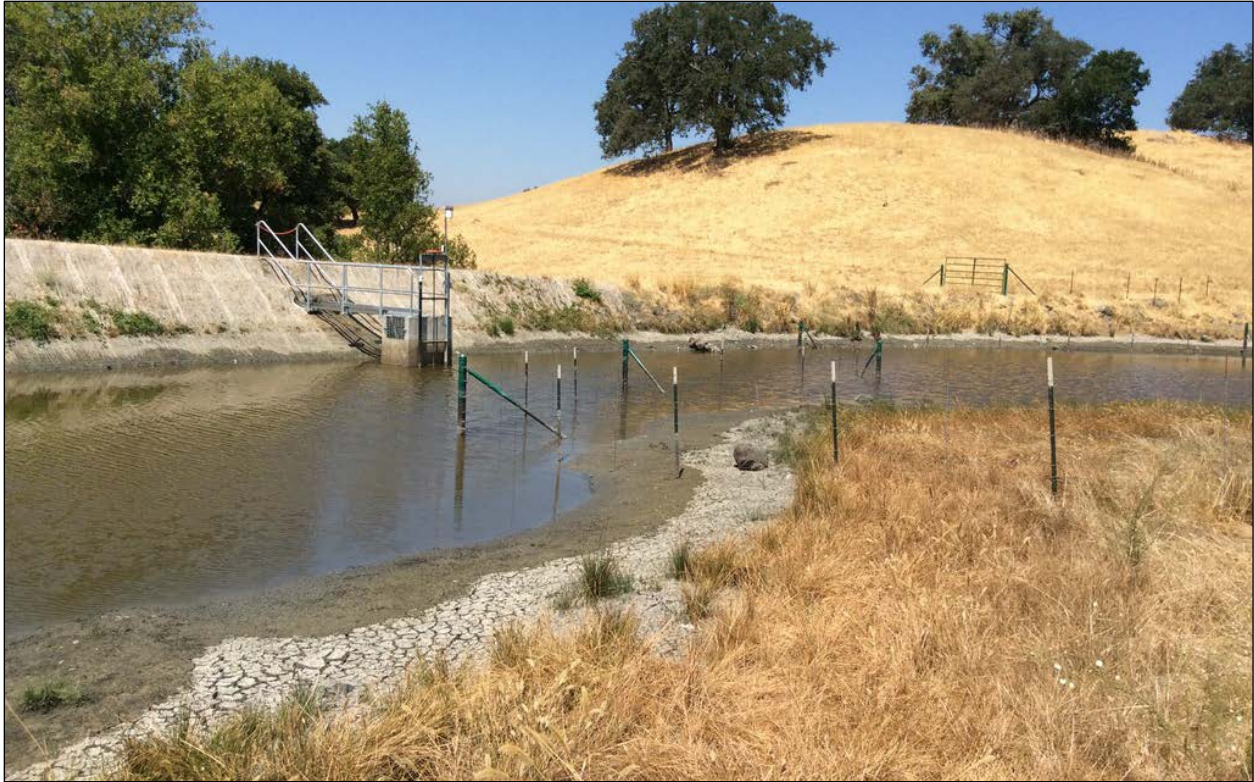
**Photo 25. Year 1 Conditions at Photo Point 10 during Vegetation Monitoring at the Pond Mitigation Site (August 8, 2017)**

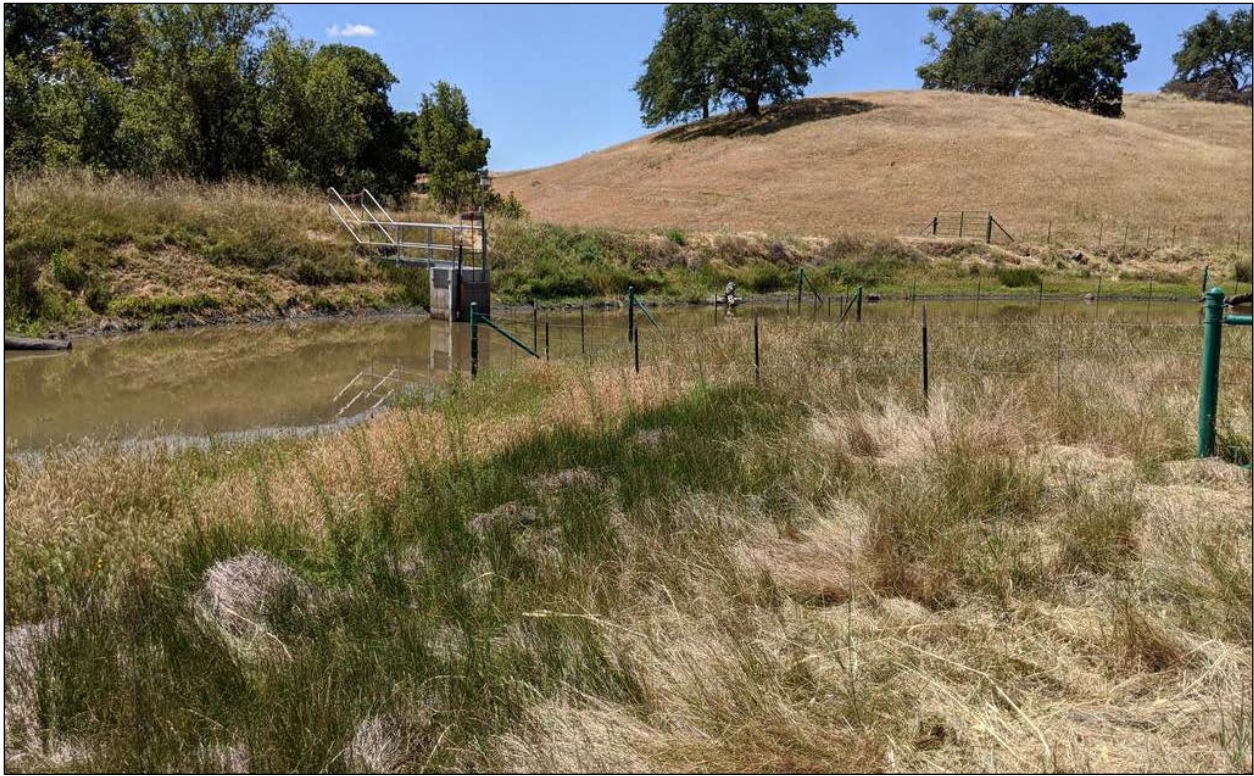
**Photo 26. Year 4 Conditions at Photo Point 10 during Vegetation Monitoring at the Pond Mitigation Site (May 20, 2020)**

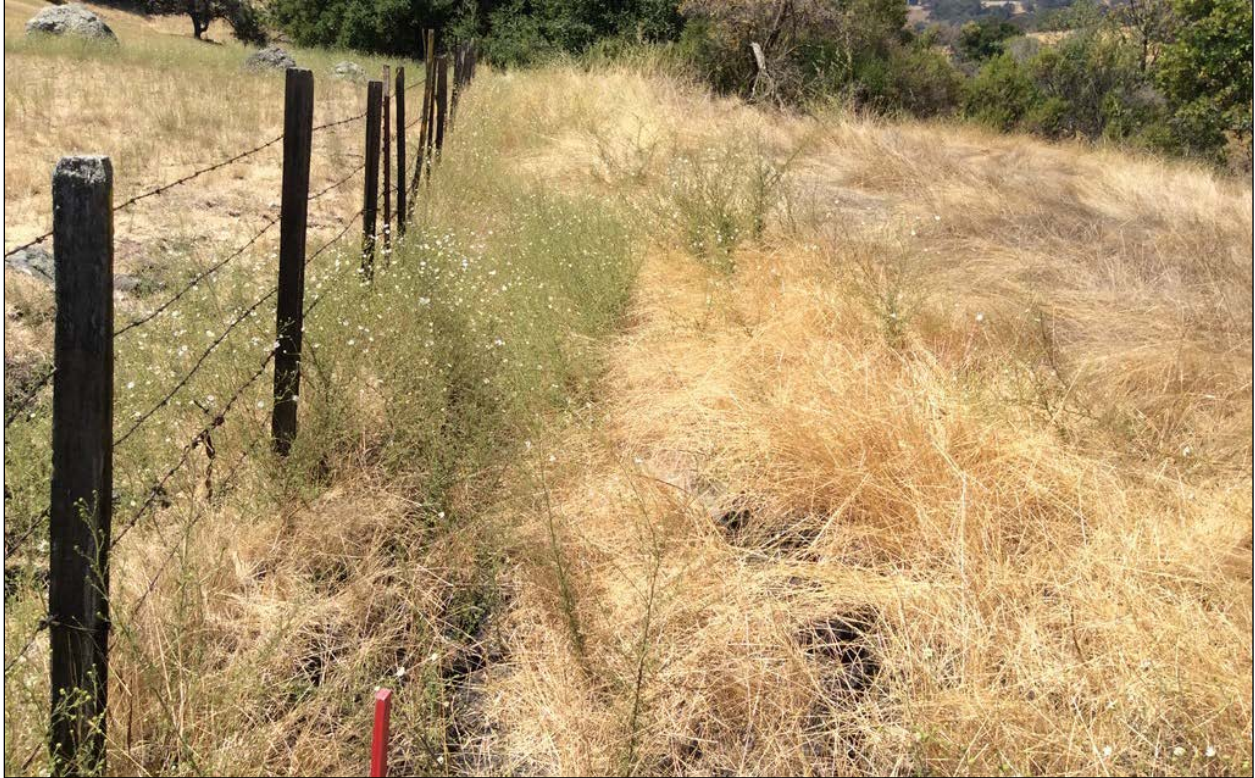
**Photo 27. Year 1 Conditions at Photo Point 11 during Vegetation Monitoring, Where the Hillside Seep Collection Ditch was Enhanced in the Seep Collection Area (August 8, 2017)**

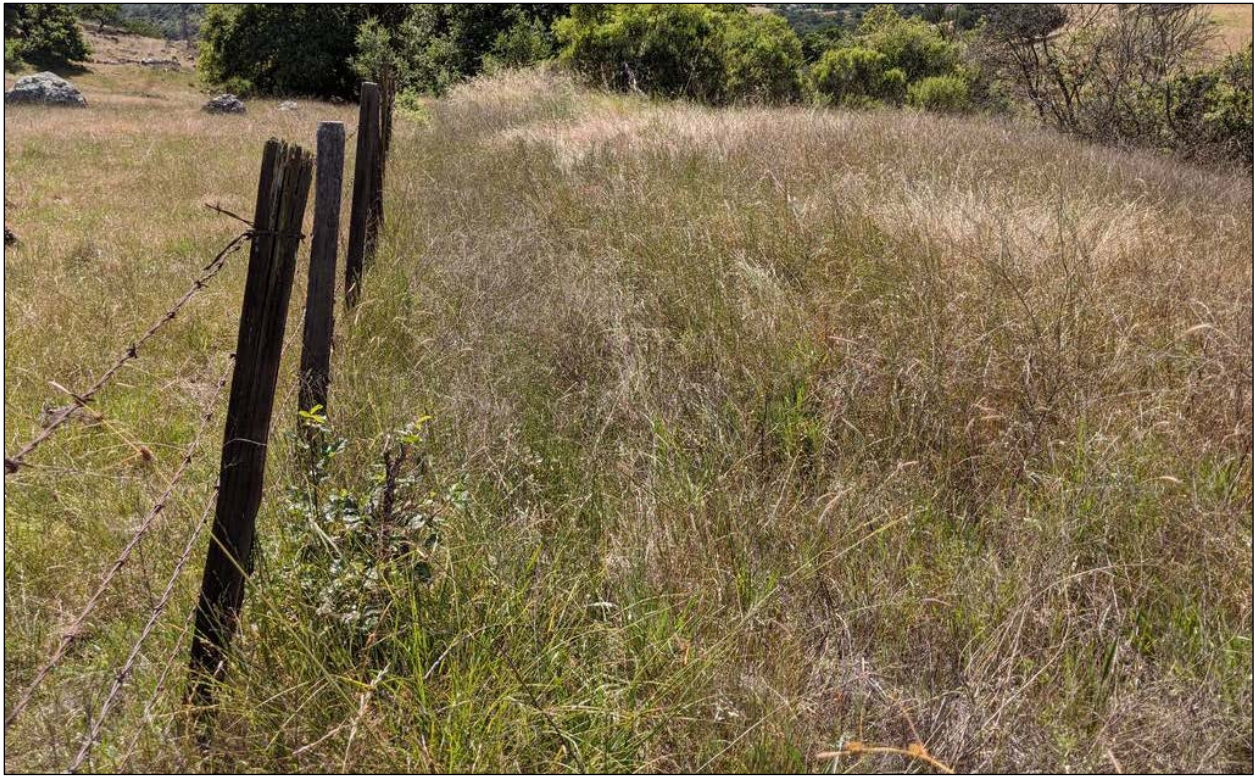
**Photo 28. Year 4 Conditions at Photo Point 11 during Vegetation Monitoring, Where the Hillside Seep Collection Ditch was Enhanced in the Seep Collection Area (May 20, 2020)**

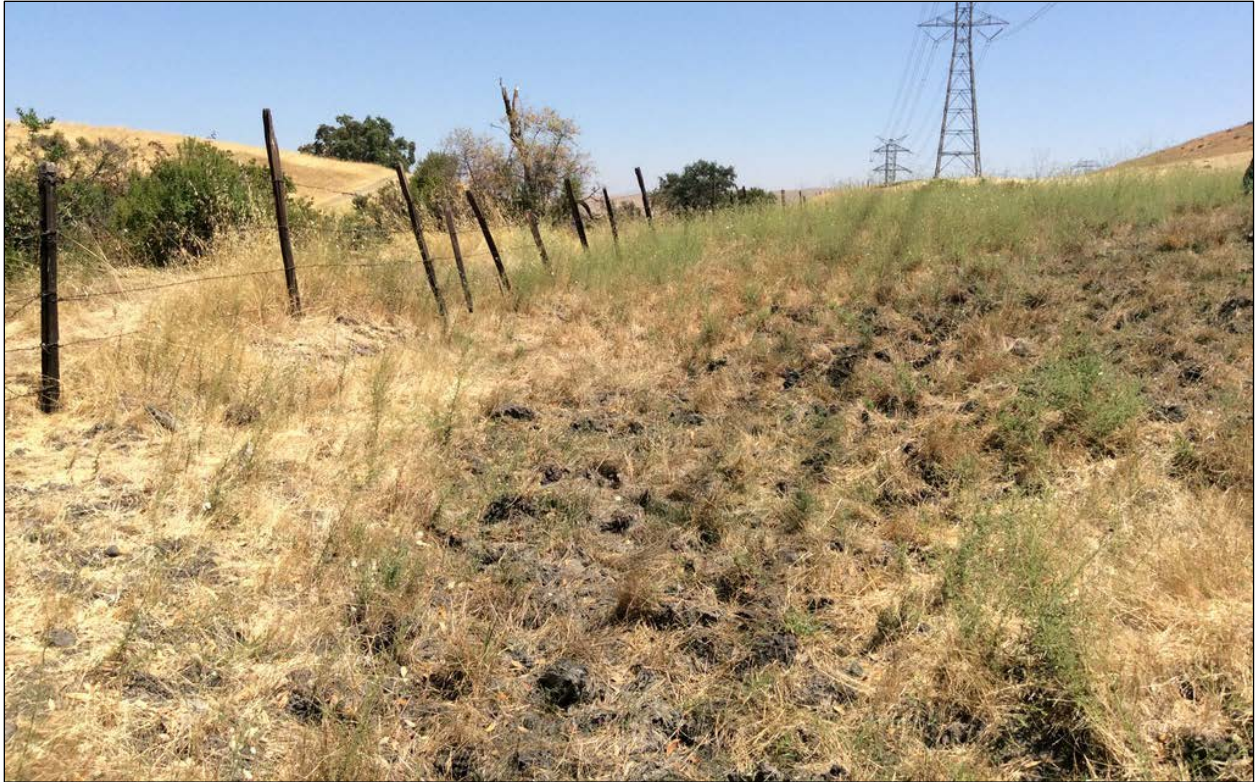
**Photo 29. Year 1 Conditions at Photo Point 12 during Vegetation Monitoring, Where the Hillside Seep Collection Ditch was Enhanced in the Seep Collection Area (August 8, 2017)**

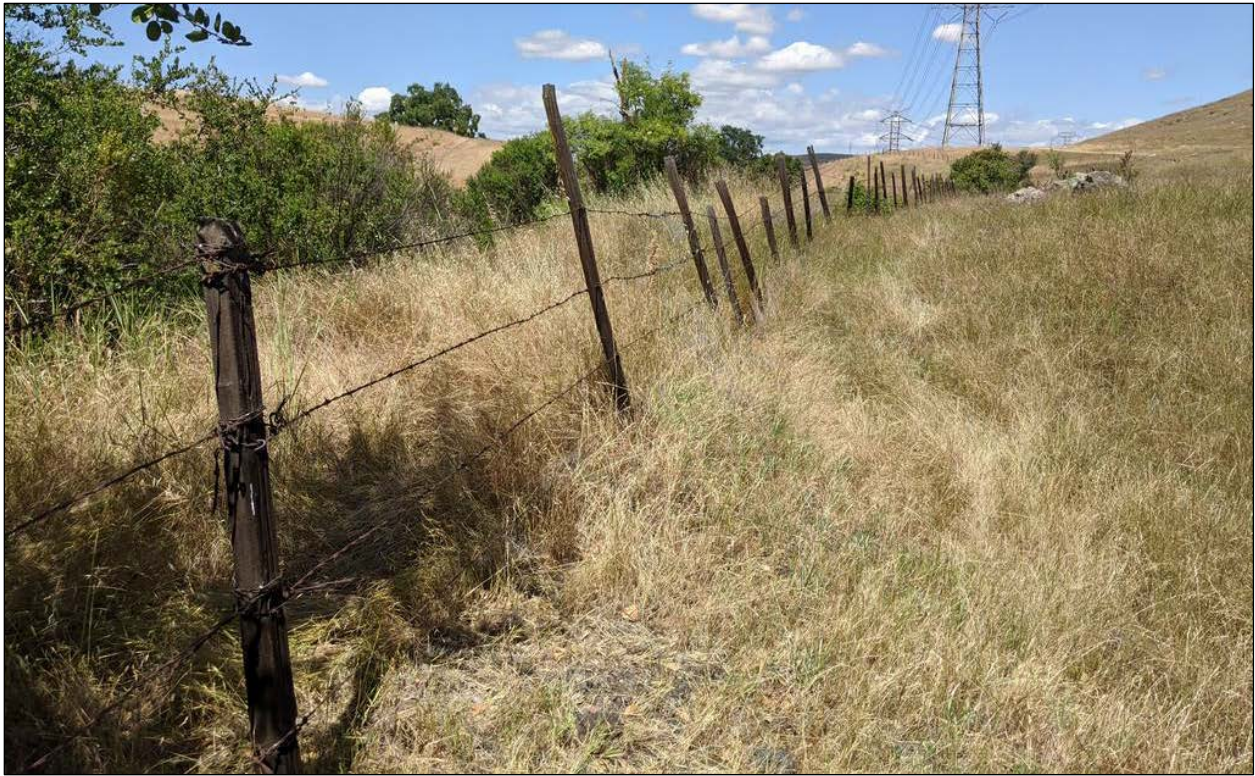
**Photo 30. Year 4 Conditions at Photo Point 12 during Vegetation Monitoring, Where the Hillside Seep Collection Ditch was Enhanced in the Seep Collection Area (May 20, 2020)**

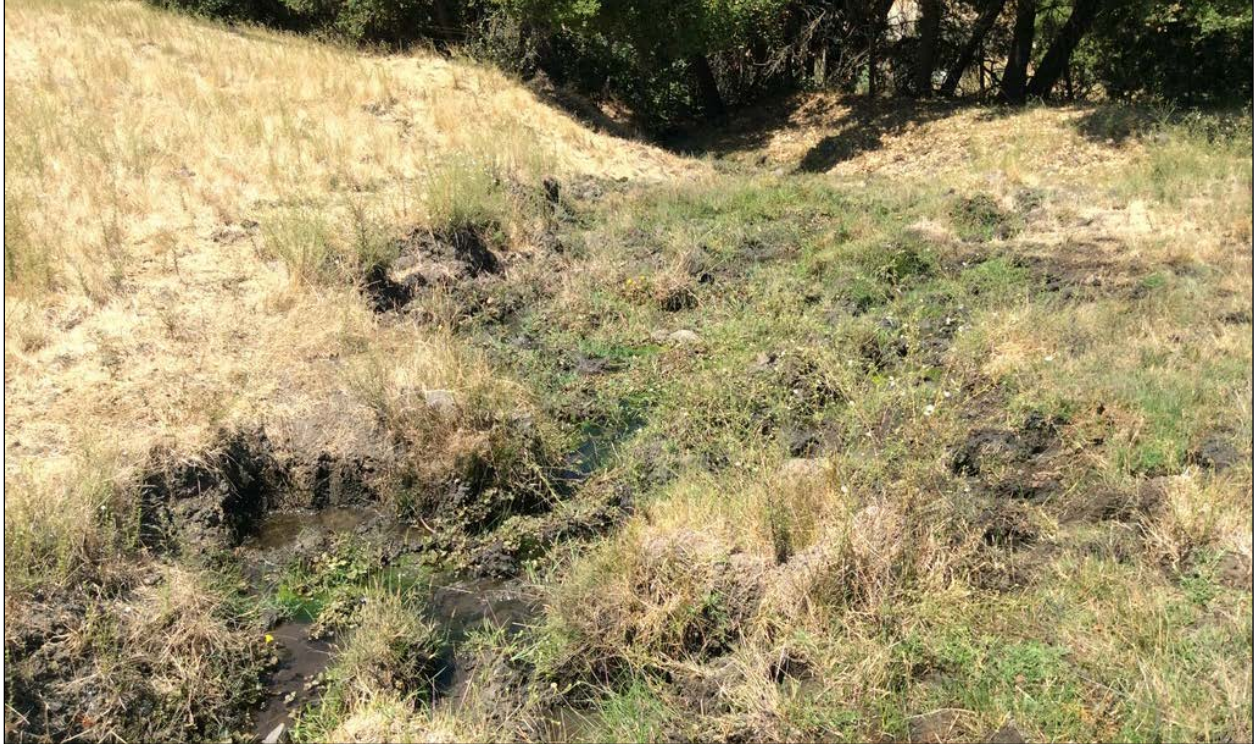
**Photo 31. Year 1 Conditions at Photo Point 13 during Vegetation Monitoring, at an Existing Seep in the Seep Collection Area That Was Not Disturbed During Construction (August 8, 2017)**

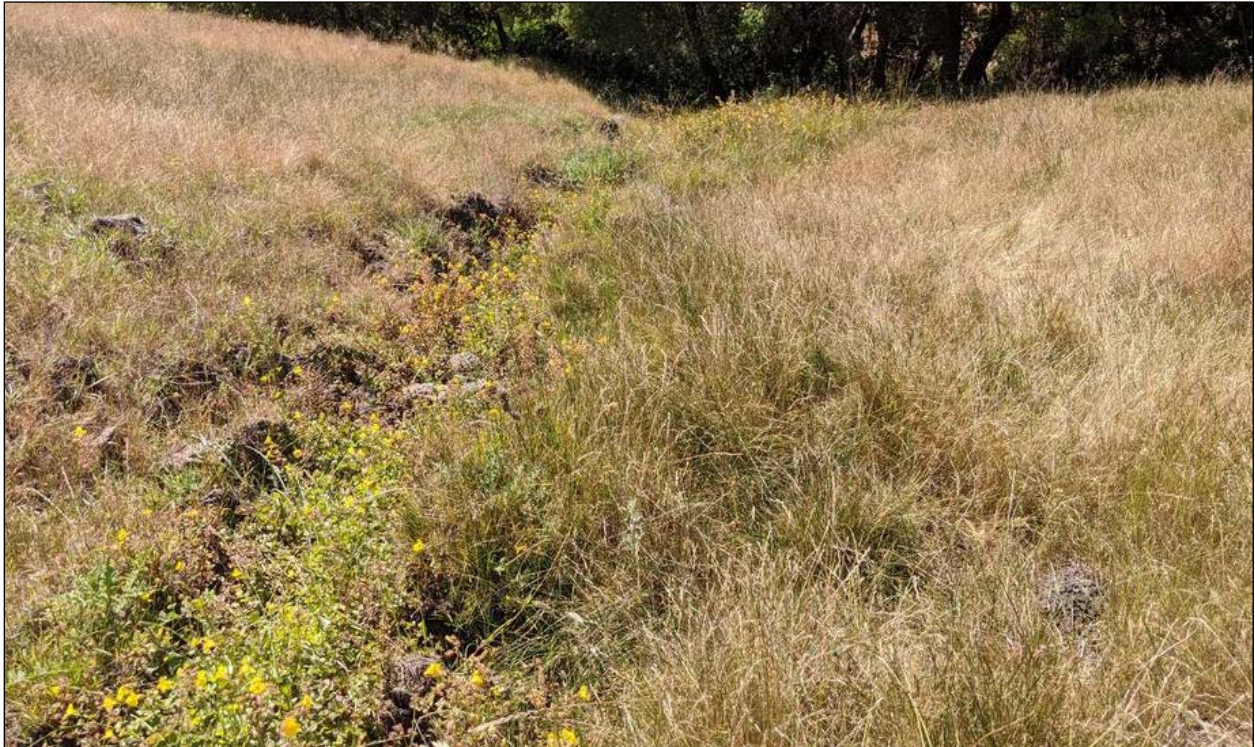
**Photo 32. Year 4 Conditions at Photo Point 13 during Vegetation Monitoring, at an Existing Seep in the Seep Collection Area That Was Not Disturbed During Construction (May 20, 2020)**

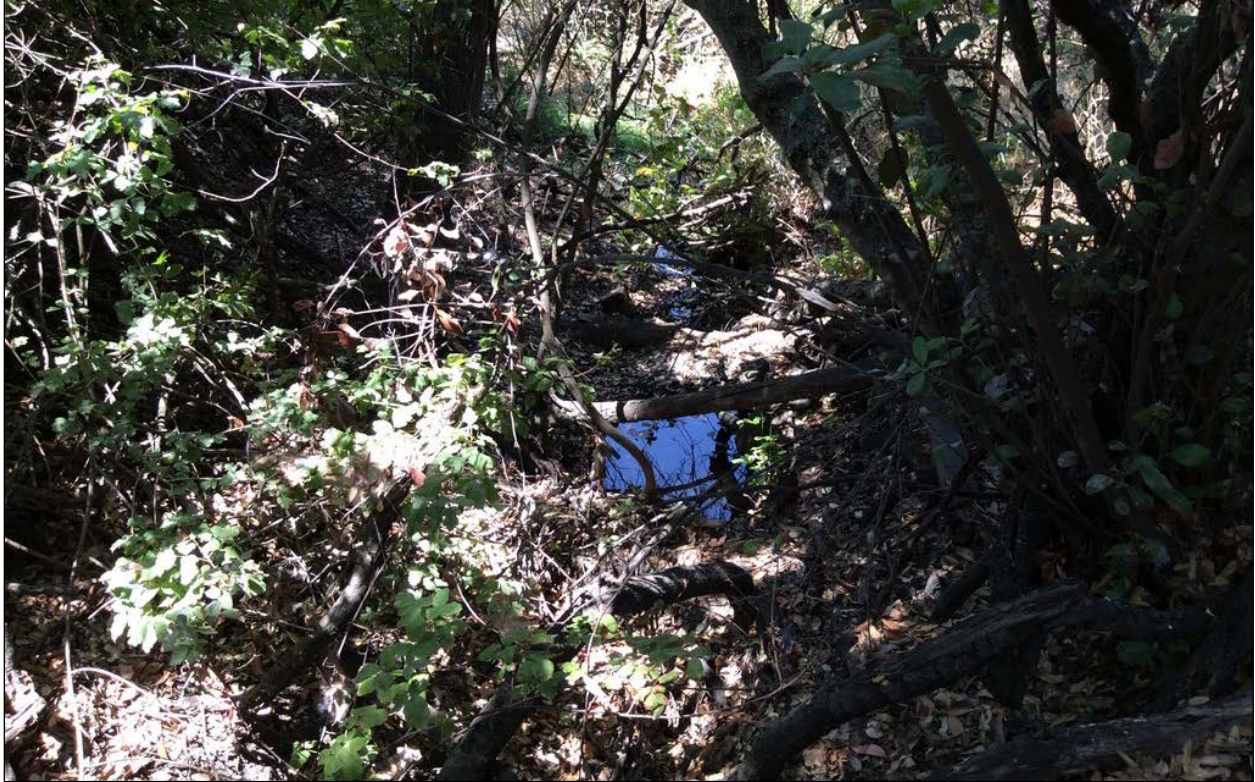
**Photo 33. Year 1 Conditions at Photo Point 14 during Vegetation Monitoring, Where Debris Jams Were Installed in the Seep Collection Area (August 8, 2017)**

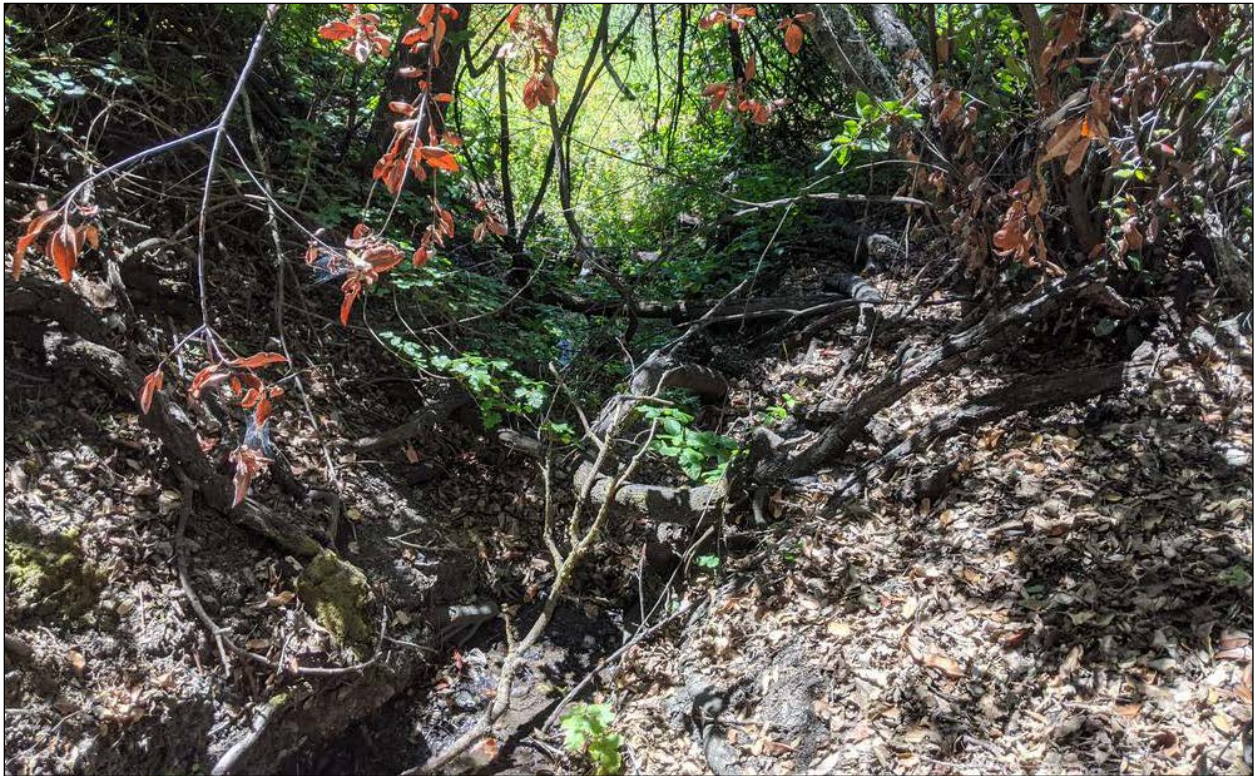
**Photo 34. Year 4 Conditions at Photo Point 14 during Vegetation Monitoring, Where Debris Jams Were Installed in the Seep Collection Area (May 20, 2020)**

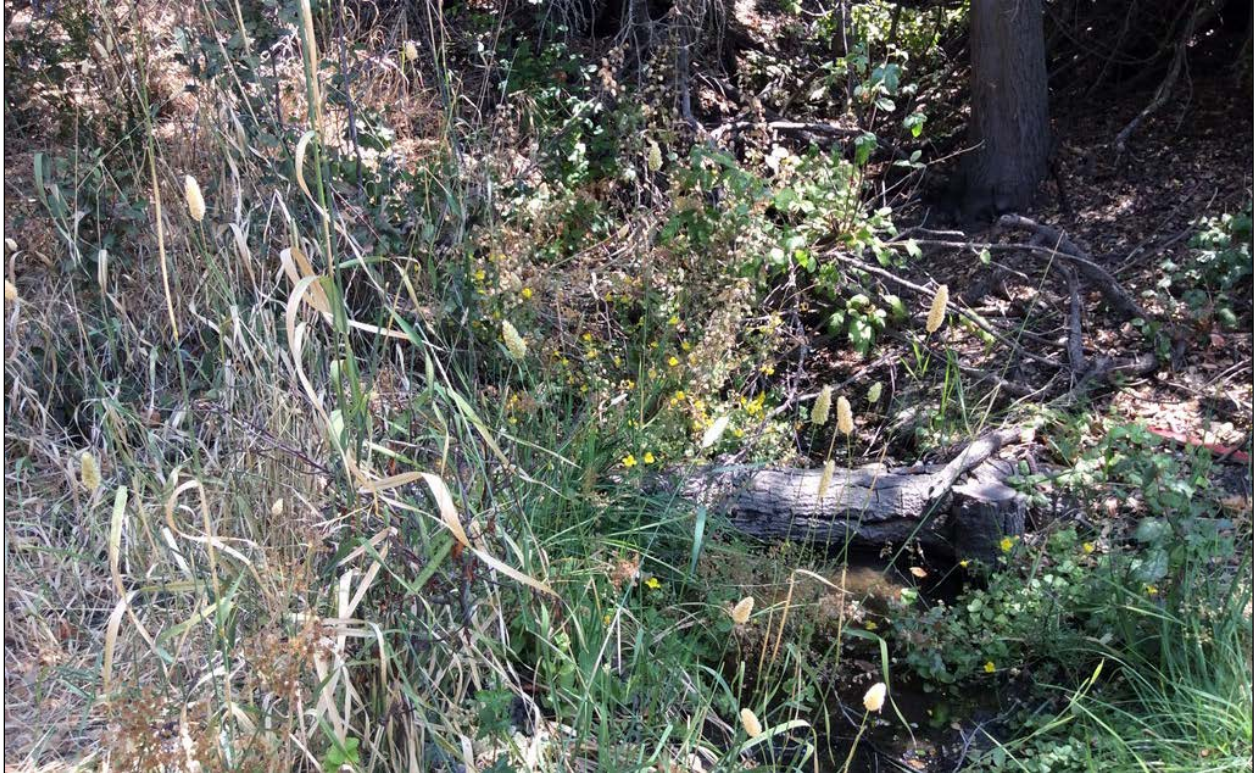
**Photo 35. Year 1 Conditions at Photo Point 15 during Vegetation Monitoring, with a Log Debris Jam Installed in the Seep Collection Area (August 8, 2017)**

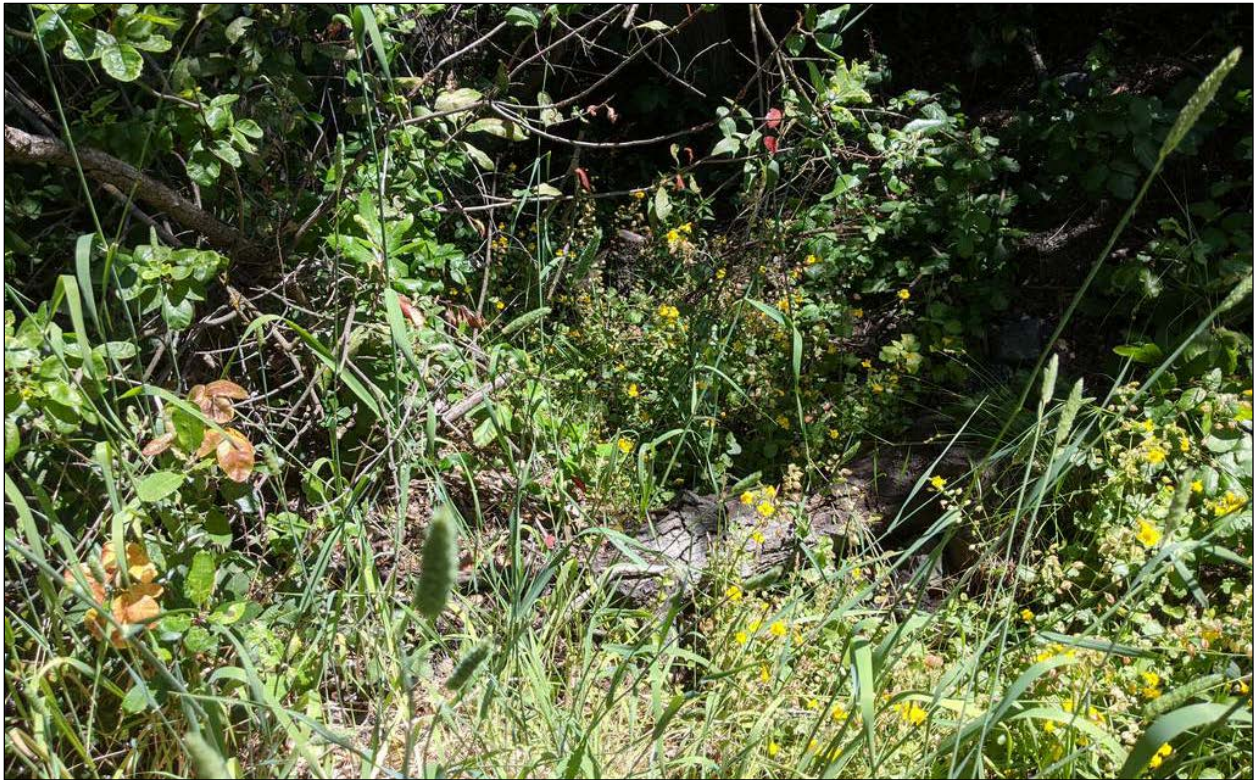
**Photo 36. Year 4 Conditions at Photo Point 15 during Vegetation Monitoring, with a Log Debris Jam Installed in the Seep Collection Area (May 20, 2020)**

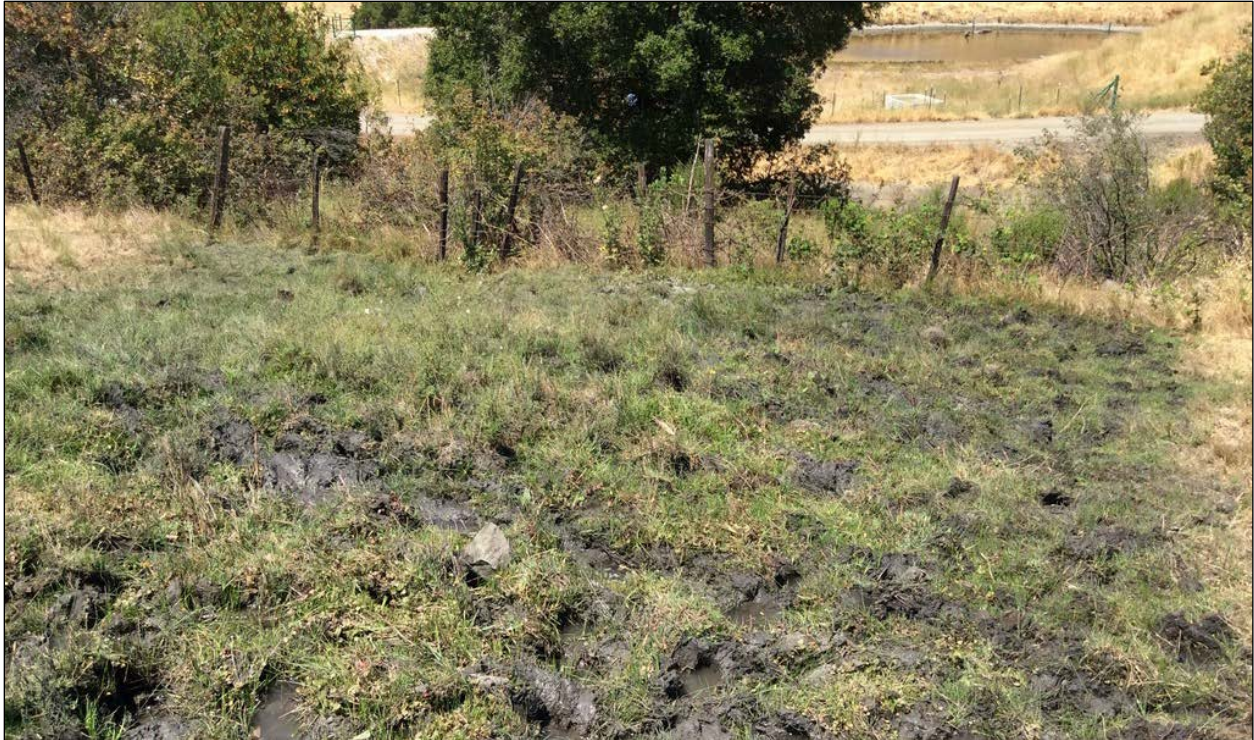
**Photo 37. Year 1 Conditions at Photo Point 16 during Vegetation Monitoring, at an Existing Seep in the Seep Collection Area That Was Not Disturbed During Construction (August 8, 2017)**

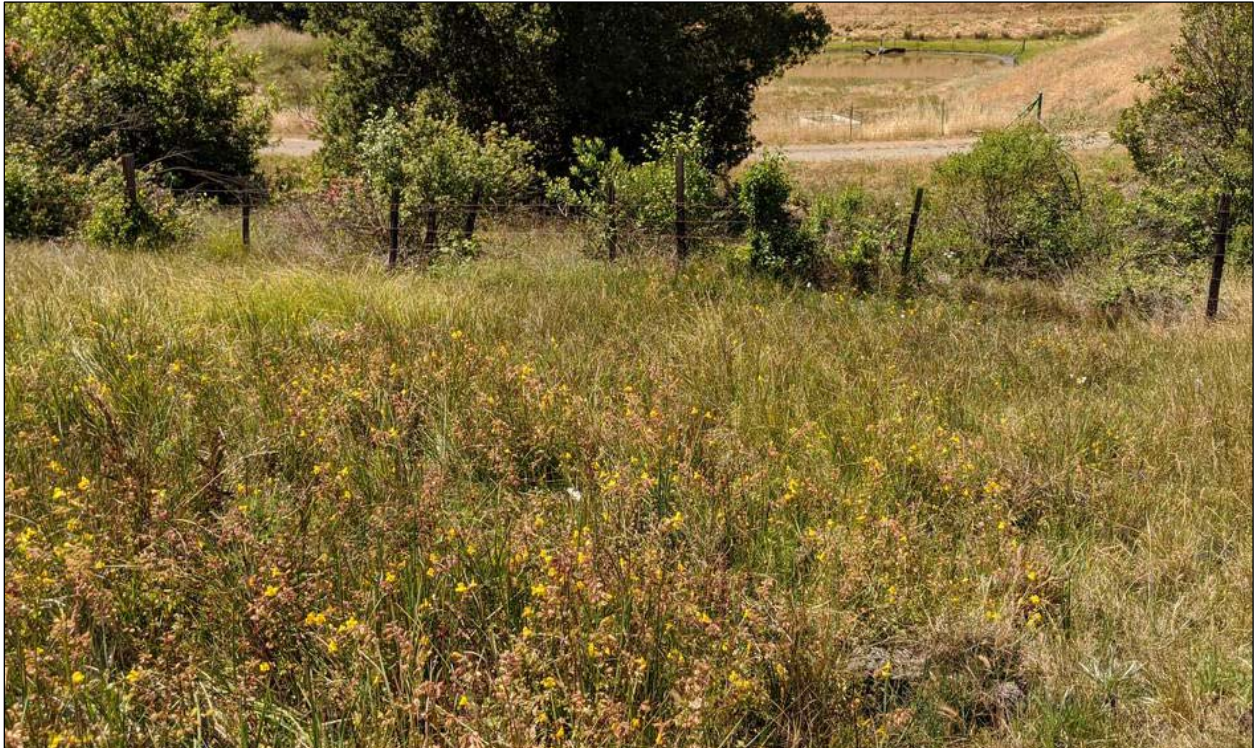
**Photo 38. Year 4 Conditions at Photo Point 16 during Vegetation Monitoring, at an Existing Seep in the Seep Collection Area That Was Not Disturbed During Construction (May 20, 2020)**

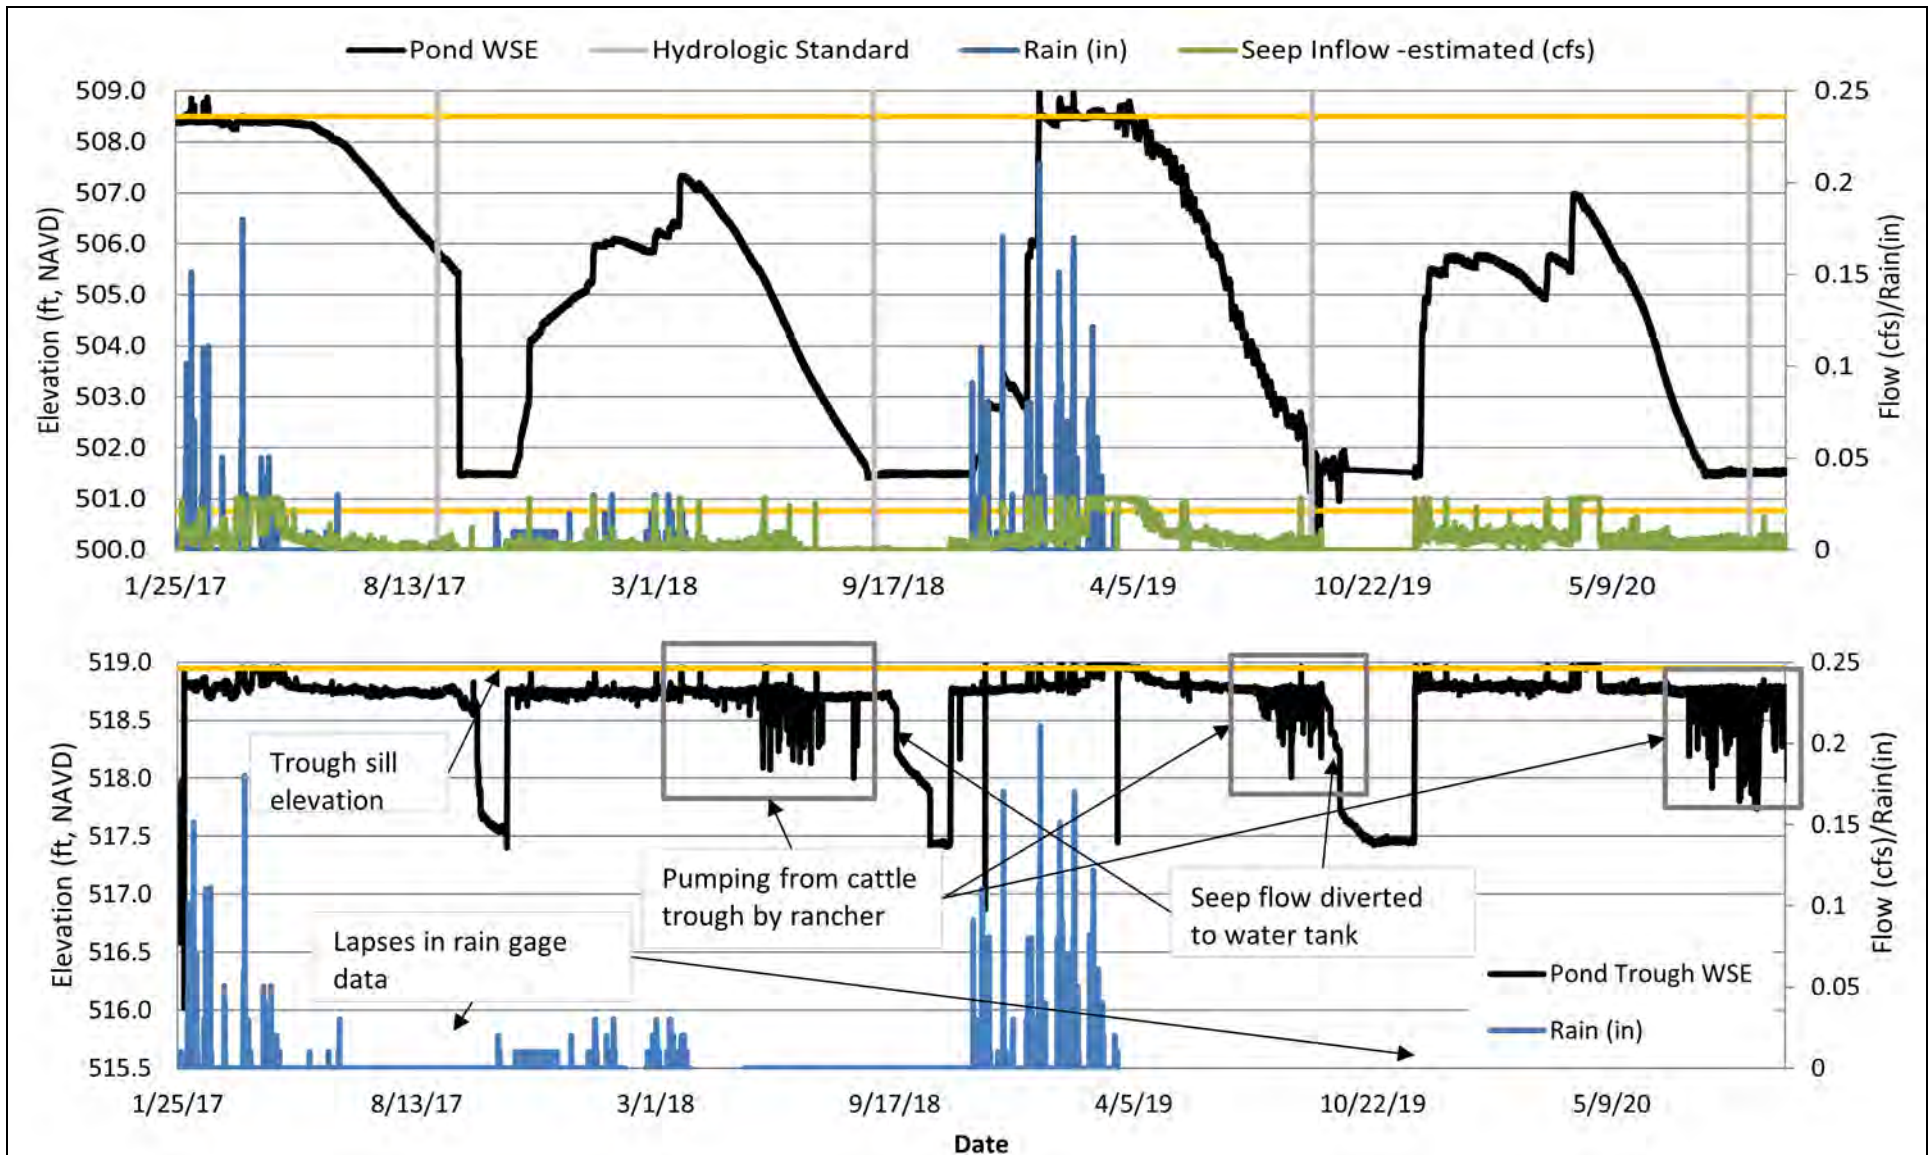
**Figure 2**

In Year 4, the pond never reached maximum capacity, but the maximum water level was observed on April 7<sup>th</sup>, 2020 (Figure 2). This peak occurred at the only time of the year when the seep flow sustained maximum estimated flows. However, this is lowest peak water level since the start of monitoring due to recording the lowest annual rainfall depth in the past 30 years. Draw down of the pond started on a similar trajectory to that of Year 2, but again, the draw down rate increased with cattle access to the water trough. The seep flow was diverted on November 3<sup>rd</sup>, 2020, but the pond completely dried out on July 26<sup>th</sup>, 2020.

Regarding hydrologic performance standards, the pond exceeded a target water depth of at least two feet (i.e., 4.8 feet) through the end of August in Year 1. In Year 2, the water depth fell below the hydrologic performance standard. The pond did not fill to capacity and did not meet the two-foot water depth target for the end of August. As shown by Figure 2, there was an increase in the draw down rate of the pond water level at the beginning of June that corresponds to the period of time that the rancher started pumping from the water trough to water cattle. In addition to this increase in draw down rate, the fact that Year 2 was a very dry WY or well below normal (average) conditions largely contributed to not meeting the two-foot water depth target at the end of August. Year 3 did meet the hydrologic performance standard (i.e., 2.49 ft). As shown by Figure 2, there was an increase in the draw down rate

Notes: Seep inflows are estimated using rating curve established by measuring trough water levels and outflows. When the trough was full the highest recorded seep inflow was 0.028 cfs. In reality, seep inflows can be greater than 0.028 cfs when the trough capacity is exceeded.

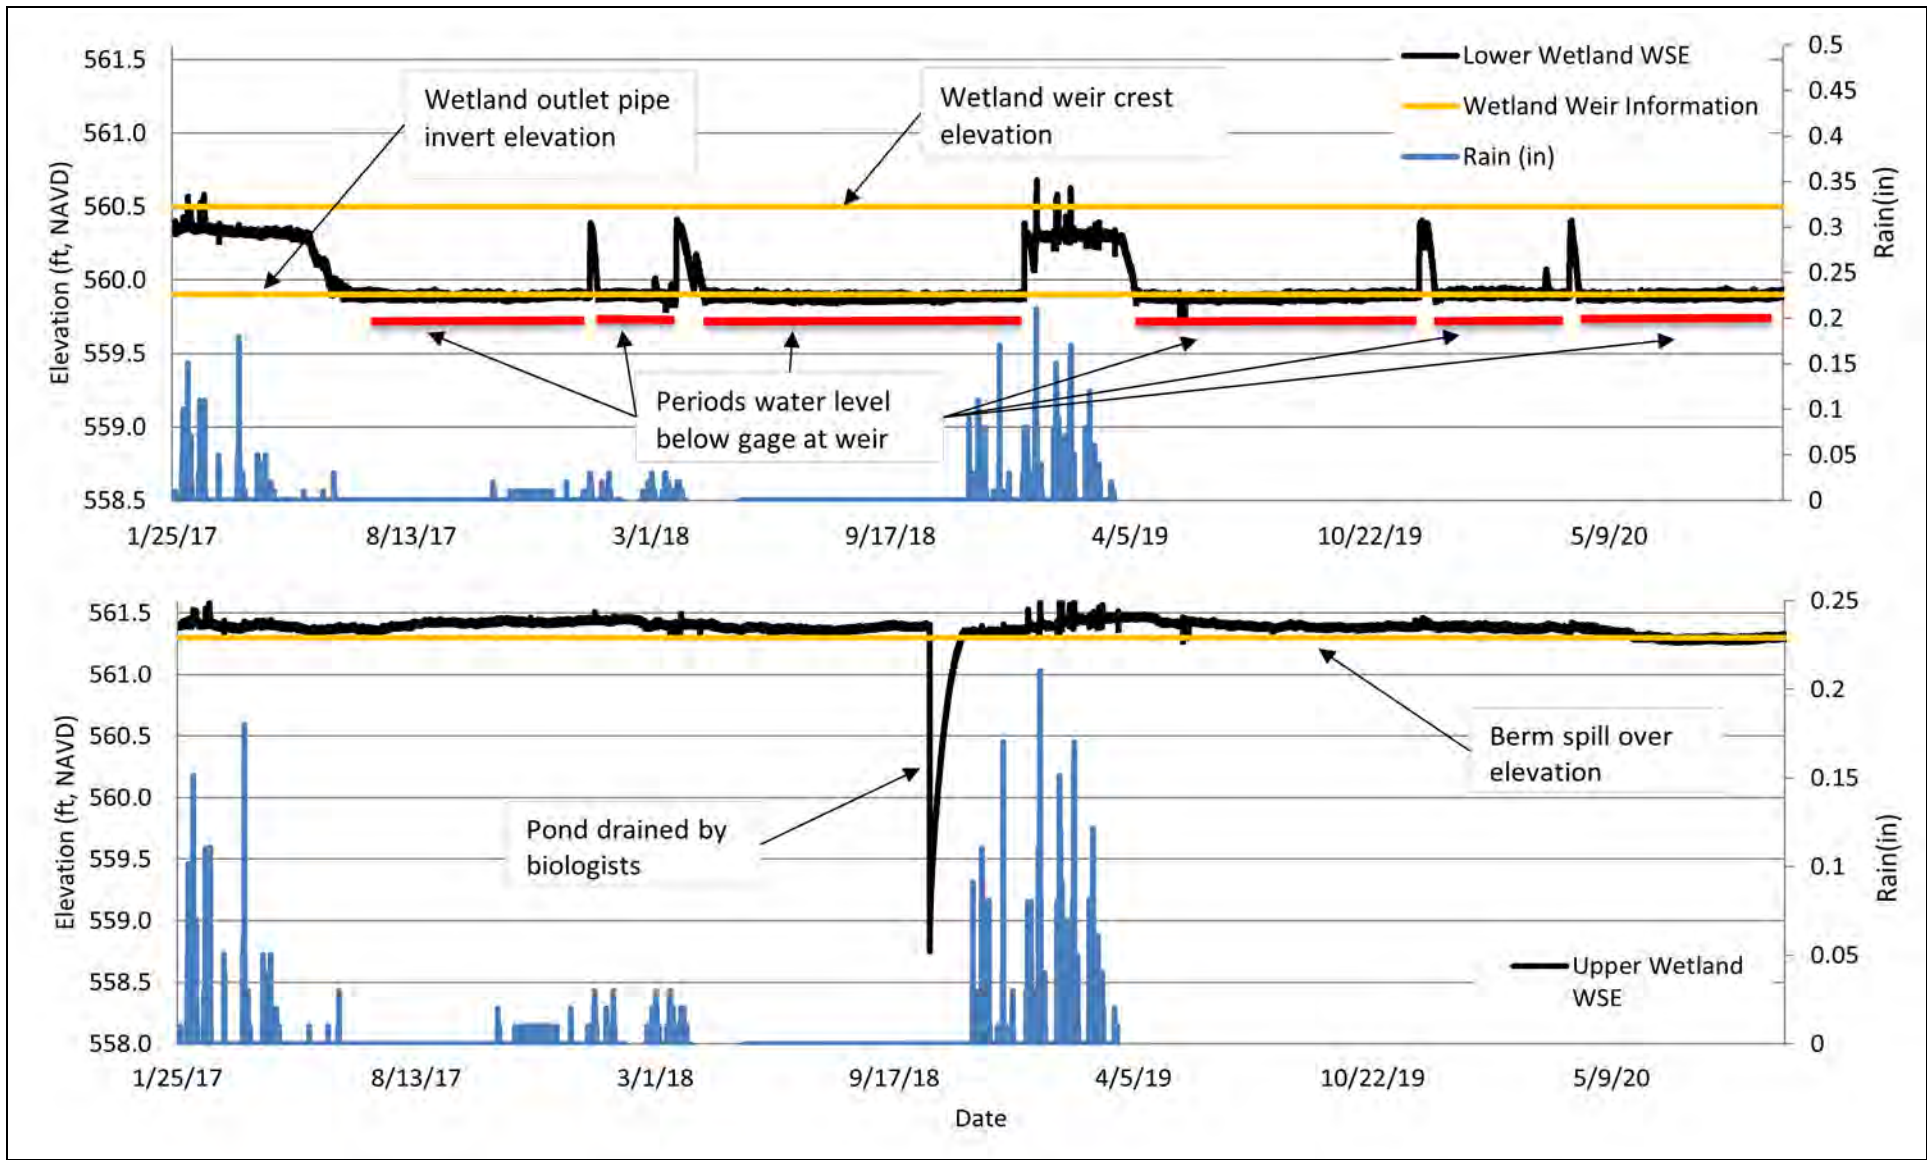
**Figure 3**

In Year 4, the upper wetland pond remained above the berm spill over elevation until June 28<sup>th</sup>, 2020, where it dropped below the berm elevation for the first time since monitoring started. However, the water level only dropped below the berm by no more than ~0.03 ft (Figure 3). The earthen outlet of the pond was still heavily saturated, which indicates water was likely still seeping into the lower wetland area

Notes:  
 7/17/2017 and 10/4/2018– Estimated dates when level logger cable was changed, water levels adjusted to account for elevation change of logger.

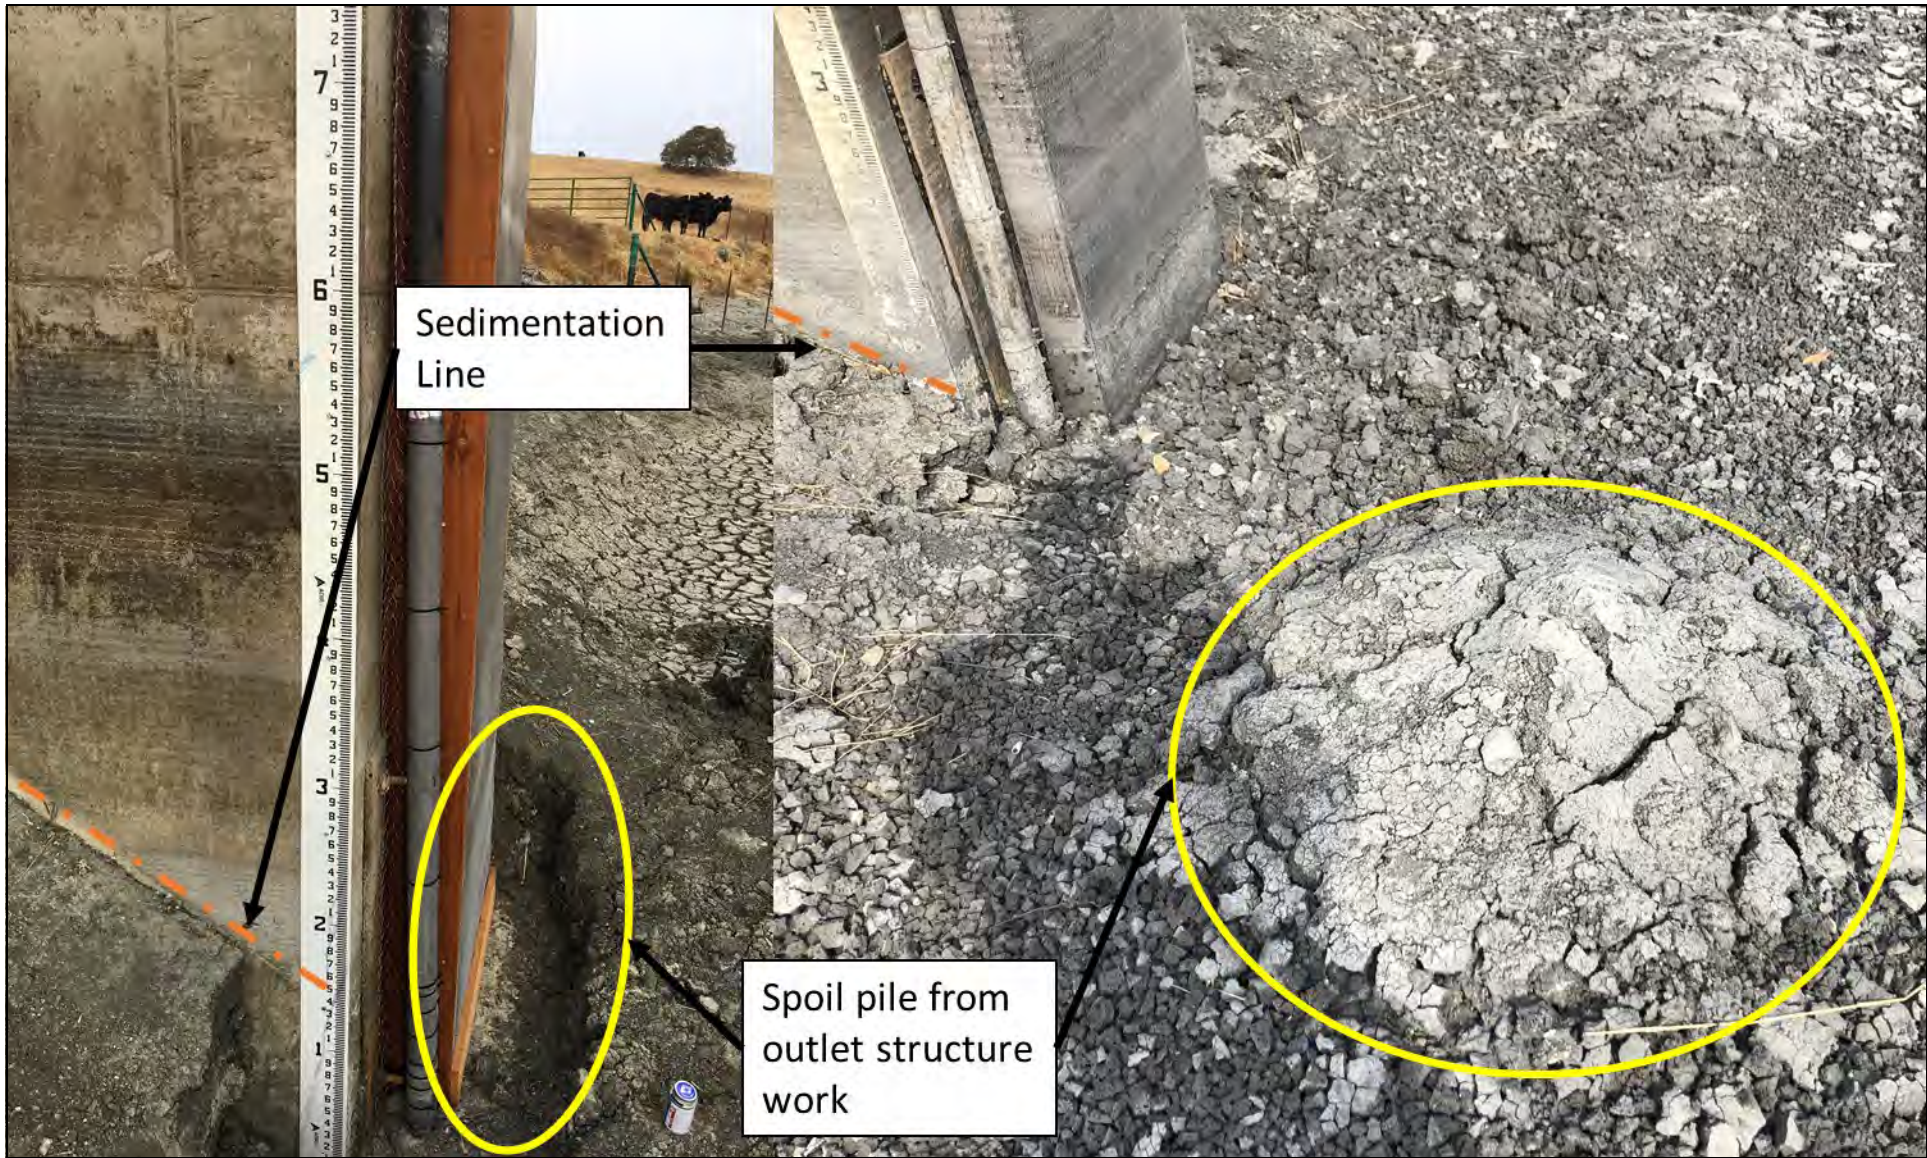
**Figure 8**

In Year 4, cbec did not resurvey the 8 transects per the monitoring plan schedule. Similar to Year 2, general observations were made in regard to the geomorphic stability of the project. Sedimentation continues to gather in lowest sections of the pond near the outlet structure. Given the approximately 0.7 ft of sedimentation that was observed in Year 2 and the maximum of 1.5 ft that was observed in Year 3, there has been little to no appreciable sedimentation in Year 4 (Figure 8). Contribution of sediment from cattle

grazing has likely continued and maintenance of the outlet structure has also caused a small, localized pile of sediment (Figure 8). Areas that previously experienced slumping have remained unchanged. No sources or evidence of sedimentation were noted in the pond of the upper wetland. Banks on the lower basin of the upper wetland were cracking due to the clay's expansion and contraction. This is an expected characteristic of the clay but will be continued to be monitored for signs of slumping.

Notes: Photos taken on 11/26/2019 (left) during pond gage re-install and 10/09/2020 (right) during a field monitoring visit.
