San Felipe Creek Restoration Project Mitigation Monitoring Annual Report Year 2 – 2020

Santa Clara Valley Habitat Agency

DUDEK

DECEMBER 2020

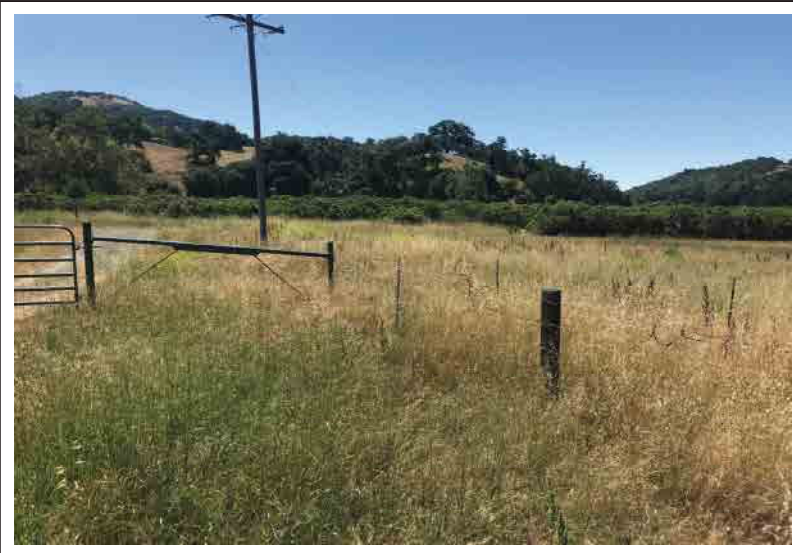
Photo 1a: East - SW03 - 06/19/2019

Photo 1b: East - SW03 - 10/28/2020

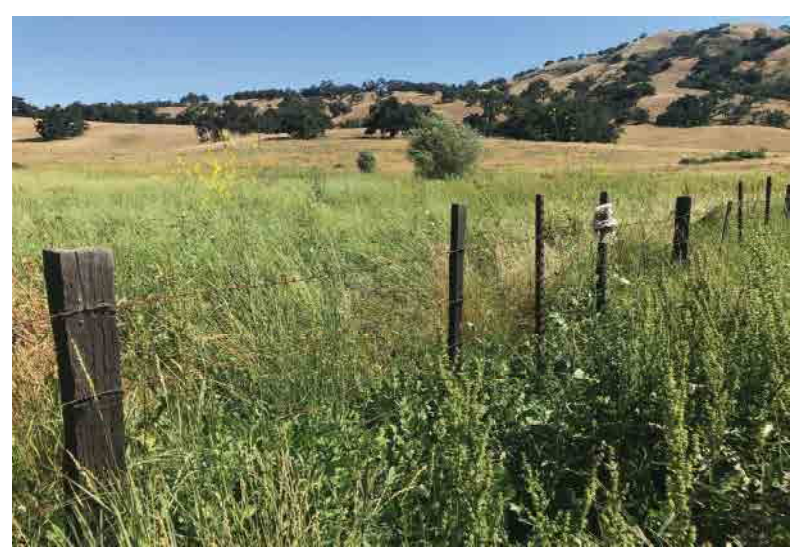
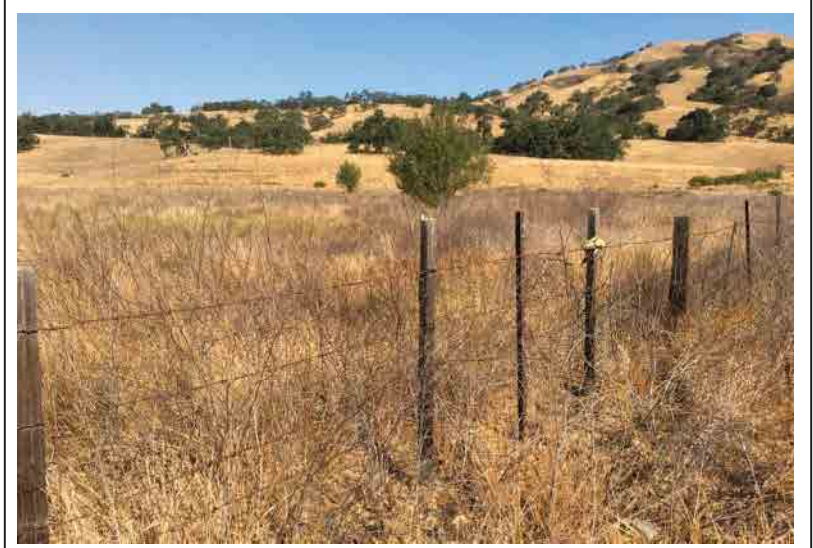
Photo 4a: Northeast - SW03 - 06/19/2019

Photo 4b: Northeast - SW03 - 10/28/2020

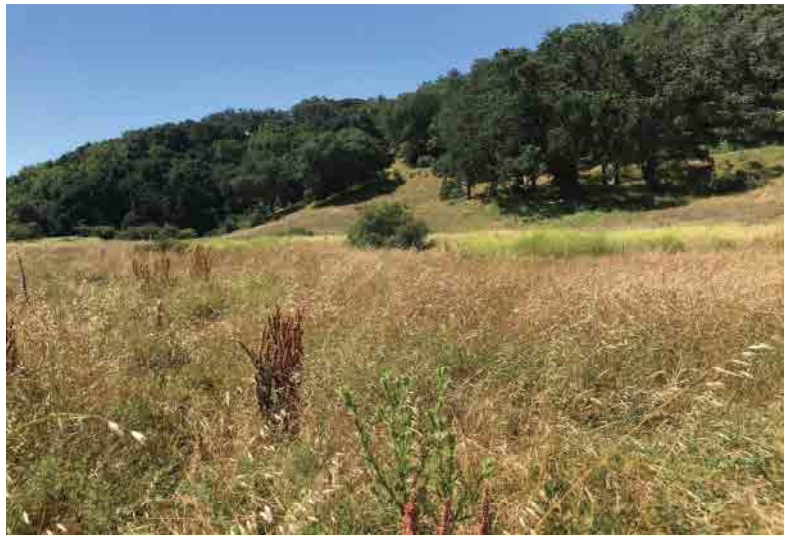
Photo 7a: Southwest - ID03 - 06/19/2019

Photo 7b: Southwest - ID03 - 10/28/2020

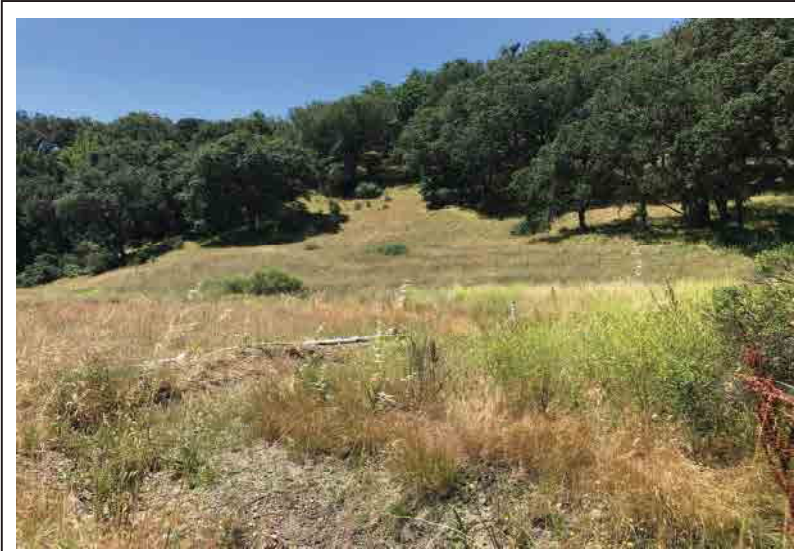
Photo 10a: Southwest - ID03 - 06/19/2019

Photo 10b: Southwest - ID03 - 10/28/2020
