Local Assistance Grant

SR-152 Pacheco Pass Wildlife Connectivity Study

October – December 2021

## Local Assistance Grant: Coyote Valley Road Ecology Study

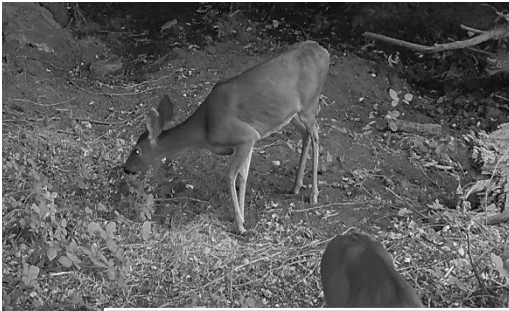
2021-10-02 Two deer browsing at westbound opening.

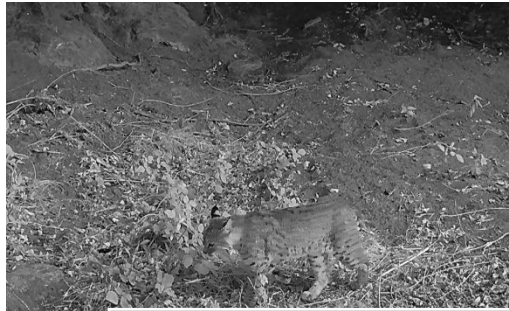
2021-10-04 Bobcat at westbound opening.

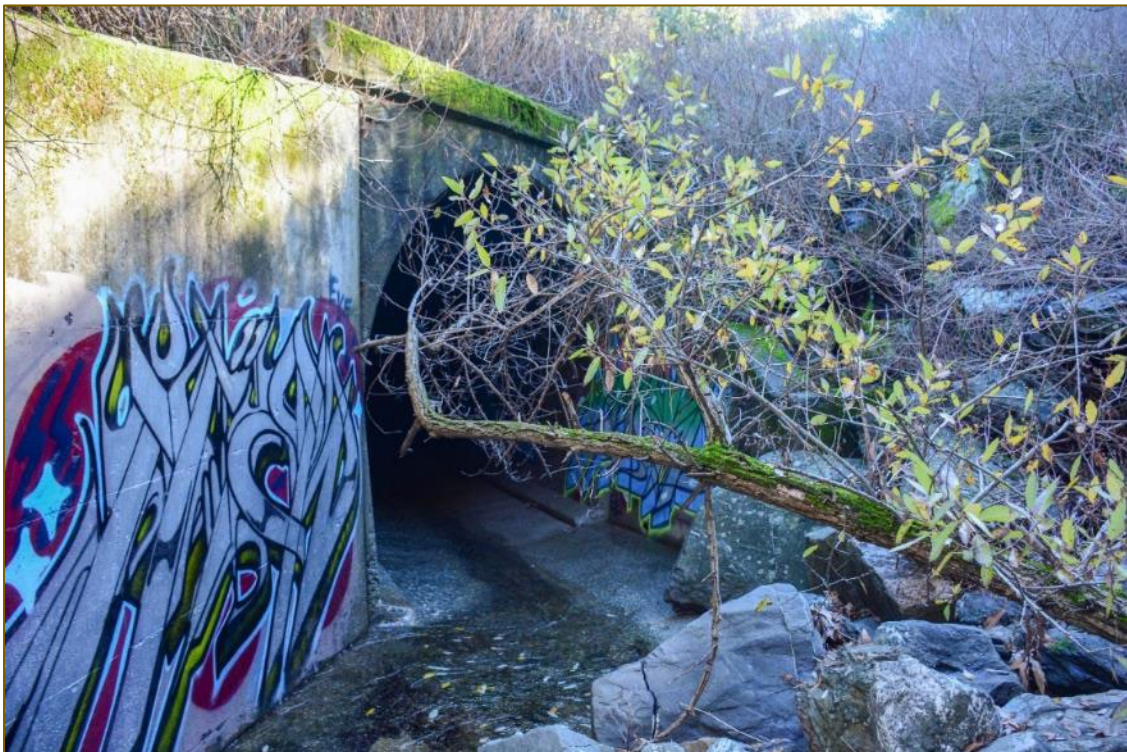
152 PM 32.3 Westbound and Eastbound

Culvert PM 32.3 is a very high use culvert for medium sized wildlife (Figure 8). In addition to being a high use culvert for a variety of species, this culvert also has one of the highest detections of gray fox (*Urocyon cinereoargenteus*) use. This includes passages of adult gray foxes traveling with pups. We recorded adults crossing with at least 2 pups on numerous occasions throughout this previous summer and into fall (2021). In addition to gray fox, there are also bobcat, coyote, raccoon, opossum (*Didelphis virginiana*), and striped skunk (*Mephitis mephitis*) passages. Adding to the diversity, this is the only culvert where we documented puma (*Puma concolor*) presence.

Making this culvert more interesting, water drains from the westbound to the eastbound opening leading to an approximate four-foot drop at the eastbound opening. This design allows for water to fill up in front of the eastbound opening forming one of the largest pools there are throughout the study area (Figure 9). This pool of water remains for the majority of the year only drying up completely in September. The condition of this pool of water creates habitat highly suitable for western pond turtle (*Actinemys marmorata*), and California red-legged frog (*Rana draytonii*). For example, almost every outing during camera servicing, we have seen western pond turtles sunning on a rock, or frogs jumping into the water.

Another factor contributing to the high amount of wildlife passages through this culvert is the opportunity to travel from the culvert to the hillside (and vice versa) at the eastbound

opening even when the pool of water is at its highest. This is because the arch of the culvert tapers down to meet the floor of the culvert creating a cement walkway for wildlife utilize as they travel to and from the hillside.

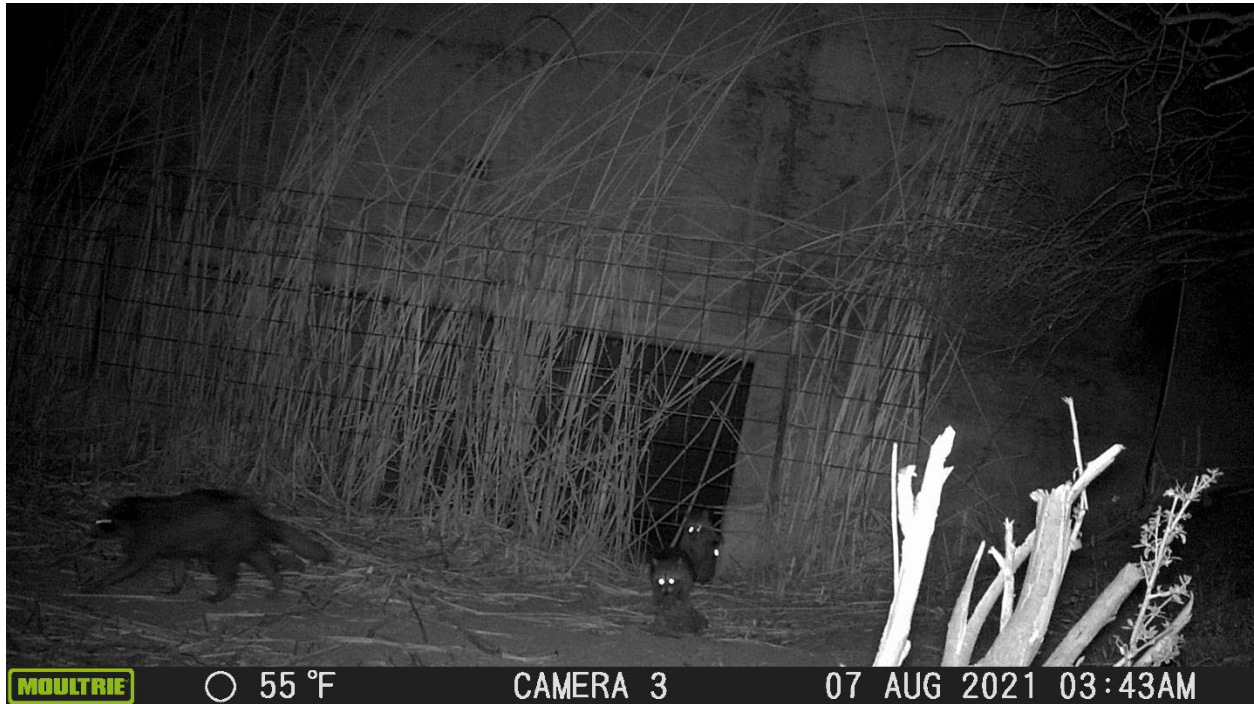
The Laguna Seca culvert at Santa Teresa Boulevard is flooded by water (Figure 6). This culvert was dry during the summer months, however, there is fencing set up on the west side of the culvert (Figure 7). This may be restricting wildlife movement through the culvert as we have only document raccoons traveling through a small opening at the bottom right section of the fence (Figure 8).

Figure 8. Raccoon adult traveling with juveniles through the Laguna Seca culvert at Santa Teresa Boulevard culvert on 8/7/2021.

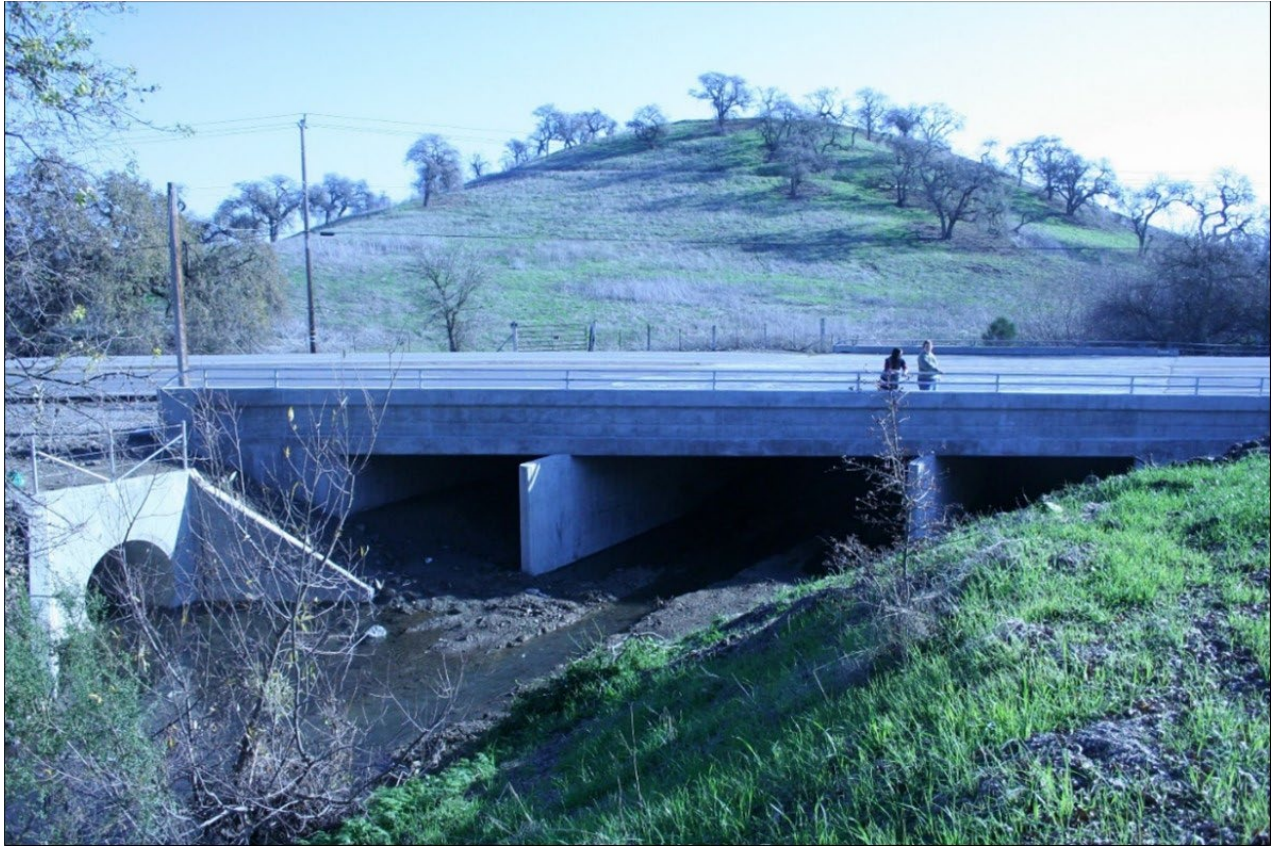
Since 2008, the sediment has significantly built up over time within the three sections of the Bailey Bridge at Fisher Creek (Figures 10-12). The bridge is currently flooded in the mid-section (Figure 13).

Figure 10: Bailey Bridge at Fisher Creek in 2008.

beginning of the monitoring period, we have only recorded raccoons using the bridge to travel under Bailey Avenue. We highly recommend clearing out the sediment build-up at the Bailey Avenue bridge to make it more permeable for large mammal movement.

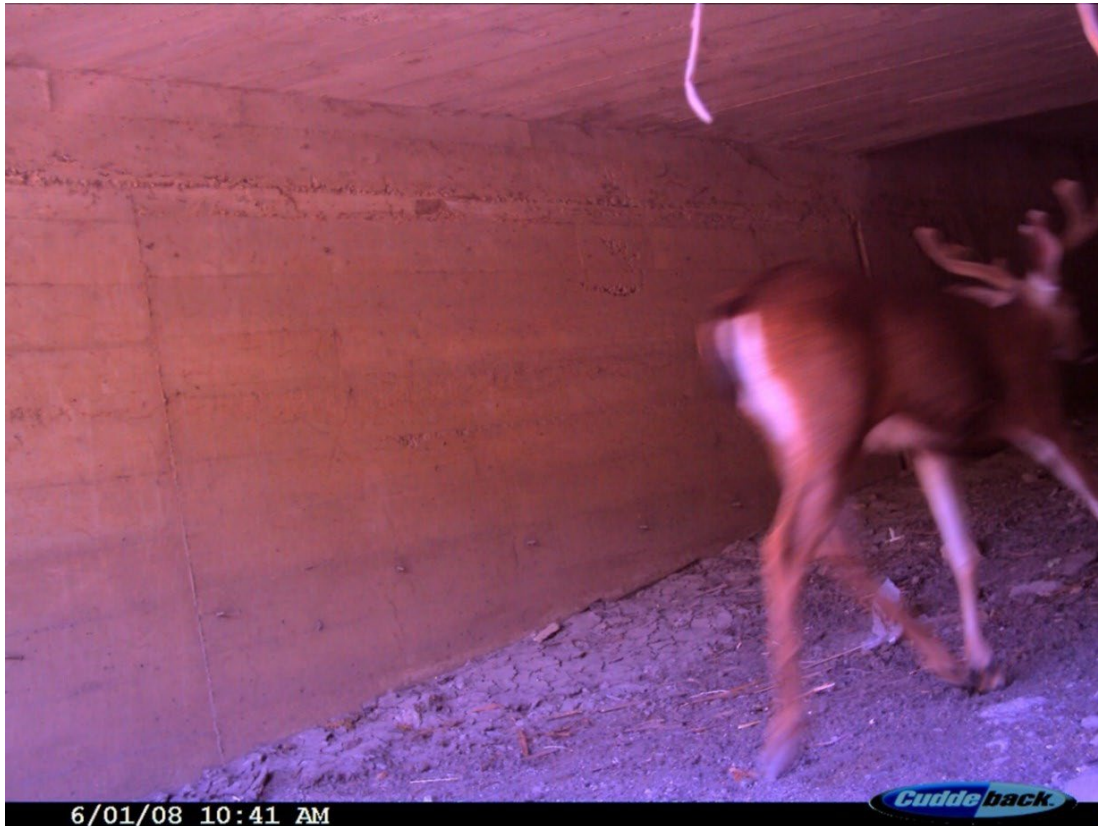
Throughout a monitoring period from 2008-2009, multiple species were recorded traveling through the Bailey Bridge at Fisher Creek. Of particular importance, deer were recorded routinely traveling through the bridge (Figure 14). The only other structure in Coyote Valley large enough to facilitate large mammal movement under roads is the Santa Teresa Boulevard Fisher Creek culvert. However, this culvert is most often flooded throughout the year, leaving only the Bailey Bridge to facilitate large mammal movement under the roads within the study area. In Figure 15, the sediment build up is so high, it is unlikely that the bridge will facilitate large mammal movement through it. Since the

Figure 14: Deer crossing beneath the Bailey Bridge at Fisher Creek on 6/1/2008, from the south most eastern section of the bridge.
