ANNUAL RESTORATION MONITORING REPORT YEAR 5

SAN FELIPE CREEK RESTORATION PROJECT
SANTA CLARA VALLEY HABITAT AGENCY

DECEMBER 2023

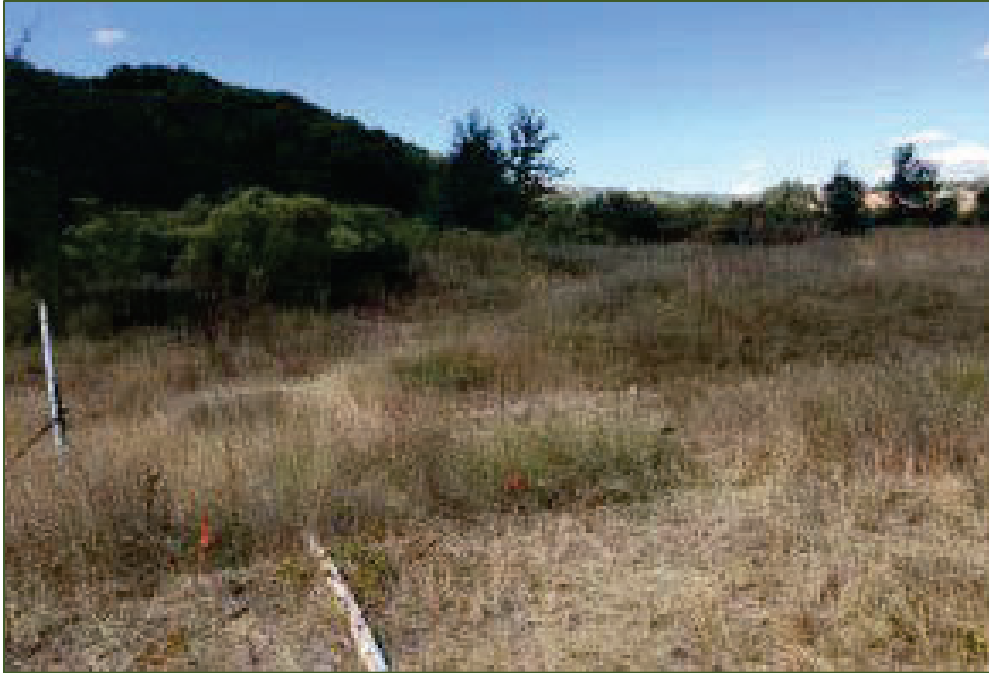
Photo Point 22

Photo 22. Year 1 (2019), facing north toward ED03-04 and AD01. Photo taken 6/19/2019

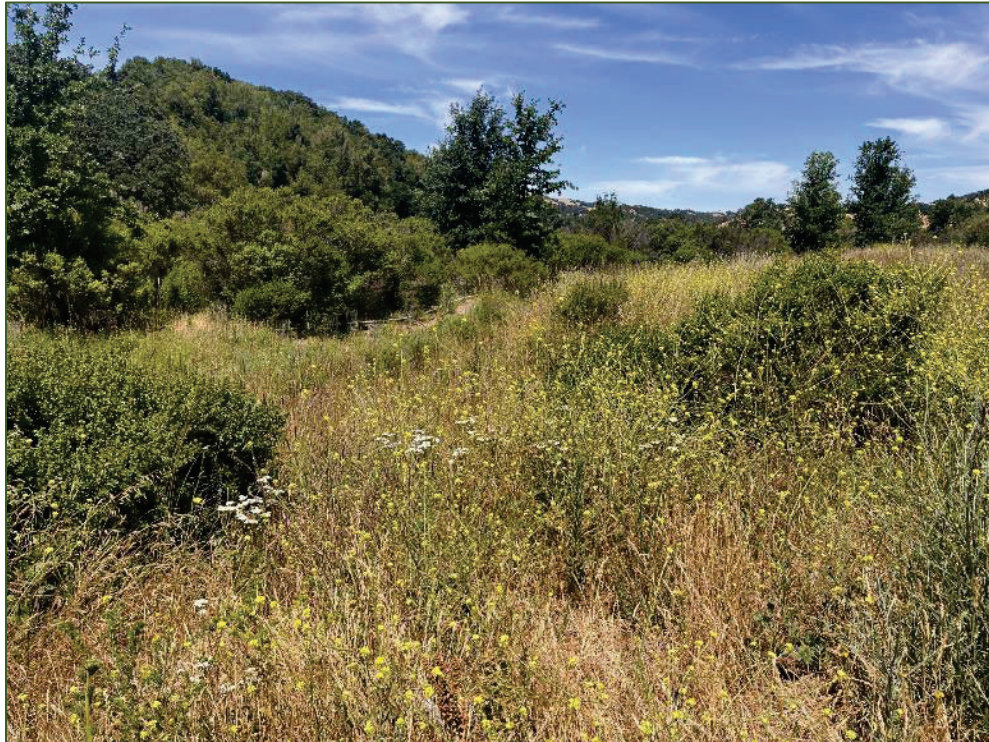
Photo 22. Year 5 (2023), facing north toward ED03-04 and AD01. Photo taken 6/15/2023

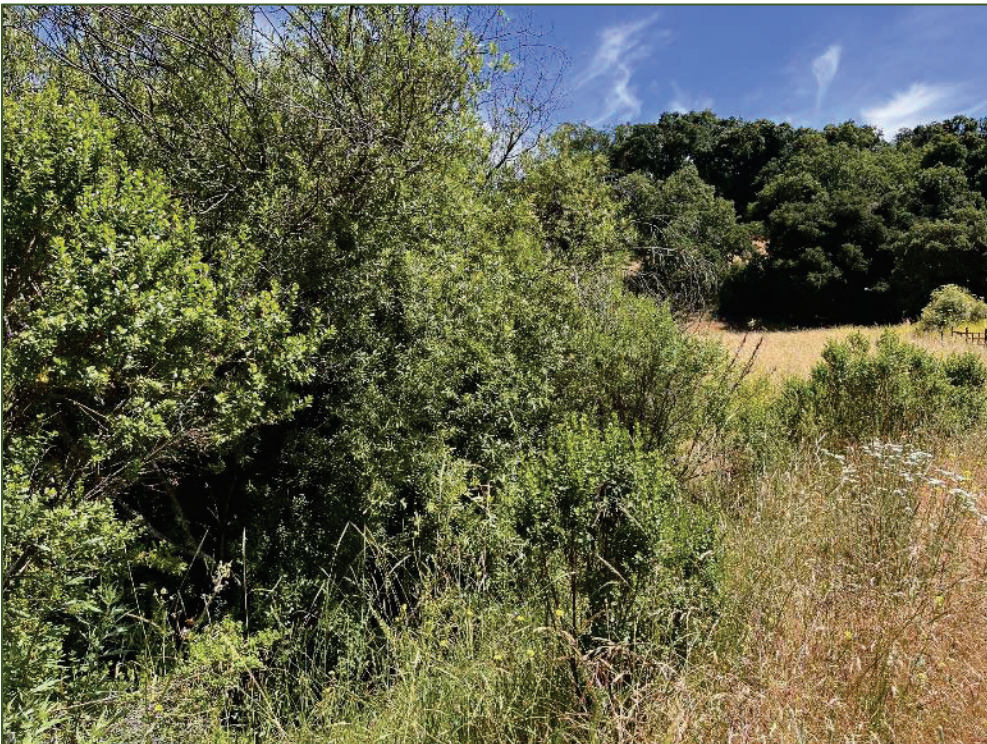
Photo 24. Year 5 (2023), facing north toward ED03-05 and AD01. Photo taken 6/15/2023

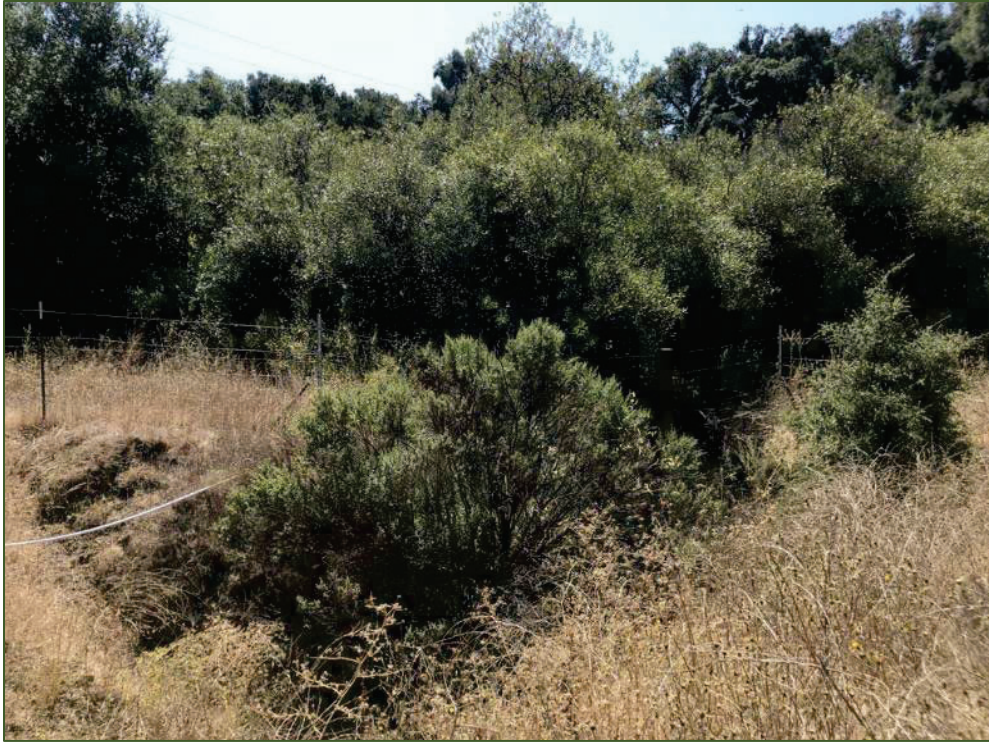
Photo Point 25

Photo 25. Year 1 (2019), facing south toward ID02. Photo taken 9/30/2019

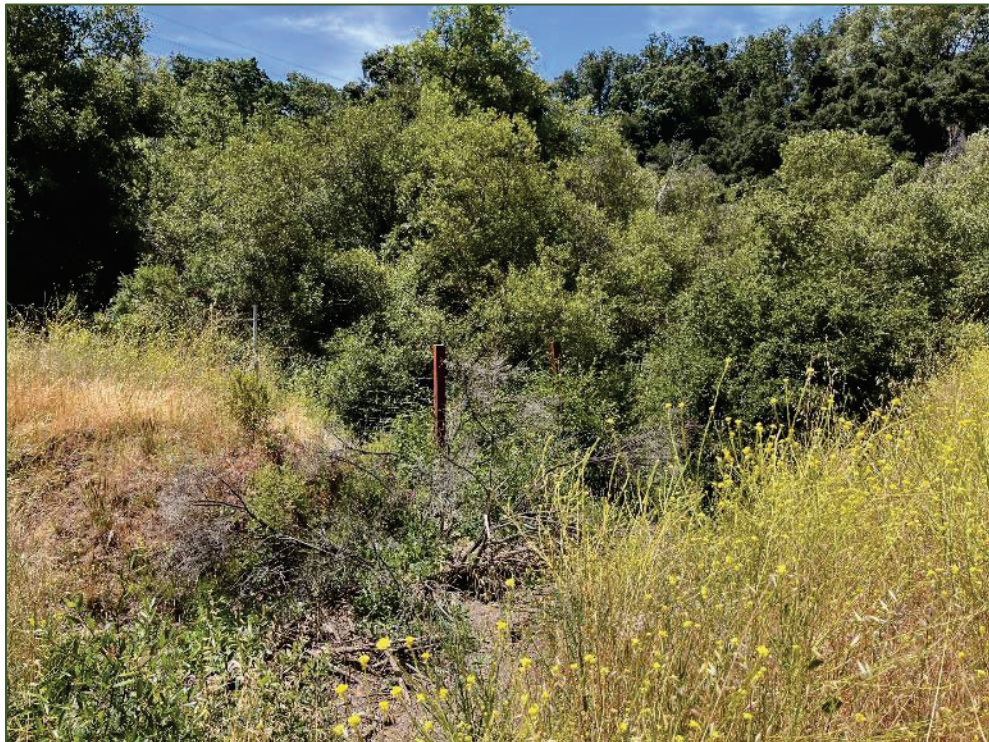
Photo 25. Year 5 (2023), facing south toward ID02. Photo taken 6/15/2023

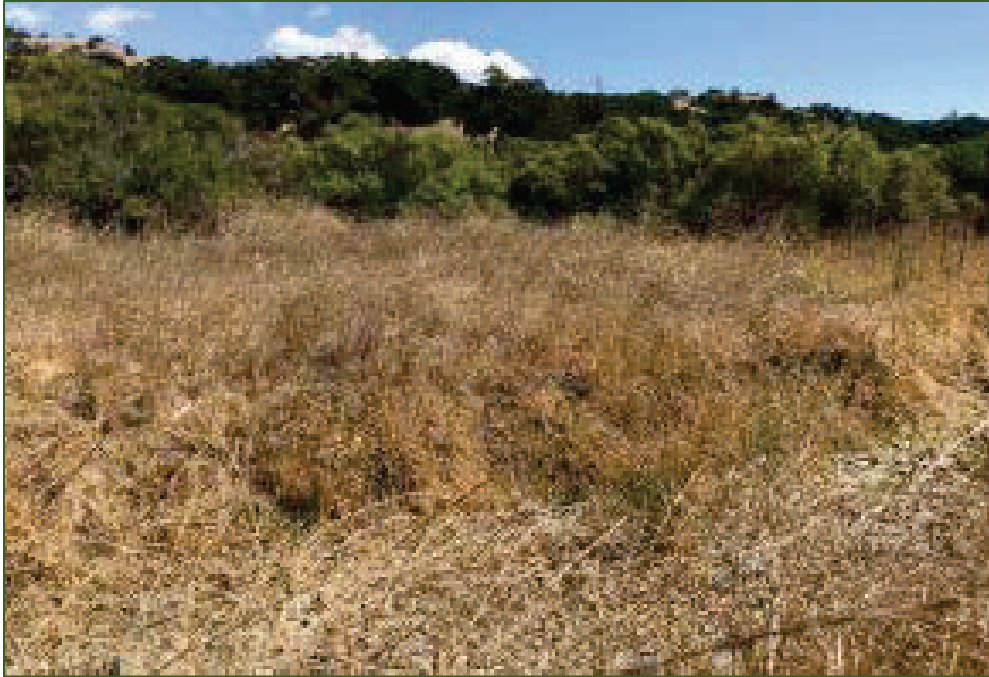
Photo Point 30

Photo 30. Year 1 (2019), facing south toward ID01. Photo taken 9/30/2019

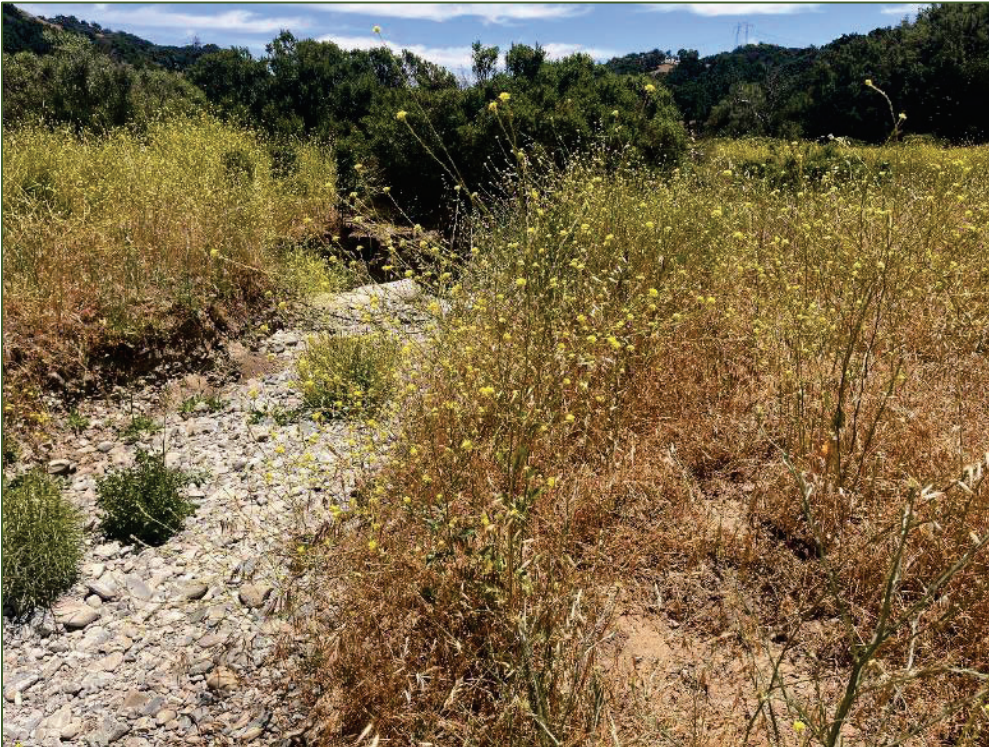
Photo 30. Year 5 (2023), facing south toward ID01. Photo taken 6/15/2023
