# ANNUAL RESTORATION MONITORING REPORT

## YEAR 6

SAN FELIPE CREEK RESTORATION PROJECT  
SANTA CLARA VALLEY HABITAT AGENCY

**FEBRUARY 10, 2025**

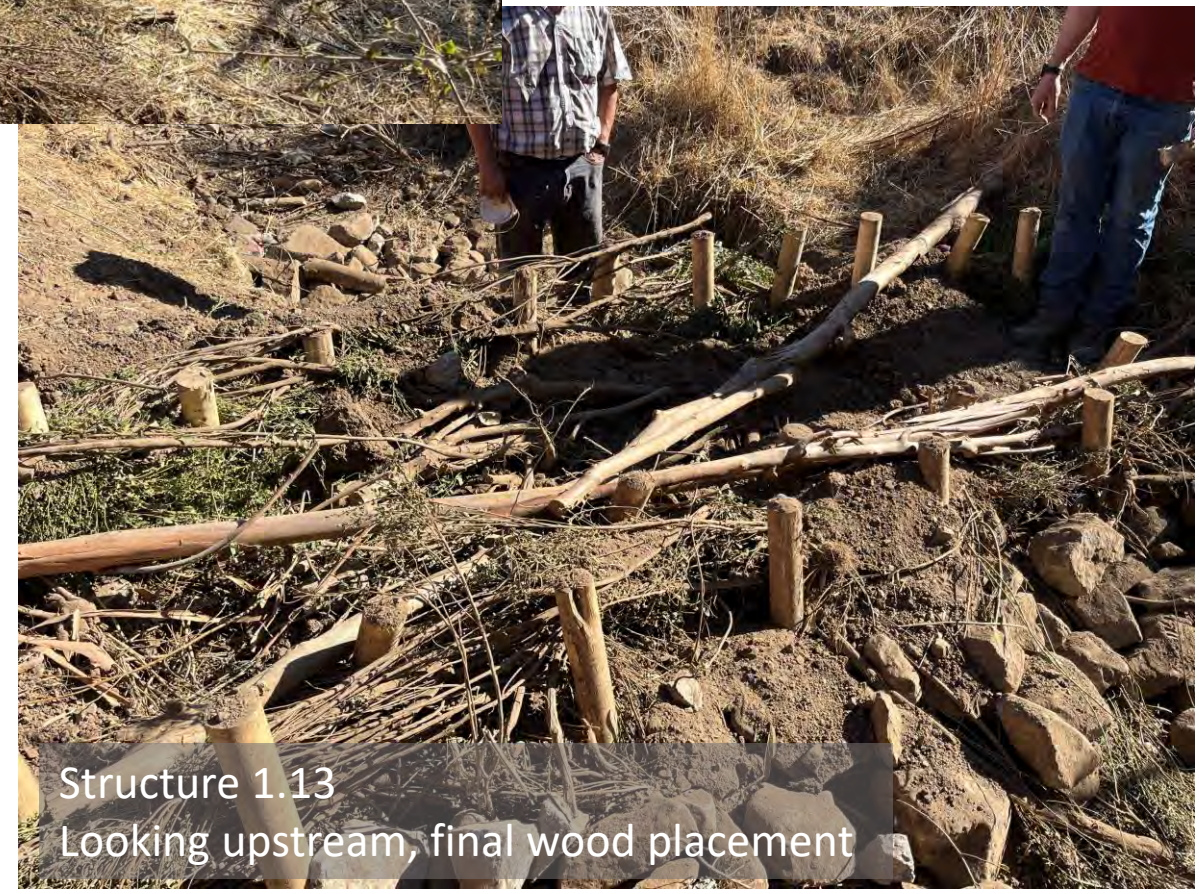
**Figure 4. Incised Eastern Tributary Type 1 Debris Jams, As-built photos, October 2024, San Felipe Restoration Project 2024 Adaptive Management, Santa Clara County, California.**

Helix installed three Type 2 timber debris jams, three Type 1 staked debris jams, and added rock to the existing terminal jam, as recommended. Design specifications as detailed in **Sheet 2** were followed closely. Some minor changes were made to the specifications based on field conditions. Photos of the completed work can be found in **Figure 4** and **Figure 5**. Deviations to the design specifications were as follows:

- c) For Jam 1.13, only one course of stakes was installed, in order to avoid negatively affecting the roots of the large oak tree on the left bank.
- d) On the middle Type 2 debris jam, a rough sawn redwood 2x6 support was split during construction. Another board was installed on the downstream side of the structure for extra support.
- e) Extra rock was placed upstream and downstream of structure 1.14 and downstream of structure 1.13.
- f) The soil that was added to structures 1.12, 1.13, and 1.14 was not jet or compacted with water due to equipment failure.
