Coyote Ridge Ponds Restoration Project, Ponds CR1 and CR4 Year 6 Monitoring Report

December 5, 2025

From: Kelli Camara, Camara Environmental Consulting *in collaboration with* Biotic Resources Group and George McMenamin, &
Nathan Hale, Santa Clara Valley Habitat Agency

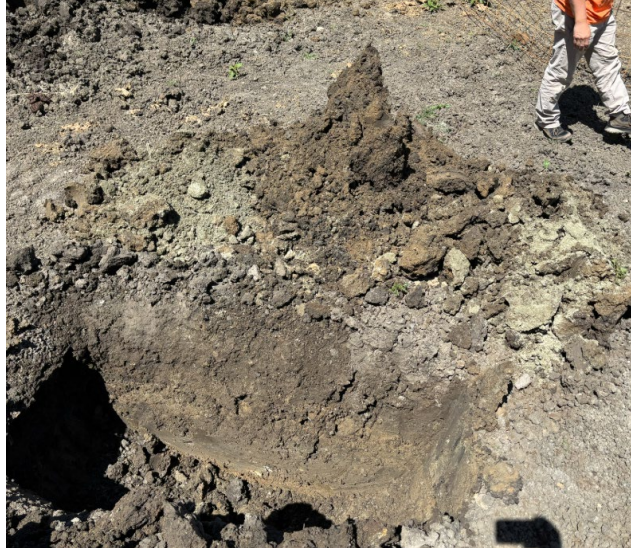
2c (9/9/2025)

Figure 2. Photos of CR-1 1-day repair. Photo 2a shows poor quality clay pond soil in test excavation; 2b shows higher quality clay soil typical of remainder of pond area in test excavation; 2c shows excavated low quality soil area—after soils were dug out—being refilled with the higher quality clay; 2d shows excavator in process of compaction of pond bottom; 2e shows completed repair with fence reinstalled (and superfluous posts removed from pond); 2f shows ingress/egress with effective erosion control after rain events: native seed germinated, wattles, straw, and scattered branches functional, and no erosional rilling.

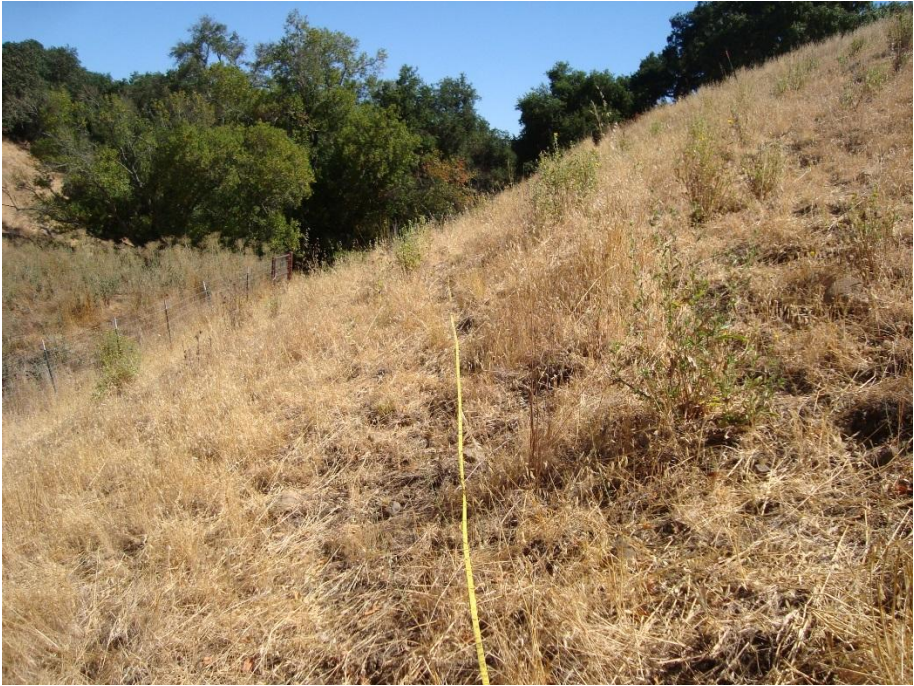
Transect T-2, July 28, 2025

The 2025 observations at CR1 found cover by all invasive plant species to be 2.8%, which meets the performance standard of $\leq 5\%$ (Figure 1). Cover was provided by yellow star thistle (1.7%) and purple star thistle (1.1%). Of the six transects used to document cover, only two transects (T-4 and T-5) supported yellow star thistle. Two of the six transects supported purple star thistle (T-2 and T-3).
