**Pacheco Creek Restoration Project
Year 2 (2025) Annual Monitoring Report**

Project No. 4291-04

December 10, 2025

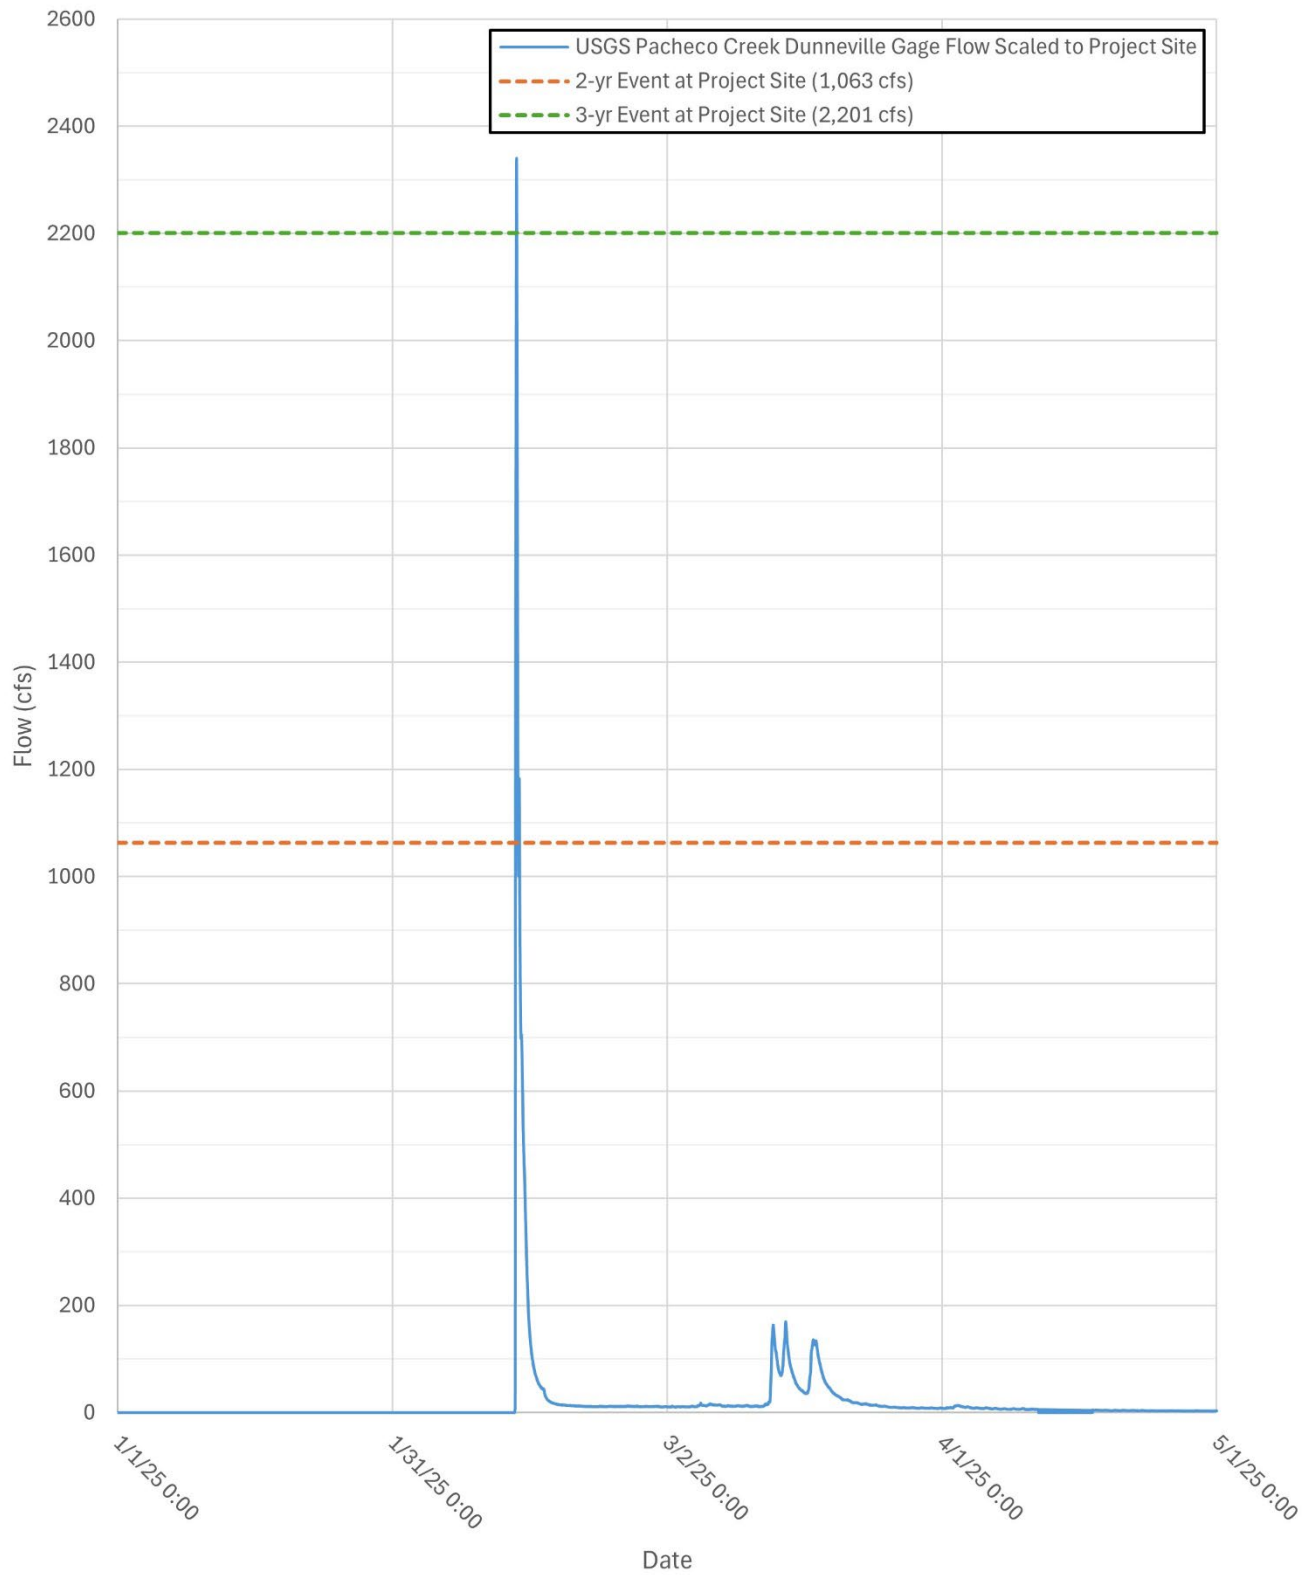
Figure 3

In Year 2, a comparison of the calculated inundation thresholds at the USGS Dunneville gage scaled to the project site indicates that half of the secondary channels experienced less than one day of inundation from one individual flood event, which was slightly larger than a 3-year event (Table 5) (Appendix A, Figure 3).

Figures 2 and 3 show the discharge data observed during the Year 1 (2023-24) and Year 2 (2024-25) winter flow seasons at the USGS Dunneville gage scaled to the project site. Comparing the calculated inundation thresholds to the scaled hydrograph indicates that each of the secondary channels experienced less than one day of inundation from only one individual runoff event (Table 1).

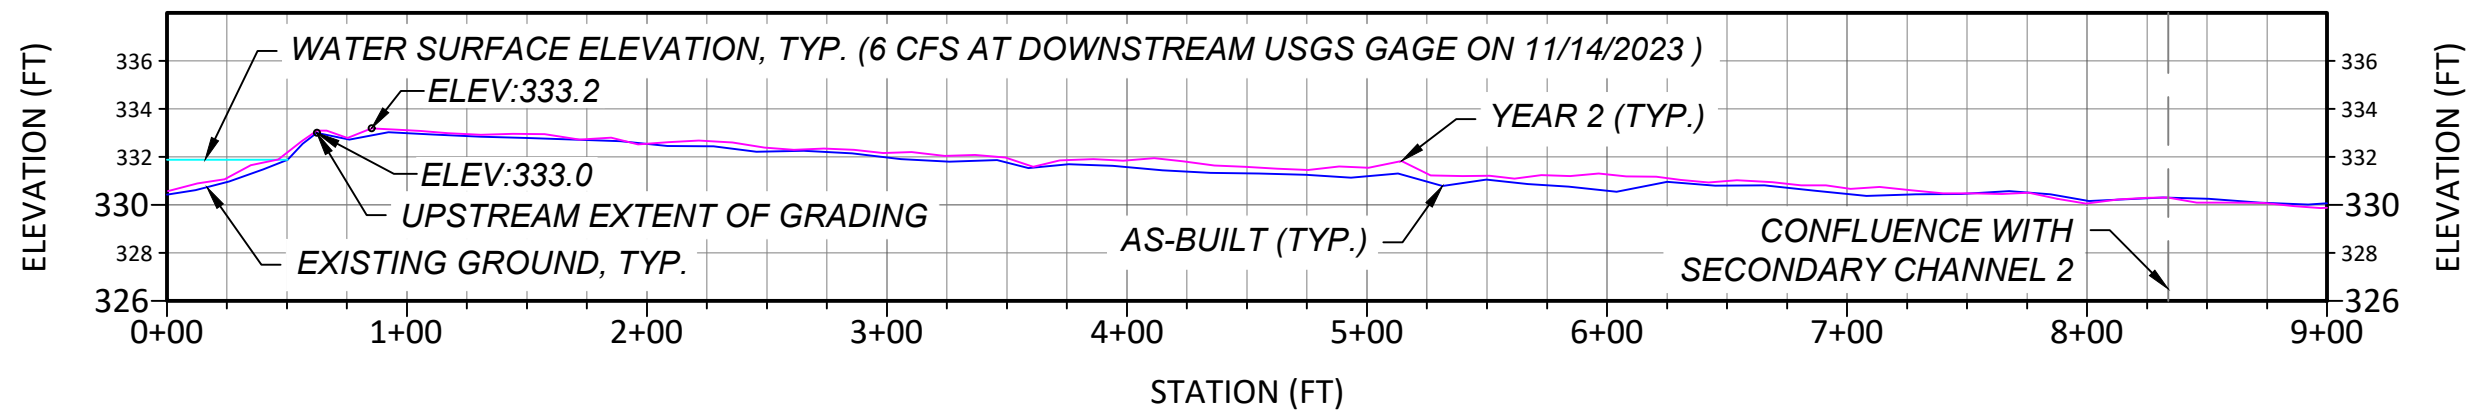
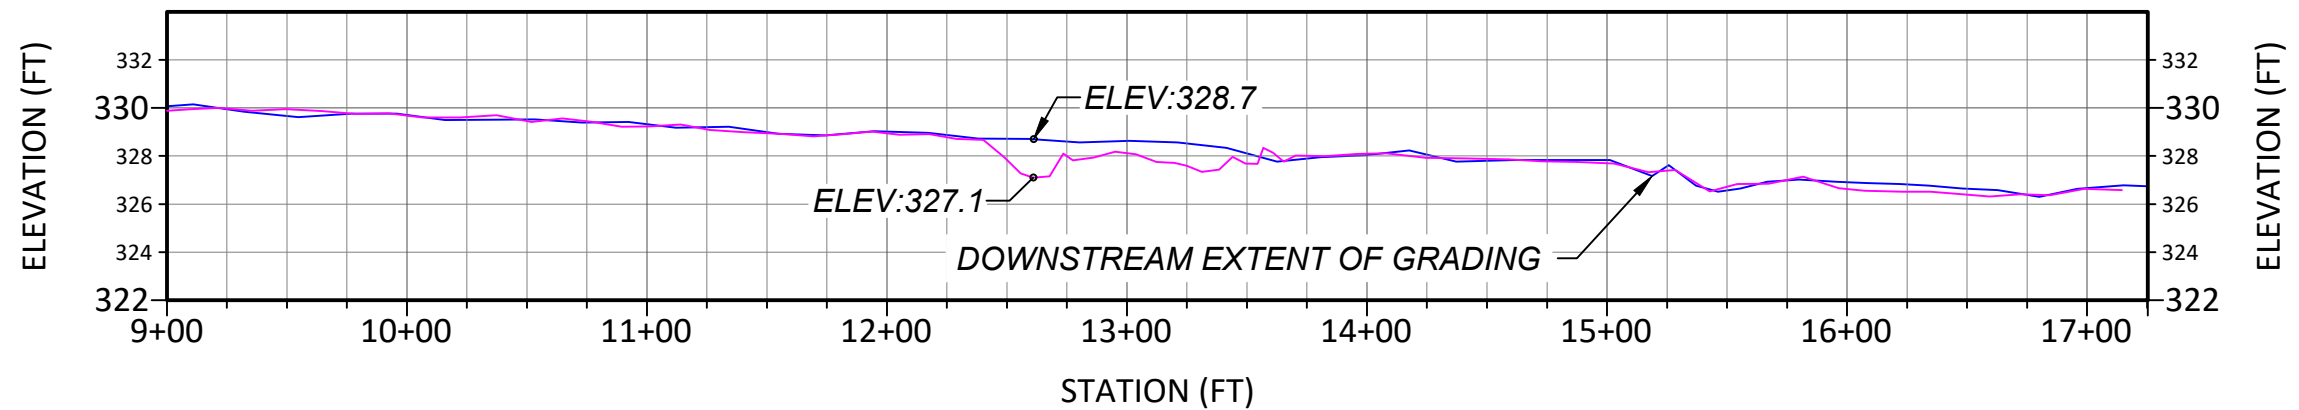
SECONDARY CHANNEL 1 PROFILE (STA 0+00 to 9+00)

The controlling thalweg elevation of secondary channel 1 increased in elevation by approximately 0.2 ft, while most of the surveyed profile remained mostly unchanged compared to the as-built condition except for an area of localized scour, located between station 12+40 and 13+60 (Figure 5). The change in the controlling thalweg elevations of secondary channels 2 and 3 between the as-built and year 2 conditions was negligible (Figure 6); however, secondary channel 3 shows signs of fine sediment deposition beginning at the downstream extent of the erosion control fabric (station 2+00) and extending down to the end of the surveyed profile. The secondary channel 4 inlet, adjacent to the previously mentioned fluvially dynamic reach of Pacheco Creek main channel, experienced an approximate 0.2 ft increase in the controlling thalweg elevation while the rest of year 2 surveyed profile varied minimally compared to the as-built condition (Figure 6). The cross-sections corresponding with secondary channels 1, 2, 3, and 4 are provided in Figures 9 through 11.

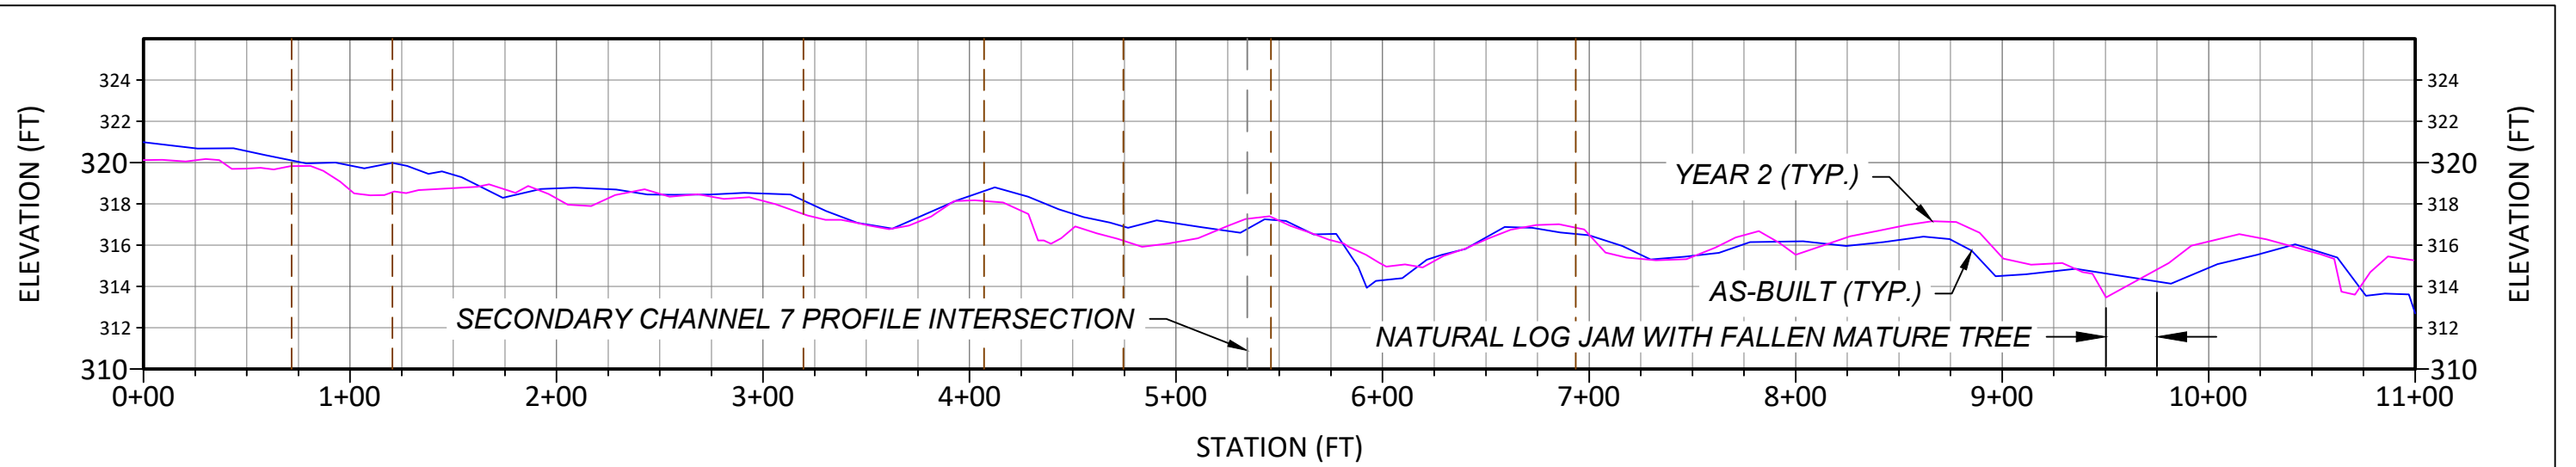
PACHECO CREEK DOWNSTREAM PROFILE
 SCALE: H1" = 80', V1" = 8'

The downstream reach of the main channel of Pacheco Creek (Figure 7) exhibited several notable instances of fluvial dynamism in the vicinity of stations 1+00, 2+15, 3+15, 4+40, 4+90, and 6+00, all of which are collocated with PALS installations that structurally failed. Despite the fluvial dynamism that occurred since the as-built condition throughout this reach, the hydraulic controlling thalweg elevations adjacent and downstream of the secondary channel 7 inlet at station 5+50 and 6+75 remained mostly unchanged. Downstream of the PALS installations, topographic change has occurred immediately upstream and downstream of a natural log jam bolstered with a fallen mature tree spanning between station 9+50 and 9+75. Pacheco Creek cross-section 4 is located at approximately station 4+30.

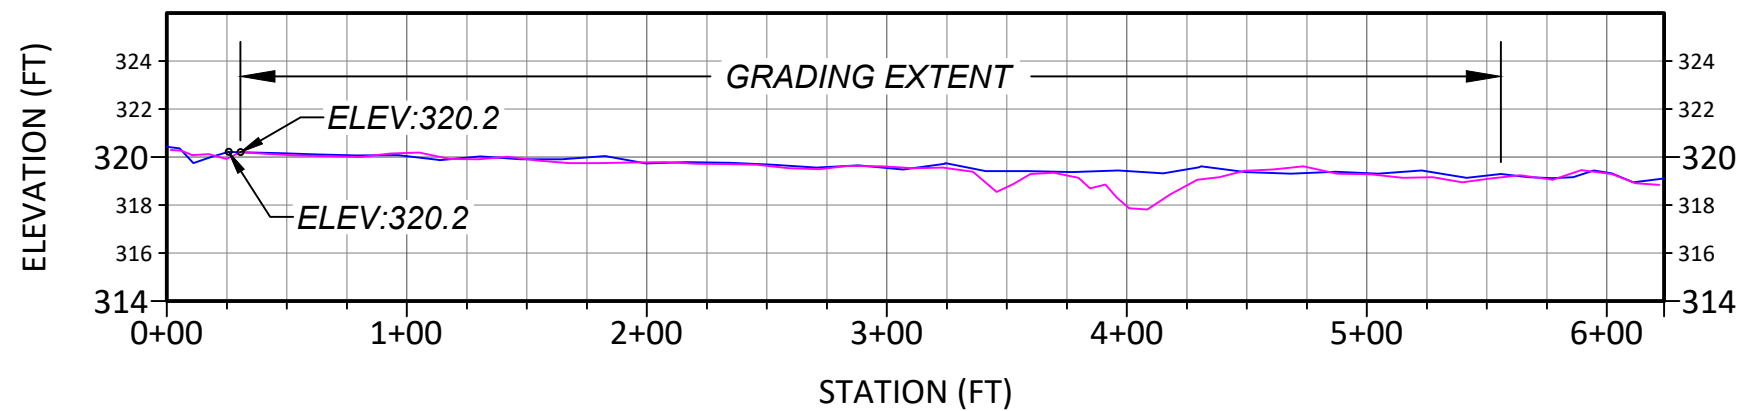
SECONDARY CHANNEL 6 PROFILE
 SCALE: H1" = 80', V1" = 8'

The inlets of secondary channels 6 and 7 maintained steady invert elevations compared to the as-built condition and experienced pockets of erosion further downstream (Figure 7). The erosion present along

secondary channel 6 spanned stations 3+35 and 4+50 along the toe of the left bank. The erosion present along secondary channel 7 occurs immediately downstream of the installed erosion control fabric and spans between stations 2+45 and 3+25 with a small mound of existing material at station 2+60. Secondary channel 8 has experienced little to no change compared to the as-built condition. The cross-sections associated with secondary channels 6 and 7 are provided in Figures 11 and 12, respectively.

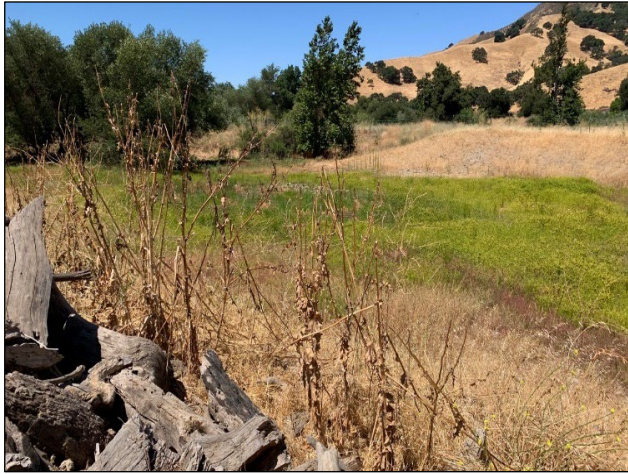
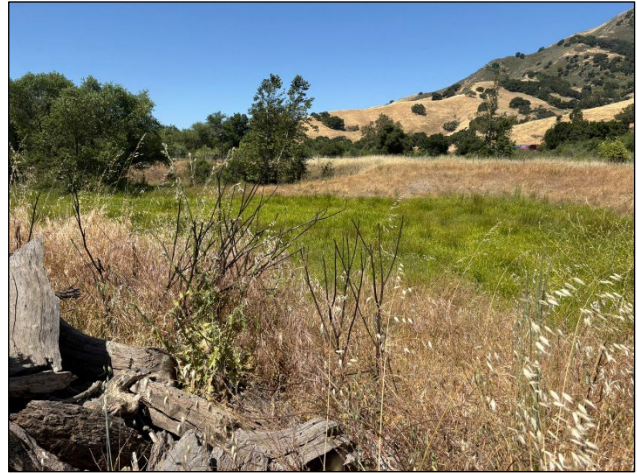
Photopoint 1. Showing Seasonal Wetland Looking Southwest in Year 1 monitoring on July 17, 2024 (Left) and in Year 2 monitoring on May 22, 2025 (Right)

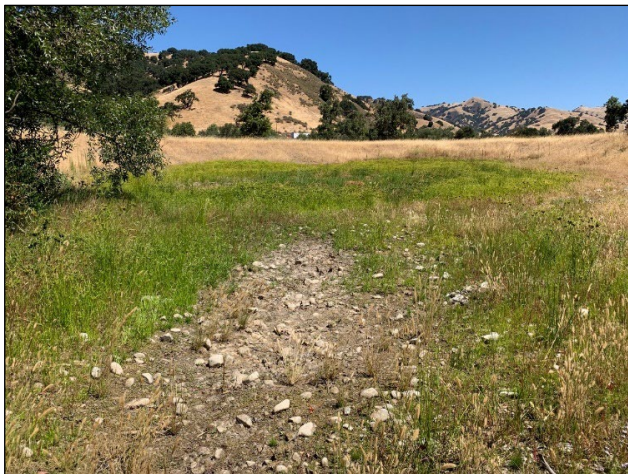
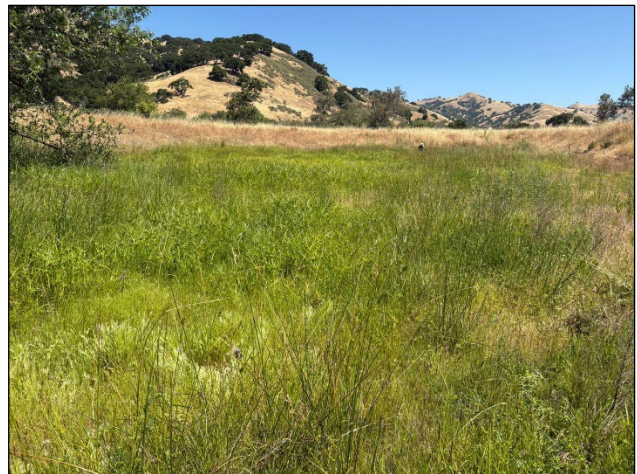
Photopoint 2. Showing Seasonal Wetland Looking North in Year 1 monitoring on July 17, 2024 (Left) and in Year 2 monitoring on May 22, 2025 (Right)

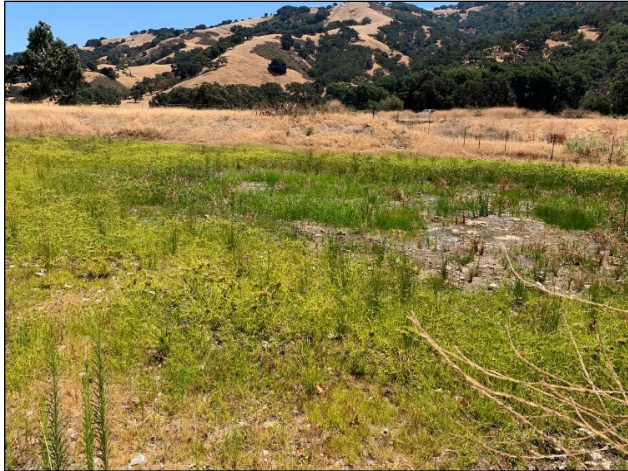
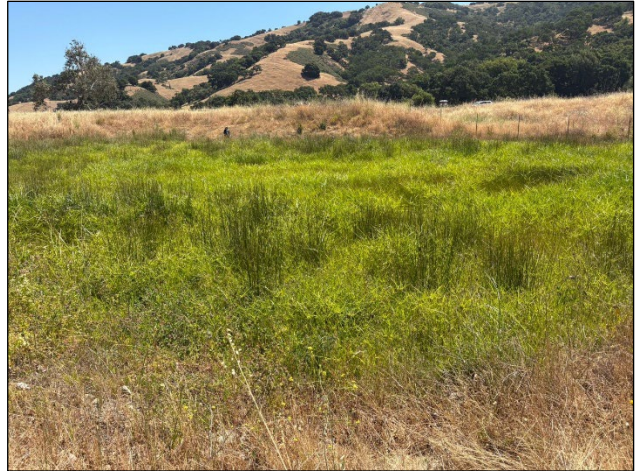
Photopoint 3. Showing Seasonal Wetland Looking Northeast in Year 1 monitoring on July 17, 2024 (Left) and in Year 2 monitoring on May 22, 2025 (Right)
