SANTA CLARA VALLEY
HABITAT AGENCY

PAJARO RIVER RIPARIAN HABITAT RESTORATION PROJECT

YEAR 1 (2025) ANNUAL MONITORING REPORT

December 5, 2025

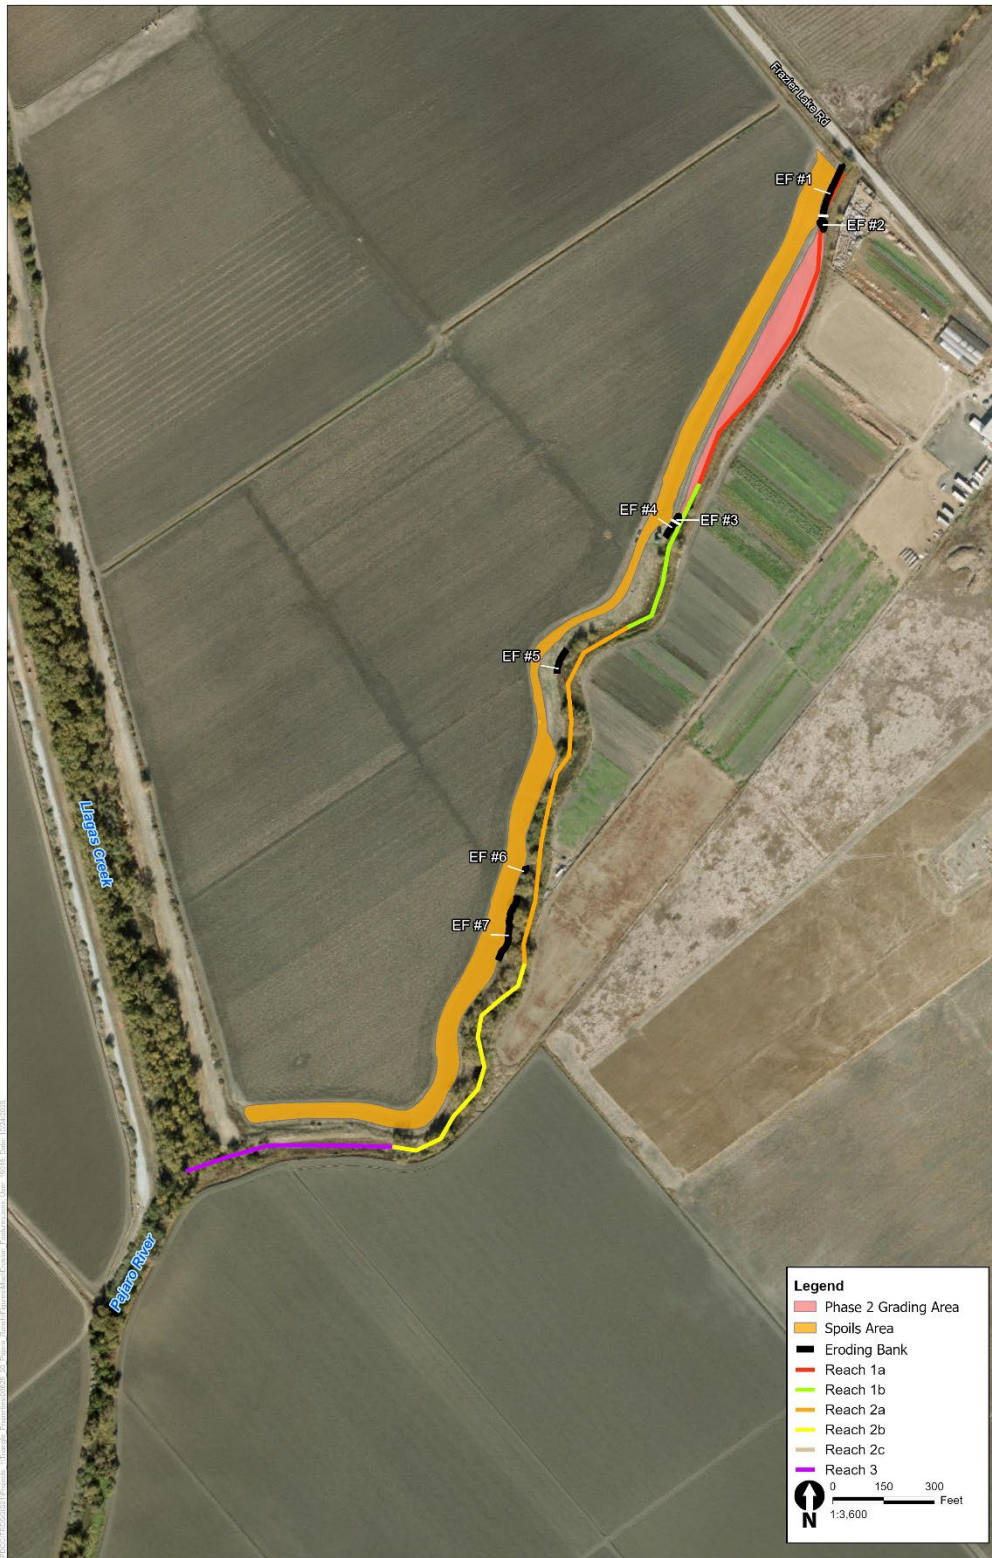
Figure 2
Pajaro River Erosion Feature Location

The relevant information collected for each erosion feature via the inventory is presented in Table 3; Figure 2 illustrates the location of each erosion feature. As shown in Table 3 and Figure 2, seven erosion features within the Project site were documented in 2025, six of which were classified as potentially unstable bank segments and one which was classified as an unstable bank segment.
