ANNUAL RESTORATION MONITORING REPORT

YEAR 7

SAN FELIPE CREEK RESTORATION PROJECT
SANTA CLARA VALLEY HABITAT AGENCY

DECEMBER 15, 2025

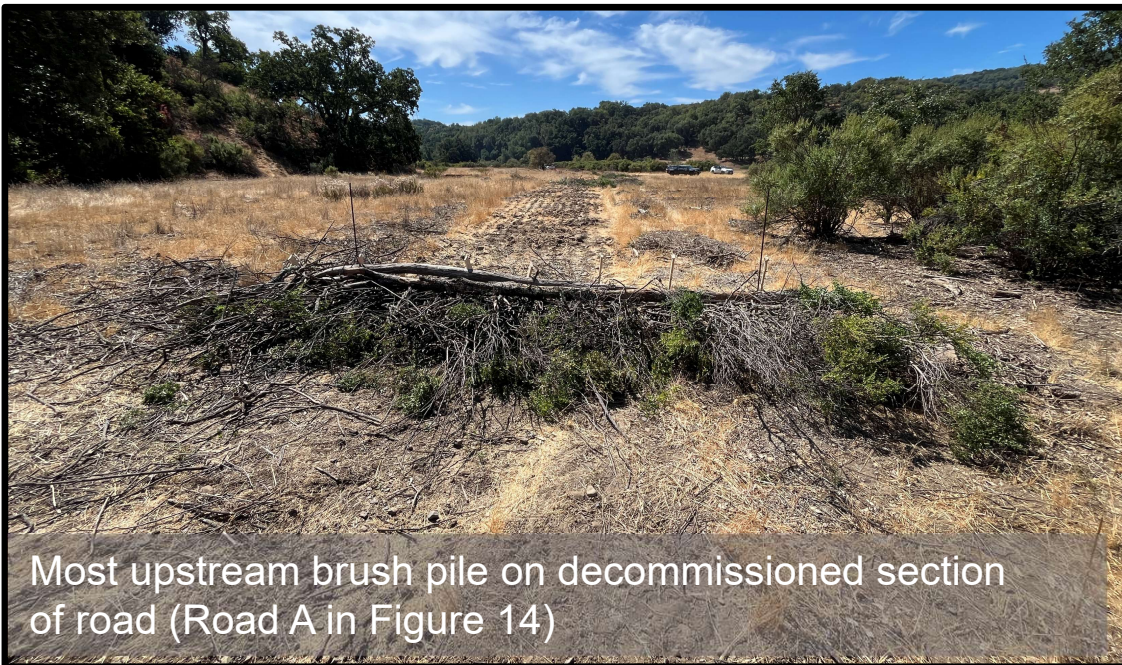
Most upstream brush pile on decommissioned section of road (Road A in Figure 14)
