North Coyote Valley Road Ecology Study 2021-2022

Prepared by Tanya Diamond & Ahíga Sandoval
Pathways for Wildlife

For Peninsula Open Space Trust (POST),
Santa Clara Valley Habitat Agency
and the California Department of Fish and Wildlife

March 2023

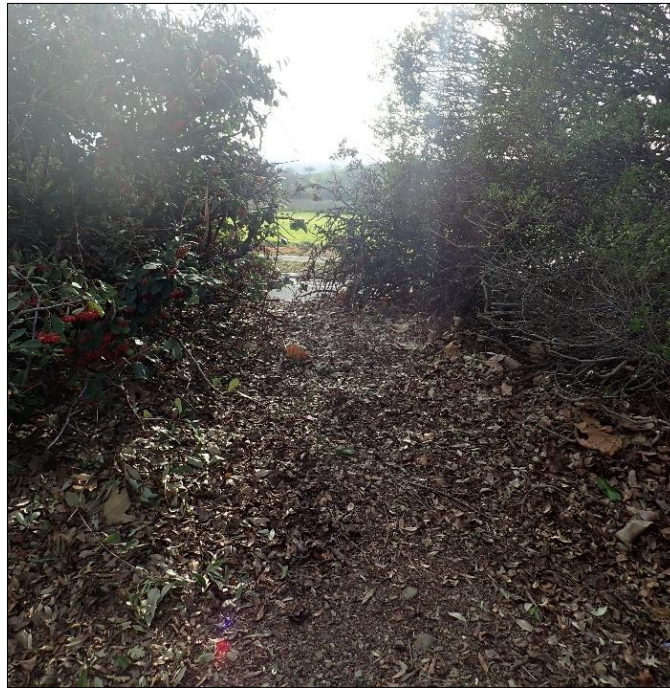
Figure 4. Vegetation break and potential thoroughfare route within the Santa Teresa Blvd. median.

where wildlife might attempt to cross Santa Teresa Blvd. at road grade. While investigating one of the breaks in the vegetation, we identified several deer tracks indicative of deer movement across Santa Teresa Blvd. (Figures 4 & 5).

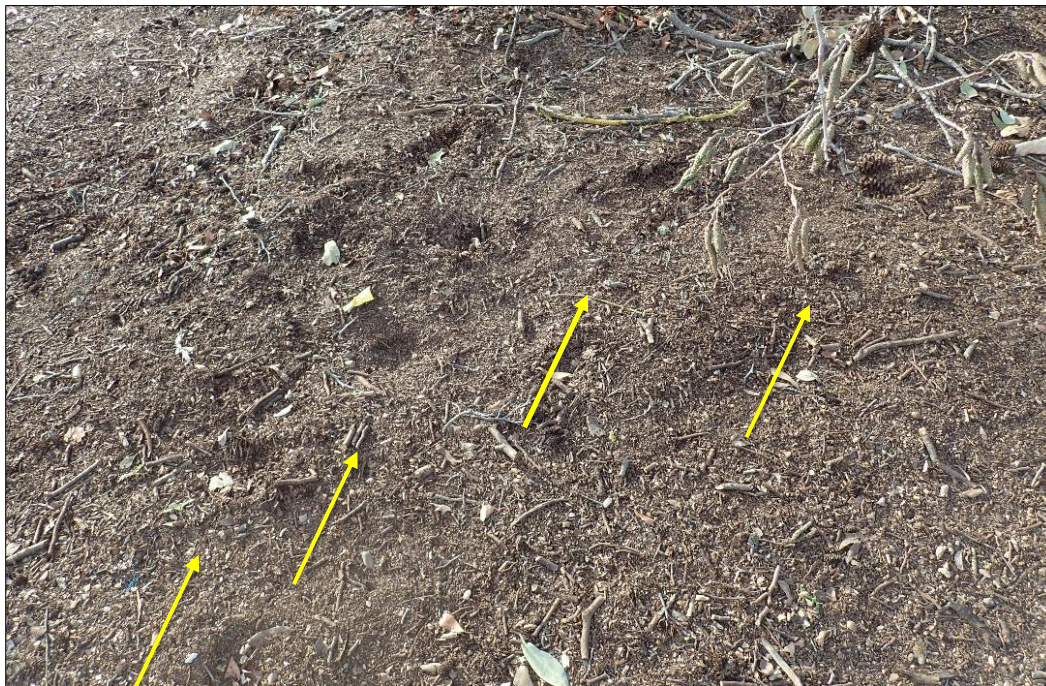
Figure 5. Deer tracks recorded at a break in the vegetation within the Santa Teresa Blvd. median.

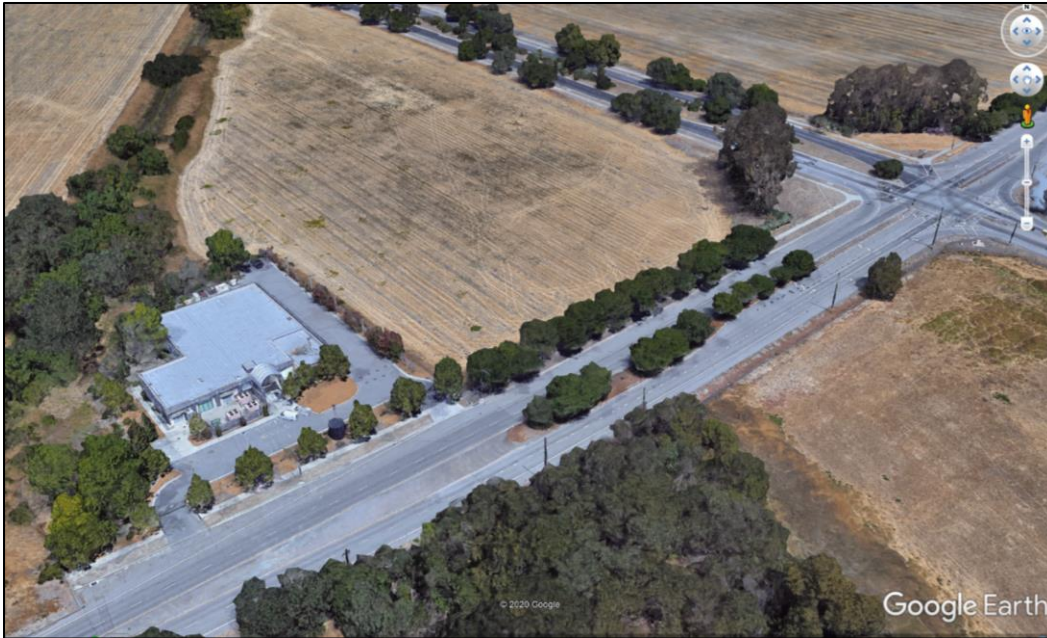
Figure 7. Bailey Ave.'s vegetated median by the intersection with Santa Teresa Blvd.

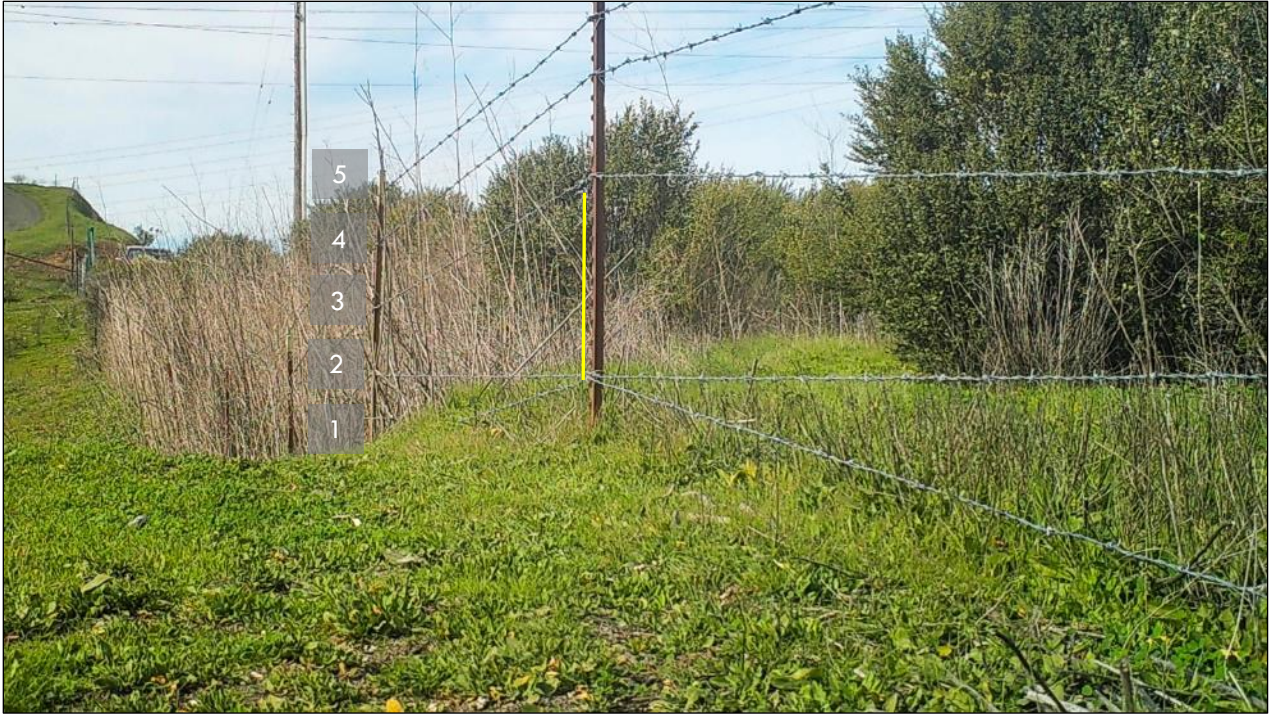
Figure 8. Five-strand barbed wire with a gap between the second and third strand from bottom.

Additionally, when we walked the entire length of fencing during the scouting phase, we documented areas with inconsistencies in the fencing structure. For example, we found areas with loose or missing strands of barbed wire, gaps, and openings in the fence line (Figures 8-10). Upon closer inspection of the areas around these openings, we also recorded hair caught on barbs, digs, and wildlife tracks leading to and from the property to Santa Teresa Blvd. and vice versa. Therefore, to gather a more comprehensive data set of how wildlife was navigating their way through the openings in the fence line, we set up camera stations at these areas as well. Figure 11 is a map showing the location and extent of fencing. We report on data from four fence line cameras and five gate cameras.

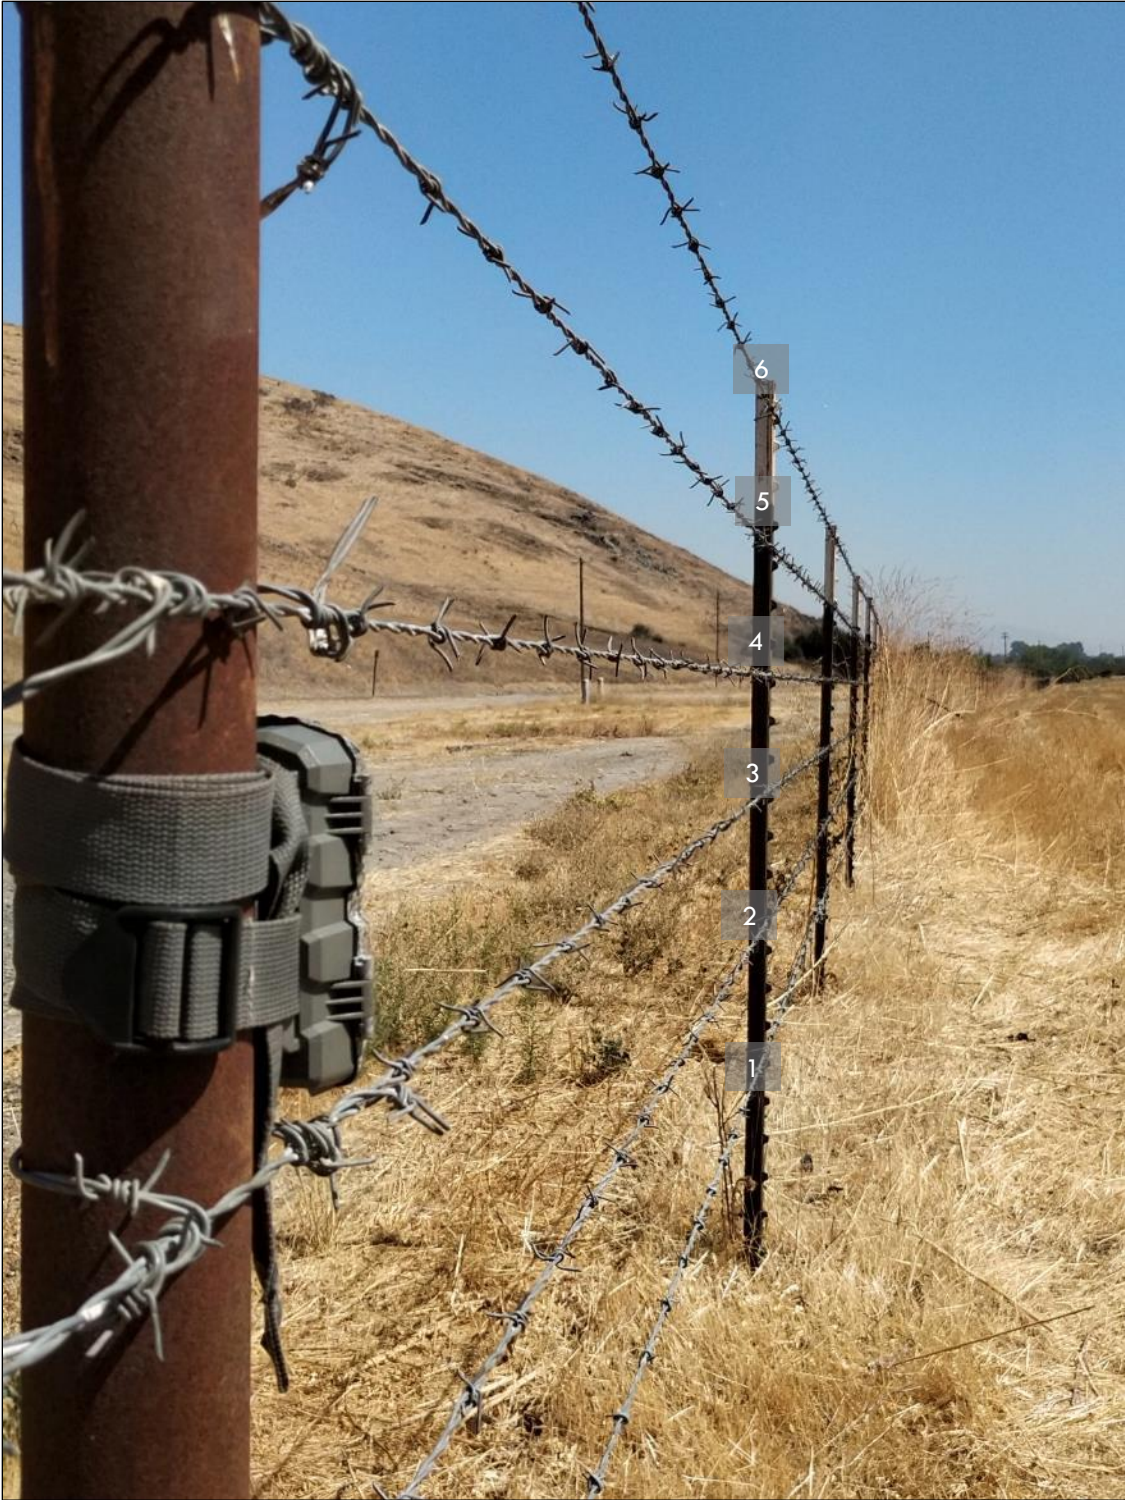
Figure 9. Six-strand barbed wire, fencing along the west side of Laguna Seca at Santa Teresa Blvd.

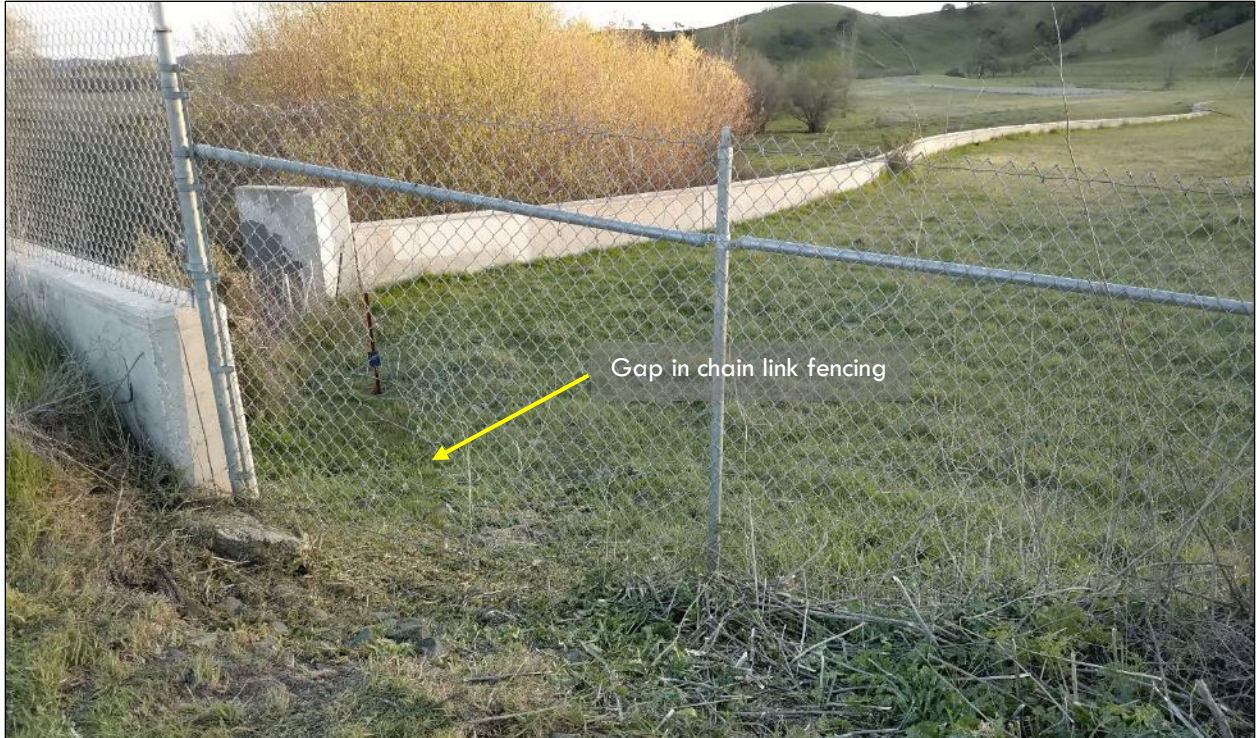
Figure 10. Gap in chain link fence near Fisher Creek Culvert.

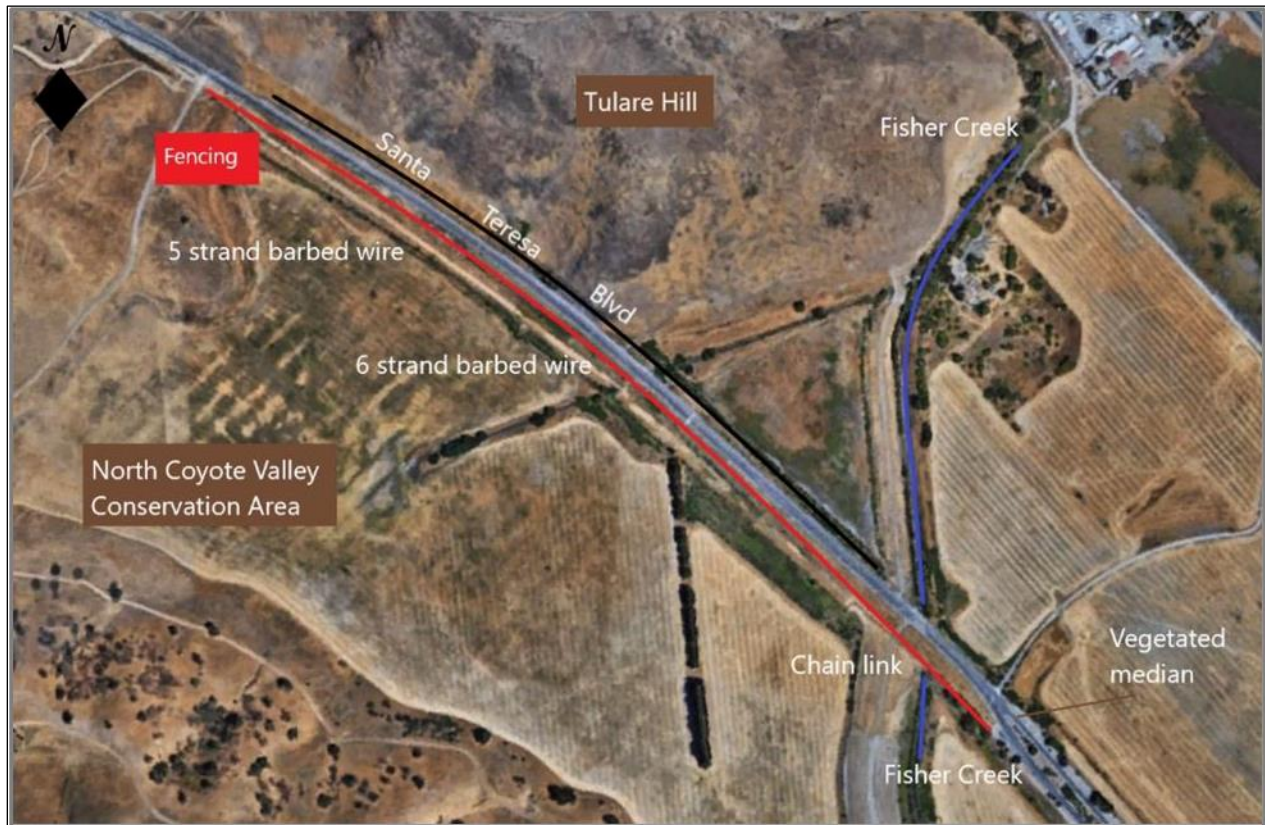
Figure 11. Map showing location and extent of fencing.

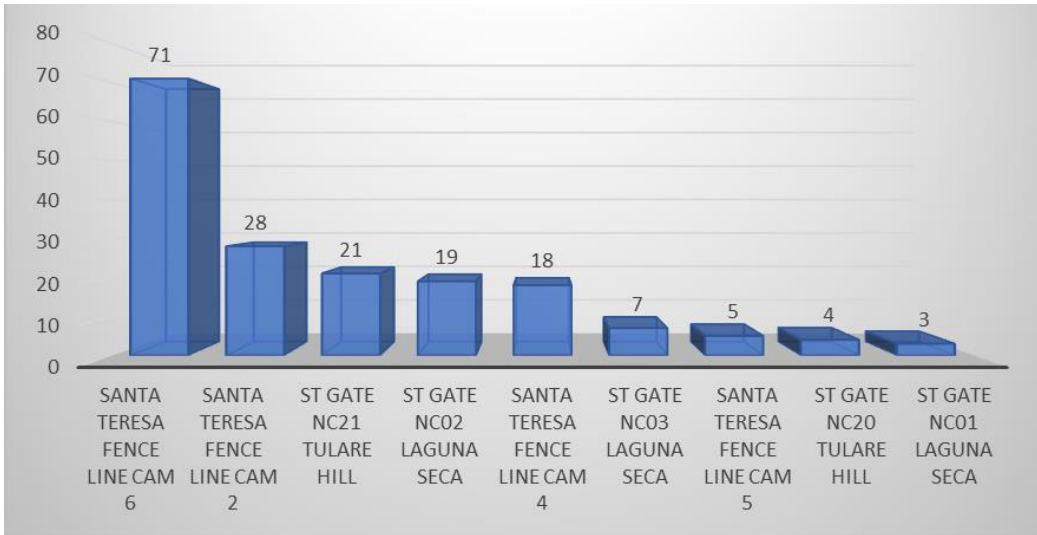
Figure 16. Standardized fence line and gate passages.

Of the culverts and bridge monitored, the Bailey Ave. culvert camera had the highest standardized passage rate (65), which made up 89% of the overall detections recorded at all three culverts and the Bailey Bridge (Figure 15). The other culverts and the bridge recorded very low rates of wildlife passages, suggesting they are not currently effective at moving wildlife safely beneath Bailey Ave and Santa Teresa Blvd. Of the fence line and gate camera sites, the Santa Teresa Fence Line Site 6 had the highest standardized passage rate (71), which made up 40% of the overall detections recorded for these sites (Figure 16).

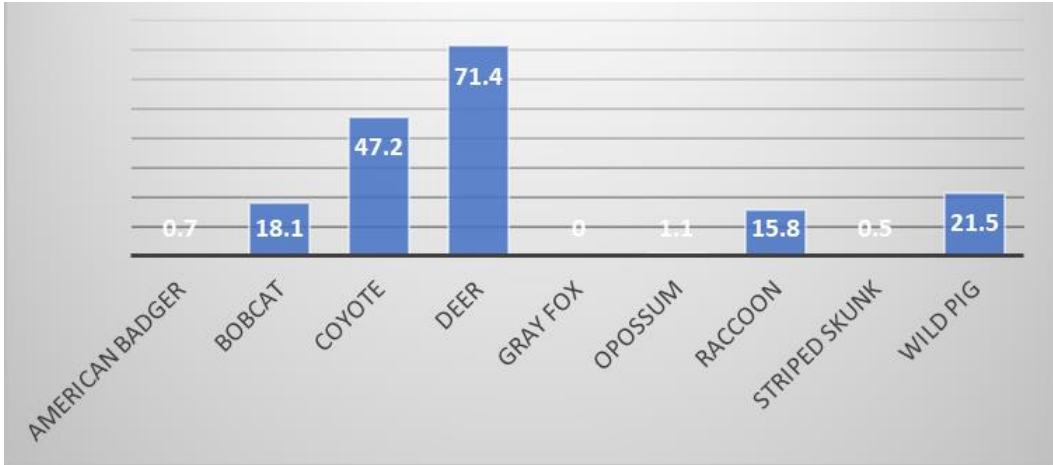
Figure 19. Standardized species passages at combined fence & gate sites along Santa Teresa Blvd.

The standardized passages and at-grade detections for species at at-grade cameras, fence and gate cameras, culverts and bridge cameras are displayed in Figures 19-21. The species with the highest standardized passages at the combined fence and gate sites were deer (71.4) and coyote (47.2) (Figure 19). The species with the highest standardized passages at the combined culverts and bridge was raccoon (66.1), with few passages by other species (Figure 20). The species with the highest standardized detections at the combined at-grade cameras along Santa Teresa Blvd and Bailey Ave were coyote (637.0), wild pig (153.5), and raccoon (58.5), with few detections of other species (Figure 21).

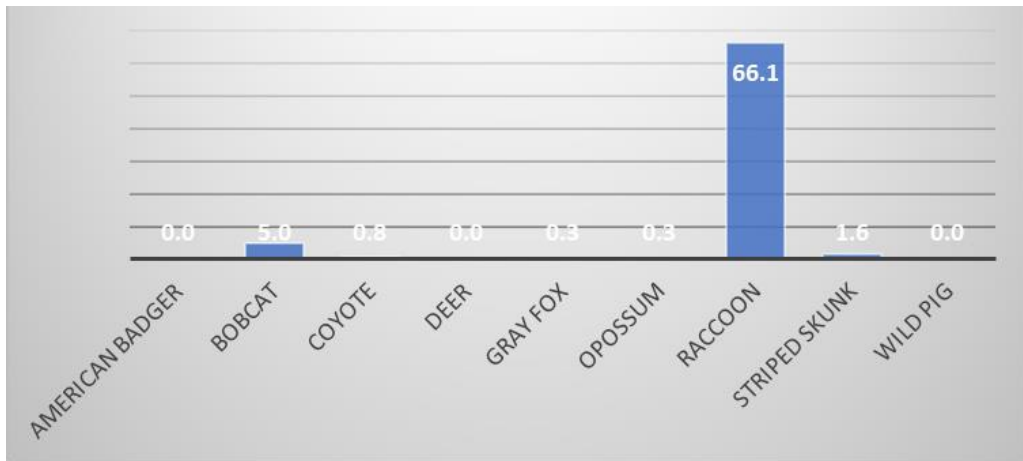
Figure 20. Standardized species passages at combined culvert and bridge sites.

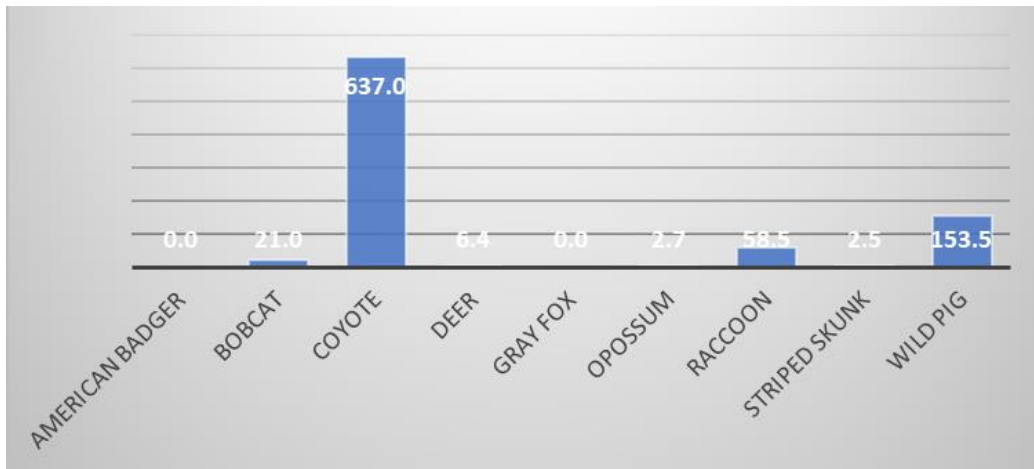
Figure 21. Standardized species at-grade detections at combined at-grade sites along Bailey Ave and Santa Teresa Blvd.

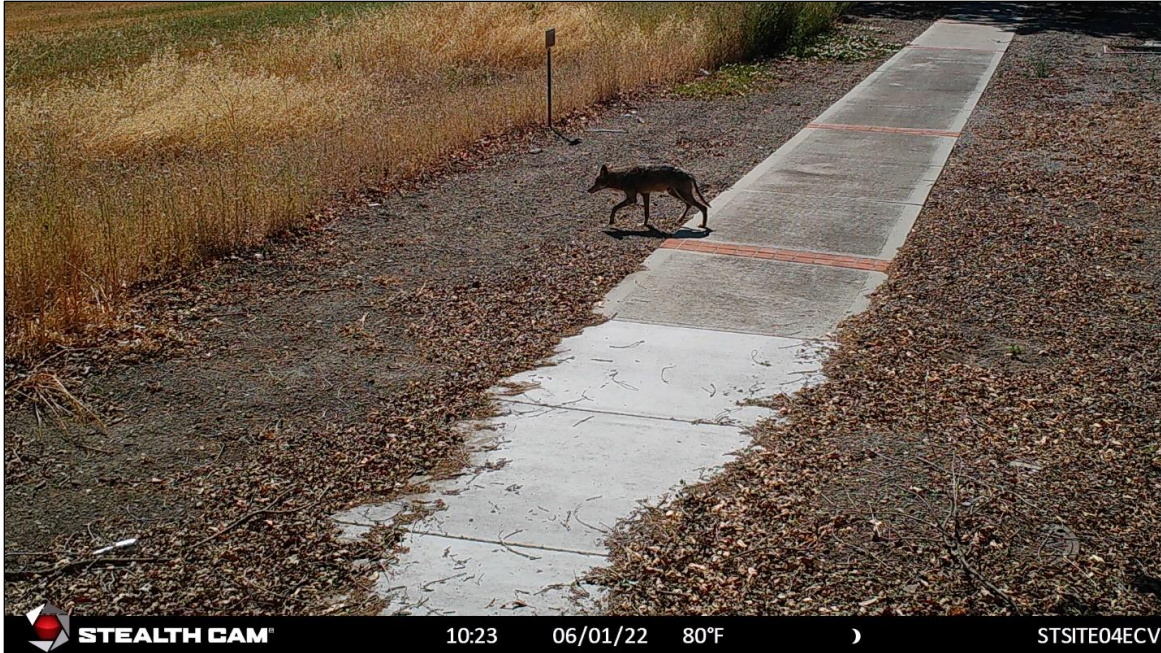
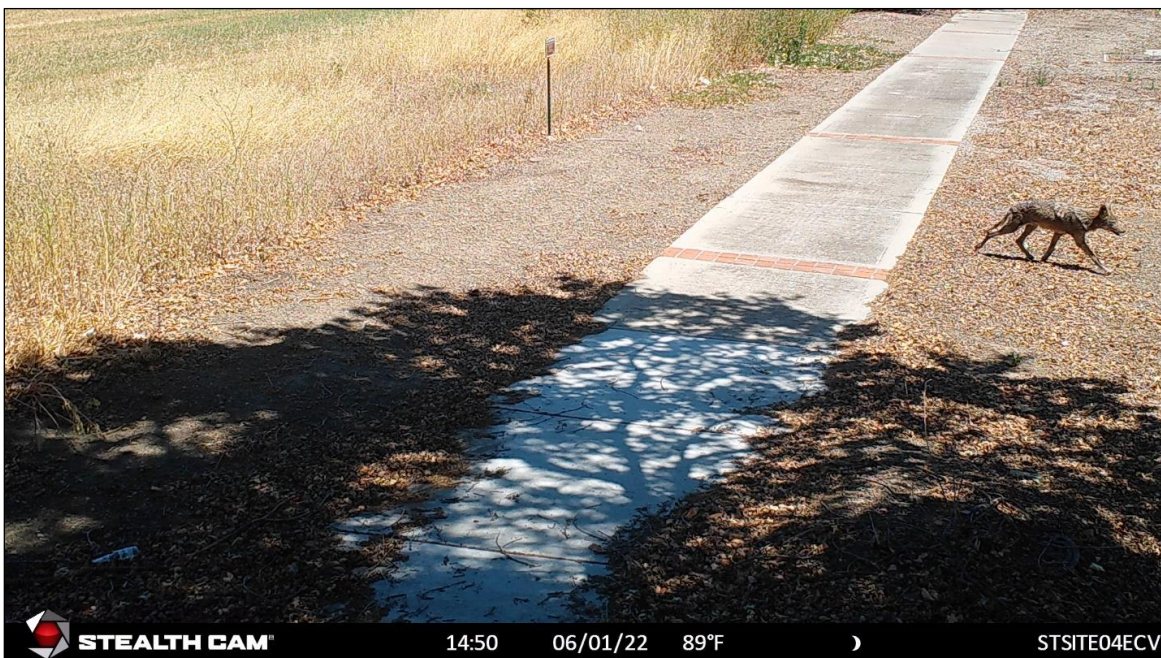
Figure 22. Santa Teresa Blvd. Site 4 E, coyote heading east into the Tulare Meadows property on 6/1/2022 at 10:23 am.

Figure 23. Santa Teresa Blvd. Site 4 E, coyote heading west out of the Tulare Meadows property on 6/1/2022 at 2:50 pm.

We did record images of animals that suggested successful passage across Santa Teresa Blvd. For example, Santa Teresa At-Grade Site 4 East recorded a coyote traveling east and west at the Tulare Meadows on the same day, 6/1/2022 (Figures 22-23). The coyote looks like it is the same individual in both pictures because of the thin tail.

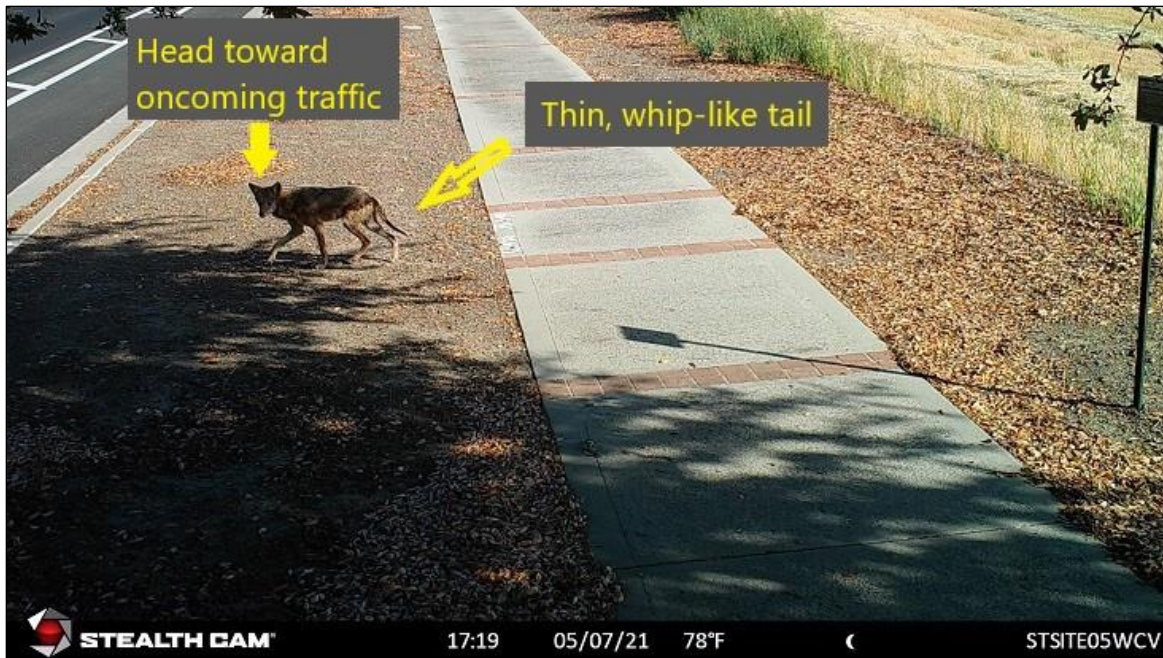
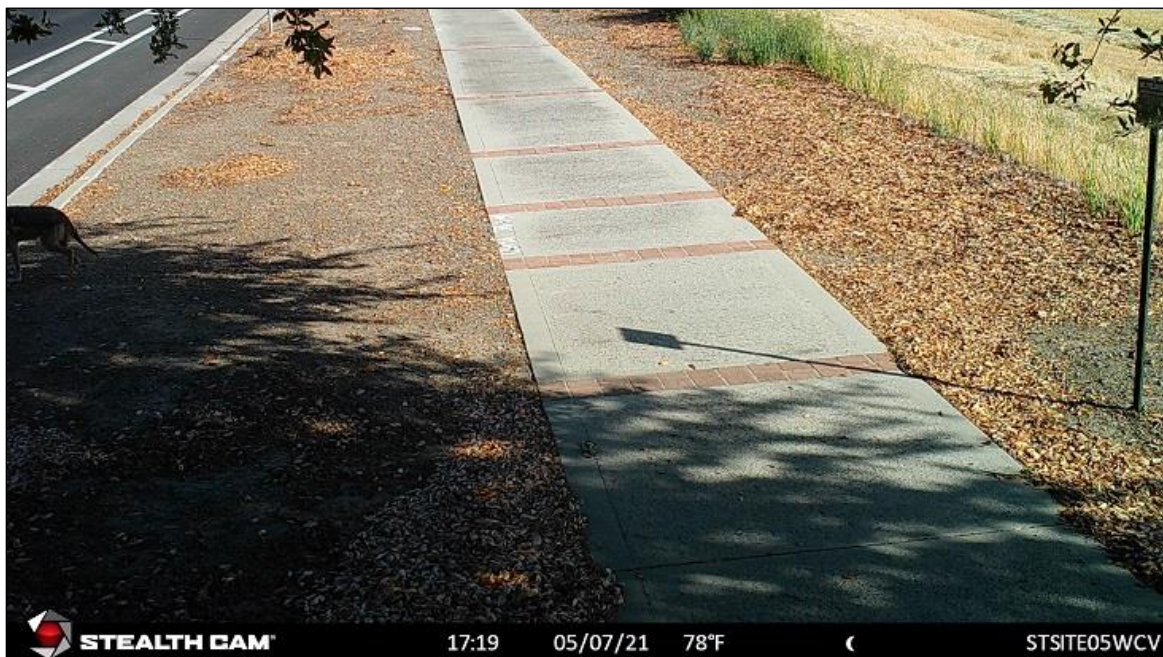
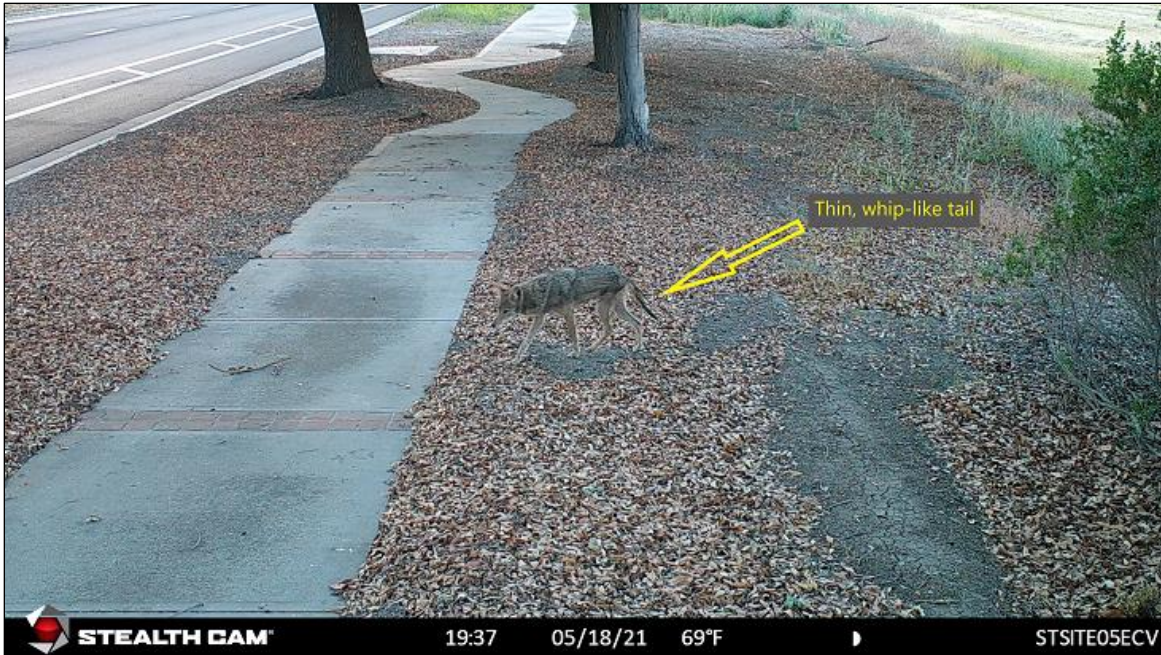
Figure 24. Coyote crossing at Santa Teresa Blvd. on 5/7/21 at Site 5 west.

Figure 25. Coyote crossing at Santa Teresa Blvd. on 5/7/21 at Site 5 west.

Figure 26. Coyote crossing at Santa Teresa Blvd. on 5/18/21 at Site 5 east.

This same coyote was also recorded on the other side of Santa Teresa Blvd approximately one year prior, suggesting it had successfully crossed the road before. The coyote was recorded heading east towards oncoming traffic to cross the road at Santa Teresa At-Grade Site 5 West on 5/7/2021 (Figures 24-25). It was then recorded on the opposite side of the road on 5/18/2021 at Santa Teresa At-Grade Site 5 East (Figure 26). Though camera traps didn't pick up this coyote on both sides of the road on the same day, this

sequence of photos across time and camera stations suggested that this coyote has successfully crossed Santa Teresa Blvd.

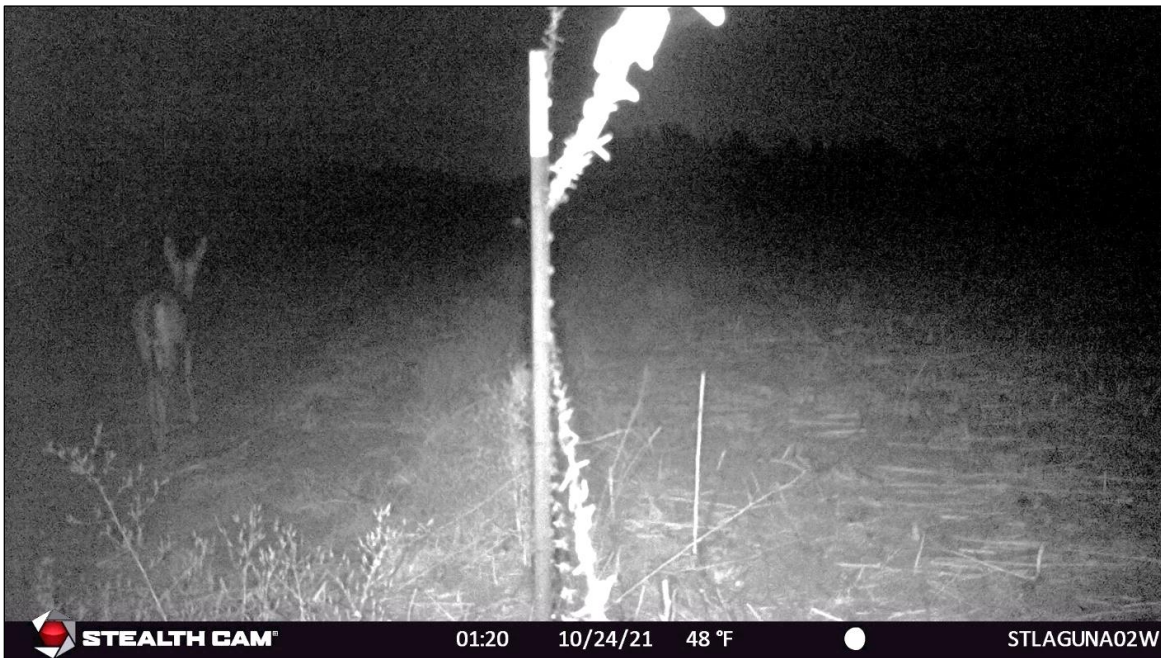
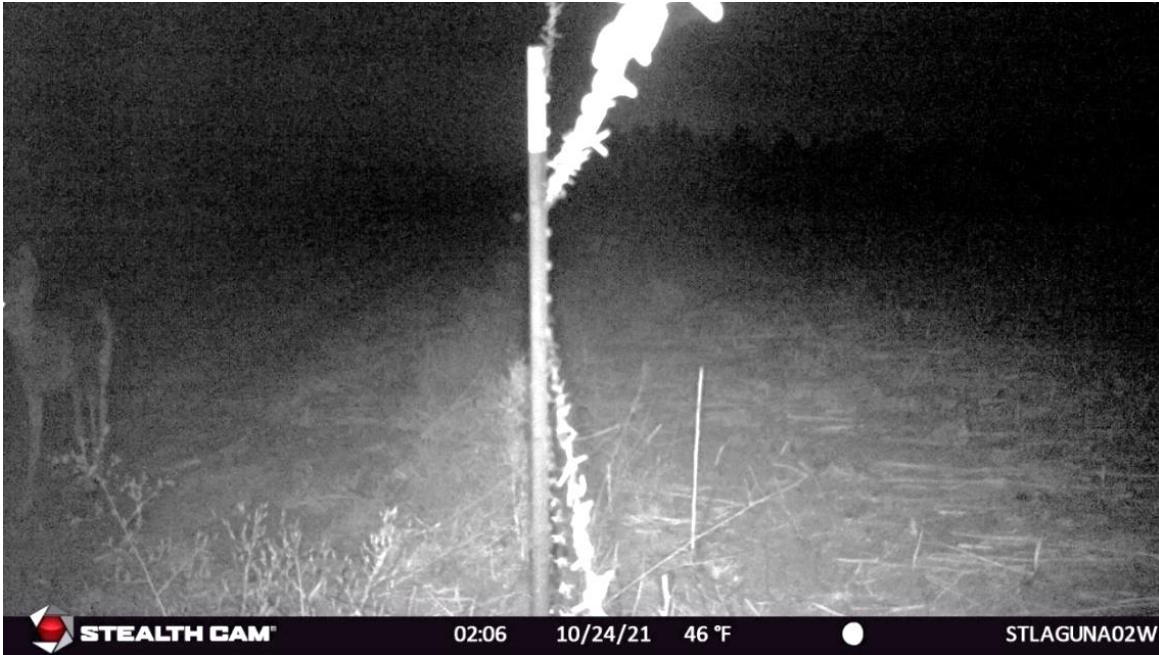
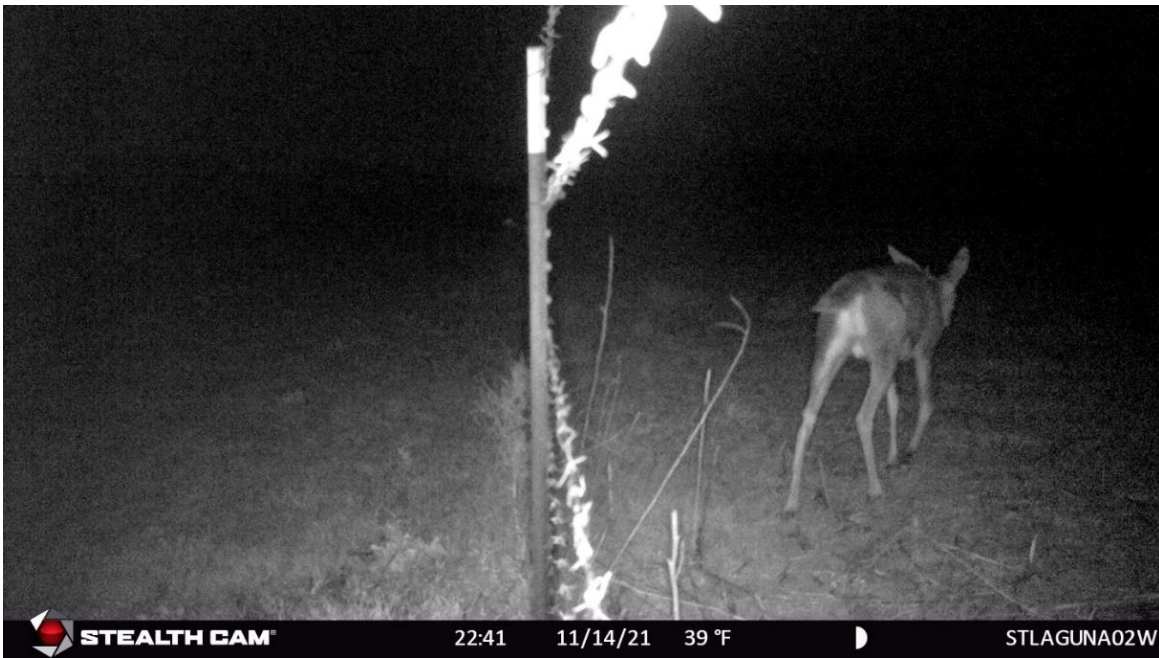
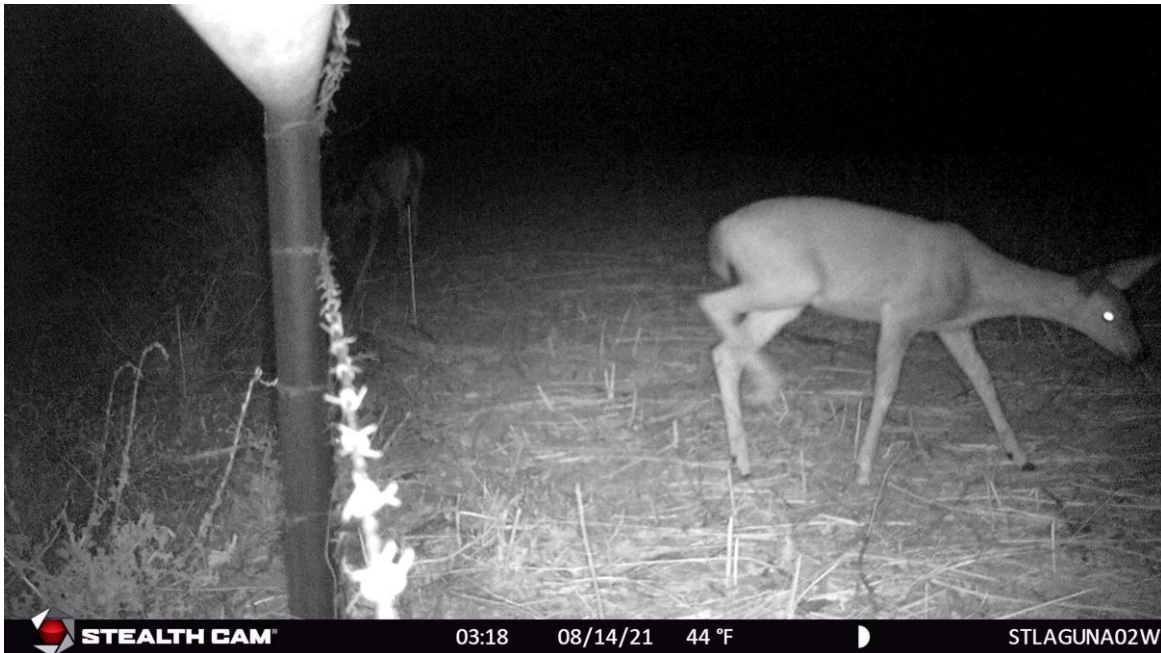
Figure 27. Deer walking south Santa Teresa Blvd. along the Santa Teresa Blvd. fence line, Site 2 on 10/24/2021 at 1:20 am.

Figure 28. Deer walking north Santa Teresa Blvd. along the Santa Teresa Blvd. fence line, Site 2 on 10/24/2021 at 2:06 am.

Figure 29. Deer walking within Laguna Seca along the fence line.

Figure 30. Two deer at Santa Teresa Blvd., walking alongside the Laguna Seca fence line on 8/14/2021.

We recorded multiple instances of individual deer walking along Santa Teresa Blvd. adjacent to the Laguna Seca fence line (Figures 27-28). The deer were walking both north and south along the fence line, with northbound being towards oncoming traffic. We also recorded individual deer walking within Laguna Seca along the fence line adjacent Santa Teresa Blvd. (Figures 29-30).

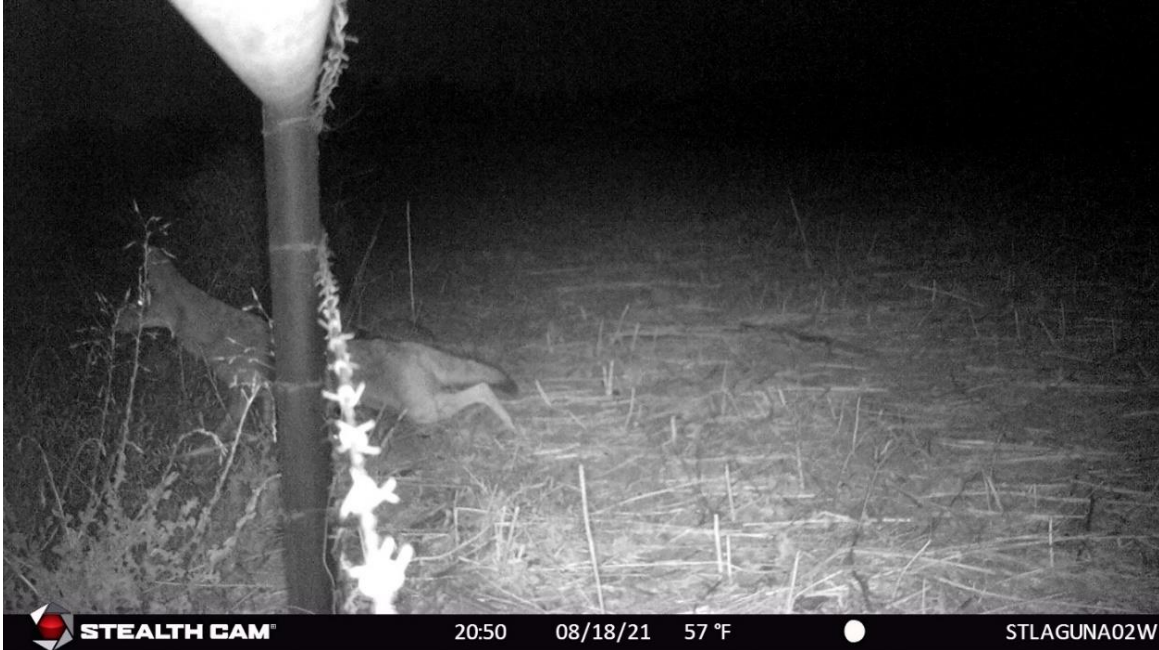
Figure 31. Coyote traveling from Santa Teresa Blvd. into Laguna Seca.

Figure 32. Coyote traveling from Santa Teresa Blvd. into Laguna Sec on 8/18/21 at 20:50.

We recorded a higher rate of passages through more permeable locations along the fence line, where there were raises in the fencing and the fencing was not so restrictive. We recorded both coyote and deer traveling through gaps in the fence line (Figures 31-32).

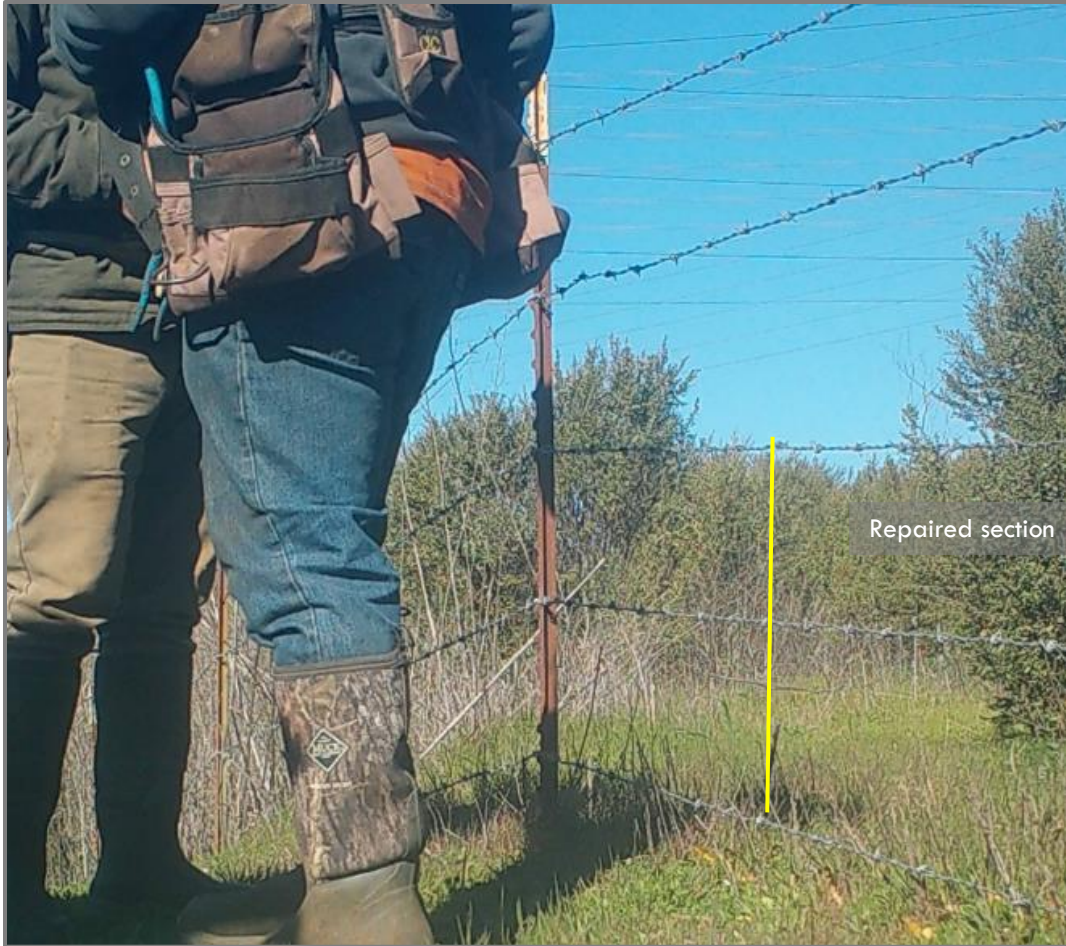
Figure 33. Two fence repair crewmembers fixing gap in five-strand barbed wire fence on 02/02/2022 at Santa Teresa Laguna Seca fence line camera site 2.

However, after nine months of data collection, in February 2022, a fence repair crew began fixing the sections of fencing which were in disrepair in order to keep cattle on the property and prevent them from accessing Santa Teresa Blvd.(Figure 33). In doing so, however, wildlife ceased to successfully cross through via the newly repaired sections. Instead, we recorded wildlife approaching the formerly open sections and then turning away (Figure 34).

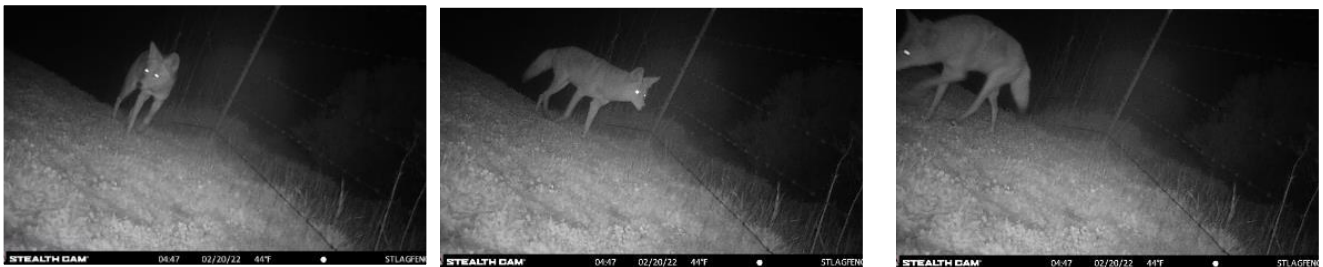
Figure 34. Sequence of captures showing coyote approaching fence, then turning away on 02/02/2022.

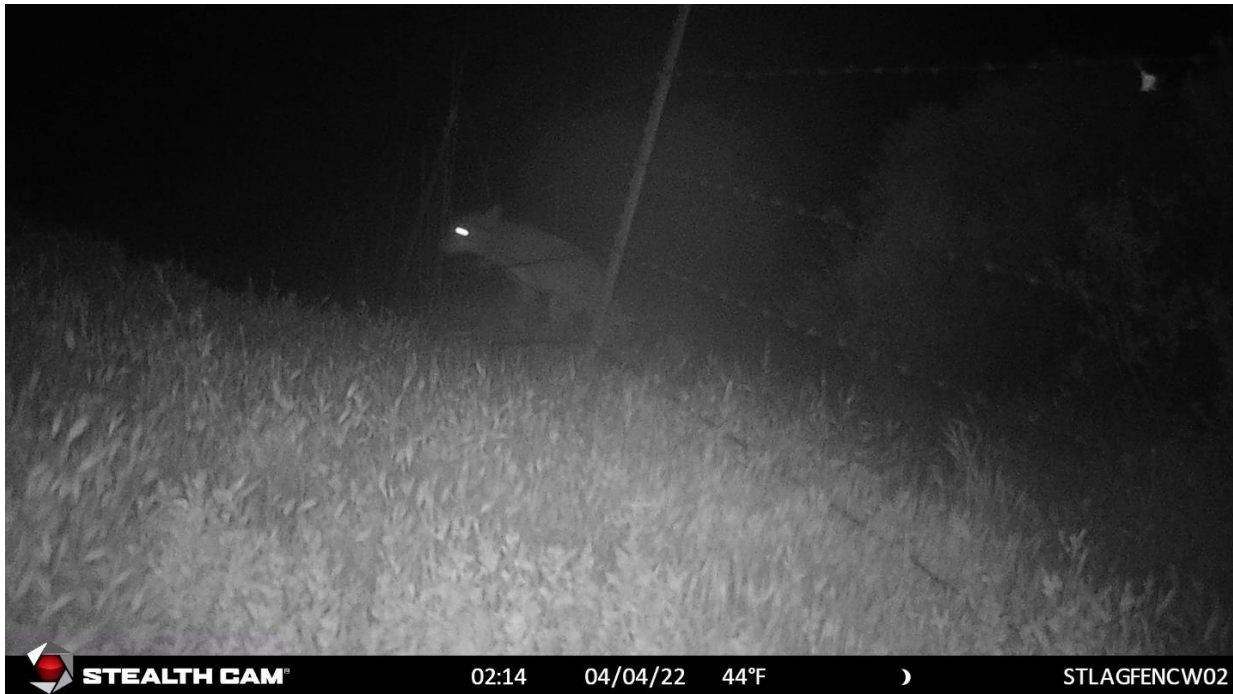
Figure 36. Coyote crossing through second and third strands of barbed wire at the Santa Teresa/Laguna fence line.

We documented similar behavior with coyotes. Coyotes will cross through, as pictured below, but on other occasions, they walk to the fence and do not cross through and instead walk along the roadside (Figure 38). Therefore, these data could be useful for future fence management as the gap between the separated strands of the five-strand barbed wire section was more permeable, allowing for deer movement through the fence line, compared to after the fence was modified to become more restrictive. After the study was concluded, the fencing was retrofitted by the grazing tenant at the end of May-early June 2022 to make it more wildlife-friendly. The bottom strand was removed and the new bottom strand was replaced with smooth wire at 18". The top strand was also replaced with smooth wire.

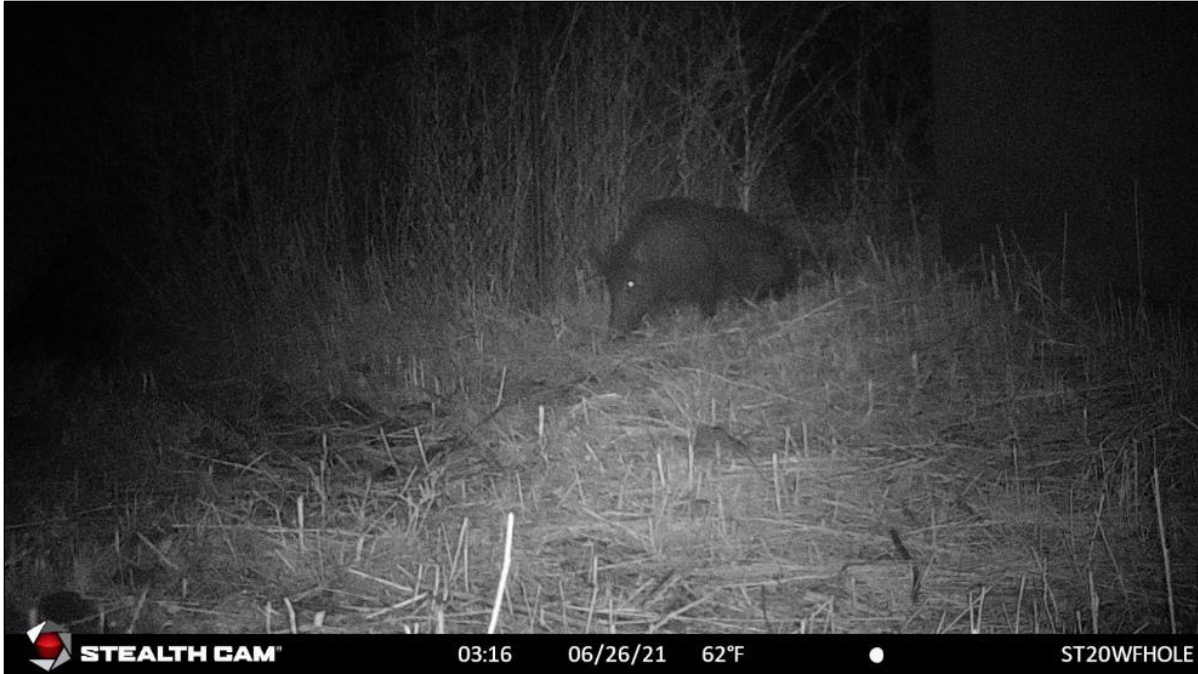
Figure 40. Wild pig crawling through gap at bottom of chain link fence near Fisher Creek.

There was a small 1 ft gap in the chain link fence on the north side of the Santa Teresa Blvd. Fisher Creek dual box culverts. This gap in the fence line had the highest number of crosses from a multitude of wildlife species even though it is one of the smallest openings in entire fence line (Figures 37-40).

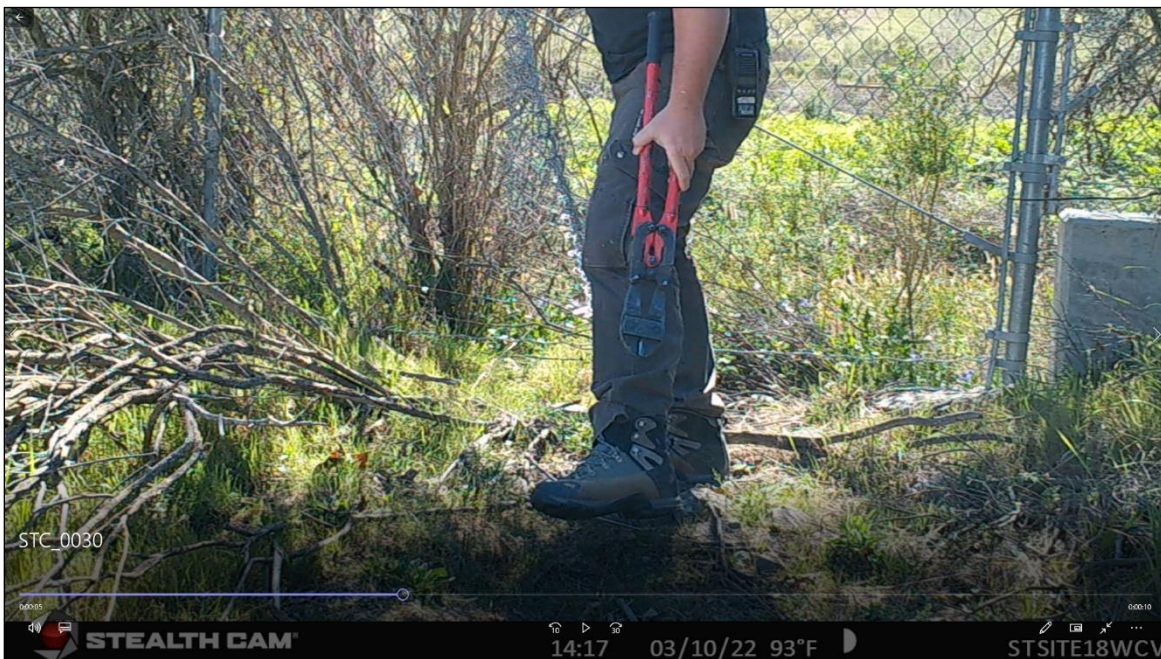
Figure 47. Santa Teresa Blvd. Site 18W, fence modification on 3/10/2022.

On 3/10/2022, an OSA technician increased the hole by cutting out a 3-ft high, 4-ft-wide section of fencing (Figure 47). This was an effective measure as we recorded a coyote and other species traveling through the hole in the fence (Figure 48). This was a great way to increase the permeability of the Santa Teresa fence line for wildlife movement between the newly protected properties.

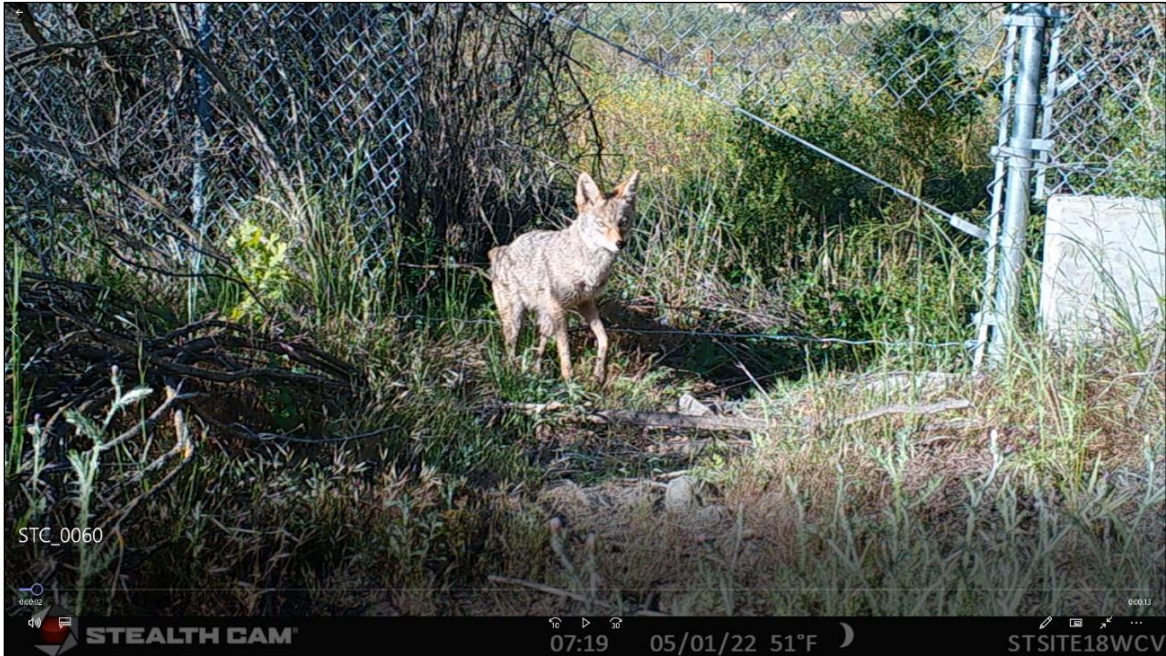
Figure 48. Santa Teresa Blvd. Site 18W, coyote, traveling through the fence modification on 5/1/2022.
