North Coyote Valley Road Ecology Study 2021-2022

Prepared by Tanya Diamond & Ahíga Sandoval
Pathways for Wildlife

For Peninsula Open Space Trust (POST),
Santa Clara Valley Habitat Agency
and the California Department of Fish and Wildlife

March 2023

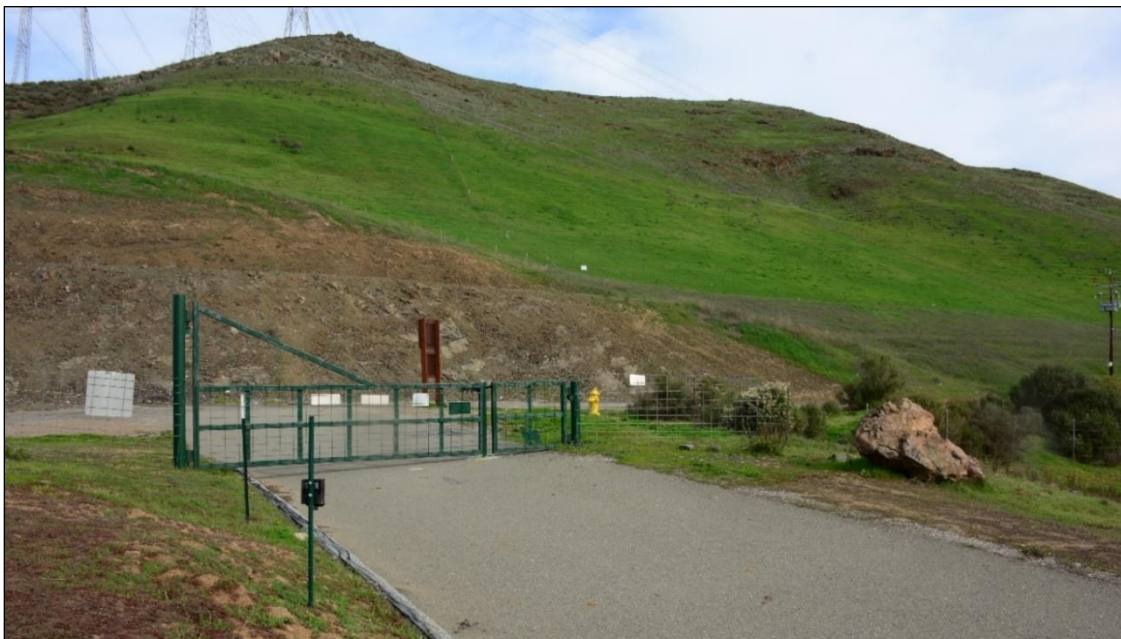
Figure 53. Gate NC01 at Laguna Seca across from Tulare Hill.

We recorded a few wildlife passages through the Laguna Seca Gate NC01, across from Tulare Hill (Figure 53). Of importance, we recorded an American badger traveling under this gate (Figure 54). We did not record any detection of American badgers during the 2018-2019 bobcat radio collar study. During T. Diamond's thesis work, a natal badger burrow den was recorded at Tulare Hill and badger burrows were recorded at the IBM property in the vicinity of this badger passage at the NC01 gate. American badgers are listed as a Species of Special Concern by the CA Department of Fish and Wildlife (<https://wildlife.ca.gov/Conservation/Mammals/Badger>).

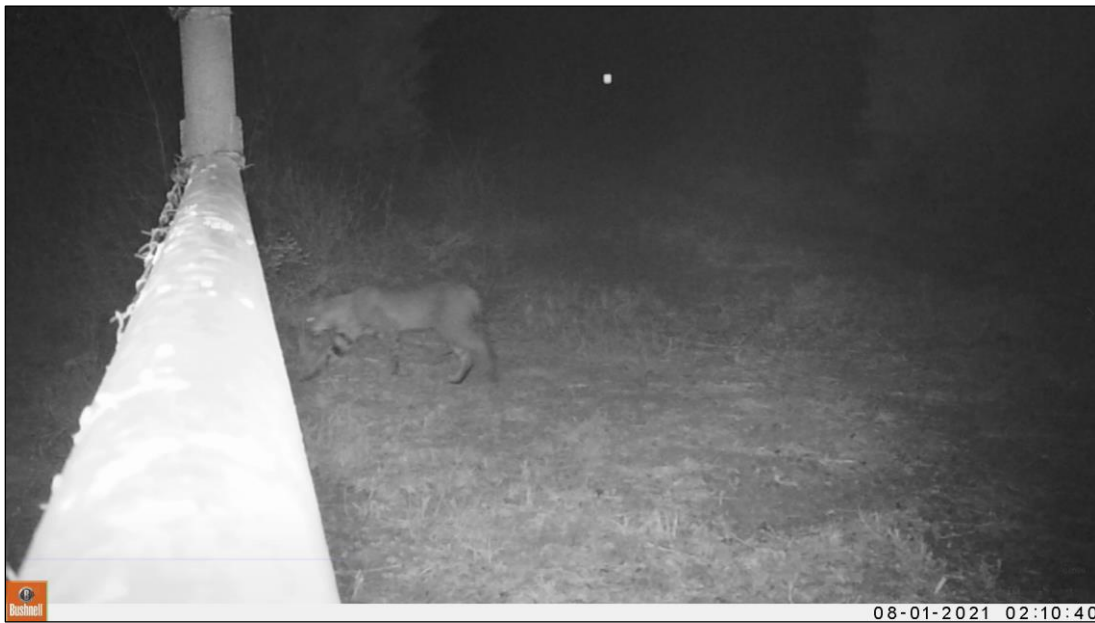
Figure 55. Bobcat walking through the Laguna Seca gate on the west side of Santa Teresa Blvd.

This gate was the most permeable gate, consisting of several horizontal bars without mesh wire between them. This gate had the highest rate of passage, with multiple species traveling through the gate each month (Figure 55). Though cows are also present at this site, we did not record any calves traveling through the gate. However, we did not record deer traveling through any of the gates along Santa Teresa Blvd., only smaller to medium-sized mammals through the gates at Tulare Hill, on the west side of Santa Teresa Blvd.

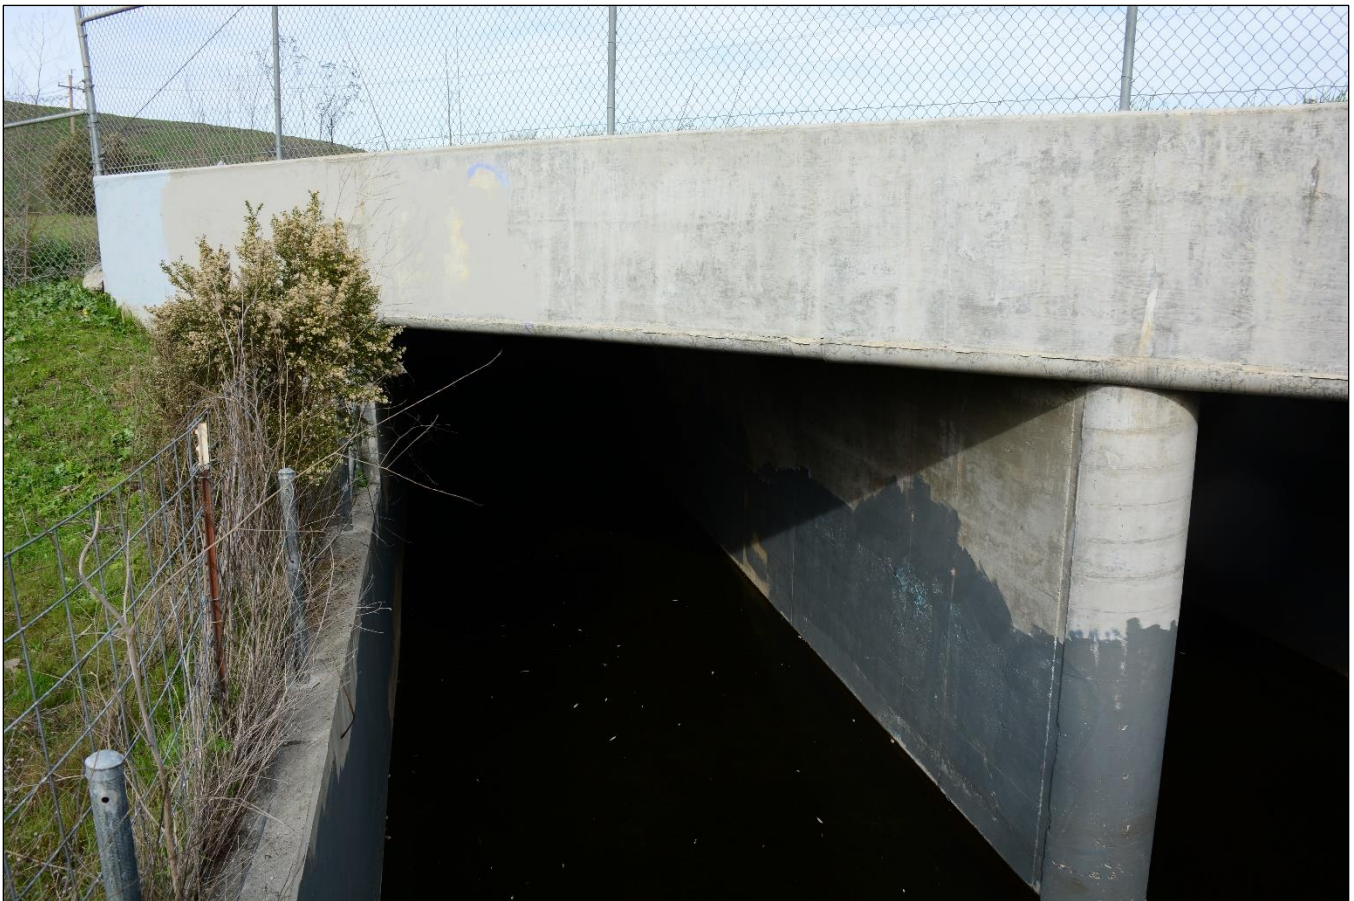
Figure 74. Santa Teresa Blvd. Fisher Creek culvert on 1/14/2022.

The Santa Teresa Fisher Creek culverts are large dual box culverts (Figure 74). However, these culverts typically remain flooded for the majority of the year unless there is a severe drought condition. In 2021, this region experienced a severe drought, resulting in the Fisher Creek culverts becoming dry (Figure 75).

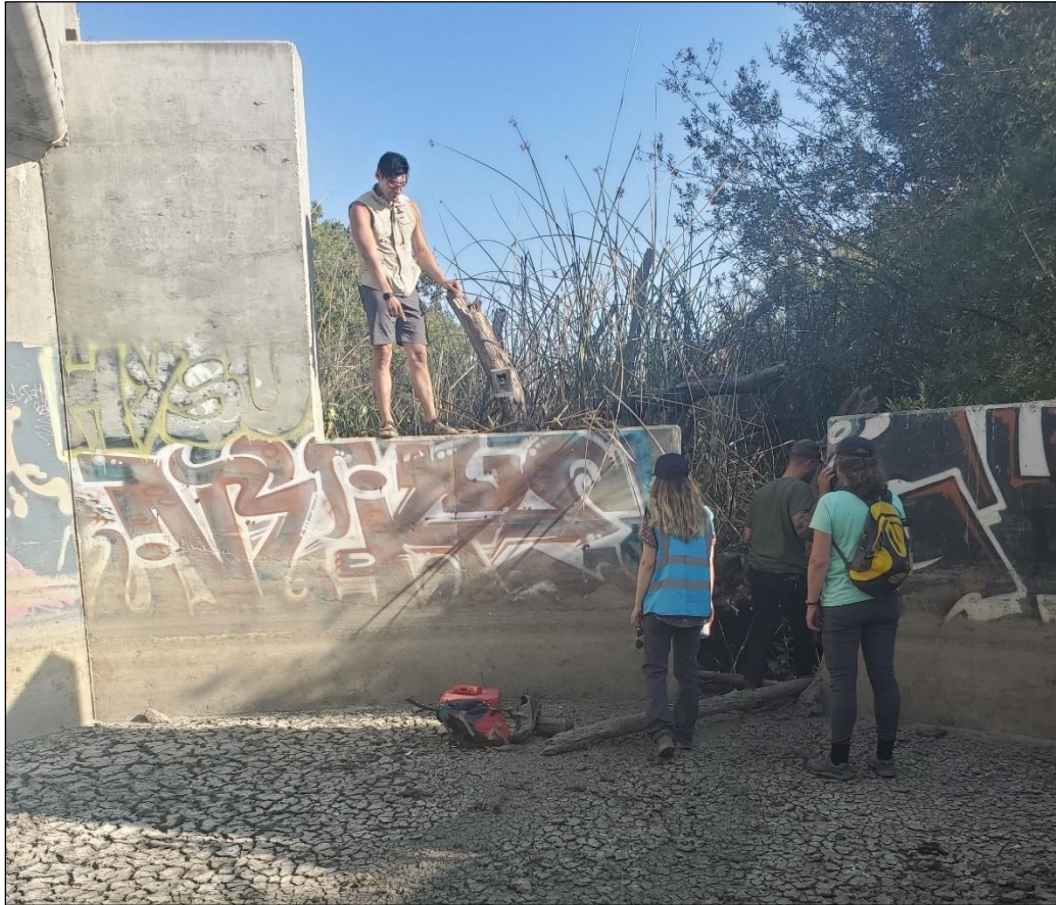
Figure 75. Camera set up with POST and PFW on 9-3-21 at the Santa Teresa Fisher Creek culverts.

We took advantage of this situation and set up cameras mid-study on September 3, 2021, during a site visit with POST, to record if animals would use the culvert to travel through under dry conditions (Figure 75).

On the west side of the dual box culverts, there is a concrete washboard that creates poor visibility through the culvert (Figure 75). There is a small opening at the culvert, which would give wildlife the opportunity to access the culvert. However, wildlife typically requires high visibility through culverts to be willing to travel through them (Safe Passages 2012).

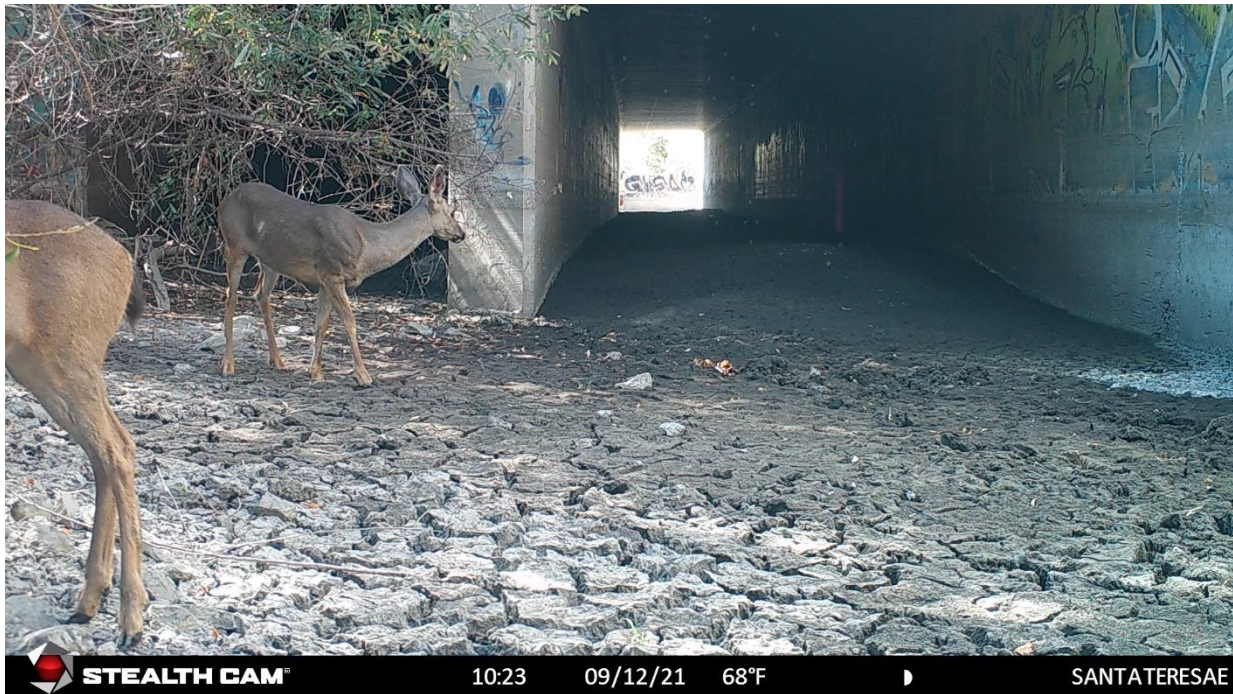
Figure 76. Deer on the west side of the Santa Teresa Blvd. Fisher Creek dual box culvert.

We also set up a camera on the east side of the dual box culvert. We did not record any wildlife passages through the culvert before it became inundated with water again. We recorded several deer on the east side of the culvert investigating the culvert but then walking away from it (Figure 76). Because this site did not record any passages by wildlife, it was not included in the 100 trap nights analysis.

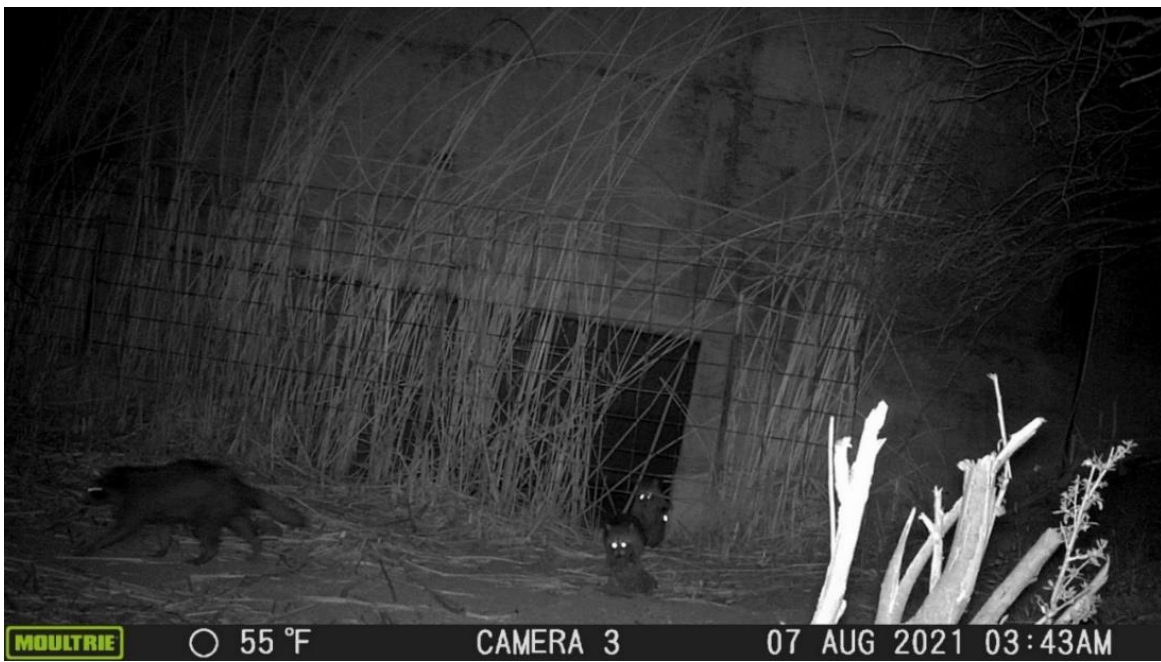
Figure 77. Raccoon family traveling through the Santa Teresa Blvd. Laguna Seca culvert.

This culvert is located at Santa Teresa Blvd. at Laguna Seca, north of Fisher Creek. There is a wire mesh gate set up on the west side of the culvert at Laguna Seca. We only recorded raccoons traveling through this culvert (Figure 77).

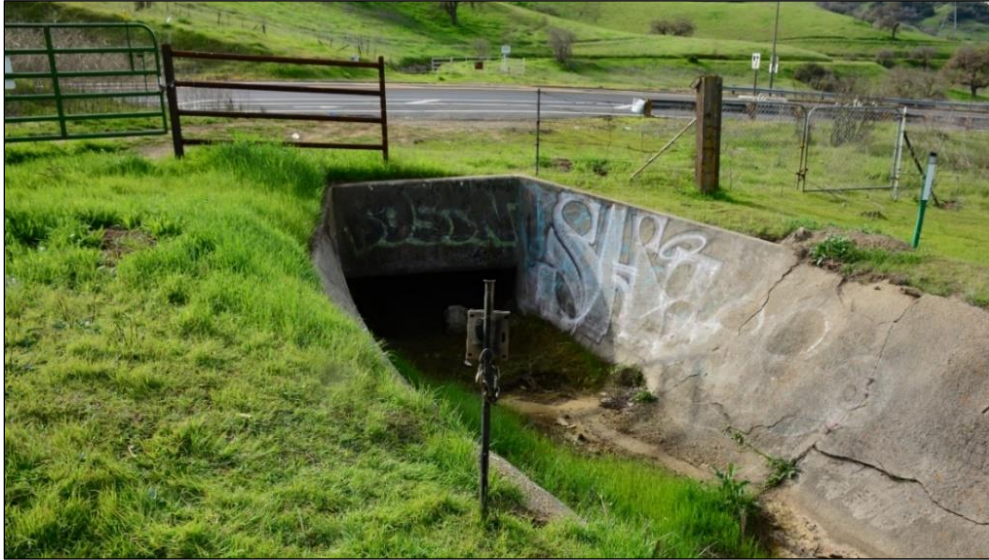
Figure 78. Coyote Alamitos Canal, northbound, on the west side of Tulare Hill.

The Coyote Alamitos Canal is a three-foot box culvert facilitating an overflow canal under Santa Teresa Blvd. (Figure 78). We only recorded six raccoons traveling through this culvert. However, during the 2019 Coyote Valley Bobcat & Gray Fox Connectivity Study, B01 Serpentine, used this culvert several times to travel both west and south through the culvert along with crossing at-grade in the vicinity of the culvert (Figures 79).

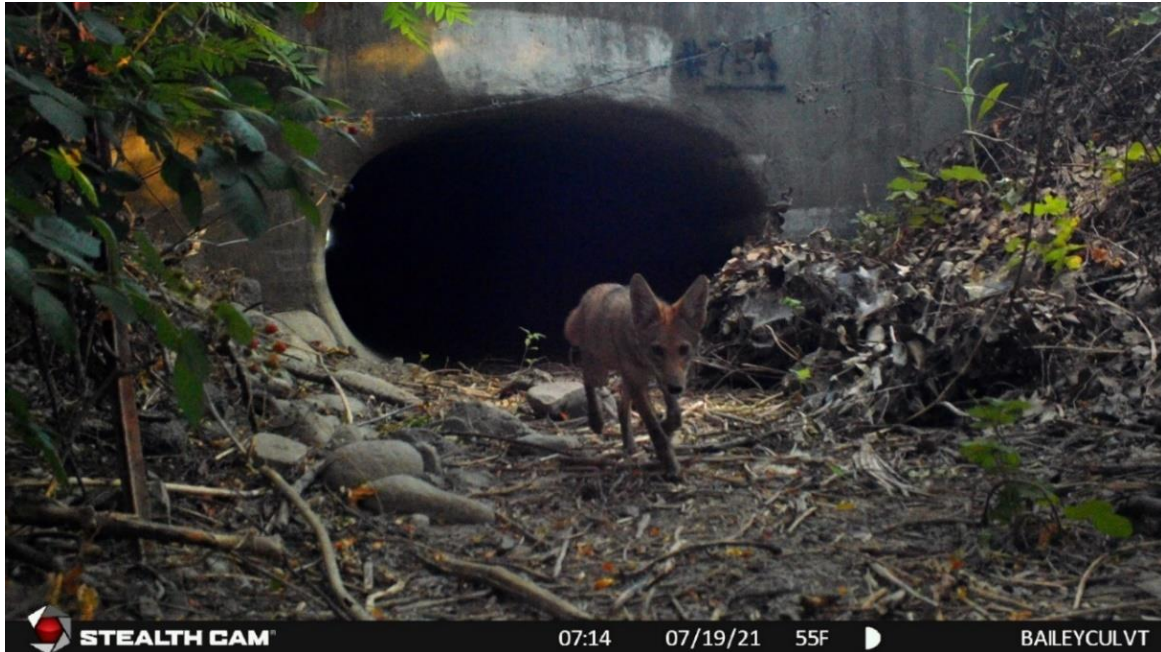
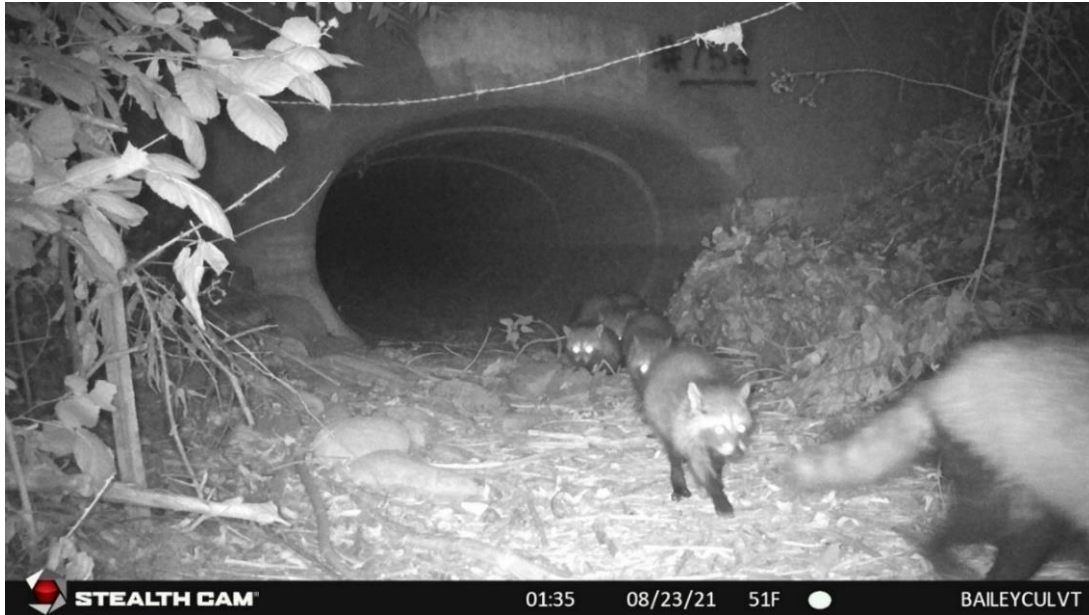
We recorded multiple species using the Bailey Ave culvert including bobcat, coyote, and raccoons, with a standardized passage rate of 74.2 (Figures 80-82). Since this is the only culvert on Bailey Ave. within the study area, it is an important location for providing safe passage under the road as a coyote puppy was

Figure 80. Bobcat recorded at the Bailey Ave. Culvert on 6/30/2021.

Figure 81. Coyote subadult recorded at the Bailey Ave. Culvert on 7/19/2021.

Figure 82. Raccoon family recorded at the Bailey Ave. Culvert on 8/23/2021.

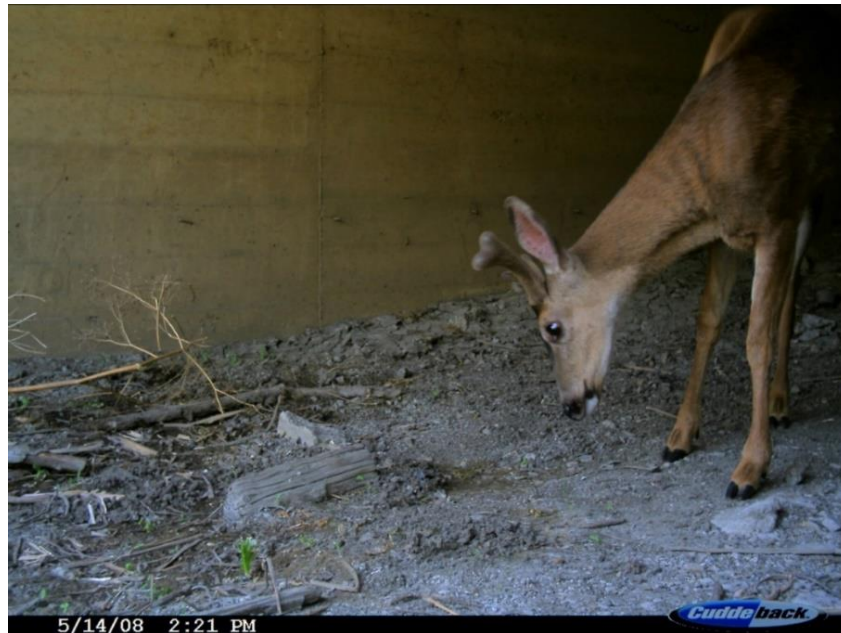
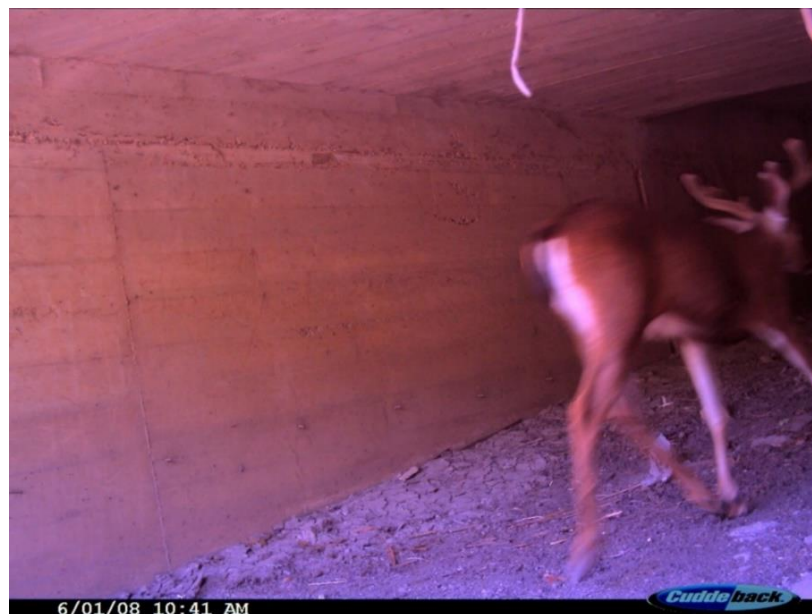
In 2008, deer, coyote, and bobcats were recorded traveling under the bridge, including two different male deer traveling both north and south under the bridge (Figures 84-85). During the 2015-2016 study, we recorded six bobcats and two deer passages (Figure 84, Diamond, T. and A. Snyder 2016). During the current study period, we only recorded two bobcat passages (Figure 87). The area beneath the bridge has filled up with sediment over the years compared to the conditions we documented in 2008. There is also restrictive fencing on the south side of the bridge. The sediment and fencing might be limiting wildlife passages, especially by larger mammals.

Figure 84. Deer crossing through Bailey Ave. Fisher Creek Bridge on 5/14/ 2008.

Figure 85. Male deer successfully crossing through the Bailey bridge at Fisher Creek in 2008.

Since 2008, two exclusionary barbed wire fences were set up at the southern opening of the bridge. In addition to the two fences, there is also sediment buildup, which has resulted in a decrease in height throughout the structure compared to the bridge's conditions in 2008 (Figure 113). During the Coyote Valley Linkage Assessment Study from 2015-2016, there were only 11 successful wildlife crossings recorded at this bridge compared to a much higher rate of passages by multiple species recorded from 2008-2010 (Safe Passages for Coyote Valley 2012, Diamond, T. and A. Snyder. 2016)

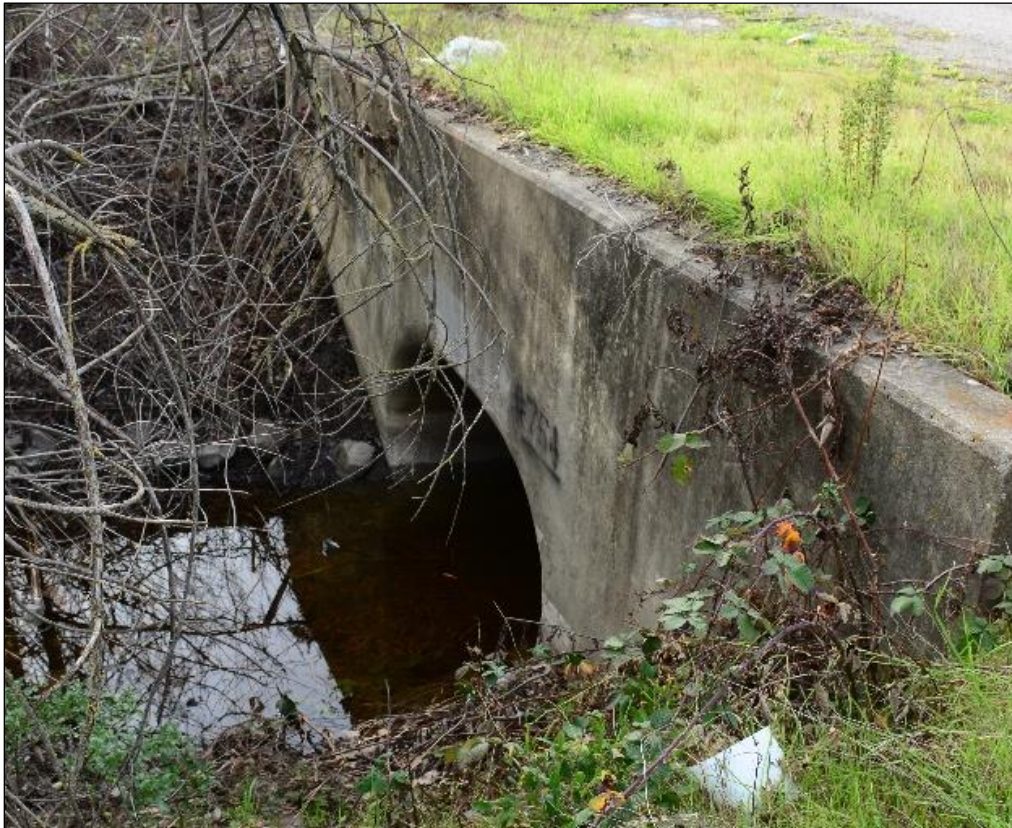
Figure 88. Bailey Ave. culvert south side on 1/14/2021.

The Bailey Ave. culvert was flooded by water on both the south and north sides (Figure 88). We previously recorded multiple species such as bobcat, coyote, skunk, and a raccoon family traveling both south and north through the culvert prior to flooding. However, after the culvert flooded, we recorded a decline in passage rates (Figure 89).

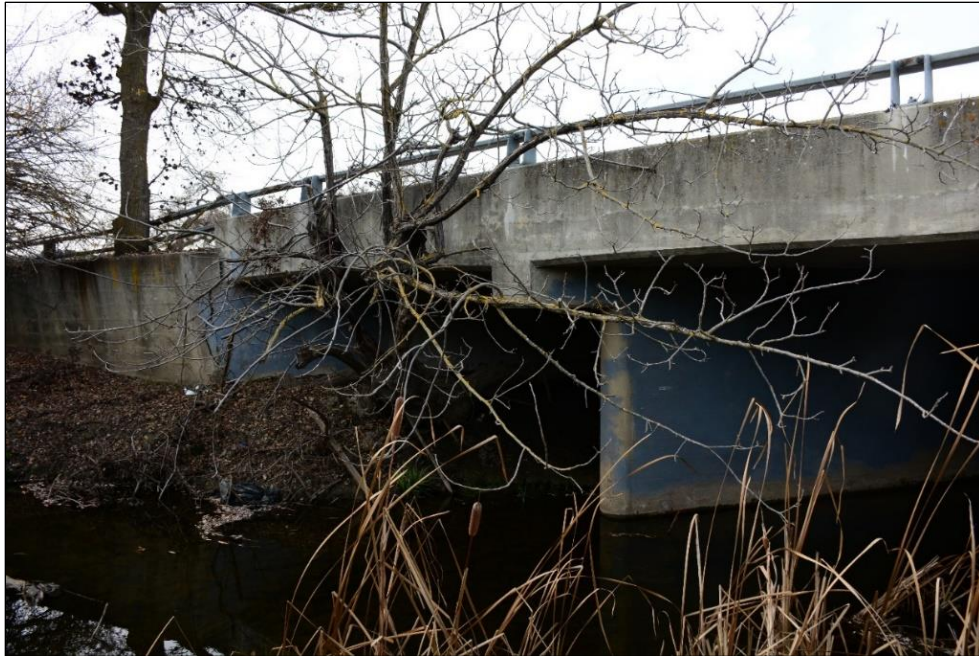
Figure 90. Bailey Ave. Fisher Creek Bridge north side on 1/14/2021.

After the first storm event, the middle of the bridge sections of the Bailey Ave Fisher Creek bridge became inundated with water (Figure 90). With the debris and sediment built up on the outer sections, there was very little bank available for wildlife to travel along under the bridge. There was a decrease in passage rates until the banks became available for wildlife to travel along (Figure 91).

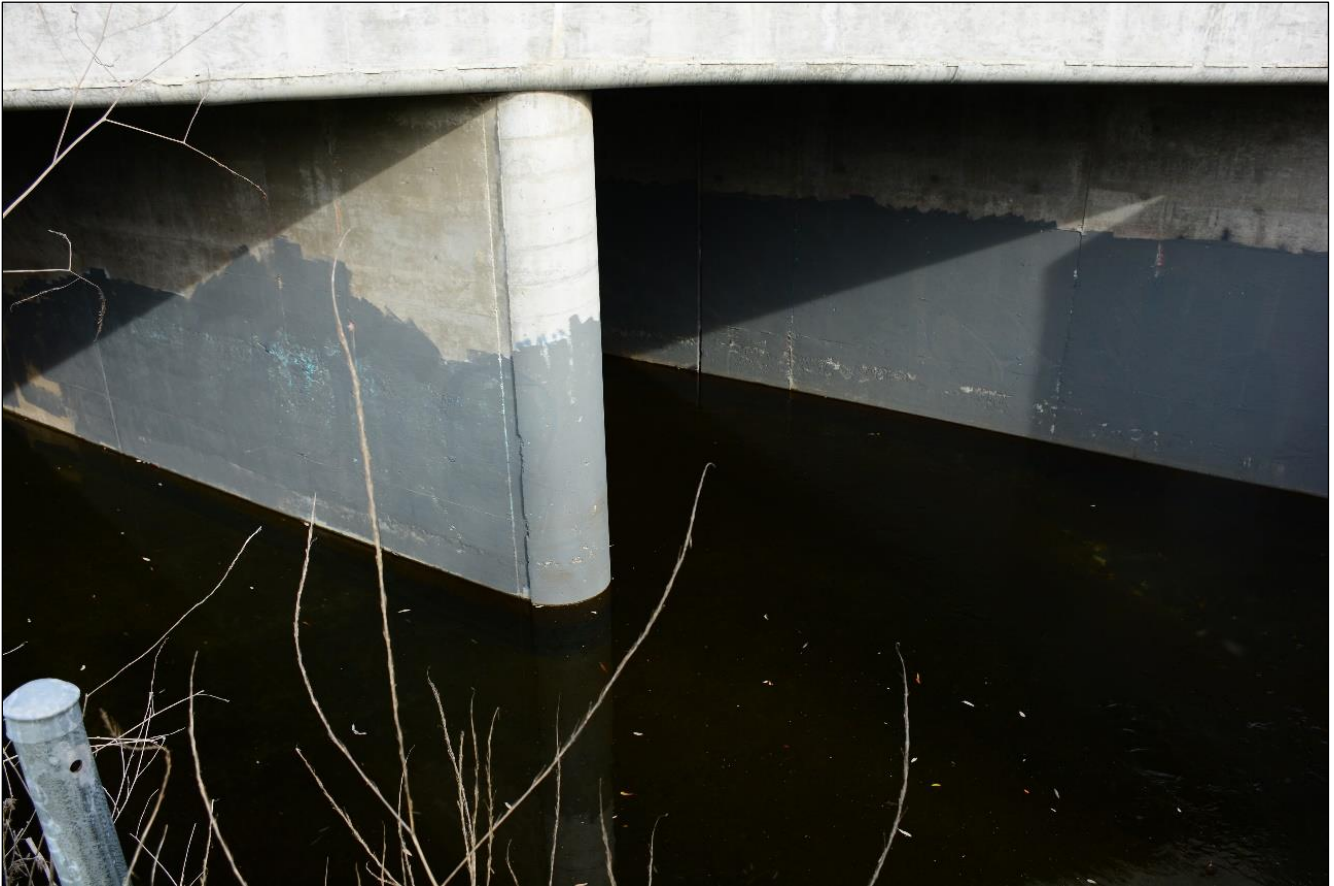
Figure 92. Santa Teresa Boulevard culvert, west side on 1/14/2021.

The Fisher Creek culvert at Santa Teresa Boulevard is a large dual box culvert that typically remains flooded throughout the year, as Valley Water pumps water through Fisher Creek to supply water to east San Jose (Figure 92). We did not document any wildlife movement through these culverts. We did not include a seasonal passage rate chart as this culvert was monitored opportunistically for a short period time when it was dry due to drought conditions but then filled up with water after the first storm event.

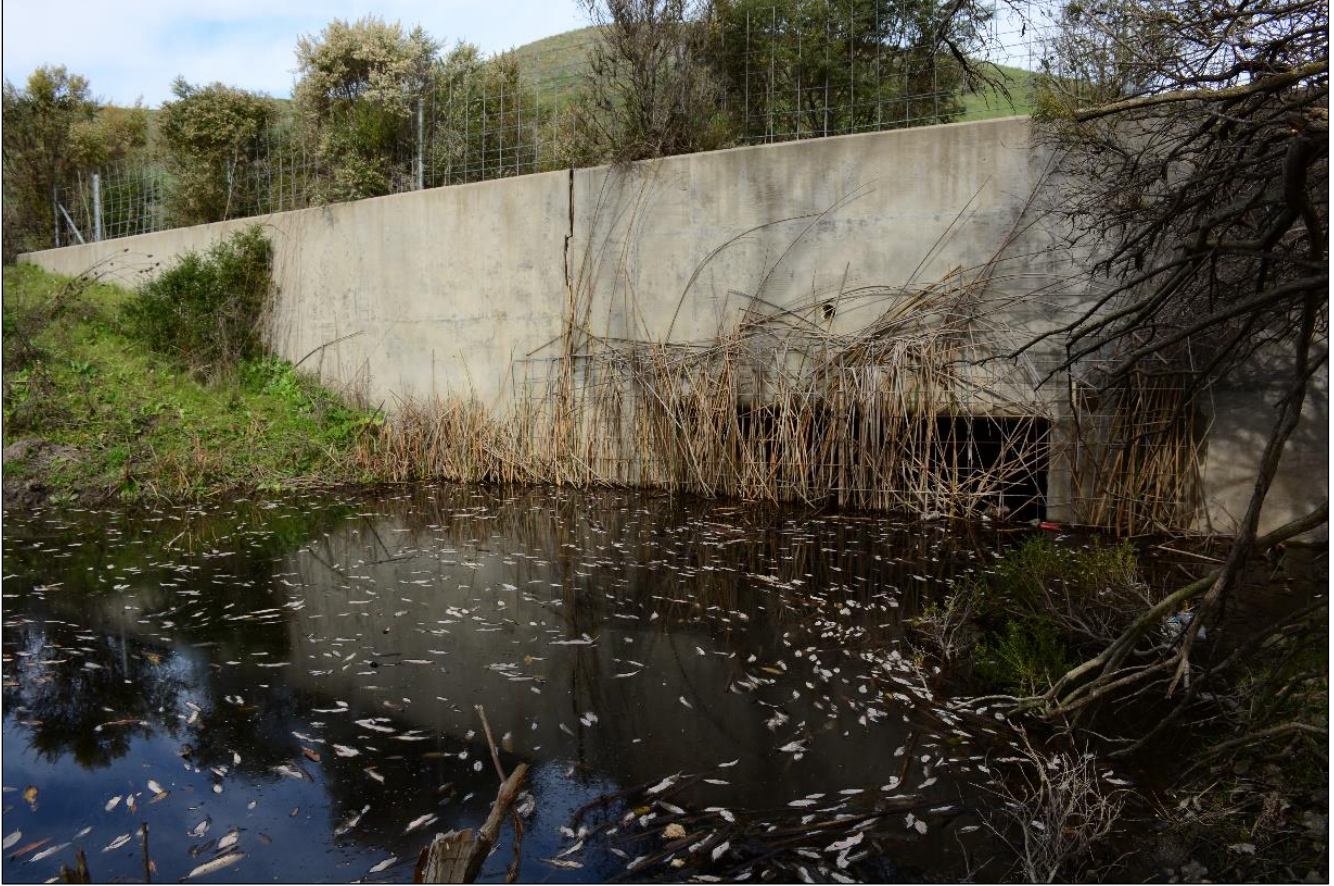
Figure 93. Laguna Seca culvert at Santa Teresa Boulevard culvert, west side on 1/14/2021.

The Laguna Seca culvert at Santa Teresa Blvd. became flooded by water after the first storm event in 2021 (Figure 93). This culvert was dry during the summer months, however, there was restrictive mesh wire fencing set up on the west side of the culvert. We only recorded a family of raccoons traveling through a small opening in the mesh fencing (Figure 77). In June 2022, after the study concluded, the mesh was removed and replaced with a few strands of barbed wire.

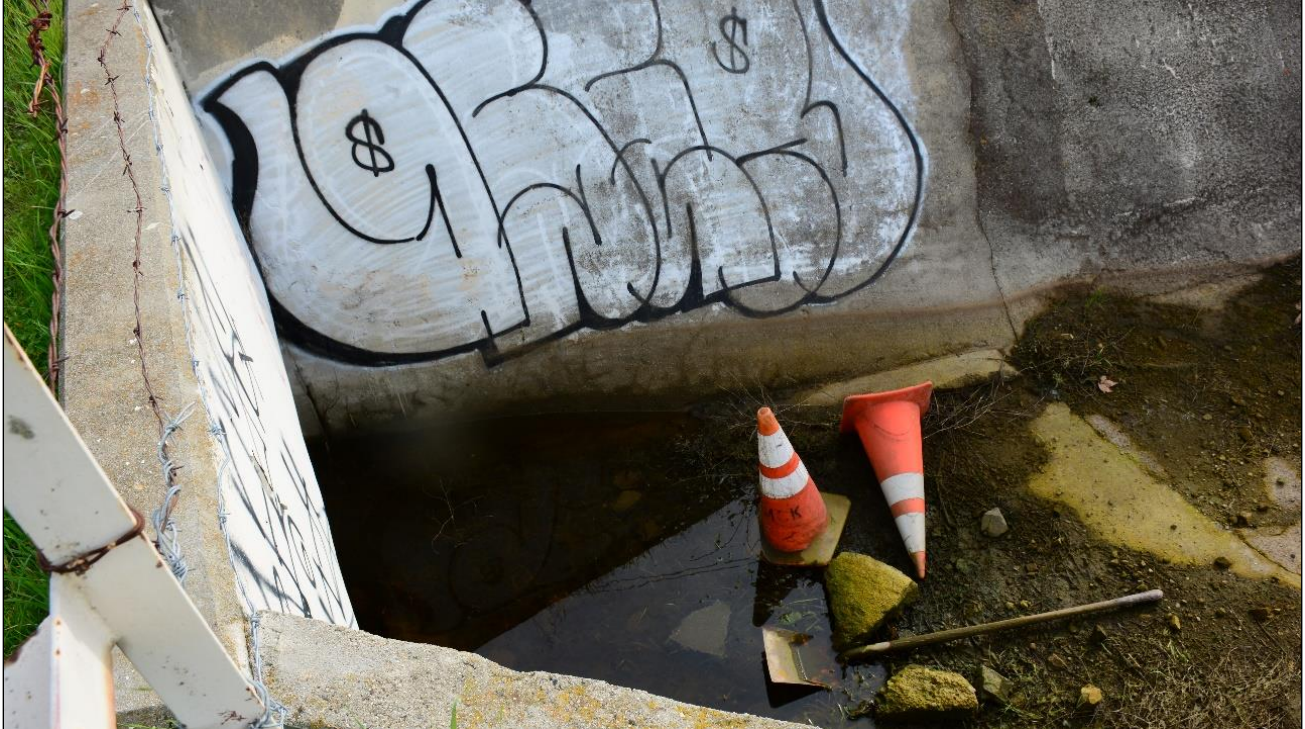
Figure 94. Coyote Alamitos Canal culvert, west side on 1/13/2021.

After the first storm event, a pool of water formed on the east side of the culvert and remained throughout the spring months (Figure 94). However, we only recorded one raccoon traveling through the culvert before the storm events.

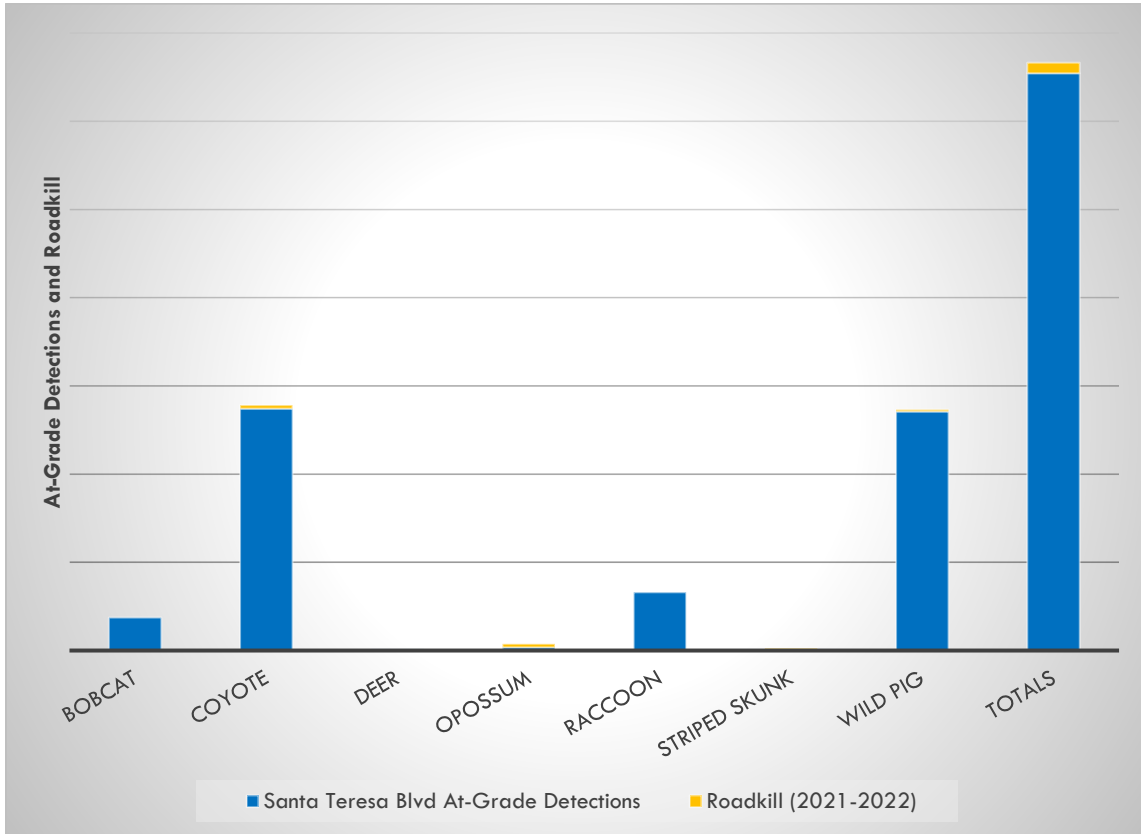
Figure 102. Standardized at-grade detections and roadkill along Santa Teresa Blvd.

We found a higher rate of standardized at-grade detections than recorded mortalities for all species on both Santa Teresa Blvd. and Bailey Ave, with a combined total of 881.5 standardized at-grade detections and 11 roadkill records across both roads (Figures 102-103).

There were frequent at-grade detections of coyote along Bailey Ave and Santa Teresa Blvd sites, but only one coyote detected as roadkill along Bailey Ave and only two coyotes detected as roadkill along Santa Teresa Blvd. Similarly, although there were frequent at-grade detections of wild pig along Santa Teresa Blvd, there was only one wild pig detected as roadkill along Santa Teresa Blvd.

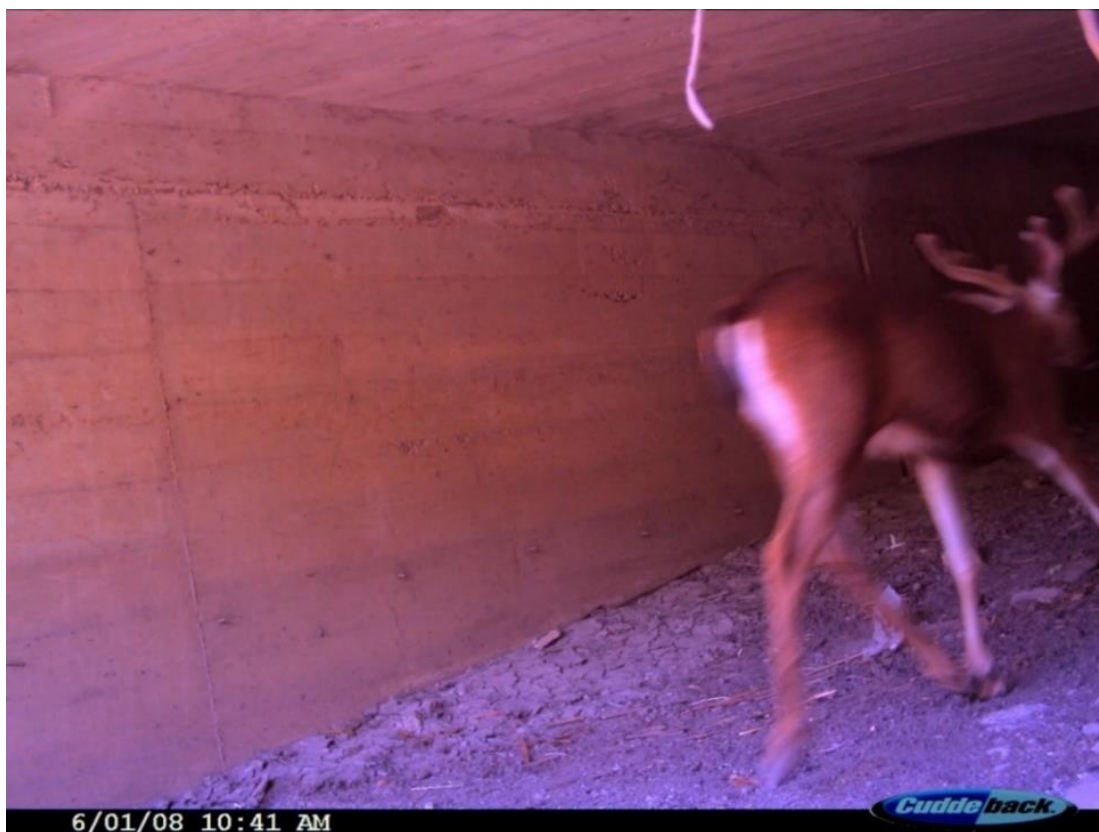
Figure 111. Male deer successfully crossing through the Bailey bridge at Fisher Creek in 2008.

We recommend exploring options to increase the permeability of the Bailey Ave. Fisher Creek Bridge for wildlife movement, such as sediment removal, fence modifications, and/or habitat restoration upstream of this site. This study recorded low rates of wildlife passage through this bridge (16 total passages), without any passages by large mammals. However, baseline data from monitoring efforts in 2008 at this bridge documented deer, coyote, bobcat, and raccoon routinely crossing through each month (Figures 111-112, Safe Passages for Coyote Valley 2012).

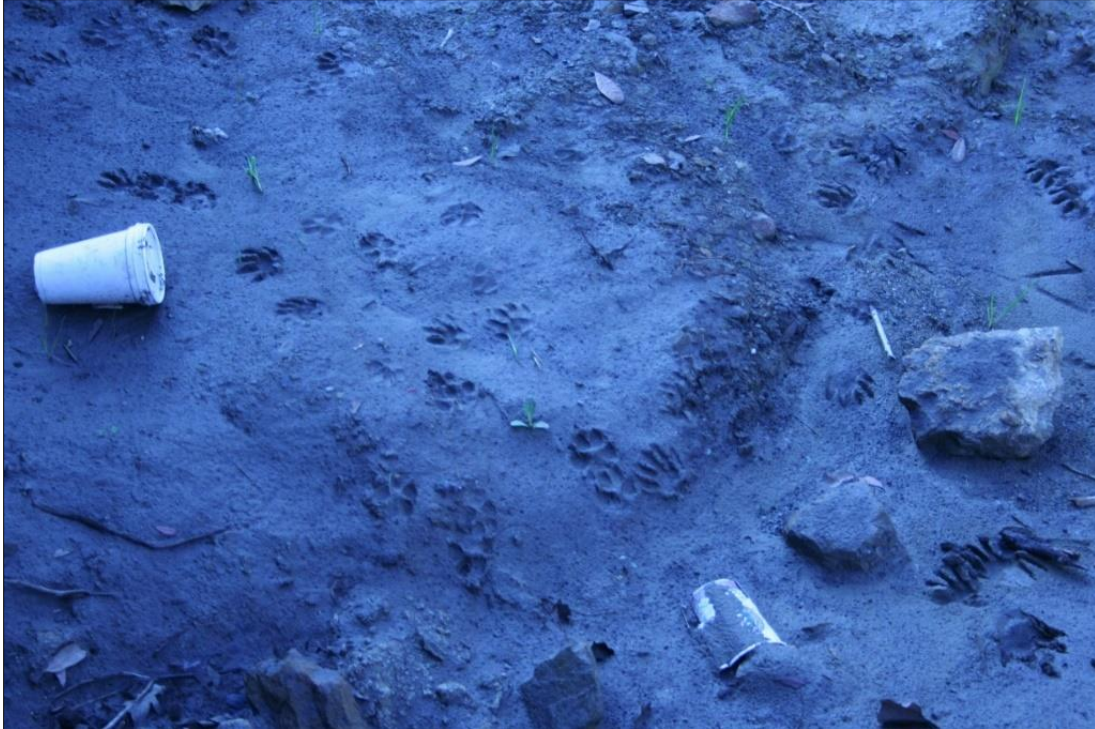
Figure 112. Coyote and raccoon tracks at the Bailey Ave. bridge at Fisher Creek in 2008.

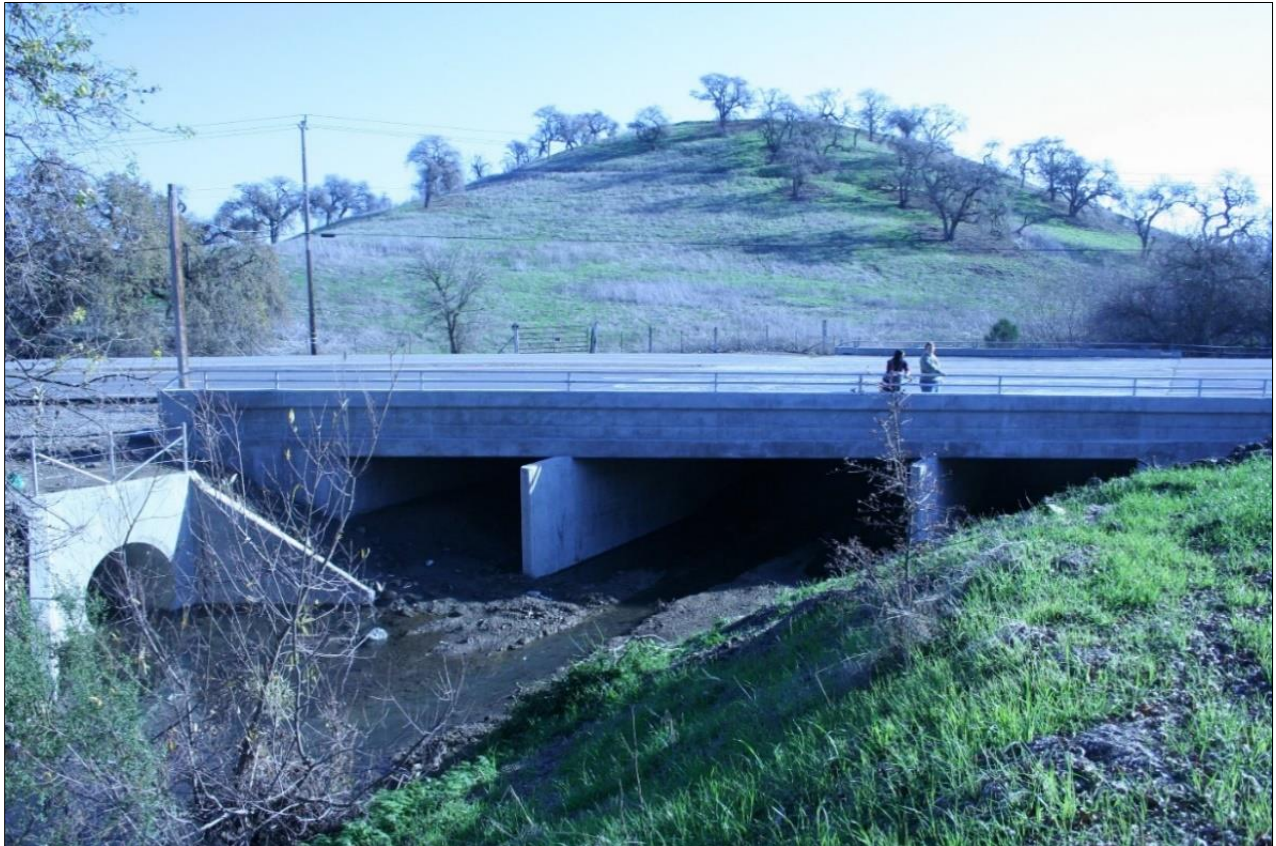
Figure 113. Bailey Ave. bridge at Fisher Creek in 2008, north side of Bailey Ave looking south towards Spreckels Hill.

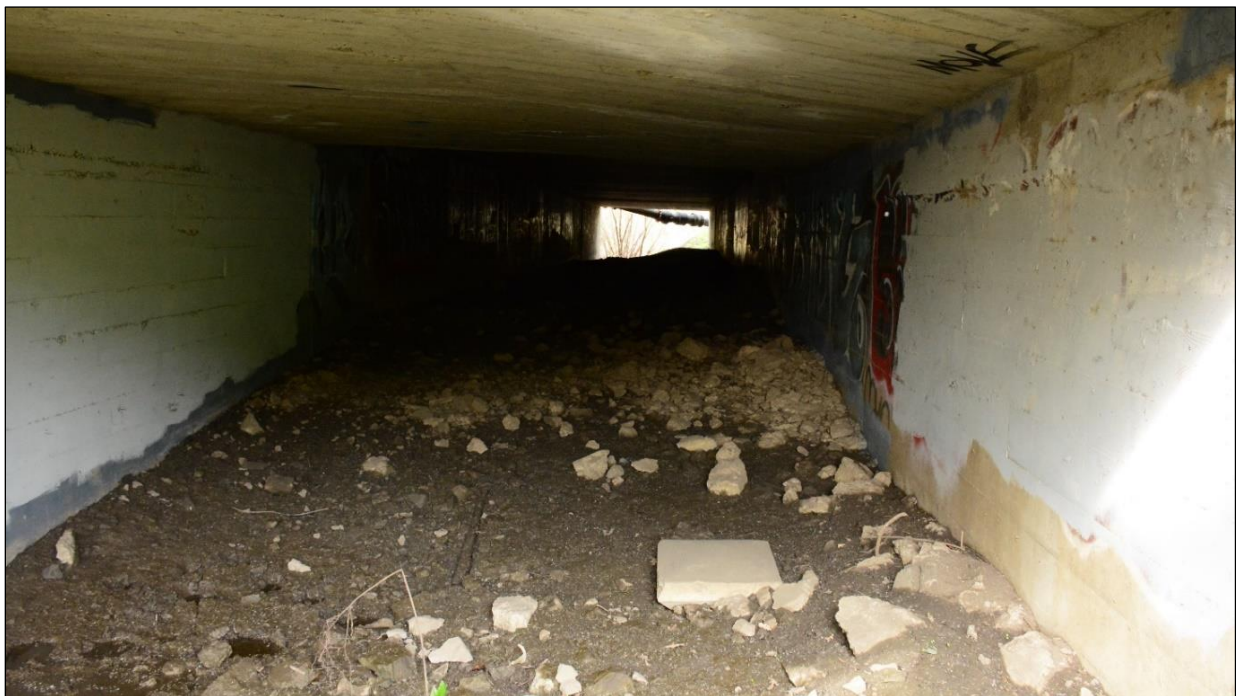
Figure 114. Bailey Bridge at Fisher Creek on 1/13/2022, eastern section of the bridge.

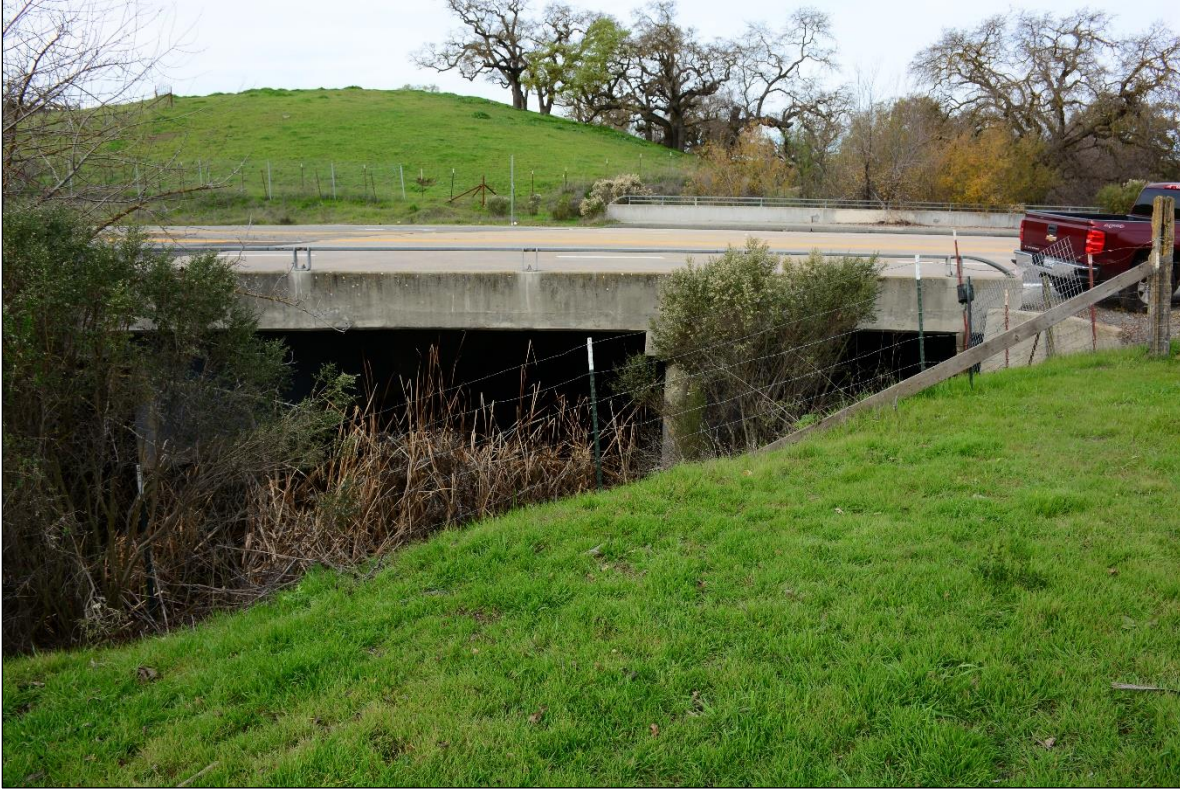
Figure 115. Bailey Bridge at Fisher Creek on 1/14/2022, south side of the bridge, eastern section.

There is also restrictive fencing on the south side of the bridge at Spreckels Hill (Figure 115). It would be highly beneficial to create a wildlife friendly fencing design to guide wildlife to the bridge as we recorded multiple at-grade wildlife crossings and wildlife-vehicle mortalities in the vicinity of the bridge.

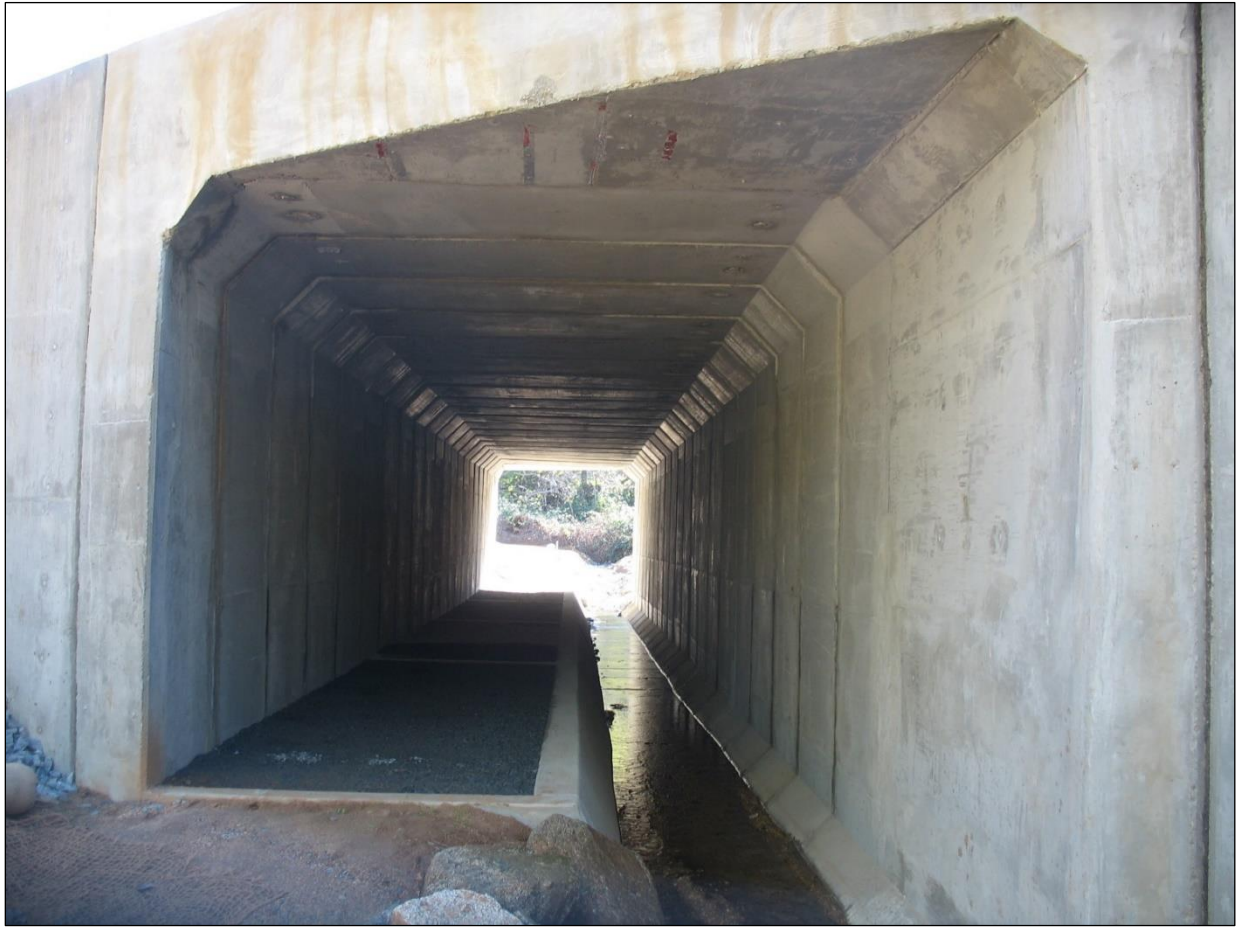
Figure 116. Culvert retrofit on SR-89 by Ken Russo, Senior Environmental Planner, Branch Chief Unit M5, Resource Biologist, Caltrans, District 3.

Another option is to retrofit the existing culverts. This could involve increasing the dimensions of the existing culverts and/or installing animal walkways as designed by Ken Russo, Senior Environmental Planner, Branch Chief Unit M5 (Acting), Resource Biologist, Caltrans, District 3. The culvert retrofit in Figure 116 was a modified culvert located along a segment of SR 89 that had documented roadkill. Ken Russo and his team retrofitted the culvert by installing an elevated walkway to provide a pathway for wildlife movement while allowing the culvert to still drain water during storm events. The culvert was monitored and proven successful, as wildlife used the culvert during storm season while water was flowing through it.
