North Coyote Valley Road Ecology Study 2021-2022

Prepared by Tanya Diamond & Ahíga Sandoval
Pathways for Wildlife

For Peninsula Open Space Trust (POST),
Santa Clara Valley Habitat Agency
and the California Department of Fish and Wildlife

March 2023

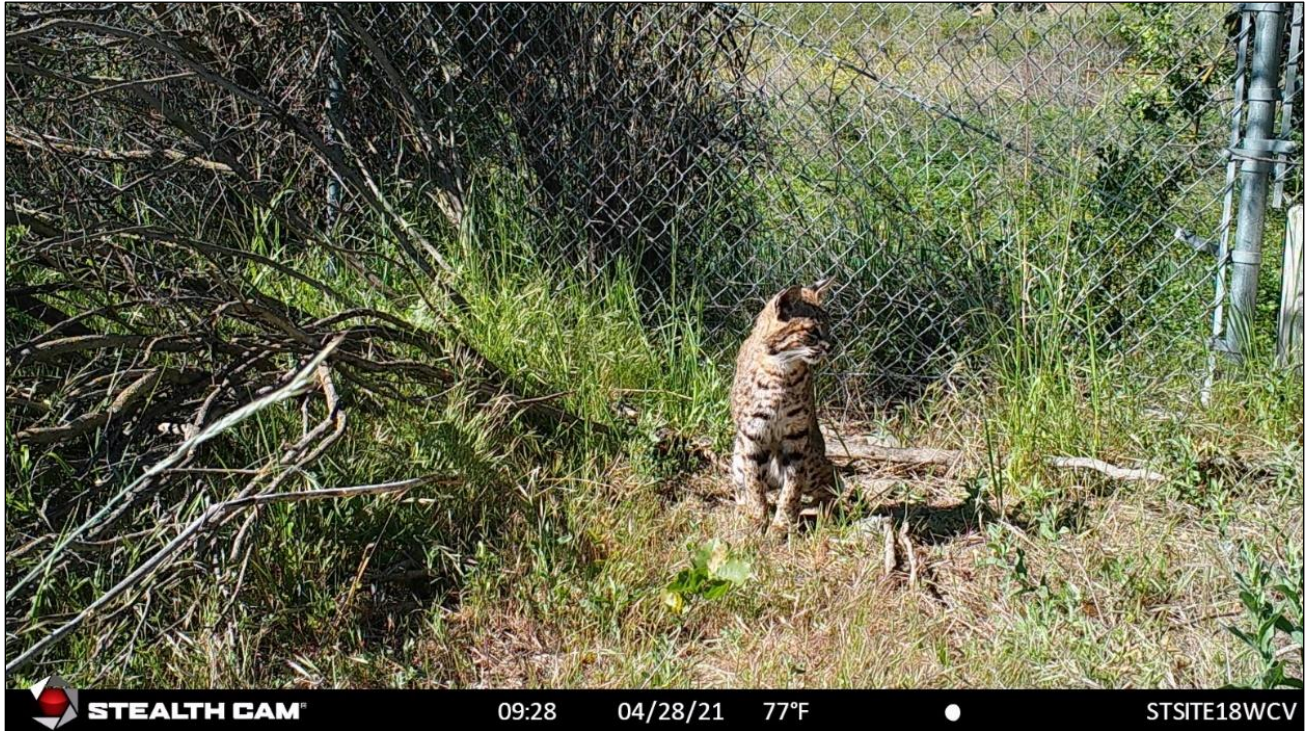
Figure 120. Bobcat at Santa Teresa Blvd. chain link fence line at Fisher Creek.

Most of the fencing along Santa Teresa Blvd. at Laguna Seca restricted wildlife movement during the study period (Figure 120). We detected higher species richness at IBM compared to Laguna Seca, which might be because of the less restrictive fencing at IBM. We recommend increasing the permeability of fencing at Laguna Seca to increase wildlife passage.

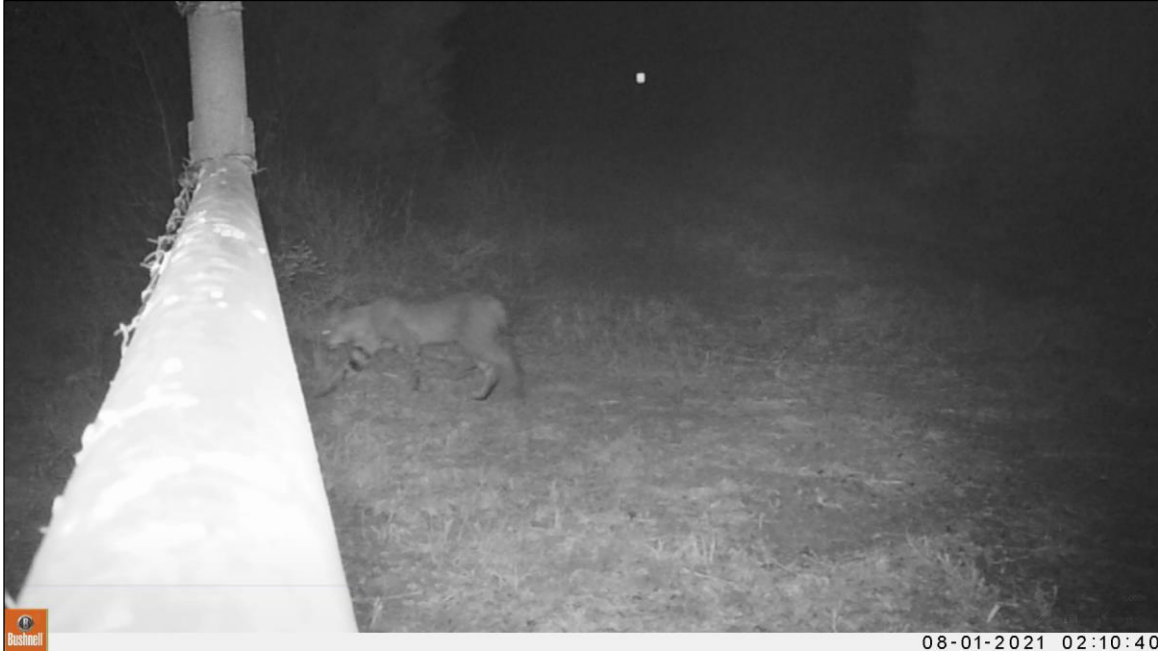
Figure 122. Bobcat walking through the Laguna Seca Gate NC02, on the west side of Santa Teresa Blvd.

We recommend modifying all gates to a similar structure as Gate NC02 at Laguna Seca to increase the permeability of the landscape between the newly protected properties. We recorded bobcats traveling through the Laguna Seca Gate NC02 and the Tulare Hill Gate NC21 (Figure 127). However, we did not record any bobcats traveling through the gates with restrictive mesh fencing at Laguna Seca Gates NC01 and NC03. We recommend replacing gates with restrictive mesh fencing to a similar design as Gate NC02. This should be compatible with livestock grazing, as we did not record cattle or calves crossing through this gate (Figure 123).

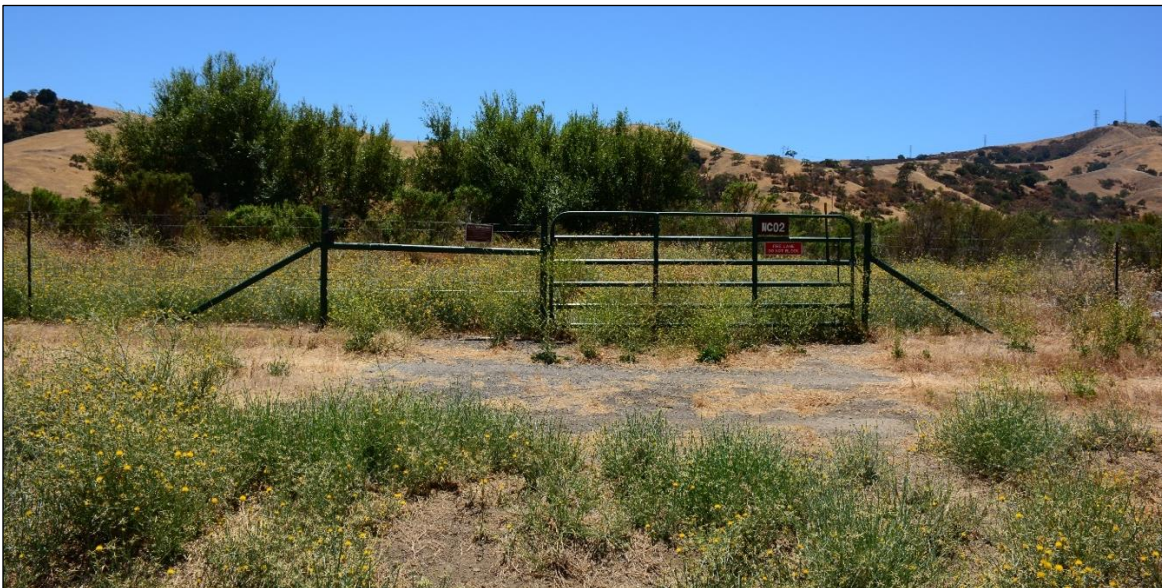
Figure 123. Laguna Seca Gate NC02.

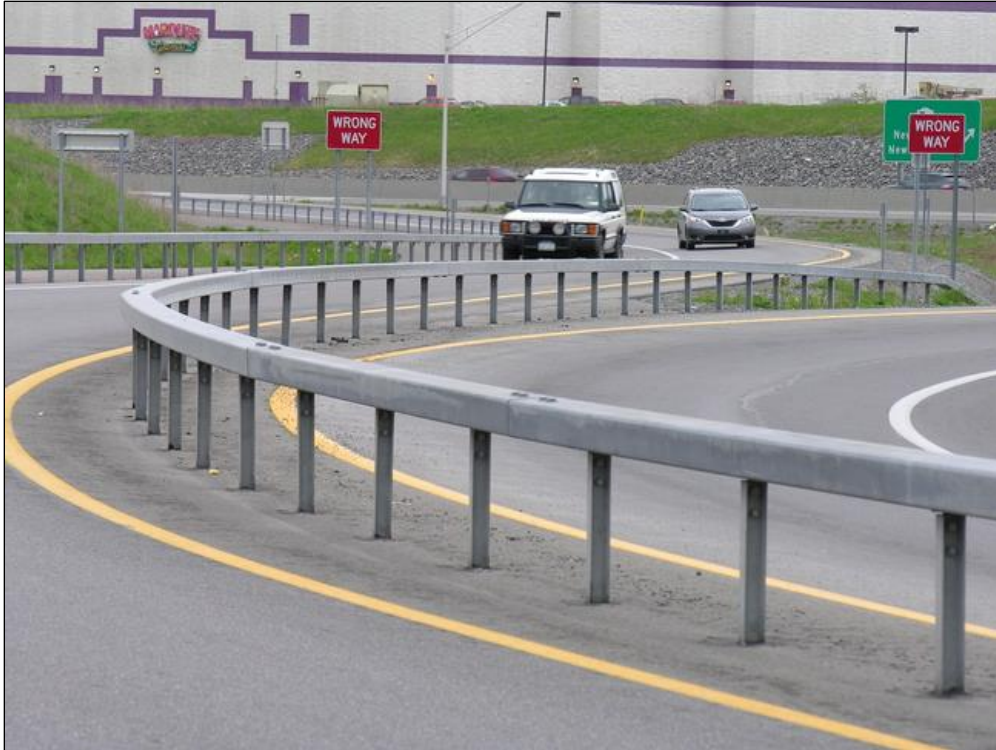
Figure 124. Example of an open median.

- **Replace sections of the cement median as an open median** from the Bailey Ave intersection to the Metcalf intersection to increase the permeability for wildlife movement through the median. A large section of SR-152 Pacheco Pass, a major commuter highway, was replaced with an open median to increase the safety of the highway for wildlife and drivers (Lindsay Vivian, Caltrans Biological Branch Chief pers. comm, 1-10-2023). Open medians include thrie-beam and cable barrier designs (Figure 124).

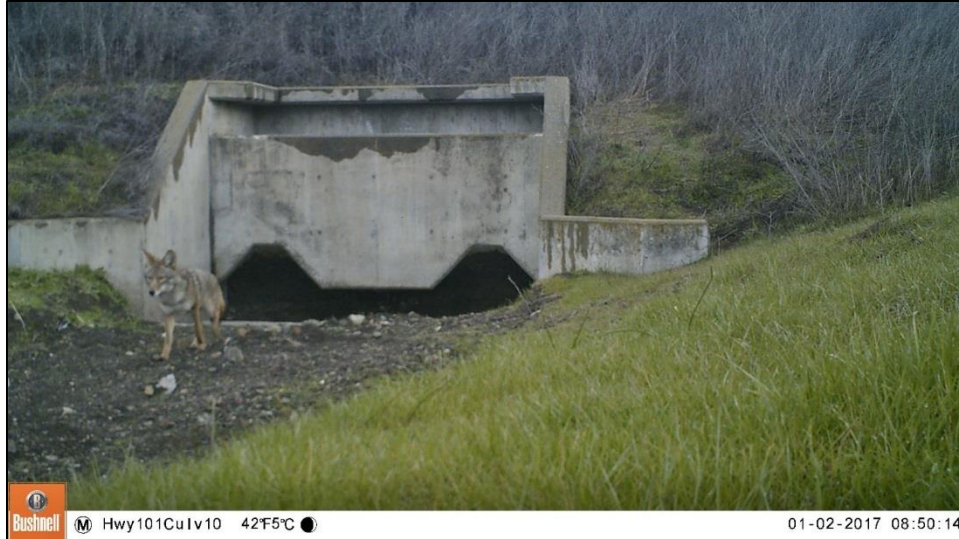
Figure 118. First coyote to travel through Culvert PM 20.98 west on 1/2/2017 after it was cleared out by Caltrans in 2016.

Furthermore, in 2016 and 2022, Caltrans cleared out several culverts within this stretch of highway to increase permeability for wildlife. In the section of US 101 that runs through Coyote Valley, there are three culverts that have the appropriate dimensions to facilitate movement by medium to large mammals: Culvert PM 20.98, Culvert PM 23.2, and Culvert PM 24.27 (Figure 117). From a previous monitoring study, these culverts were documented to have consistent wildlife movement through them (Diamond & Johnston unpublished data 2007-2008). However, over the course of approximately six years (from 2008 to 2014), the culverts became completely obstructed by debris at their western openings. After these culverts were cleared out in 2016, we documented successful wildlife passages through them (Diamond, T. and A. Snyder. 2018b, Figures 118-119).

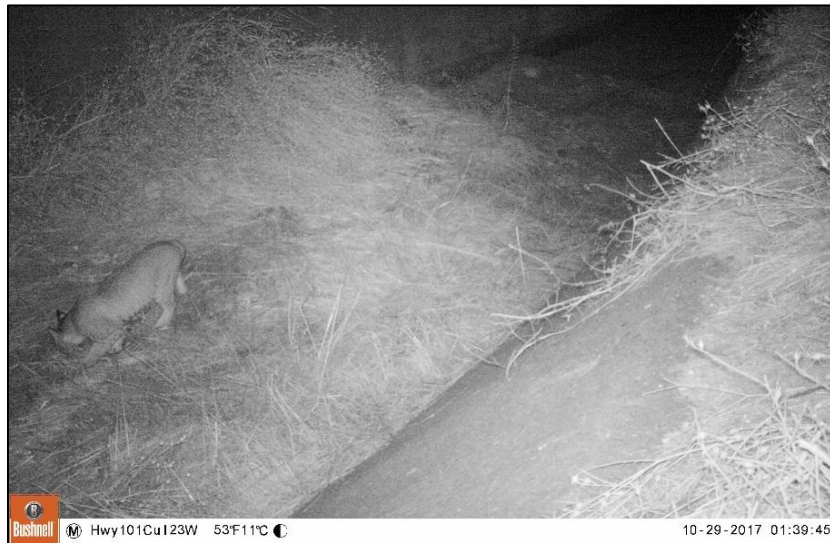
Figure 119. Bobcat traveling west through Culvert PM 24.27 west on 10/29/17 after Caltrans removed the exclusionary fencing that was set up in front of the culvert in 2016.
