San Felipe Creek Restoration Project Mitigation Monitoring Annual Report Year 2 – 2020

Santa Clara Valley Habitat Agency

DUDEK

DECEMBER 2020

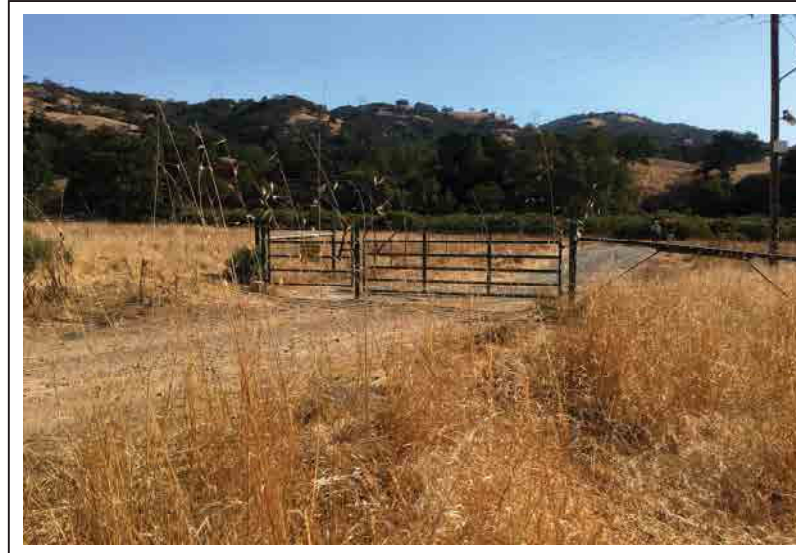
Photo 1a: East - SW03 - 06/19/2019

Photo 1b: East - SW03 - 10/28/2020

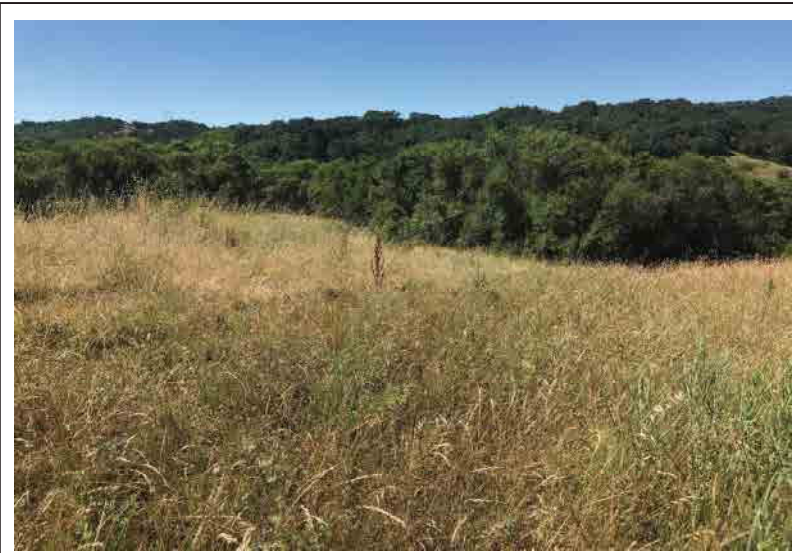
Photo 2a: Southwest - SW03 - 06/19/2019

Photo 2b: Southwest - SW03 - 10/28/2020

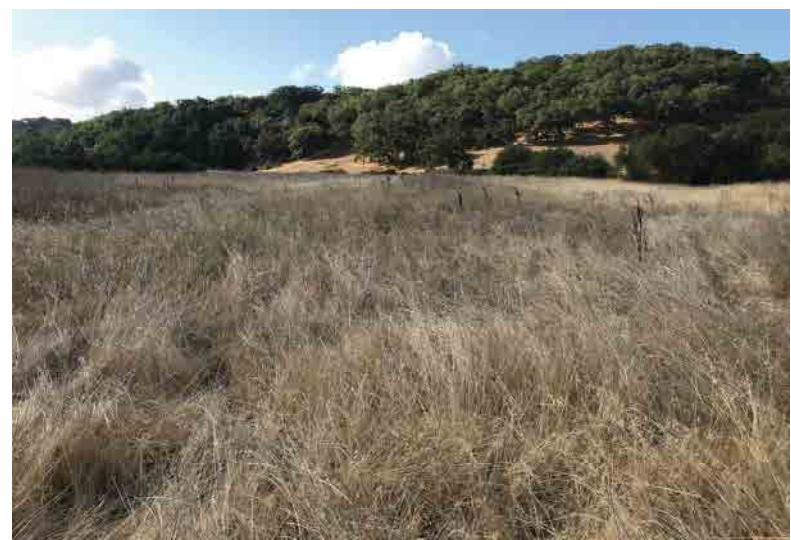
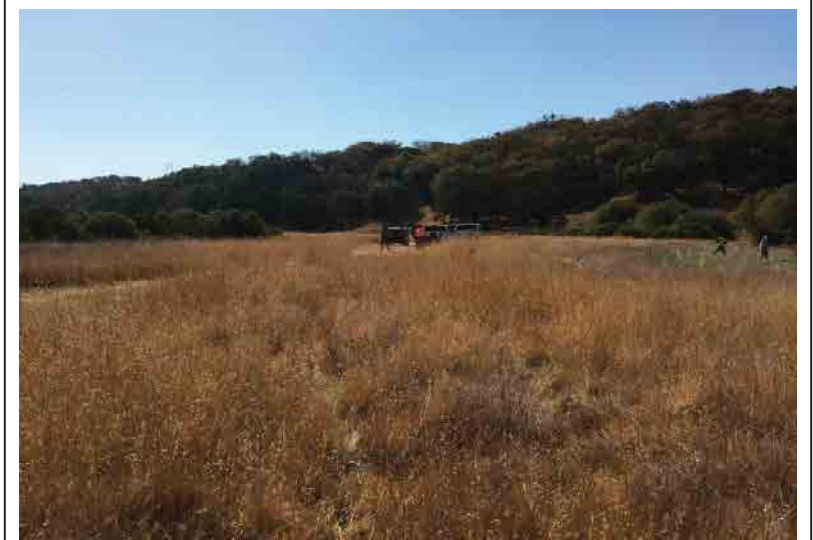
Photo 3a: Southwest - ED02 - 09/30/2019

Photo 3b: Southwest - ED02 - 10/28/2020

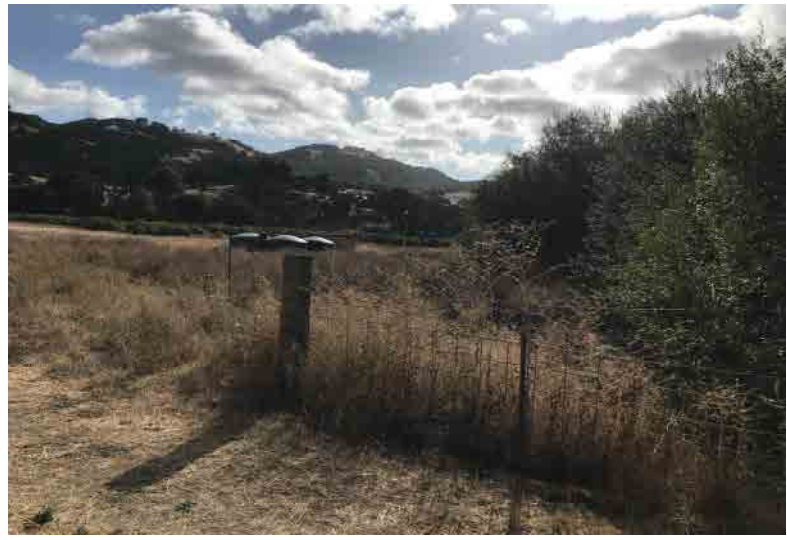
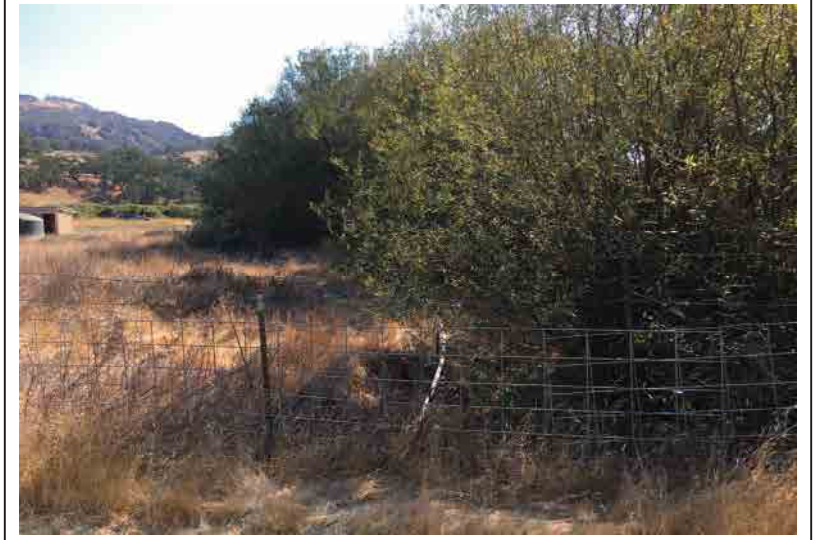
Photo 5a: South - ID03 - 09/30/2019

Photo 5b: South - ID03 - 10/28/2020

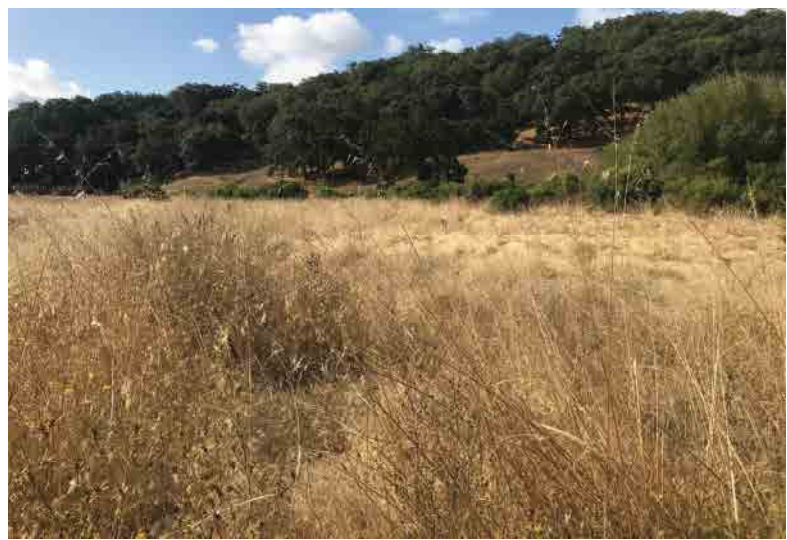
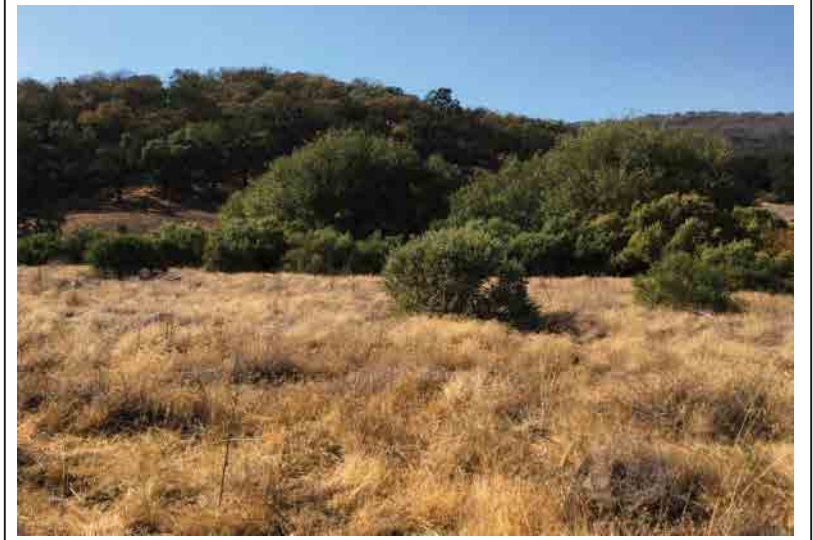
Photo 6a: West - ID03 - 09/30/2019

Photo 6b: West - ID03 - 10/28/2020

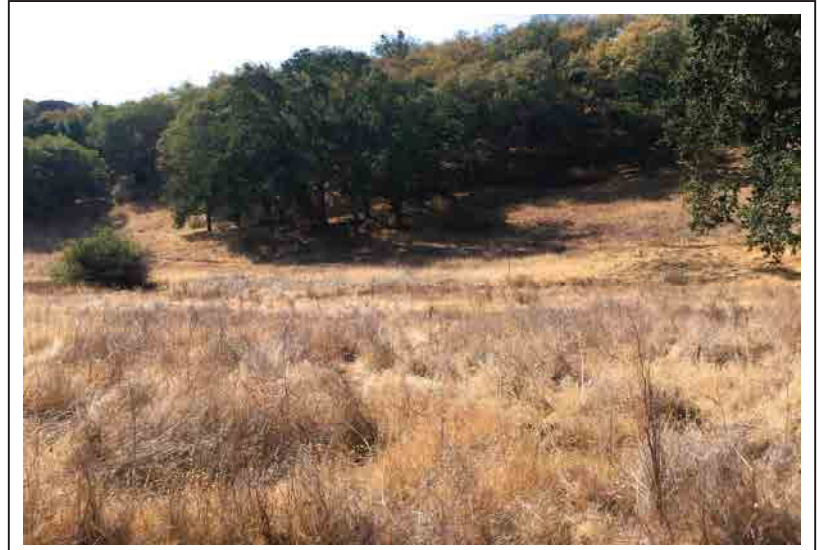
Photo 7a: Southwest - ID03 - 06/19/2019

Photo 7b: Southwest - ID03 - 10/28/2020

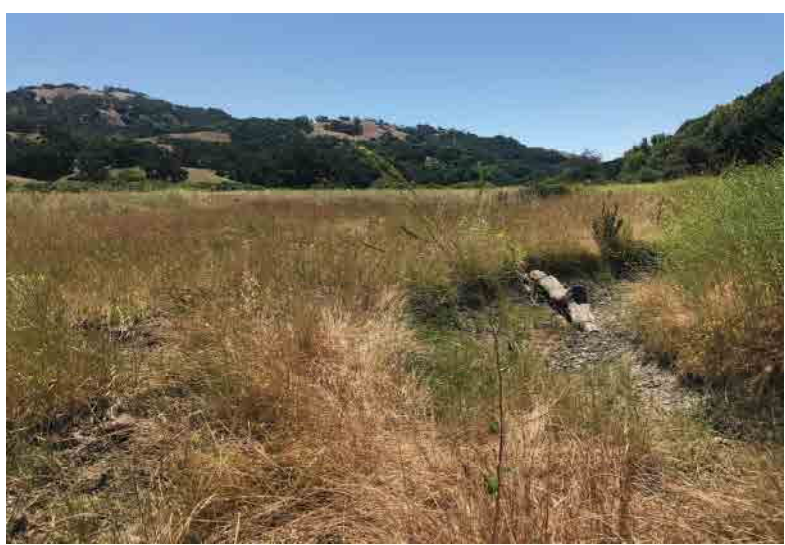
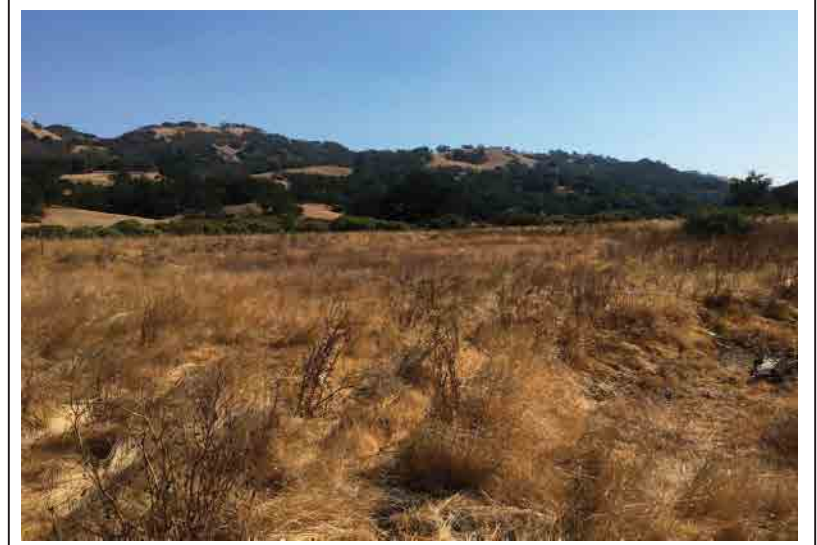
Photo 8a: South - ID03 - 06/19/2019

Photo 8b: South - ID03 - 10/28/2020

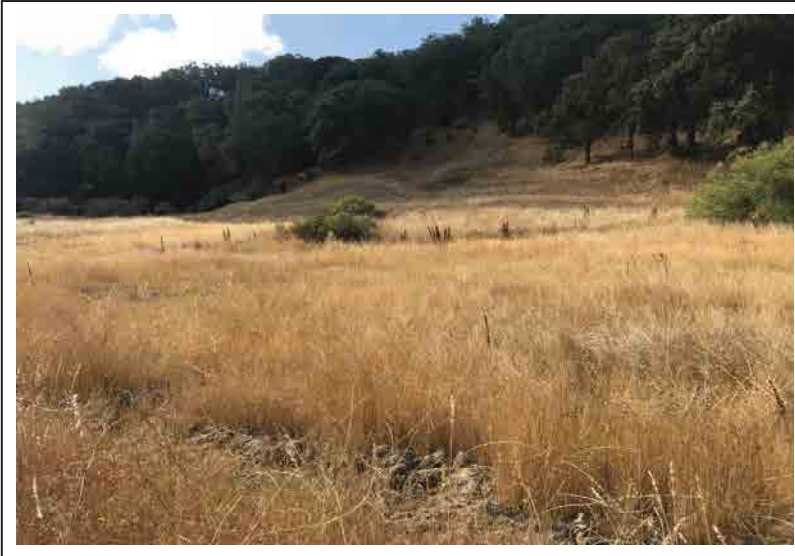
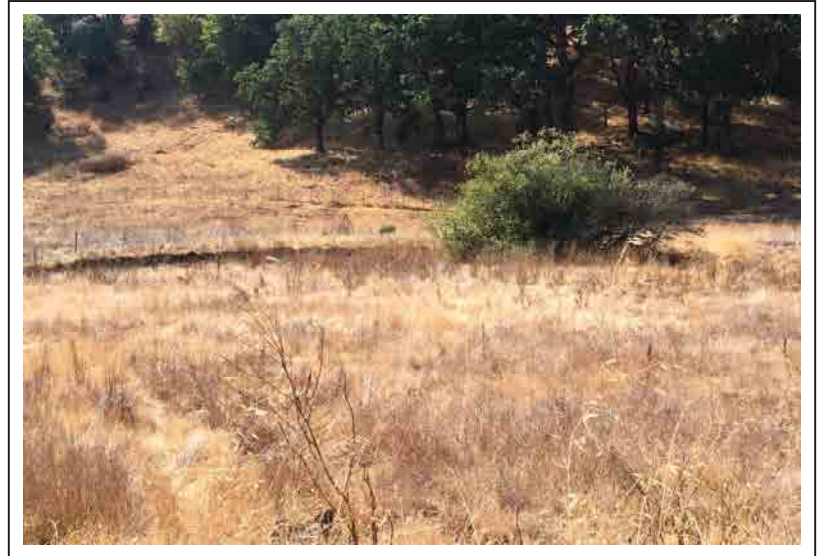
Photo 9a: West - ID03 - 09/30/2019

Photo 9b: West - ID03 - 10/28/2020

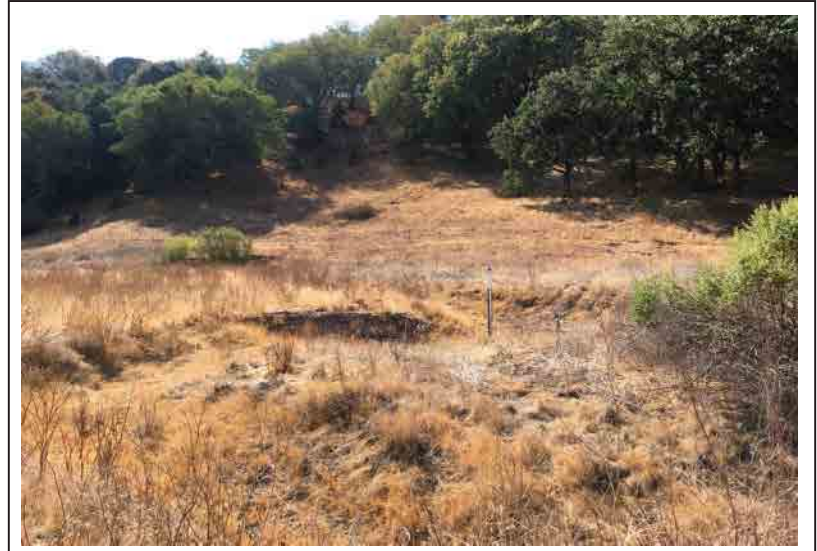
Photo 10a: Southwest - ID03 - 06/19/2019

Photo 10b: Southwest - ID03 - 10/28/2020

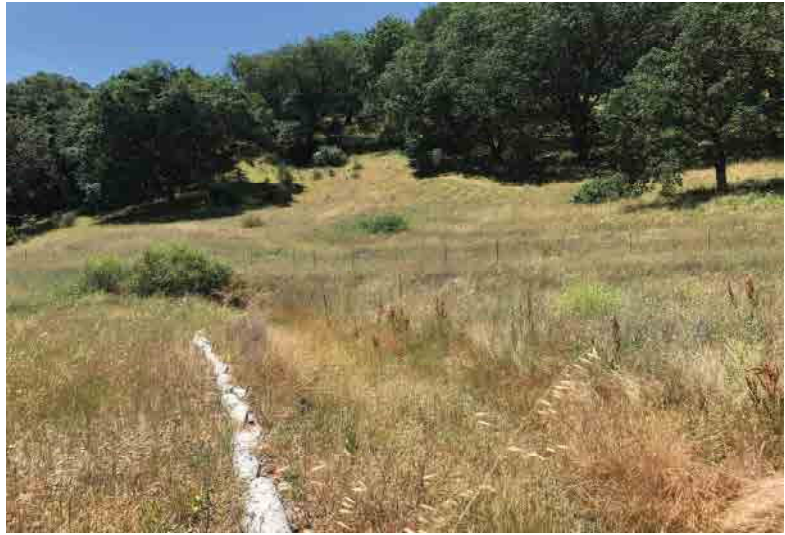
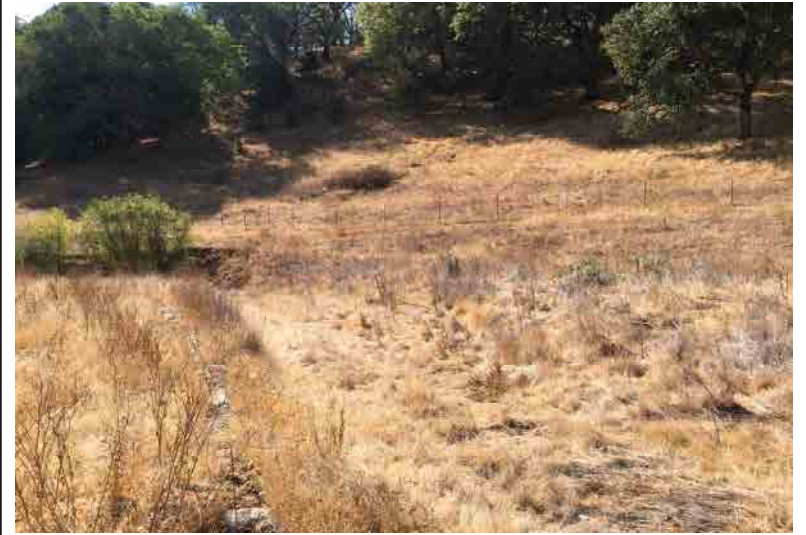
Photo 11a: West - ID03 - 06/19/2019

Photo 11b: West - ID03 - 10/28/2020

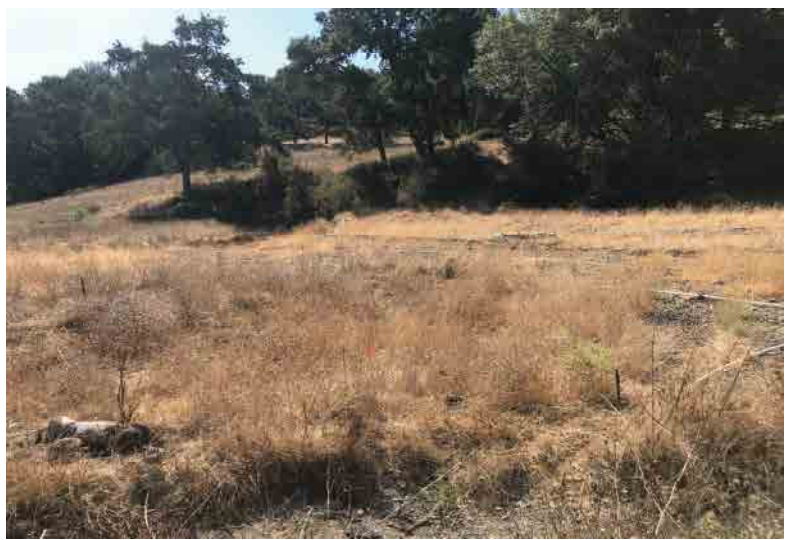
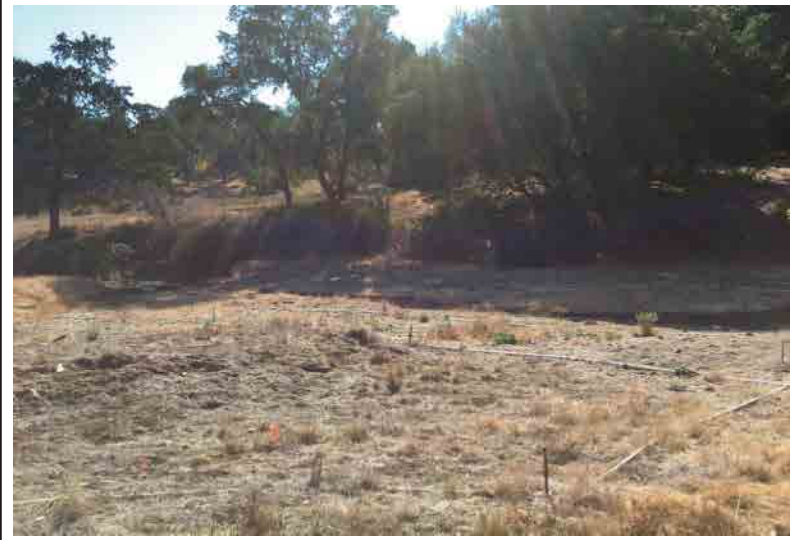
Photo 12a: South - ID03 - 09/30/2019

Photo 12b: South - ID03 - 10/28/2020

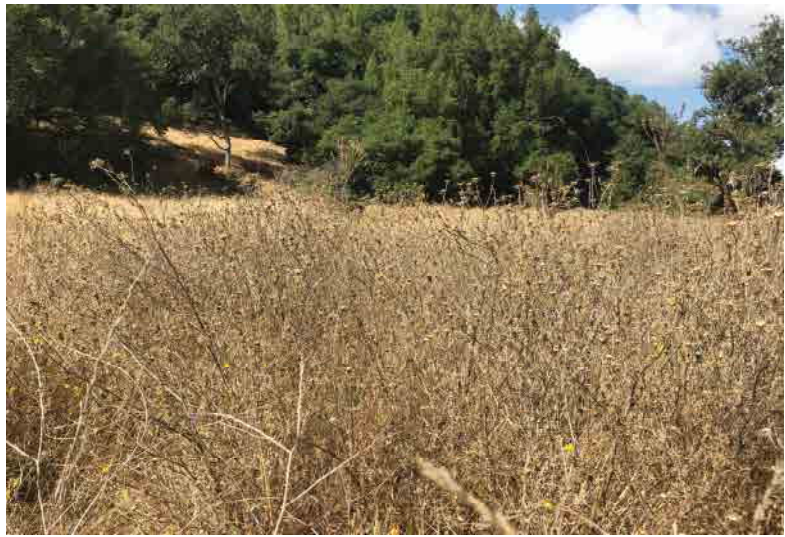
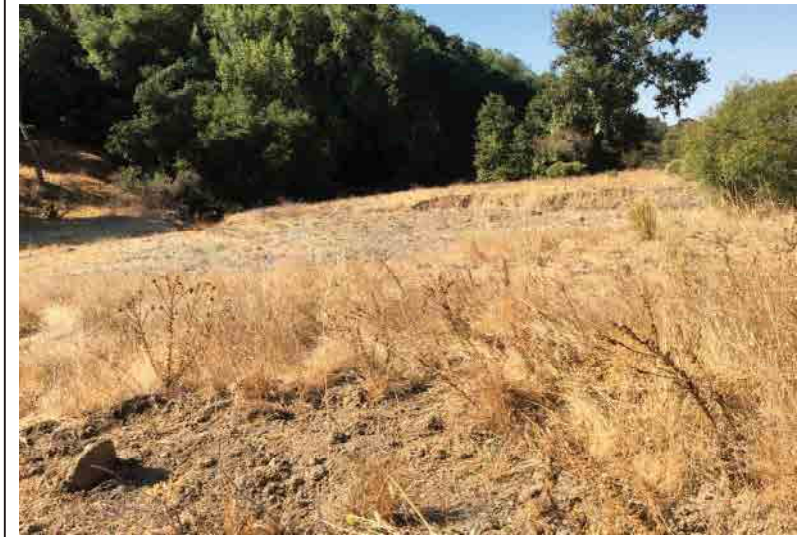
Photo 13a: North - ID03 - 09/30/2019

Photo 13b: North - ID03 - 10/28/2020

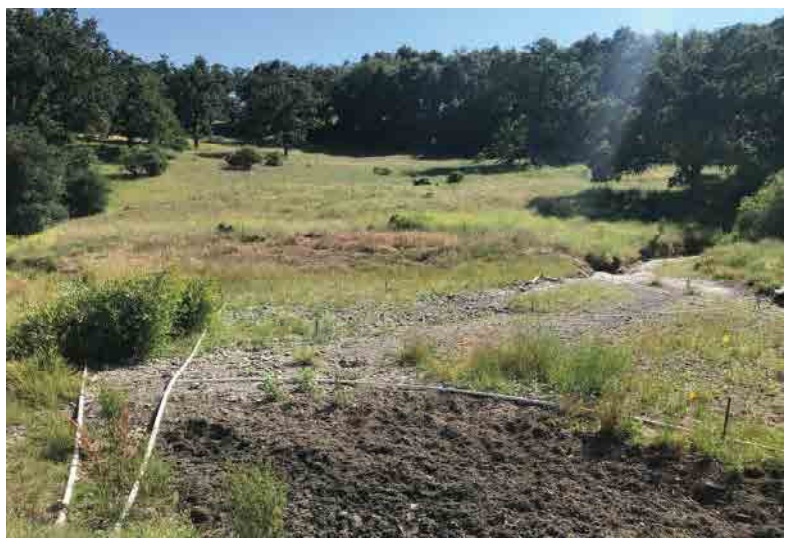
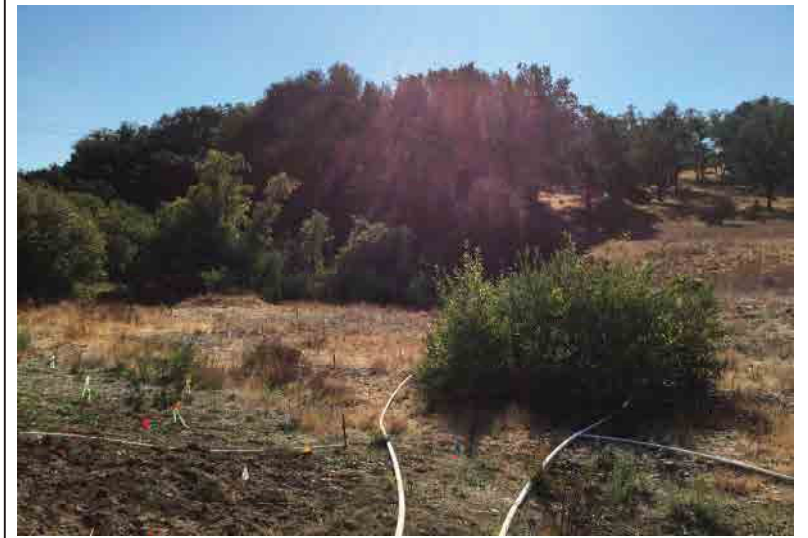
Photo 14a: West - ID03 - 06/19/2019

Photo 14b: West - ID03 - 10/28/2020

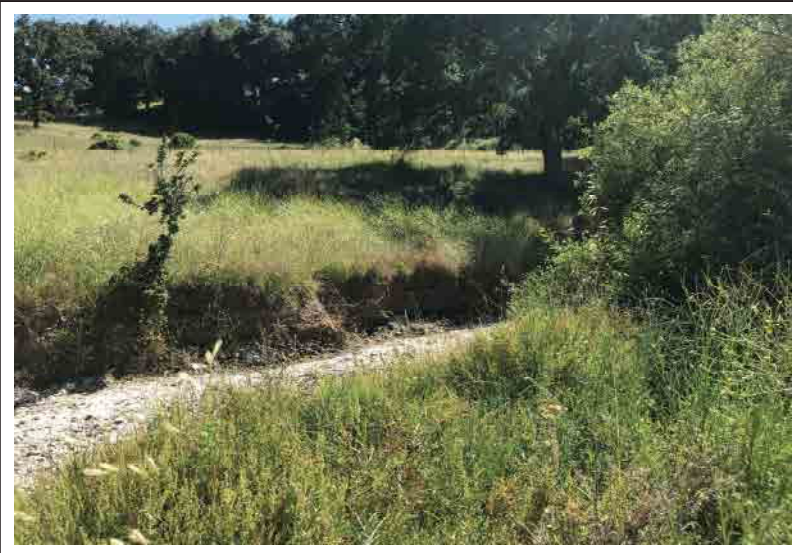
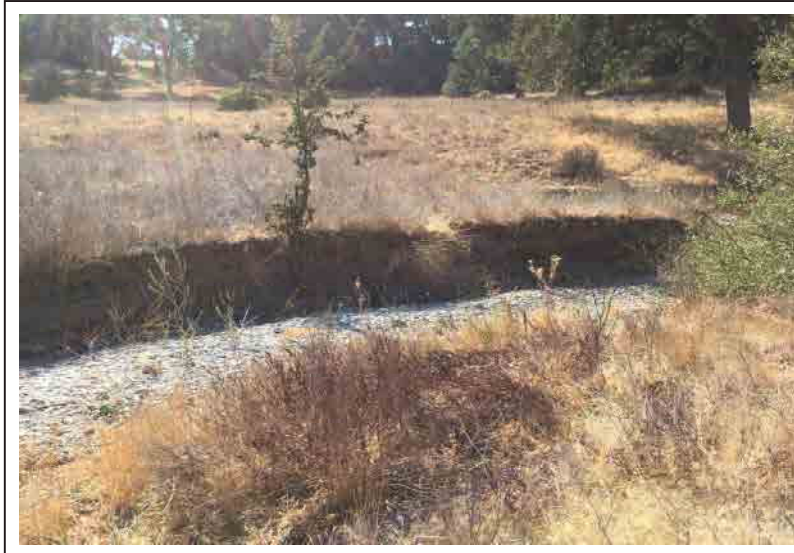
Photo 15a: West - ID03 - 06/19/2019

Photo 15b: West - ID03 - 10/28/2020

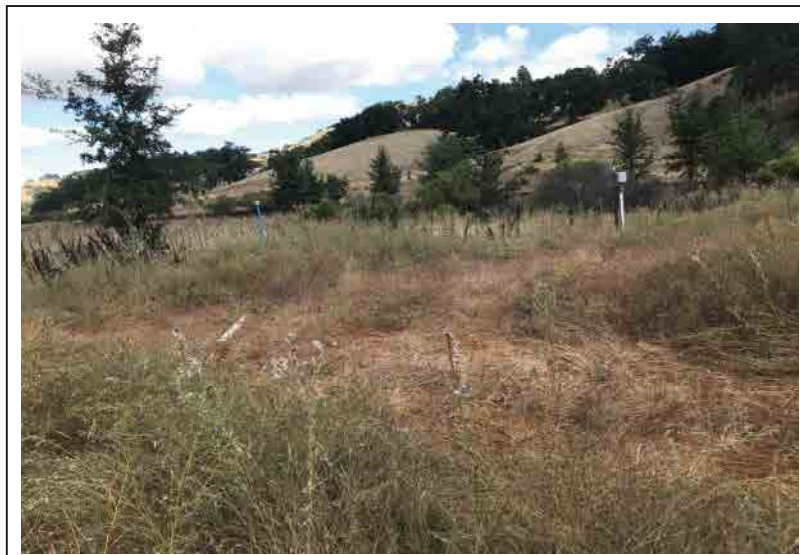
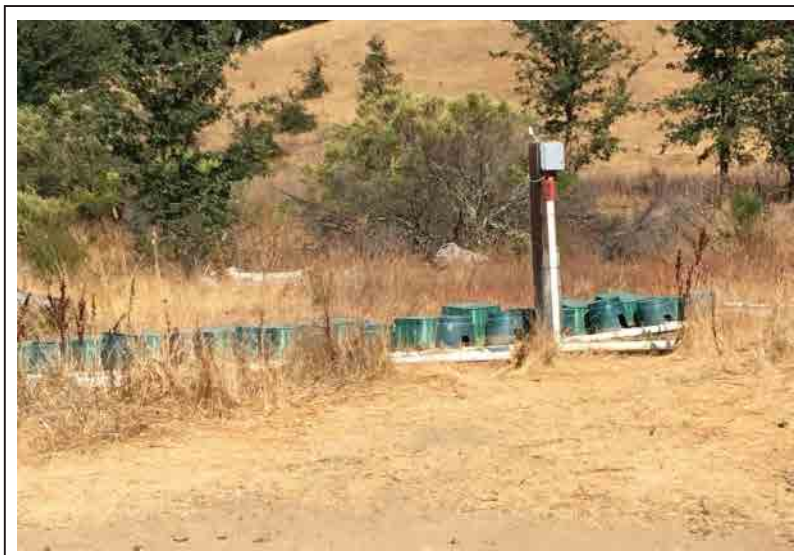
Photo 16a: East - ES03-01 / SW04 - 09/30/2019

Photo 16b: East - ED03-01 / SW04 - 10/28/2020

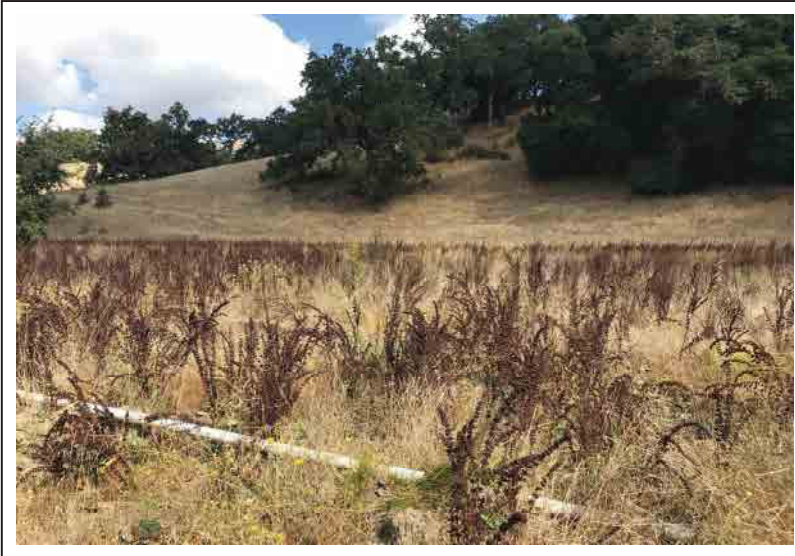
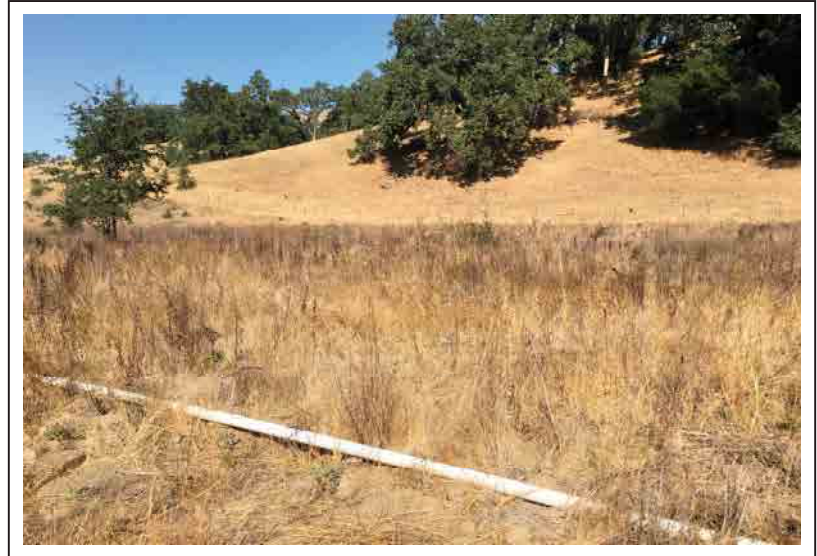
Photo 17a: - ED03-01 / SW02 - 09/30/2019

Photo 17b: East - ED03-01 / SW02 - 10/28/2020

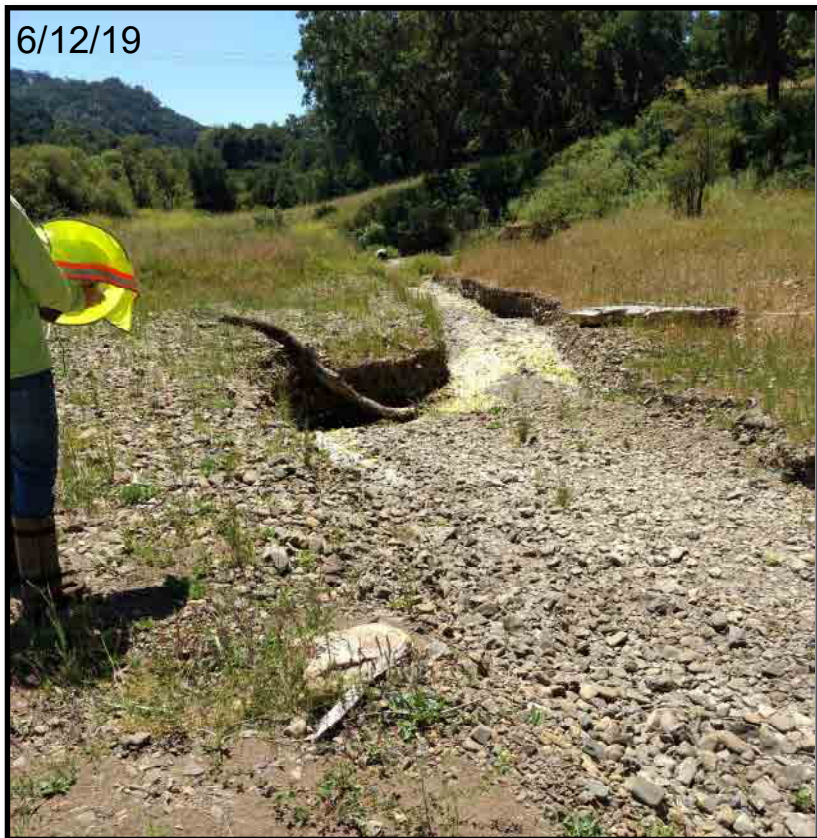
Year 1 topographic data (Donaldson and others, 2020) indicated that some areas of the floodplain at ID03-02, on San Felipe Creek, experienced over 1 foot of incision where the new cutoff channel formed through the created floodplain during the first year after construction. However, it should be noted that the new channel thalweg elevation is very close (i.e. less than 1-foot vertical difference) when compared to the former channel elevation. Follow-up observations during WY2020 suggest the cutoff channel changed little during WY2020 (**Figure 14**). The channel incision is localized and appears to be accompanied by a similar amount of deposition in the original channel, thus extensive channel incision on San Felipe Creek is not anticipated as a result of current channel dynamics. Thus, we interpret that Success Criterion 4 is being met at this location. However, based on a collaborative review at the end of WY2020, the Team seeks to offset the risk of a new channel evolving to become a dominant and/or incising single thread channel. Thus, the Team has proposed to install an engineered debris jam in the inlet of the new channel to force flows to spread across the created floodplain area. This plan is described in the Draft San Felipe Creek Restoration Remediation Plan (Sweesy, 2020).

Figure 14. Comparison of San Felipe Creek at created floodplain ID03-02 between Year-1 and Year-2, looking downstream, San Felipe Creek Restoration Project, Joseph D. Grant Park, Santa Clara County, California.

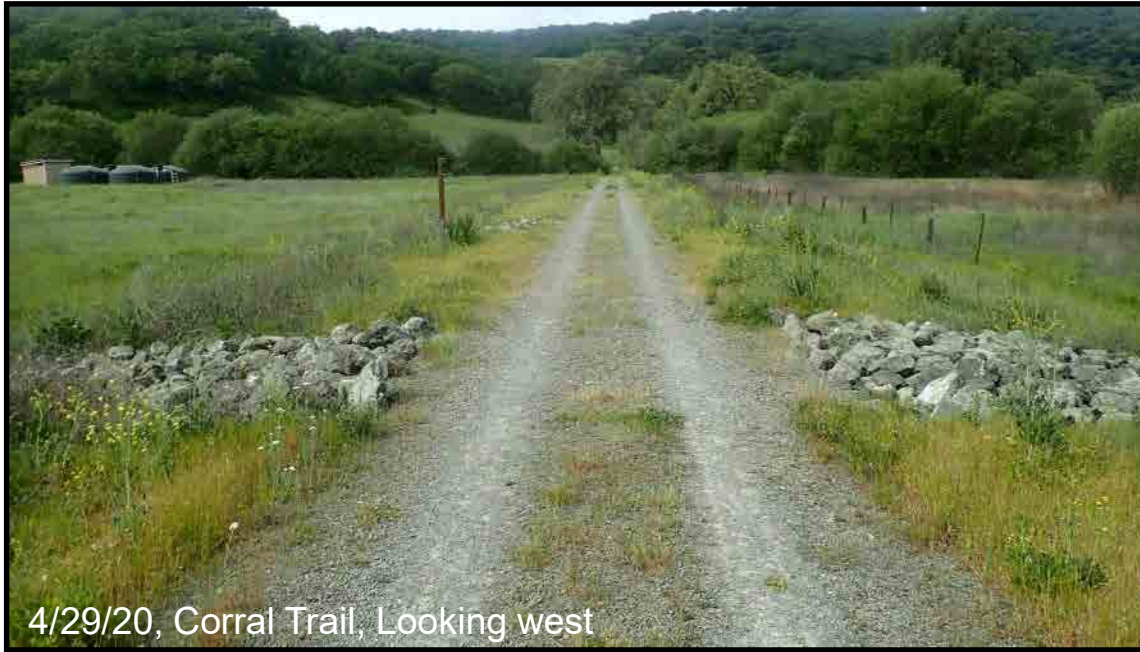
4/29/20, Corral Trail, Looking west

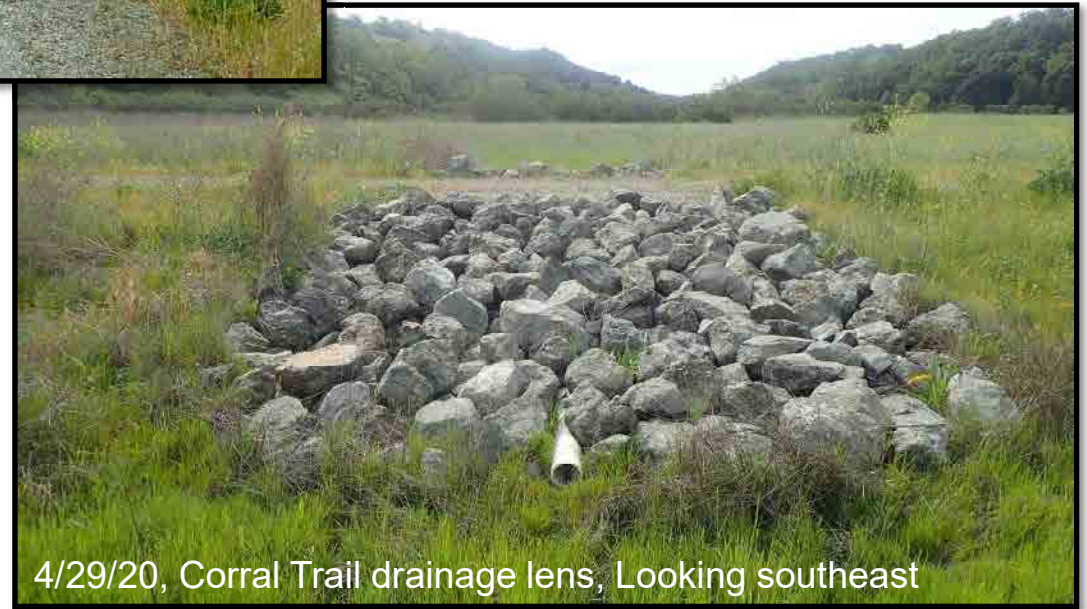
4/29/20, Corral Trail drainage lens, Looking southeast

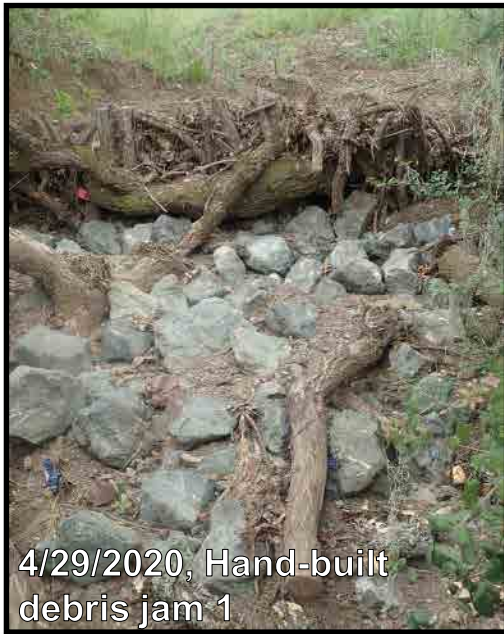
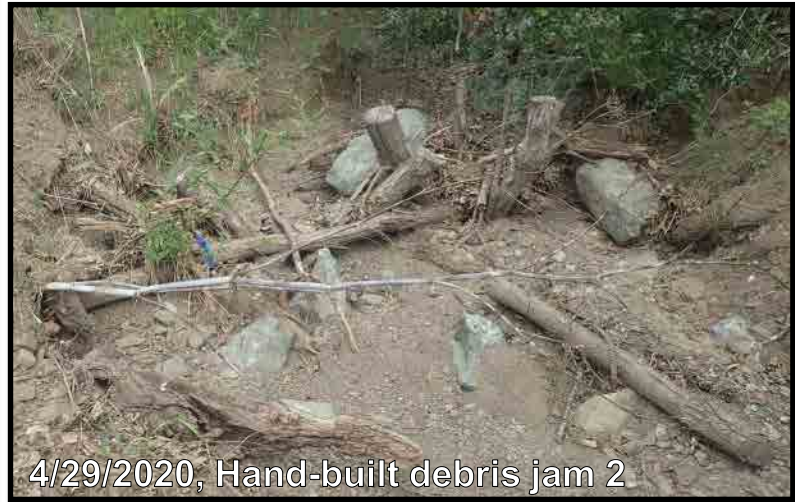
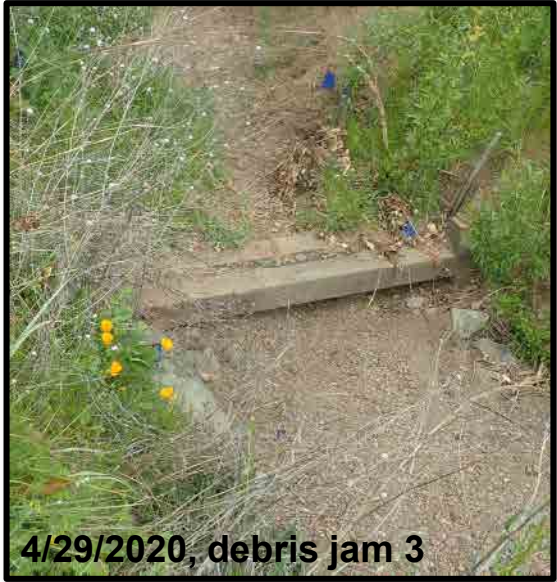
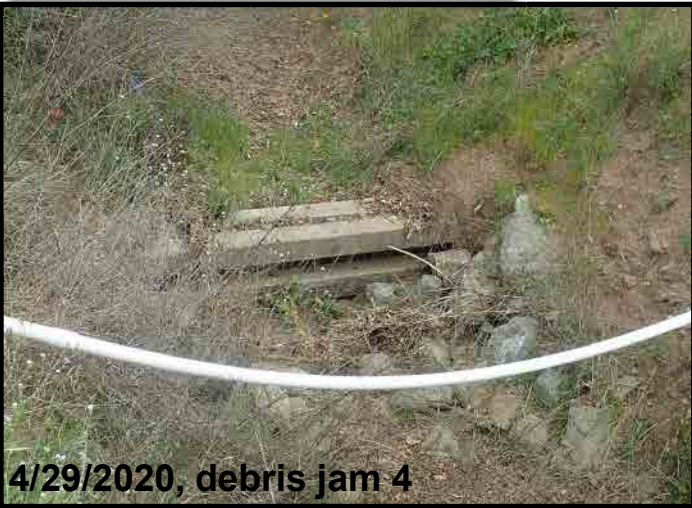
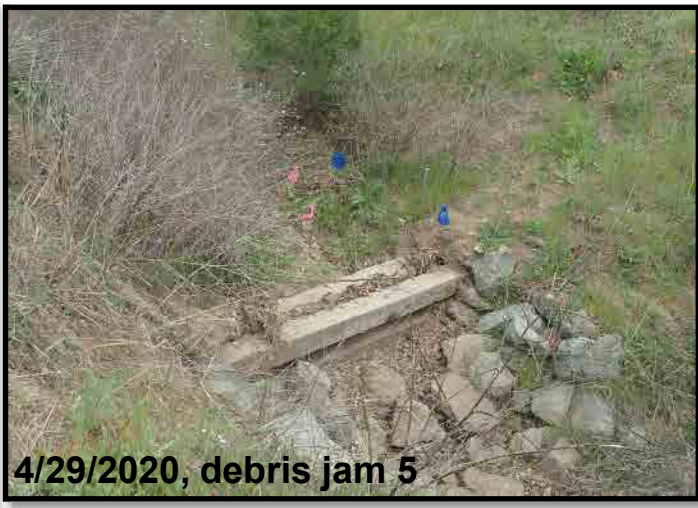
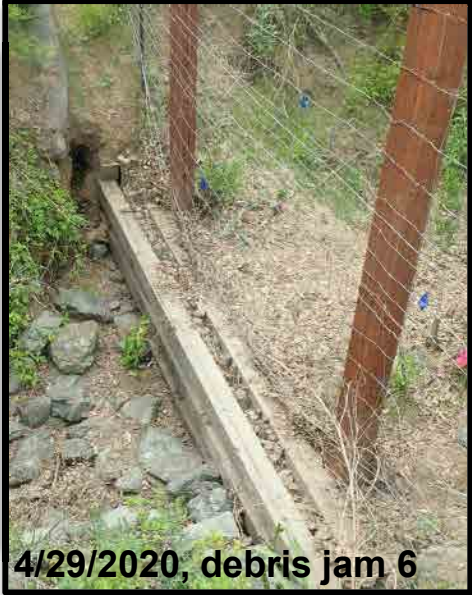
Figure 16. Staked debris jams at ID02-01, April 29, 2020, San Felipe Creek Restoration Project, Joseph D. Grant Park, Santa Clara County, California.

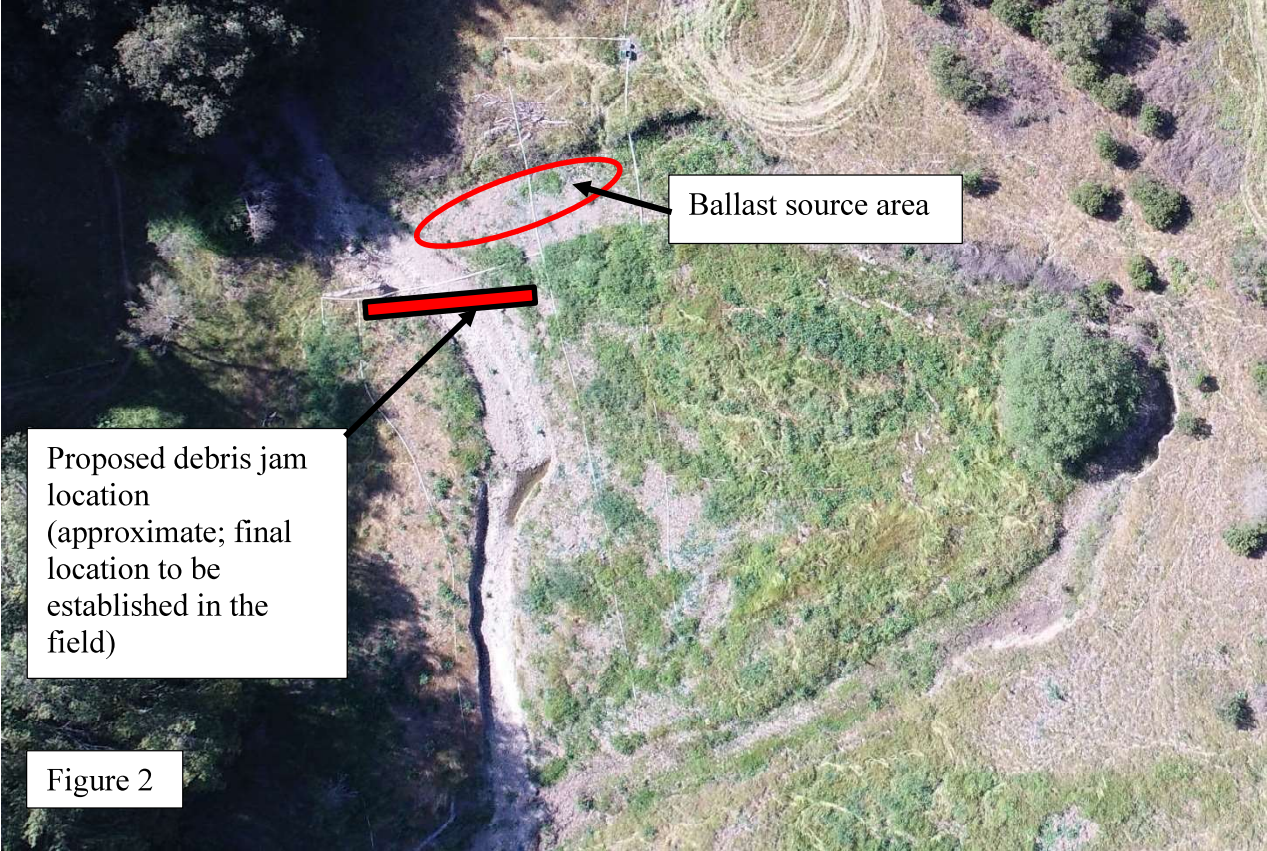
Figure 2 shows the cutoff channel that formed in 2019 as seen in May 2020. Figure 3 shows the upstream entrance to the cutoff channel. Overall, ID03-02 is currently functioning as expected with respect to the anticipated dynamic channel movement, sediment sequestration, and sediment transport continuity as outlined in the MMP.

The proposed solution is to install a debris jam accompanied by slash in the newly-formed cutoff channel. The debris jams are intended to raise water surface elevations in order to enhance overbank flow onto and through the created inset floodplain and into secondary channels. The debris jam should be constructed at the location indicated in Figure 2 under the direction of the engineer's representative. A typical plan for constructing the debris jam is presented in Attachment C.
