# ANNUAL RESTORATION MONITORING REPORT

## YEAR 4

SAN FELIPE CREEK RESTORATION PROJECT  
SANTA CLARA VALLEY HABITAT AGENCY

**JANUARY 2023**

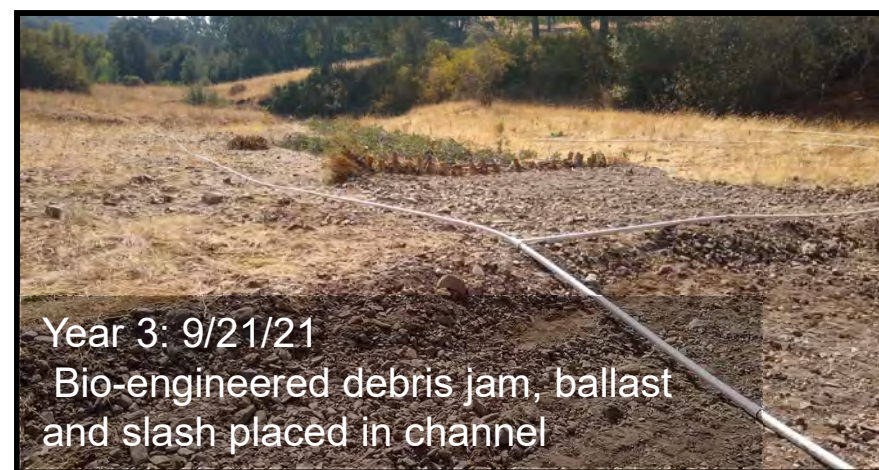
Year 3: 9/21/21

Bio-engineered debris jam, ballast and slash placed in channel

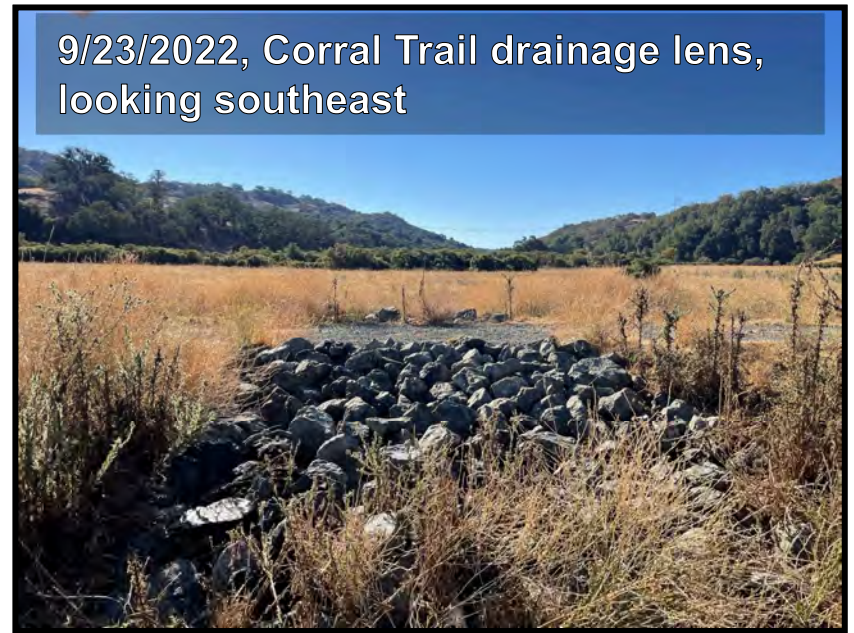
9/23/2022, Corral Trail drainage lens, looking southeast

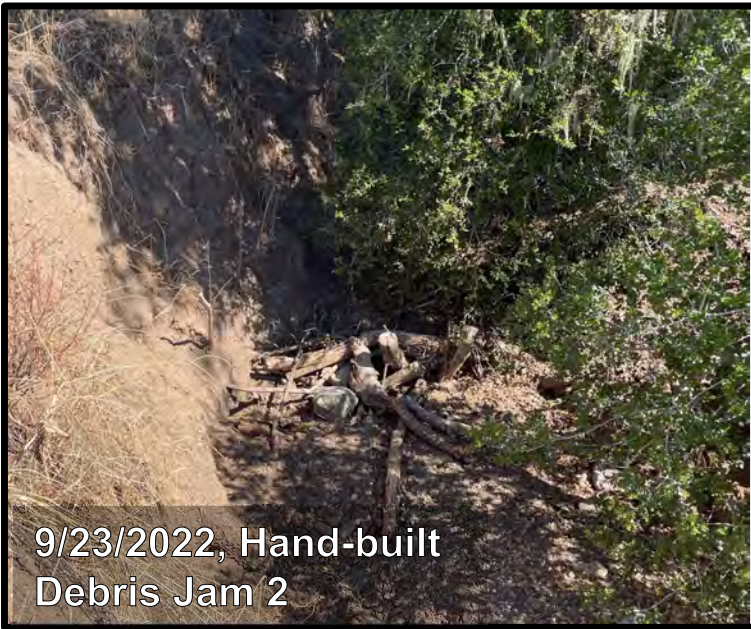
9/23/2022, Hand-built  
Debris Jam 2

At this time, we recommend adding a second course of staked debris jams, as outlined in the MMP, during summer 2023. At this point as all jams are considered to be "full", trapped sediment and debris has had the opportunity to consolidate, and additional aggradation could take place with additional structures, and would benefit the system with continued progress toward a long-term goal of reversing incision in this channel.

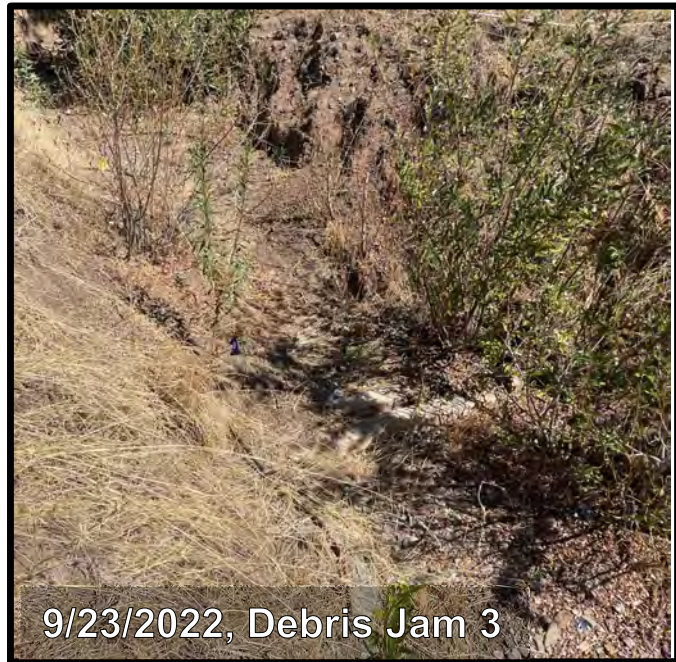
9/23/2022, Debris Jam 3

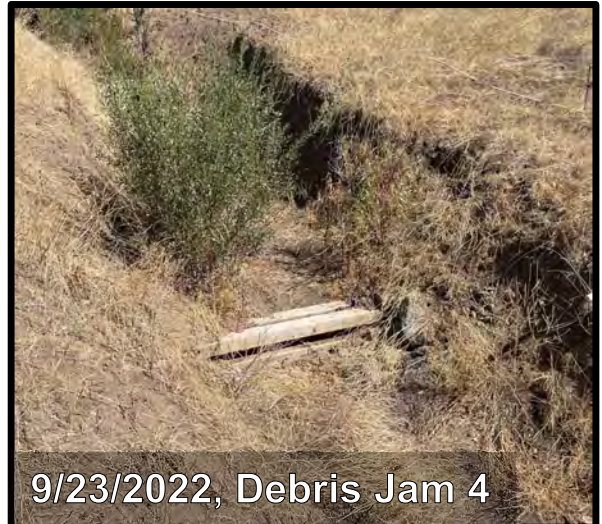
9/23/2022, Debris Jam 4

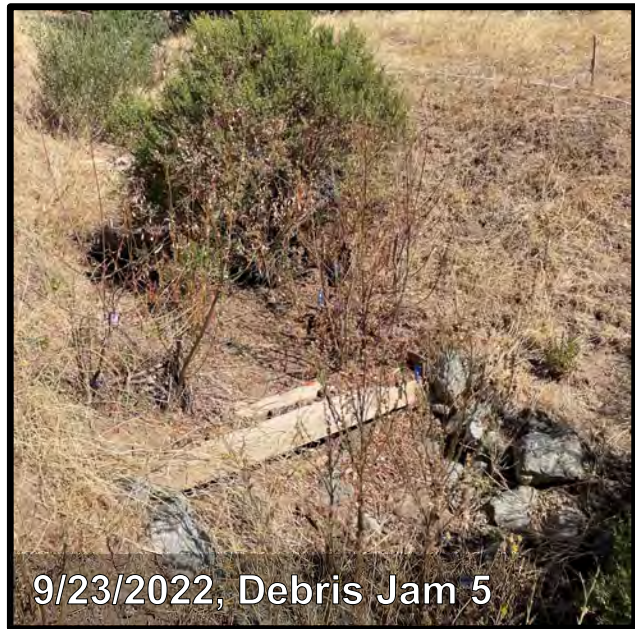
9/23/2022, Debris Jam 5

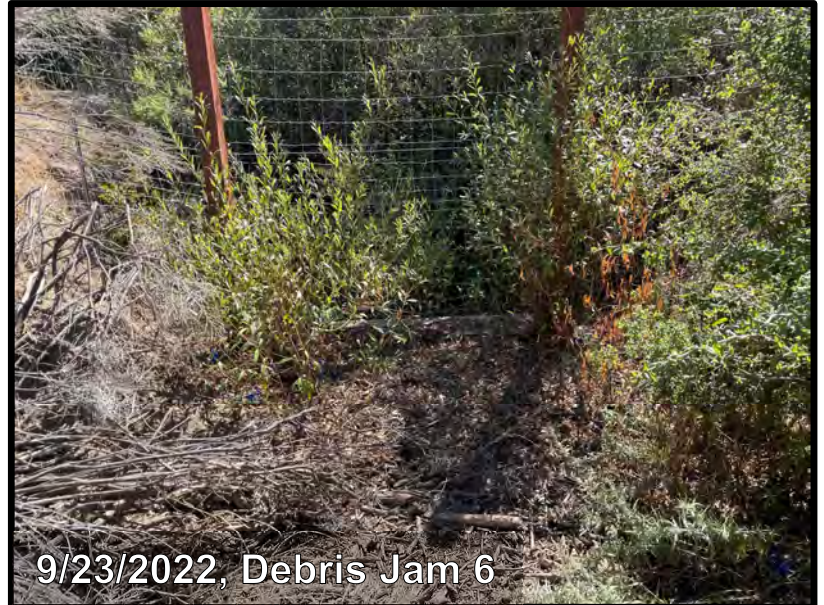
9/23/2022, Debris Jam 6
