ANNUAL RESTORATION MONITORING REPORT YEAR 5

SAN FELIPE CREEK RESTORATION PROJECT
SANTA CLARA VALLEY HABITAT AGENCY

DECEMBER 2023

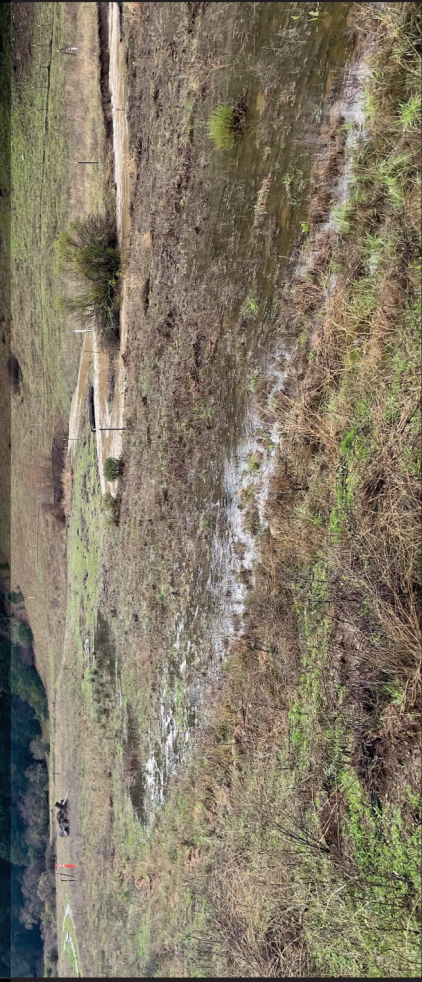
ID03-01a: 1/10/2023

Floodplain inundation near upstream end of created floodplain feature. Looking downstream from left bank.

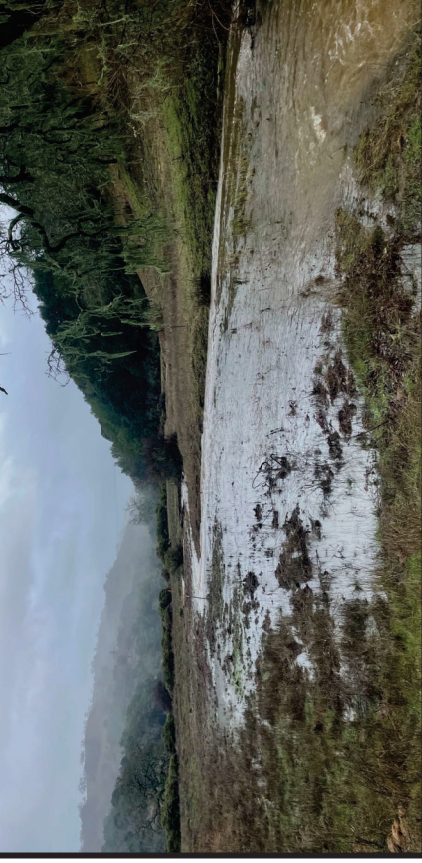
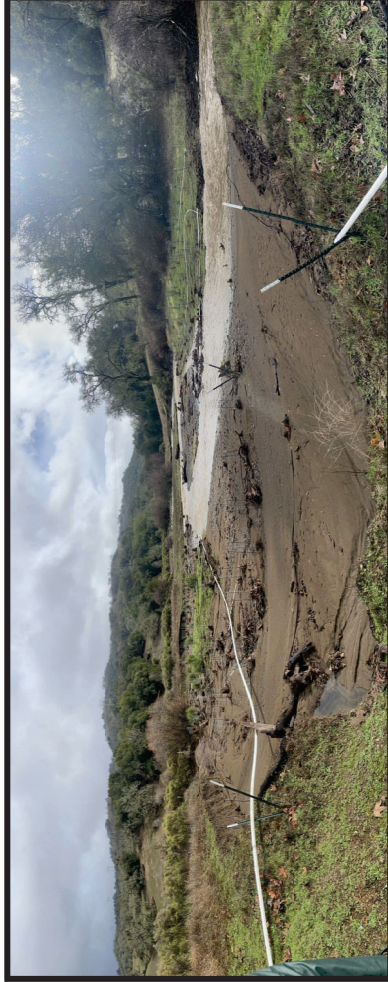
ID03-03/04: 1/10/2023

Flows spreading across the floodplain at ID03-03 and ID03-04 (background). San Felipe Creek enters from the right of frame.

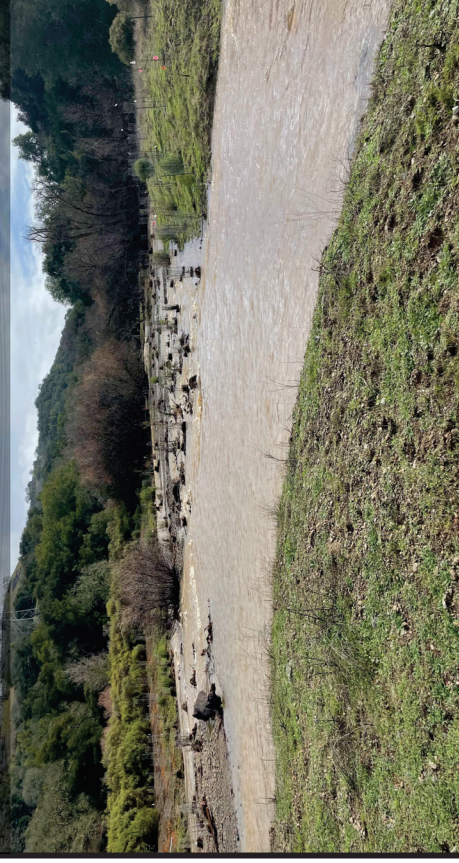
ID03-02: 1/10/2023

Floodplain inundation occurred and low flow channel relocated to the center of the created floodplain feature. San Felipe Creek enters from the right of the frame.

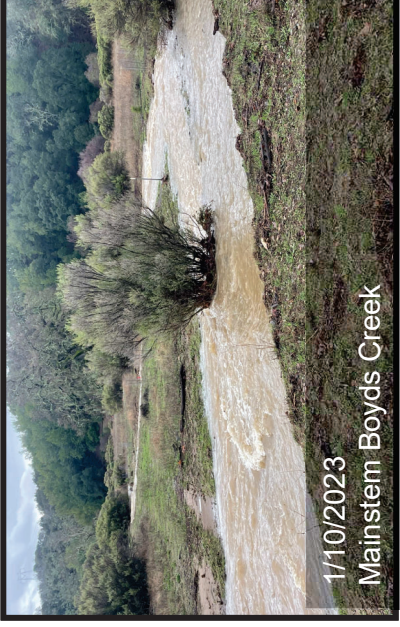
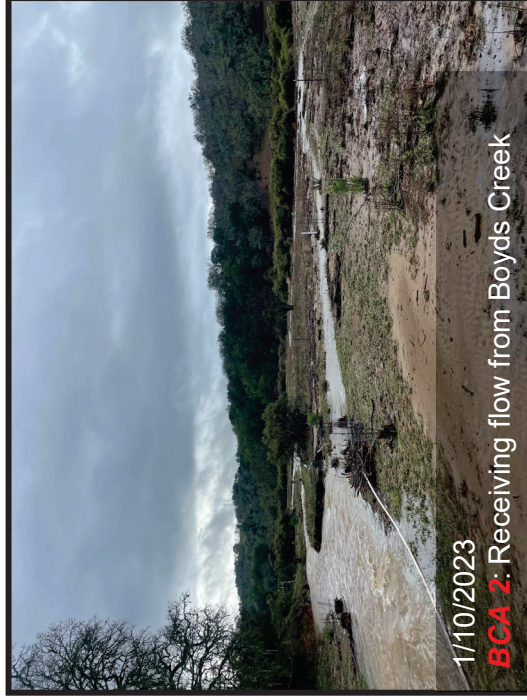
Figure 15. Observations of flow in all Boyds Creek distributary channels, January 10, 2023. Year 5 San Felipe Creek Restoration Project, Joseph D. Grant Park, Santa Clara County, California. Physical Success Criterion 3 was met in 2023. We are not concerned about the progression of the pre-existing knickpoint on BCA 4, the channel has not headcut to the buried log grade control installed as part of the project.

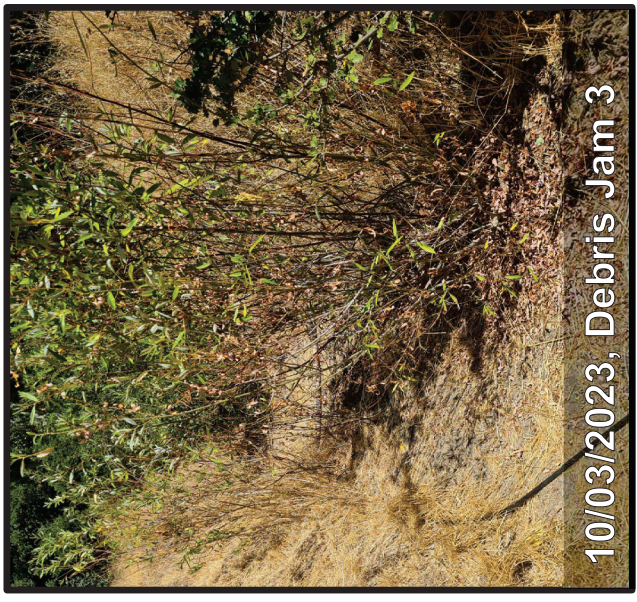
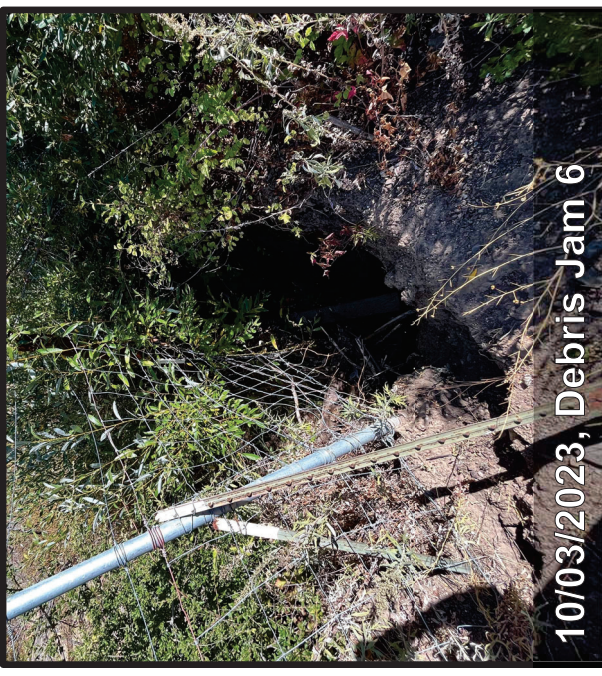
Staked debris jams were installed in the Incised Tributary (ID02-01), including four standard staked debris jams and two hand-built staked debris jams utilizing slash and cobbles. Based on direct observations and **Figure 13d** the staked debris jams appeared to both retain and release sediment between Year 0 and Year 5. In the same timeframe the channel appears to have widened (**Figure 13d**). These processes are to be expected. During WY2023, following winter high flows we observed that all but one of the staked debris jams are functioning as intended, serving to capture episodic sediment delivered during high flows and meter sediment out during intermediate flows (**Figure 19**). Erosion occurred at the downstream-most staked debris jam (Debris Jam 6, **Figure 19**) during WY2023. Debris wracked on the fence, which caused streamflow to erode the banks adjacent to the staked debris jam on both the right and left sides and

Figure 19. Staked debris jams at ID02-01, September 23, 2022, San Felipe Creek Restoration Project, Joseph D. Grant Park, Santa Clara County, California.

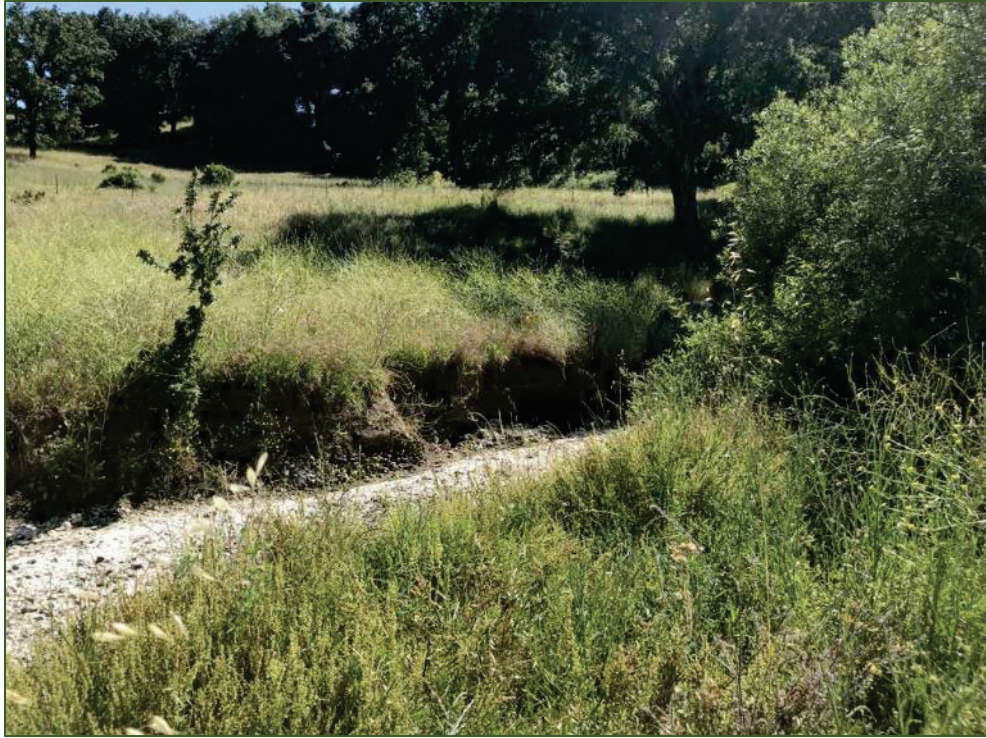
Photo Point 15

Photo 15. Year 1 (2019), facing west toward ID03. Photo taken 6/19/2019

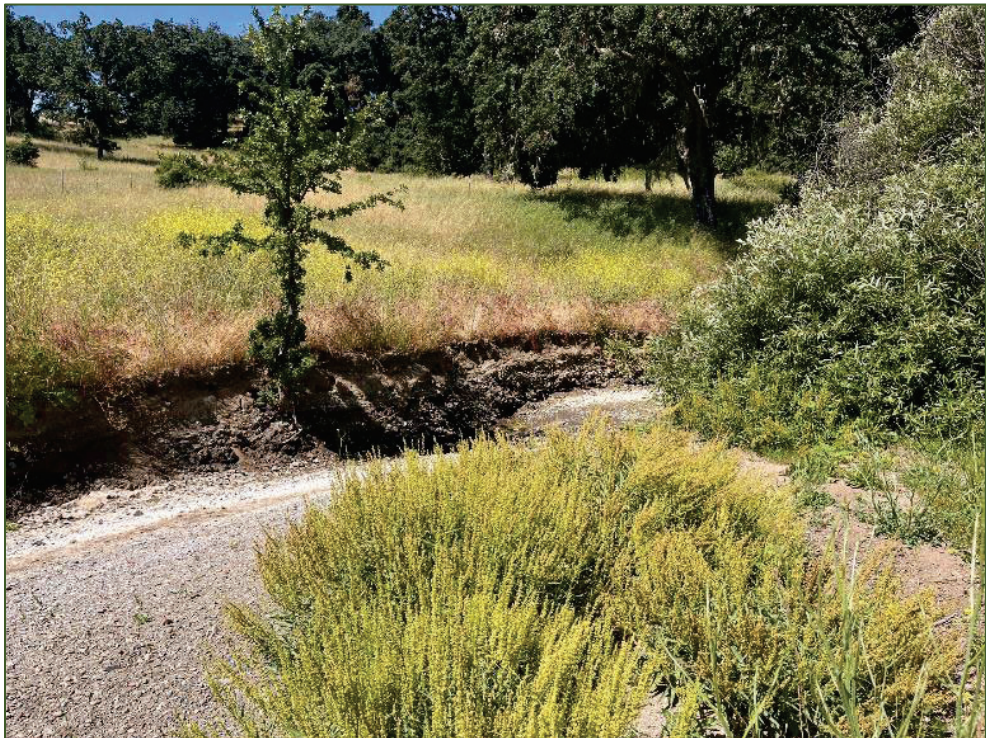
Photo 15. Year 5 (2023), facing west toward ID03. Photo taken 6/15/2023

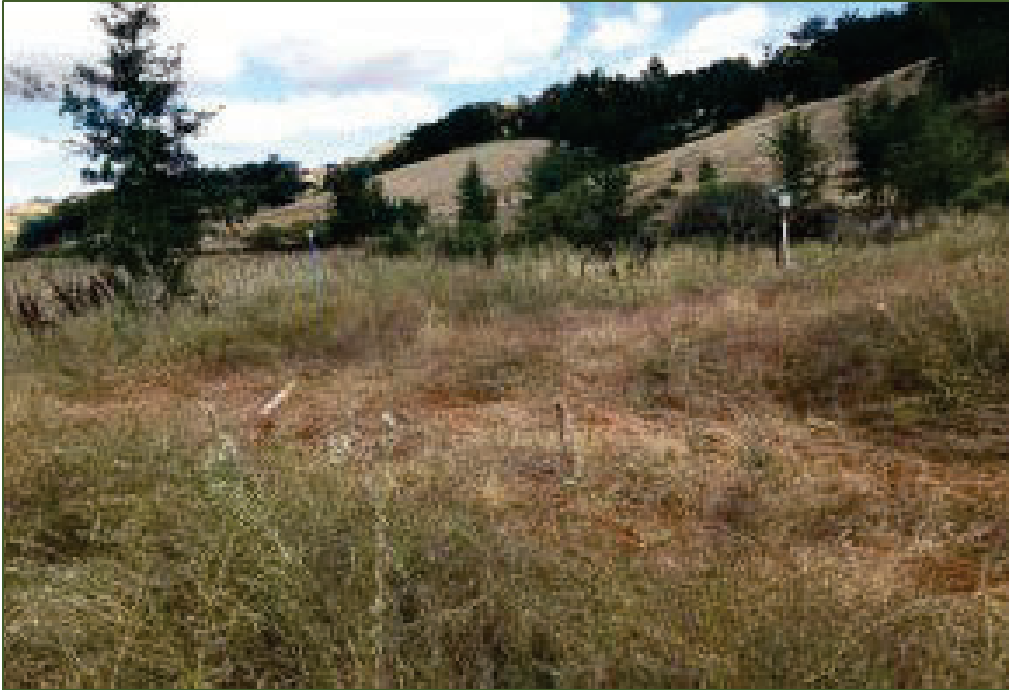
Photo Point 16

Photo 16. Year 1 (2019), facing east toward ED03-01 and SW04. Photo taken 6/19/2019

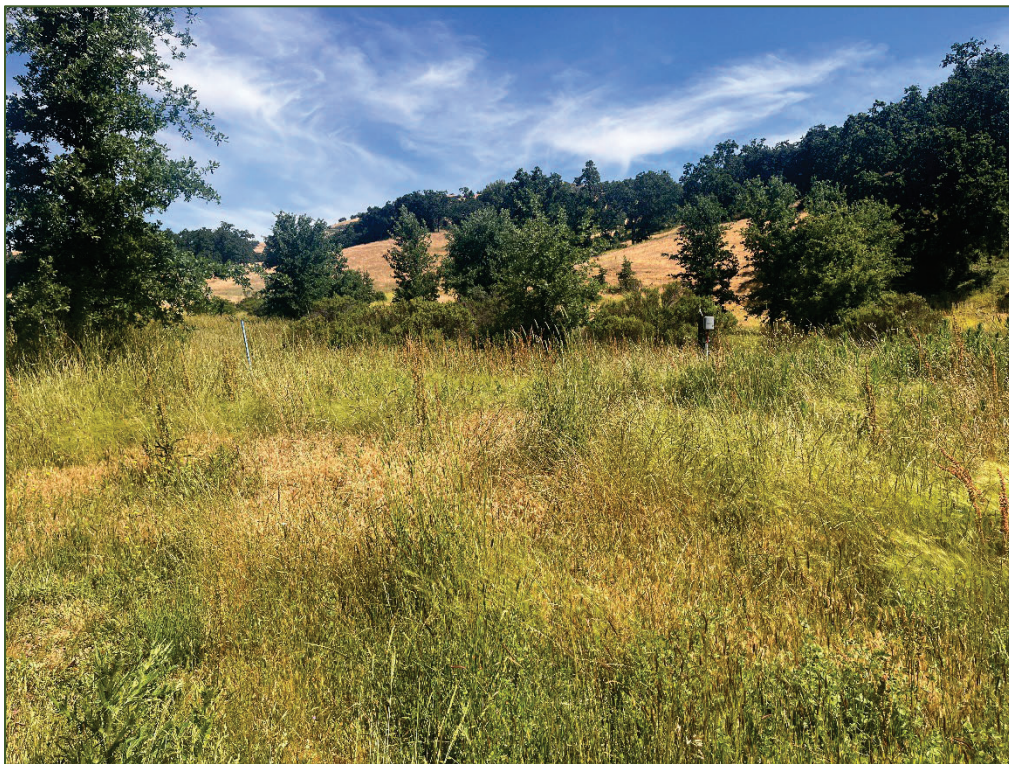
Photo 16. Year 5 (2023), facing east toward ED03-01 and SW04. Photo taken 6/15/2023

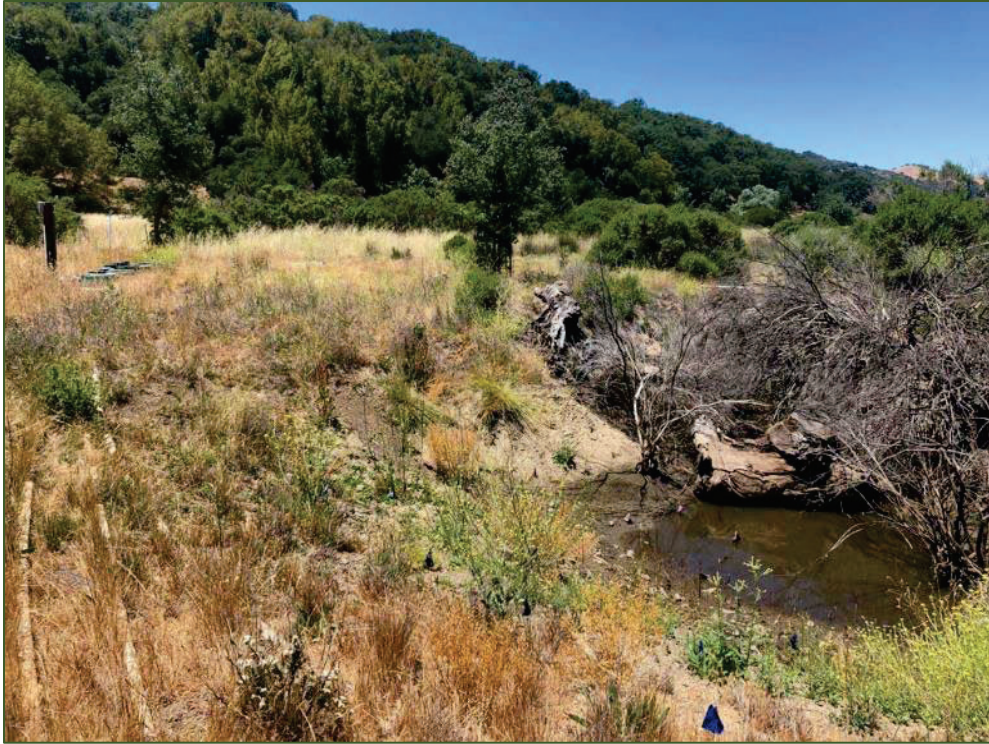
Photo Point 16*

Photo 16*. Year 3 (2021), facing northwest toward ED03-01. Photo taken 6/21/2021

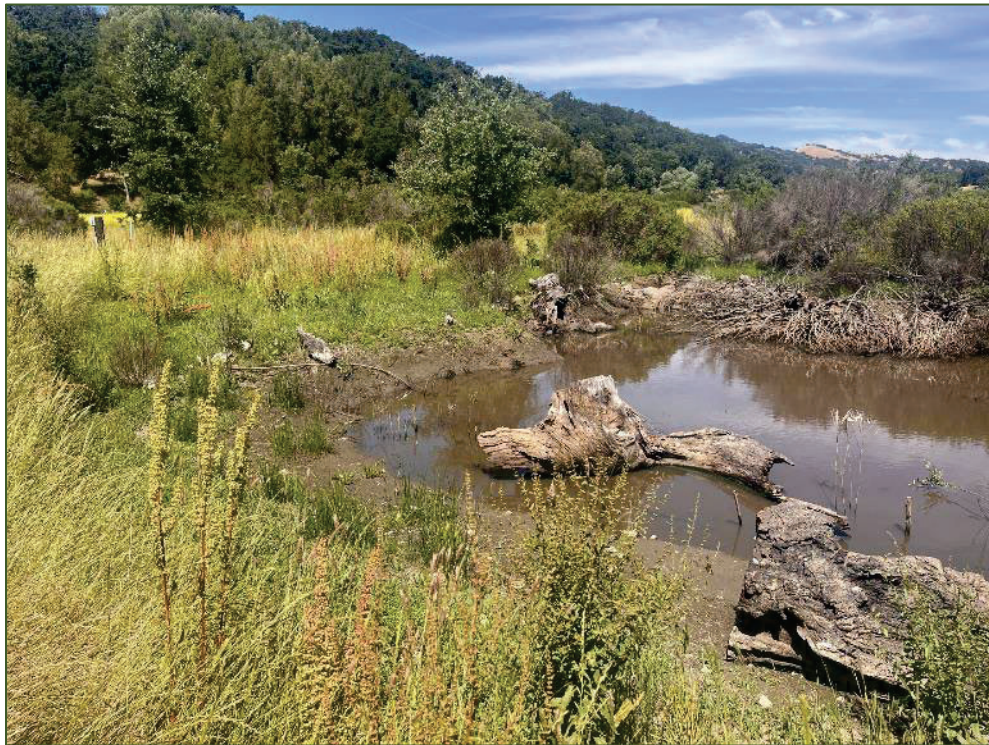
Photo 16*. Year 5 (2023), facing northwest toward ED03-01. Photo taken 6/15/2023

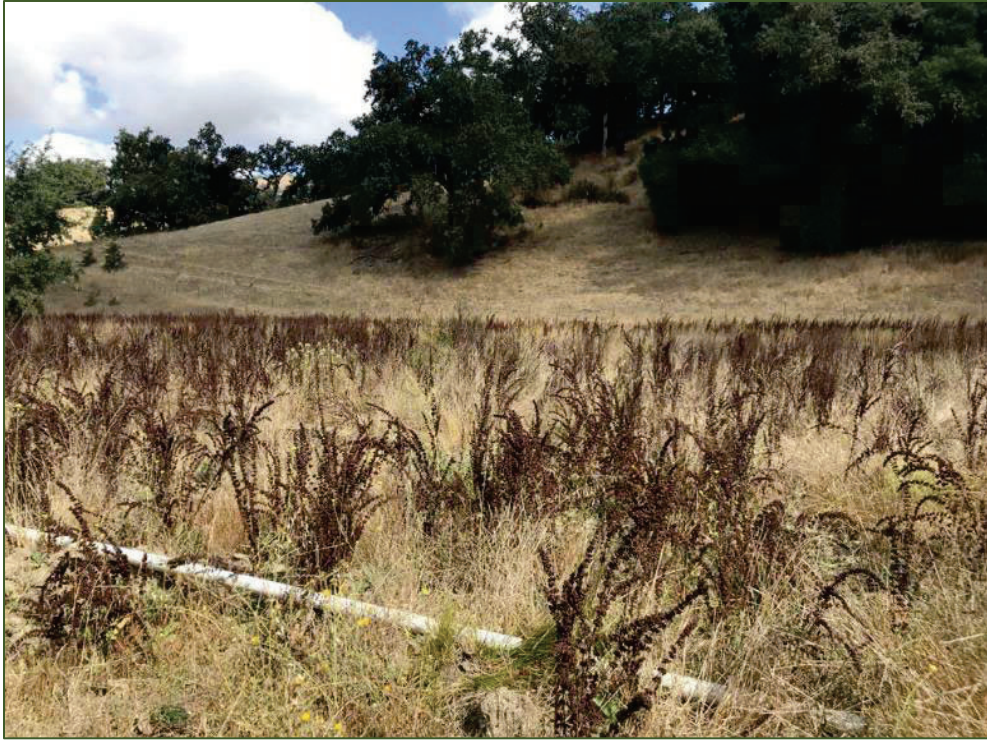
Photo Point 17

Photo 17. Year 1 (2019), facing east toward ED03-01 and SW02. Photo taken 9/30/2019

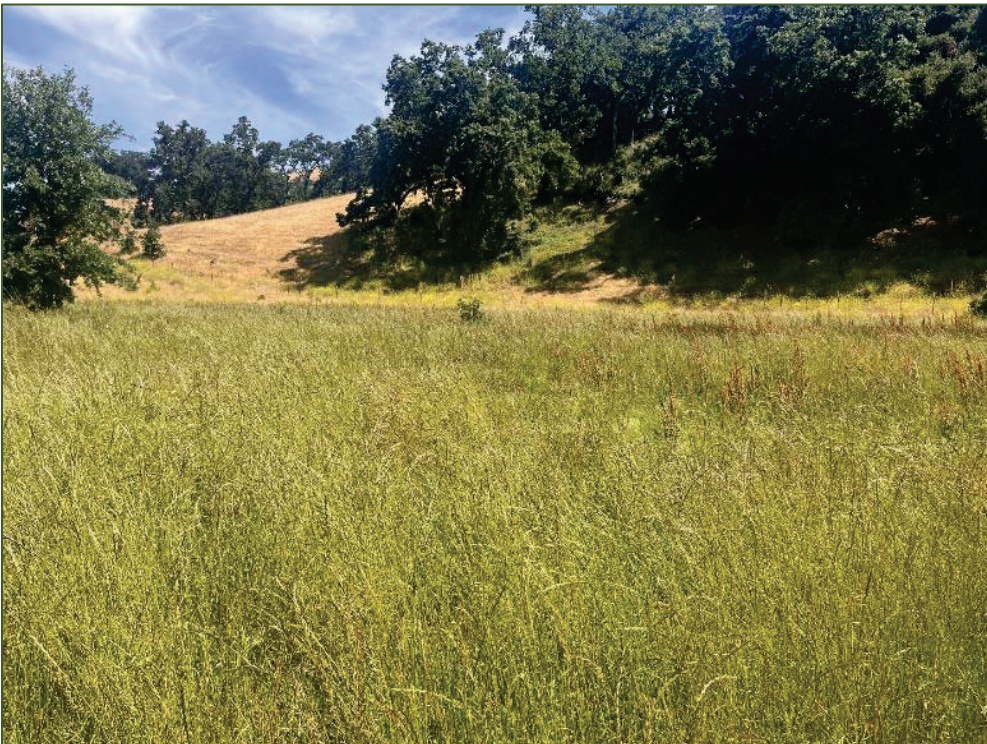
Photo 17. Year 5 (2023), facing east toward ED03-01 and SW02. Photo taken 6/15/2023

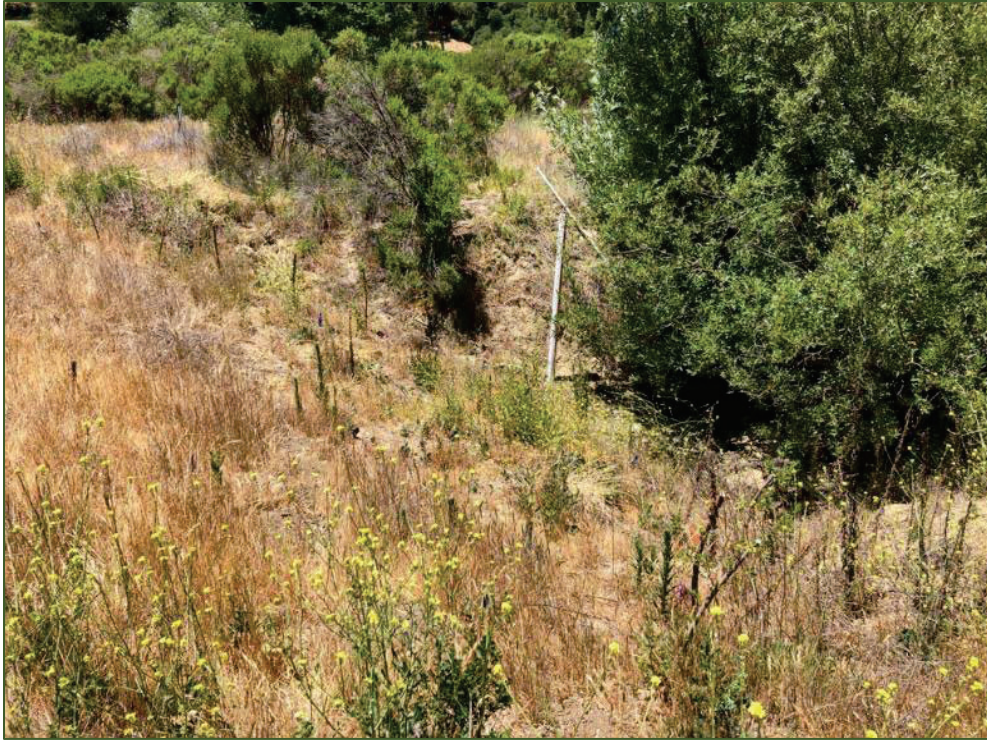
Photo Point 17*

Photo 17*. Year 3 (2021), facing west toward ED03-02. Photo taken 6/21/2021

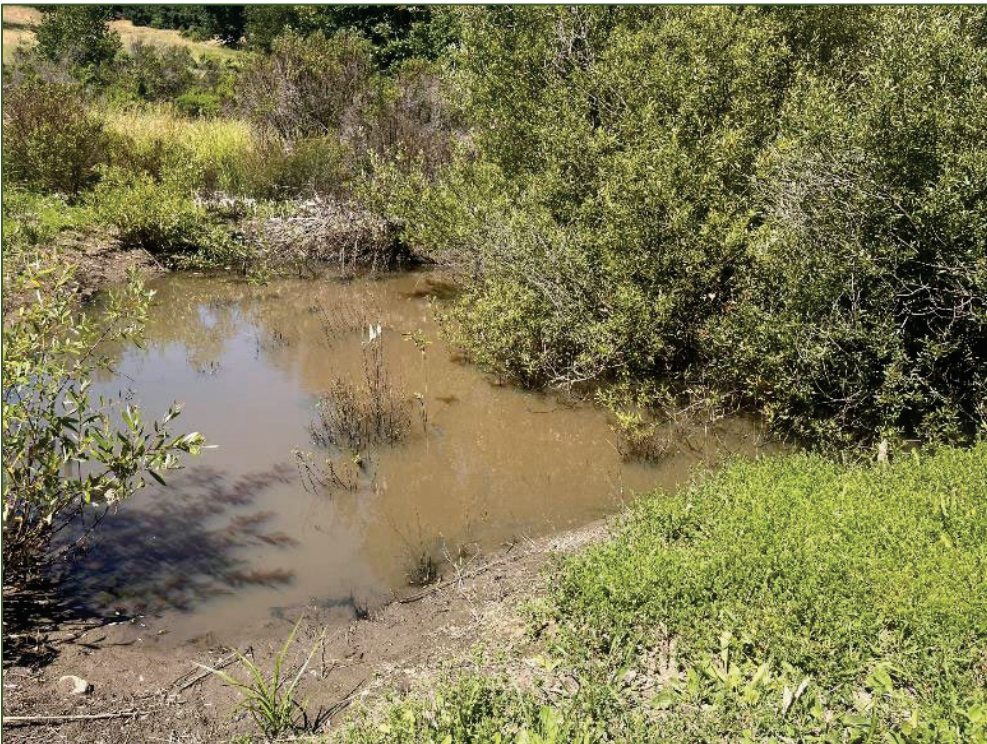
Photo 17*. Year 5 (2023), facing west toward ED03-02. Photo taken 6/15/2023

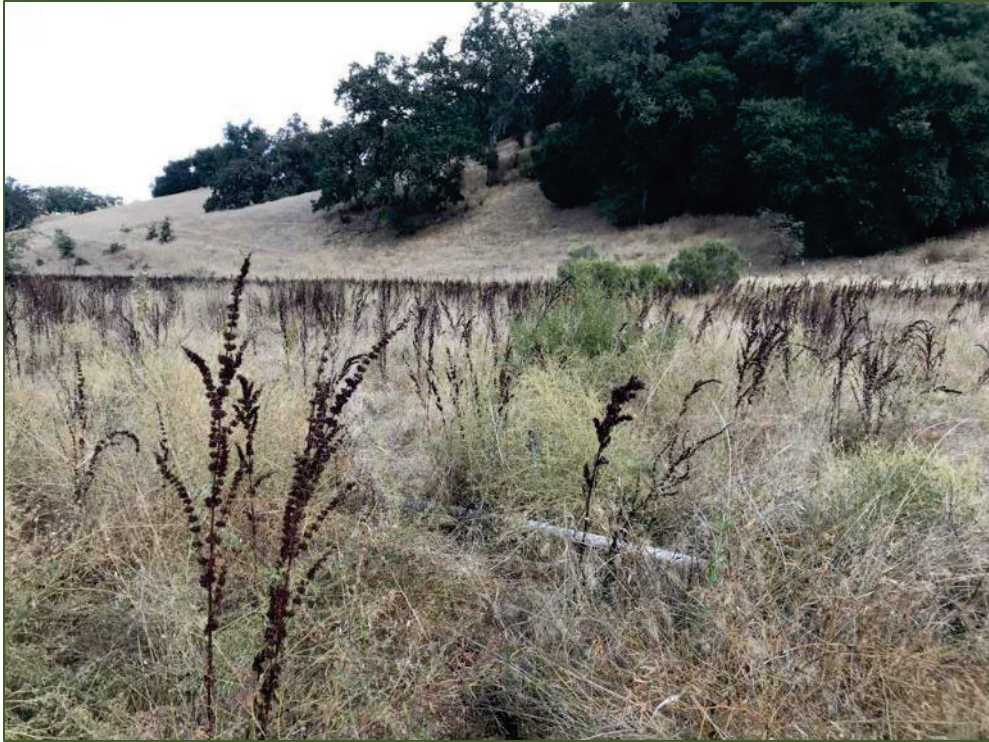
Photo Point 18

Photo 18. Year 1 (2019), facing east toward ED03-02 and SW02. Photo taken 9/30/2019

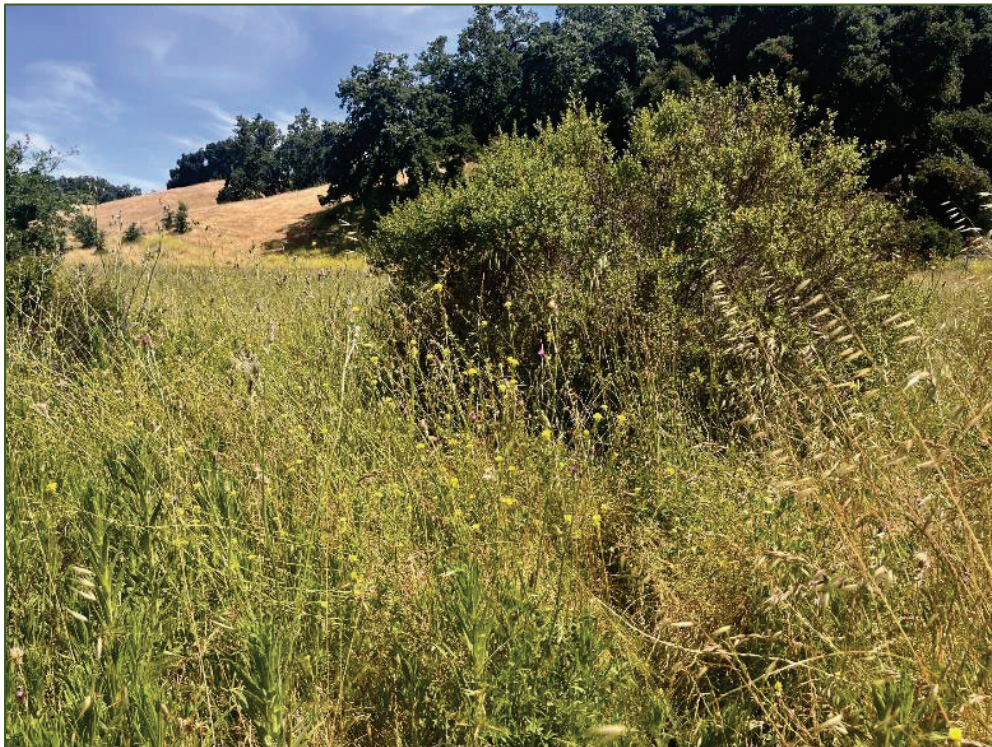
Photo 18. Year 5 (2023), facing east toward ED03-02 and SW02. Photo taken 6/15/2023

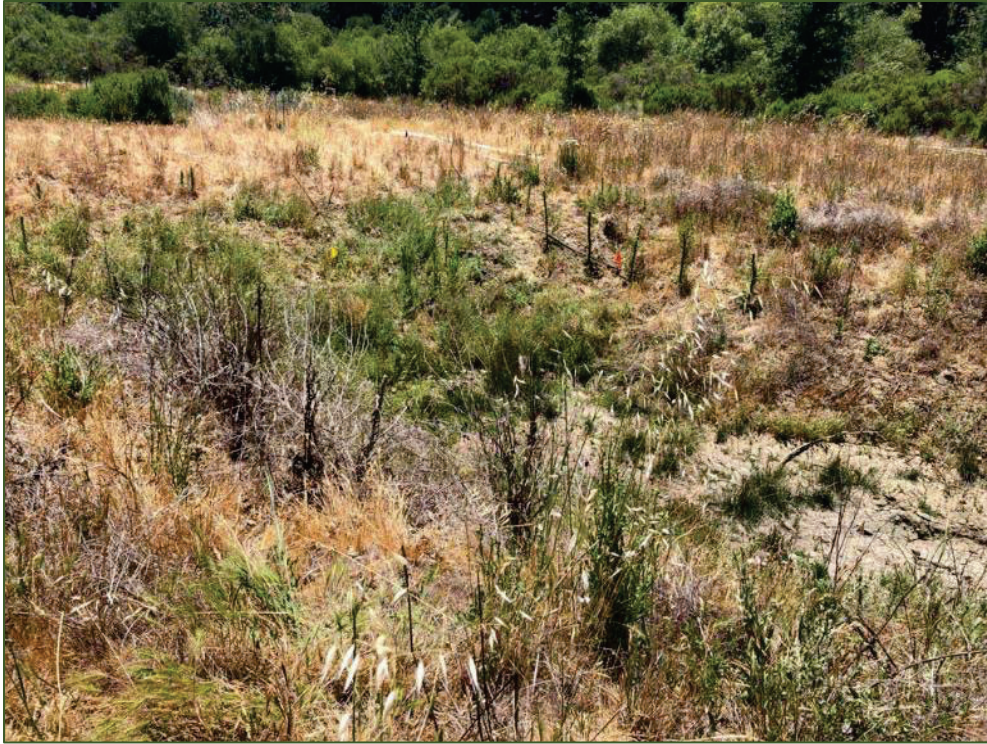
Photo Point 18*

Photo 18*. Year 3 (2021), facing southwest toward ED03-03. Photo taken 6/21/2021

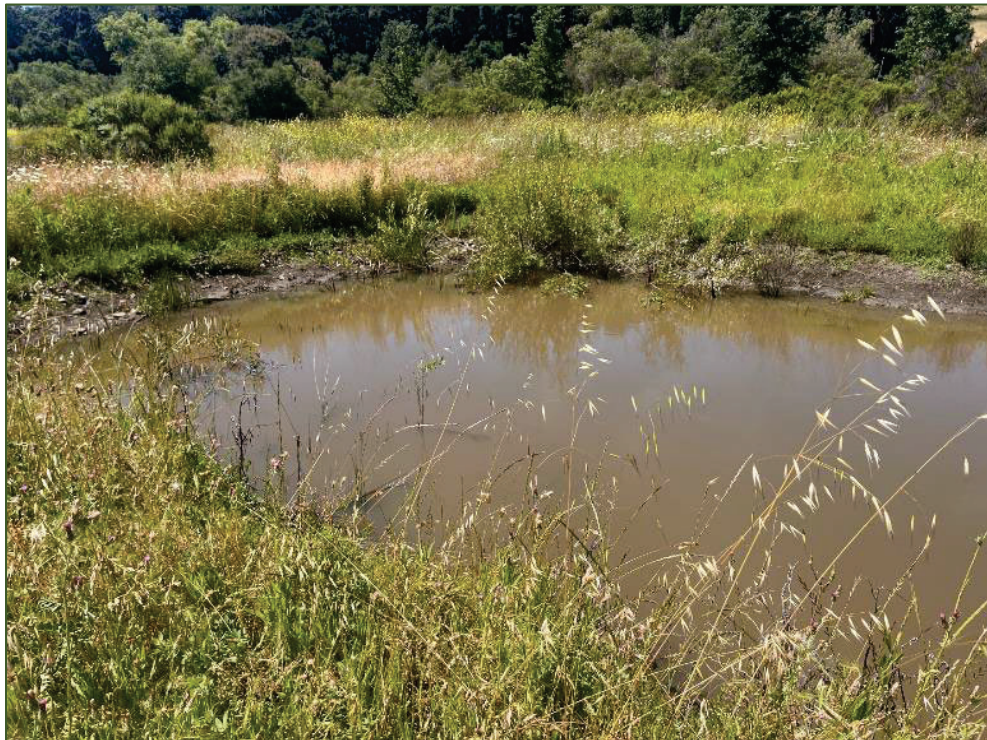
Photo 18*. Year 5 (2023), facing southwest toward ED03-03. Photo taken 6/15/2023

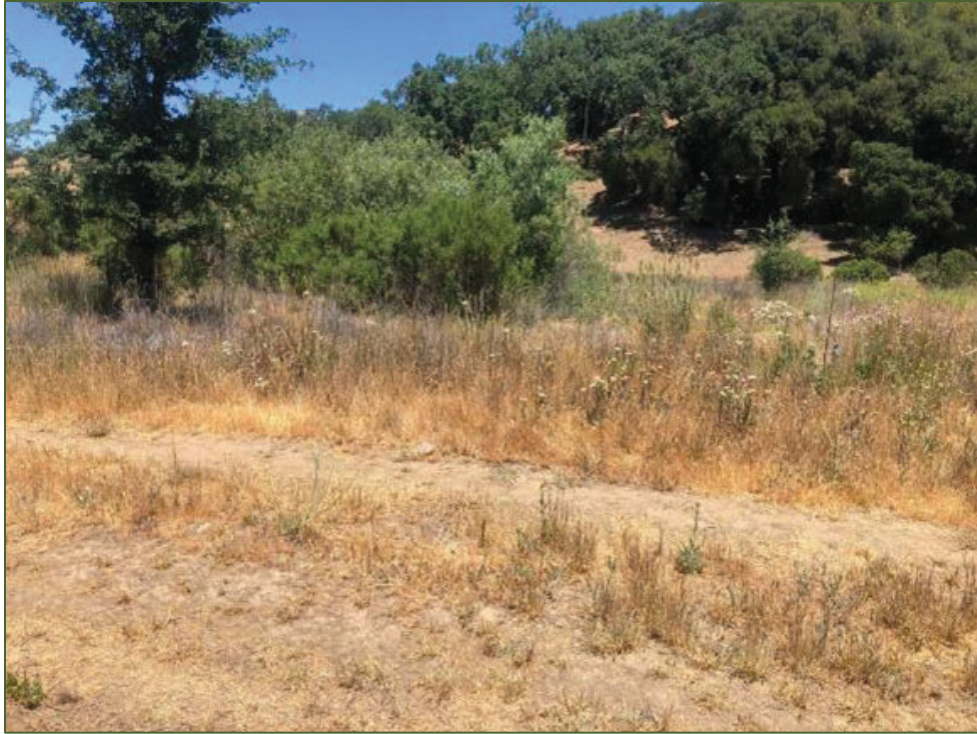
Photo Point 19*

Photo 19*. Year 3 (2021), facing west toward ED03-02 and SW04. Photo taken 6/21/2021

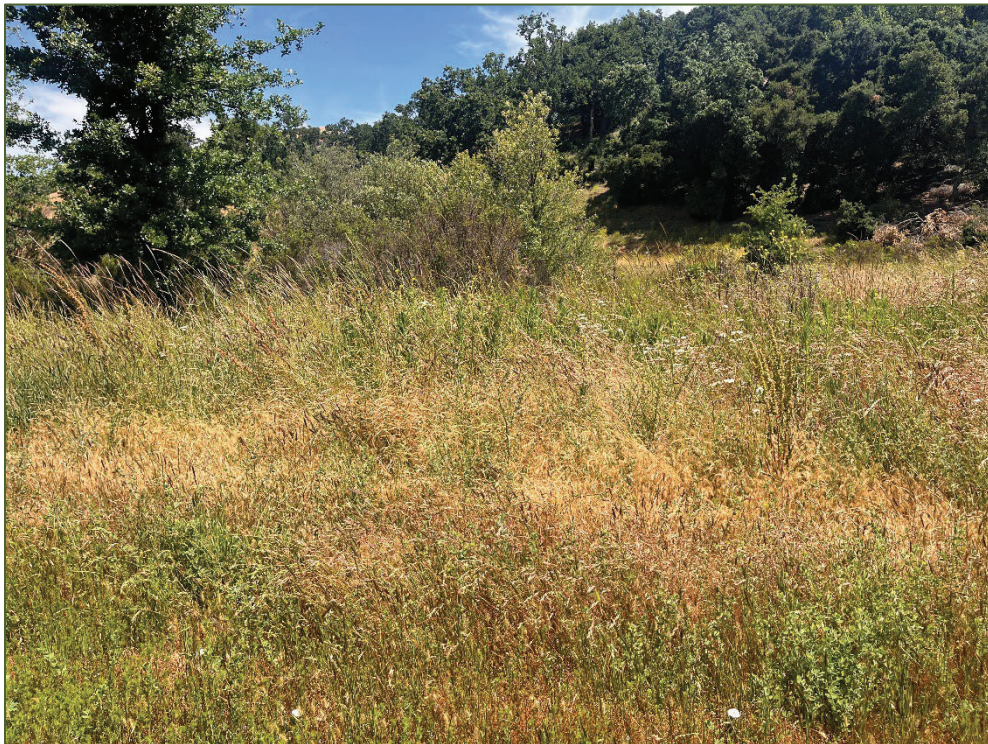
Photo 19*. Year 5 (2023), facing west toward ED03-02 and SW04. Photo taken 6/15/2023

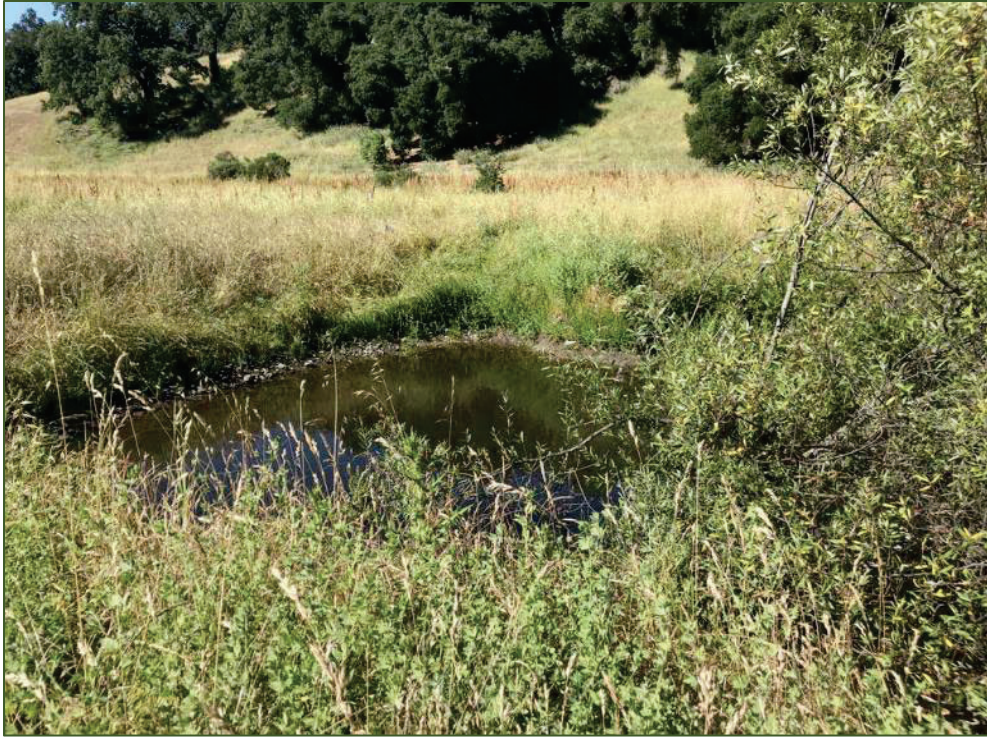
Photo Point 20

Photo 20. Year 1 (2019), facing northeast toward ED03-03 and SW04. Photo taken 6/19/2019

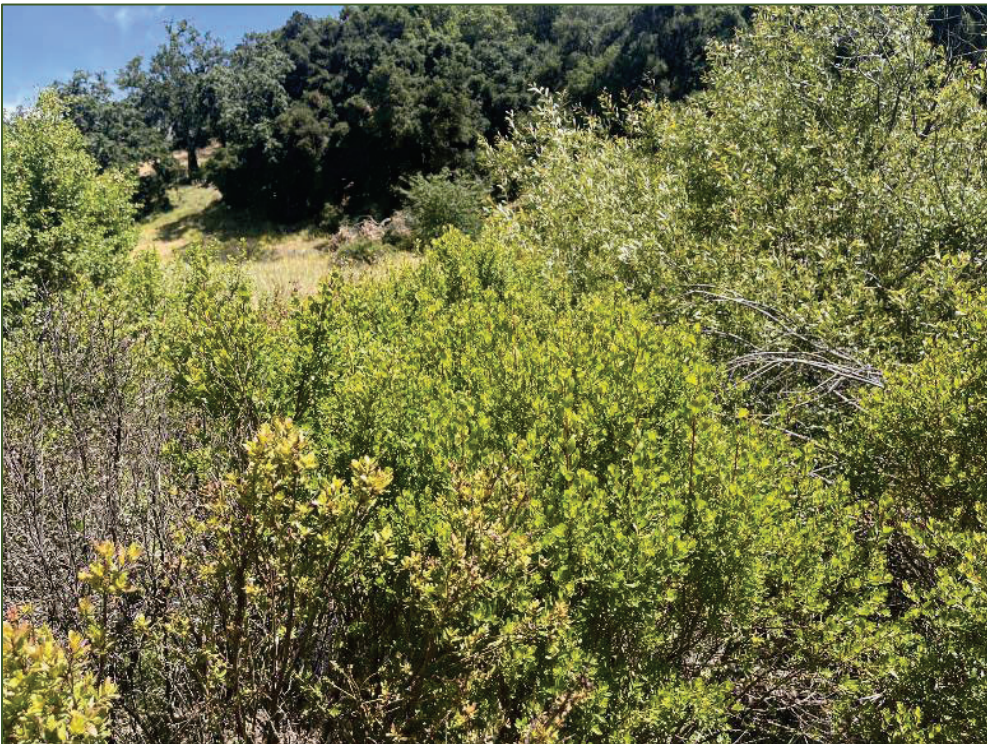
Photo 20. Year 5 (2023), facing northeast toward ED03-03 and SW04. Photo taken 6/15/2023

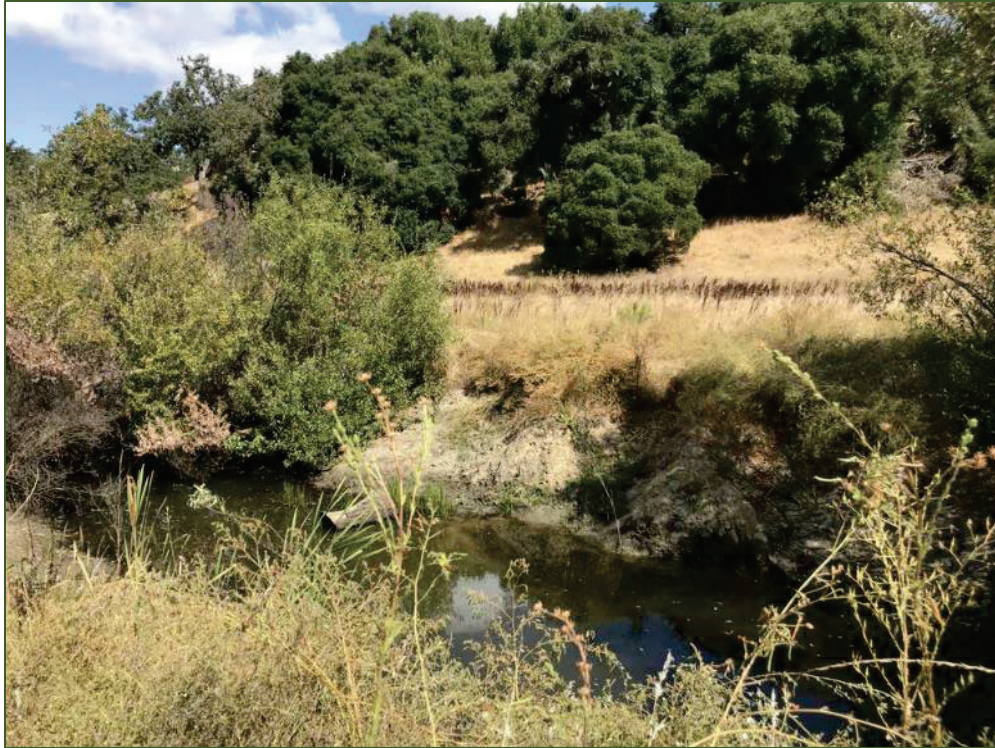
Photo Point 21

Photo 21. Year 1 (2019), facing east toward ED03-03 and AD01. Photo taken 9/30/2019

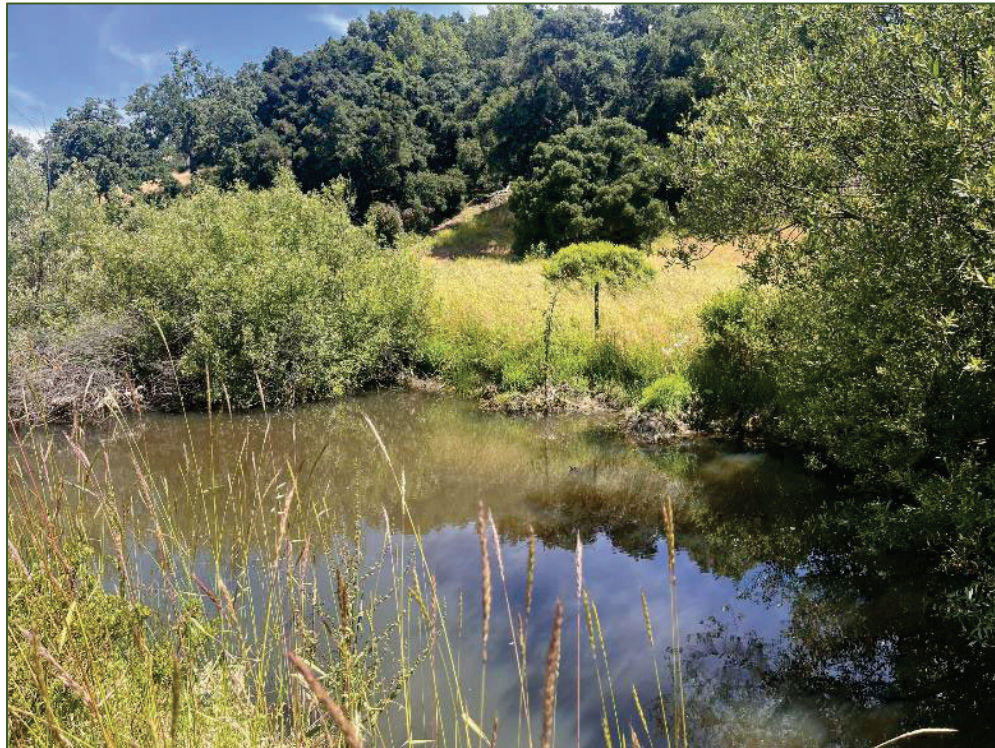
Photo 21. Year 5 (2023), facing east toward ED03-03 and AD01. Photo taken 6/15/2023

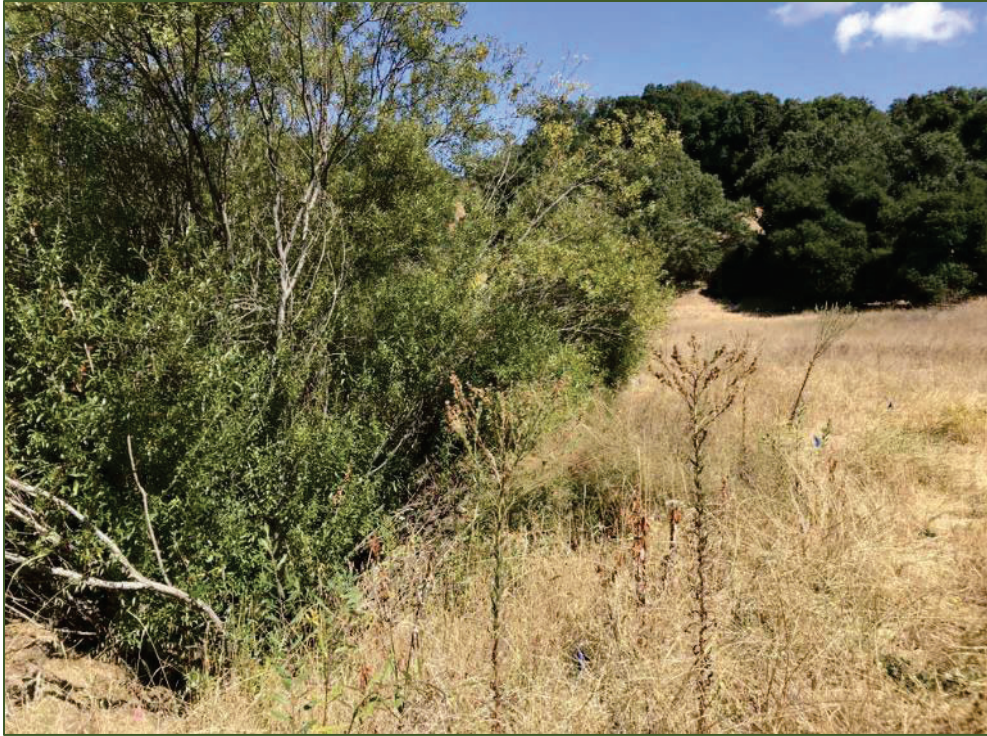
Photo Point 24

Photo 24. Year 1 (2019), facing north toward ED03-05 and AD01. Photo taken 9/30/2019

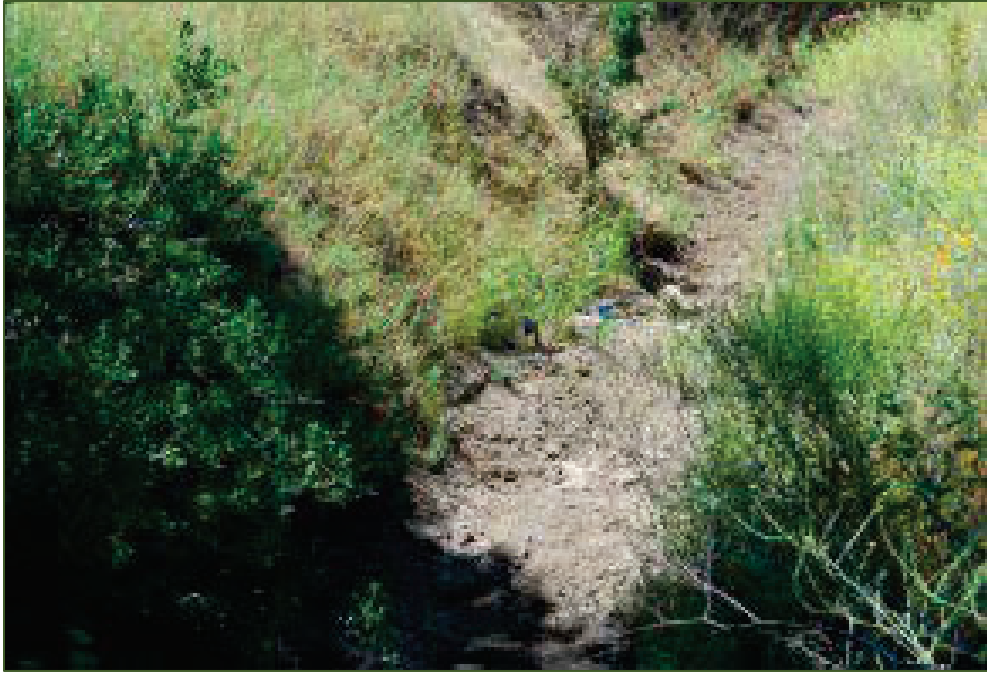
Photo Point 26

Photo 26. Year 1 (2019), facing west toward ID02. Photo taken 6/19/2019

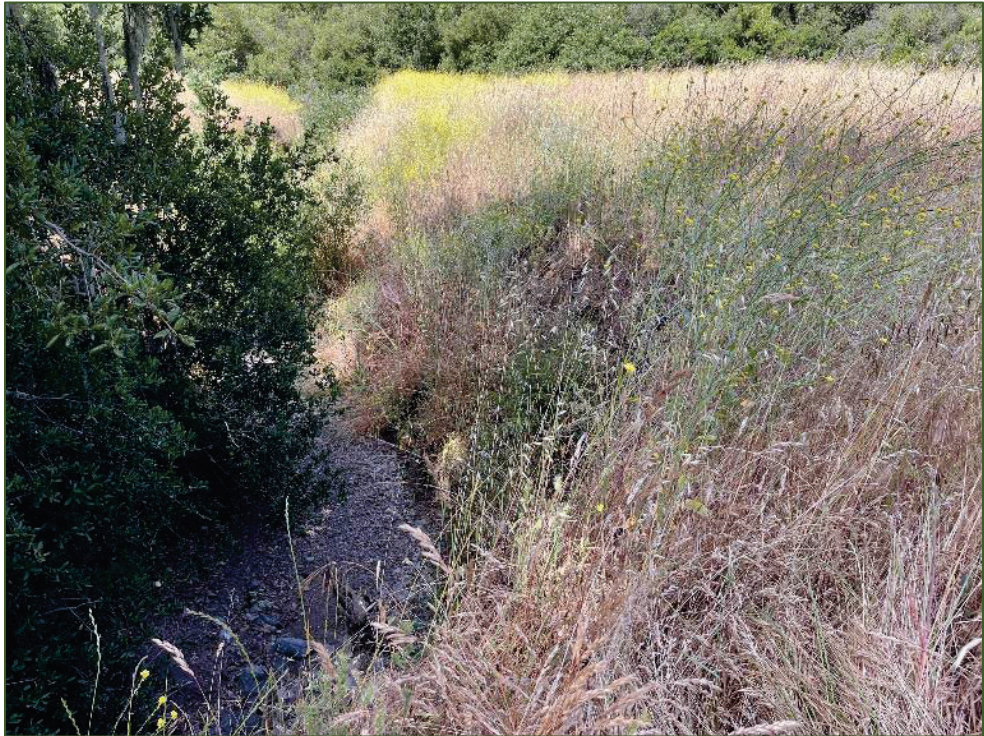
Photo 26. Year 5 (2023), facing west toward ID02. Photo taken 6/15/2023

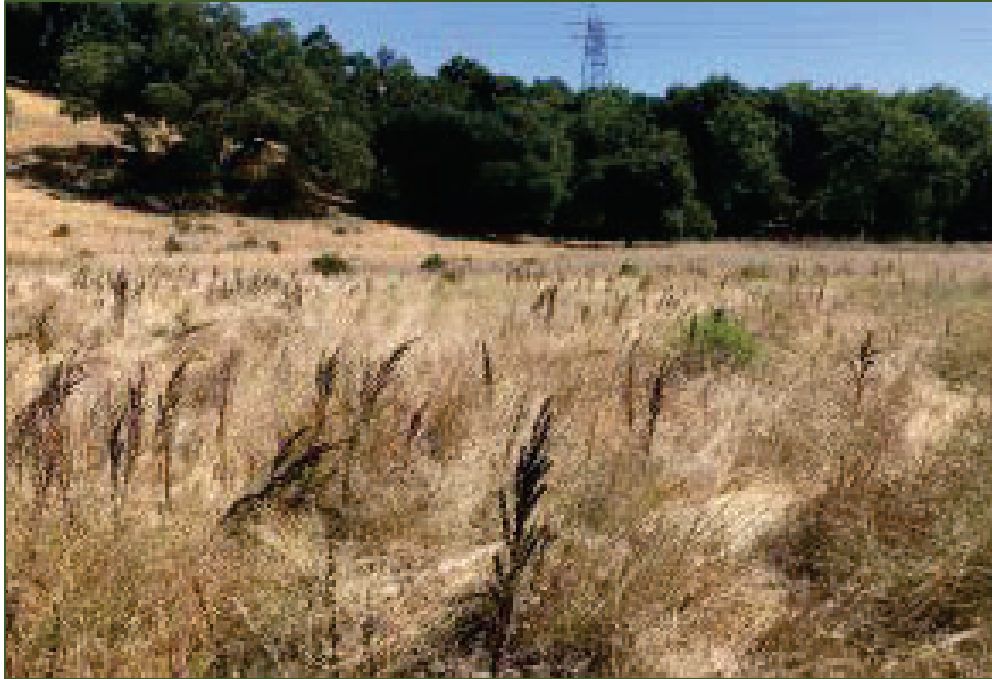
Photo Point 27

Photo 27. Year 1 (2019), facing east toward ED03-03 and SW02. Photo taken 9/30/2019

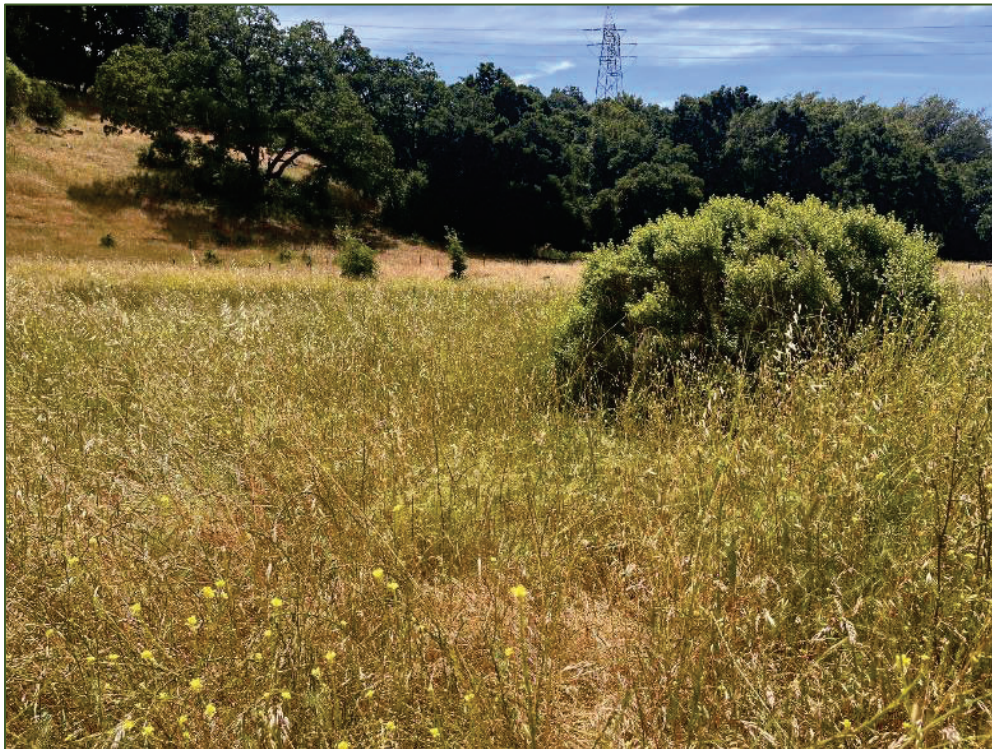
Photo 27. Year 5 (2023), facing east toward ED03-03 and SW02. Photo taken 6/15/2023

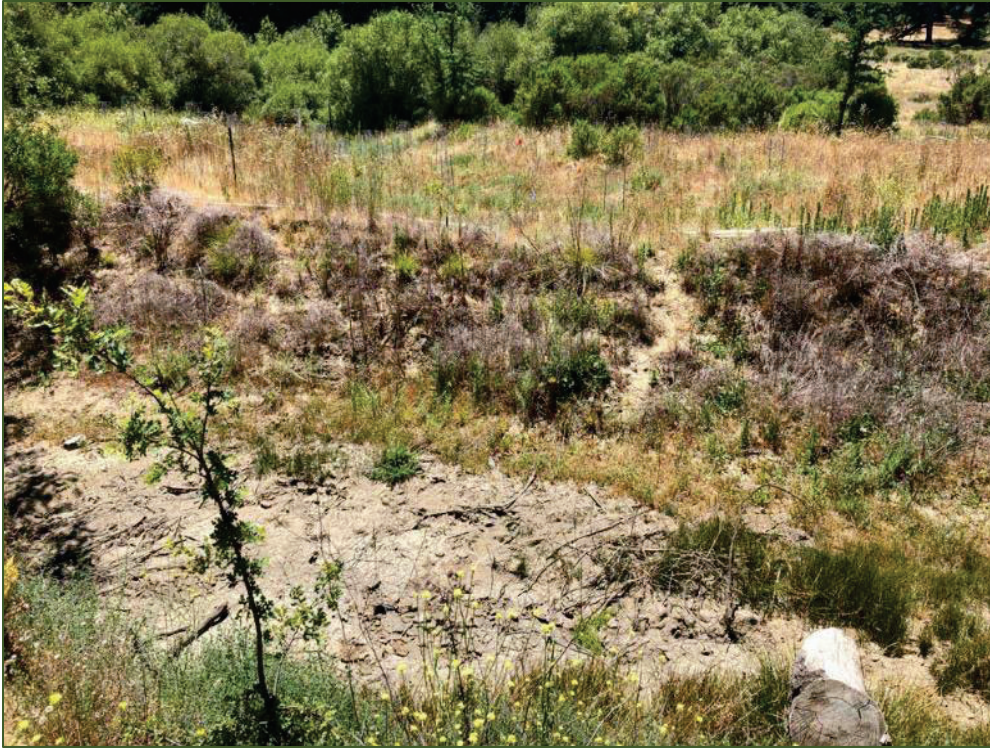
Photo Point 27*

Photo 27*. Year 1 (2019), facing west toward ED03-03. Photo taken 6/21/2021
