ANNUAL RESTORATION MONITORING REPORT YEAR 5

SAN FELIPE CREEK RESTORATION PROJECT
SANTA CLARA VALLEY HABITAT AGENCY

DECEMBER 2023

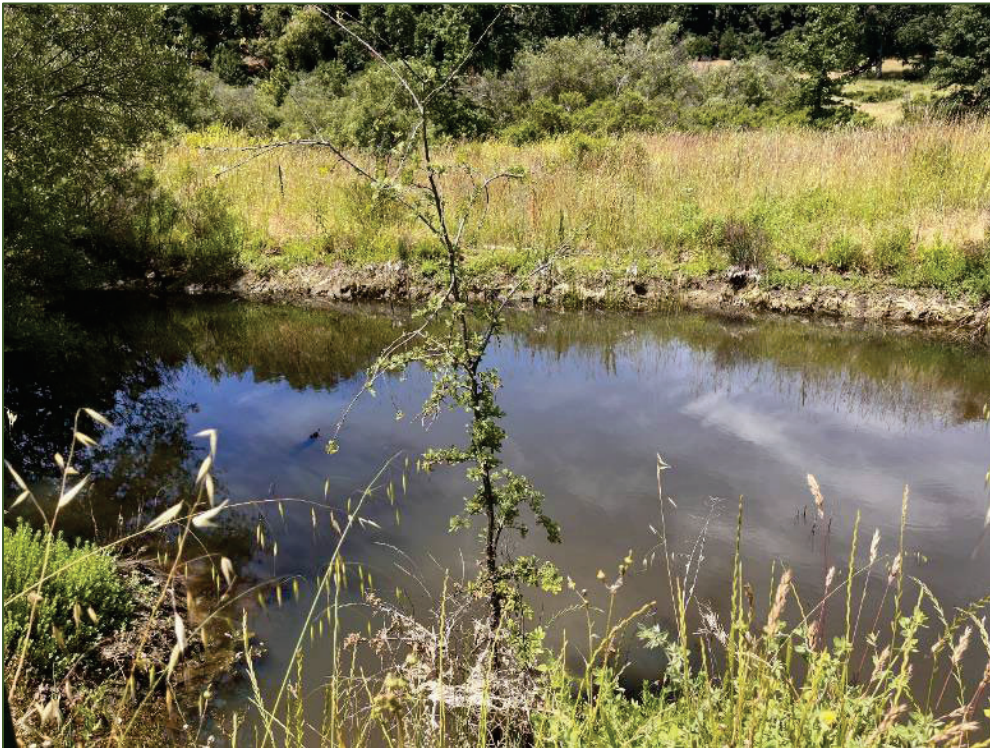
Photo 27*. Year 5 (2023), facing west toward ED03-03. Photo taken 6/15/2023

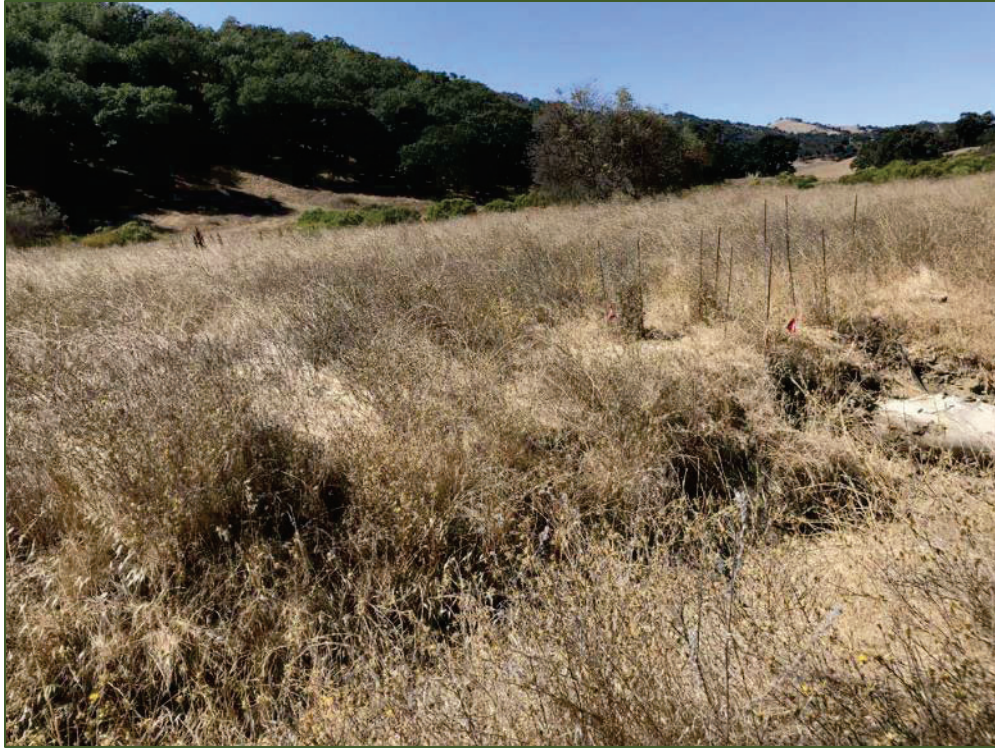
Photo Point 29

Photo 29. Year 1 (2019), facing north toward ID01. Photo taken 9/30/2019

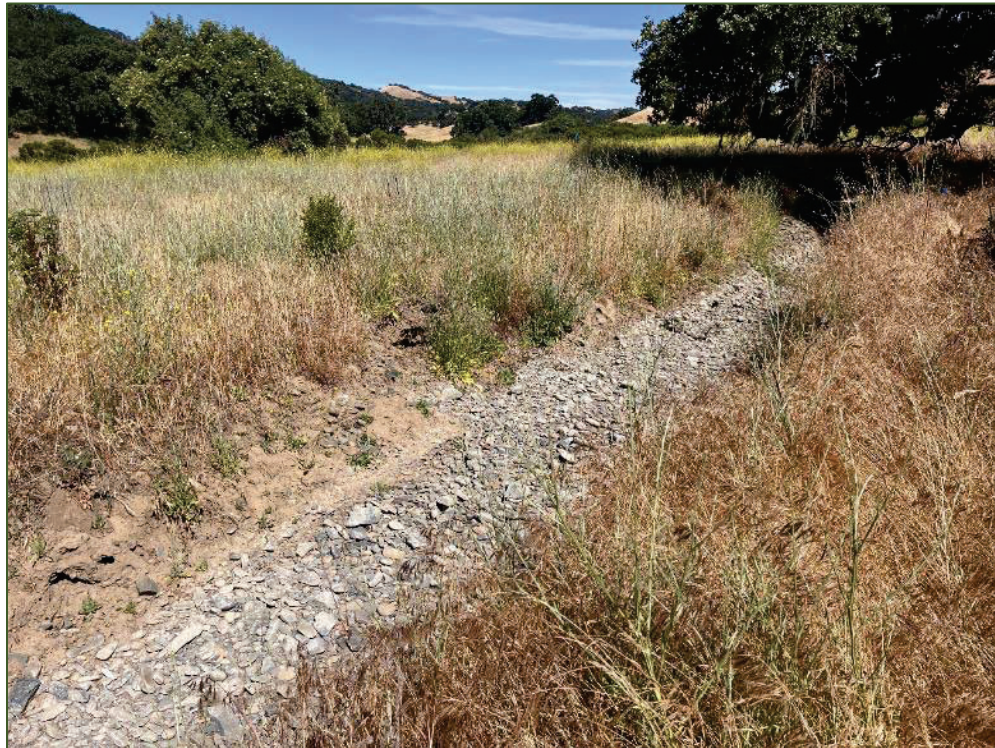
Photo 29. Year 5 (2023), facing north toward ID01. Photo taken 6/15/2023

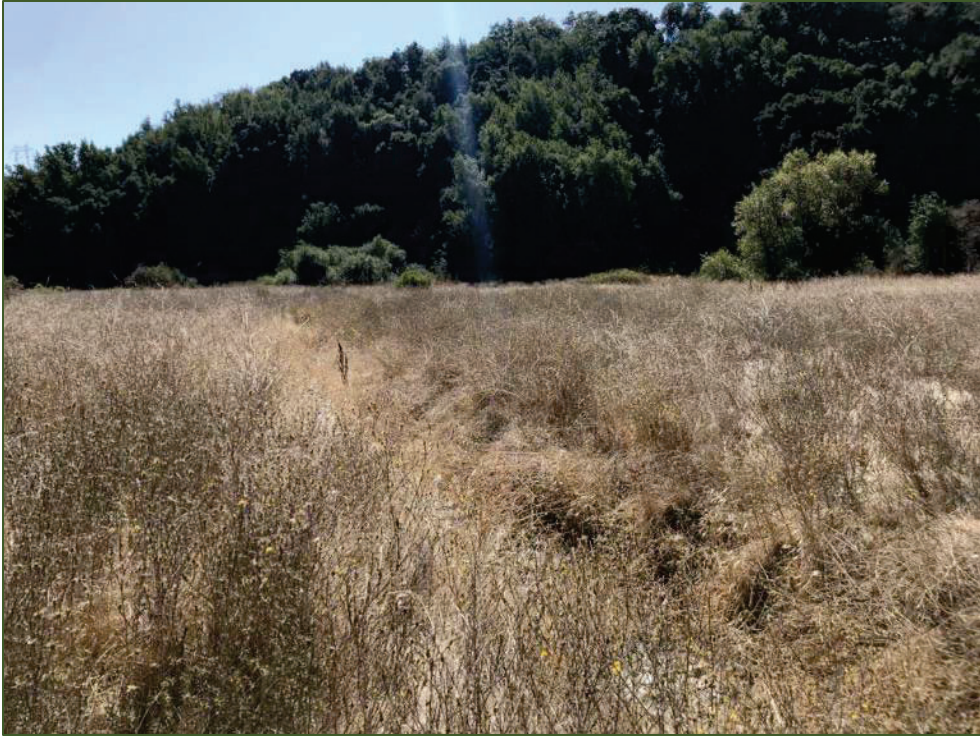
Photo Point 29*

Photo 29*. Year 1 (2019), facing southwest toward ID01. Photo taken 9/30/2019

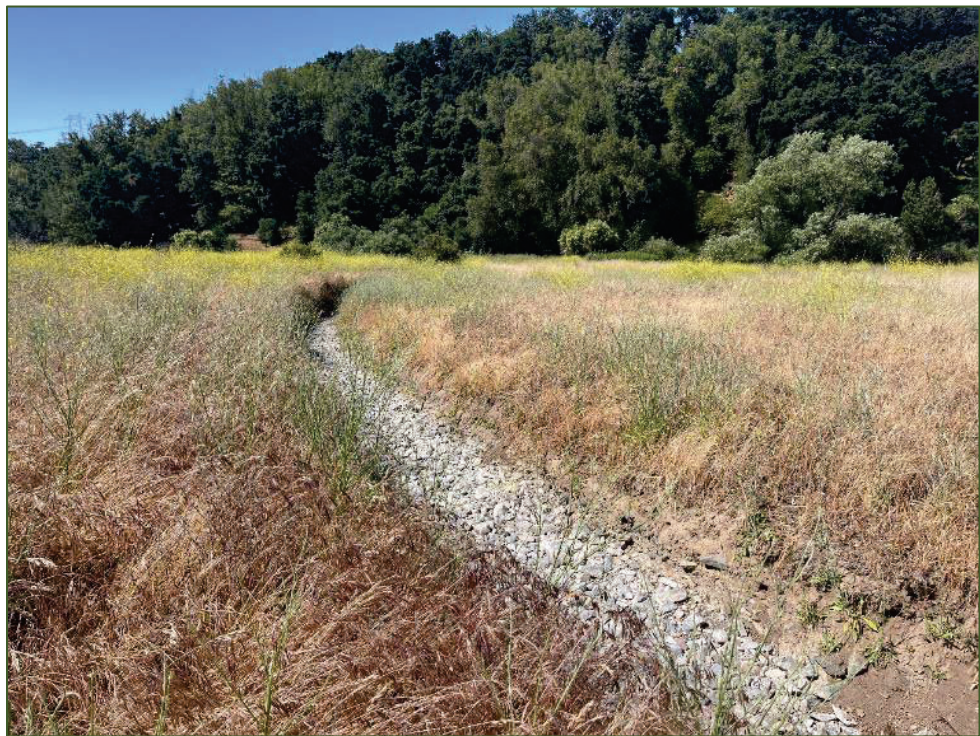
Photo 29*. Year 5 (2023), facing southwest toward ID01. Photo taken 6/15/2023

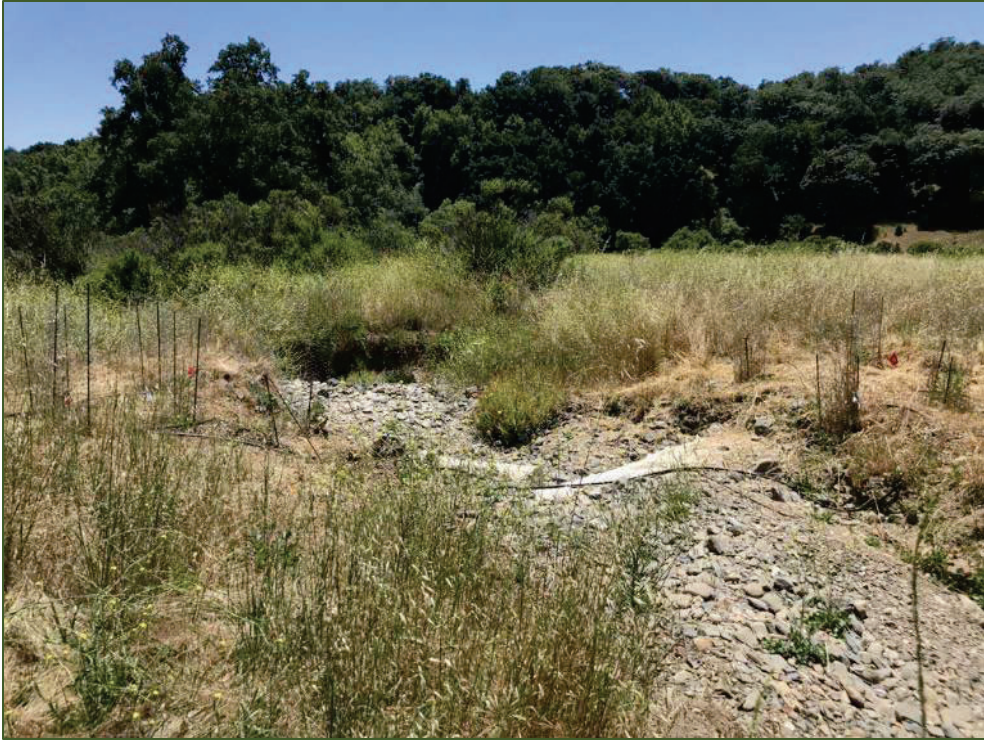
Photo Point 31

Photo 31. Year 1 (2019), facing east toward ID01. Photo taken 6/19/2019

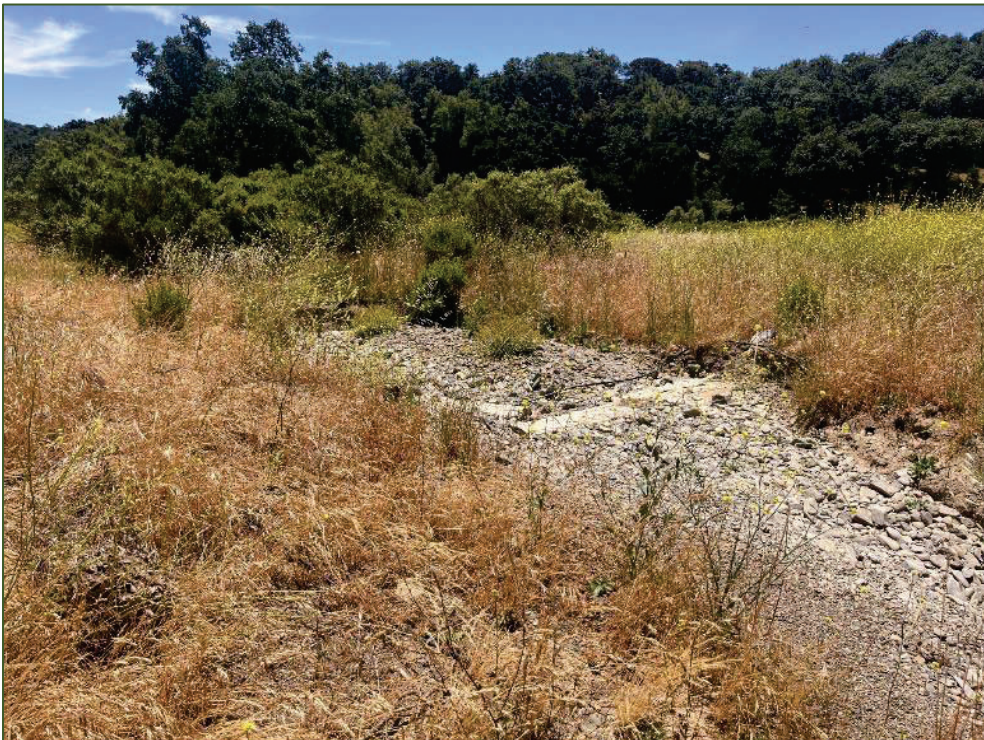
Photo 31. Year 5 (2023), facing east toward ID01. Photo taken 6/15/2023
